Franklin Central Supervisory Union

STRUCTURAL ENGINEERING REPORT ❖

26-30 Catherine Street, St. Albans, Vermont

Date of Inspection: June 1, 2017

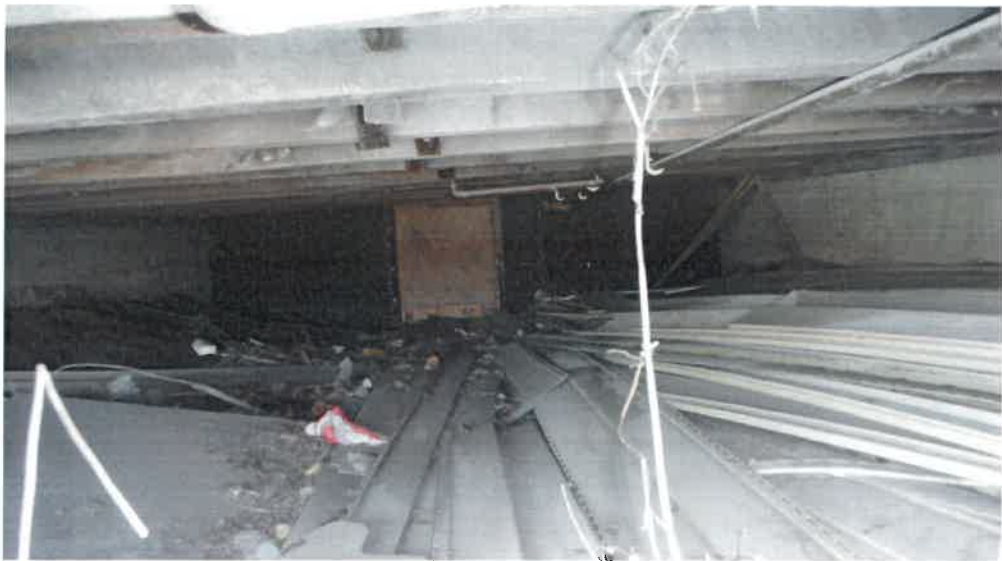
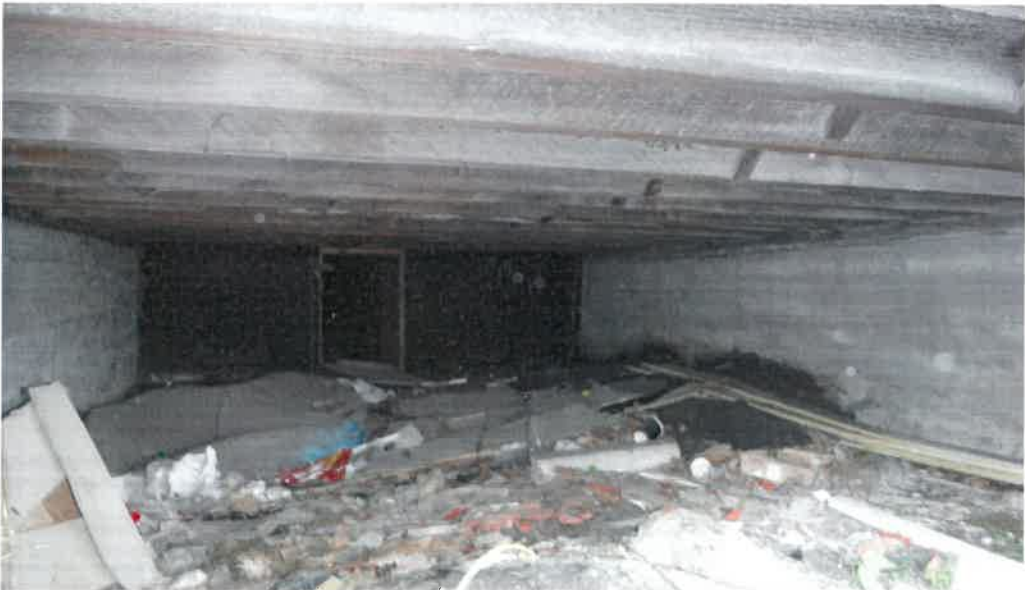
The wood framed floor present at the majority of the building is constructed of 3"x12" wood joists spaced at 16 inches on center. These joists span between concrete foundation walls and are exposed to the outside. Crawlspace areas between foundation walls are accessed from the westerly exterior of the building.

Typical Crawlspace and Floor Framing

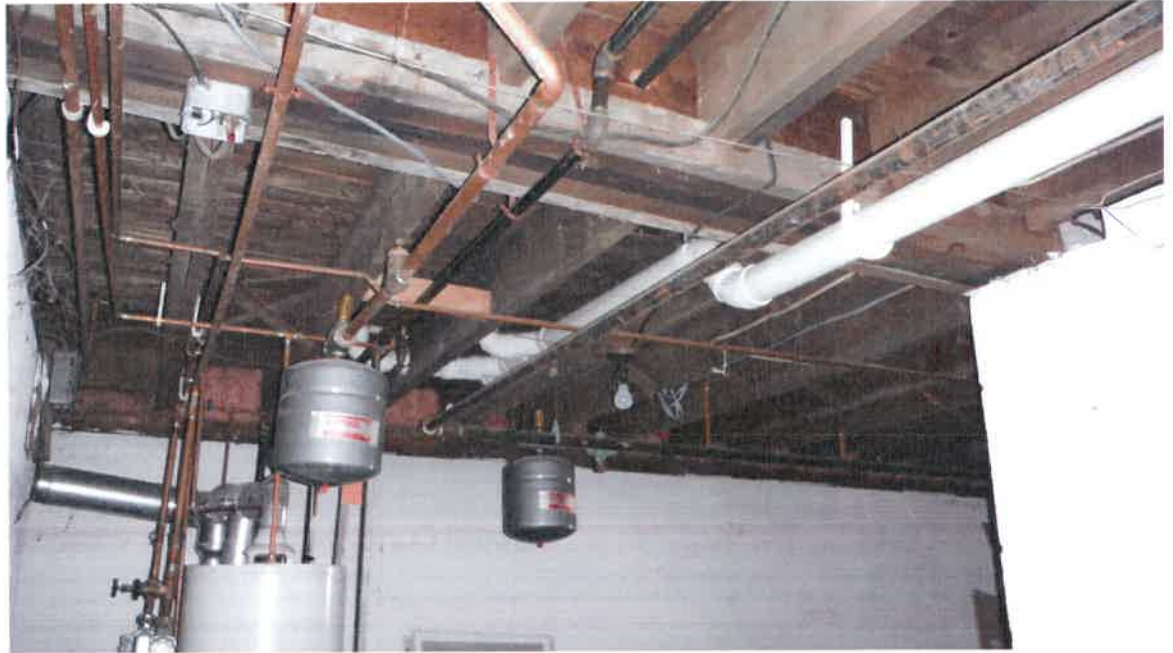
The wood framed floor at the basement mechanical room is constructed of 2x10 floor joists spaced at 16 inches on center. The joists and their supports are performing well.

The floor framing at the basement mechanical area is performing well and is expected to continue to perform well. The concrete slabs on grade present in the building are performing well and will not need any structural attention for FCSU use. Finally, the wood framed floor areas have very strong construction, are performing well and will not need attention.

First Floor Framing at Basement Mechanical Room

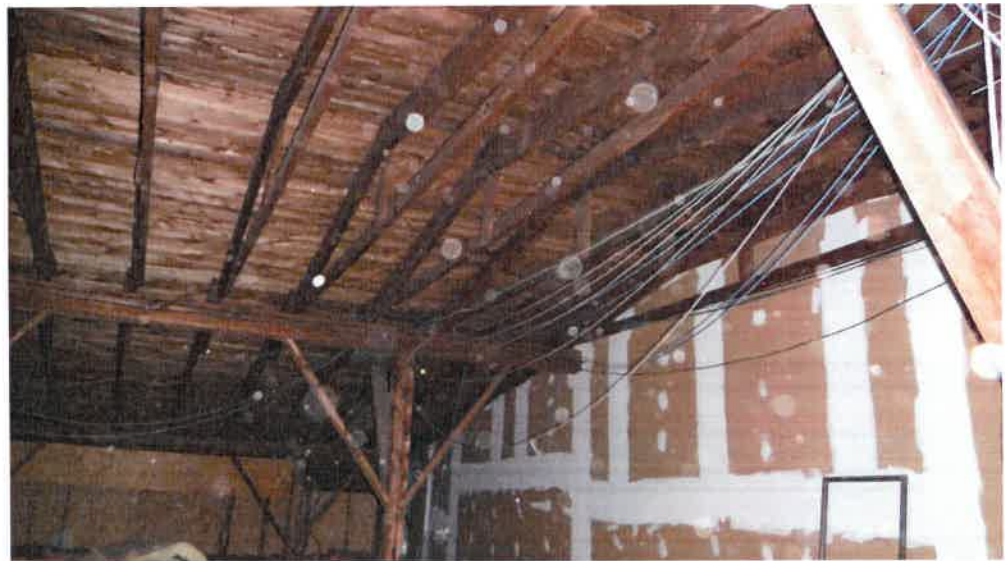
The existing roof structure is performing well. However, it does not meet today's codes for snow load capacity. This condition is not uncommon with older buildings. In the event of a major building renovation or significant increase in attic insulation, the roof framing will may need reinforcement.

Typical Roof Construction

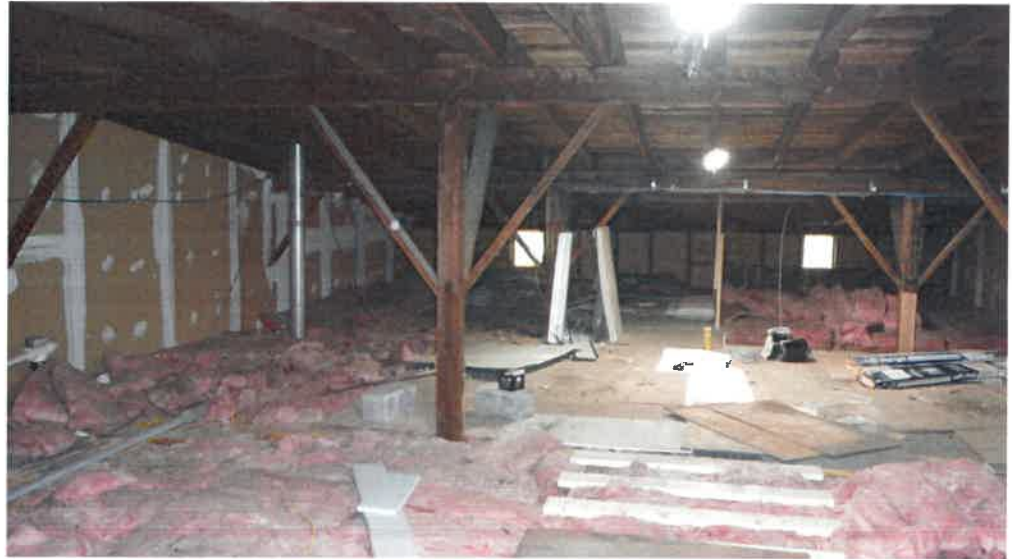
Attic, No Storage, Access Only

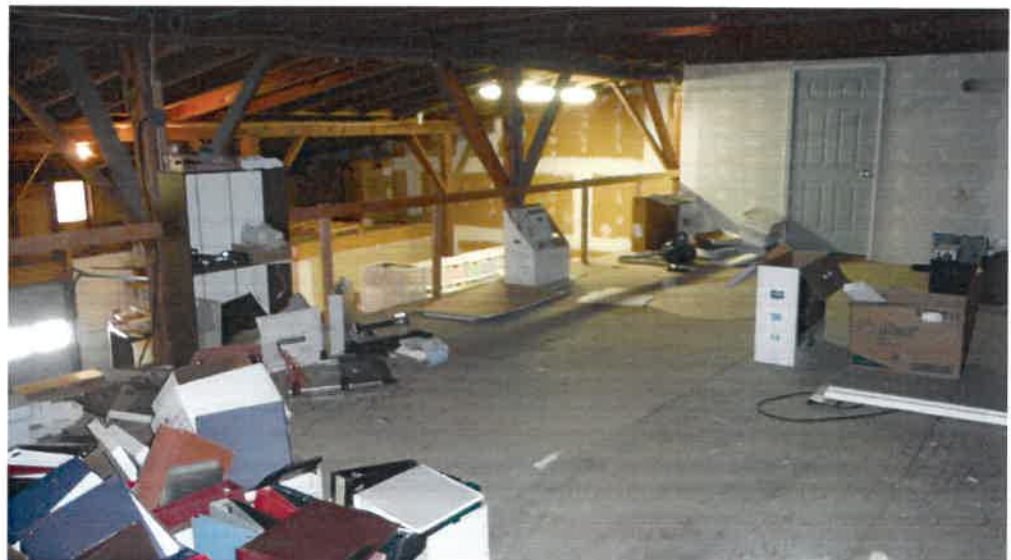
Attic storage areas can continue to be used as they are today. If any heavier items or accumulation of heavy items are planned, then further structural evaluation is recommended to assure the safety of the floor. Determination of floor capacities was not in the scope of this review.

Attic Storage with IT Room- South End
