Comprehensive Facility Assessment Report

Seminole County Schools

2020

Altman + Barrett Architects

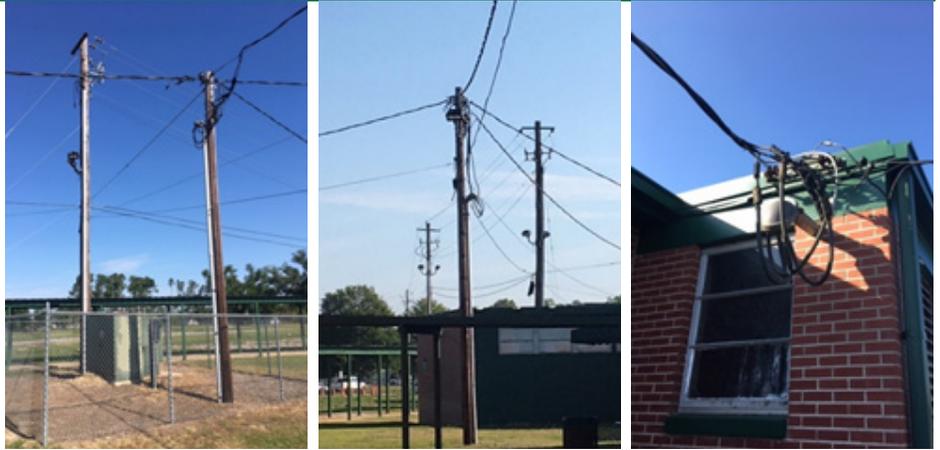
•The Utility Company Power Provider to the site is Georgia Power Company. Being that there are numerous buildings, some buildings are served underground off a pad mount transformer. However, numerous ones are served with overhead services. The Owner advised that several years ago the overhead transformers had failed (fire) at the rear of Building 2010. Based on such a new pad mount transformer was installed.

- All overhead services be reworked such that all service on site is underground. This is from an aesthetic stand point as well as underground services without pole mounted transformer are typically a safer installation on a school site. This work would be in conjunction with new power panel upgrades and replacements as well. Buildings: 2010, 2030, 2040, 2050, 2070, Head Start (Building 600).

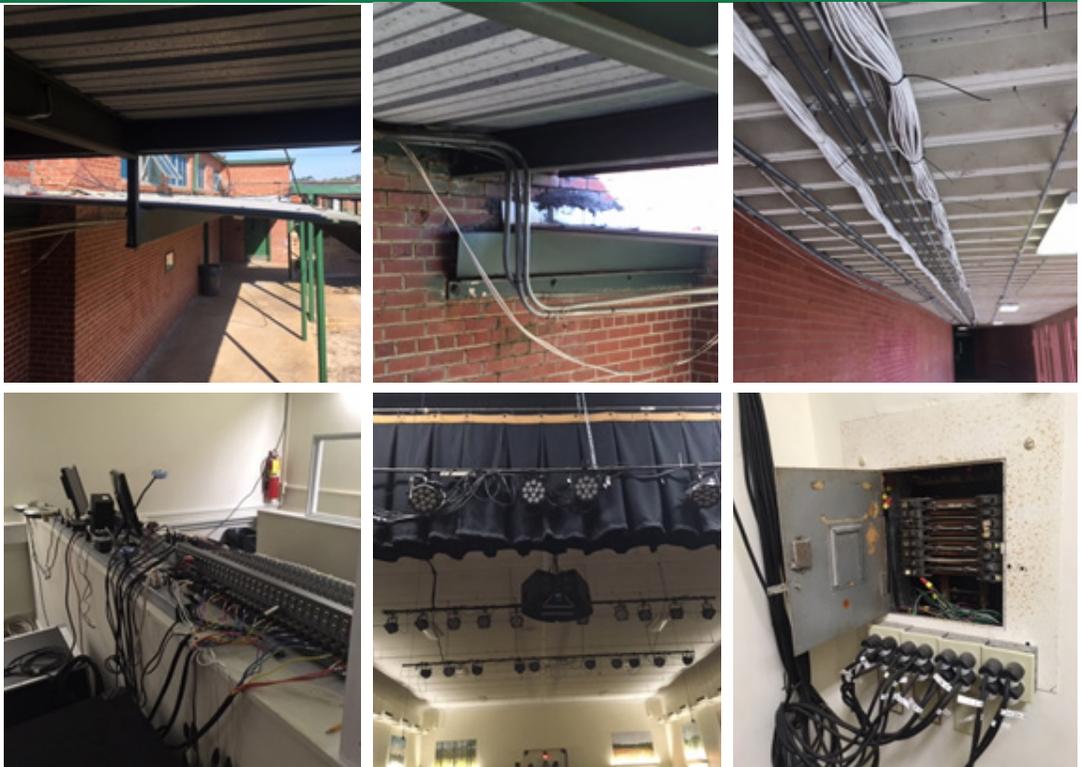
•At the rear of Building 2010, (and various other buildings) there are a large number of conduits and low voltage cabling routed over canopies. These canopies extend to multiple other buildings and contain power and low voltage systems. The recommendation would to be route these systems underground for aesthetic reasons as well as protecting pathways for lightning protection.

- Building 2010 contains the Auditorium which is used for productions and plays. There have been some LED lighting upgrades and retrofits. There is also a sound platform in the rear of this building with lighting control and sound control. Based on the age of this building, it is recommended that all new electrical infrastructure be installed along with all associated low voltage systems consisting of lighting, dimming, and sound system
- Install GFCI receptacles where required in Kitchen.
- Install additional circuits at Serving Line.
- Correct faulty lighting over Kitchen Point of Sale Area.

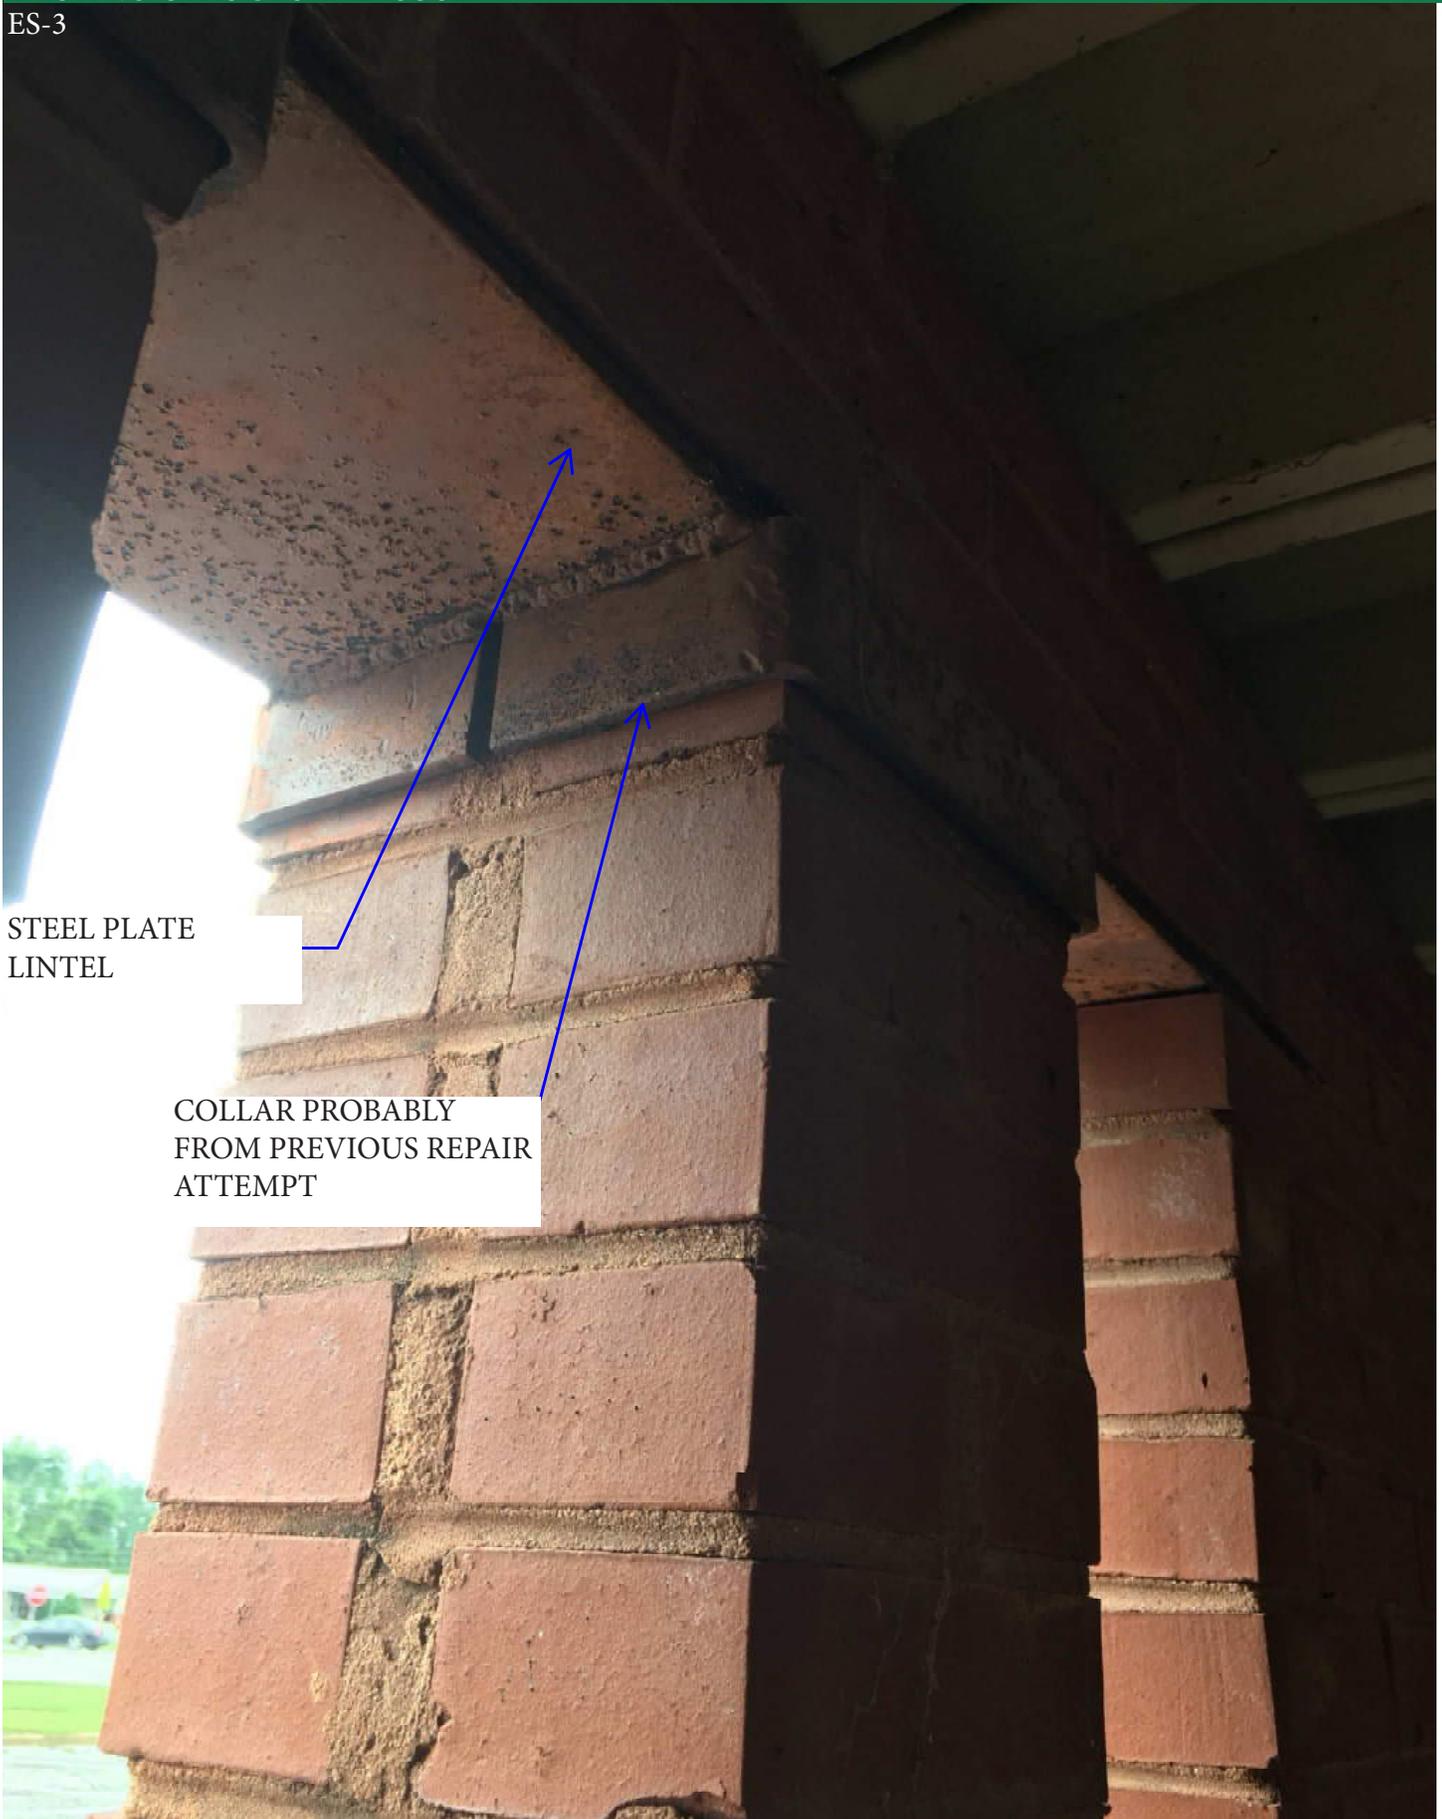
ES-3

STEEL PLATE
LINTEL

COLLAR PROBABLY
FROM PREVIOUS REPAIR
ATTEMPT

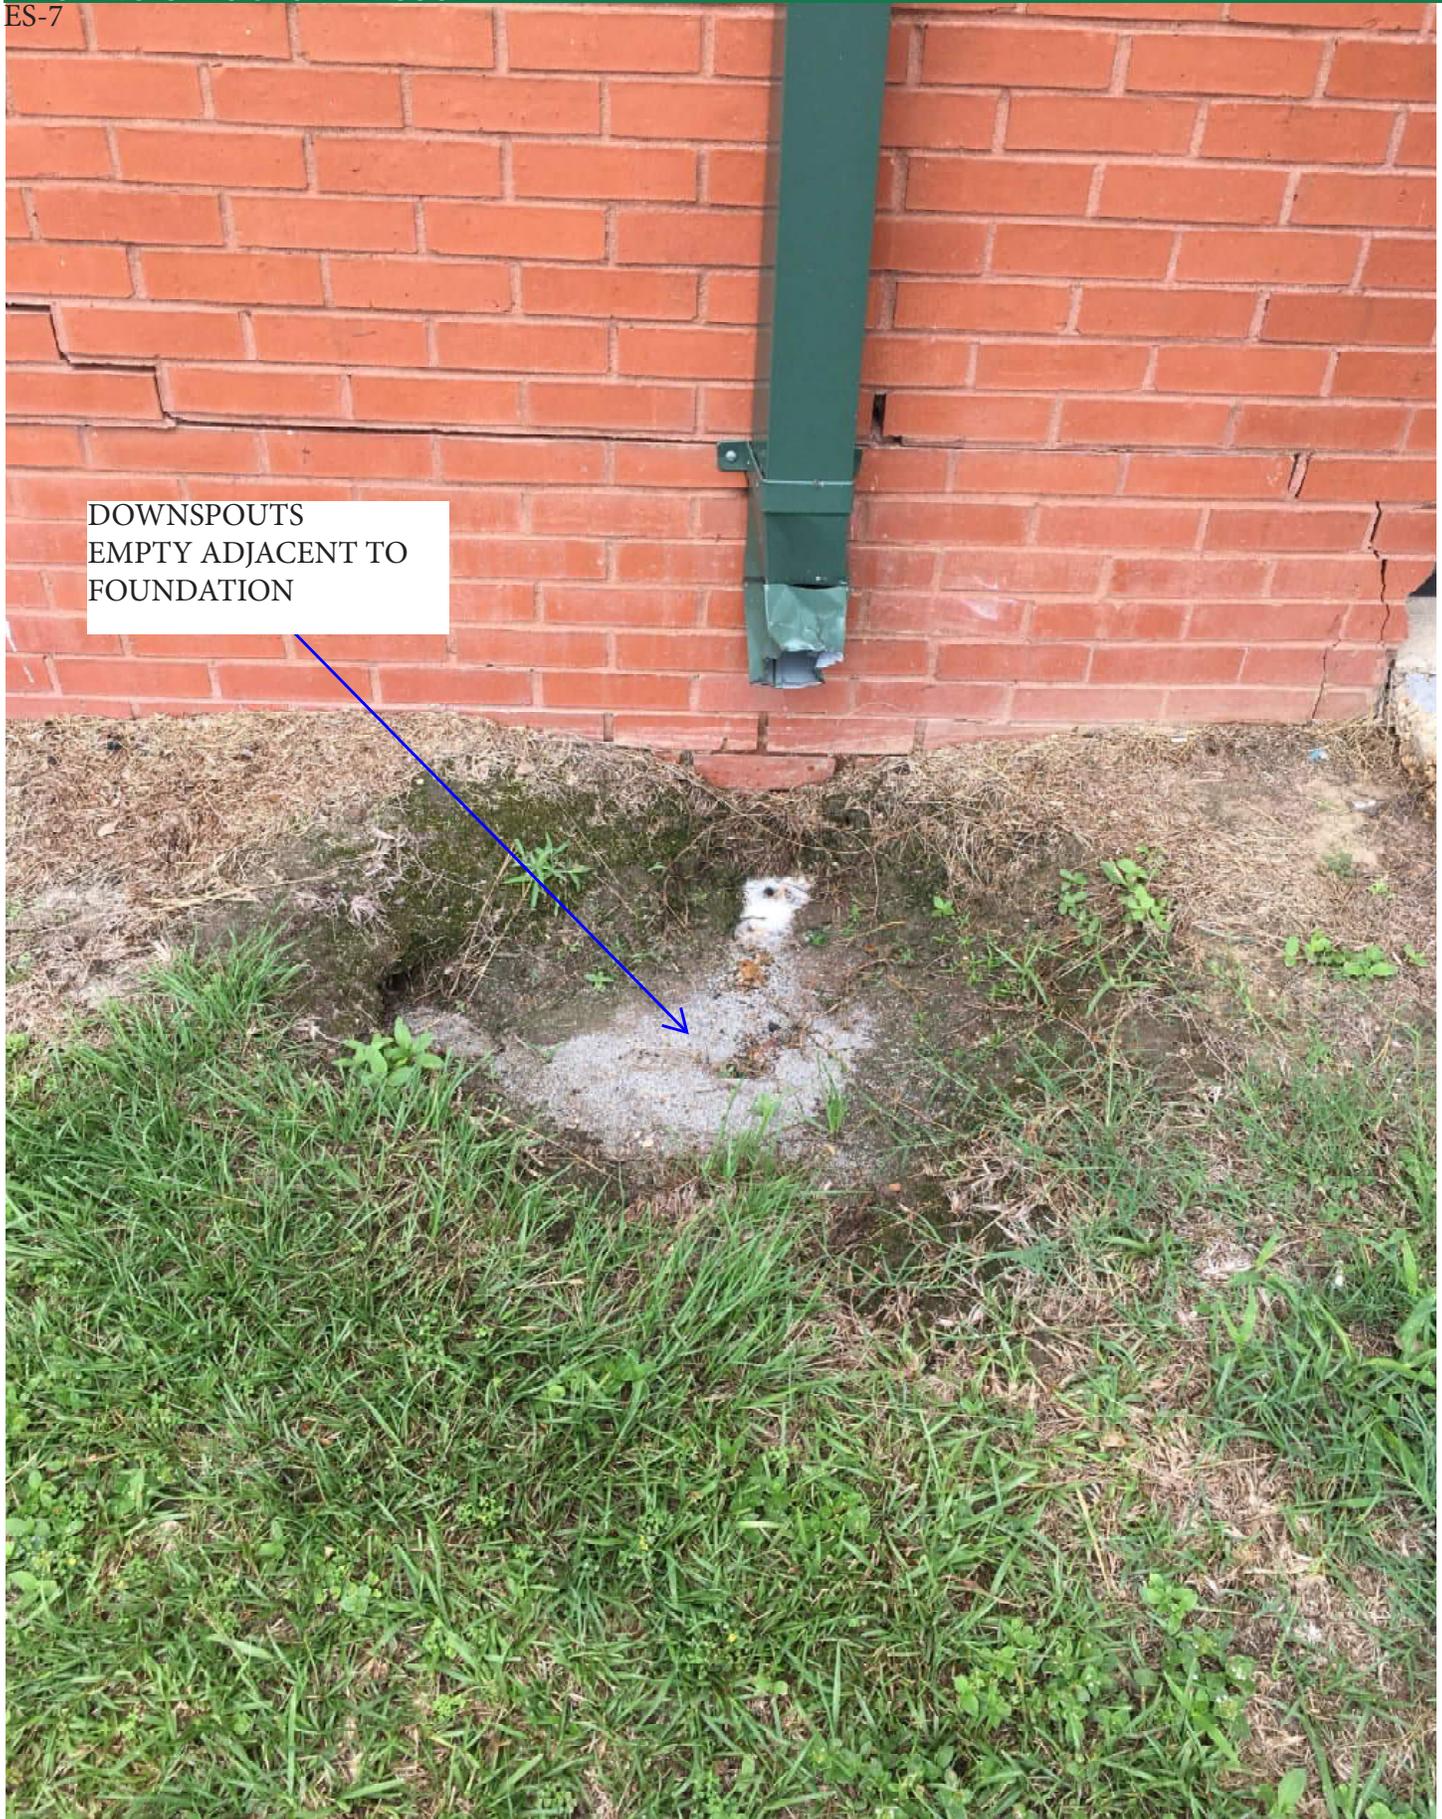
ES-7

DOWNSPOUTS
EMPTY ADJACENT TO
FOUNDATION

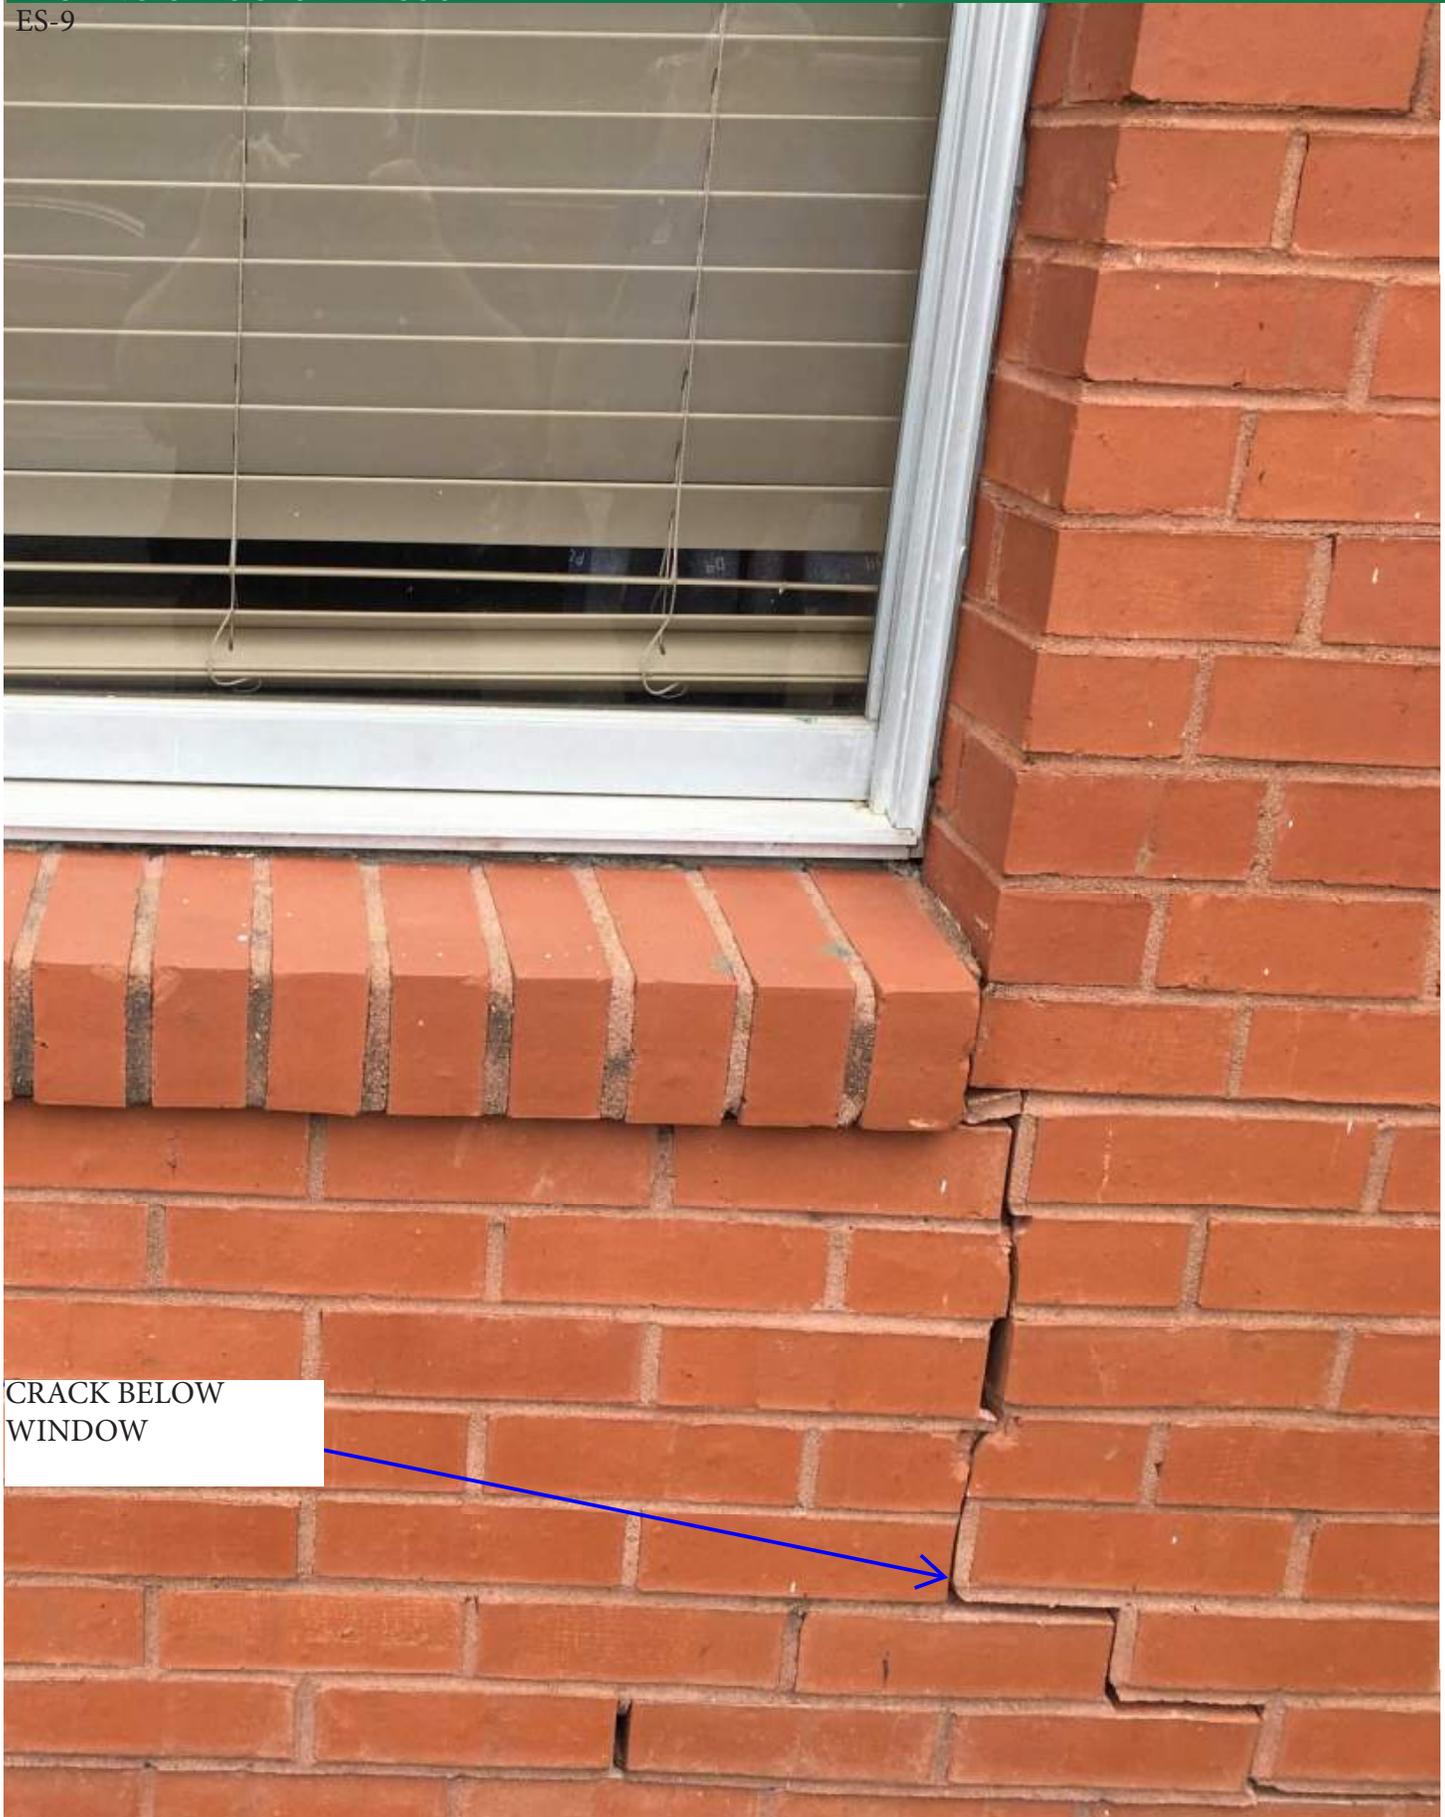
ES-9

CRACK BELOW WINDOW

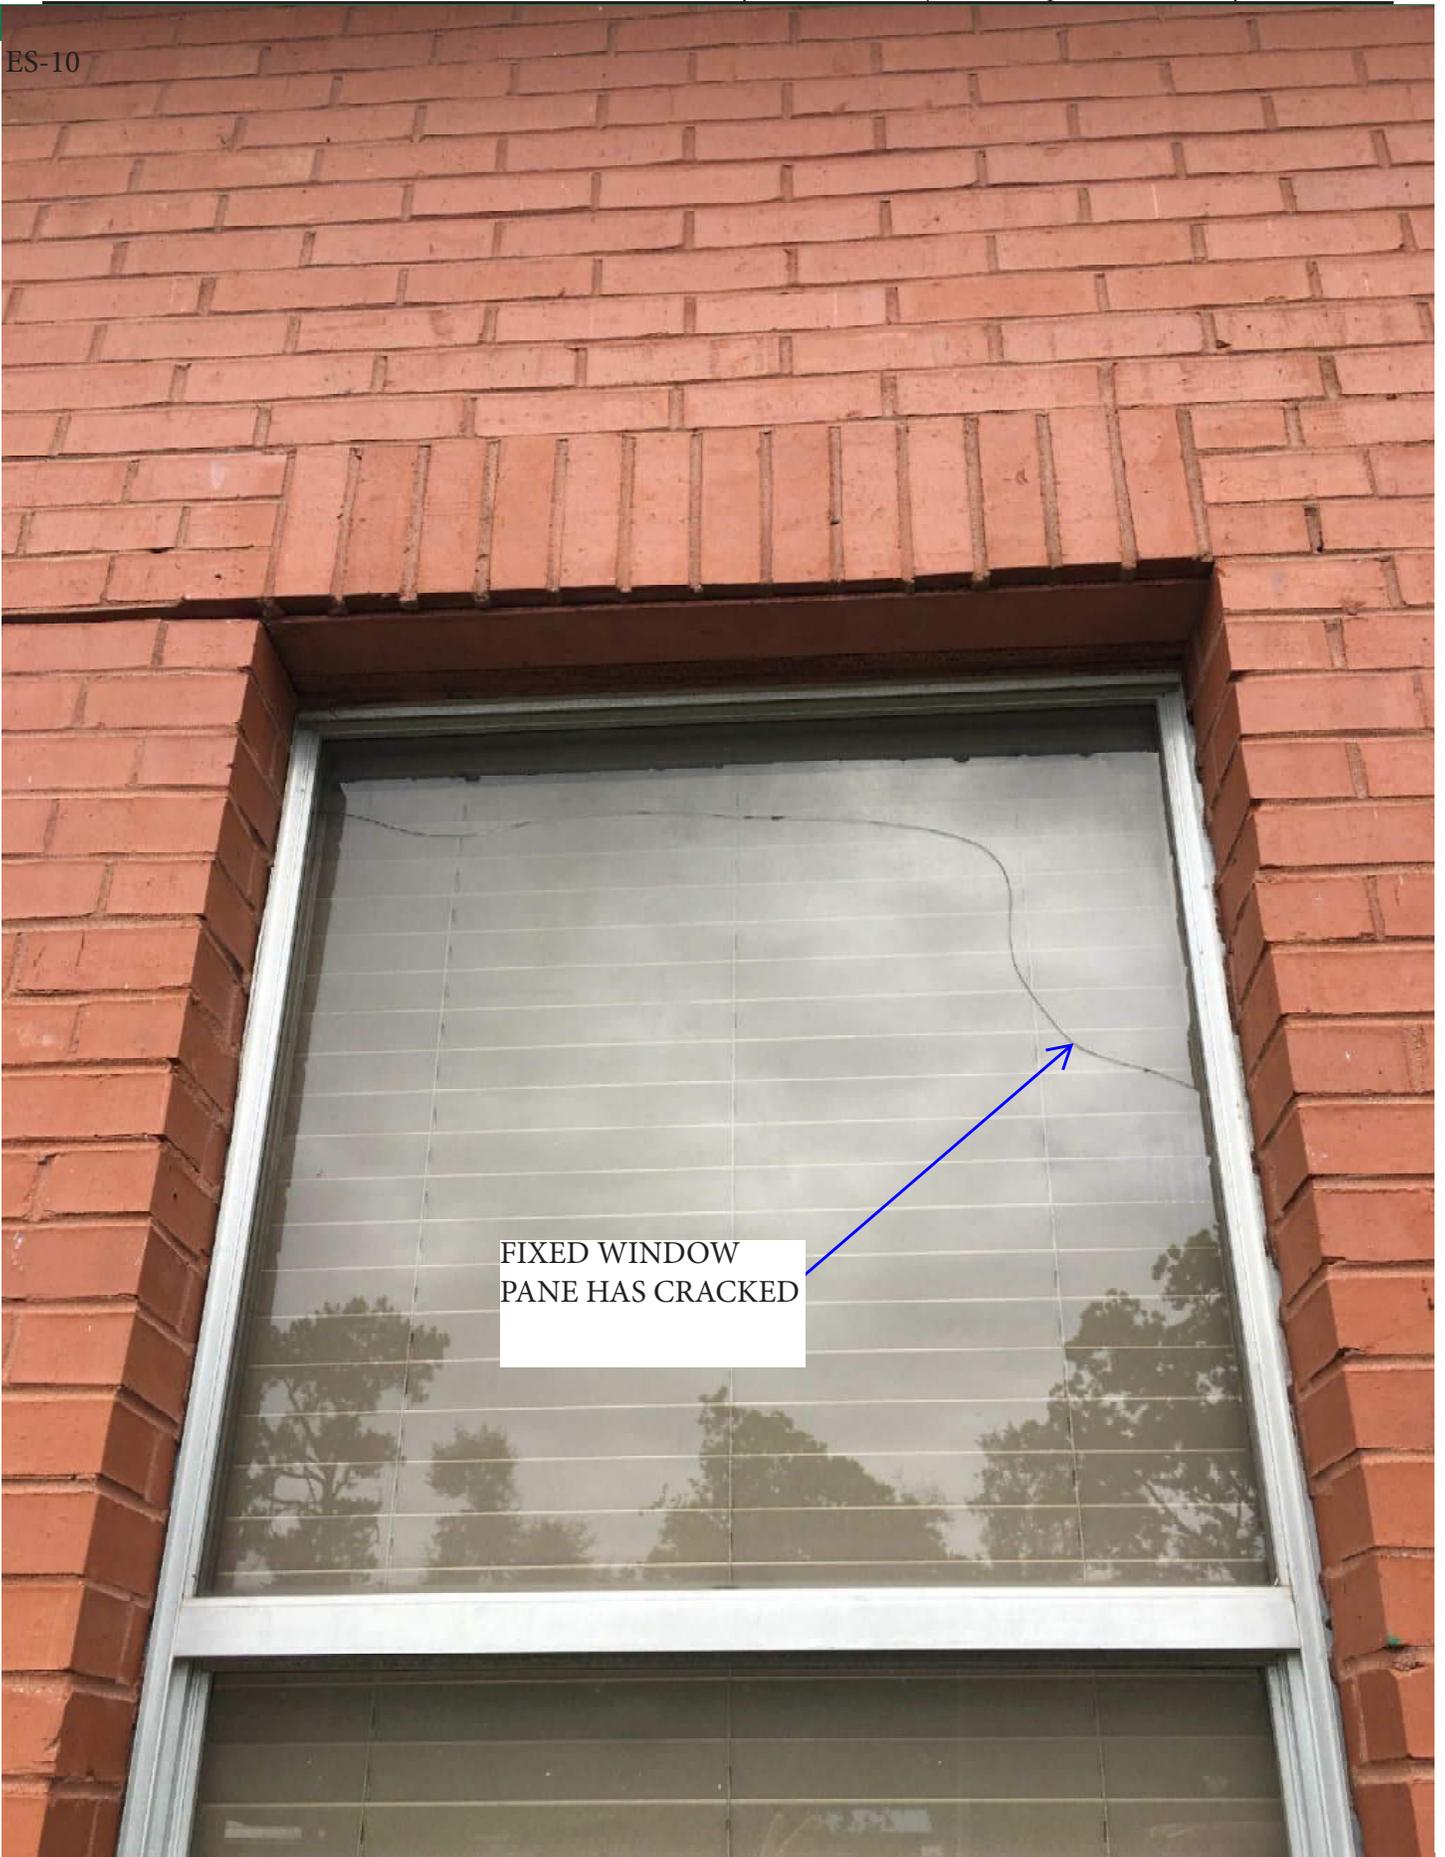
ES-10

FIXED WINDOW
PANE HAS CRACKED

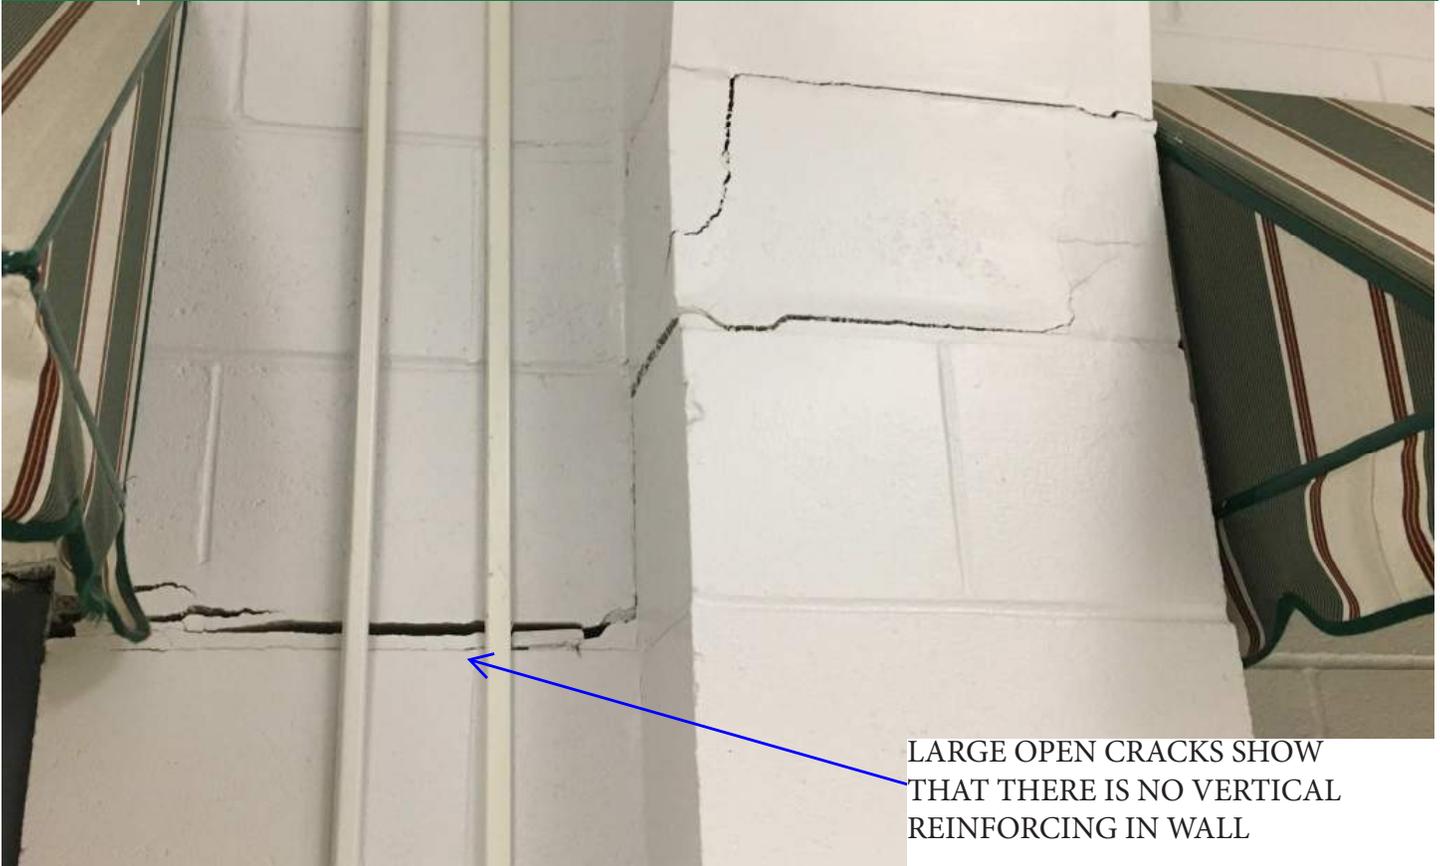
LARGE OPEN CRACKS SHOW THAT THERE IS NO VERTICAL REINFORCING IN WALL

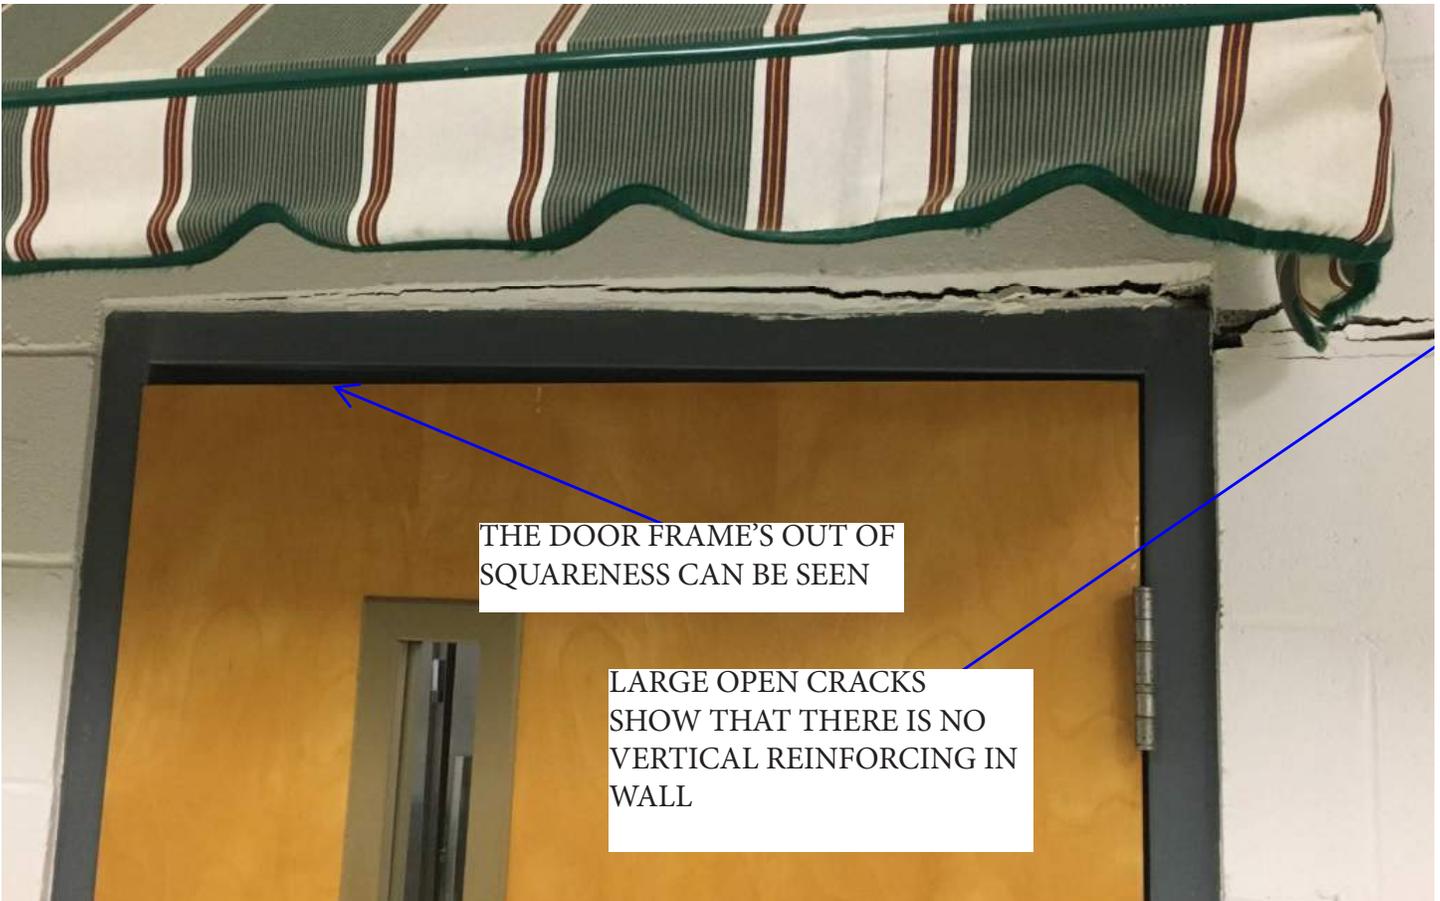
THE DOOR FRAME'S OUT OF SQUARENESS CAN BE SEEN

LARGE OPEN CRACKS SHOW THAT THERE IS NO VERTICAL REINFORCING IN WALL

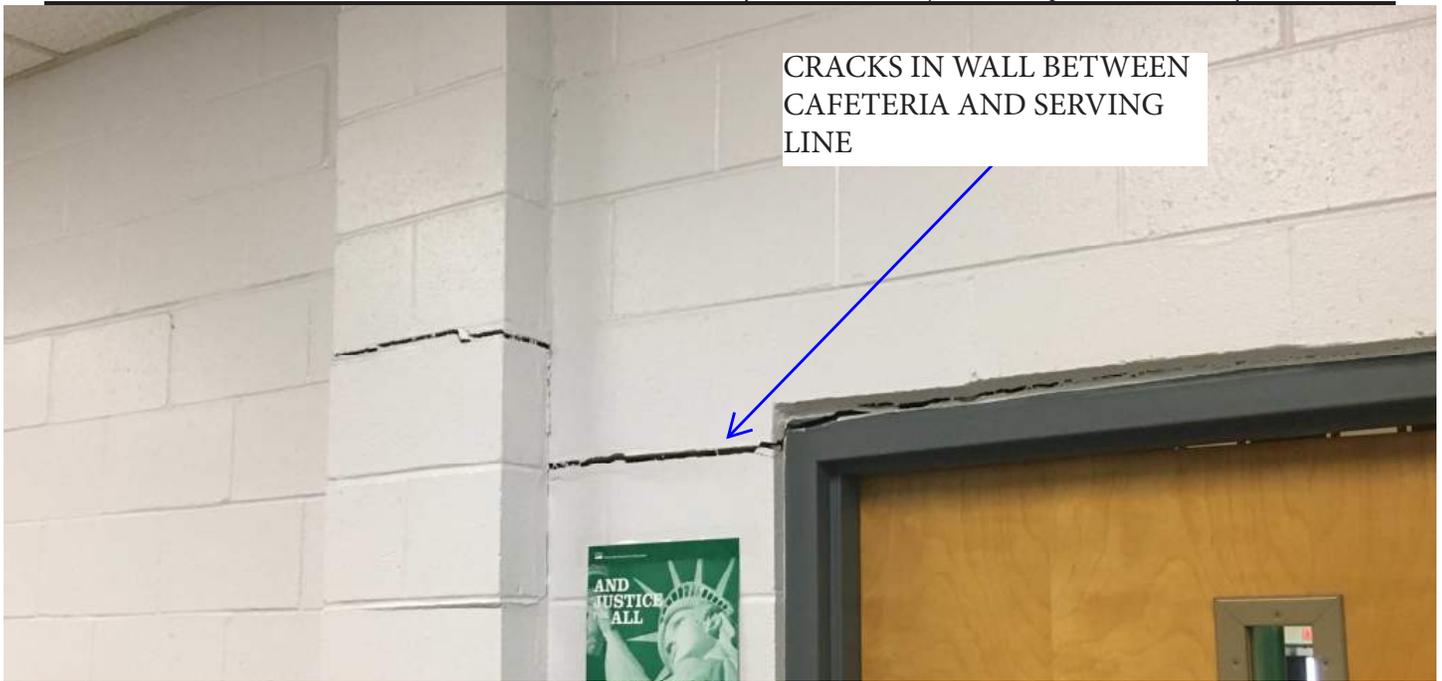
The third area is a conference or work room near the cafeteria. These cracks [Photos M/HS- 13 and 14] while unsightly are not structurally consequential. The most probable cause is restraint created by a lack of properly placed masonry control joints.

CRACKS IN WALL BETWEEN
CAFETERIA AND SERVING
LINE

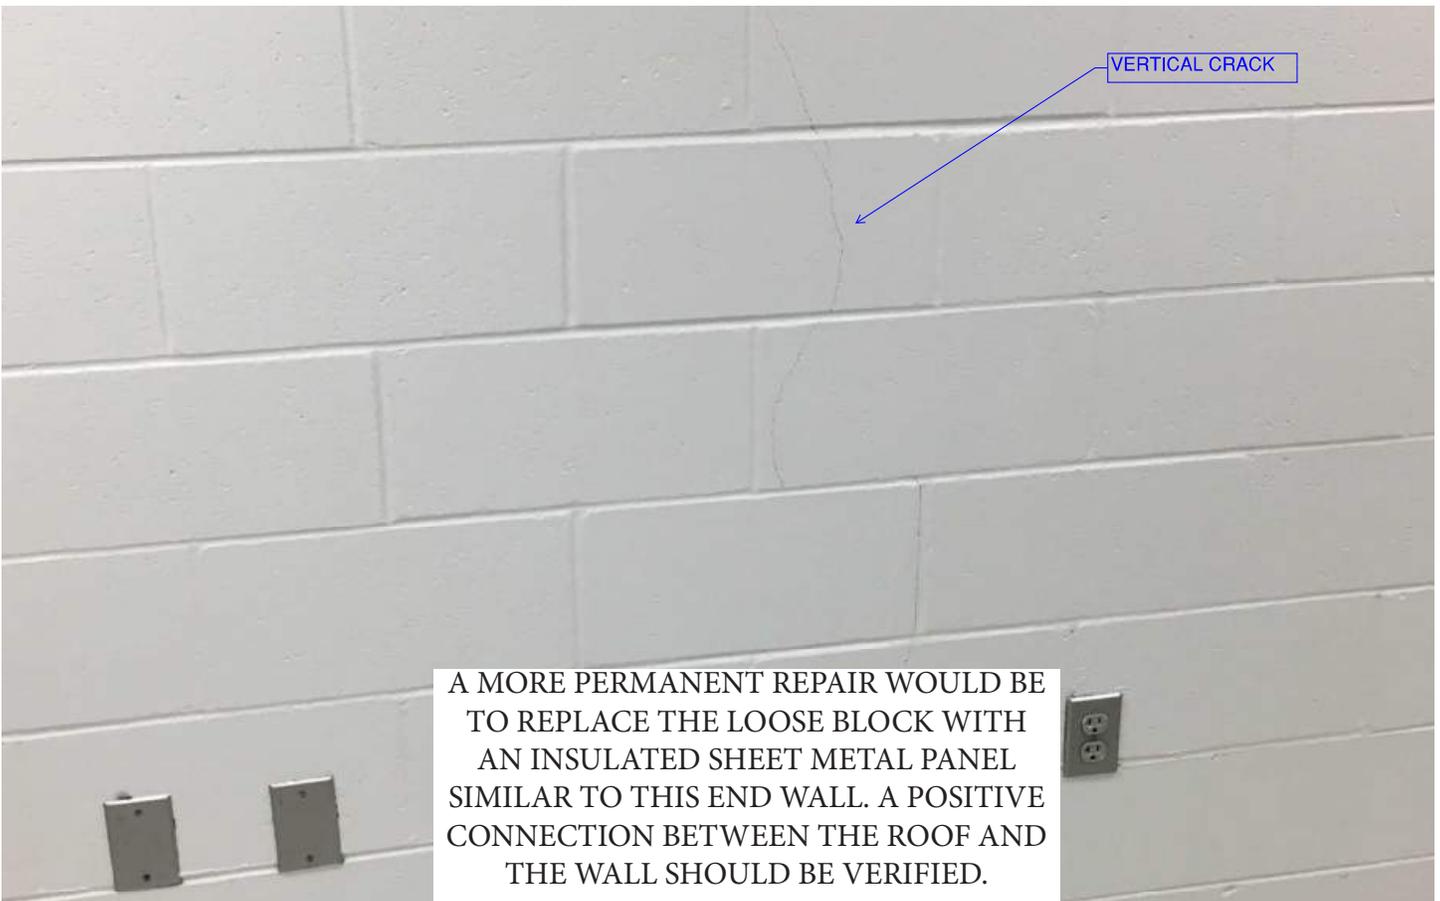
INFILL CMU AT LOADING DOCK CANOPY OUTSIDE THE KITCHEN

VERTICAL CRACK

A MORE PERMANENT REPAIR WOULD BE TO REPLACE THE LOOSE BLOCK WITH AN INSULATED SHEET METAL PANEL SIMILAR TO THIS END WALL. A POSITIVE CONNECTION BETWEEN THE ROOF AND THE WALL SHOULD BE VERIFIED.

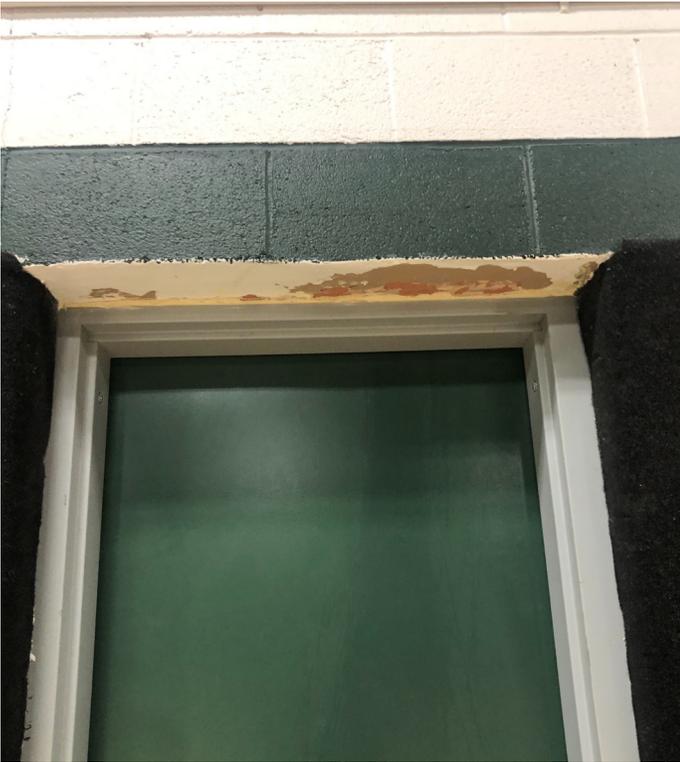
Door soffit damage

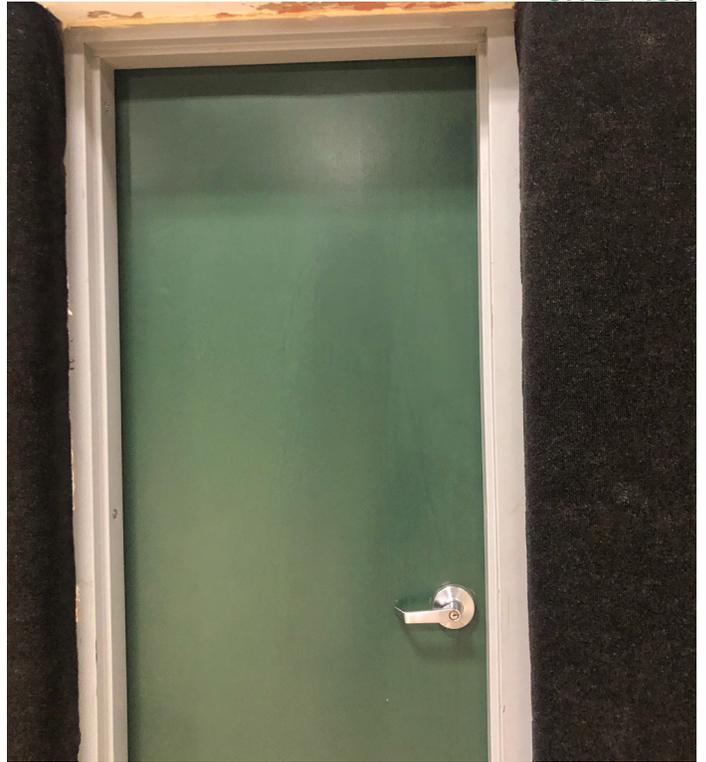
Door width not ADA compliant

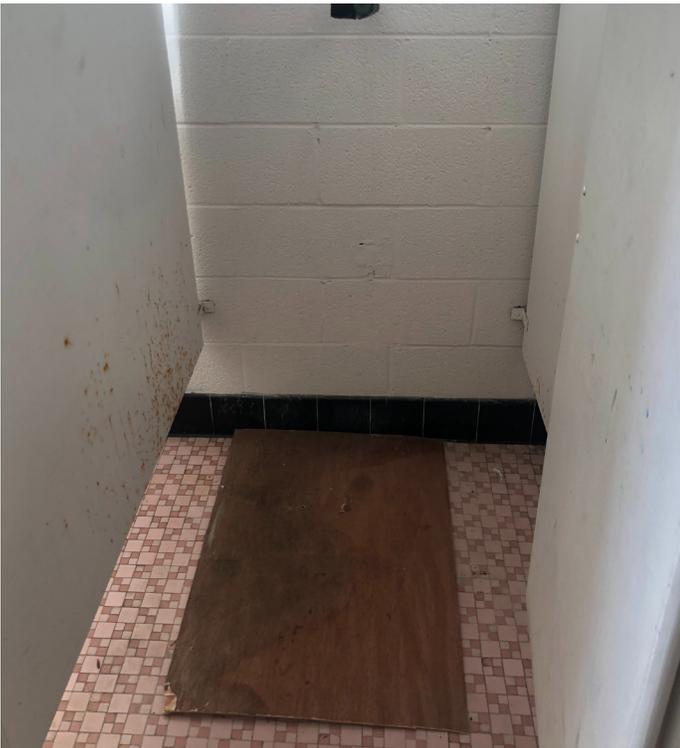
Toilet removed due to backup issues / Rust and damage of toilet and shower partitions

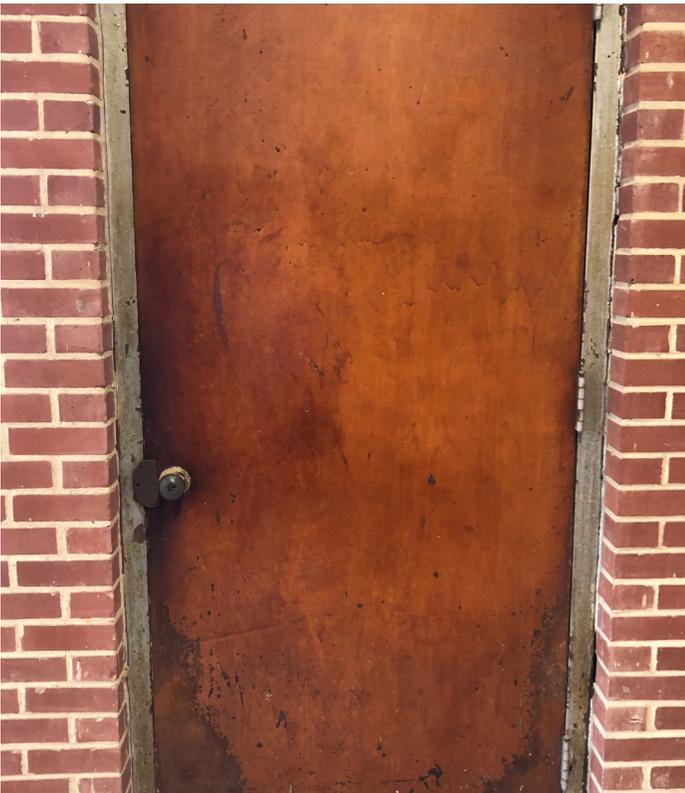
Damage to door / door hardware not ADA compliant

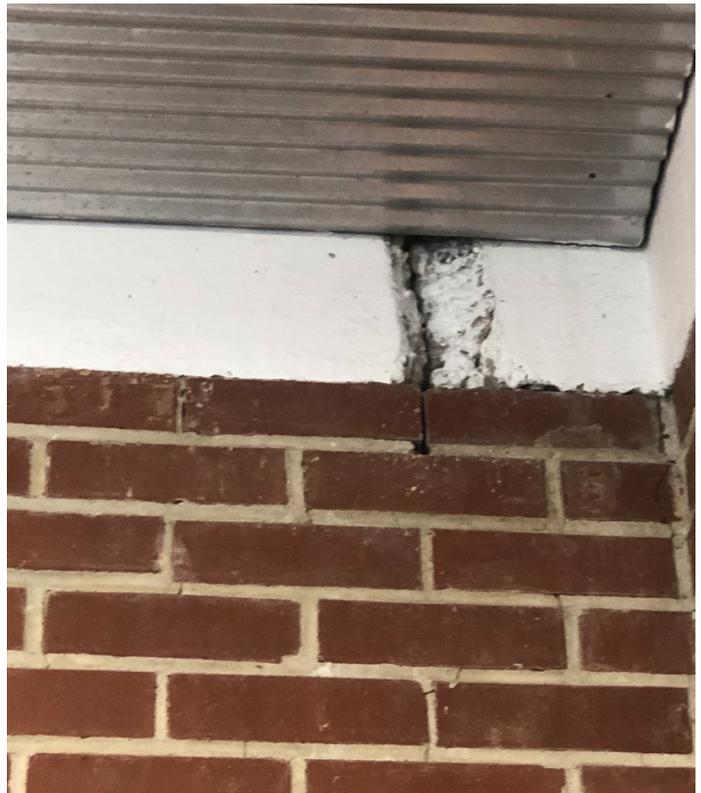
Building settling crack - area for water infiltration

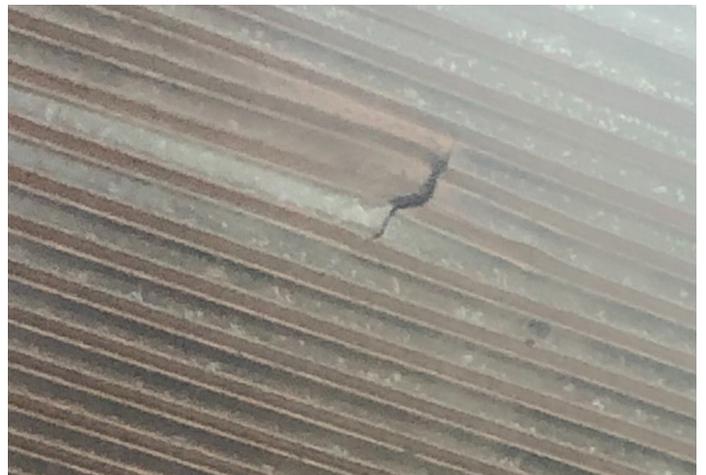
Building damage - area for water infiltration

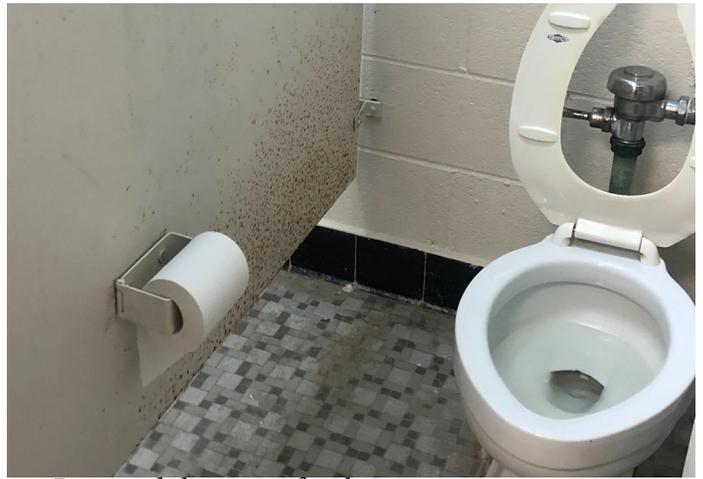
Rust and damage of toilet partitions separators

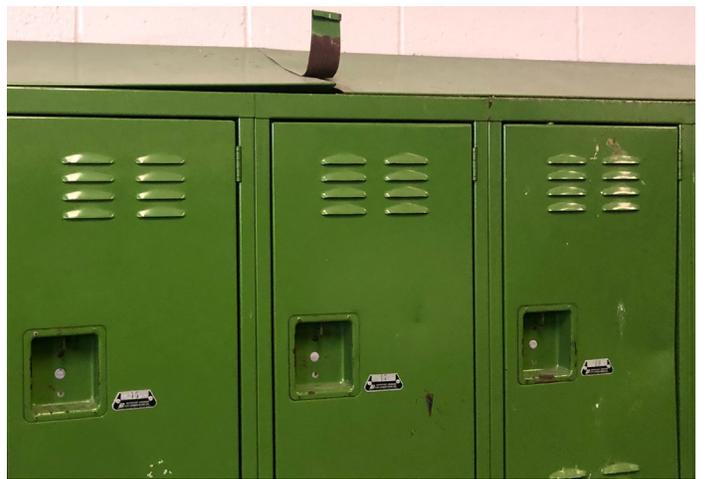
Damage to lockers

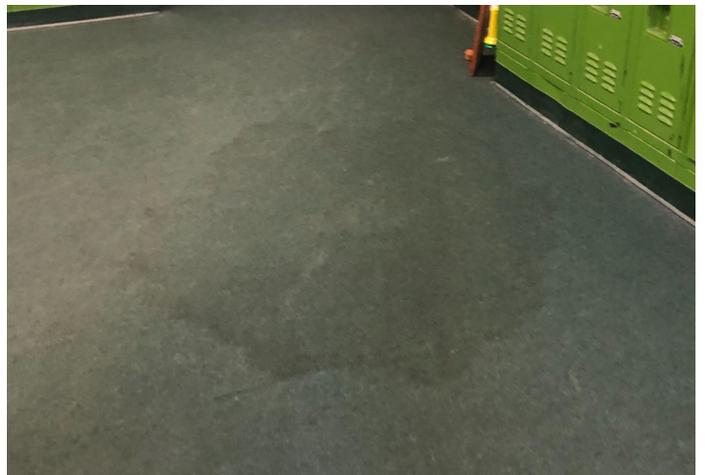
Water damage visible on floor / potential mold area

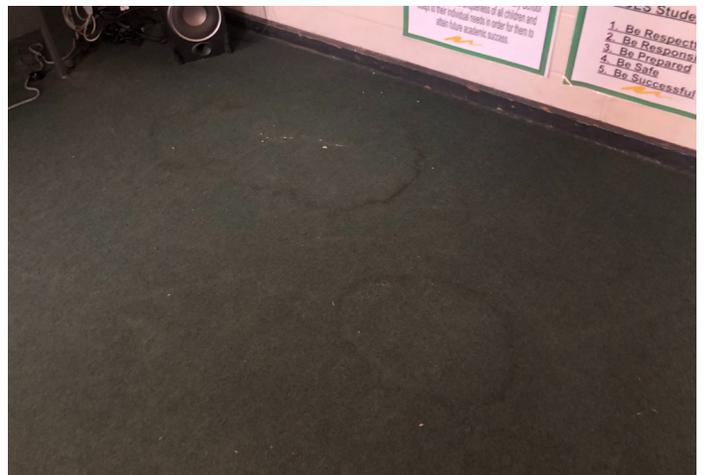
Evidence of water damage on carpet

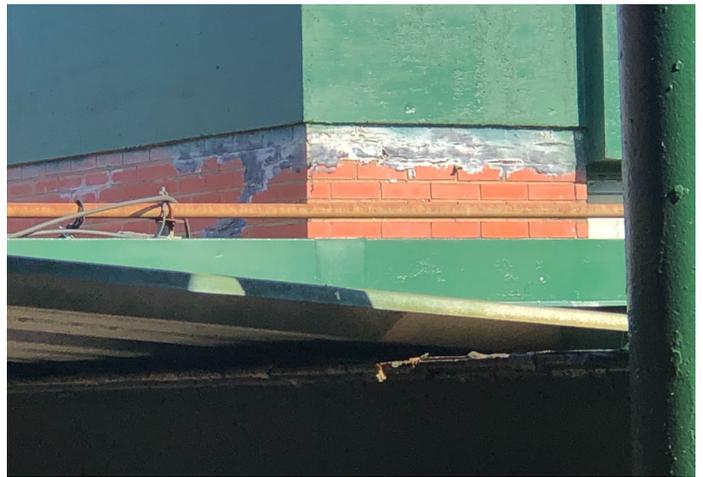
Wall damage from water infiltration. Area of brick removal, spray barrier, brick replacement needed.

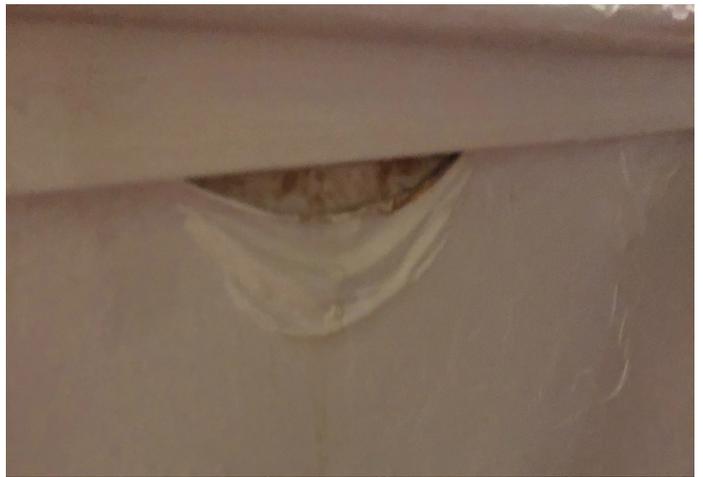
Water damage in plaster wall system in auditorium

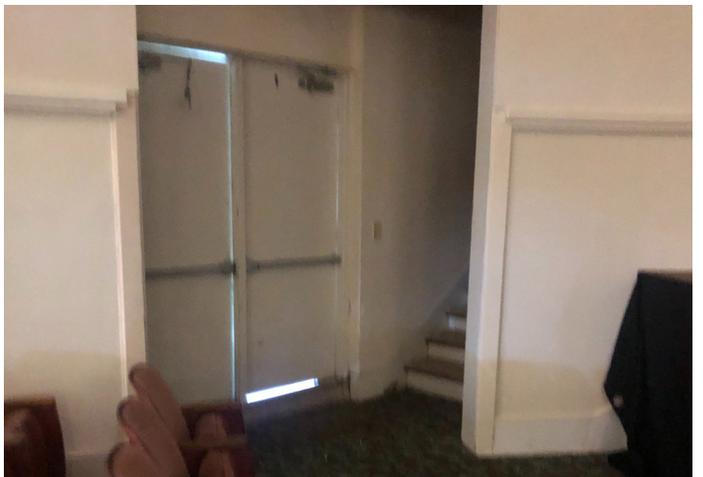
Water damage in plaster wall system in auditorium

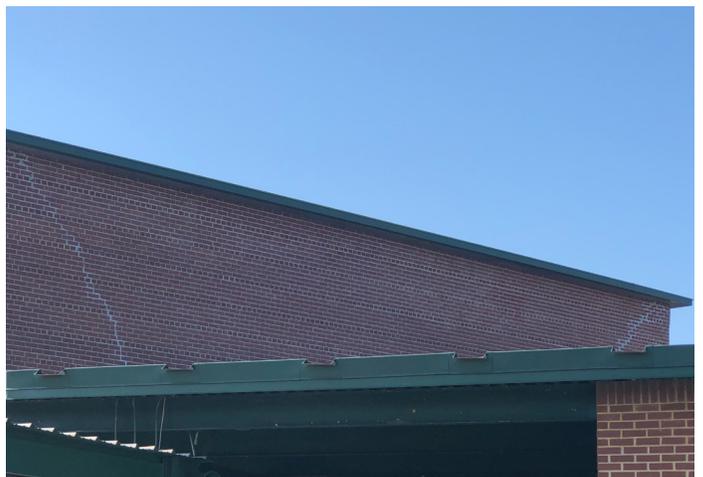
Wall damage from water infiltration. Area of brick removal, spray barrier, brick replacement needed.
