Comprehensive Facility Assessment Report

Seminole County Schools

2020

Altman + Barrett Architects

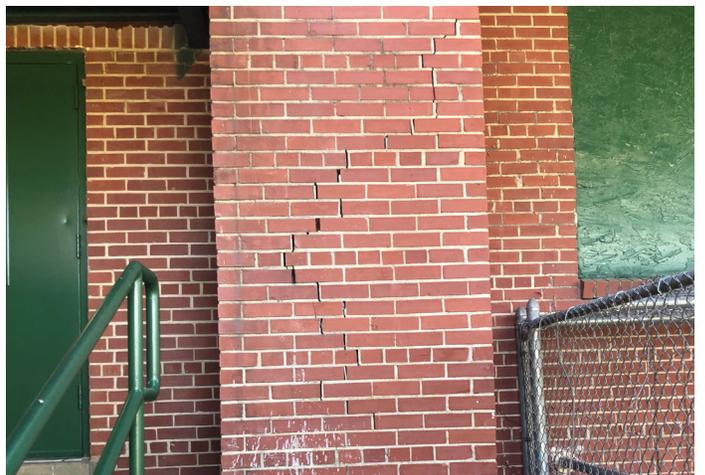
Wall damage from water infiltration. Area of brick removal, spray barrier, brick replacement needed.

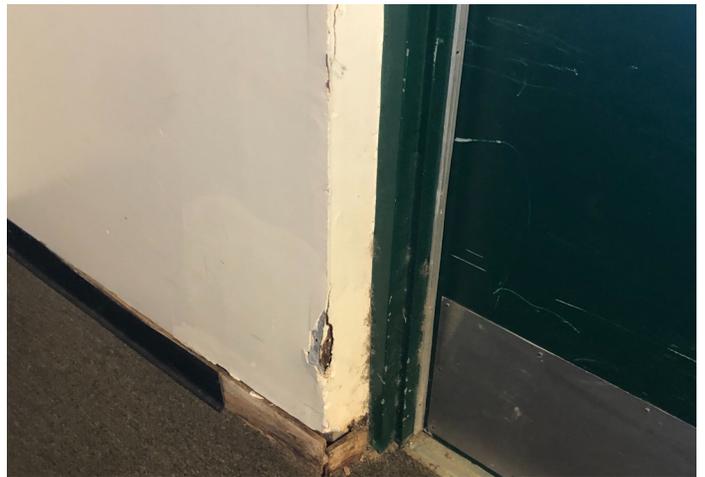
Damage to wall, base, and door.

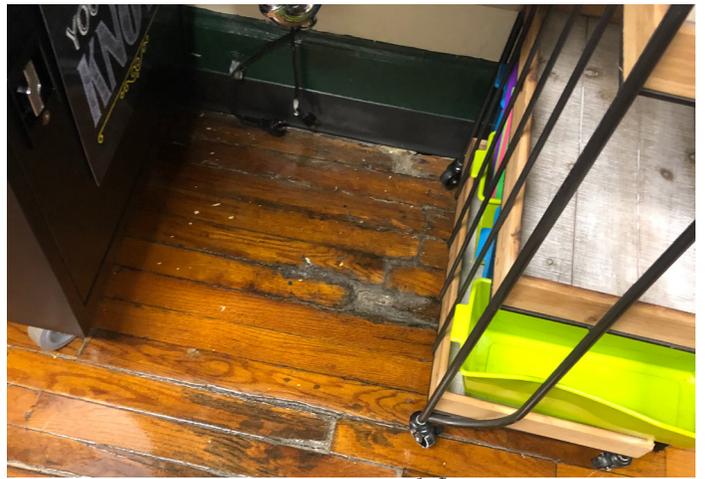
Damage om wood floors

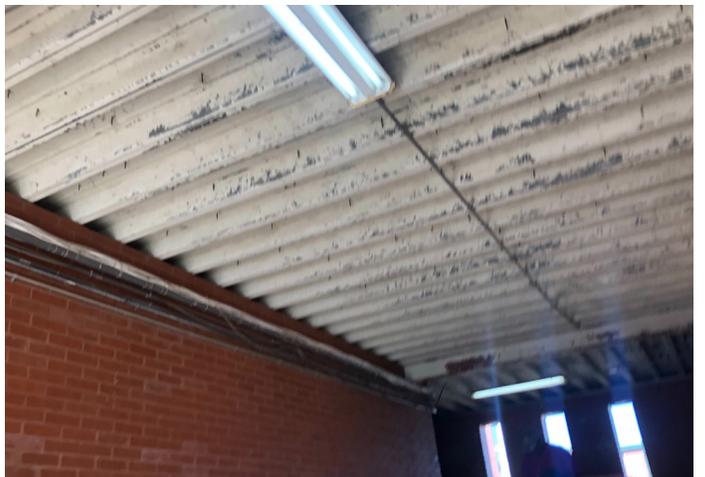
Damage to covered walkway canopy

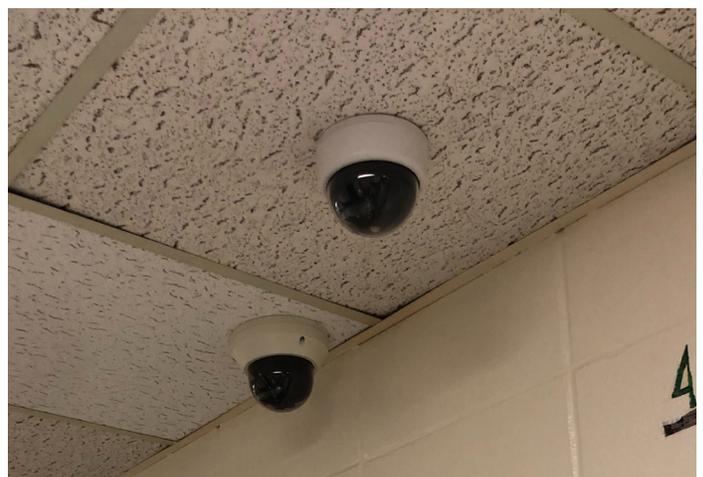
Ceiling tiles showing humidity is too high in building, sagging.

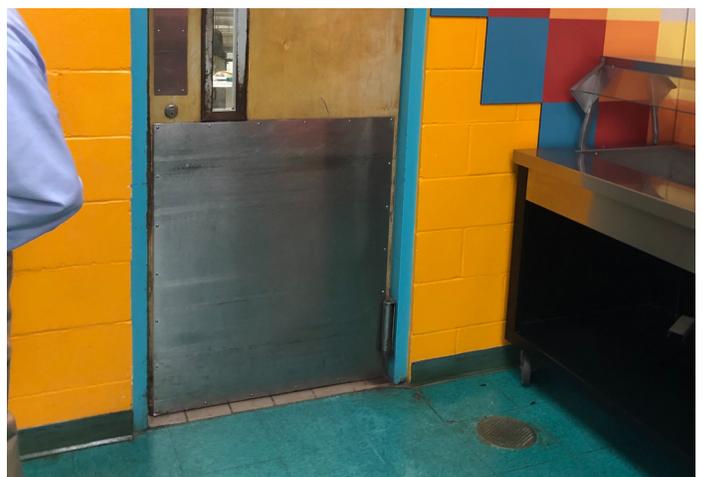
VCT tile damage

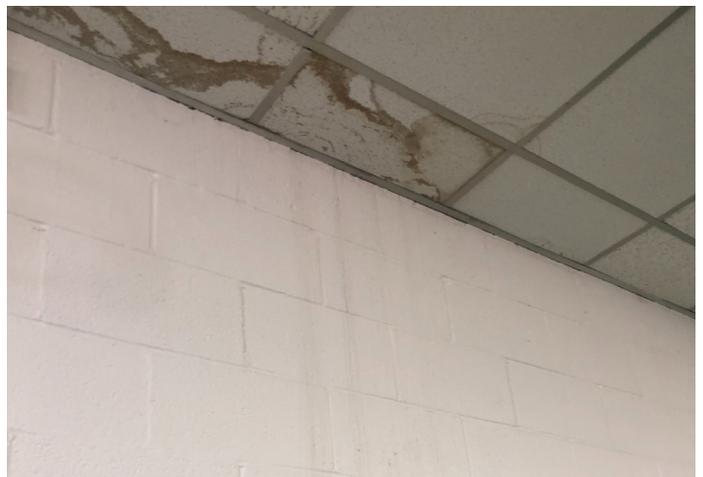
Consistent ceiling tile water damage throughout building

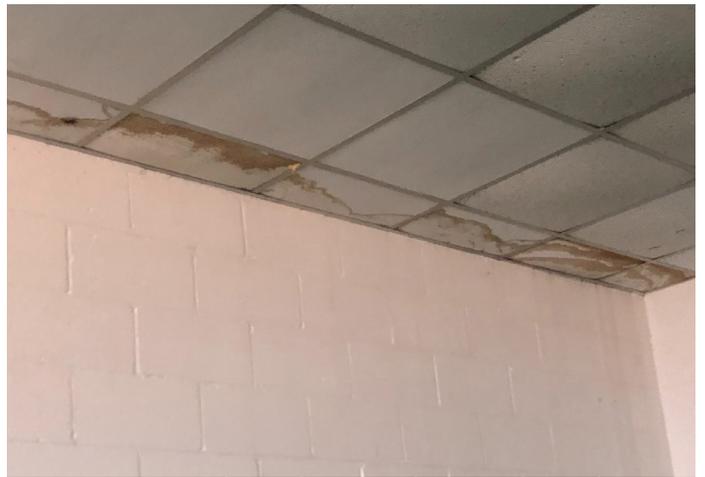
Consistent ceiling tile water damage throughout building

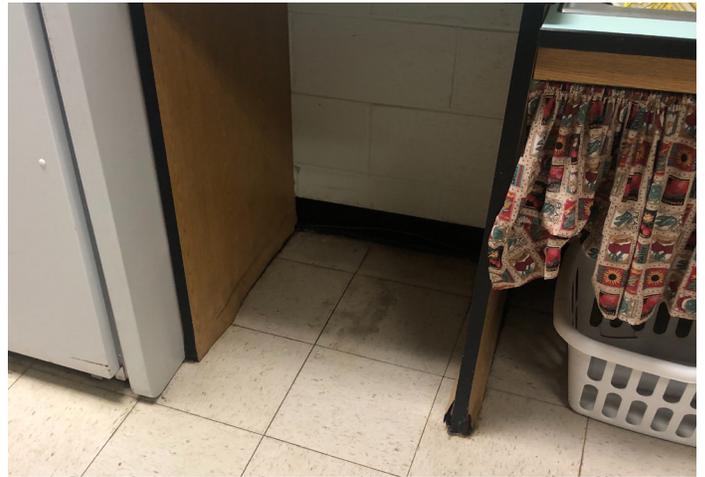
Interior water damage from courtyard walls.

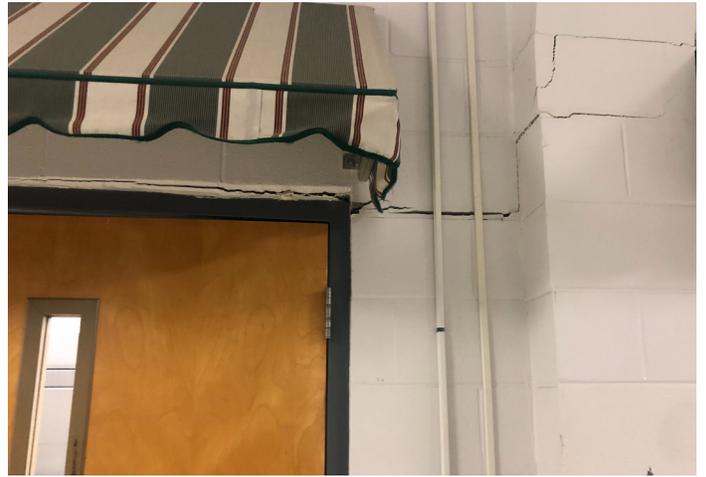
Structural issue / Wall has failed.

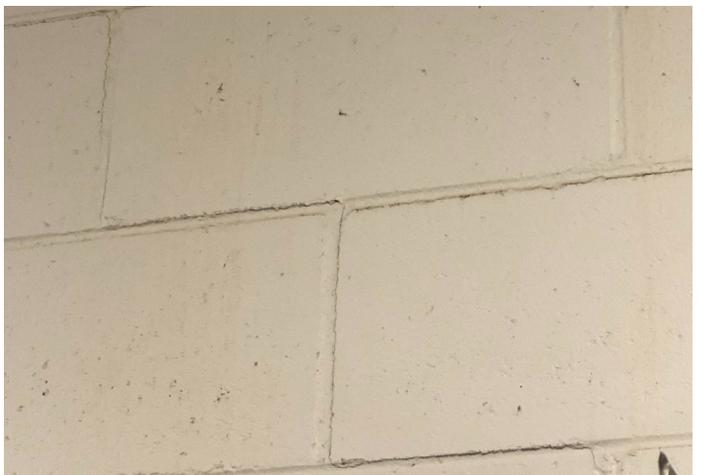
Structural issue / Wall has failed.

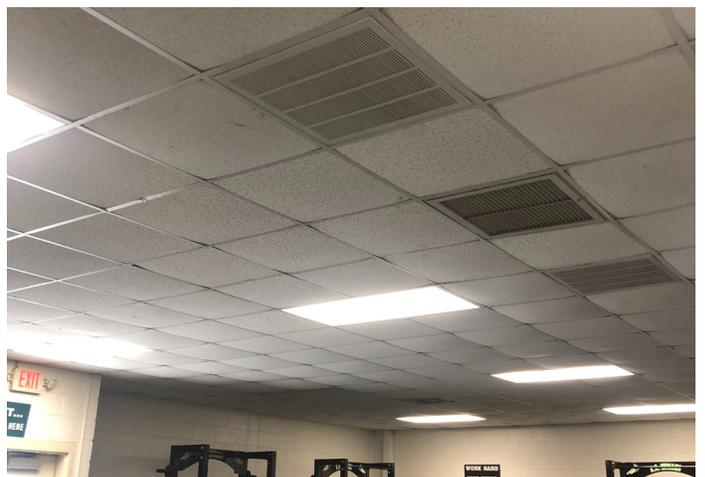
Sagging ceiling tiles due to high humidity

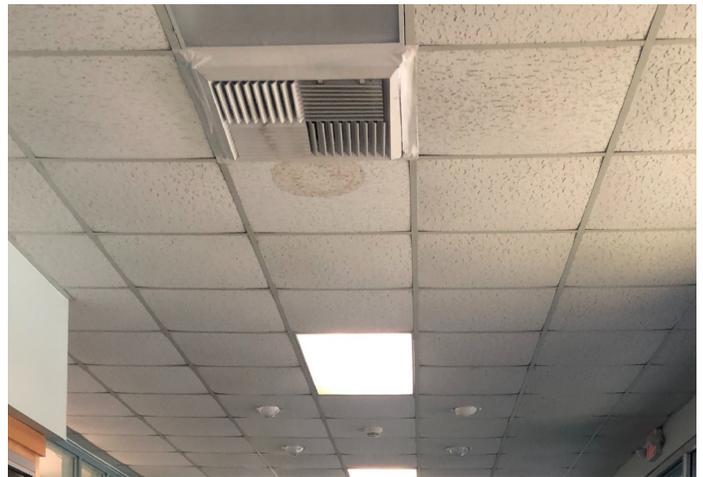
Consistent ceiling tile water damage throughout building
