<b>Douglas Unified School District, #27</b> Amendment #1		1132 E 12 Street Douglas, AZ 85607
	IFB: 21-007-22 <b>PROJECT: Weatherization, Roofing, and Structural Repairs at Faras Elementary</b>	Page 1 of 53

**Geotechnical Engineering Report  
Faras Elementary School – Distress Evaluation  
410 West Fir Avenue  
Pirtleville, Arizona  
RAMM Project No. G24634**

Subject: Geotechnical Engineering Report  
Faras Elementary School – Distress Evaluation  
410 West Fir Avenue  
Pirtleville, Arizona

**APPENDIX C  
EXCERPTS  
BRODERICK ENGINEERING LLC  
STRUCTURAL ANALYSIS REPORT**

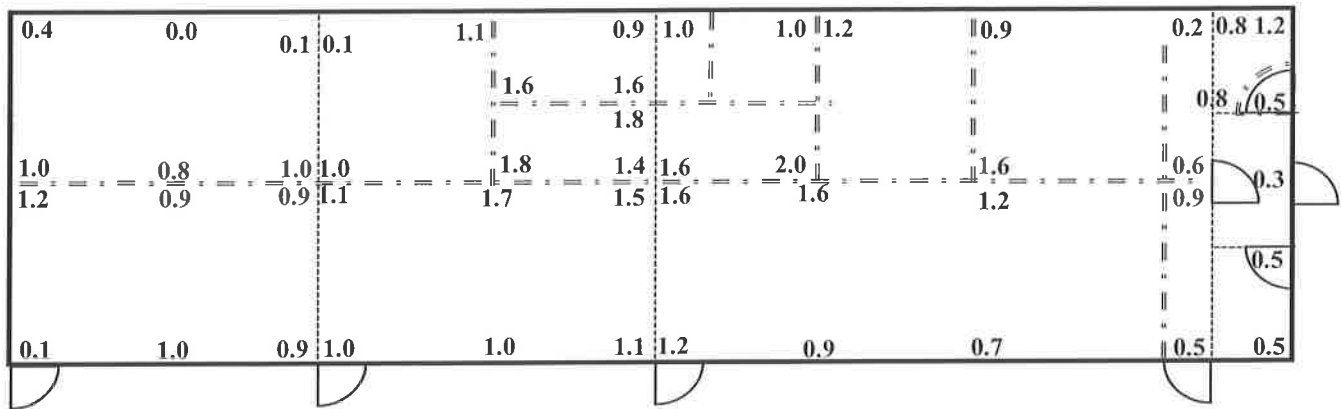
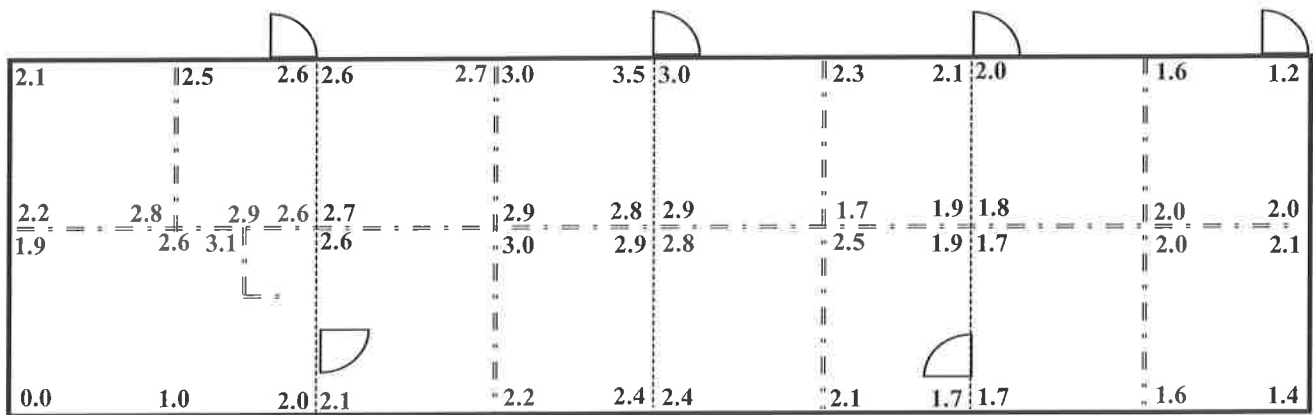
SITE PLAN

Distress in the form of cracks in the exterior and interior walls and in the floors were observed in both buildings. The exterior wall cracks were located along the east wingwall end of the north and south buildings and along the west wingwall and the south face near the southwest corner of the south building. Interior wall cracks were observed along the north wall near the west end of the north building and the west end and above a doorway on the north side near the midpoint of the south building. The cracks were generally  $\frac{1}{16}$  to  $\frac{1}{2}$  inches wide and typically exhibited a linear to stair-stepped pattern with little to no apparent horizontal displacement across the cracks. The cracks in the concrete slab-on-grade floors were located along the east-west axis of both buildings and extended the full length of each building. Each building had numerous north-south, generally evenly spaced cracks. The north-south cracking extended across the full length of the building predominantly in the south building. The cracks were generally  $\frac{1}{8}$  to  $\frac{5}{16}$  inches in width with no apparent to some vertical displacement. Sounding of the floor slabs with a 16-ounce hammer on both sides of the cracks indicated possible voids beneath the slab, typically within 6 to 18 inches interior of the crack.

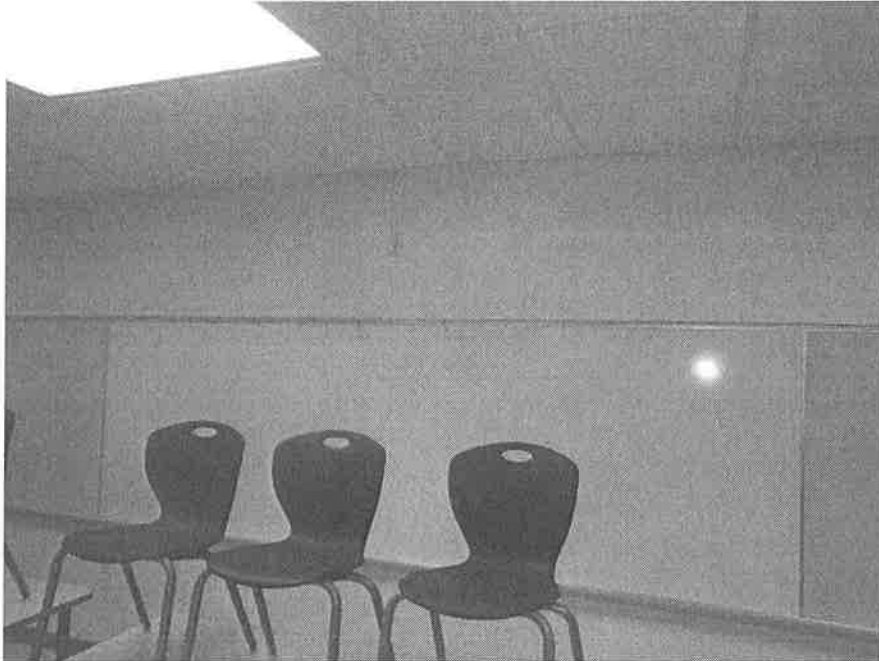
**Picture 9**

During our visual investigation, noticeable interior concrete slab-on-grade cracks and exterior masonry wall cracks were observed at both buildings. The slab cracks run full length in the east-west direction, at the middle of each building, and are most noticeable near the east and west exterior ends of each building (see pictures 1 & 2 of the north and south buildings respectively). Exterior wall cracks were observed at the east wall of the south building near the opening (see picture 3), at the south wall of the south building near the westernmost masonry control joint (see picture 4), at multiple locations along the west wall of the south building (see pictures 5 and 6), and at the east wall of the north building near the opening (see picture 7). Interior wall cracks were observed at the south end of the westernmost masonry partition wall of the south building (see picture 8), and near the middle of the westernmost steel stud partition wall of the north building (see picture 9).

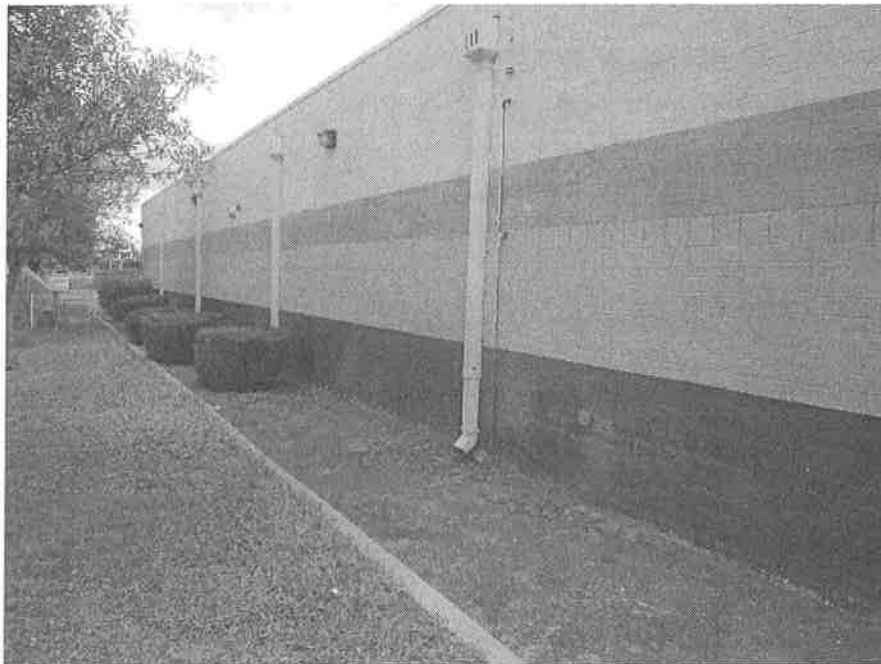
**Picture 10**

It appears that positive drainage away from the exterior perimeter does not occur for both the north and south classroom buildings, which may be a contributing factor in allowing water to infiltrate the soils near building foundations. Downspouts and planters occur around the (3) non-courtyard sides of each building (see picture 10 of the north building and pictures 11 and 12 of the south building).

Based on the findings from the geotechnical investigation and relative floor surveys, water infiltration near the perimeter of the buildings will most likely need to be mitigated by creating positive surface drainage away from the buildings; possibly by constructing new concrete slabs. Additionally, if it is determined that specific wall and footing locations of the buildings have experienced significant settlement, helical piers could be installed in order to help stabilize the existing foundations and jack up the settled building elements to a near level condition. Helical piers, if required, shall be designed by a licensed structural engineer.
