Tuxedo UFSD

Visual Inspection Findings

02.14.2023

George Grant Mason ES – VI Identified Conditions

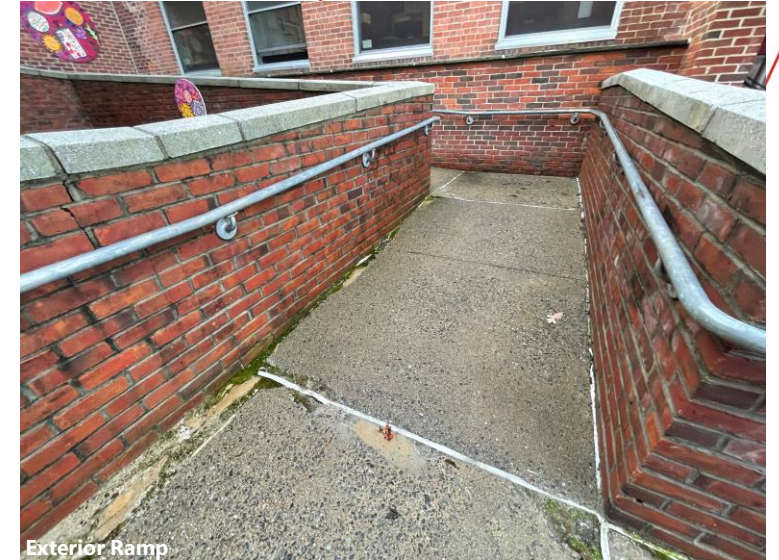
Exterior Ramp

- **(VI Item #44) Exterior Steps, Stairs, and Ramps (S)** - Lichens growth at various locations on ramp; concrete spalling throughout; railings need repainting

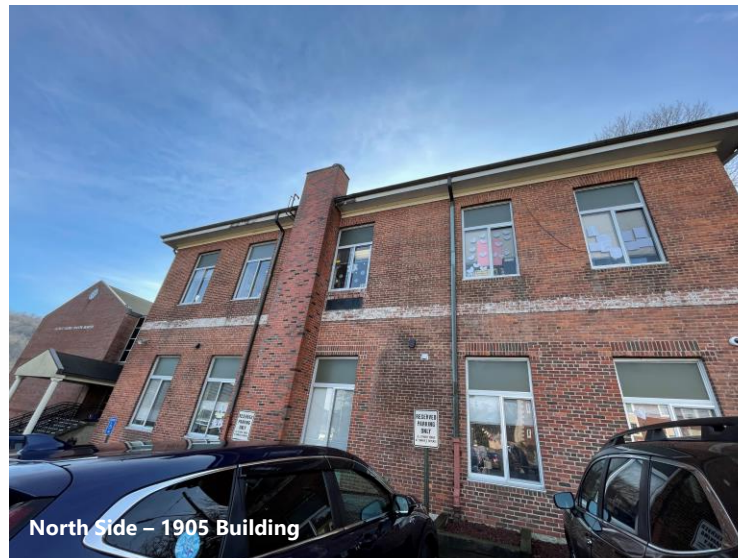
North Side - 1905 Building

- **(VI Item #46) Windows** - All windows in 1905 building are beyond their useful lifespan and need to be replaced
- **(VI Item #47) Roof and Skylights (S)** - Lichens growth on asphalt shingles; 1905 bldg roof shingles showing signs of wear and tear; fascia trim, soffit, gutters need replacement. 2001 flat roof beyond useful life span, bubbling/soft spots throughout; several membrane patching spots observed

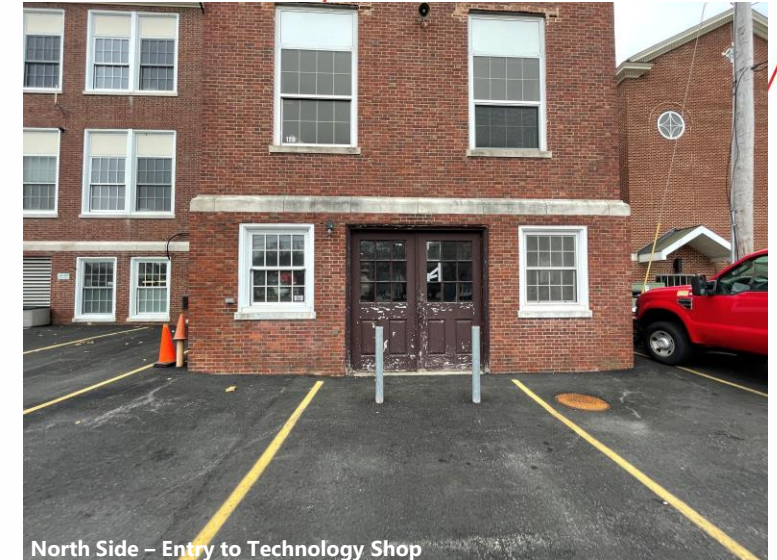
North Side – Entry to Technology Shop

- **(VI Item #43) Exterior Doors and Hardware (S)** - 1931 Bldg. doors are beyond useful lifespan
- **(VI Item #47) Roof and Skylights (S)** - Lichens growth at several locations on 1931 bldg. flat roof. 1931 skylight leaking into auditorium below. Some areas of 2003 addition flat roof are bubbling.
- **(VI Item #50) Carpet** - Old/stained carpet at various locations incld. balcony seating @ Auditorium
- **(VI Item #56) Interior Doors and Hardware** - 1931 Bldg doors need to be replaced
- **(VI Item #57) Interior Stairs (H)** - 1931 Bldg. stair handrails do not meet code (29"H); 2003 addition stair wall handrails do not meet code (33"H), guardrail is 33"H and acting as handrail on opposite side

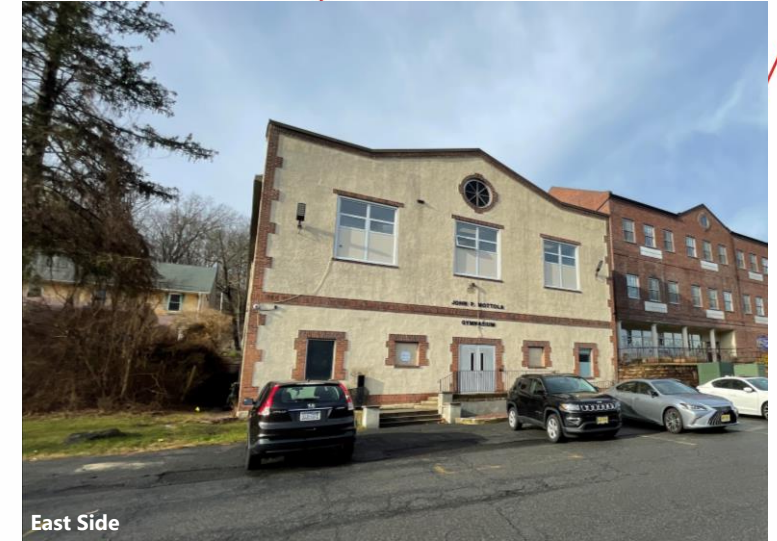
East Side

- **(VI Item #30) Sidewalks** - Replace select sections of curbing.
- **(VI Item #40) Exterior Walls/Columns (S)** – Wall plaster in need of repair around perimeter of bldg; Lichens growth at several locations; brick in need of repointing. Gable ends at gym sagging and insulation face peeling off.

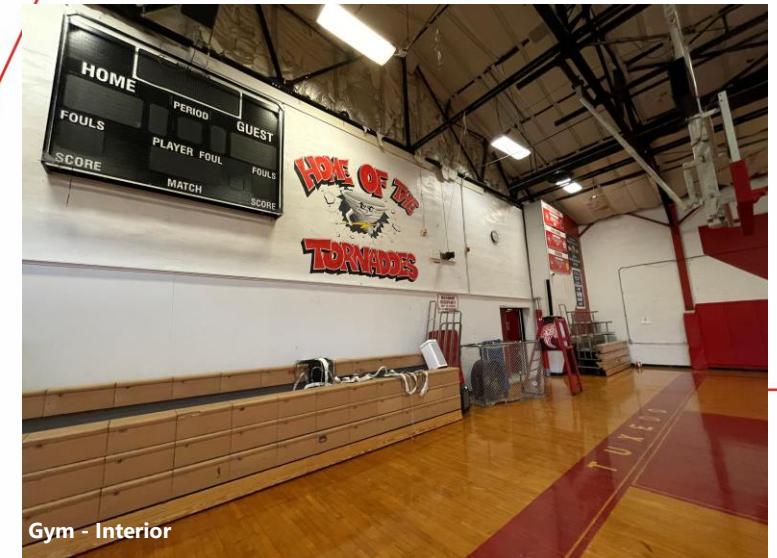
Gym - Interior

- **(VI Item #52) Hard Flooring (concrete; ceramic tile; stone; etc)** - Ceramic tile in lockers and toilets showing signs of wear and tear.
- **(VI Item #54) Ceilings (H)** - Insulation at gym ceiling sagging and insulation backing peeling off; wood panels clg in storage CL needs replacement; stained ACT throughout.

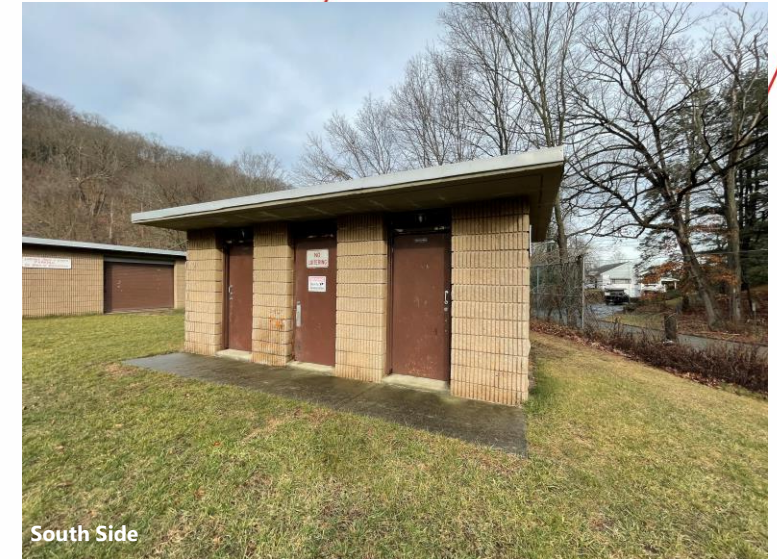
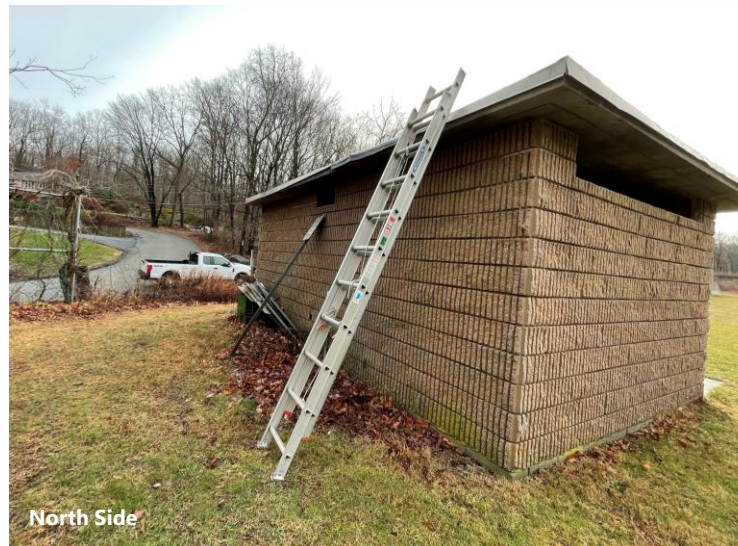
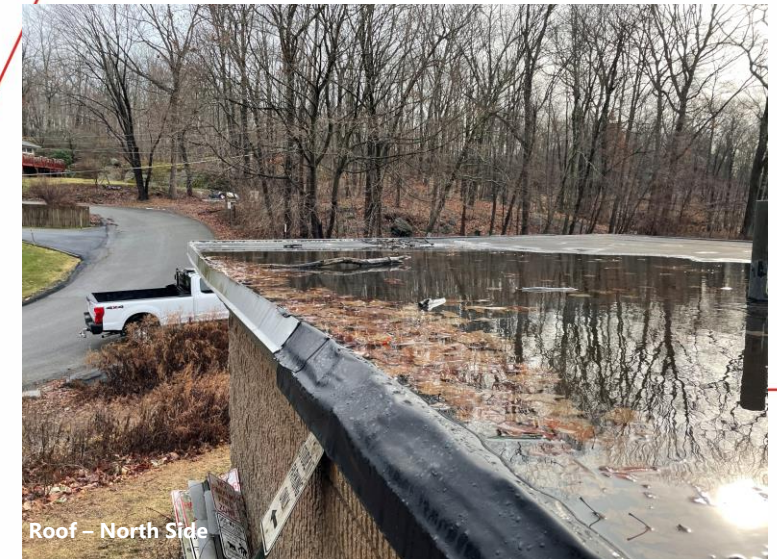
- **(VI Item #28) Site Stormwater Management System (Catch basins, manholes, culverts, retention basins, etc.)** – Video inspect system recommended.
- **(VI Item #43) Exterior Doors and Hardware (S)** - Exterior doors and frames are rusting and beyond useful life
- **(VI Item #47) Roof and Skylights (S)** - Roof membrane patch appears to be installed over metal edge on a section of the roof. Metal roof edge trim missing in some areas. Roof membrane in need of replacement. No active leaks.

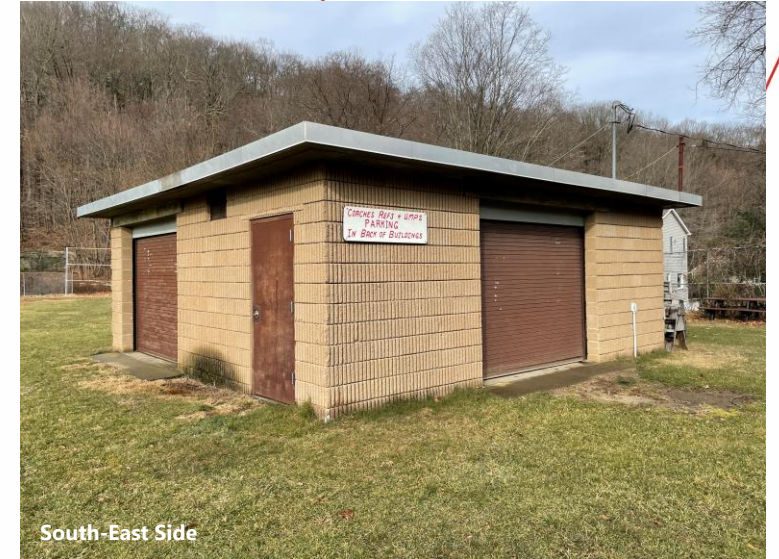
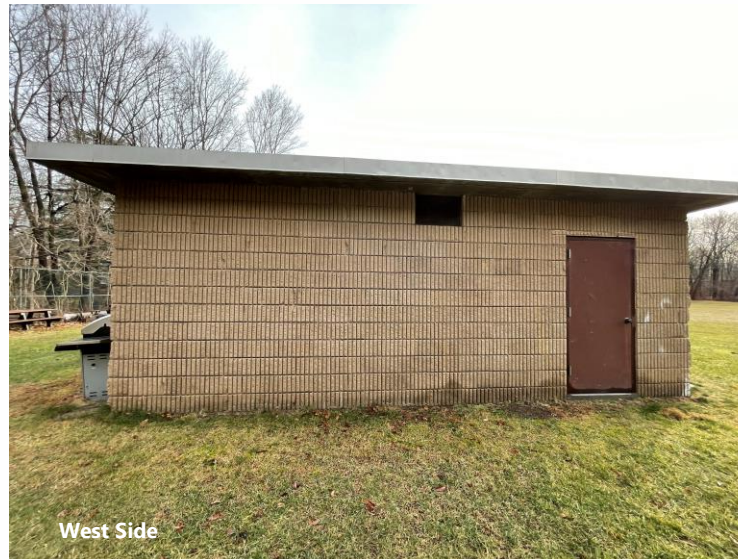
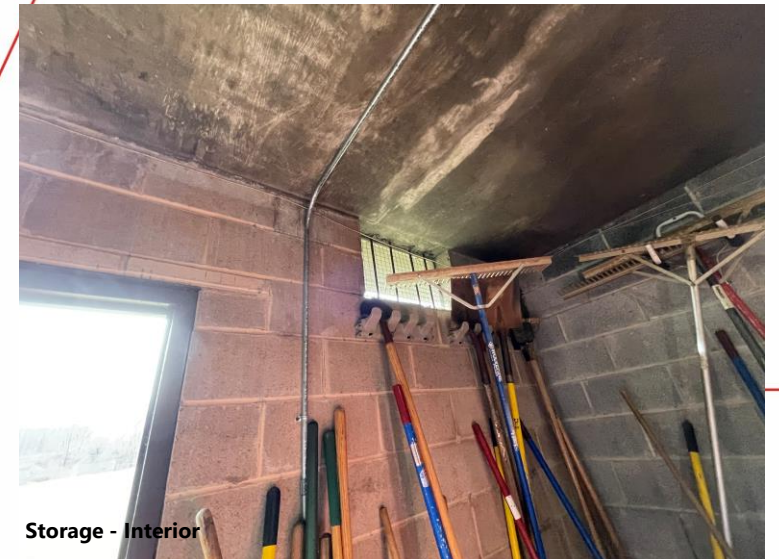
- **(VI Item #43) Exterior Doors and Hardware (S)** - Exterior doors and frames are rusting and beyond useful lifespan.
- **(VI Item #46) Windows** - Wall openings have steel bars horz and vert, covered by wired mesh
