# STOUGHTON FACILITIES MASTER PLAN AND FACILITIES CONDITION REPORT

Town of Stoughton, Massachusetts

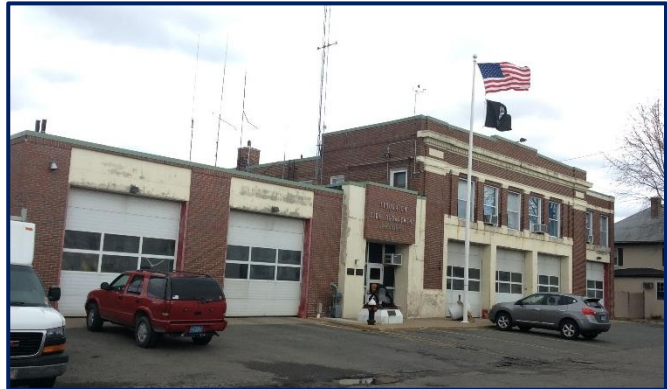
GENERAL: Fire Station #1 was renovated in 1969 and in 1971 minor upgrades have been made on interior spaces by the town. Building appears to be in fair to poor condition.

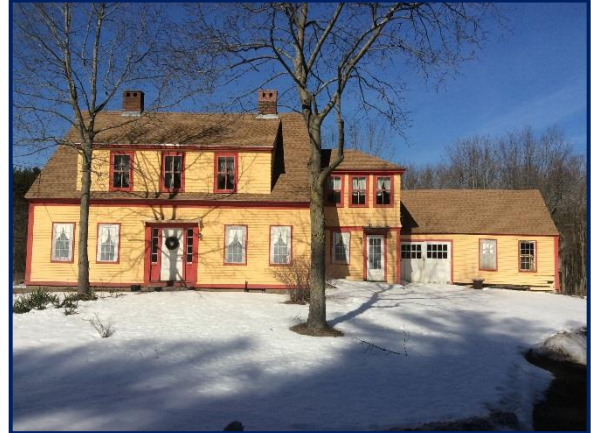
GENERAL: The Capen-Reynold's Farmhouse, the oldest part was built in 1757 and was deeded to the Town of Stoughton. Since that time the building has been deteriorating and disrepair. There are multiple issues with the building both interior and exterior. Structurally the building is standing but would require a structural engineer to further investigate the structural integrity of this building.

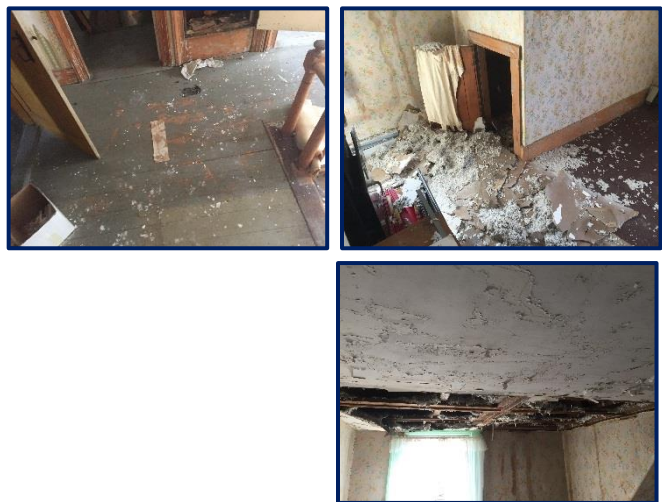
Insulation is exposed in walls and ceilings throughout the building. The building has not been heated or conditioned for many years and windows are broken. Moisture, birds and rodents and droppings have been spotted in the building.

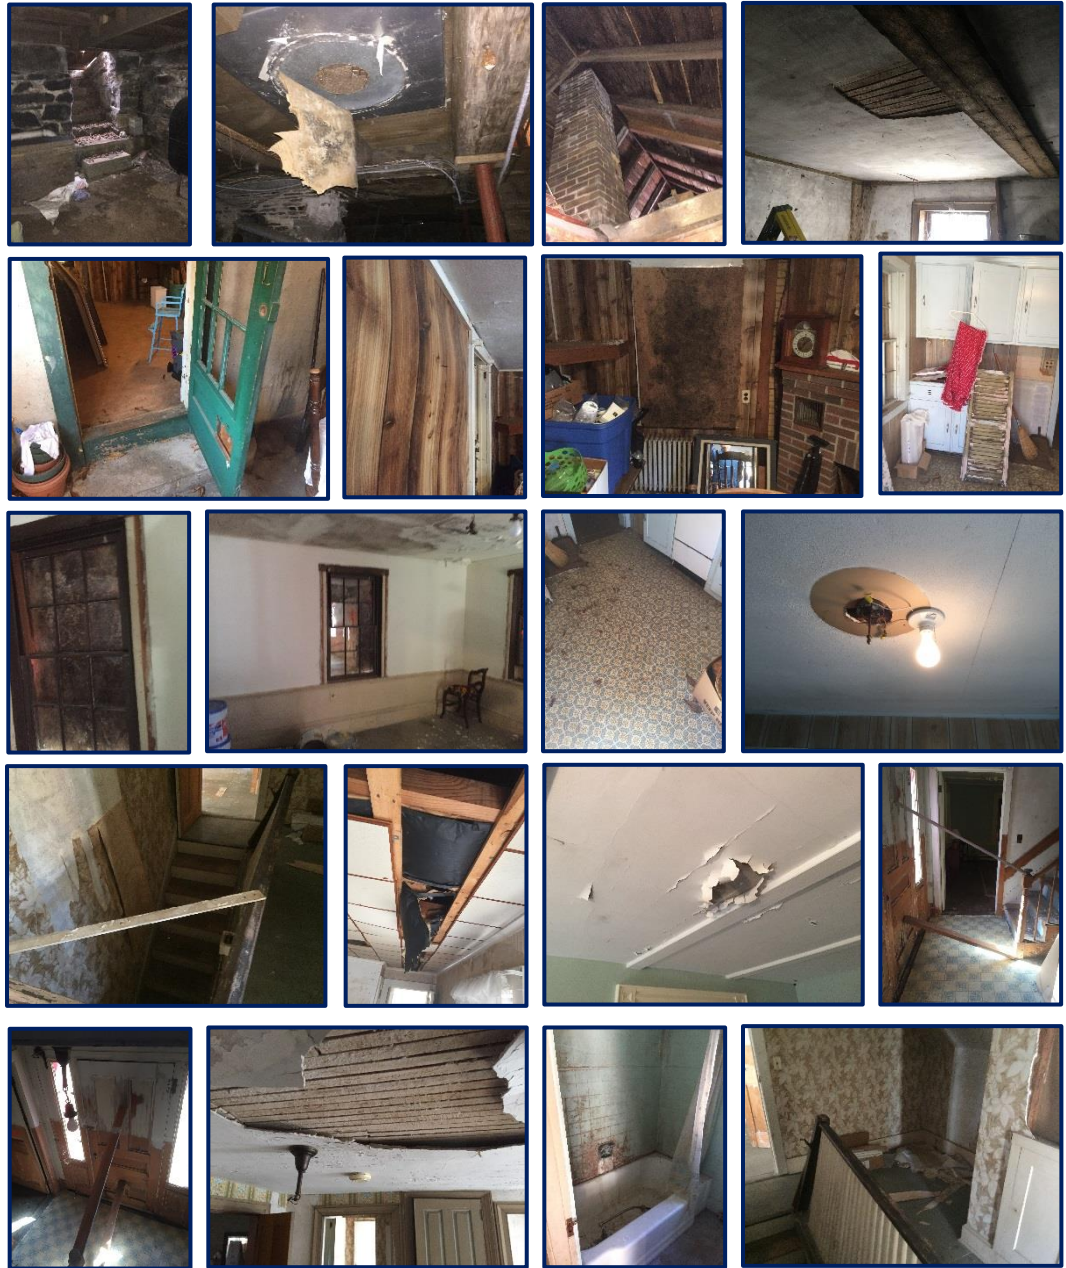
Floors, walls, ceilings, stairs, doors, windows, cabinets, basement, electrical, mechanical and plumbing and etc. are in poor condition.

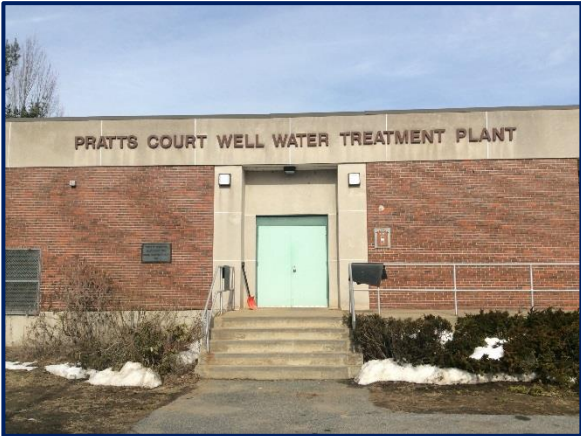
GENERAL: Pratts Court Water Treatment Plant appears to be in fair condition. Finishes in the interior and the exterior need to be repaired and refinished. The building is not ADA accessible.
