# **JONESVILLE COMMUNITY SCHOOLS FACILITIES ASSESSMENT**

November 21, 2022

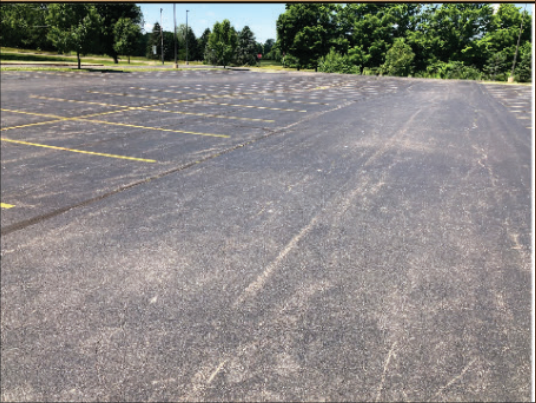
Parking Lot	<input checked="" type="checkbox"/>	<input type="checkbox"/>	<input type="checkbox"/>	<input type="checkbox"/>	<input type="checkbox"/>	Front drop-off loop and area in front of the dumpster pad are in need of repairs/replacement	Recommend replacement in the next 5-7 years. Approximately 25,000 s.f.	\$91,667

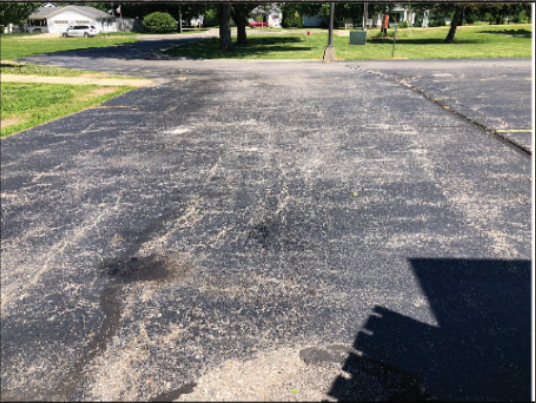
Parking Lot	<input checked="" type="checkbox"/>	<input type="checkbox"/>	<input type="checkbox"/>	<input type="checkbox"/>	<input type="checkbox"/>	Bus and Parent drop off area. Per district is congested and needs improvement	Recommend engaging a civil engineer to discuss current situation and feedback from community. Have a civil engineer develop concepts for improvement

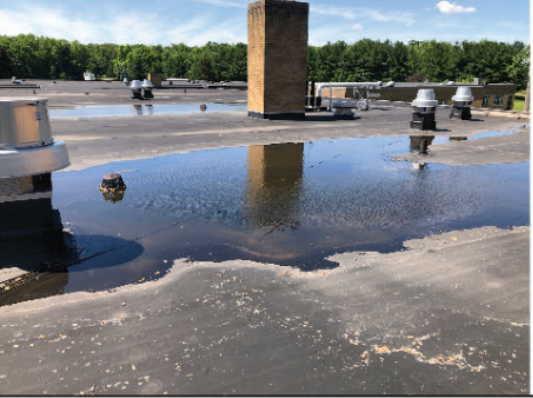
Roof Membrane	<input checked="" type="checkbox"/>	<input type="checkbox"/>	<input type="checkbox"/>	<input type="checkbox"/>	<input type="checkbox"/>	2010 addition roof material is EPDM and in overall good condition	Recommend new roof overlay over the existing roof membrane in the next 10-15 years. Repair current leak at Gym

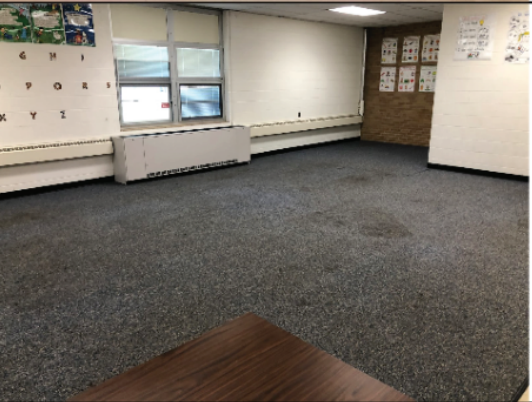
Floor Finishes	<input type="checkbox"/>	<input checked="" type="checkbox"/>	<input type="checkbox"/>	<input type="checkbox"/>	<input type="checkbox"/>	Building entry point flooring	Recommend installing walk-off carpet squares. Approximately 1,150 s.f.	\$9,200

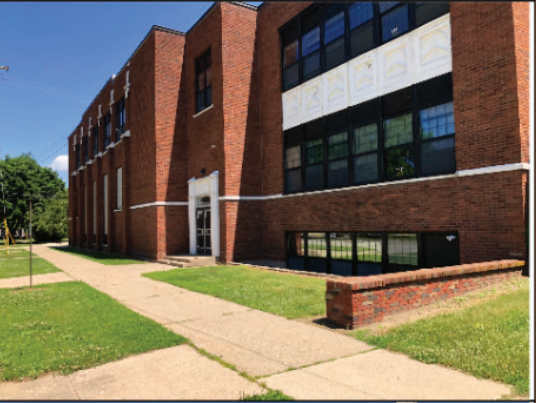
Exterior Elements	<input type="checkbox"/>	<input checked="" type="checkbox"/>	<input type="checkbox"/>	<input type="checkbox"/>	<input type="checkbox"/>	There is no barrier-free access to the main entrance of the building	Recommend constructing a new ramp or installing a lift at the main entrance Approximately 35 l.f.	\$2,625

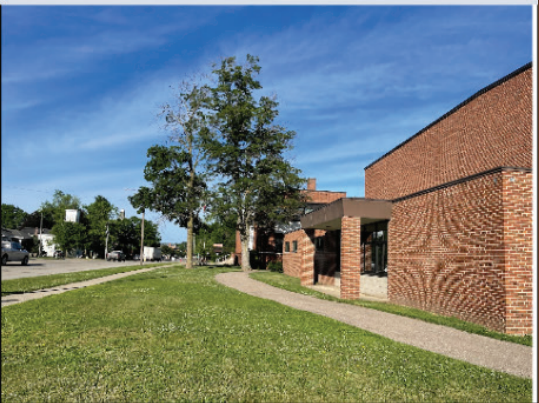
Parking lot lighting	<input type="checkbox"/>	<input checked="" type="checkbox"/>	<input type="checkbox"/>	<input type="checkbox"/>	<input type="checkbox"/>	Exterior building mounted lighting has been replaced with LED wall packs. Many are early generation LED drivers and have issues.	Replace all wall packs with new LED fixtures with 10 year warranties.	\$50,000

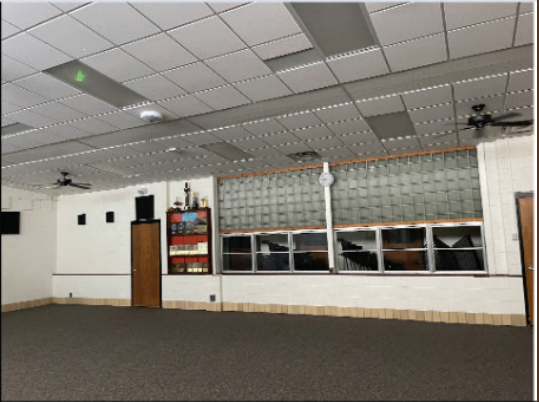
Receptacles & circuiting	<input type="checkbox"/>	<input checked="" type="checkbox"/>	<input type="checkbox"/>	<input type="checkbox"/>	<input type="checkbox"/>	Much of the wiring and associated devices appear to be older with old wiring. Branch wiring should be replaced as part of panel upgrades.	Replace branch wiring and associated devices as part of panelboard replacement. Plan for 3-4 circuits in each room with 10-12 outlets in each room. Each teacher station and associated projector shall be on a dedicated circuit.	\$379,770

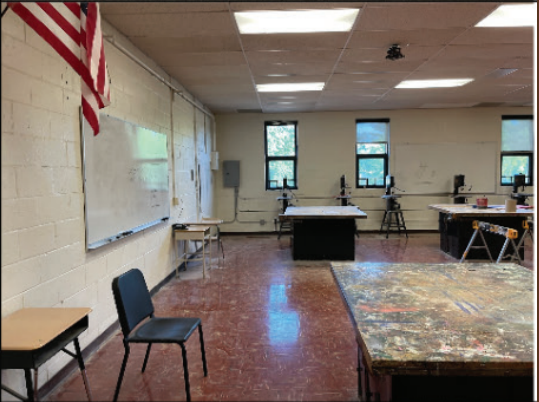
Lighting controls	<input type="checkbox"/>	<input checked="" type="checkbox"/>	<input type="checkbox"/>	<input type="checkbox"/>	<input type="checkbox"/>	There are lighting controls in the corridors and classrooms.	When interior lighting is replaced upgrade/replace existing lighting controls.	\$303,816

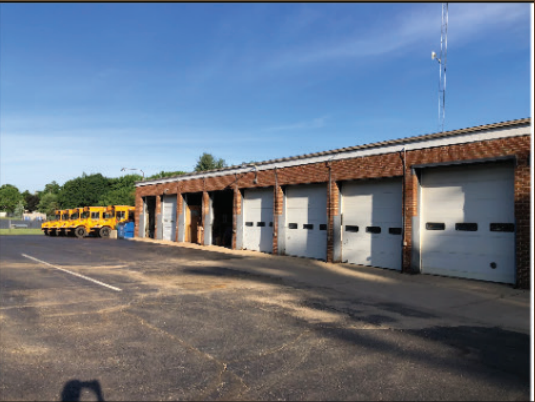
Roof Membrane	<input type="checkbox"/>	<input type="checkbox"/>	<input type="checkbox"/>	<input checked="" type="checkbox"/>	<input type="checkbox"/>	Roof membrane was replaced in 2010 with new Duralast roof membrane. Presume warranty is still good.	Recommend monitoring roof membrane conditions, repair leaks as they appear		
Structural Elements	<input type="checkbox"/>	<input checked="" type="checkbox"/>	<input type="checkbox"/>	<input type="checkbox"/>	<input type="checkbox"/>	Steel lintels at the overhead doors are sagging	Engage a structural engineer and architect to investigate. Scraping/sand blasting and paint recommended at minimum. 7 Doors	\$105,000

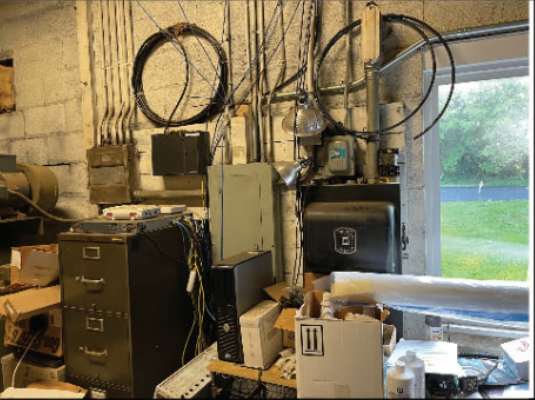
Distribution & branch panels	<input checked="" type="checkbox"/>	<input type="checkbox"/>	<input type="checkbox"/>	<input type="checkbox"/>	<input type="checkbox"/>	Panels are old and should be replaced.	Upgrade panels and associated feeders.	\$15,000

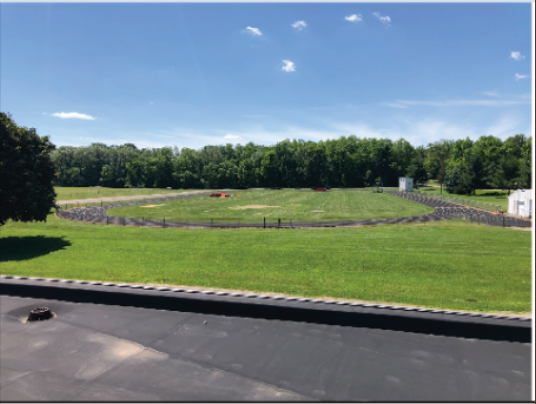
Barrier Free Access	<input checked="" type="checkbox"/>	<input type="checkbox"/>	<input type="checkbox"/>	<input type="checkbox"/>	<input type="checkbox"/>	There is currently no current barrier free access or facilities	Recommend to provide barrier free access to all athletic sites with sidewalks if complex is to remain at current site	\$70,500

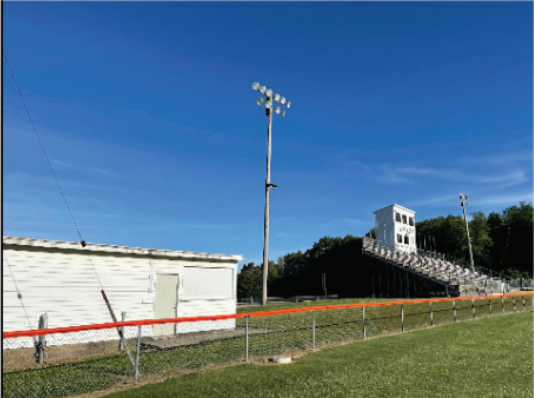
Parking lot lighting	<input type="checkbox"/>	<input checked="" type="checkbox"/>	<input type="checkbox"/>	<input type="checkbox"/>	<input type="checkbox"/>	None	Add lights in the parking area.		
Interior lighting	<input checked="" type="checkbox"/>	<input type="checkbox"/>	<input type="checkbox"/>	<input type="checkbox"/>	<input type="checkbox"/>	All interior lighting is old fluorescent type and at the end of its life.	Replace all lighting with LED, high abuse type.	\$10,000
