ICON
ARCHITECTURAL GROUP

FACILITY ASSESSMENT FOR HILLSBORO PUBLIC SCHOOLS

Hillsboro, ND | April 2022

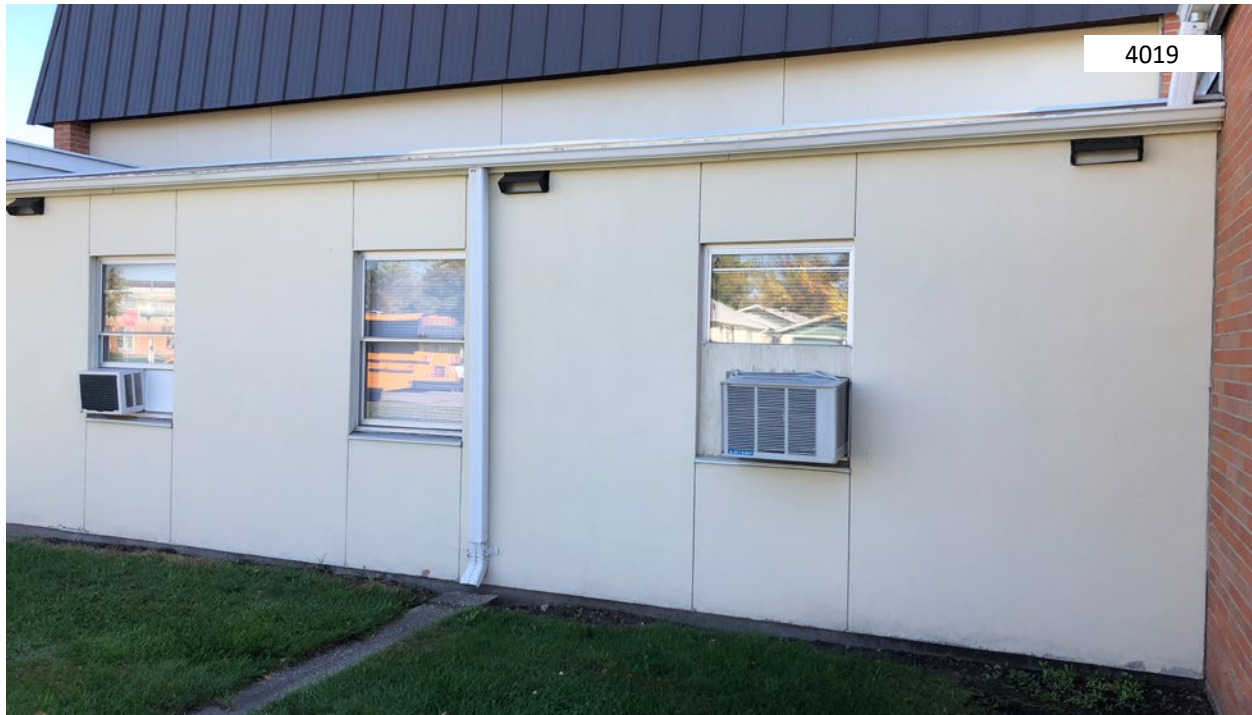
The windows are past their life expectancy, and several are completely covered with plywood and window air conditioning units.

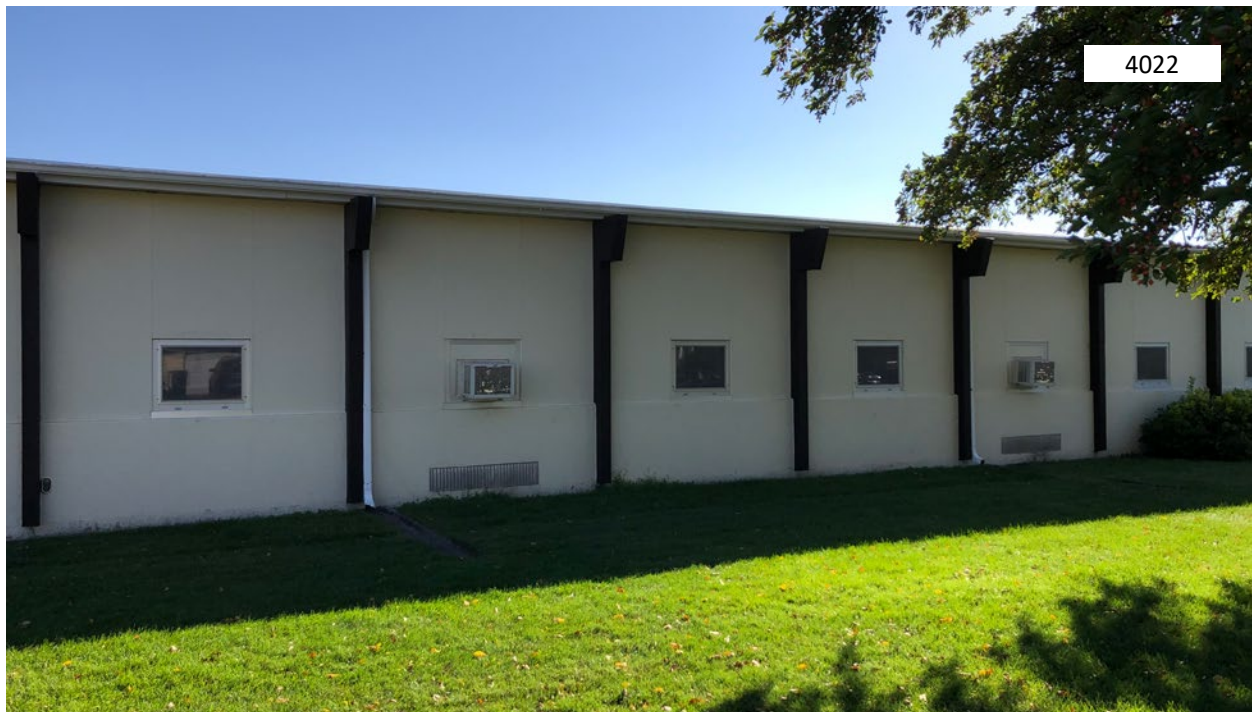
Per current code, 62 square feet of daylight is required in each classroom, but only 15 square feet is provided along the west classrooms.

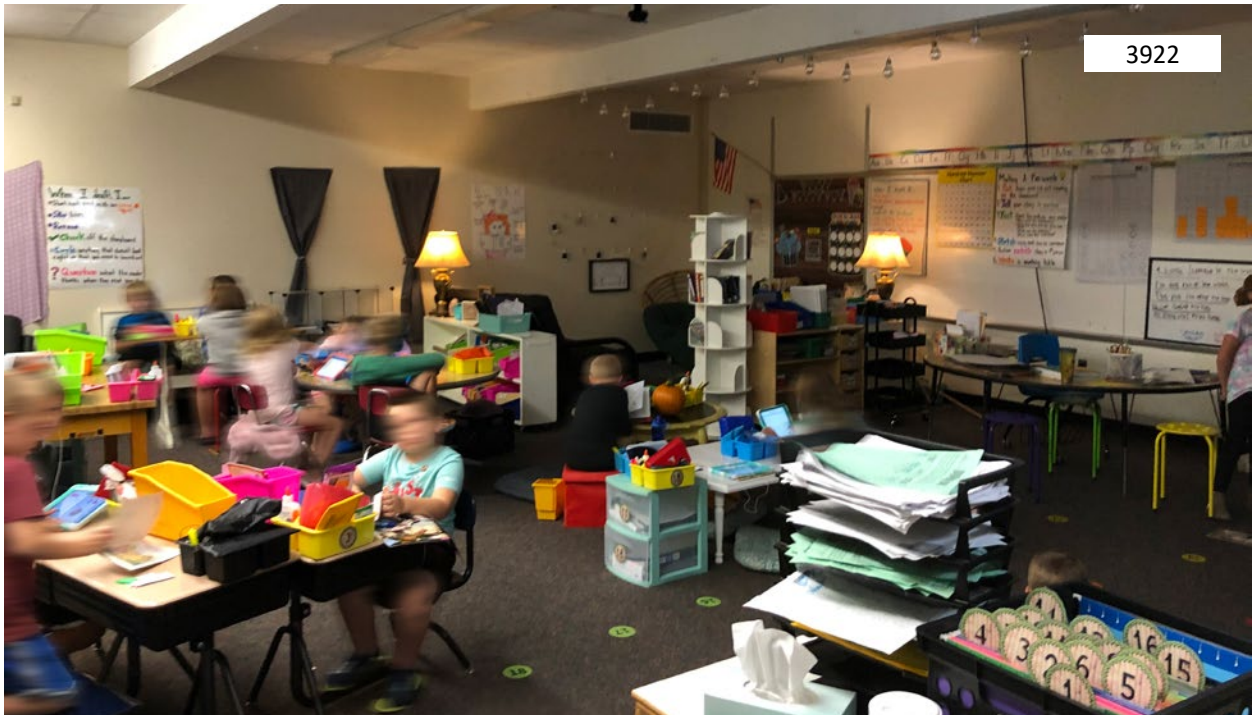
Many classrooms are interior and have no natural daylight.

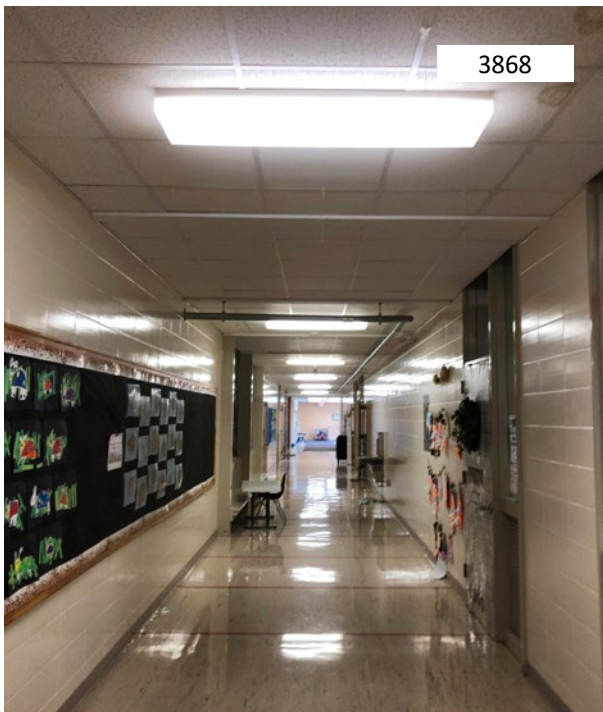
The acoustic ceiling tile is dated and stained from several roof leaks and should be scheduled to be replaced in the event sprinklers are installed in this section of the building.

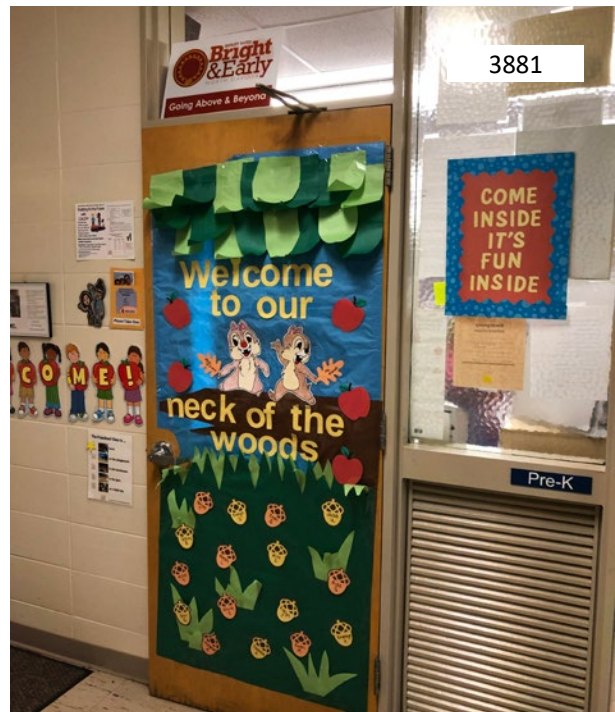
Door frames are chipping and would benefit from repainting and doors should be scheduled for replacement in the future.

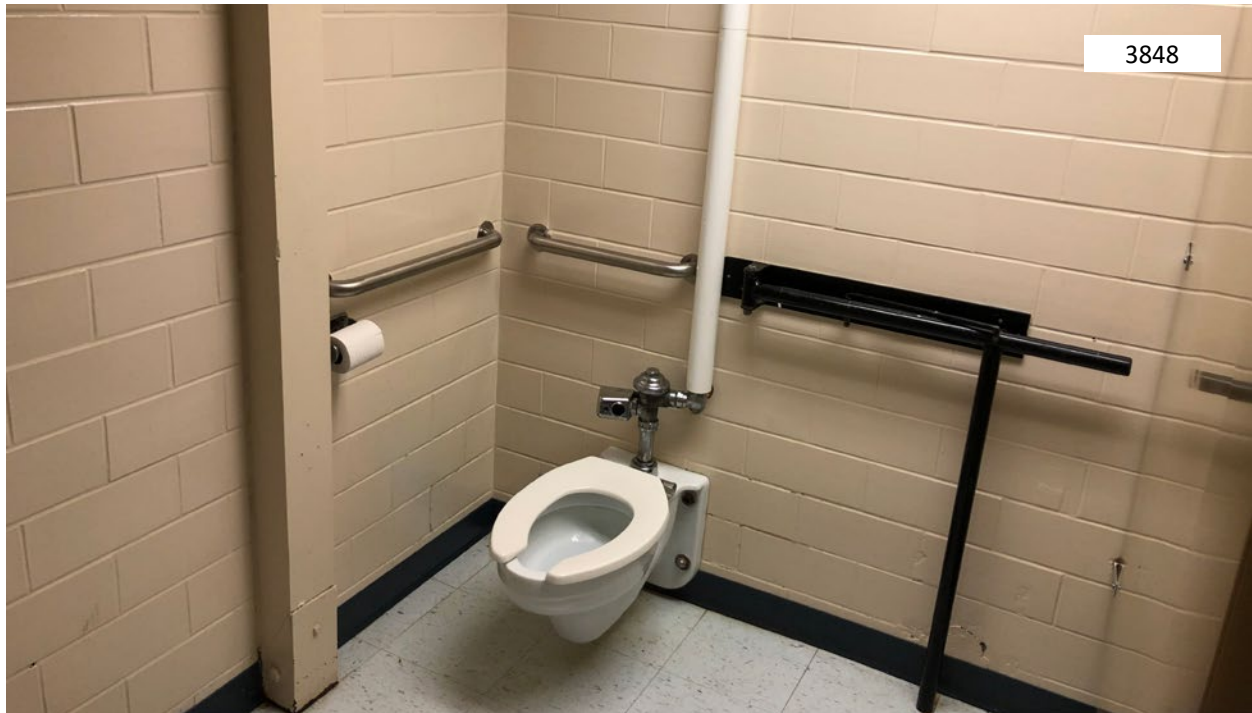
- Per the most recent energy code, the exit from the lunchroom needs vestibule doors that are currently missing.
- There is not an ADA accessible stall in the girl's restroom off of the lunchroom. In the boy's restroom, the ADA accessible stall does not meet regulations with grab bars or turning clearances.

There is not an ADA accessible stall in the girl's restroom off of the lunchroom. In the boy's restroom, the ADA accessible stall does not meet regulations with grab bars or turning clearances.

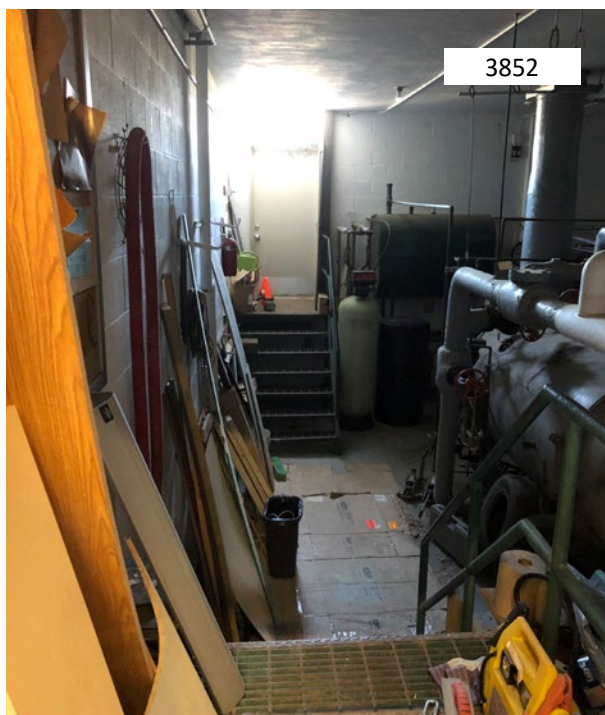
The boiler room is not accessible due to the stairs being the only entry point.

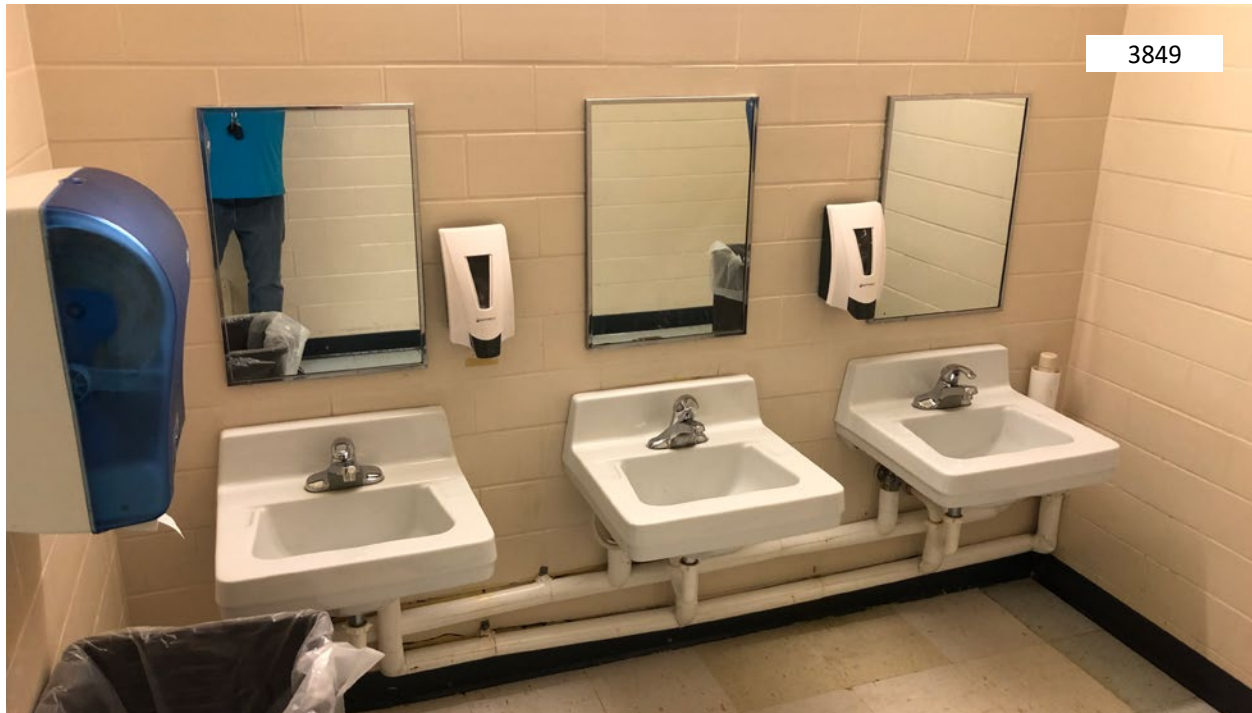
3849

In the restrooms next to the office, the sinks are too high and it is missing vertical grab bars.

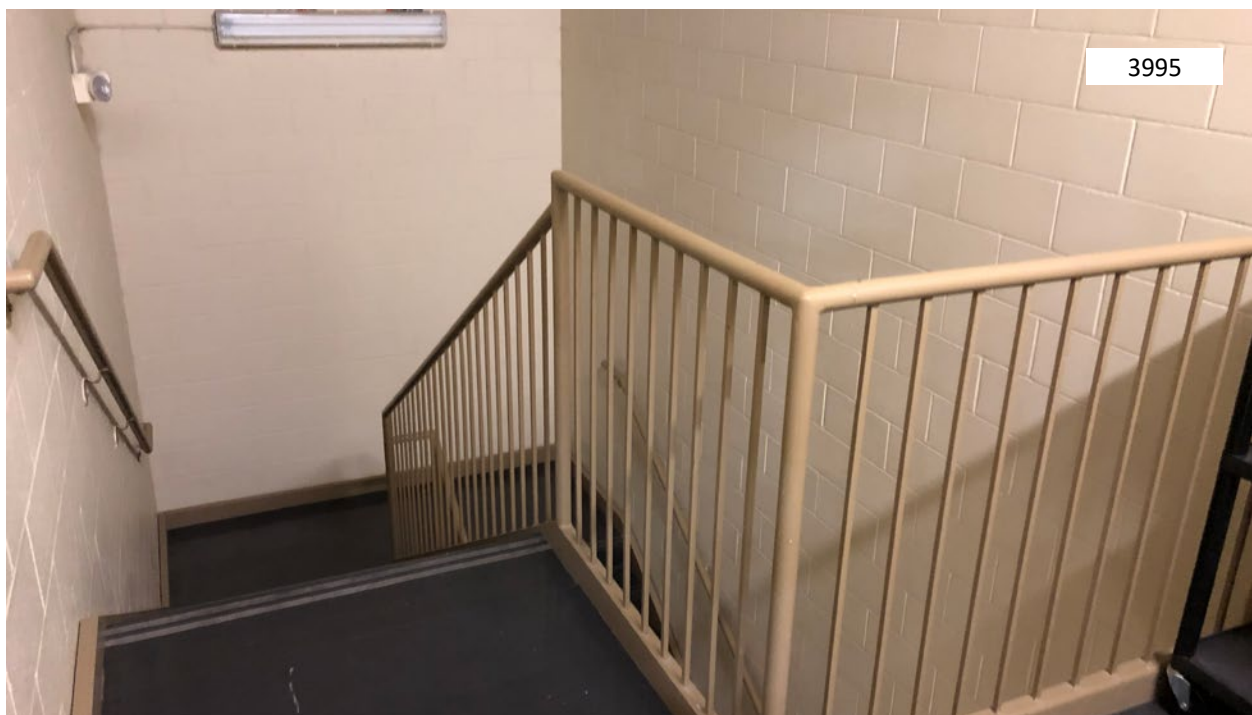
3995

There is no handrail on the guard rail on the stairs leading up to the mezzanine, and the guard railings are too short.

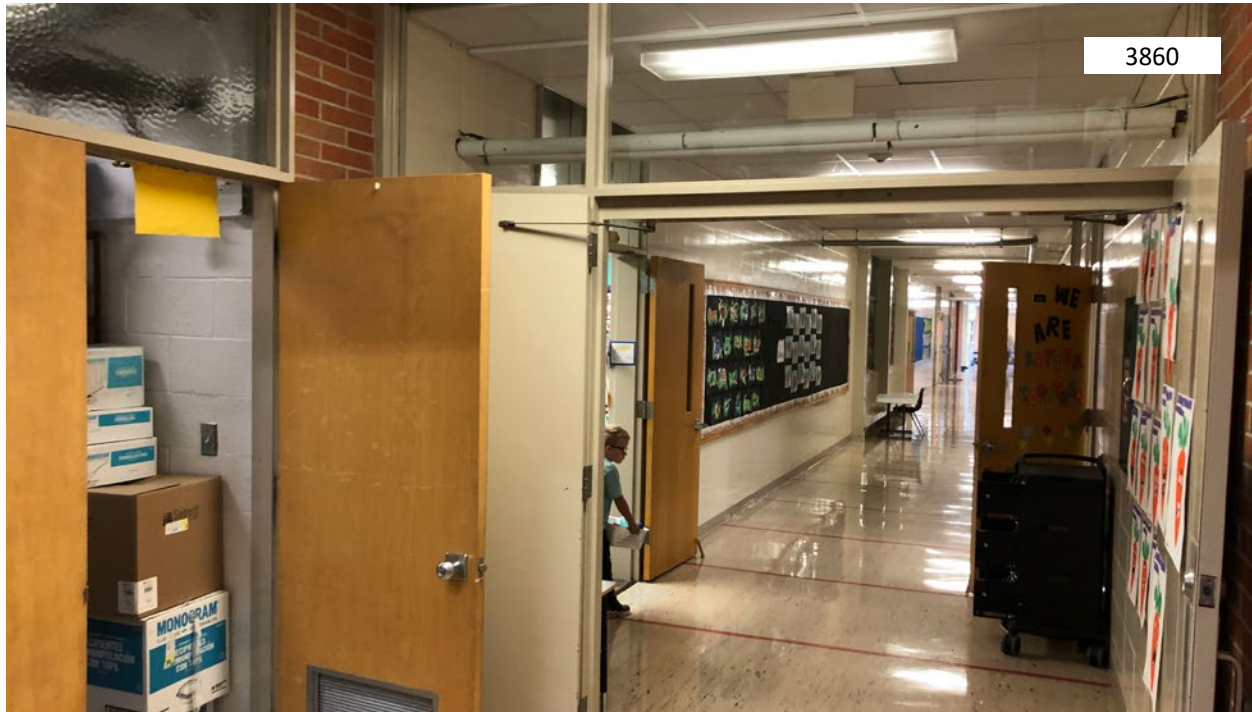
Due to the entire building not being equipped with a sprinkler system, corridor doors must be rated with rated hardware and no air movement from rooms into corridor is allowed.

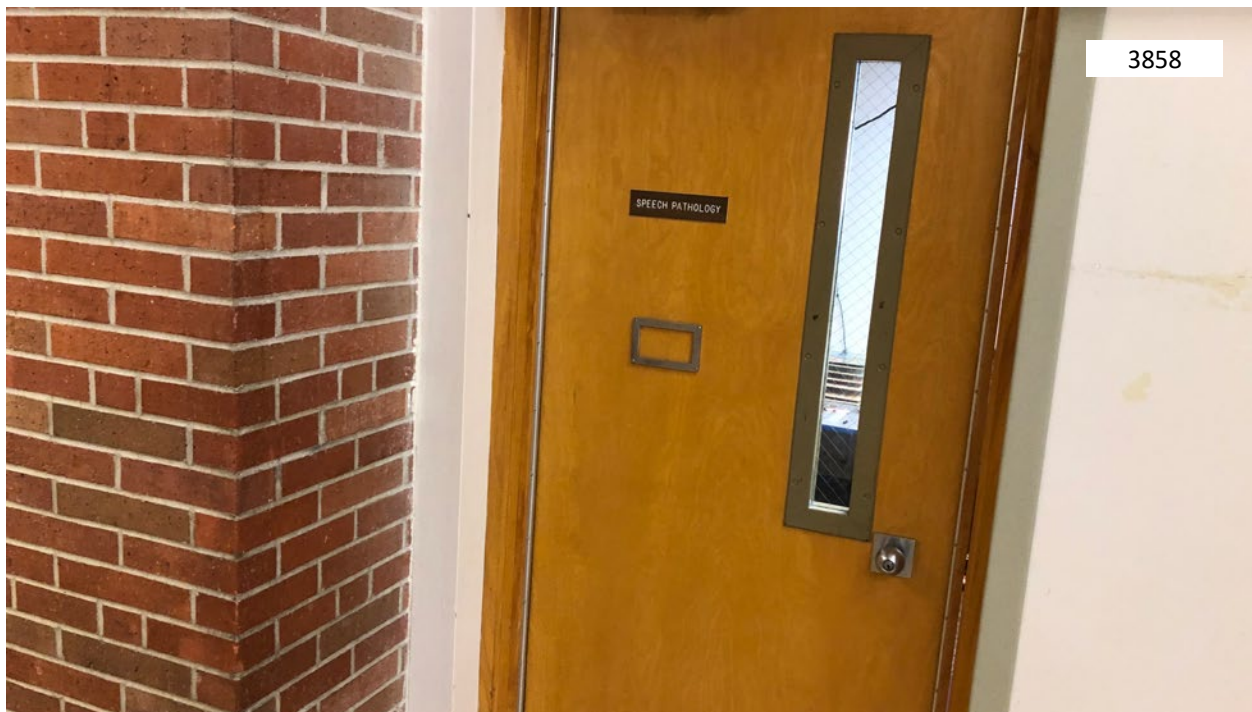
Throughout the facility, the door handles are round knobs and need to be the accessible lever design.

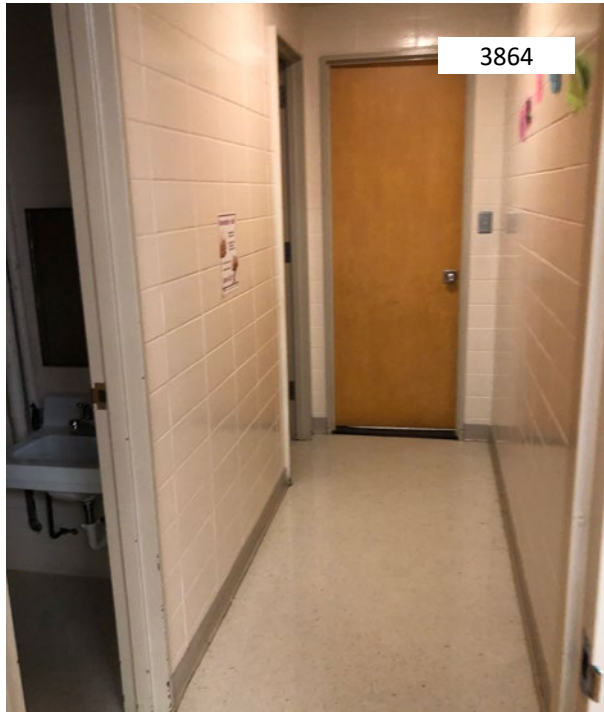
Corridor space within the Jack & Jill restrooms in the Kindergarten areas are too narrow and do not provide the required turn-around space.

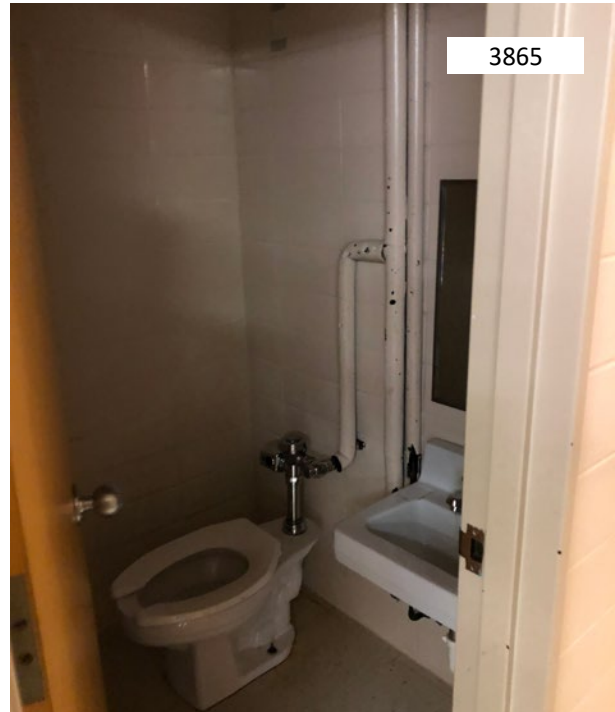
Vertical grab bars are missing at all toilets throughout the facility, excluding the fitness center.

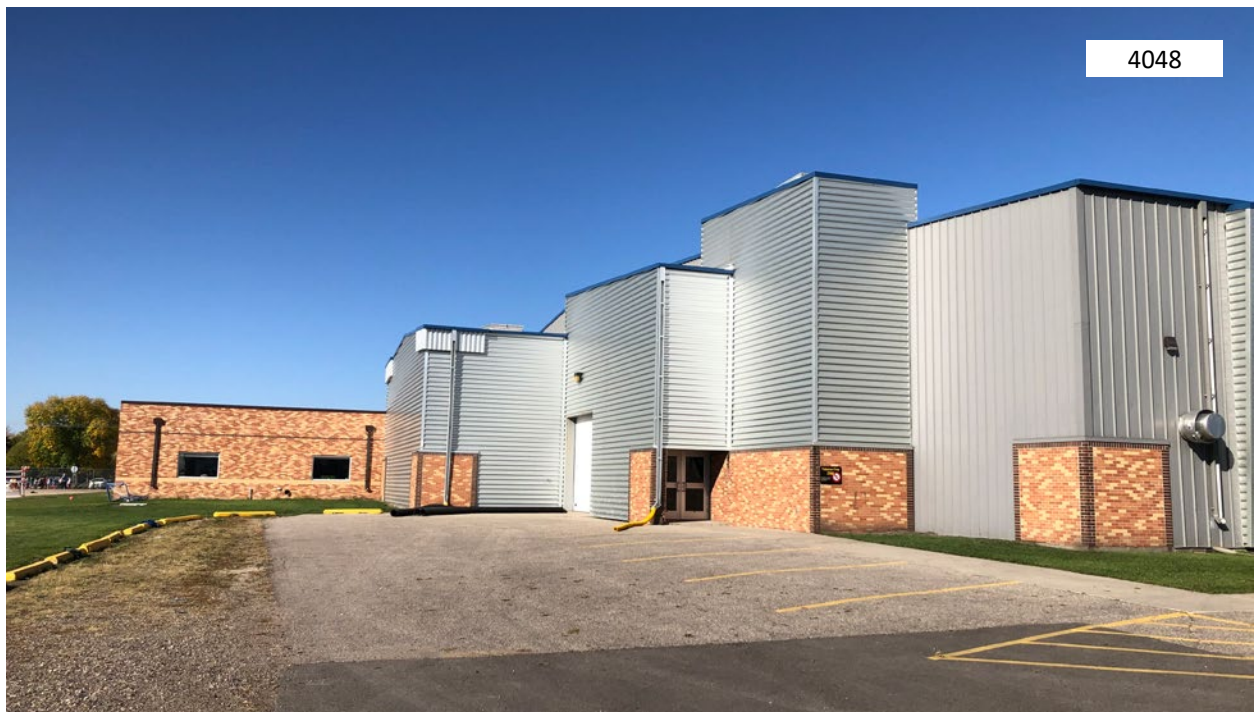
The southeast gym exit has pavement that is sunk around the stoop and is no longer accessible.

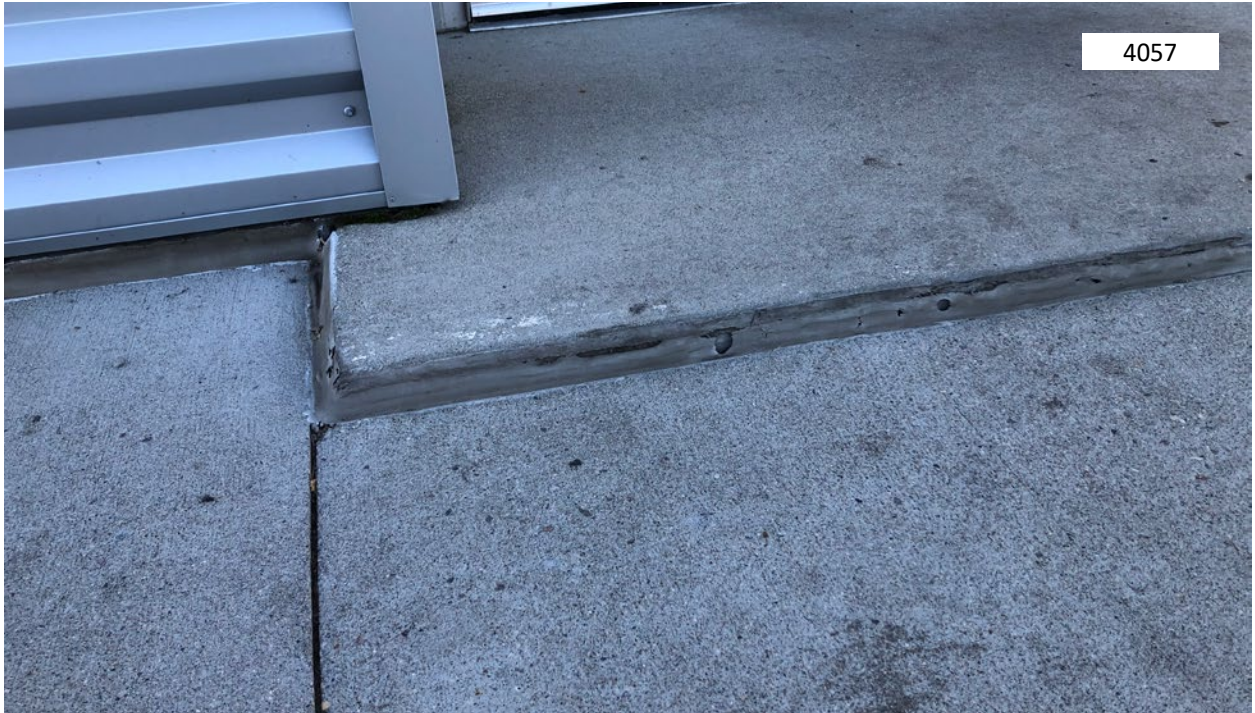
The fitness center exit has pavement that is sunk around the stoop and is no longer accessible.

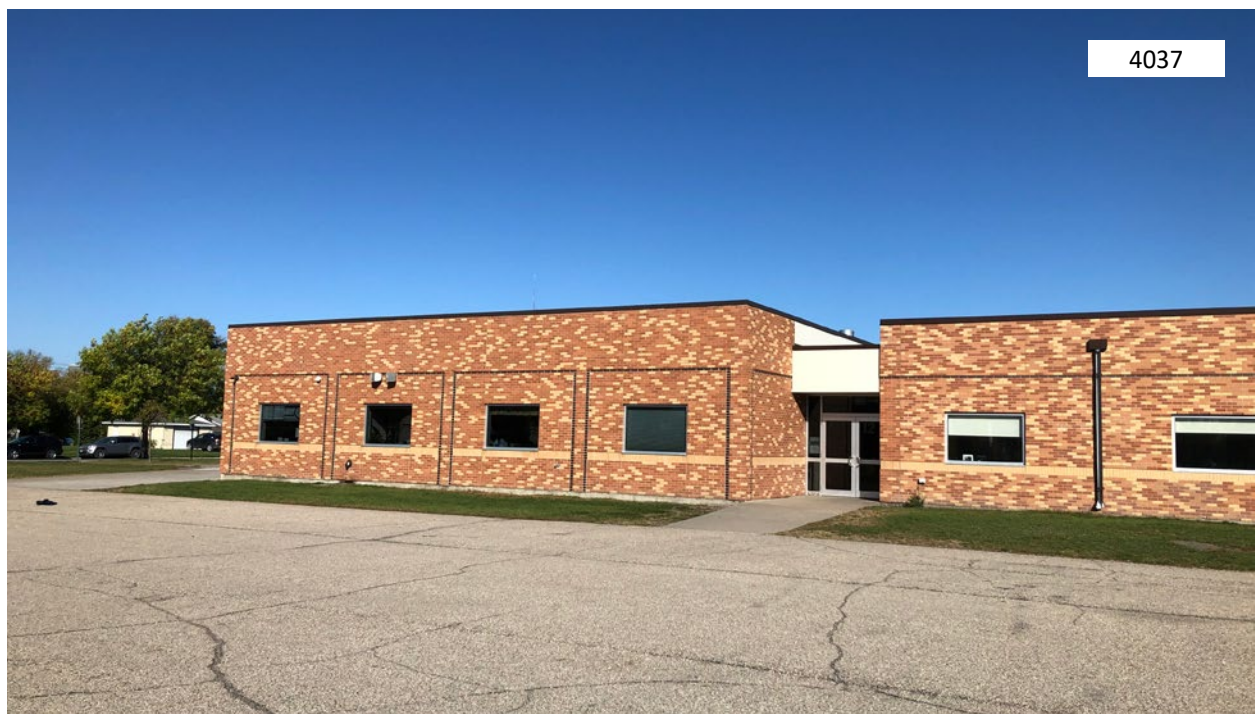
Surrounding asphalt pavement ranges from fair to good condition.

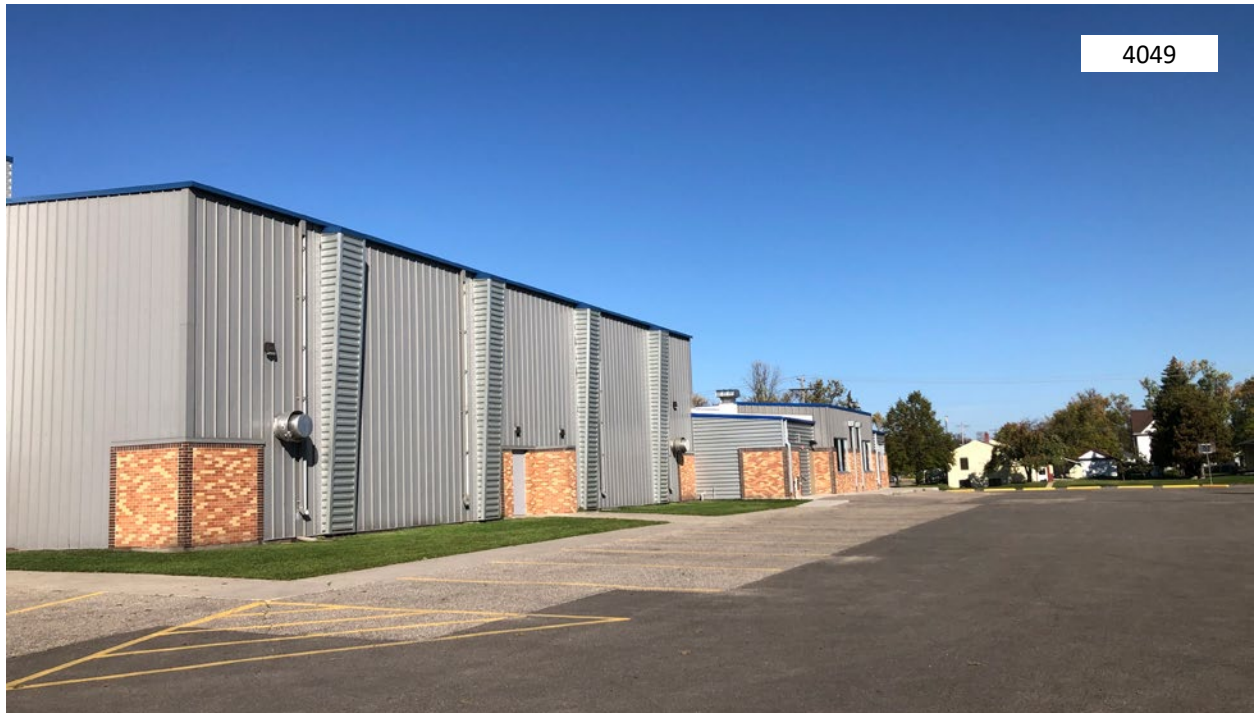
4049

Parking lot striping is in good condition and is easily distinguishable.

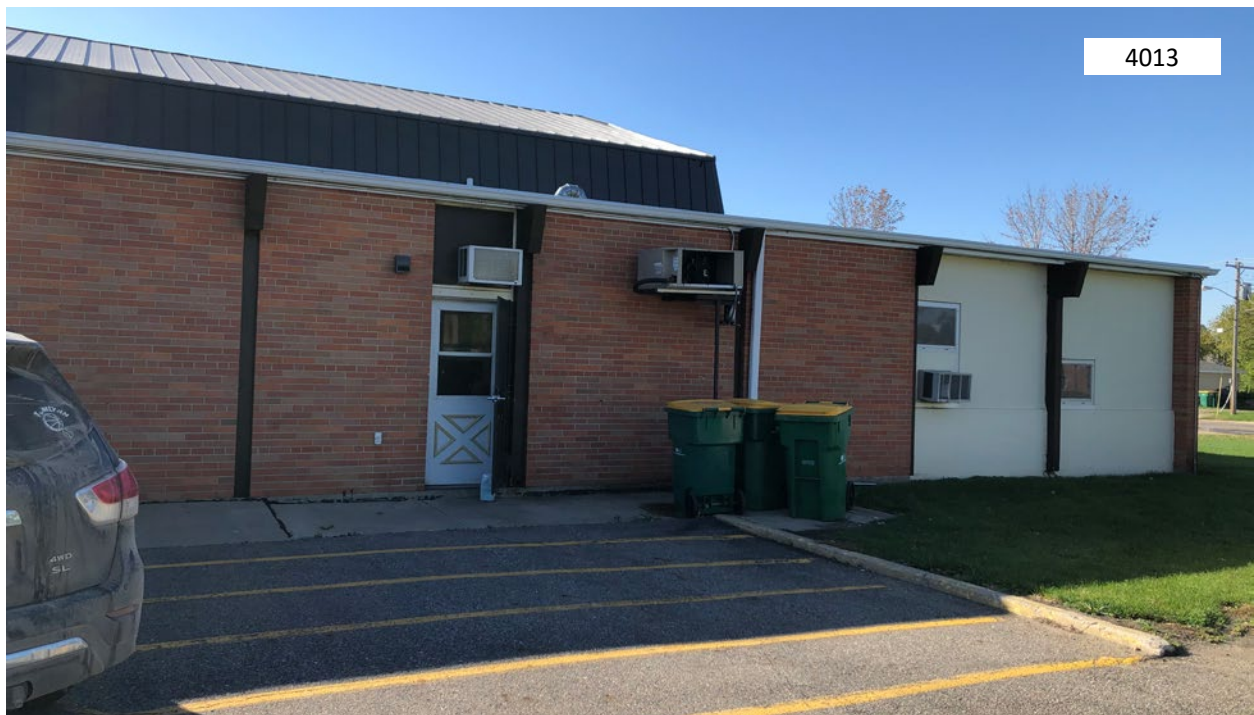
4013

Sidewalks along and around the original building along the northwest are heavily cracked and sunken around the kitchen entrance and should be replaced.

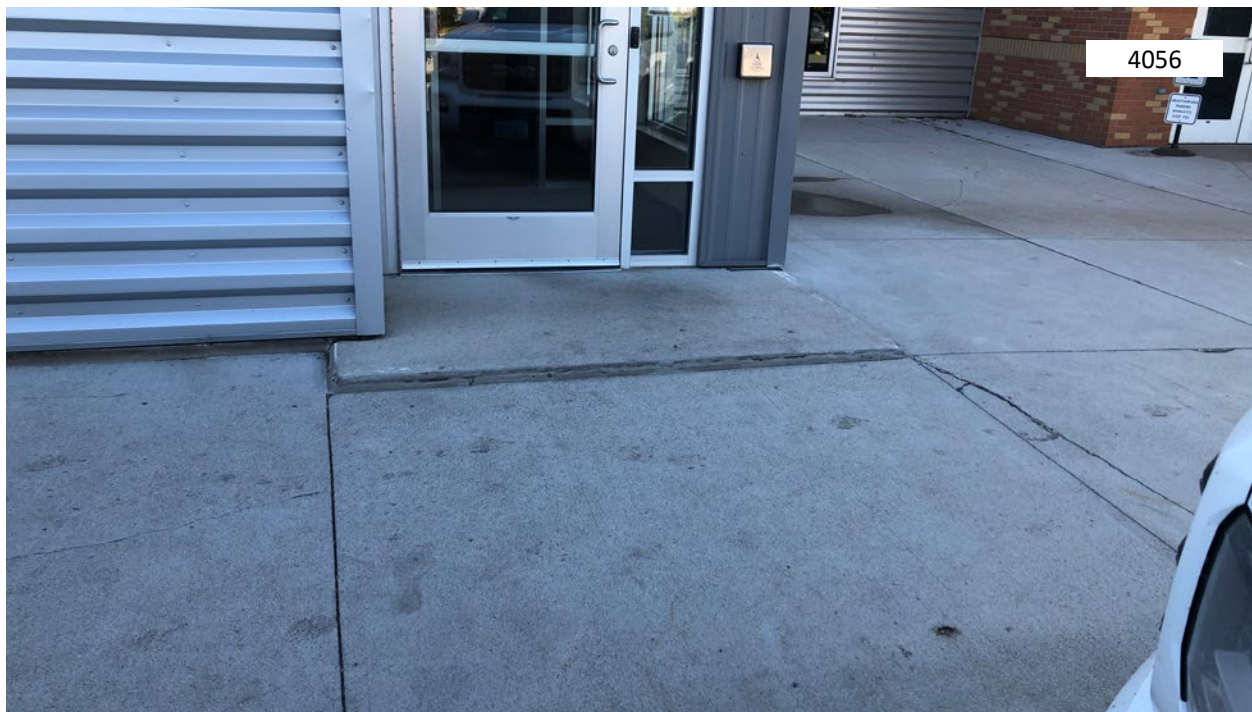
The main entrance into the fitness center is no longer handicap accessible due to the surrounding concrete sinking at the entrance stoop forming a ledge. This should be replaced.

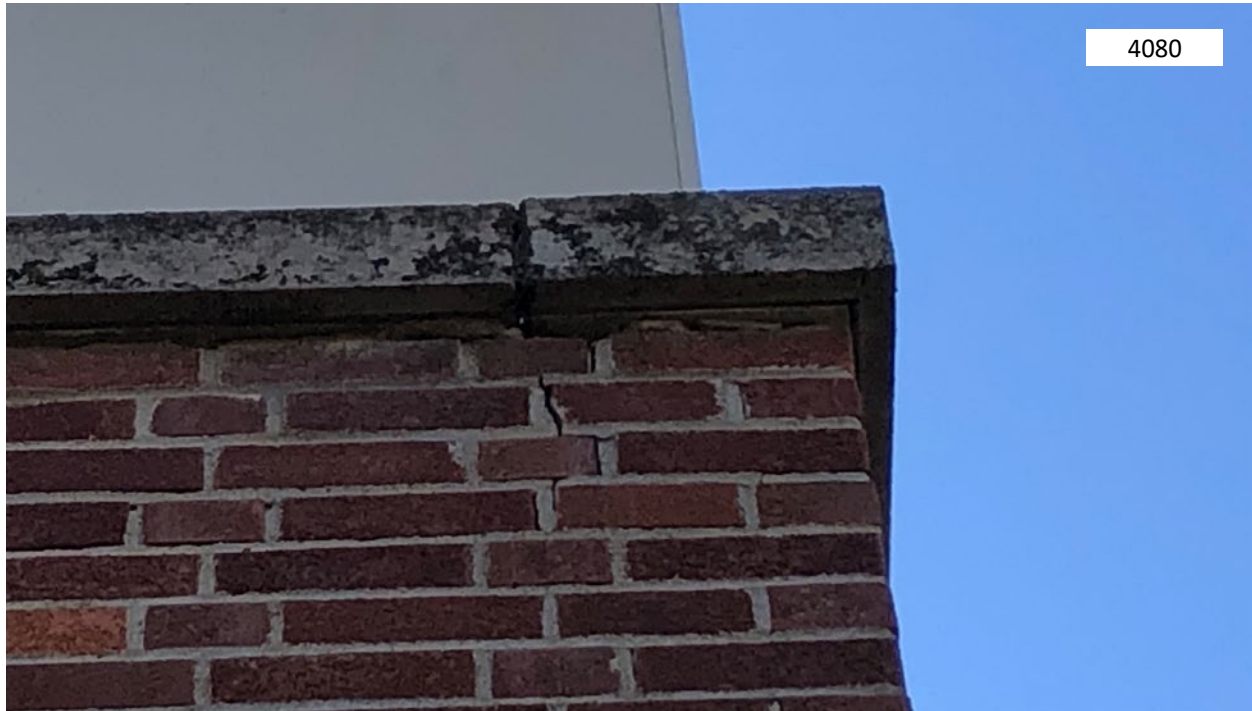
4080

Areas with exterior brick in most need of attention are on the northwest corner of the gymnasium and around the original 1894 boiler room.

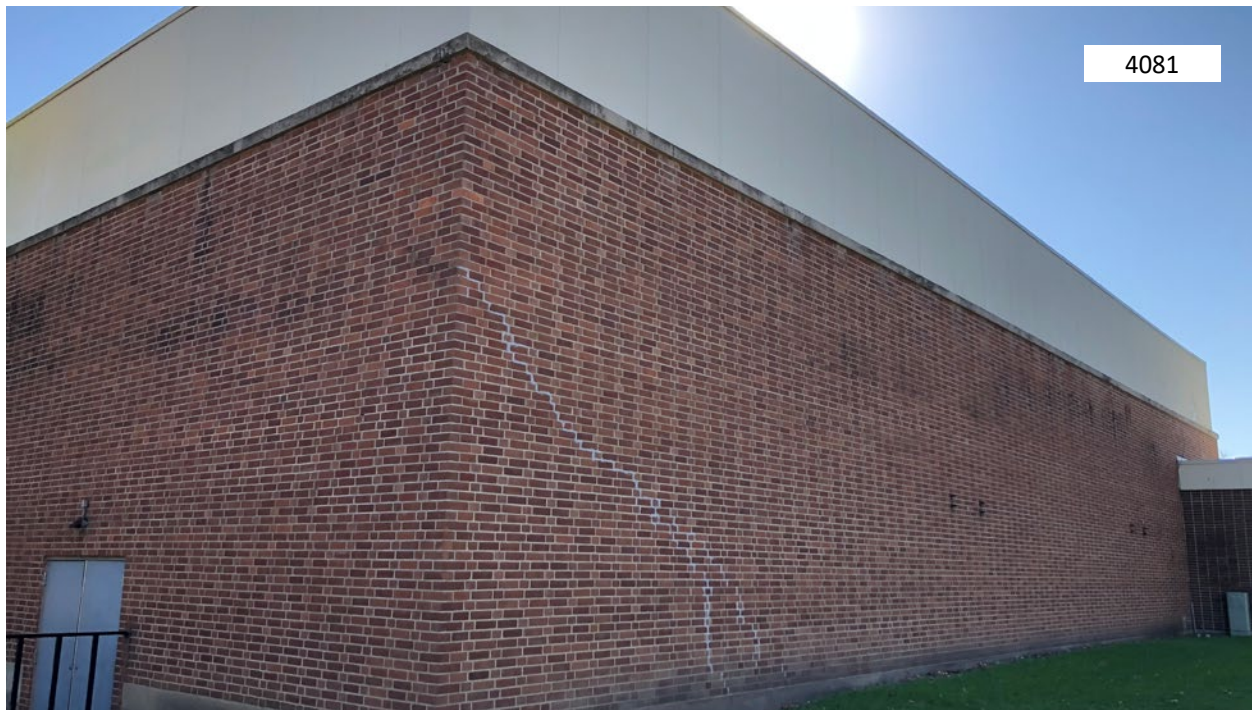
4081

Areas with exterior brick in most need of attention are on the northwest corner of the gymnasium and around the original 1894 boiler room.

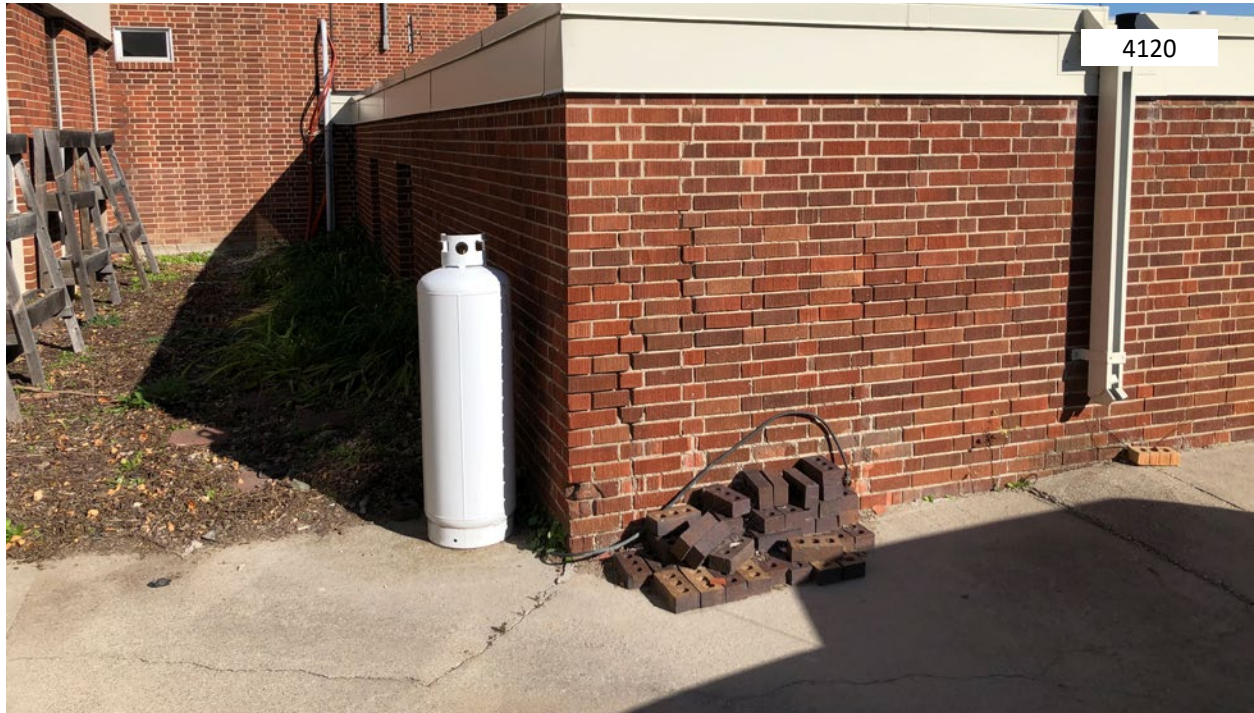
Areas with exterior brick in most need of attention are on the northwest corner of the gymnasium and around the original 1894 boiler room.

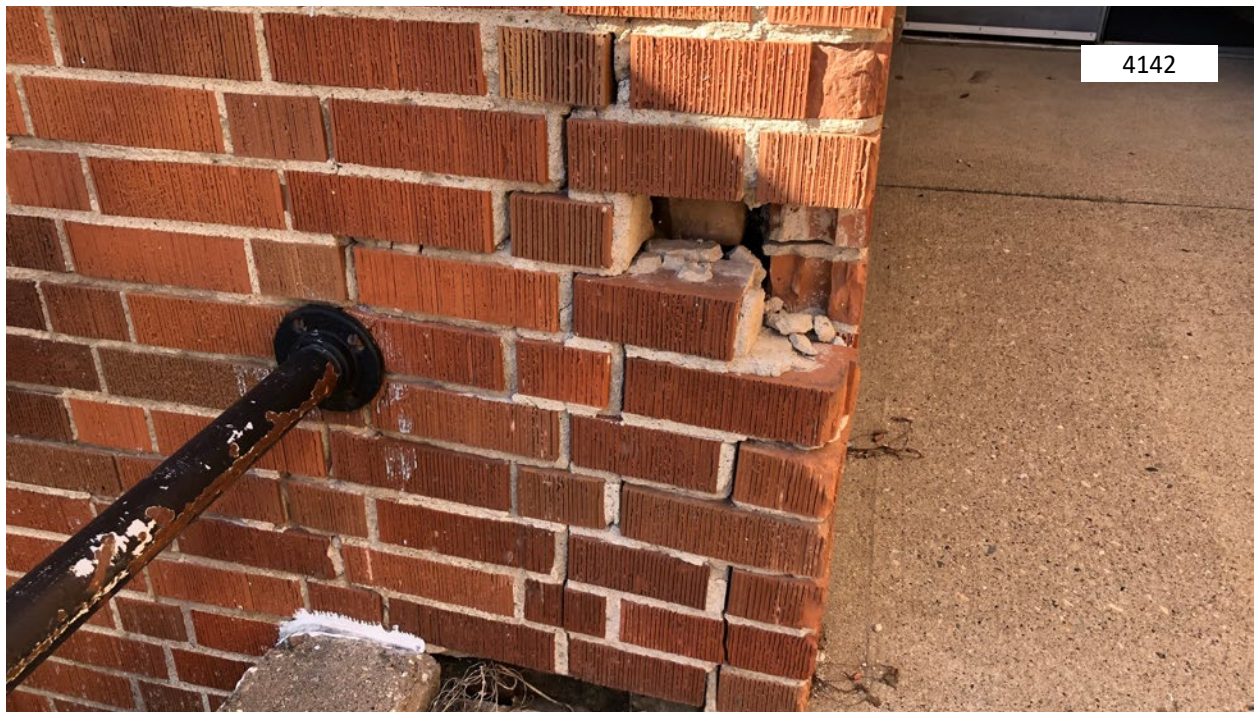
Areas with exterior brick in most need of attention are on the northwest corner of the gymnasium and around the original 1894 boiler room.

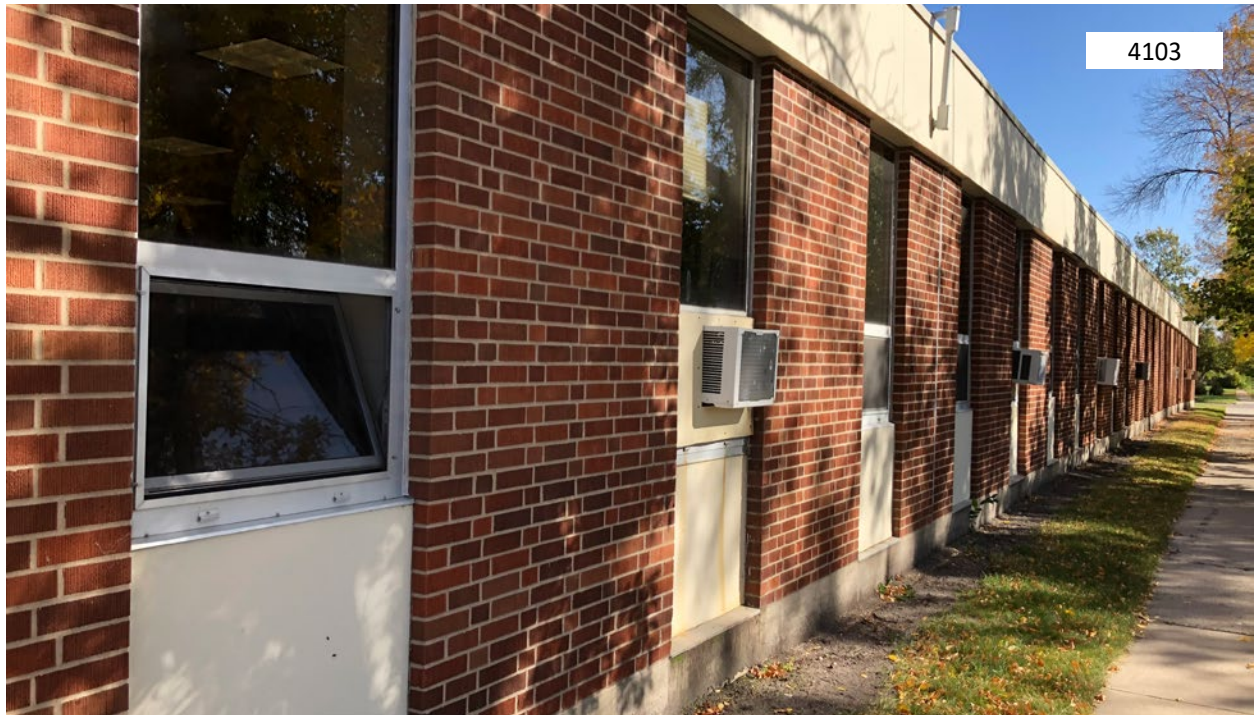
4103

The exterior windows throughout the building are past their life expectancy and need replacing.

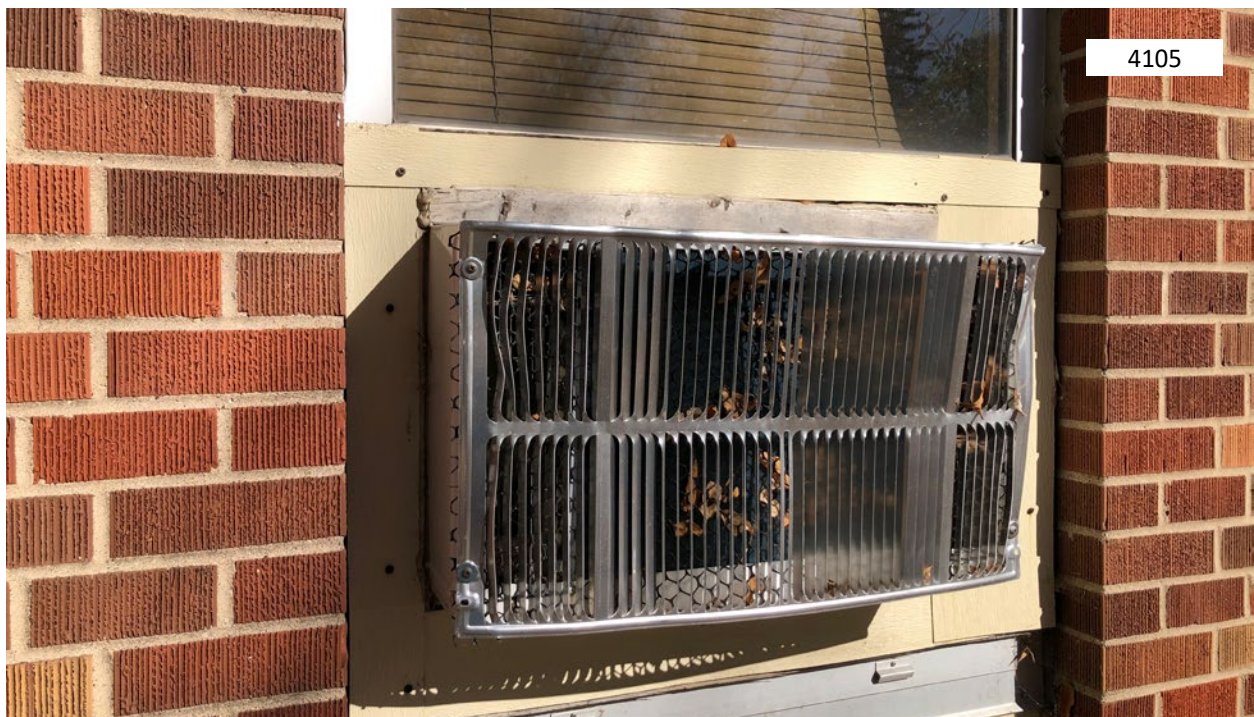
4105

The exterior windows throughout the building are past their life expectancy and need replacing.

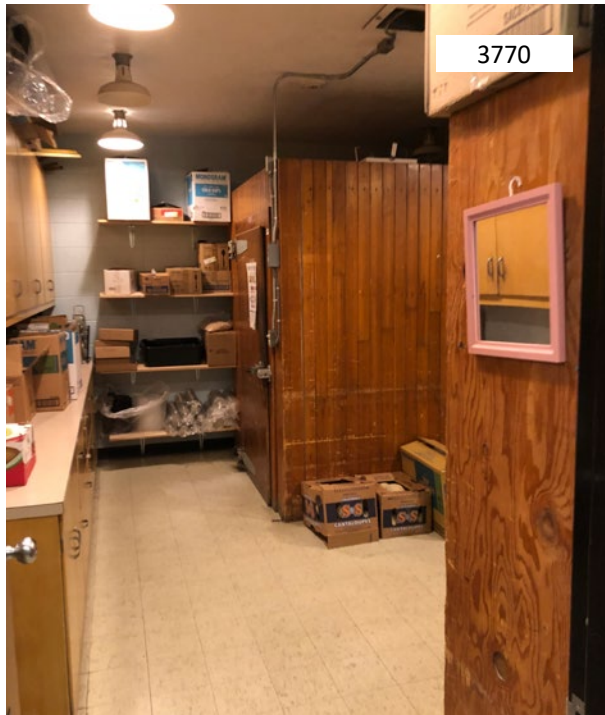
The kitchen is small with many dated pieces of equipment, specifically the coolers and freezers.

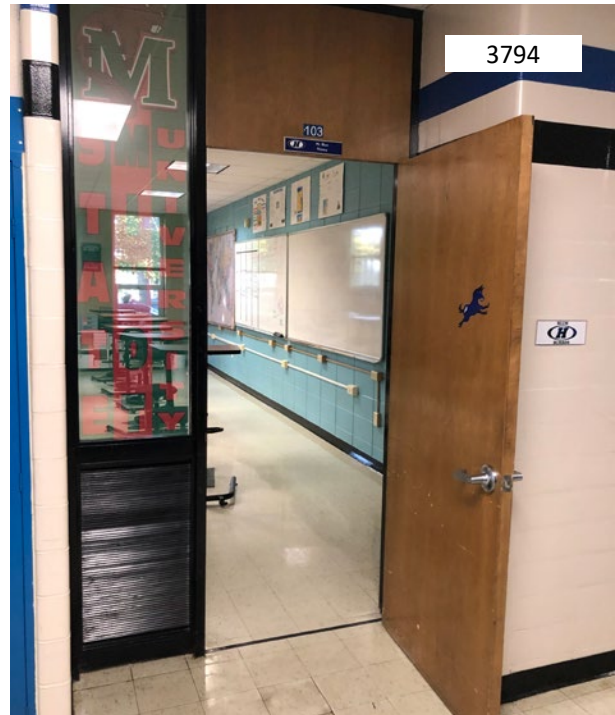
The flooring throughout the building is either 9x9 asbestos-based VCT or 12x12 VCT and it is past its life expectancy.

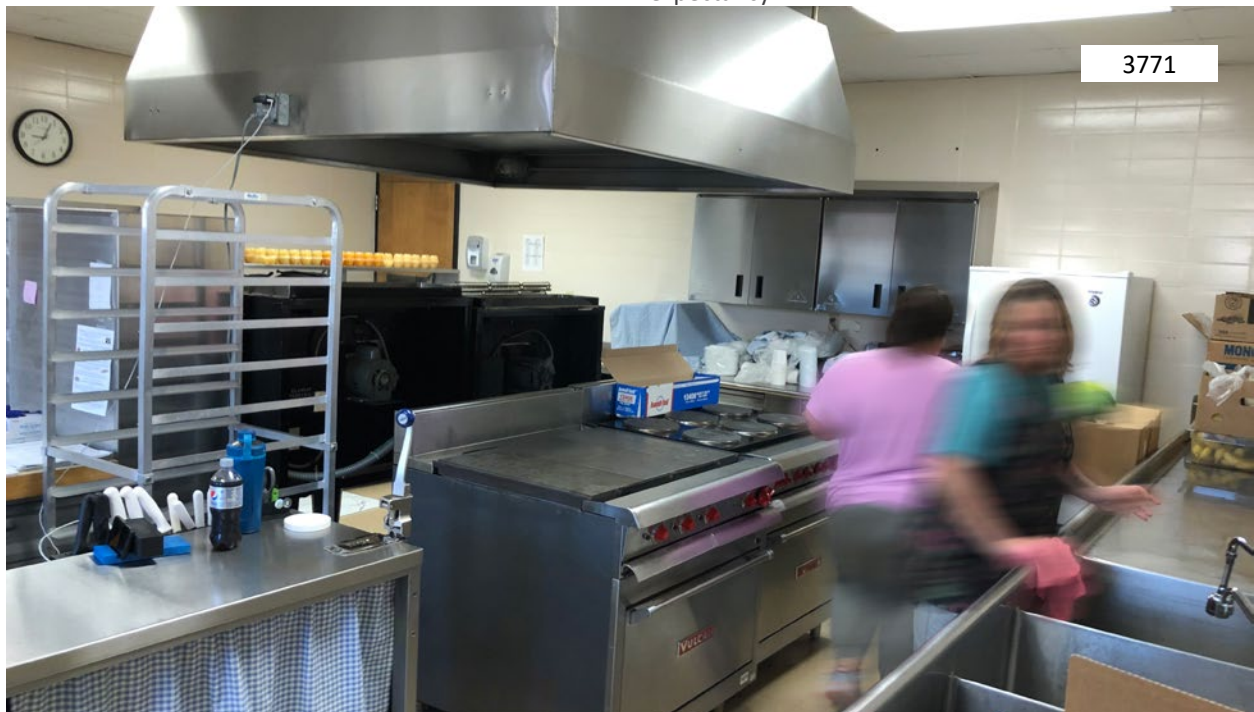
The kitchen is small with many dated pieces of equipment, specifically the coolers and freezers.
