ICON
ARCHITECTURAL GROUP

FACILITY ASSESSMENT FOR HILLSBORO PUBLIC SCHOOLS

Hillsboro, ND | April 2022

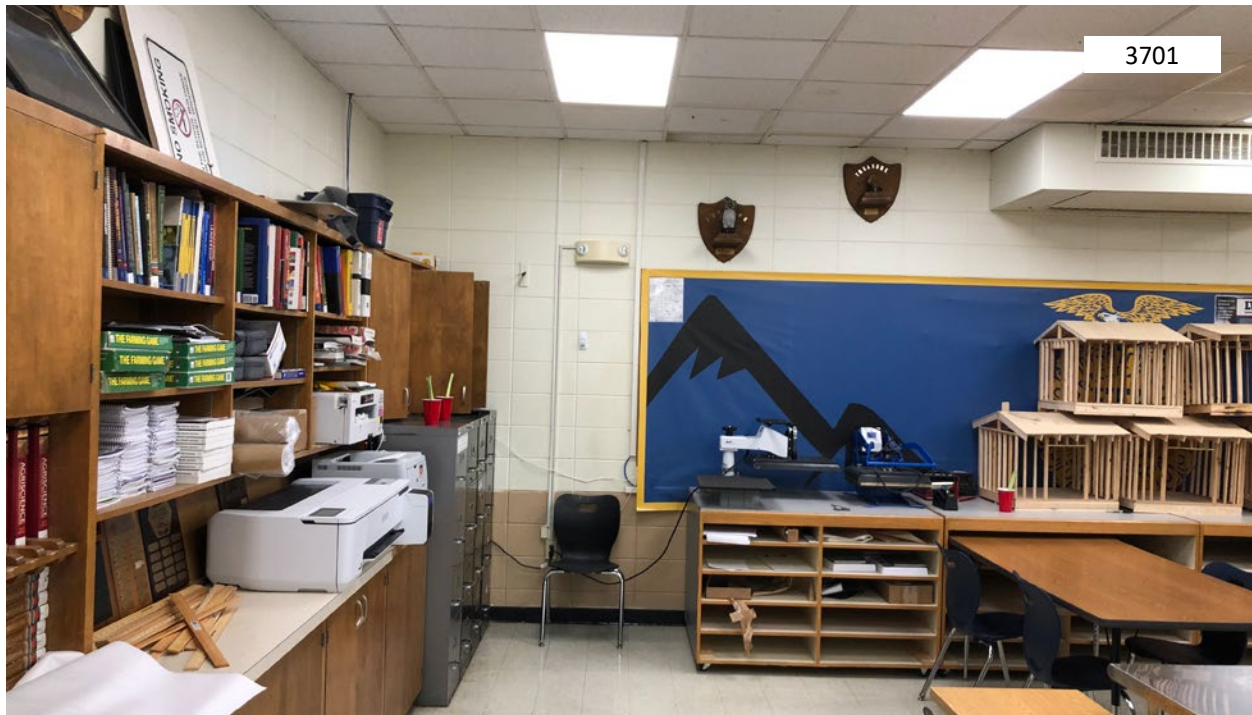
It is unknown if the carpeting was placed over existing VCT. Ceilings are manly 2x2 acoustic ceiling tile.

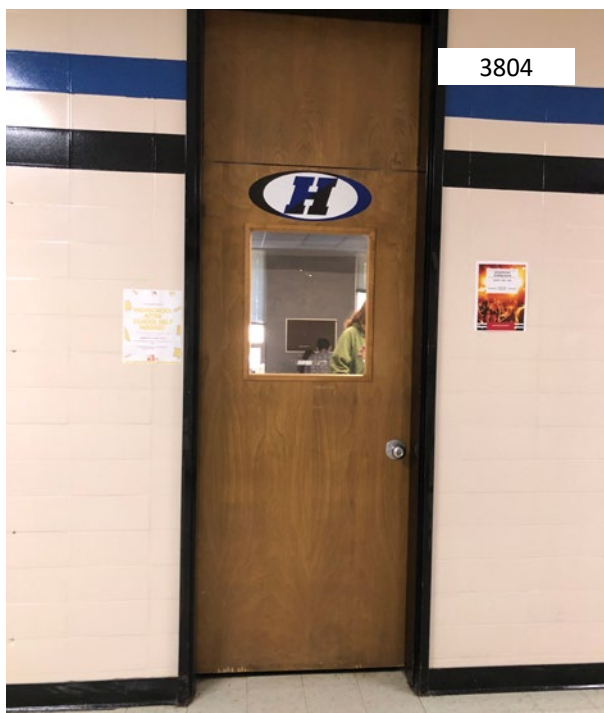
Wood doors and hardware throughout the facility are past their life expectancy.

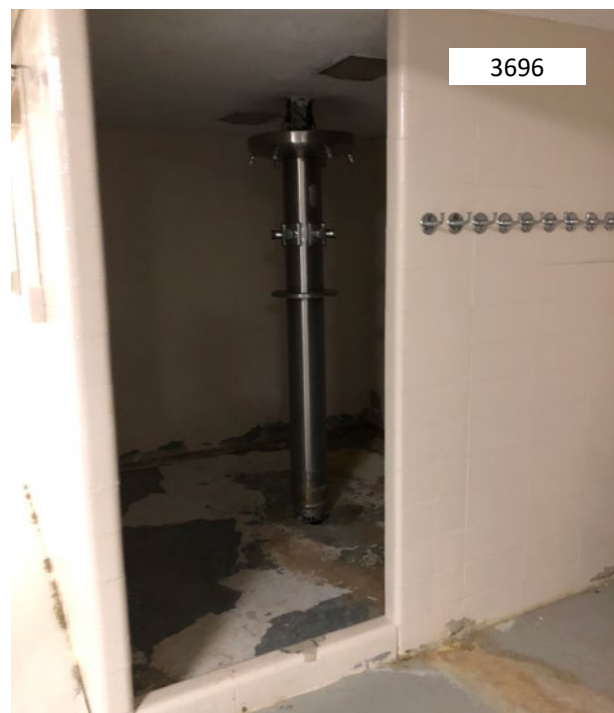
. All finishes within the girl's locker room are past their life expectancy and requires renovating.

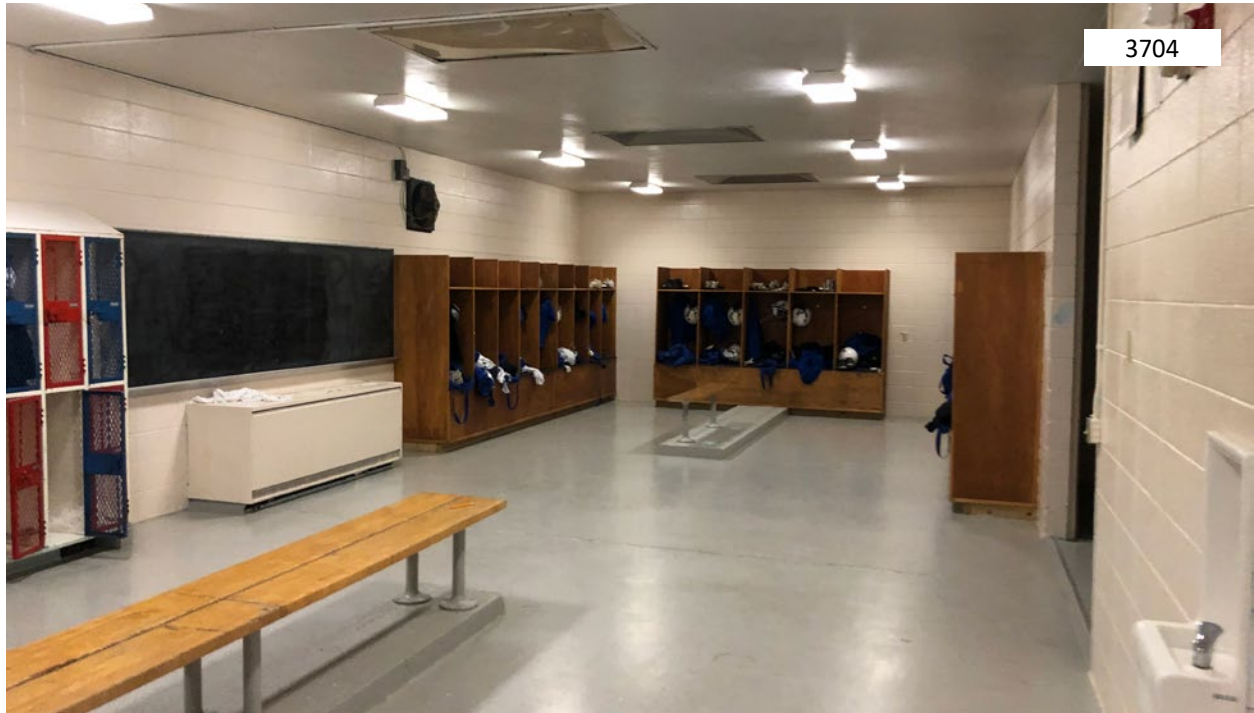
Lockers, finishes, flooring, and showering facilities within the boy's locker room needs renovating.

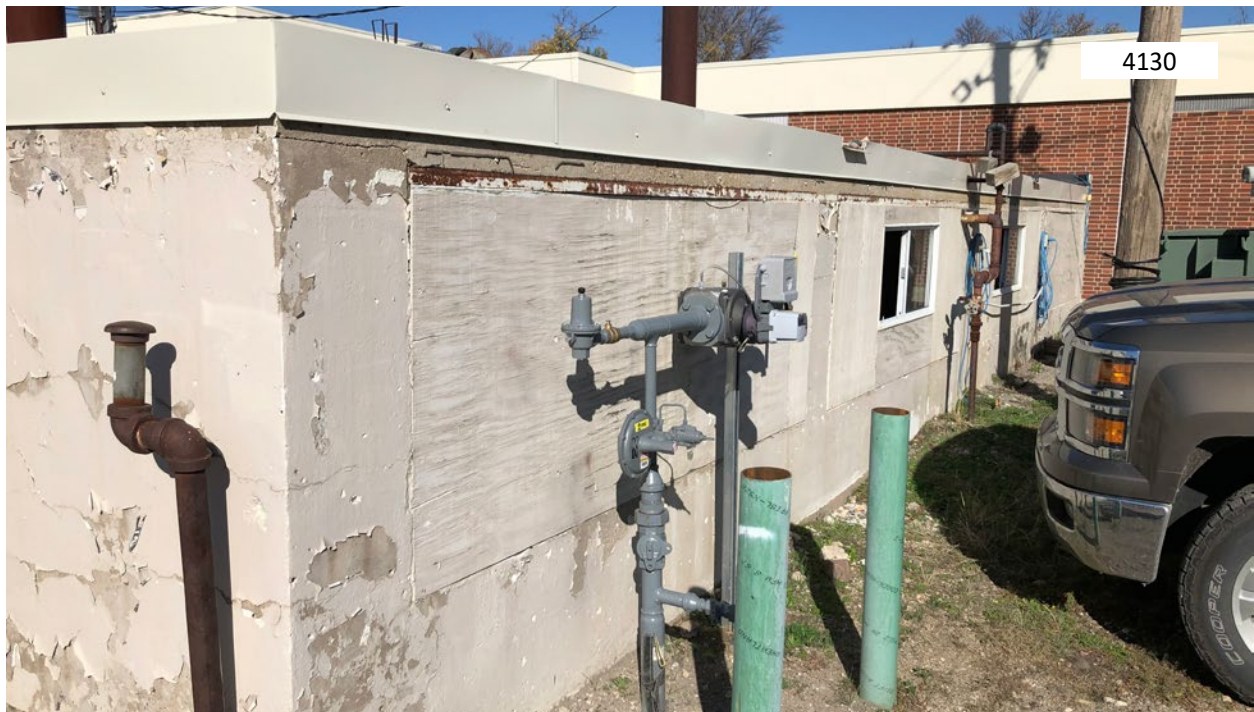
All portions of the original 1984 school are in poor condition and in need of a complete renovation or replacement.

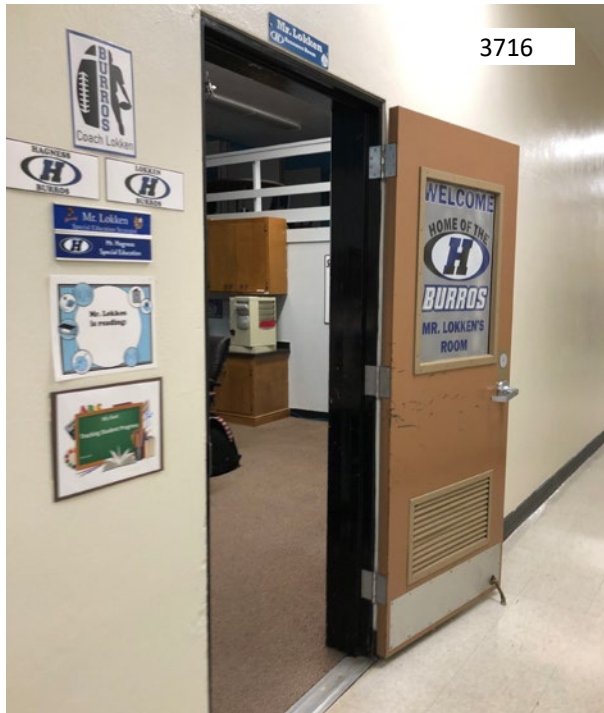
Corridor doors not rated or have return grills for air exchange. Fire rated door hardware is not present on corridor doors.

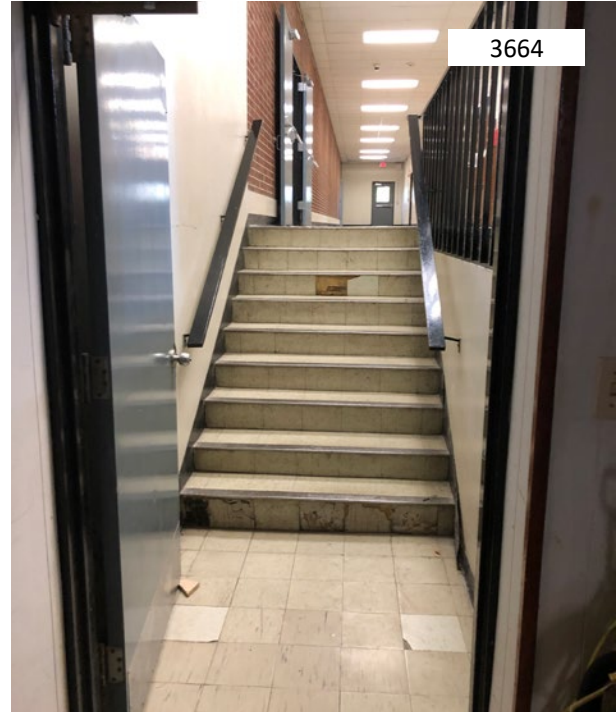
The handrails and guard railings throughout all stairs within the facility do not meet accessibility requirements.

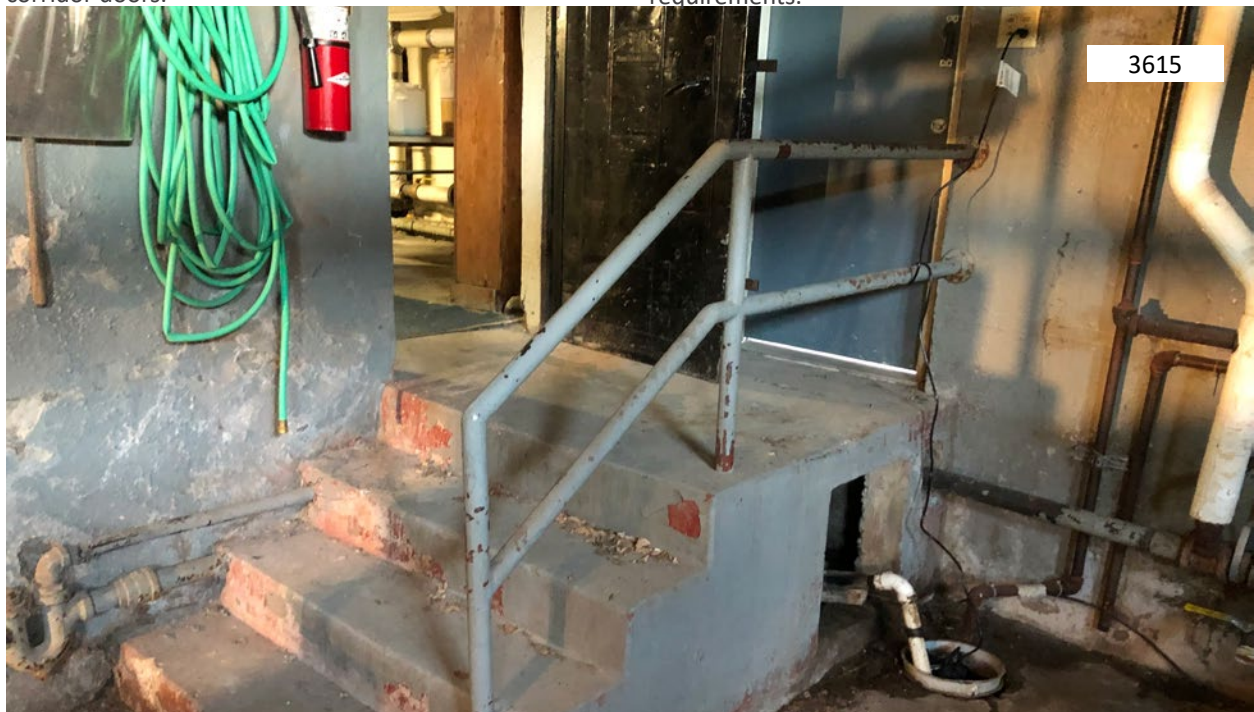
The boiler room is in a lower level and is not accessible from either school or from the outside.

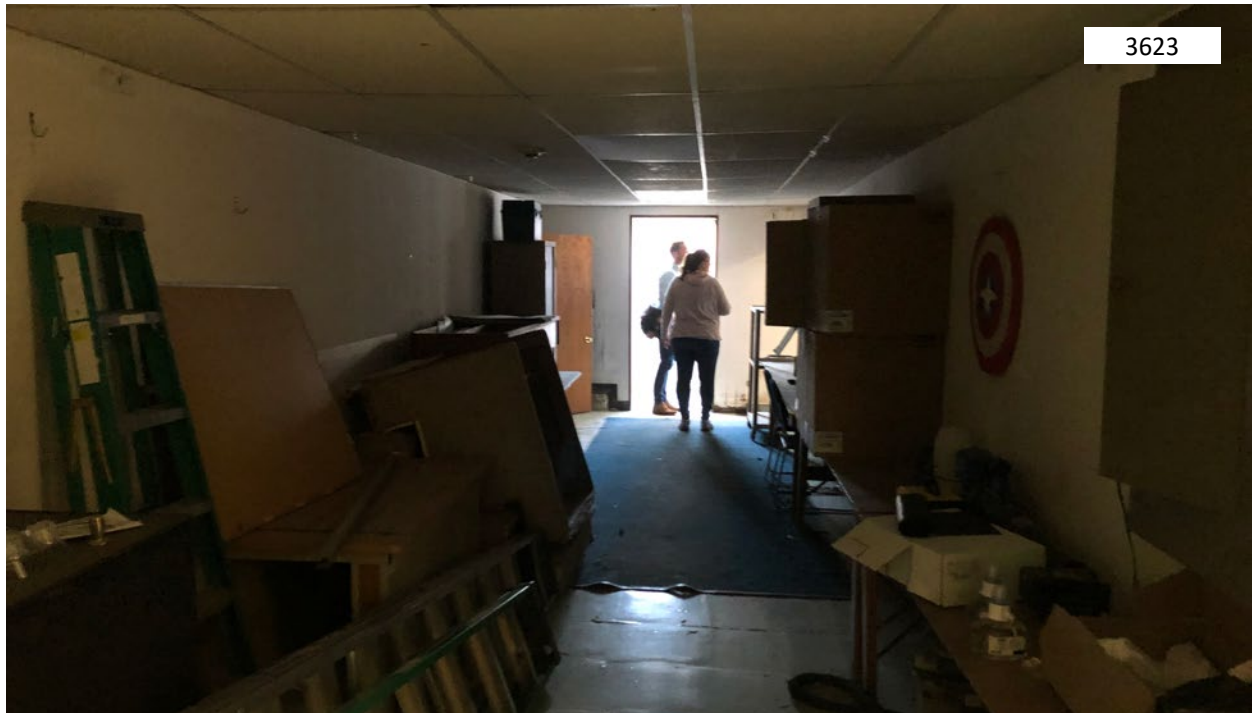
3623

The art supplies and kiln room are in a lower level and is not ADA accessible due to it only having stairs.

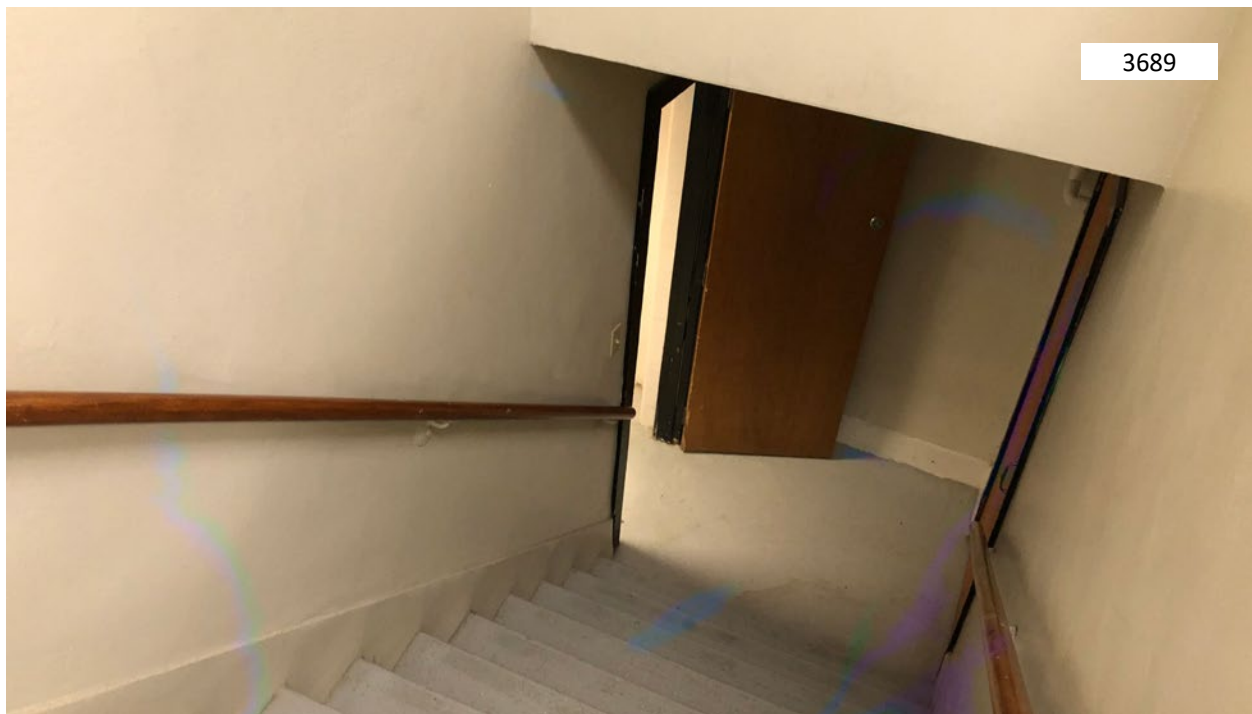
3689

The girl's locker room is underneath the stage and is not accessible due to only having stairs. The second exit to the west is locked shut, this does not allow for the minimum accessible means of egress and is very unsafe under emergency conditions.

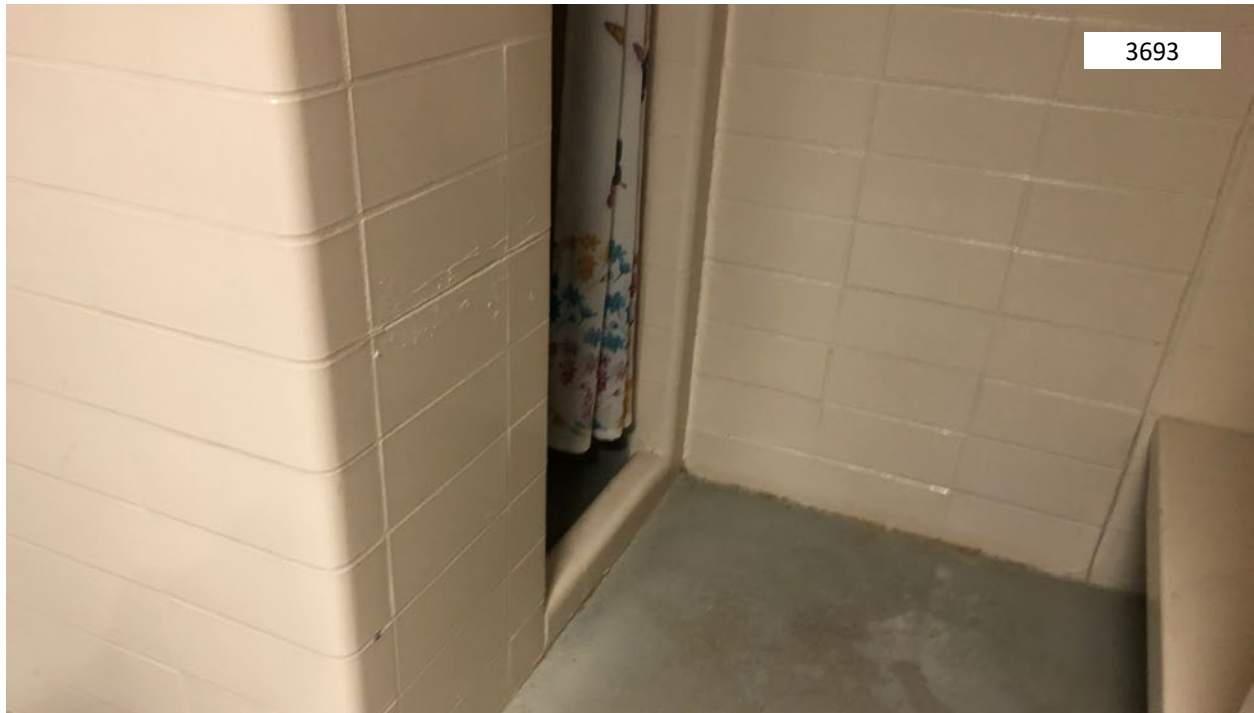
The locker room is not ADA accessible including the showers (curb in front of the shower), toilets (no grab bars, turning clearances), and sinks (clearance issues).

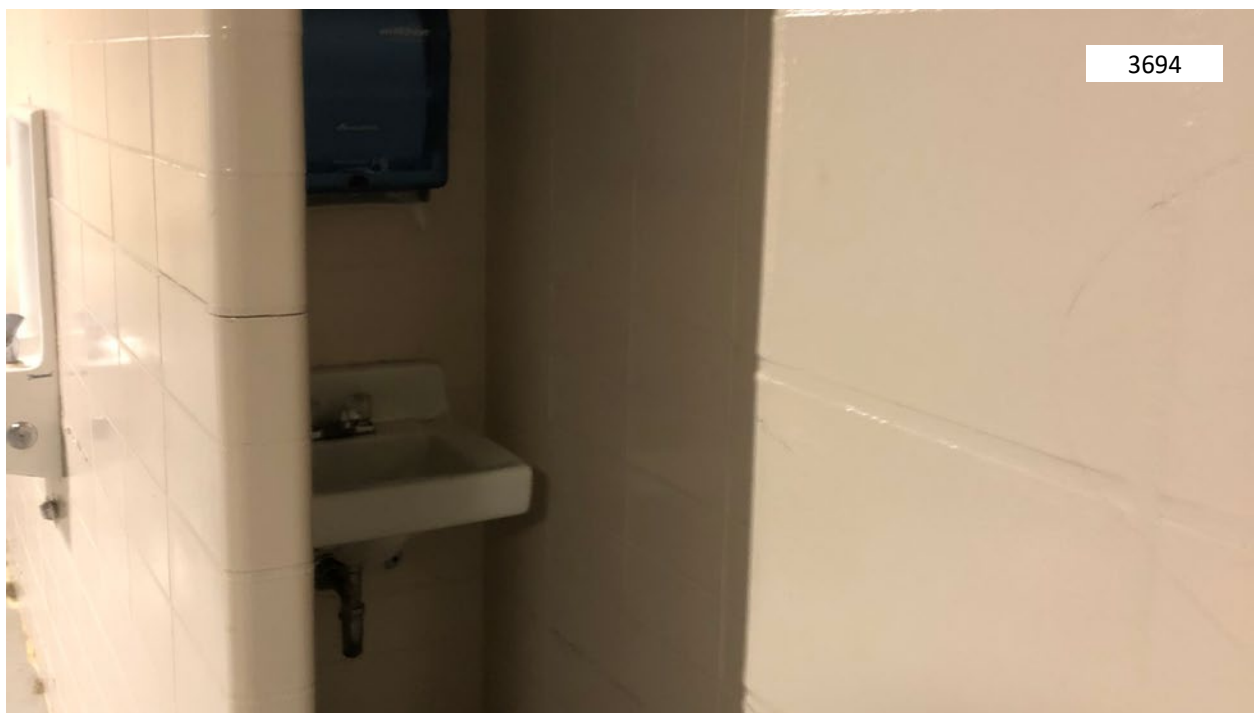
The locker room is not ADA accessible including the showers (curb in front of the shower), toilets (no grab bars, turning clearances), and sinks (clearance issues).

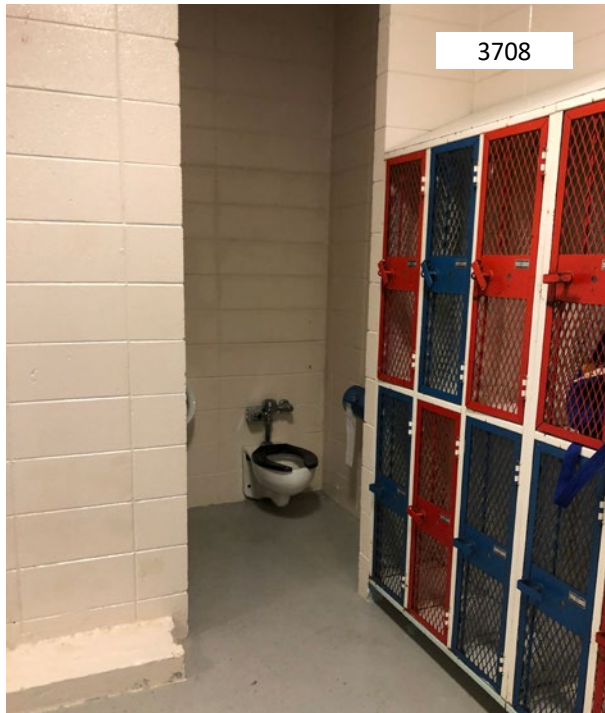
Boy's locker room is missing accessible toilet.

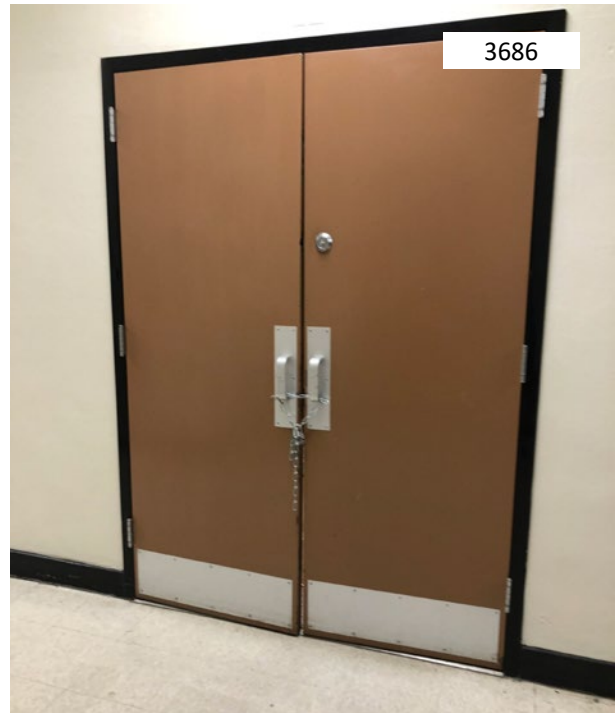
Multiple exits from the gymnasium are chained or padlocked shut and is very unsafe under emergency conditions.

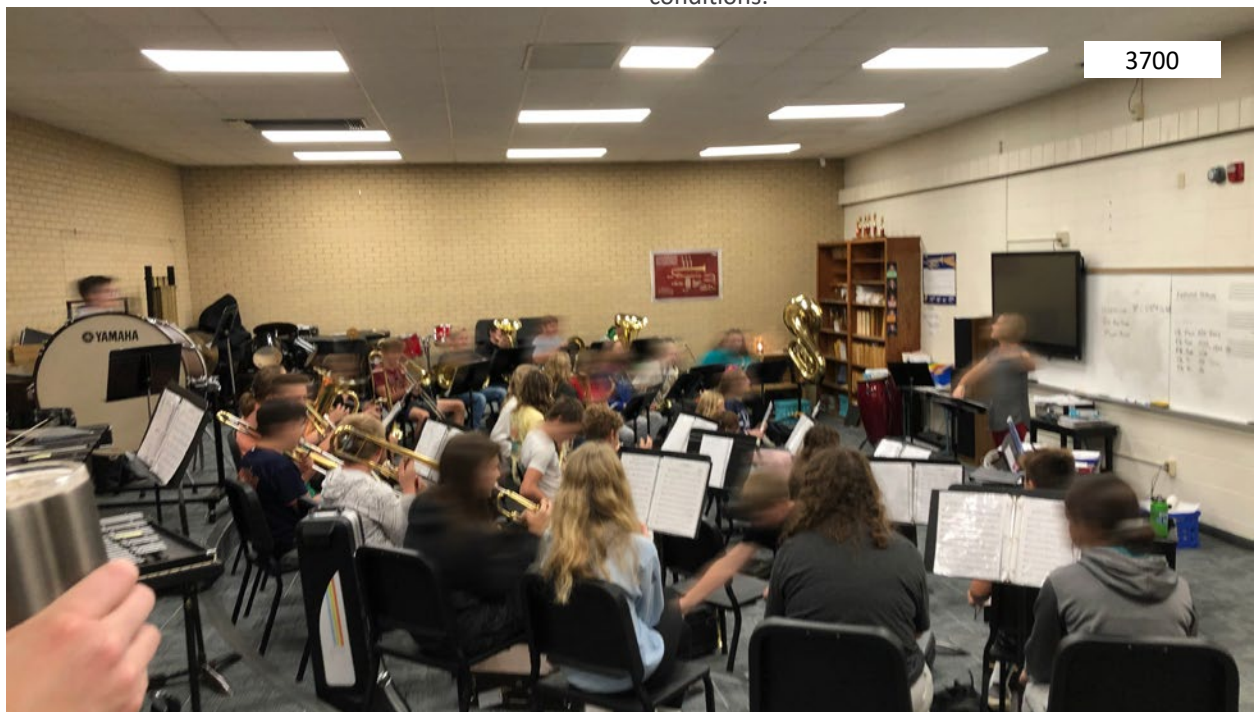
Music room enters to upper tier area and there is no ramp down to the main level.

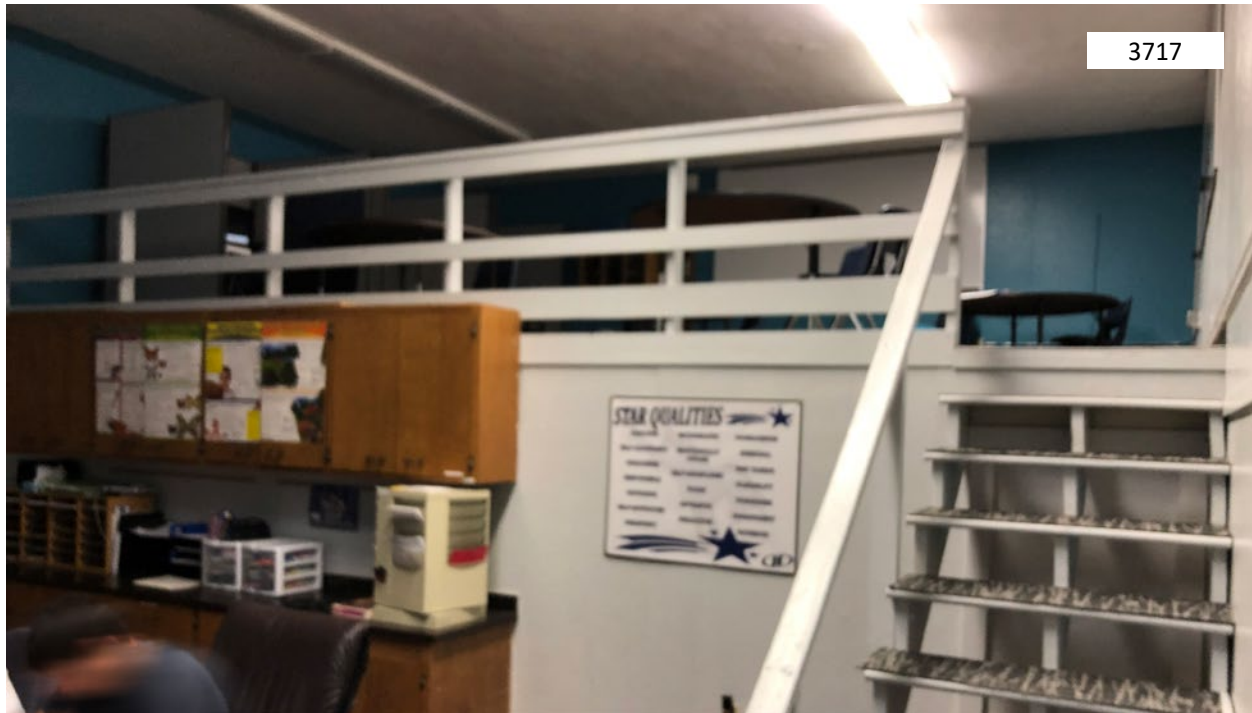
The special education room has a second level and is constructed of wood (not permitted in a 2B noncombustible construction building), and is not accessible with only stairs.

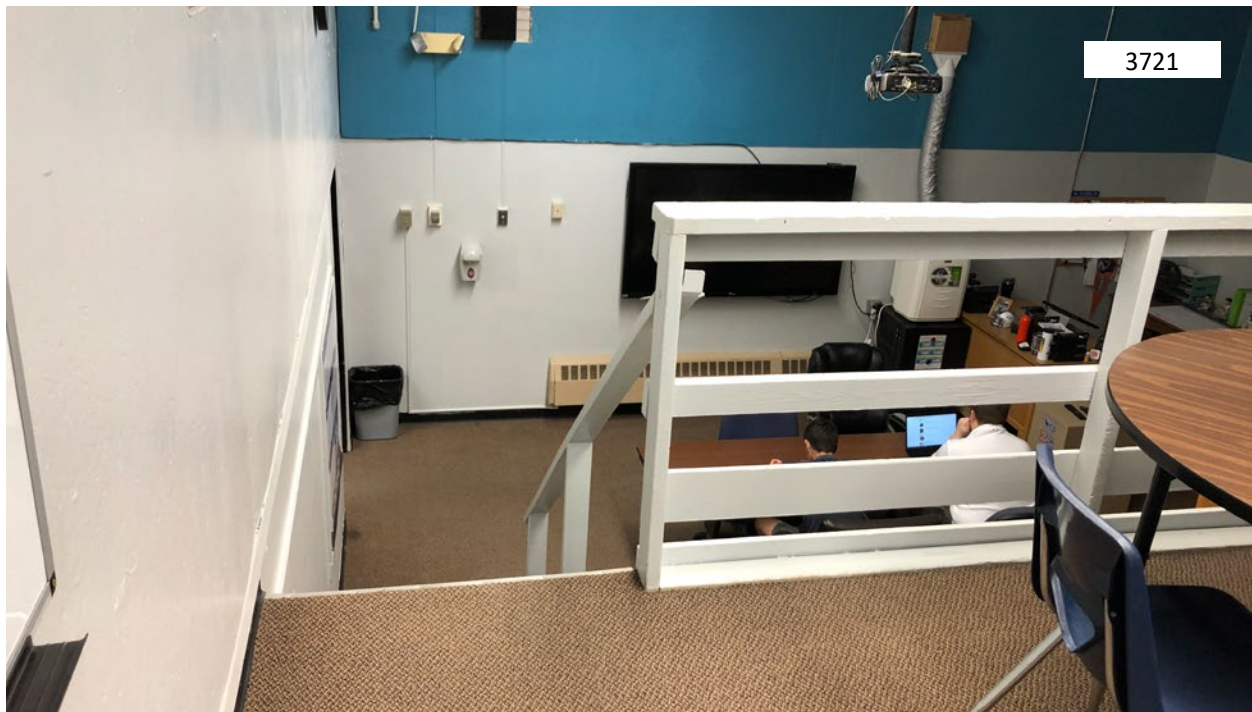
The stairs do not meet minimum tread depth or riser height requirements, no riser backs on stairs, and guard railings and hand railings do not meet minimum requirements.

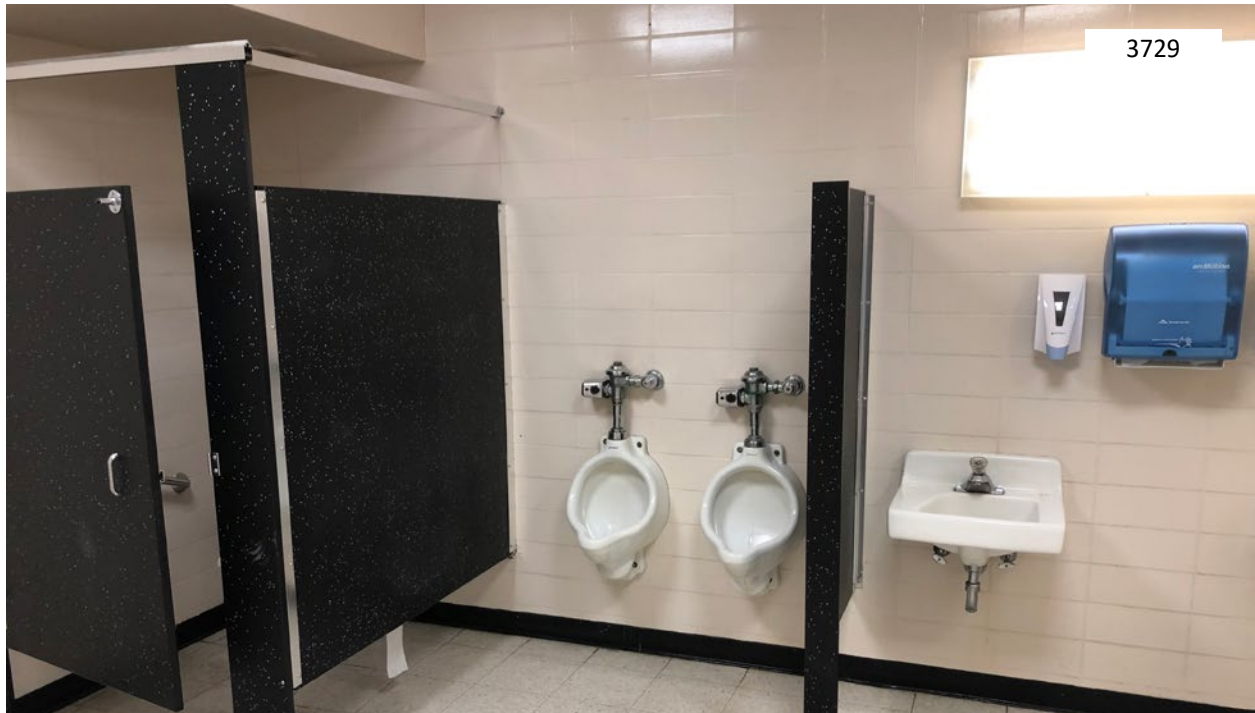
3729

In the main restrooms, the toilet partitions are too small for ADA clearances, the urinals and sinks are too high, the grab bars are the wrong size and were installed at incorrect heights.

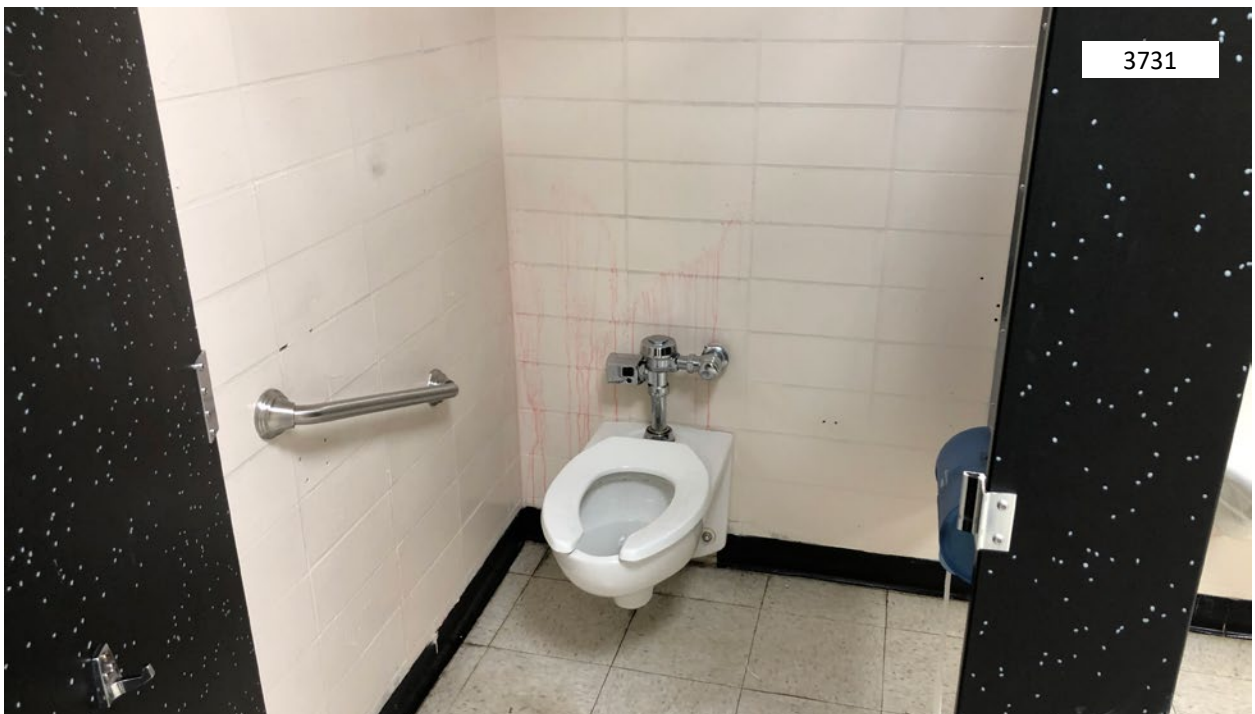
3731

In the main restrooms, the toilet partitions are too small for ADA clearances, the urinals and sinks are too high, the grab bars are the wrong size and were installed at incorrect heights.

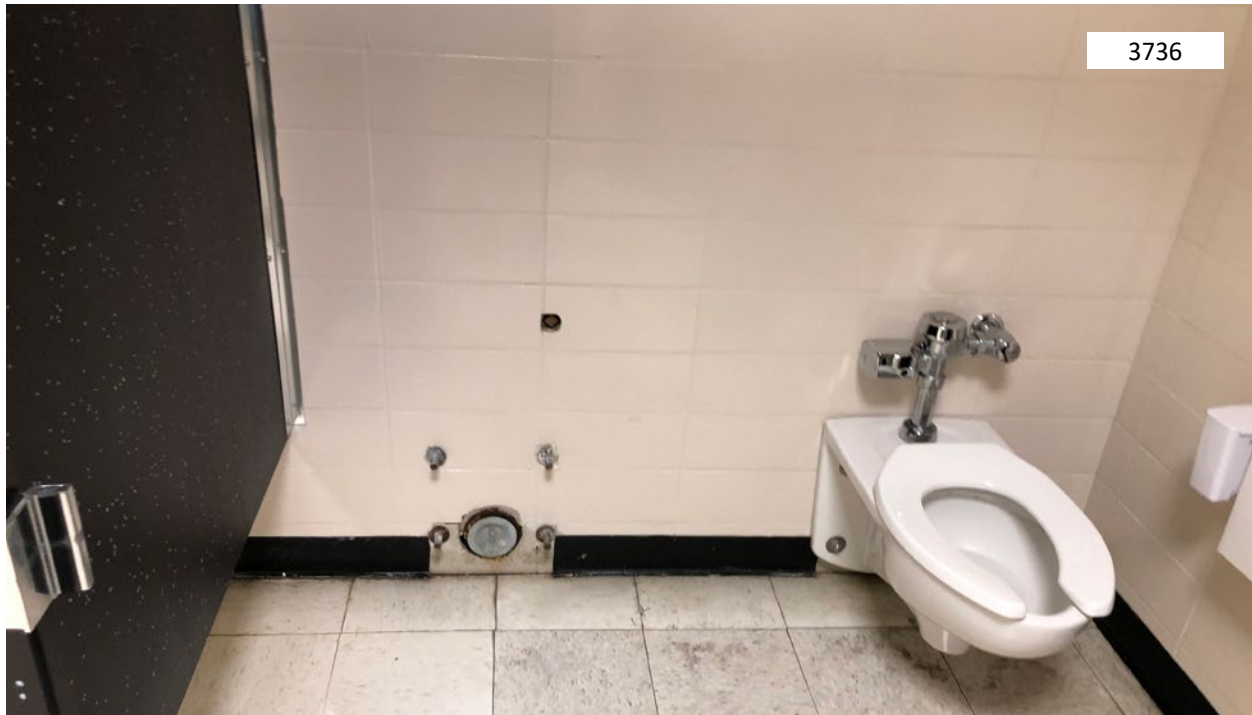
In the main restrooms, the toilet partitions are too small for ADA clearances, the urinals and sinks are too high, the grab bars are the wrong size and were installed at incorrect heights.

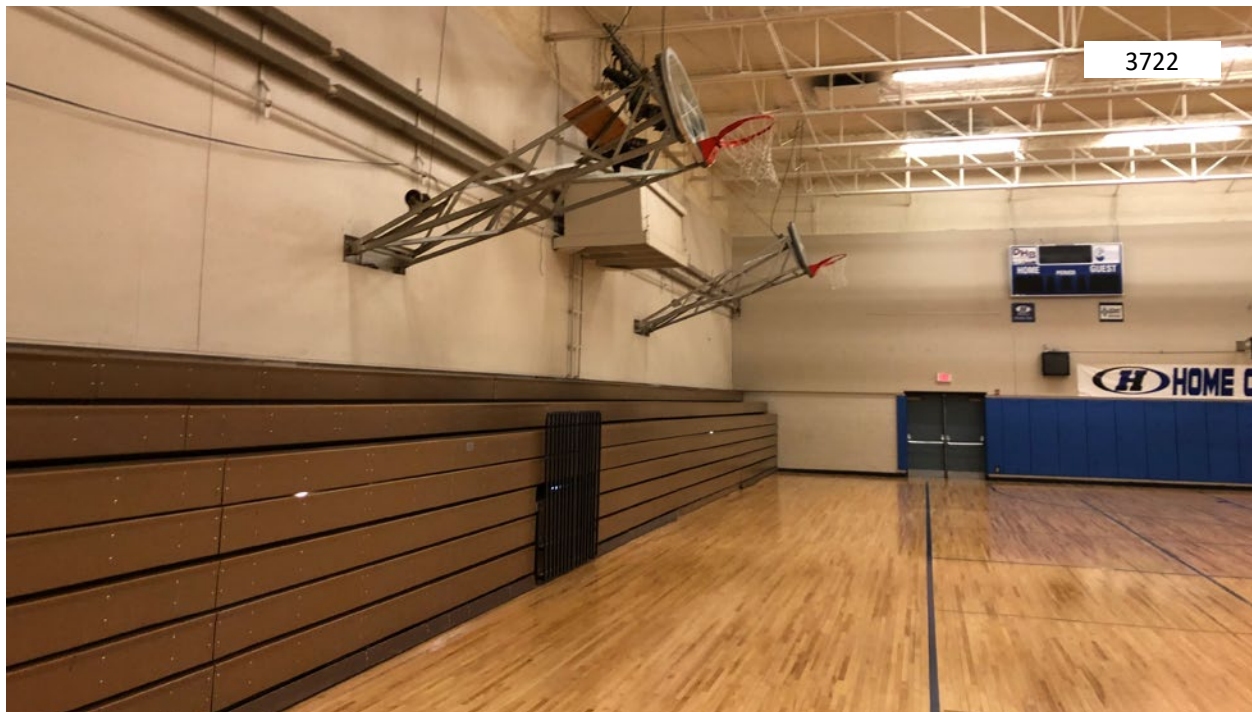
There are no accessible locations within the gymnasium bleachers.

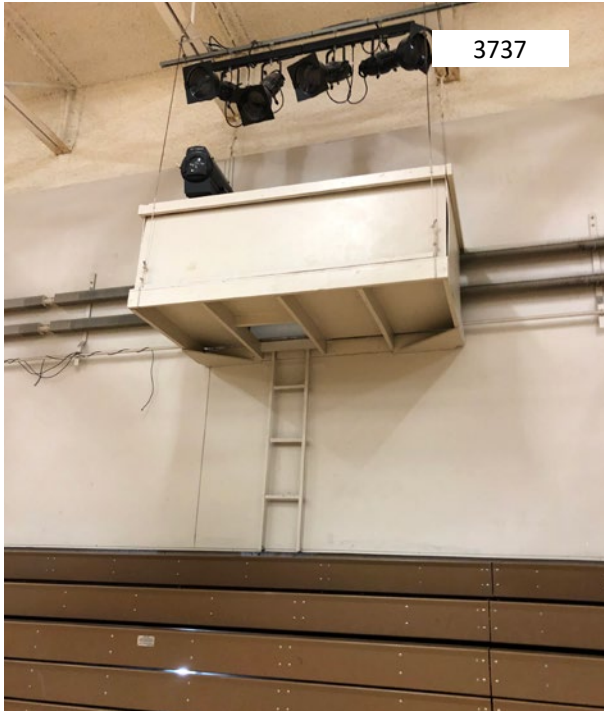
The radio/spotlight platform within the gymnasium is not accessible.

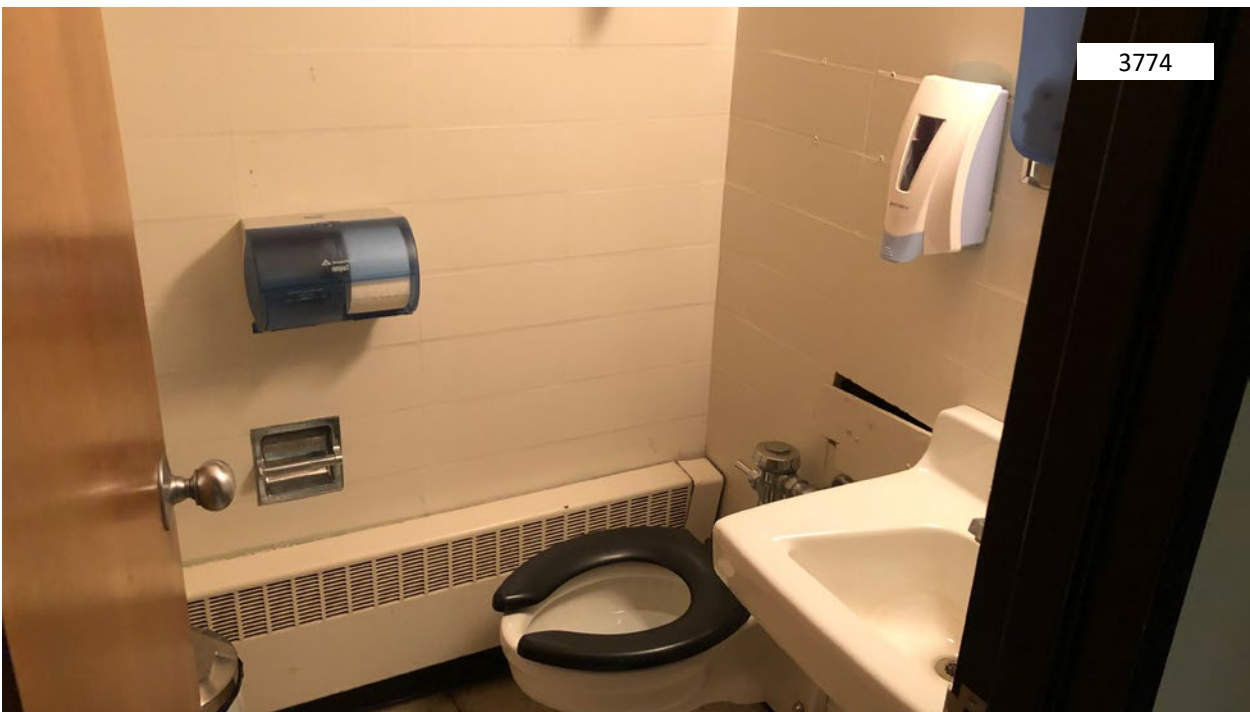
The kitchen restroom is not accessible due to the door into restroom being too small and there are no grab bars.

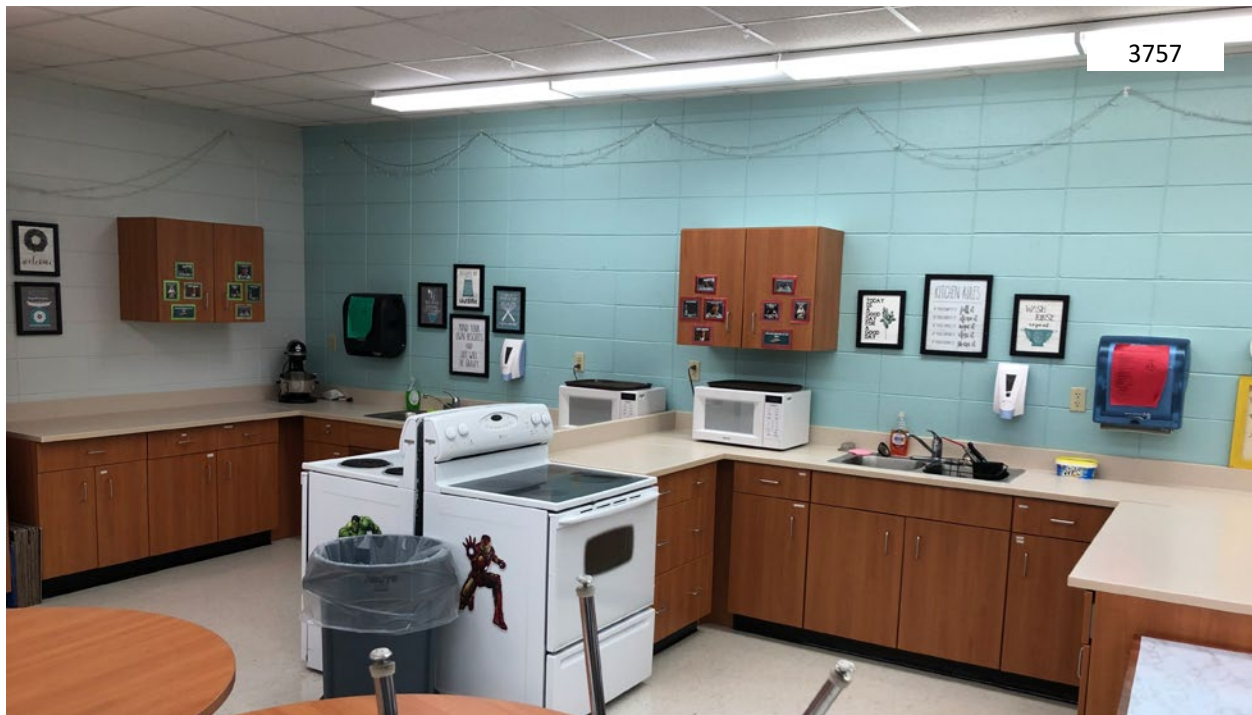
The FACS room is missing an accessible kitchen station.

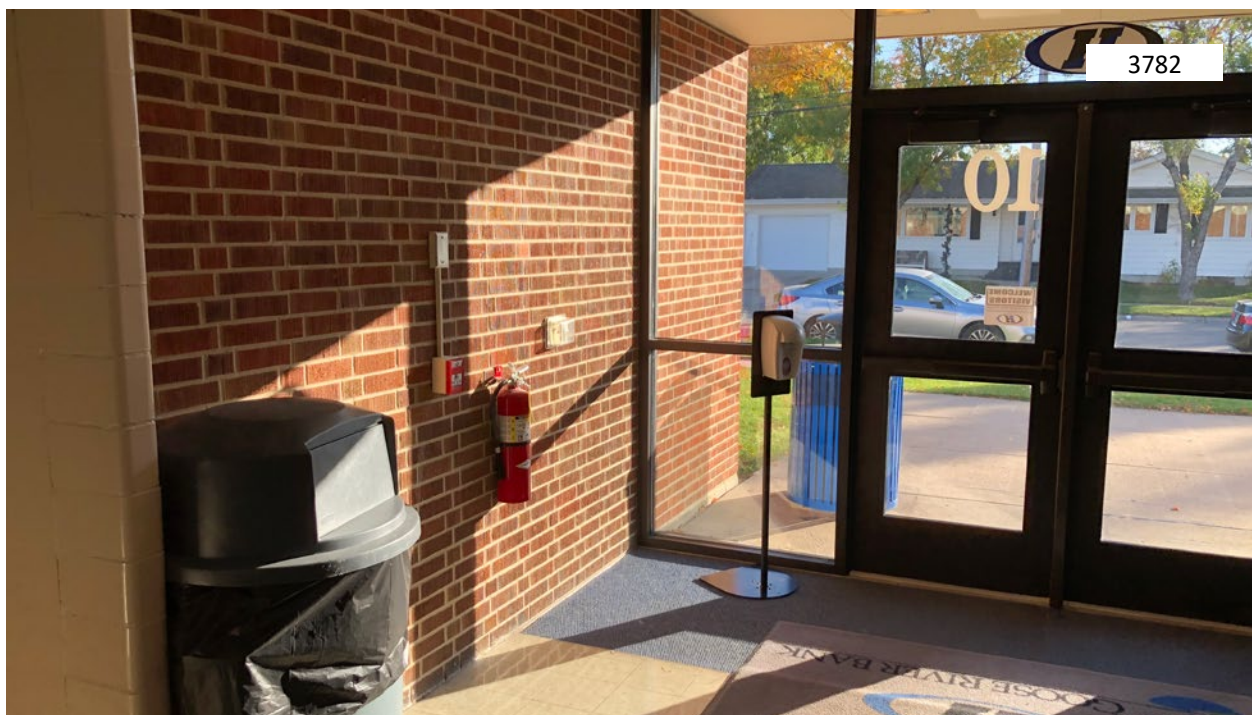
Various exterior doors do not contain a vestibule that is required per new energy code.

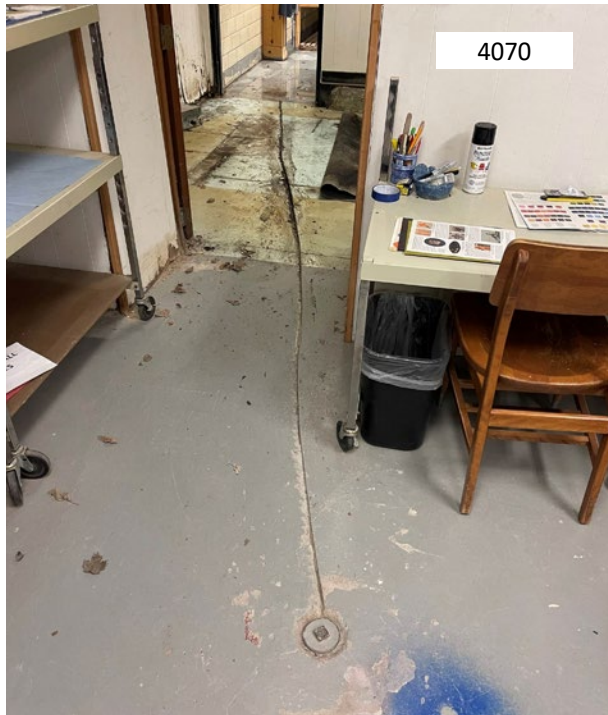
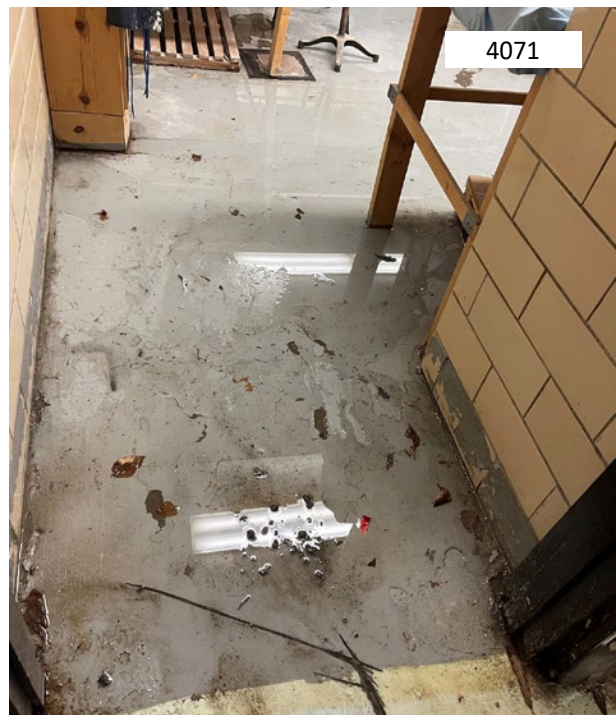
Ground water enters into boiler room from the walls after hard rains. This typically floods student art areas within the original 1894 addition.

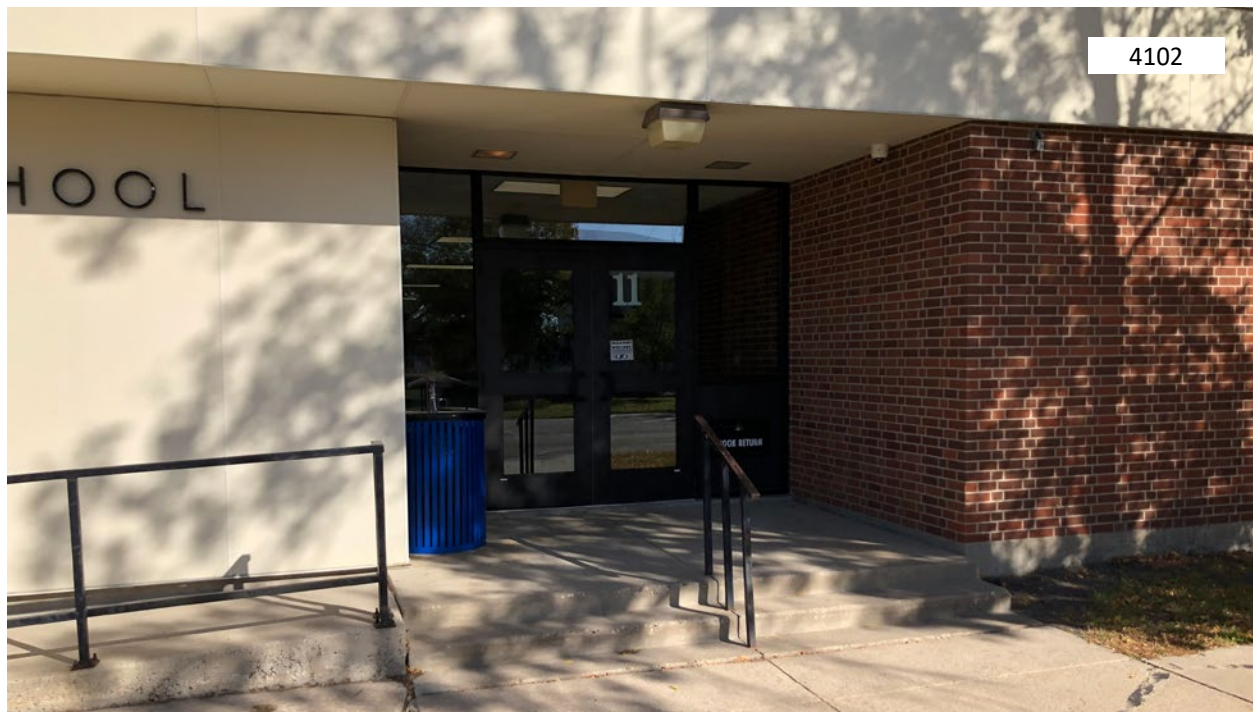
The southwest entrance has a ramp that does not meet handicap accessible requirements for slope and guard railings.

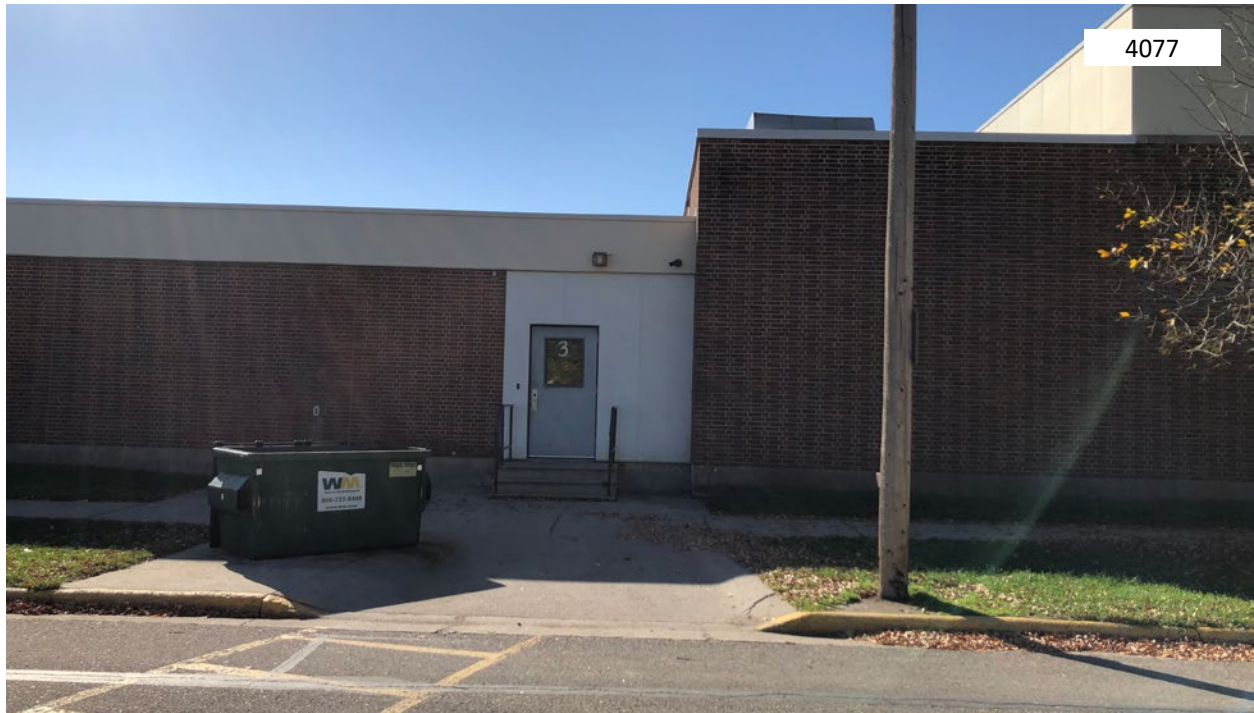
4077

The emergency exit for the gymnasium along with exit 3 on the north end has stairs and is not handicap accessible.
