ICON
ARCHITECTURAL GROUP

FACILITY ASSESSMENT FOR HILLSBORO PUBLIC SCHOOLS

Hillsboro, ND | April 2022

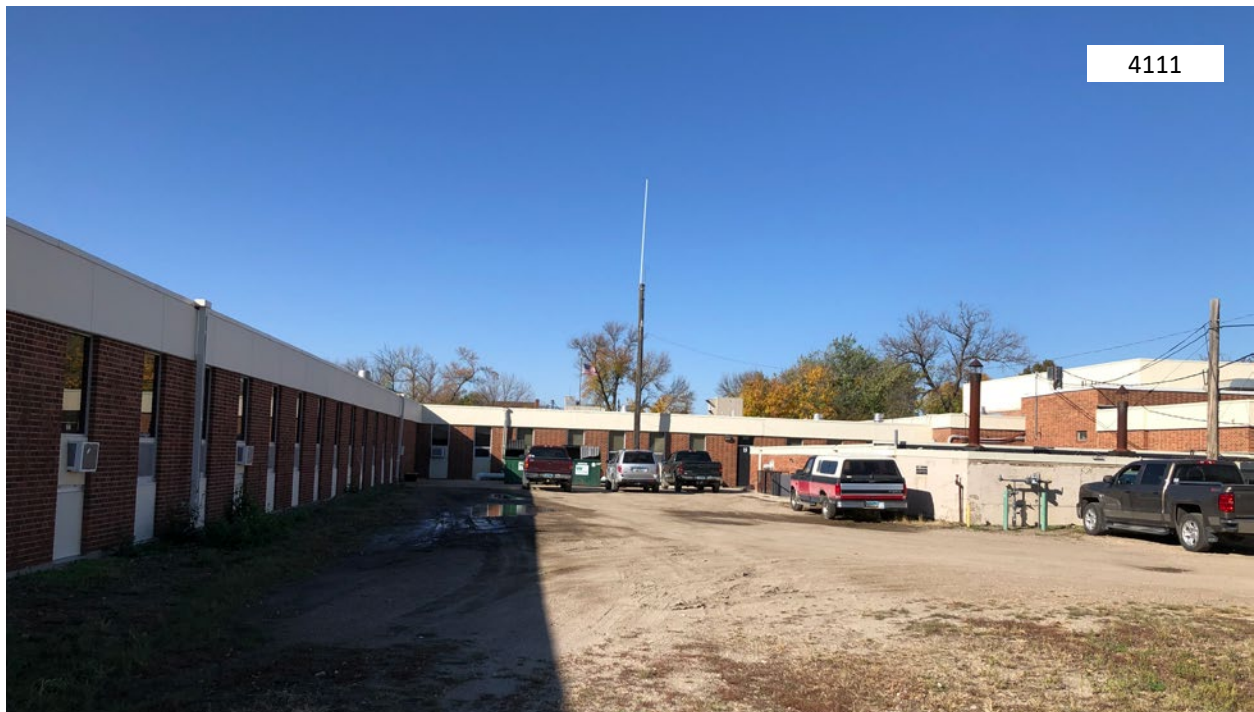
4111

The only on-site parking is on the east side of the site and is gravel. The area is not well-defined and can be very muddy with inclement weather.
