Building Information - Marietta City SD (44321) - Harmar Elementary School

Program Type	Classroom Facilities Assistance Program (CFAP) - Regular
Setting	Small City
Assessment Name	Harmar Elementary School
Assessment Date (on-site; non-EEA)	2017-10-17
Kitchen Type	Warming Kitchen
Cost Set:	2019
Building Name	Harmar Elementary School
Building IRN	15297
Building Address	100 Fort Square
Building City	Marietta
Building Zipcode	45750
Building Phone	740-374-6510
Acreage	4.00
Current Grades:	PK-5
Teaching Stations	26
Number of Floors	3
Student Capacity	356
Current Enrollment	262
Enrollment Date	2017-10-17
Enrollment Date is the date in which the current enrollment was taken.	
Number of Classrooms	26
Historical Register	NO
Building's Principal	Cheryl Cook
Building Type	Elementary

Building Pictures - Marietta City SD(44321) - Harmar Elementary School(15297)

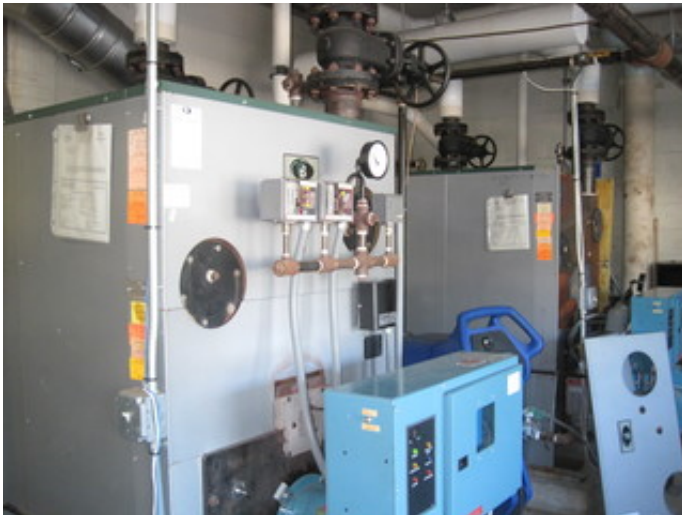
Description: The overall structure is heated by two gas-fired steam boilers. The boilers were manufactured in 2006 and are in good condition. Low pressure steam is distributed throughout the building to unit ventilators in the classrooms, finned radiation in the basement and a steam heating coil in the air handling unit for the gymnasium. The system does not provide the required outdoor air as per OBBC requirements or OSDM design standards. The system temperature controls are predominantly pneumatic; however, there is a stand-alone direct digital control (DDC) system controlling the boilers. The structure is not equipped with air conditioning. There is no room for above-ceiling ductwork.

Rating: 3 Needs Replacement

Steam heating boilers

Recommendations: Provide new overall heating system to meet OFCC design standards, including air conditioning.

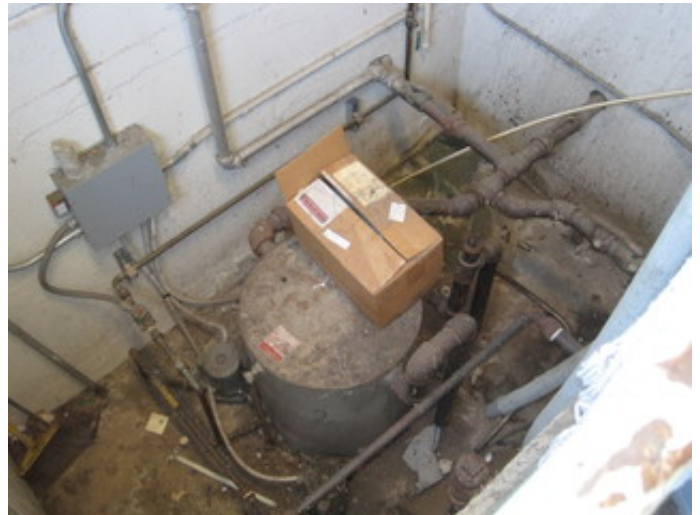
Steam condensate return pump

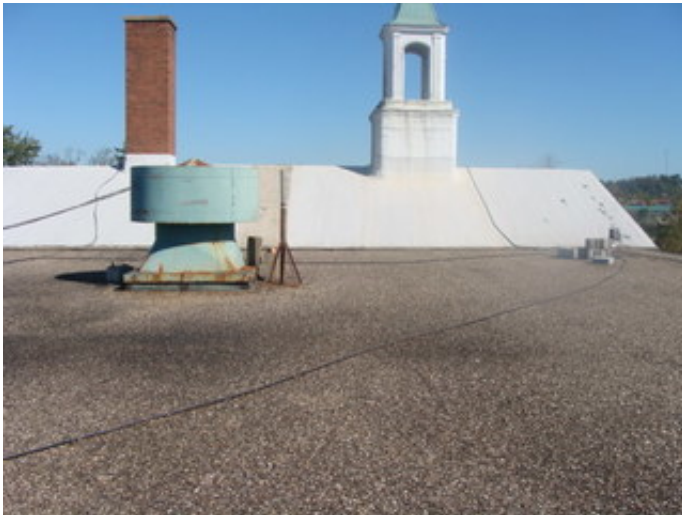
Rating: 3 Needs Replacement

Existing Roof

Recommendations: The roof over the overall facility requires replacement to meet Ohio School Design Manual guidelines for age of system and due to condition. Add overflow drains as well.

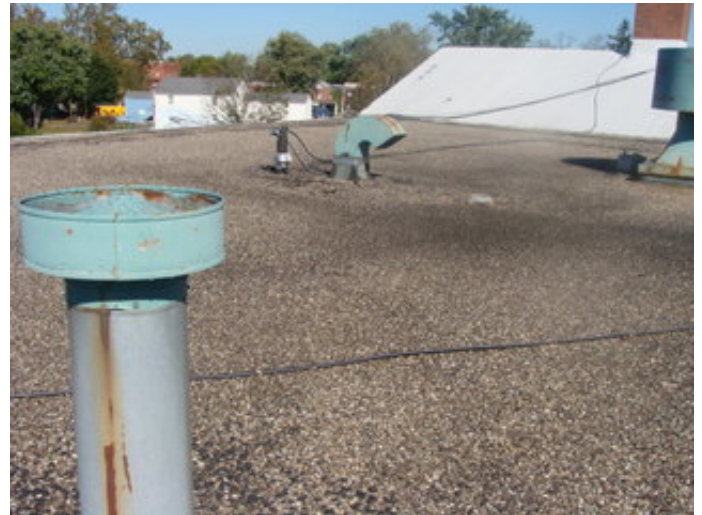
Existing Roof

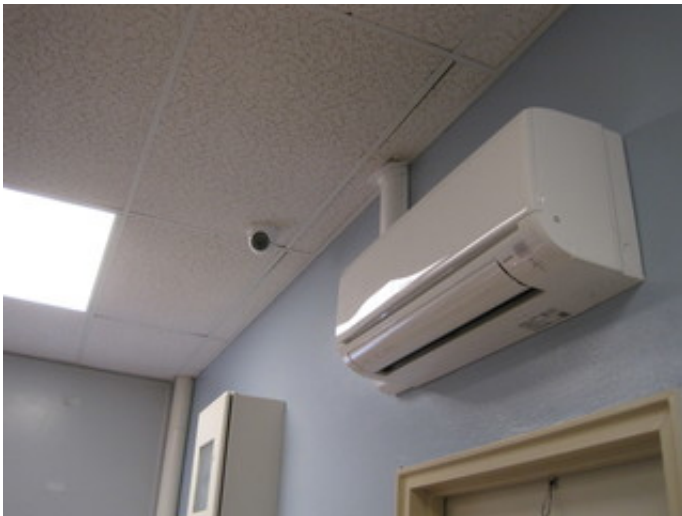
Description: The overall facility is not equipped with air conditioning. The gymnasium has a forced-air heating and ventilating unit on the stage in fair condition. The main office, teacher's lounge and nurse's clinic have a Mitsubishi City-multi variable refrigerant flow (VRF) system, which is in good condition.

Ductless split-system A/C unit

Recommendations: Provide an air conditioning system to meet OFCC design manual requirements. Pricing included in Item A.

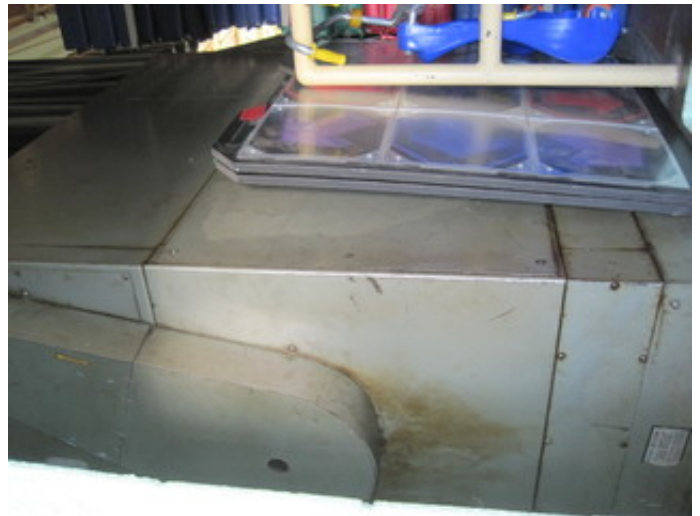
Gymnasium H&V unit

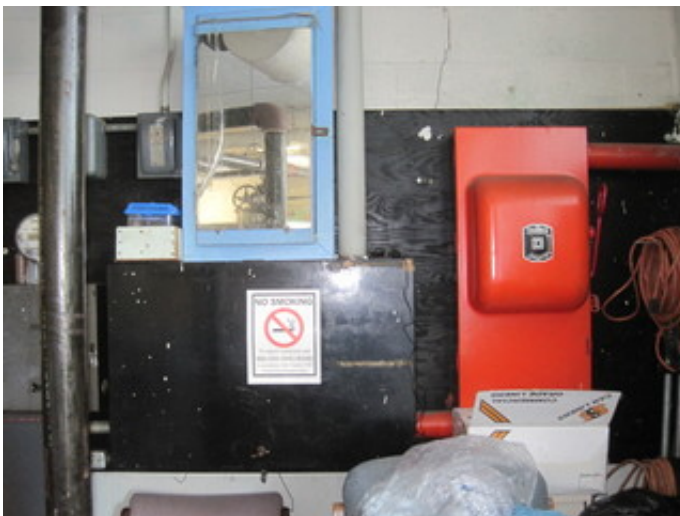
Description: The school has a 600 Amp 240/120 Volt, single phase, three wire electrical service. Service from a pole-mounted transformer extends overhead to the back of the building. The electrical distribution and service entrance are original and were installed in 1954. The service is in poor condition. Panels are fully loaded. Some new panels have been installed; however, the 50 year old wiring has been reused.

Rating: 3 Needs Replacement

1954 Main electrical service

Recommendations: Provide 1200 Amp, 480/277 Volt electrical service. Provide pad-mounted oil-filled transformer to accommodate new electrical service. Provide new electrical distribution to include panels, receptacles, conduit, and wiring.

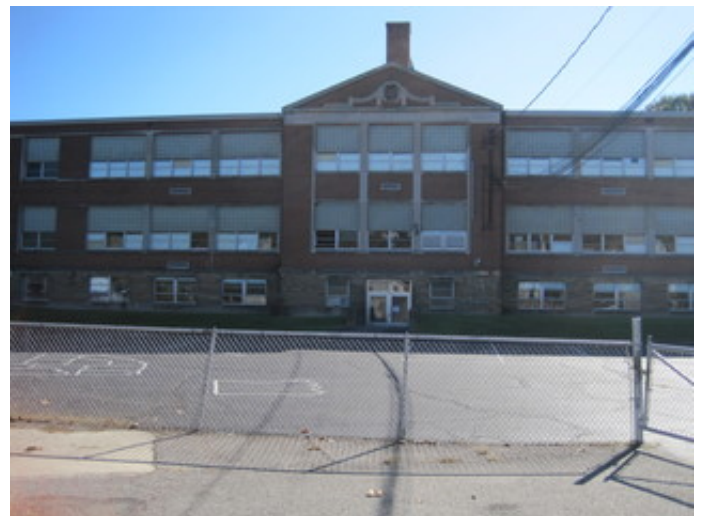
Overhead electrical service to bldg

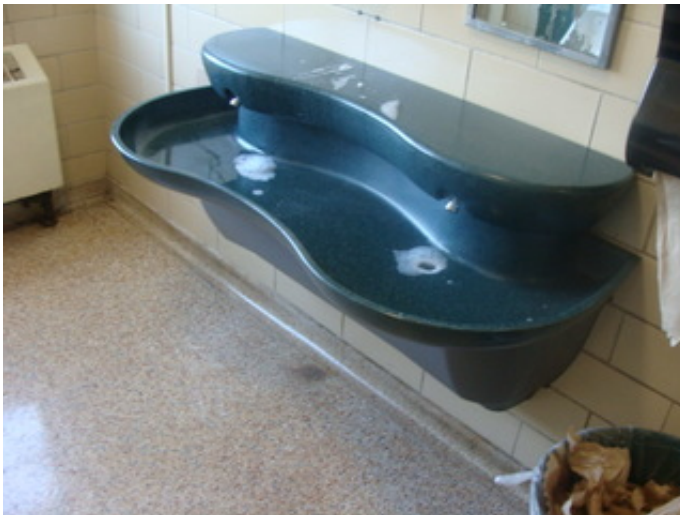
Description: The boys' restrooms have floor-mounted toilets, wall-mounted urinals with manual flush valves, and wall-mounted wash fountains. They are in good condition. The girls' restrooms contains floor-mounted toilets and wall-mounted wash fountains. These fixtures are in good condition. The school contains six electric water coolers (EWC's), some with bottle filling stations. They are in fair to good condition. The staff restrooms contain floor-mounted toilets and wall-hung lavatories that are in poor condition. The facility has two water heaters: one gas-fired tank-type water heater for general use, and one electric tank-type water heater for the kitchen. Both heaters are in good condition. There is a backflow preventer (BFP) on the domestic water service; however it is not a reduced pressure principle BFP as required by Code. It is in fair condition, but must be replaced. There is a 4" domestic water service line, which reportedly was replaced from the tap to the building 4-5 years ago. Domestic water piping in the mechanical room is galvanized, but most piping throughout the building has been changed to copper.

2-head washfountain

Recommendations: Replace all plumbing fixtures. See Item "O" Handicap Access for additional fixture replacement. Provide a new backflow preventer.

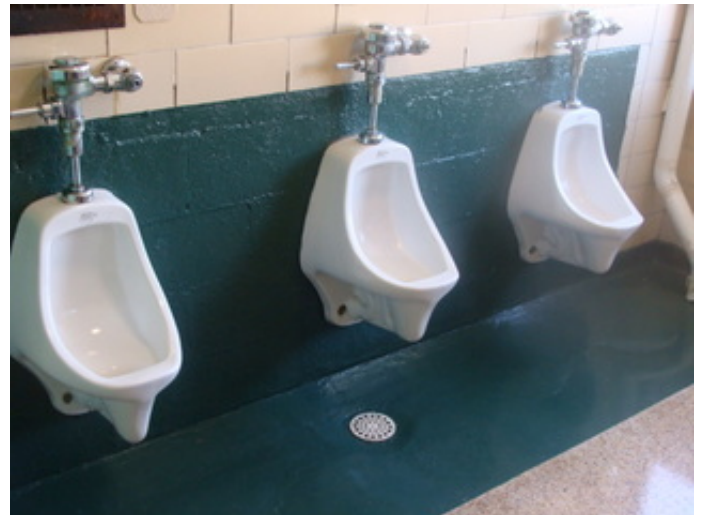
Wall-mtd urinals

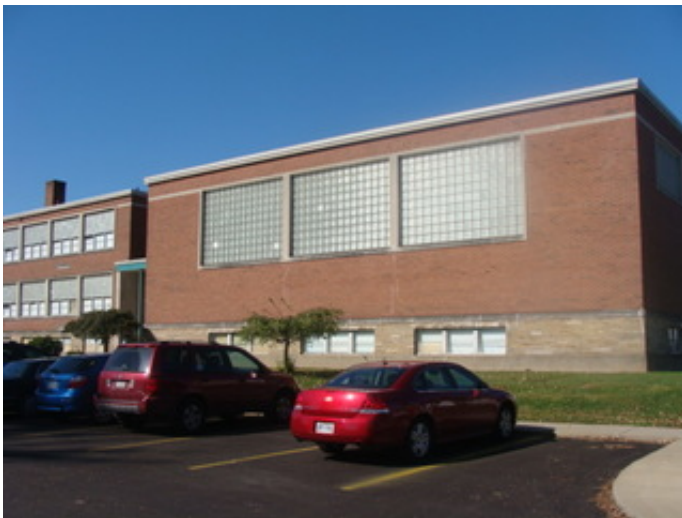
Description: The overall facility is equipped with single glazed windows and are in poor condition. Window system seals are in poor condition, with minimal air and water infiltration being experienced. Window system hardware is in fair condition. The window system features no blinds. The window system is not equipped with insect screens on operable windows. There are glass block windows in the gym addition, in fair condition.

Rating: 3 Needs Replacement

Glass Block at the Gym

Recommendations: Replace the existing non-insulated window system and glass block with a new insulated window system to comply with Ohio School Design Manual requirements.

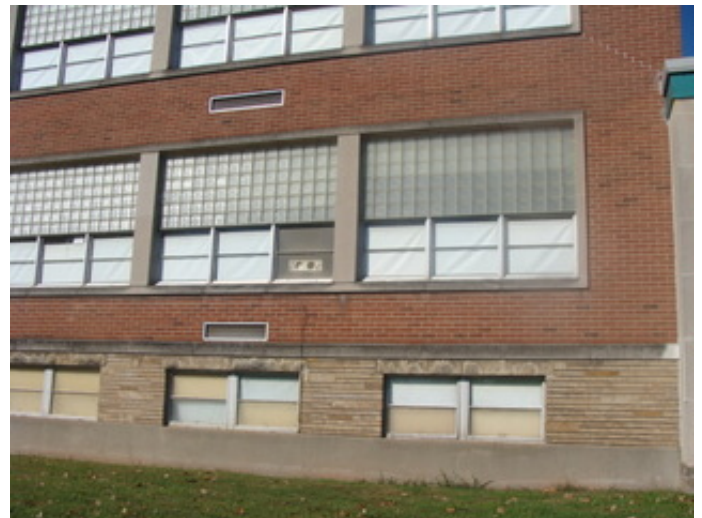
Typical Classroom Windows

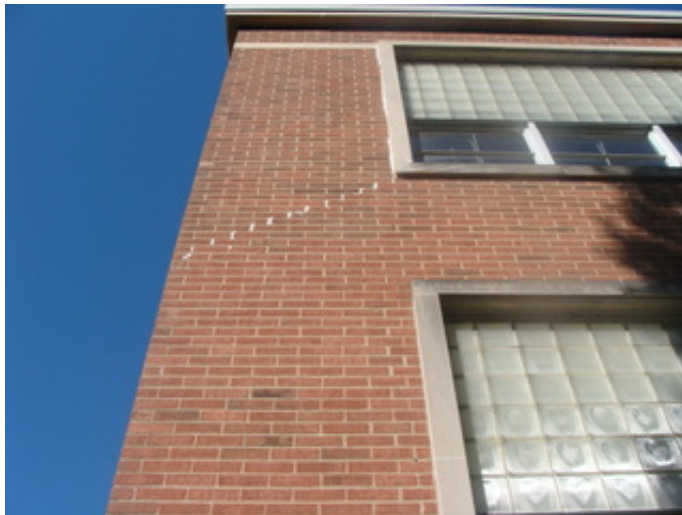
Description: The overall facility has a brick veneer on a masonry bearing wall system which displayed locations of deterioration, and is in fair condition. The exterior masonry appears to have appropriately spaced and adequately caulked control joints in fair condition. Control joints are not provided at lintel locations at doors and windows. The school does not contain expansion joints, and none are needed as there is no indication of exterior masonry cracking or separation. The exterior masonry has not been cleaned and sealed in recent years, and shows evidence of minor mortar deterioration. Interior walls are concrete masonry units and glazed block and are in fair condition. The window sills are stone, and are in fair condition. The exterior lintels are steel, and are in fair condition.

Rating: 3 Needs Replacement

Repaired brick

Recommendations: Provide tuckpointing in all areas of mortar deterioration as required through the overall facility. Provide masonry cleaning, sealing, caulking as required through the overall facility. Provide masonry/brick infills where unit ventilation will be removed.

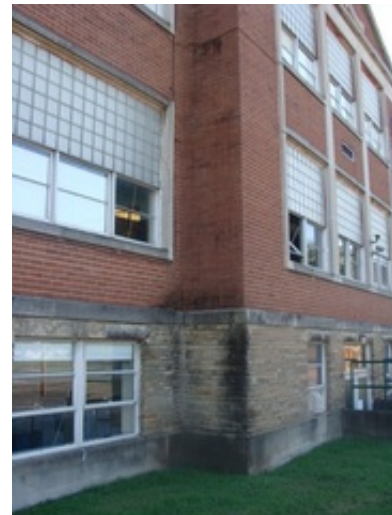
Uncleaned brick

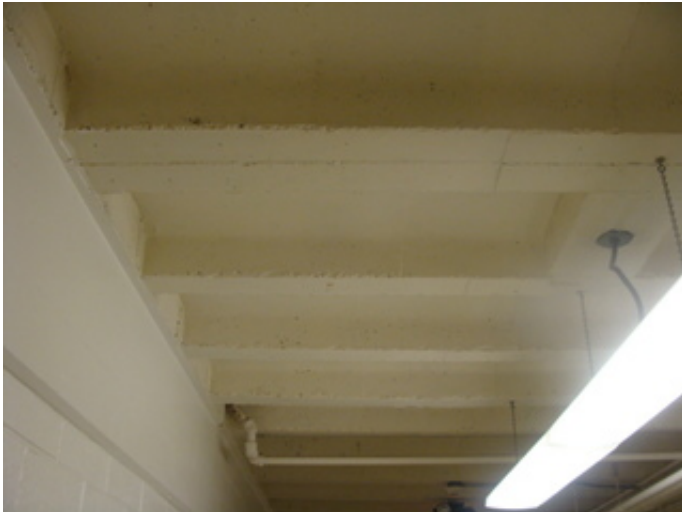
Poured Slab above basement floor

Recommendations: Existing conditions require no renovation or replacement at the present time.

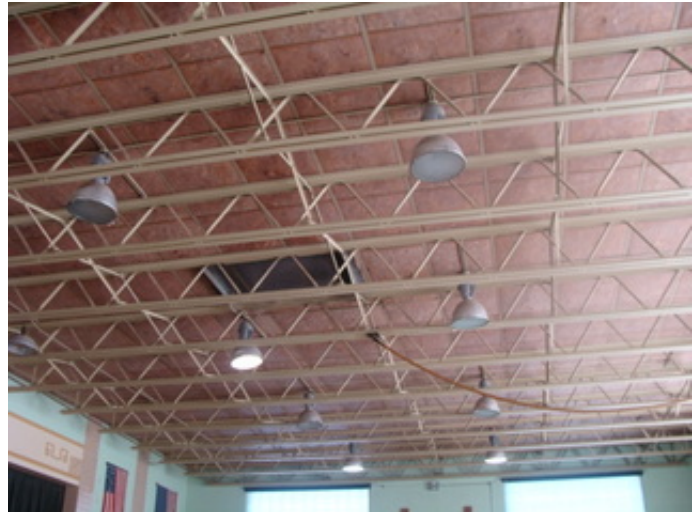
Steel Trusses at Gym

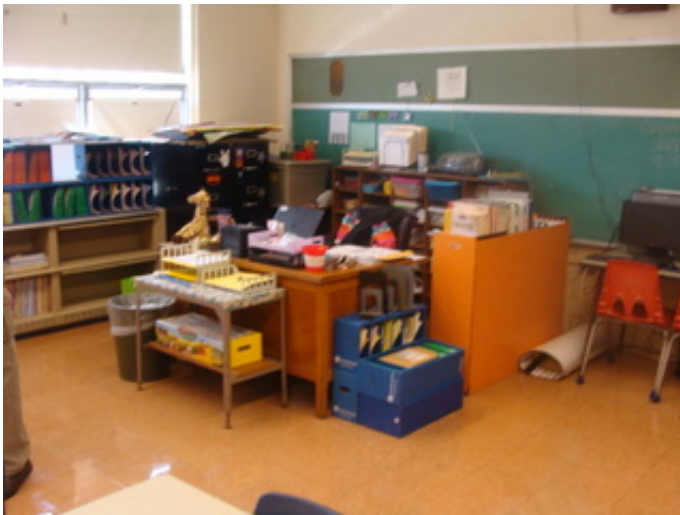
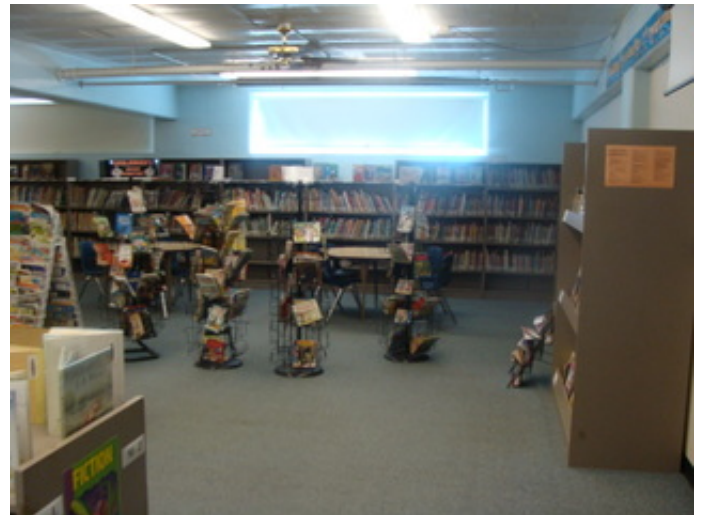
Description: The overall facility features conventionally partitioned Classrooms with VAT and VCT flooring, suspended ceilings, as well as painted wall finishes, and they are in good condition. The overall facility has Corridors with terrazzo flooring, suspended ceilings, as well as tile wall finishes, and they are in good condition. The overall facility has Restrooms with ceramic flooring, painted ceilings, as well as tile wall finishes, and they are in good condition. Toilet partitions are plastic, and are in fair condition. Classroom casework in the overall facility is wood construction with plastic laminate tops, is inadequately provided, and in fair condition. The lockers, located in the Classrooms and Corridors, are adequately provided, and in fair condition. The Art program is not equipped with a kiln. The facility is equipped with wood and metal interior doors that are partially recessed with and without proper ADA hardware and clearances, and in fair condition. The Gymnasium space has VAT type flooring, open ceilings, as well as painted wall finishes, and they are in fair condition. Student Dining shares the Gymnasium space. The existing Kitchen is a Warming Kitchen only, is undersized based on current enrollment, and the existing Kitchen equipment, installed in 1954, is in poor to fair condition. The Kitchen hood is in fair condition, and is not equipped with the required UL 300 compliant wet chemical fire suppression system.

Rating: 3 Needs Replacement

Recommendations: Provide complete replacement of finishes (and casework) due to installation of systems outlined in Items A, C, D, E, I, K, L, M, N, T, U. Provide for the replacement of all kitchen equipment due to age and condition.

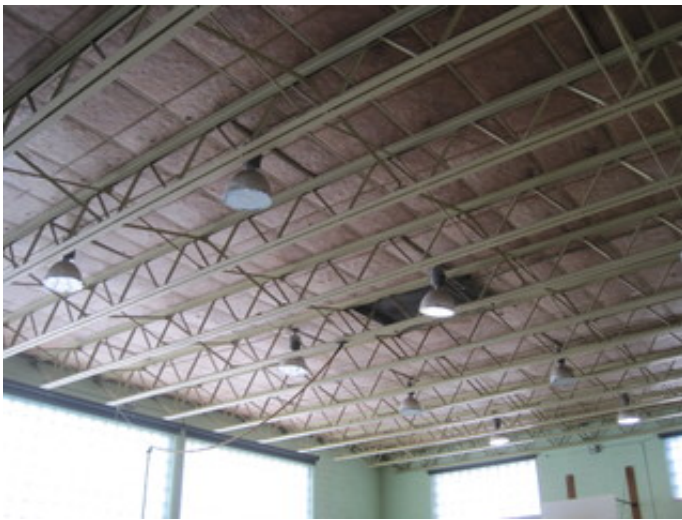
Rating: 3 Needs Replacement

Gymnasium lighting

Recommendations: Install new lighting system due to sprinkler installation under Item U: Life Safety.

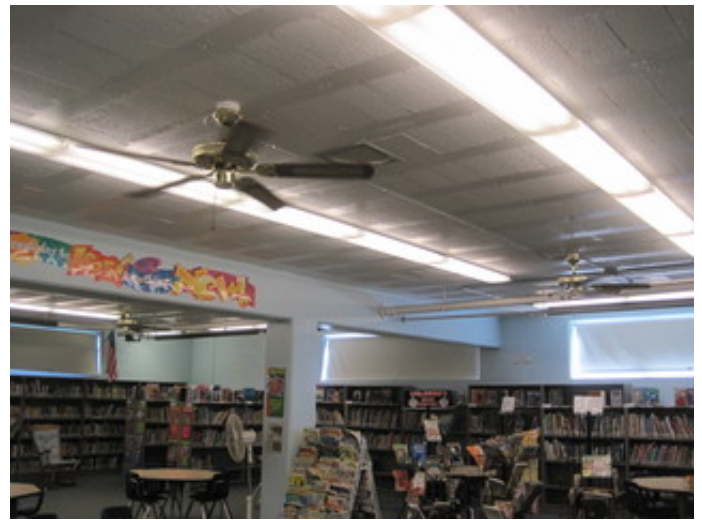
Classroom surface-mtd. lighting

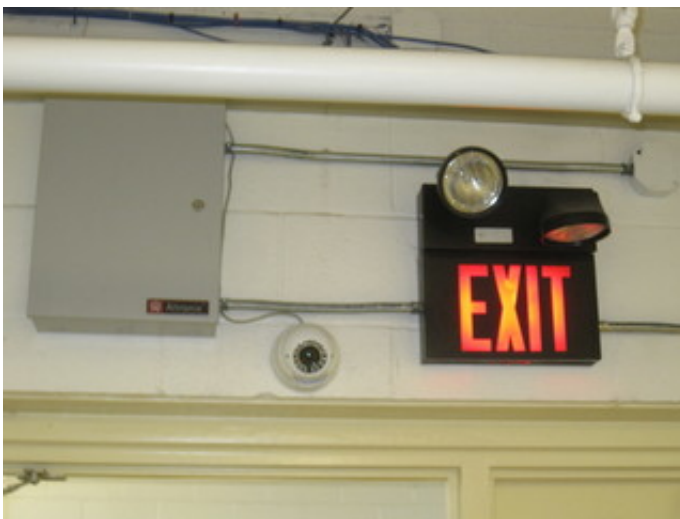
- Description:** The security system is comprised of motion sensors, interior and exterior cameras, door contacts, and an electronic keypad. The site lighting is not adequate.
- Rating:** 3 Needs Replacement
- Recommendations:** Provide new security system to include digital cameras, digital video storage, door contactors, and motion sensors. System shall have microprocessor control for all installed components at a central location. Provide new site lighting to provide the illumination required by the Ohio School Design Manual.

Security camera

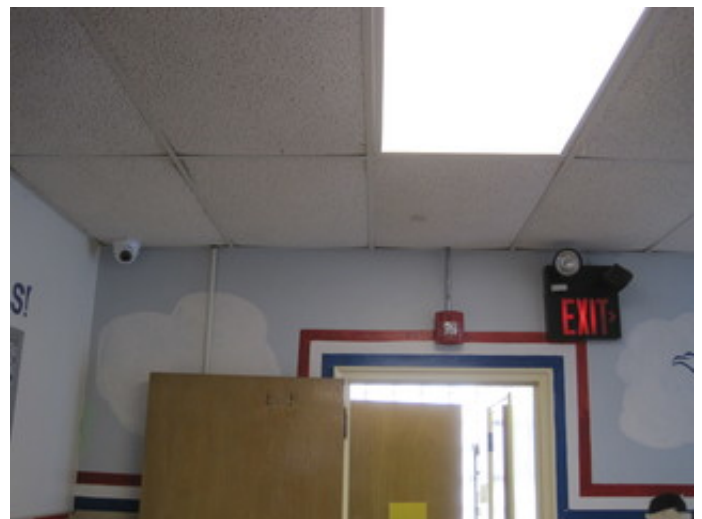
Security camera in corridor

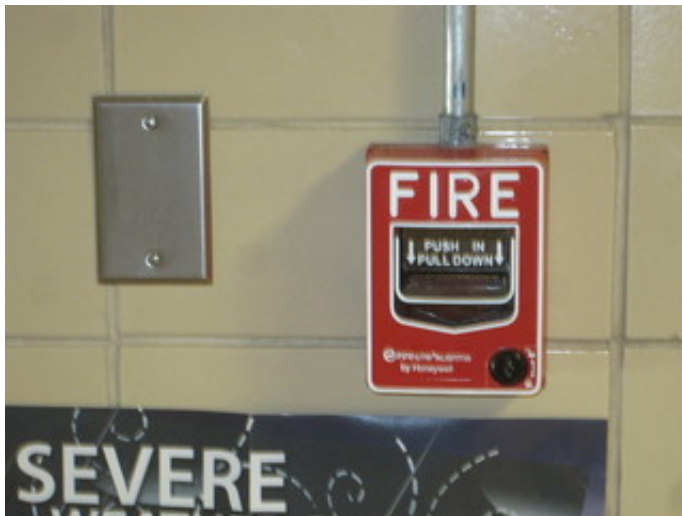
Rating: 3 Needs Replacement

F.A. pull station

Recommendations: Provide new devices to include horn/strobes, smoke detectors, tamper/flow switches to comply with current applicable codes and Ohio School Design Manual.

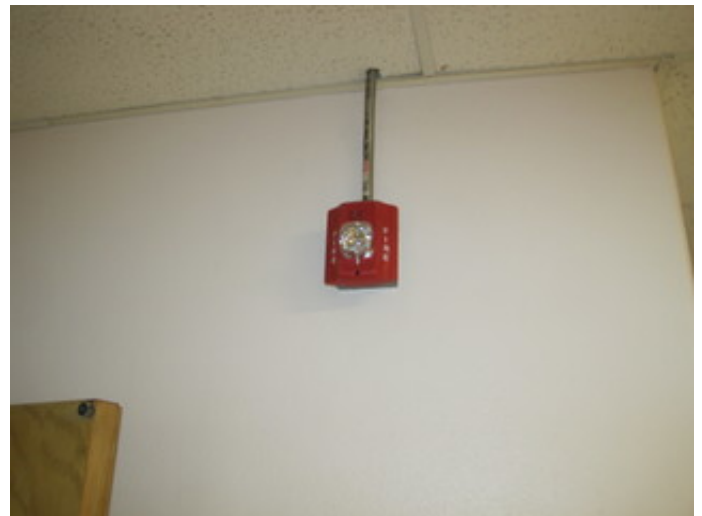
F.A. audio/visual alarm

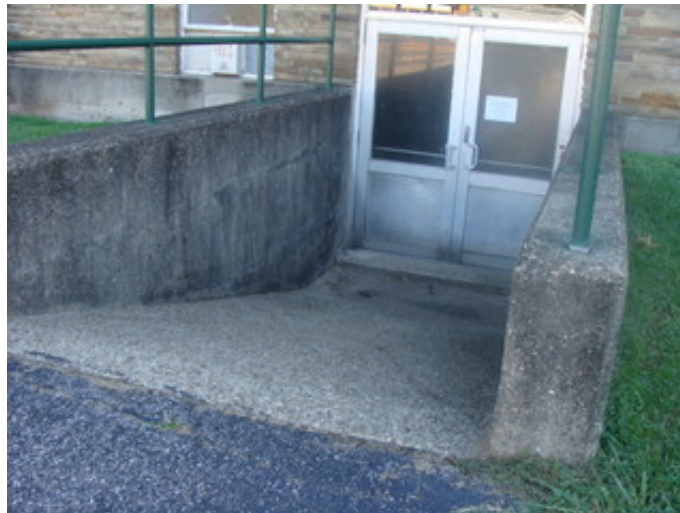
Rating: 3 Needs Replacement

Steep Ramp down to Basement

Recommendations: Provide ADA-compliant signage, power assist door opener, chair lifts, elevators, electric water coolers, toilets, sinks, urinals, toilet partitions, toilet accessories, doors and frames, door hardware in the overall facility to facilitate the school's meeting of ADA requirements.

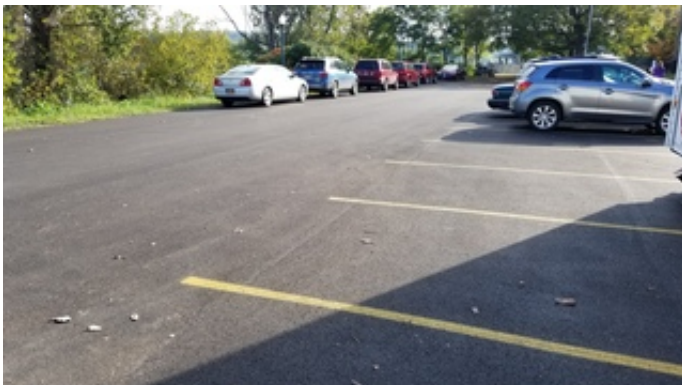
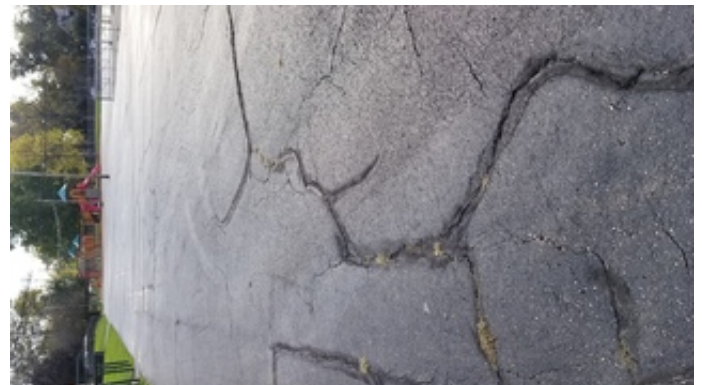
Description:	Harmar Elementary School is located in a small town setting on a medium sized parcel. Access is via public roads from southwest of the site. There is defined separation between bus traffic and other vehicular or pedestrian traffic. Buses stack on the public roads surrounding the western side of the building. Parking is adequate in number, and is available in both a parking lot and on the street. Visitor parking is not defined as separate from staff parking. An adequate amount of ADA parking stalls are provided but are not properly striped or signed. The paving is in new condition in the eastern lot, but the hard surface playground is cracked. Sidewalk is in moderate to good condition, but stairs are poor. There are no ADA access points to the building from the sidewalk. Playground equipment is in average condition. There are some drainage issues present on the site.
Rating:	3 Needs Replacement

Recommendations:	A light overlay should be installed on the hard surface playground. Concrete stairs and sidewalk should be replaced where cracked and creating a trip hazard. Any clogged catch basins should be cleaned out and jetted. ADA parking stalls need to be restriped and a new compliant sign needs installed at 2 additional stalls. Additional parking is required. An ADA access route to the building must be installed. Playground equipment should be replaced where rusted or damaged. Existing cracked detectable warnings should be replaced.

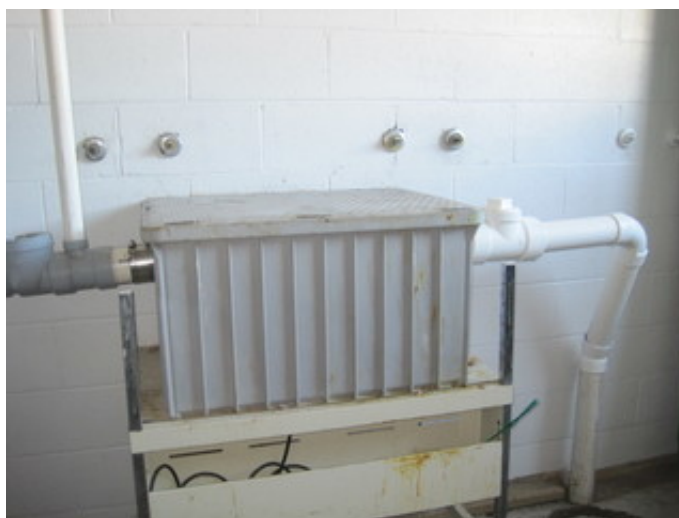
Description: The sanitary sewer drains to a municipal system with no reported problems and is in good condition. There is a grease waste interceptor located in the basement below the kitchen that handles the kitchen grease waste from the 3-compartment sink.

Kitchen grease waste interceptor

Recommendations: No work required.

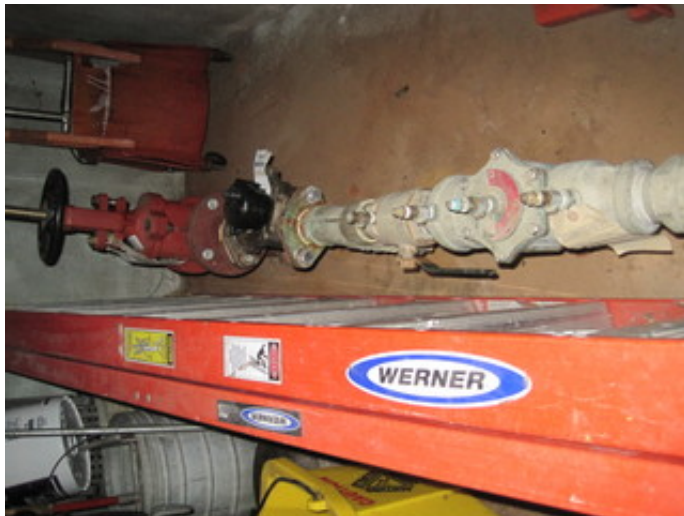
Description: The domestic water supply comes from a municipal system, which provides adequate pressure and capacity for the needs of the school. The service line was reportedly replaced 4-5 years ago. The water service is metered and there is a backflow preventer; however, the BFP does not meet current Code. The water piping is a combination of galvanized and copper pipes. The existing water supply does not have adequate capacity and pressure for the needs of the schools future fire suppression system.

Water meter & backflow preventer

Recommendations: Increase water service size for fire suppression which is included in the cost for the fire suppression system installation funded under Item U - Life Safety.

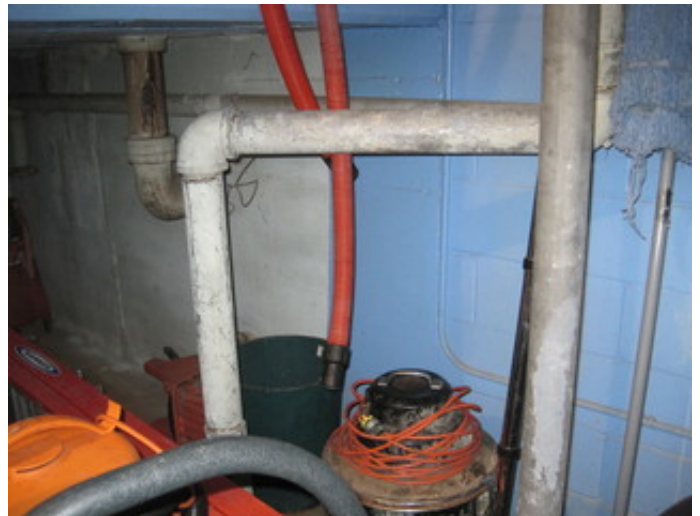
Galvanized domestic water piping

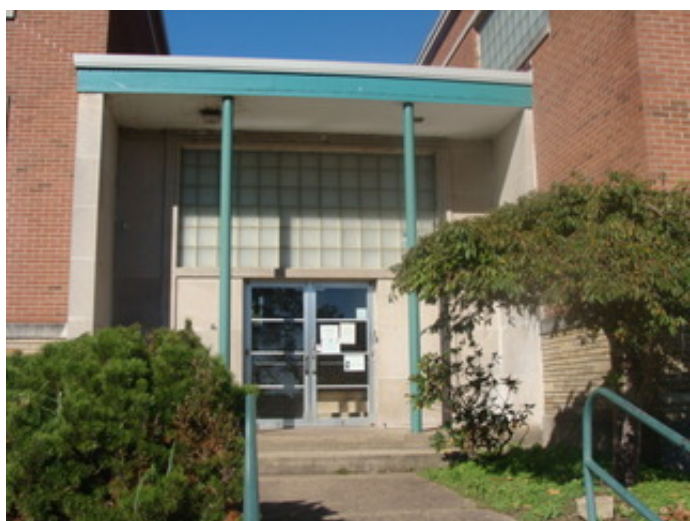
Rating: 3 Needs Replacement

Doors to Gym

Recommendations: Provide all new doors on the entire facility.

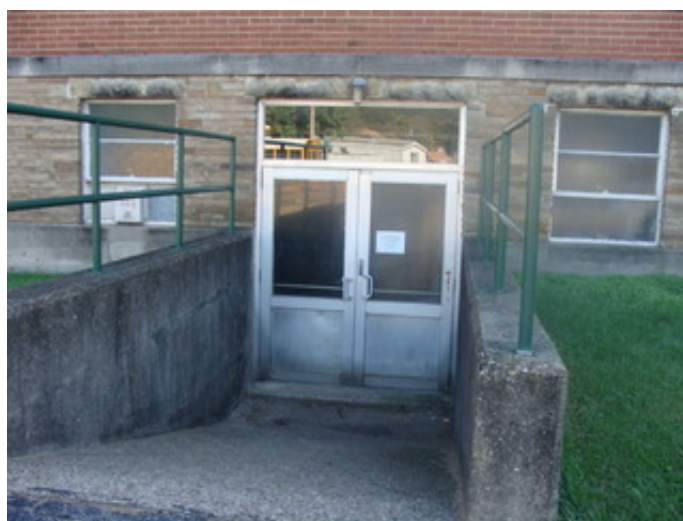
Typical Exterior Door

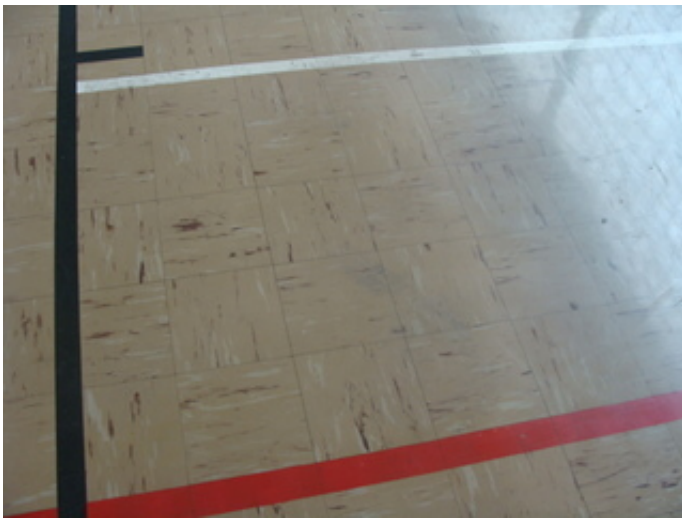
Description: The School District provided the AHERA three year reinspection reports, prepared by ASTAR and dated 10/2017, documenting known and assumed locations of asbestos and other hazardous materials.

Rating: 3 Needs Replacement

Gym VAT

Recommendations: Remove all hazardous materials, inclusive of asbestos-containing materials in the overall facility, as noted in the attached Environmental Hazards Assessment.

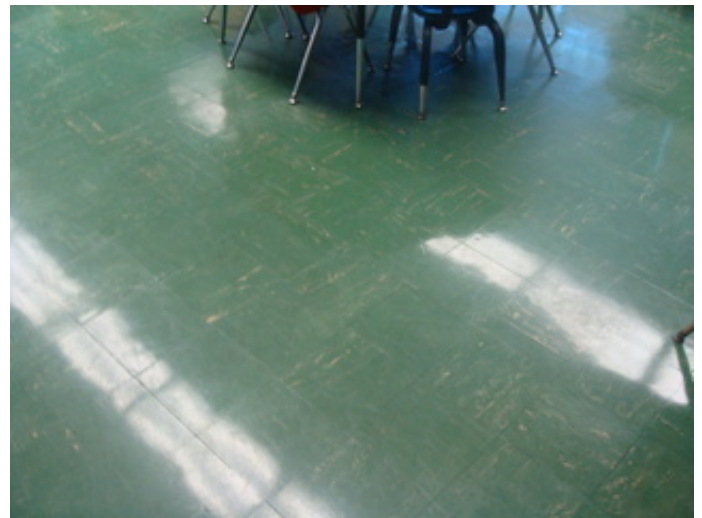
Classroom VAT

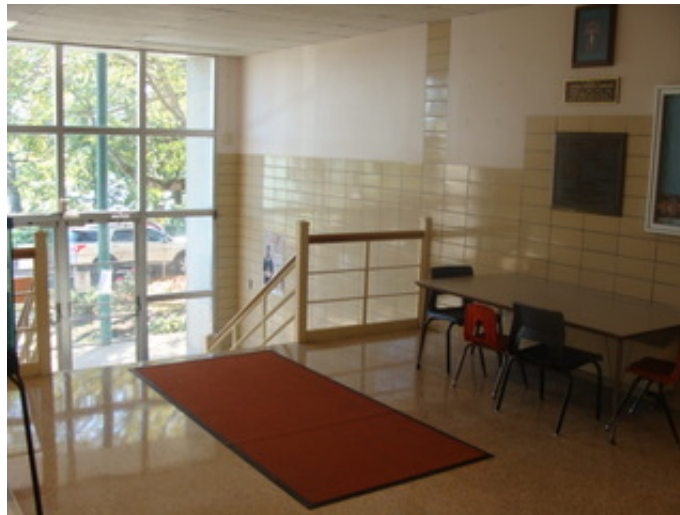
Rating: 3 Needs Replacement

Recommendations: Provide facility with automated fire suppression system. Enclose the stairs to the rear of the building and provide all stairs with new hand/guard rails per OBBC code requirements.

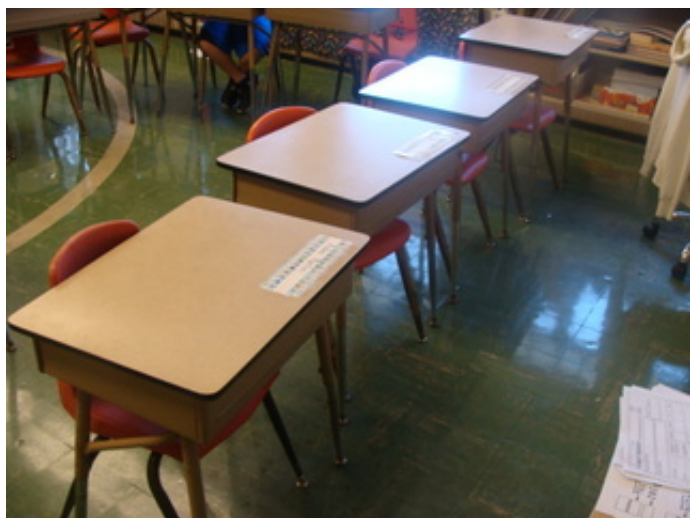
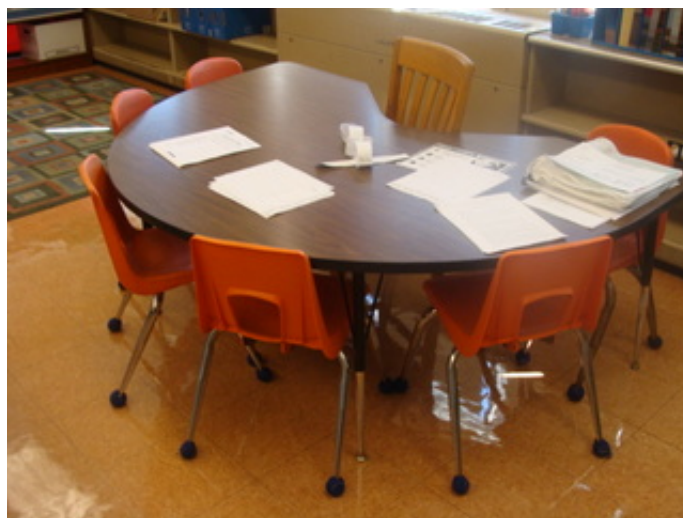
Description: The typical Classroom furniture is mismatched, and in generally poor to fair condition. The facility's furniture and loose equipment were evaluated in item 6.17 in the CEFPI section of this report, and on a scale of 1 to 10 the overall facility received a rating of 3 due to observed conditions, and due to the fact that it lacks some of the Design Manual required elements.

Rating: 3 Needs Replacement

Recommendations: Provide for replacement of outdated or inadequate furniture.

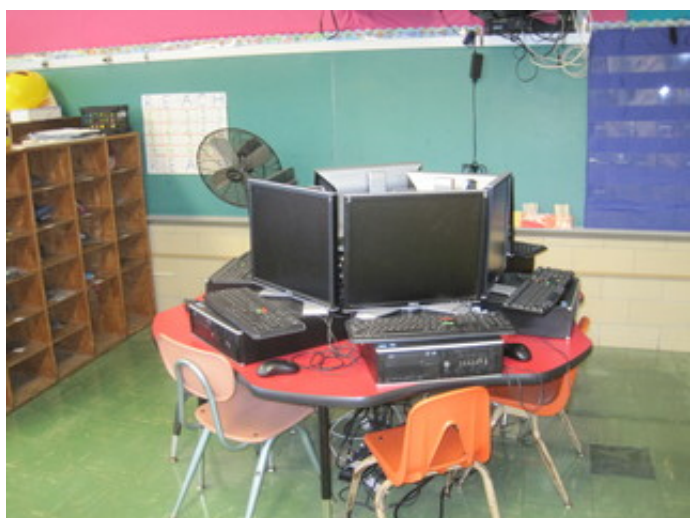
Rating: 3 Needs Replacement

Classroom computer stations

Recommendations: Provide technology upgrades, wiring and system per the OSDM guidelines.

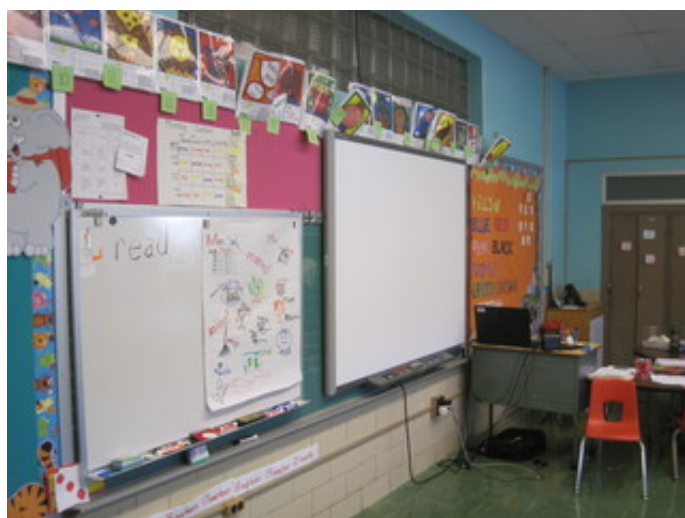
Classroom smartboard
