HOWELL MIDDLE SCHOOL

HOWELL MIDDLE SCHOOL 2502 Fannin Victoria, TX 77901	
Year(s) Built:	1970, 1990, 1999
Approx. Total Building Square Footage	130,322 SF
Approx. Total Site Area	20.1 Acres
Potential Capacity	920
Current Enrollment	873

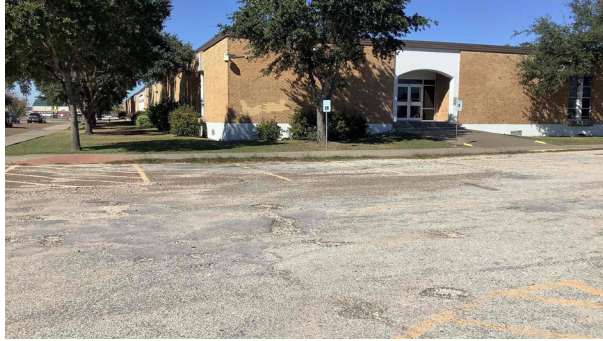
1.1 - Accessible parking not properly identified with signage, access aisles, and accessible route to sidewalk (potentially not sufficient accessible parking – verify counts)

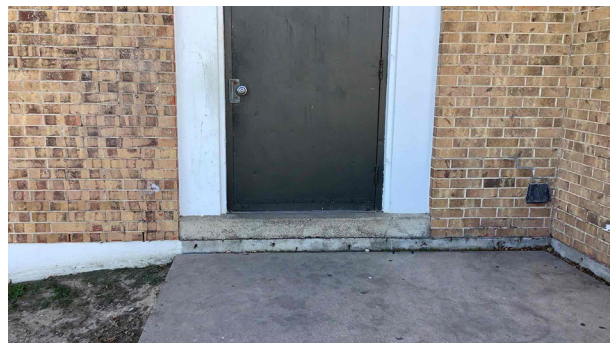
1.6 - No landing or ramp at exterior door step for access

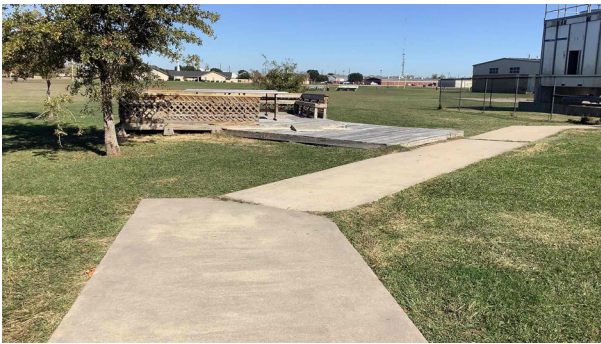
1.9 - Concrete path is disjointed with tripping hazard

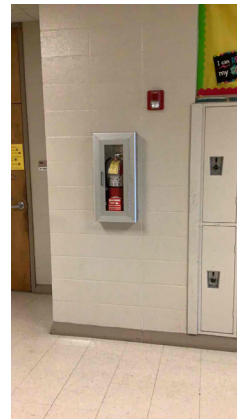
1.10 - Fire extinguisher cabinet mounted too high – handle above 48 inches

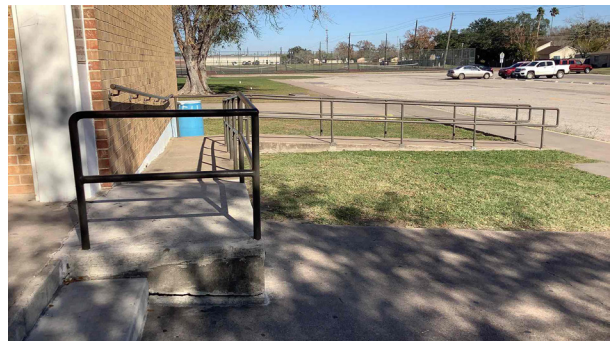
1.18 - Ramp handrails not compliant and stairs missing handrails

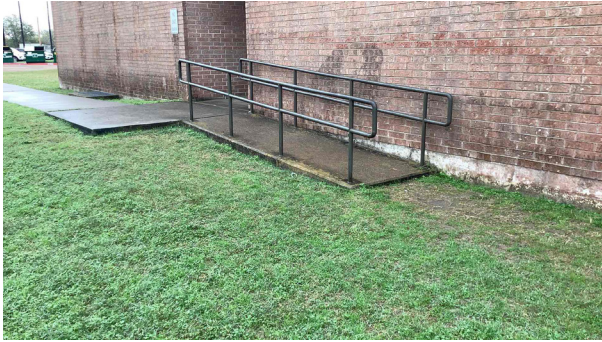
1.19 - Ramp to nowhere block ramp at landing or extend walk beyond

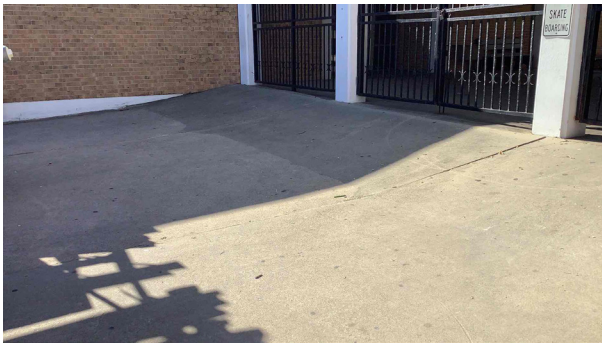
1.21 - Sloped walk to gates exceeds 5% making condition a ramp with no railing

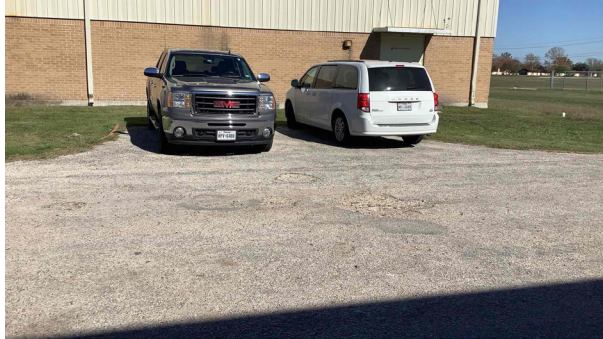
2.1 - Cars parked in fire lane blocking fire apparatus turn-around clearances

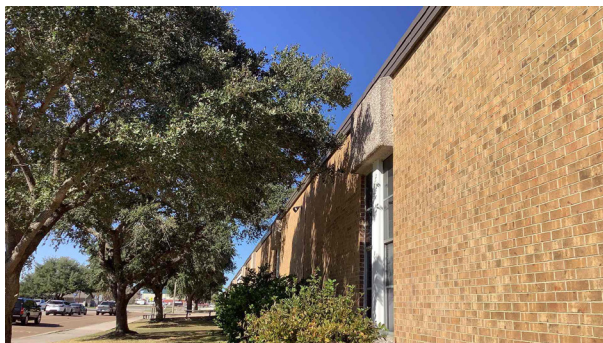
2.4a - Trees and bushes along building need to be trimmed to prevent damage to walls, roof, flashing or other building components

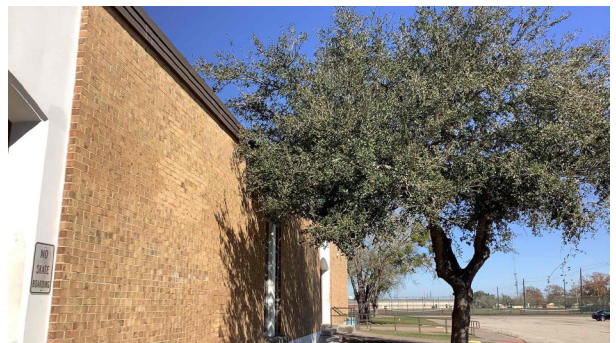
2.4b - Trees and bushes along building need to be trimmed to prevent damage to walls, roof, flashing or other building components

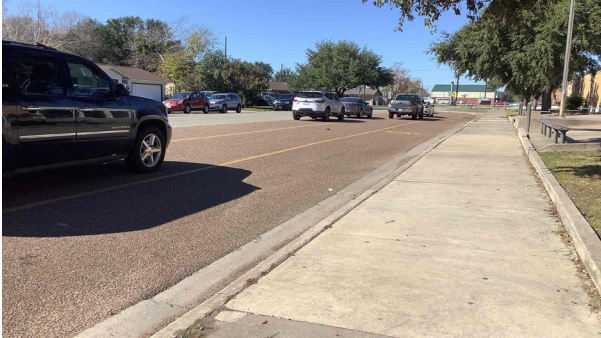
3.1 - No accessible pedestrian loading zone along drop off/ pickup area; multiple lanes for pickup causing students to walk across lanes of traffic

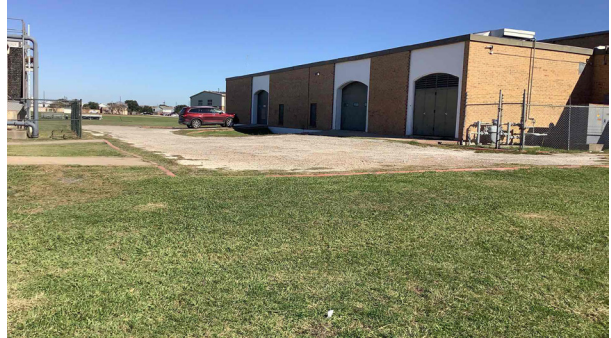
3.2a - Service drive/ fire lane severely potholed and deteriorated

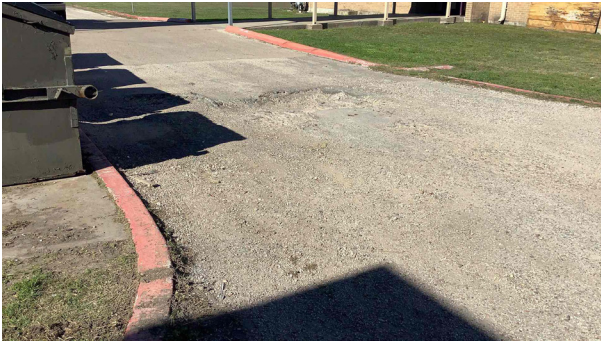
3.2b - Service drive/ fire lane severely potholed and deteriorated

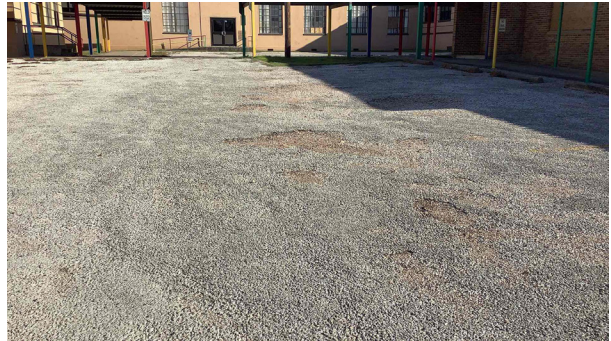
3.3a - Heavily deteriorated and potholed staff parking lot

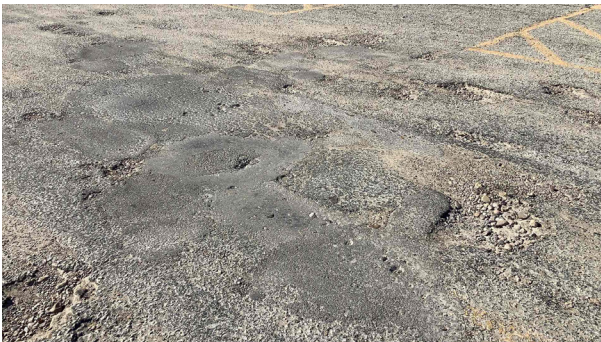
3.3b - Heavily deteriorated and potholed staff parking lot

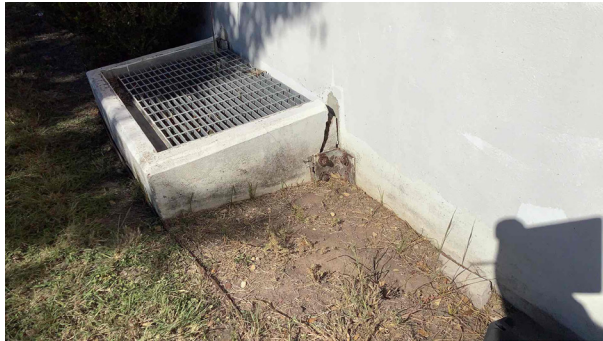
4.1 - Areaway attachment to building broken causing areaway to shift

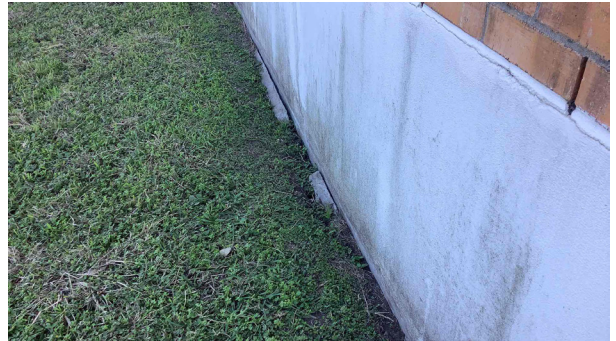
4.2a - Retainer blocks separating from building and in some locations they appear to be pushing in under the building

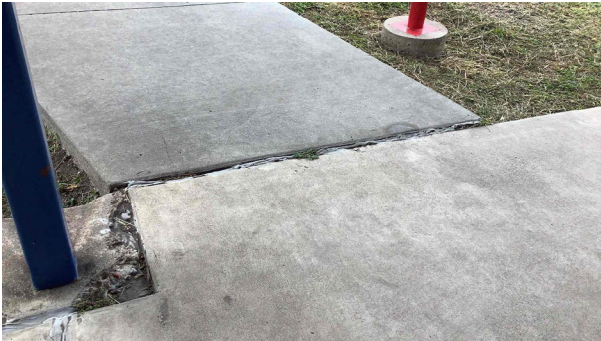
5.1 - Concrete settling at step allowing water under flatwork

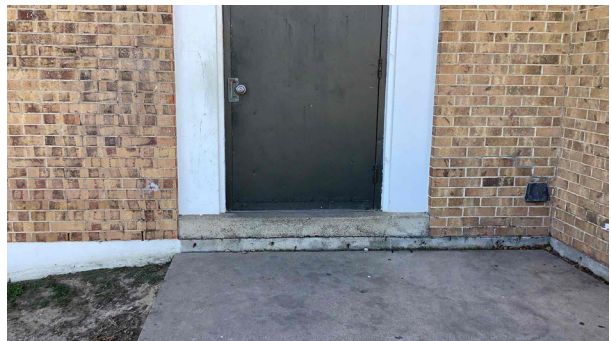
5.4 - Locations where concrete is settling adjacent to building creating step hazards and exposing concrete dowels

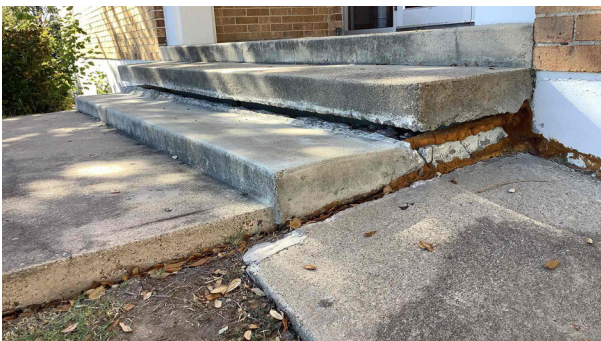
5.5a - Concrete walk at main and side entrances settling creating "floating" step – not compliant with code for step heights and concern step could break/ collapse

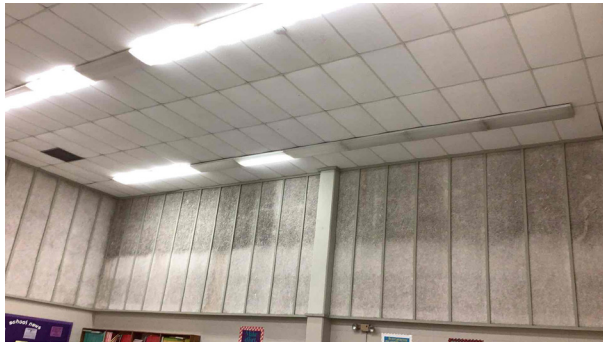
6.1 - Acoustical wall panels in band and choir very dirty

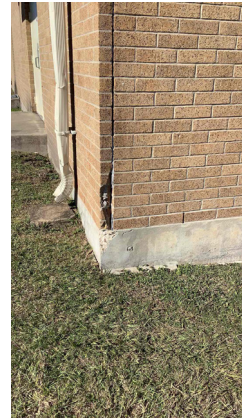
6.2 - Brick corner cracked at gymnasium corner – appears to be from something hitting building (mower, vehicle, etc.)

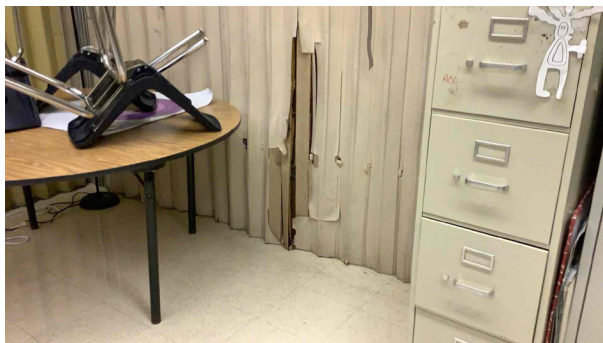
6.3 - Folding partition walls in old auditorium converted classrooms heaving damaged

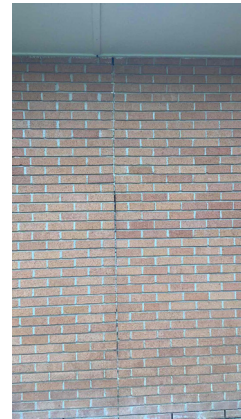
6.4 - Building sealants drying out, cracking and failing allowing moisture into building envelope

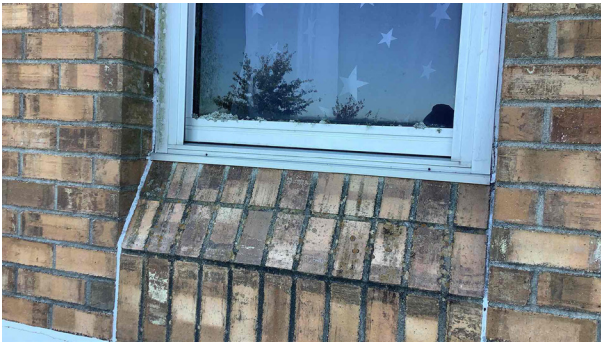
7.1 - Growth on windows, frames, sills, etc. at locations along north wall where windows are in shade

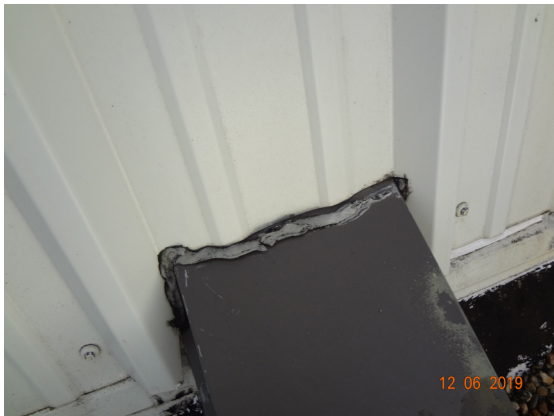
Failed sealant was observed consistently throughout the campus

Our overall recommendation is to replace the built-up roof sections and ancillary metal components, installing insulation to meet 2015 IECC requirements, raising equipment curbs as necessary, and to obtain a two-year contractor warranty, as well as a 20-year roof manufacturer warranty.

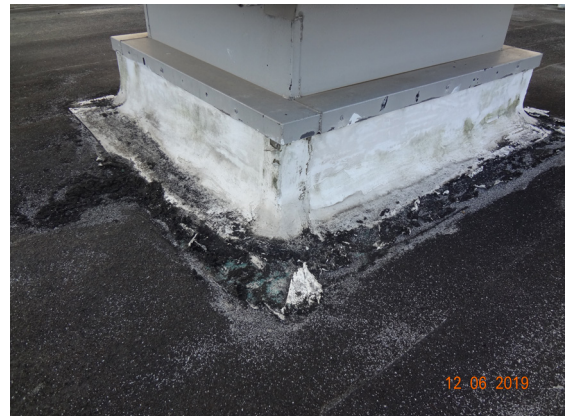
Base flashings observed throughout the campus appeared to be in consistently poor condition, in some cases potentially allowing moisture infiltration

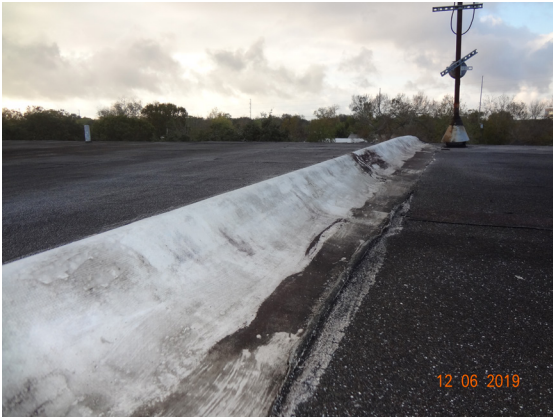
Materials installed to expansion joints appeared to be deteriorated and brittle

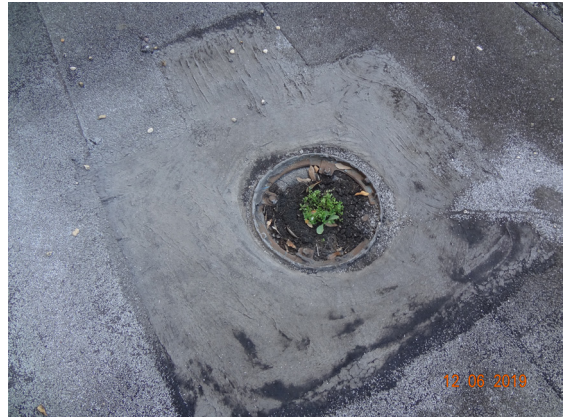
Roof drain strainer missing and drain body filled with debris and growing plants

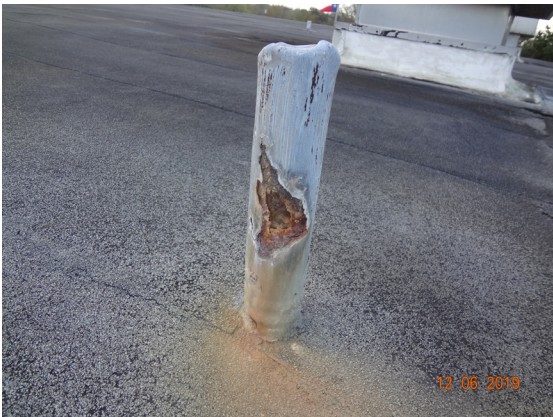
Damaged and rusted lead flashing was observed installed to vent pipe penetrations.

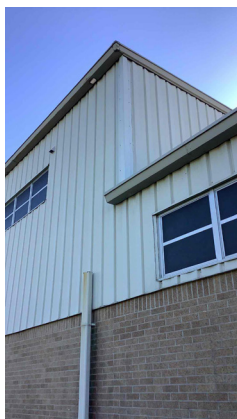
8.1 - Gutter downspouts disconnected from gutter at roof

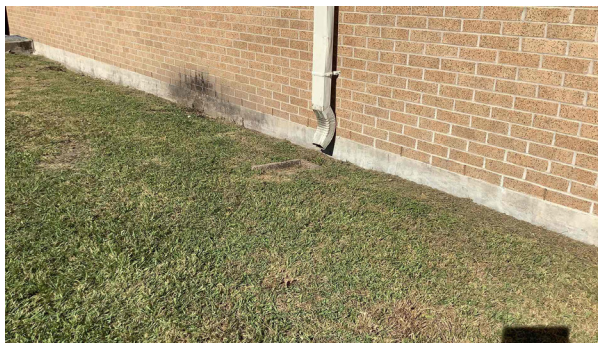
8.2 - Downspouts along gymnasium wall damaged and discontinuous in locations

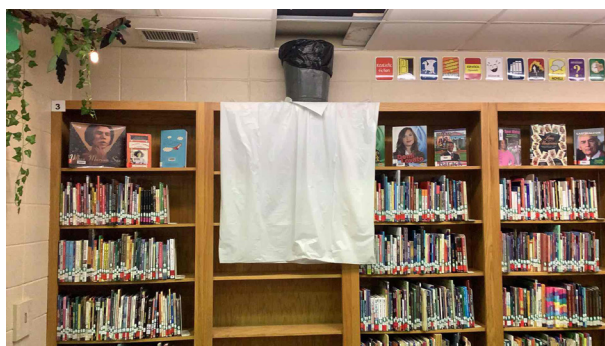
8.3a - Roof leak in library forcing removal of books and draping shelves with plastic

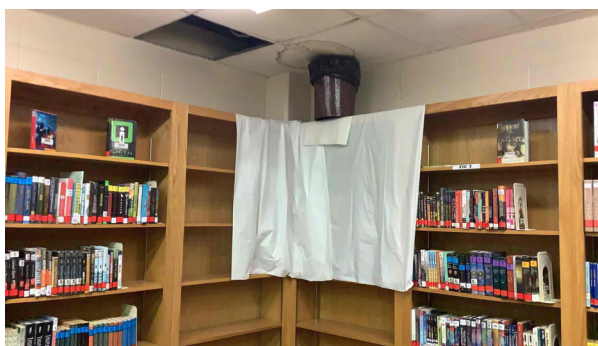
8.3b - Roof leak in library forcing removal of books and draping shelves with plastic

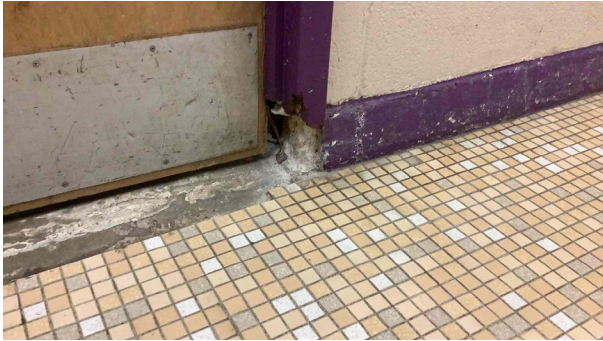
9.1a - Bathroom mosaic tile cracked and missing in locations (noticed rusted door frame base)

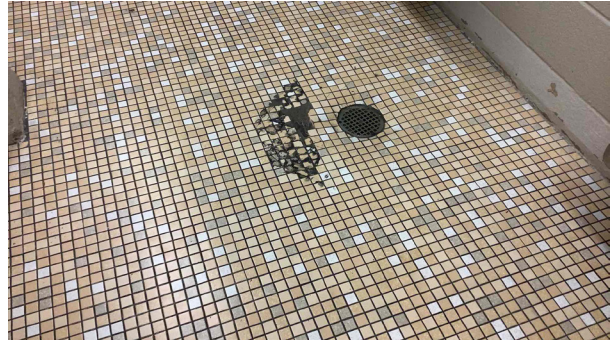
9.1b - Bathroom mosaic tile cracked and missing in locations

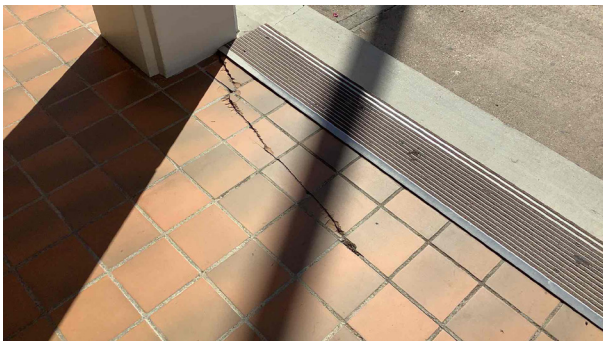
9.2 - Floor tile at front entrance steps cracked – concern indicative of underlying cracking where steps are floating

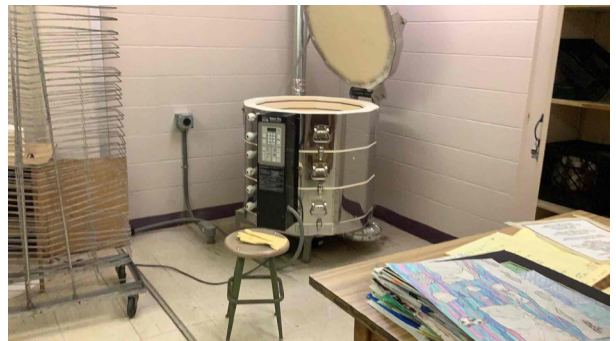
9.3 - Kiln sitting directly on VCT – should be on concrete or similar

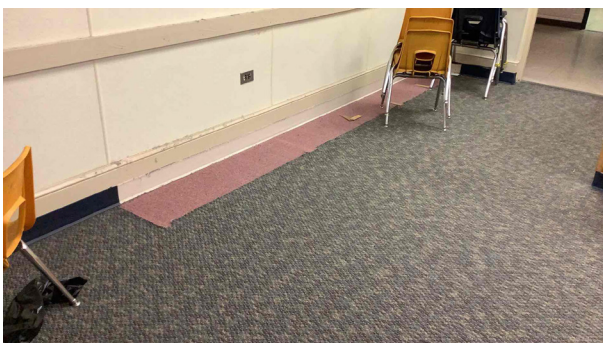
9.4 - Library carpet worn in traffic areas but in generally good condition

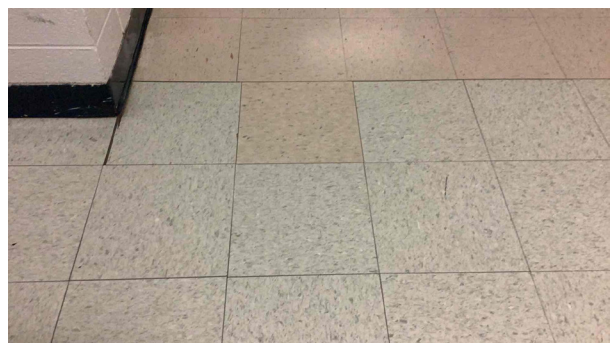
9.5 - Mismatched VCT at replacement areas

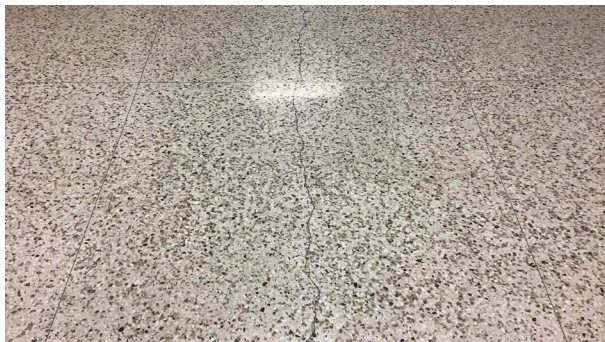
9.6 - Terrazzo corridors cracked – down center of hallway

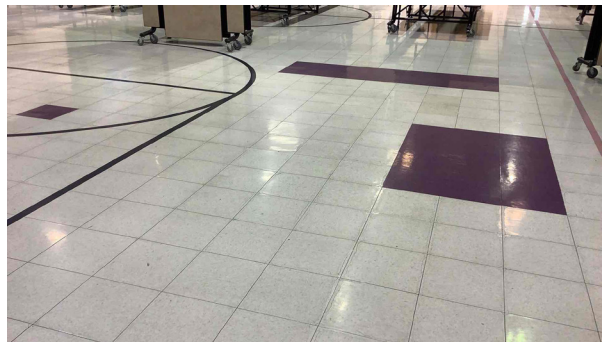
9.7a - VCT gaps (likely due to movement of tile from adhesive failure)

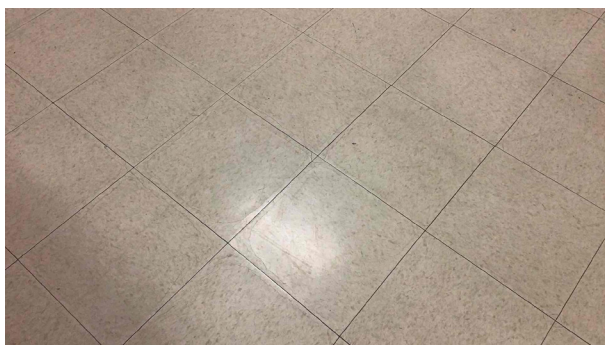
9.7b - VCT gaps (likely due to movement of tile from adhesive failure)

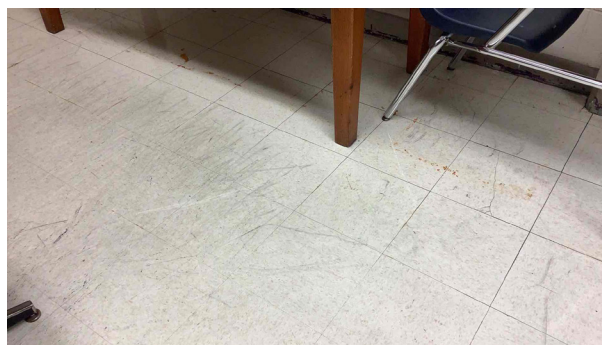
9.8 - VCT scuffed heavily at chair locations – appears to be stripped and waxed on regular schedule

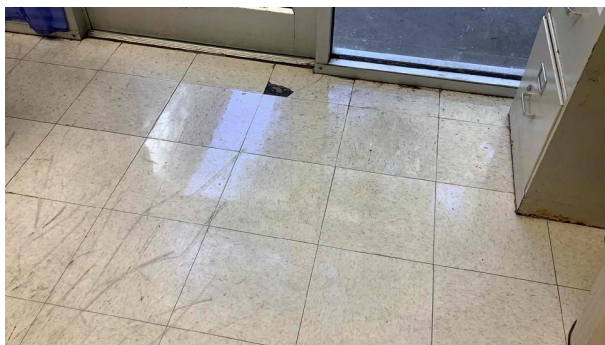
9.9 - VCT curling at corners and edges and damaged at exterior door (wet) location

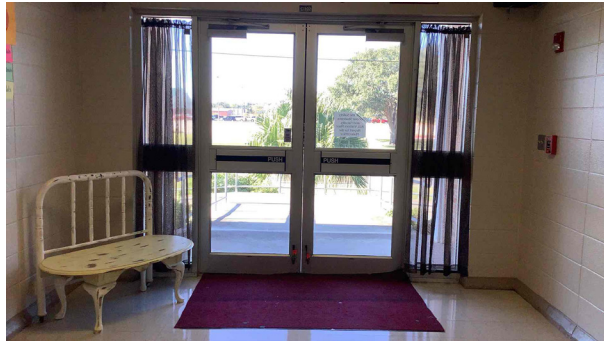
10.1 - Bottom rail of existing storefront doors (must be 10" for accessibility)

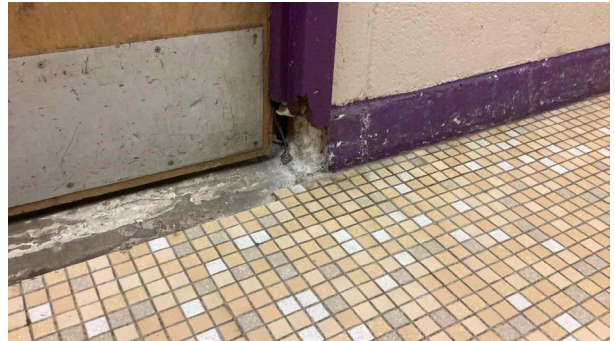
10.2a - Interior door frames rusting at base where heavy mopping occurs (kitchen and bathrooms)

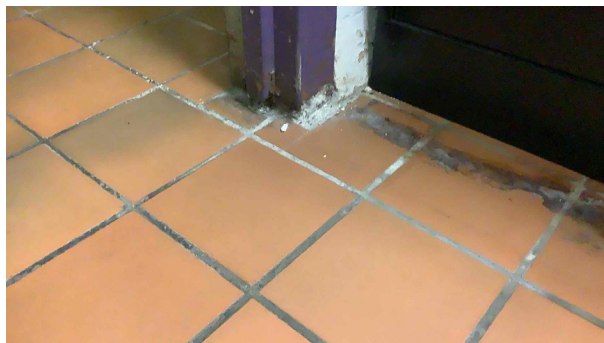
10.2b - Interior door frames rusting at base where heavy mopping occurs (kitchen and bathrooms)

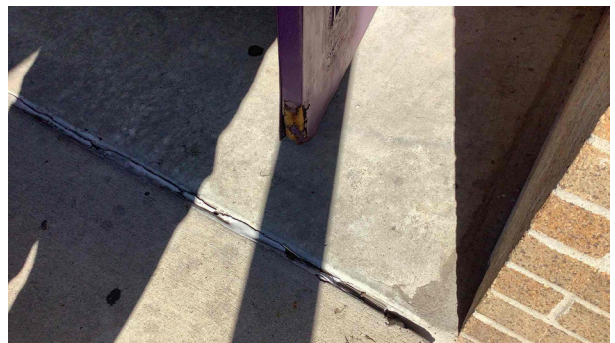
10.3 - Exterior steel doors rusting along bottom edges

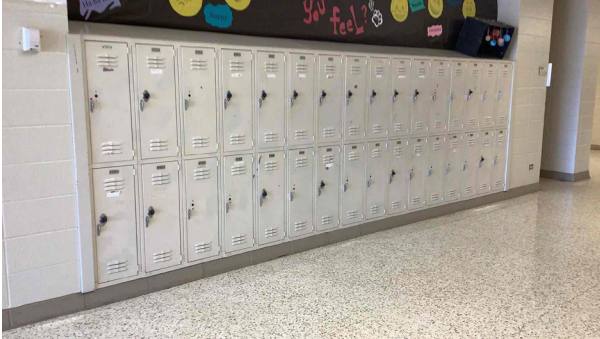
11.1 - Campus lockers unused and in fair condition

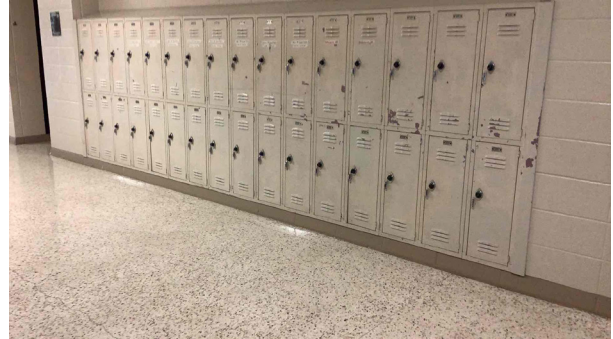
11.2 - Locker finish peeling

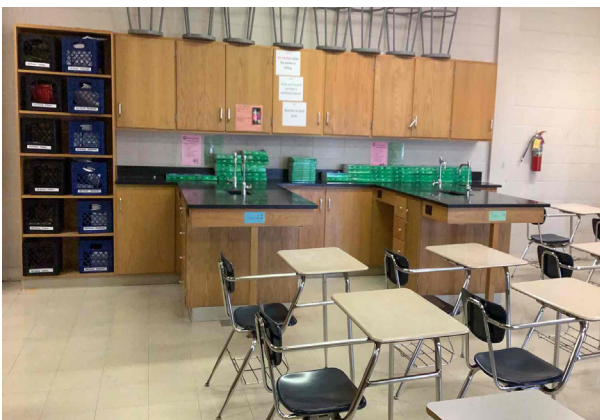
12.1 - General condition of existing – old, but still functioning

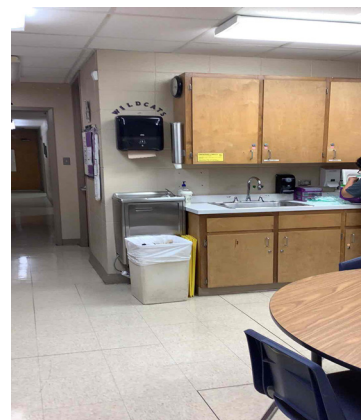
12.2 - Sink base cabinets not compliant for accessibility

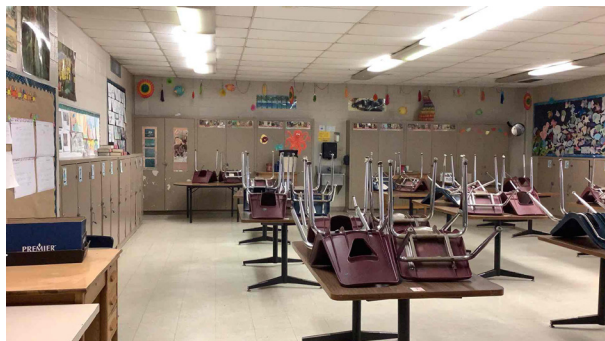
13.1a - Sagging tiles in classrooms

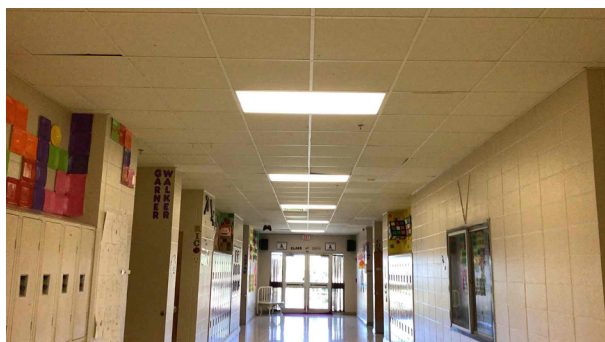
13.2 - Grid damage in hallways not allowing tile to sit flush

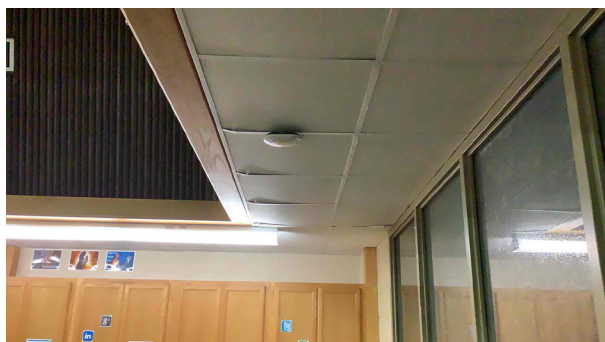
13.3 - Grid damage in library not allowing tile to sit flush setback

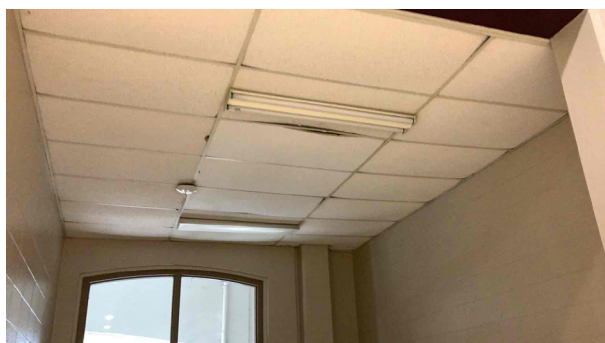
13.4 - Tile sagging and hanging below grid, likely from high humidity

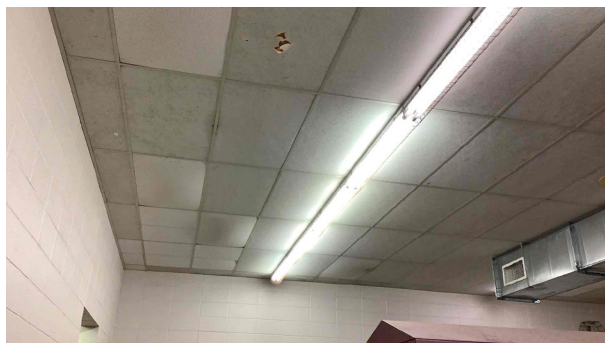
13.5 - Mismatched tile throughout from replacement over years

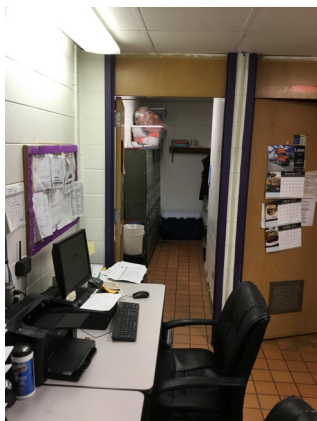
15.1a - Walk-in cooler freezer - frost build-up on freezer door

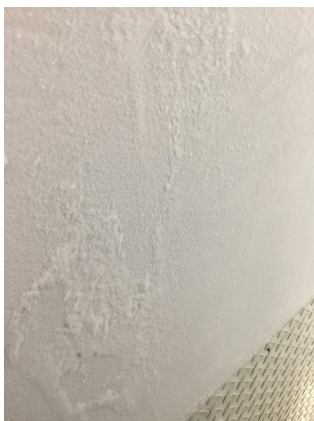
15.1c - Walk-in cooler freezer - frost build-up on freezer door

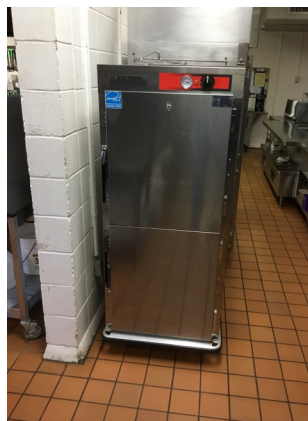
15.2 - Mobile heated cabinet - located behind serving counter, not adequate for back up

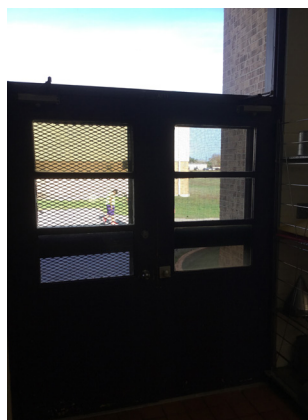
15.4 - Receiving door - no air screen

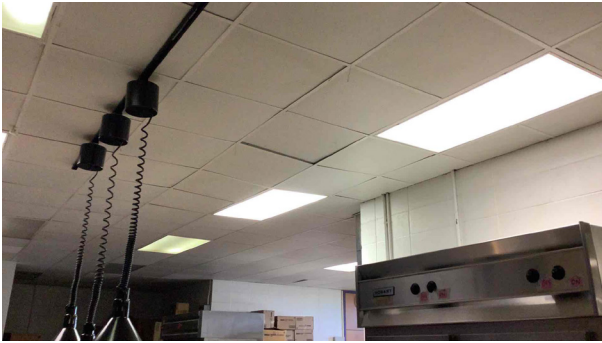
15.6 - Ceiling tile dirty, ceiling grid sagging and missing tile

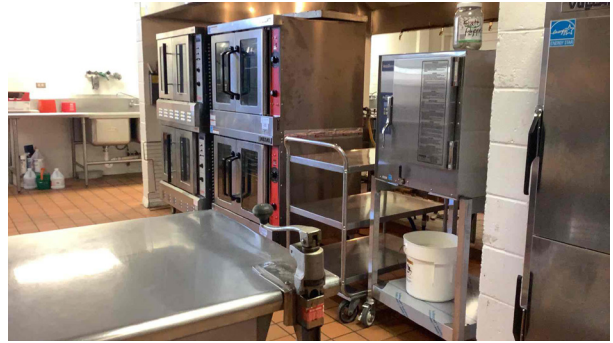
15.7 - Equipment is in fair condition

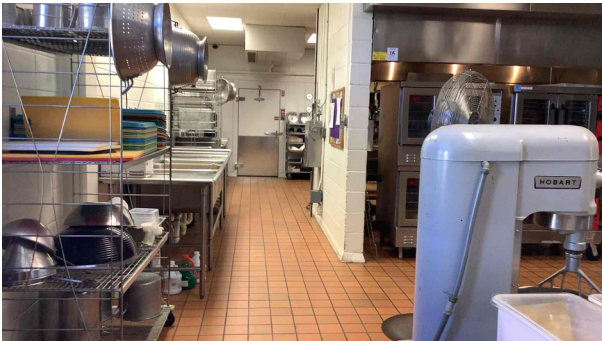
15.8 - Floor tile is in good condition.

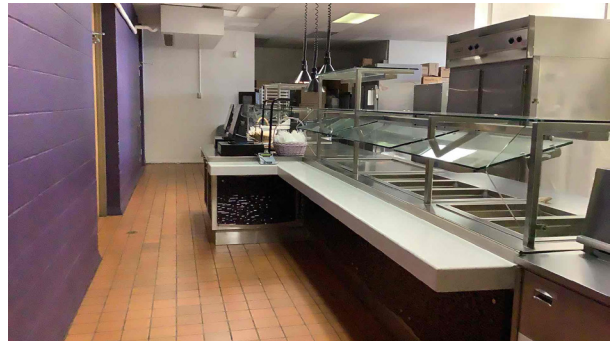
15.9 - Four serving lines for serving students

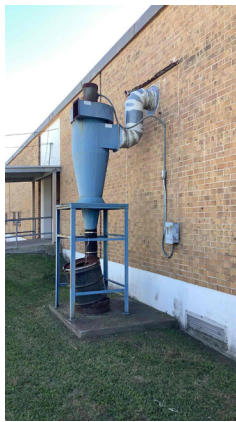
16.1 - Exterior dust collection barrel rusted – evidence that roof cover for dust collector removed

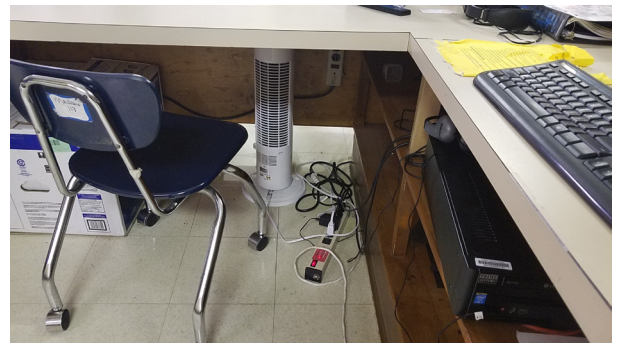
16.2 - Space heaters being used under desk

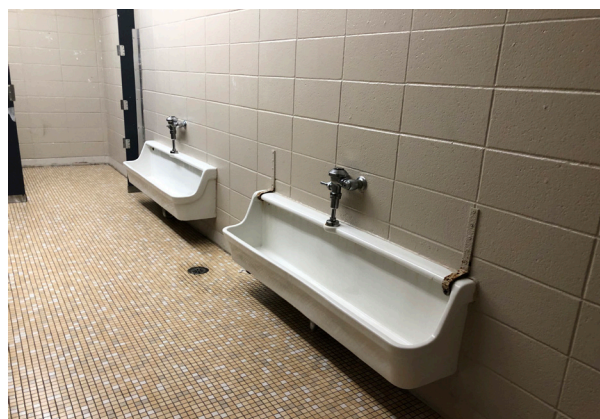
16.14 - Trough urinals are not ADA/TAS compliant
