Bald Eagle Area School District

# District Wide Feasibility Study

February 27, 2018 CRA Project No. 3097

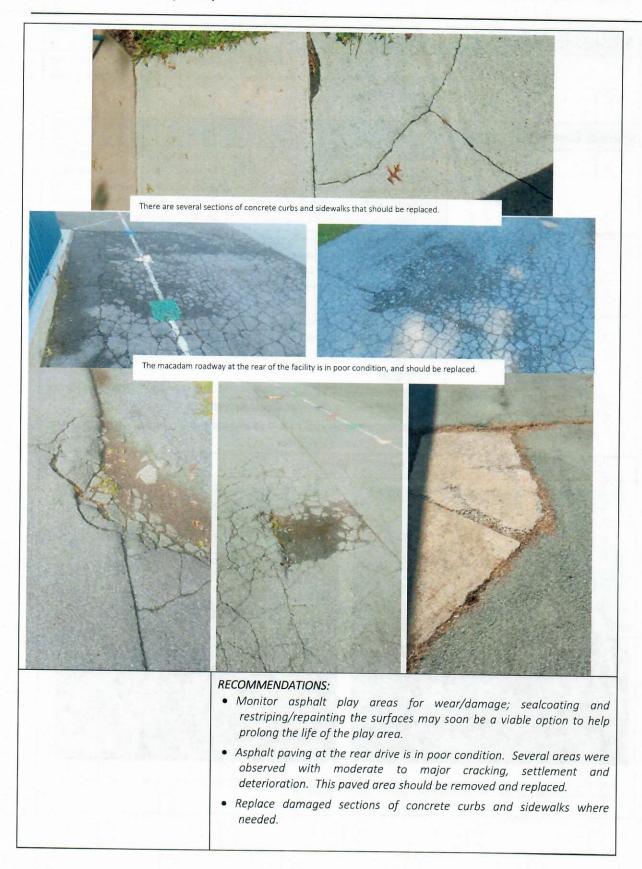
Accessibility, Walkways and Curbing:	The main entrance of the building does not meet minimum handicapped accessibility requirements, requiring stairs to access the entrance. The entrance doors are not sized appropriately to permit accessibility. There are some exterior doorways that step down to the pads. Concrete sidewalks, plazas and curbs appear to be in fair to good condition. <u>Concern:</u> Some of the sidewalks and curbs were previously replaced.
Site Amenities:	although there are some locations that are badly cracked.  n/a.
Site Amenities.	nya.
Site Lighting:	n/a.

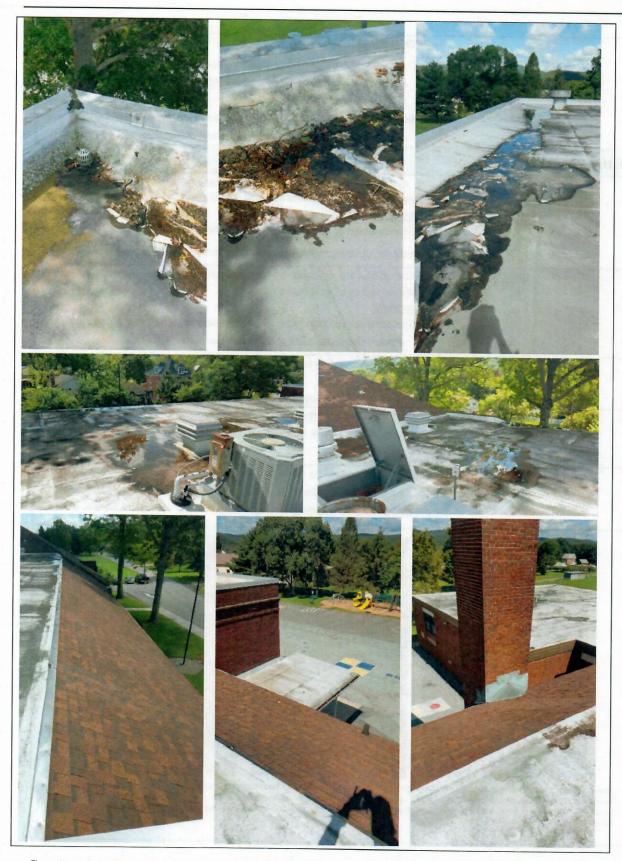
Both pictures depict the condition of the original painted plywood roof fascia trim; the paint is peeling badly and the wood is rotting in some locations; these systems should be replaced with prefinished metal fascia and break metal trim components.

These pictures depict the current condition of the roofing systems. The asphalt shingle roof is in good condition. The coated epdm roof system is failing. Consideration should be made to fully replace the membrane roof areas.

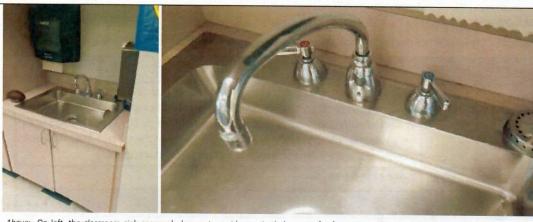
Above: On left, the classroom sink casework does not provide required clearance for front-approach. On the left, the sink controls do not meet ADA requirements for size/shape.

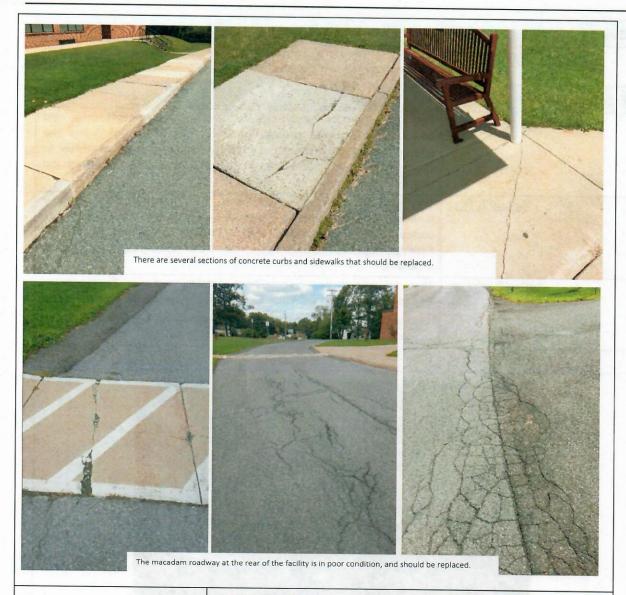
City Annualities	although there are some locations that are cracked and spalled.
Site Amenities:	n/a.
Site Lighting:	n/a.

- Monitor asphalt play areas for wear/damage; sealcoating and restriping/repainting the surfaces may soon be a viable option to help prolong the life of the play area.
- Asphalt paving at the rear drive is in poor condition. Several areas were observed with moderate to major cracking, settlement and deterioration. This paved area should be removed and replaced.
- Replace damaged sections of concrete curbs and sidewalks where needed.

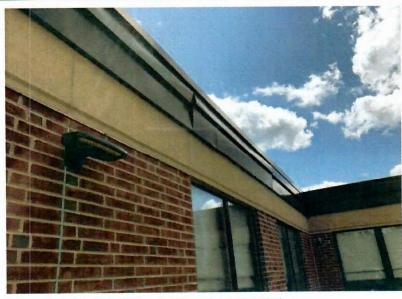
This image depicts the damage at the roof trim fascia. This item should be repaired and maintained.

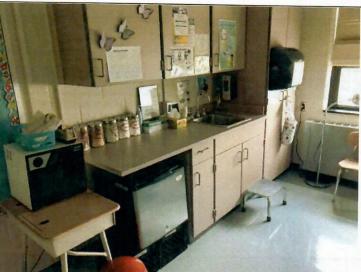
Above: On left, the classroom sink casework does not provide required clearance for front-approach. On the right, the Faculty sink assemblies do not meet ADA requirements.

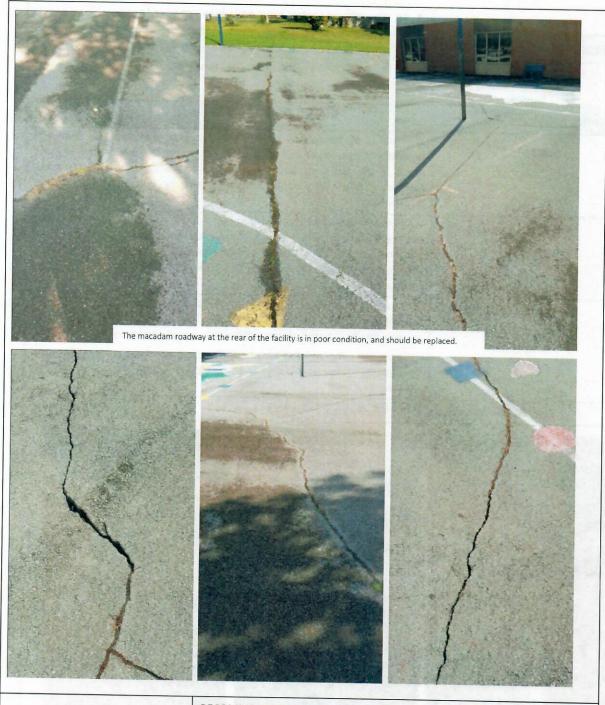
- Monitor asphalt play areas for wear/damage; sealcoating and restriping/repainting the surfaces may soon be a viable option to help prolong the life of the play area. Larger cracked areas should be remediated.
- Asphalt paving at the rear drive is in poor condition. Several areas were observed with moderate to major cracking, settlement and deterioration. This paved area should be removed and replaced.

Replace missing control joints and sealant at paved areas.	
Building Structure		
<u>Structural System:</u>	Primarily a one-story structure; the structural system is steel-framed construction. The roof deck is also steel.	
Exterior Envelope - Roof		
Roof System:	The roof is predominantly single-ply membrane over rigid insulation and tapered crickets, structurally-sloped to roof drains; the original building and much of the additions slope toward the perimeter, in which the water commonly flows into either scupper drains or gutters and then into downspouts.	
Flashing & Trim:	"Flat" roof edges are capped with a metal fascia/gravel stop system; other flashing includes traditional roof-to-wall terminations. The sloped roof portions consist of standard perimeter/edge trims, such as fascia's, flashings, ridge caps and drip edges. Overall, all the flashing/trim is in good condition.	
<u>Soffits/Overhangs:</u>	There are various types and conditions of soffits/overhangs. The facility has aluminum roof trim and wall fascia. Painted wood soffits are present at window heads. Painted plaster soffit is present at entrances and overhangs. Concerns: The painted wood soffits above windows is degrading and chipping. These soffits should be addressed before the integrity of the material is lost.

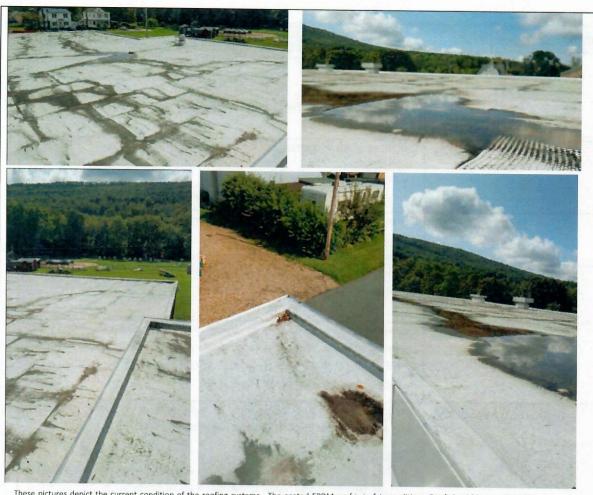
These pictures depict the current condition of the roofing systems. The coated EPDM roof is in fair condition. Roof should be monitored for leaks and maintained.

- The coated EPDM roof is in good-fair condition. It should be monitored for leaks and maintained.
- Repair wood soffits at window heads.
