Rangely School District RE-4

Facility Maintenance Master Plan

**Updated October 4, 2021*

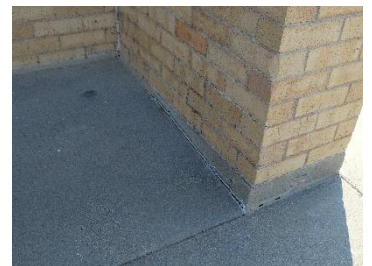
Crack propagation can be found in multiple areas throughout the building's exterior.

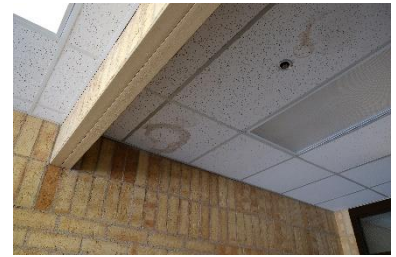
Water leaks visible on the ceiling tiles.

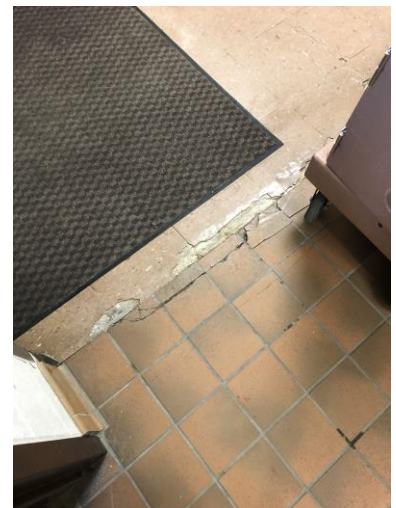
- 1) Carpeted floors are nearing the end of their service life and are showing signs of wear.
- 2) VCT and quarry tiles have become damaged at the kitchen/corridor transition due to lack of proper transition between the flooring types.
- 3) The fire alarm system has exceeded its expected service life.

The damaged VCT and quarry tiles at the transition into the kitchen.

- 1) Replace all carpet with long lasting, well-wearing carpet.
- 2) Remove and replace the damaged VCT and quarry tiles and install a proper transition strip to prevent future damage.
- 3) Replace the fire alarm system with a new, modern fire alarm system.
- 4) Standardize classroom layout
- 5) Demolish all old/abandoned in place power and network runs in the classrooms
- 6) resurface the stairs
- 7) All new casework throughout the school
- 8) Repaint the lockers and add tackboard above the lockers

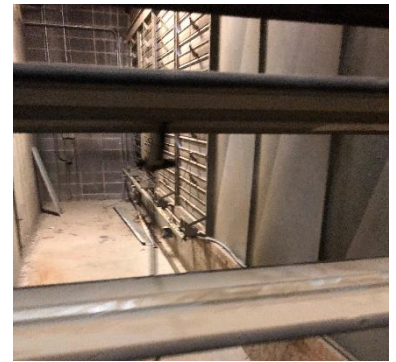
Inadequate outside air intake dampers

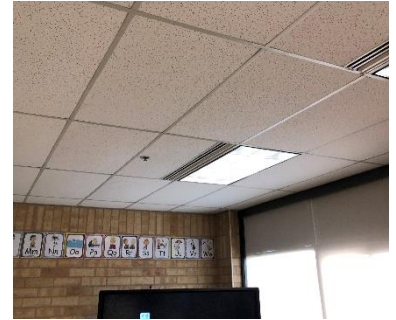
Poorly located ceiling air diffusers

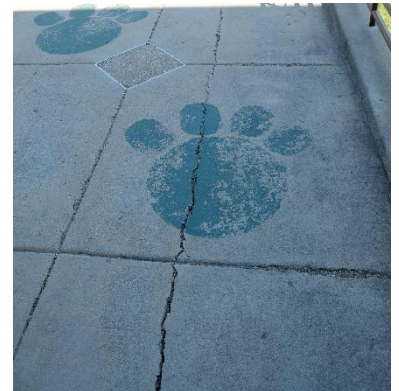
Cracking Sidewalks at the MS/HS

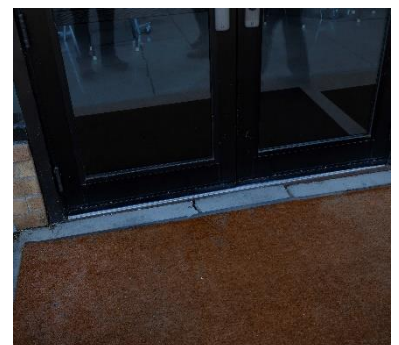
Crack Propagation Into the Facility

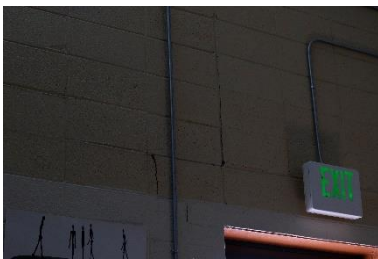
Interior Crack Propagation on Gymnasium Walls

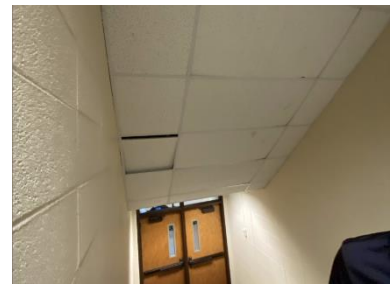
Failing Ceiling Tile

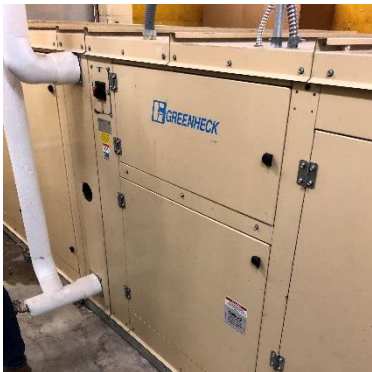
Dilapidated and inefficient multi-zone air handlers condition the classrooms in the 1967 wing. Air quality, comfort, and fire code issues were observed with these systems.

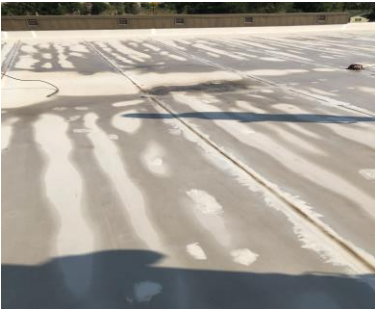
Sections of the roof on top of the building are draining inadequately and have seen previous repairs. Numerous adhesive materials used for patching have failed.

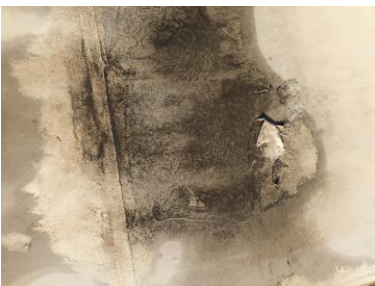
Water damage on the roof is causing interior damage.

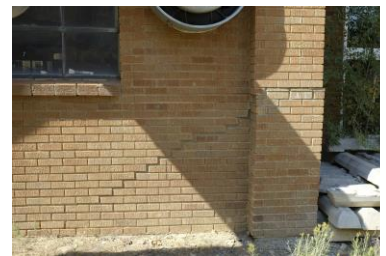
Exterior brick walls have some damage, which is caused by settling.

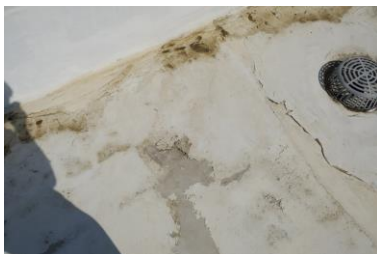
Water damage and failed repairs on roof causing interior damage.

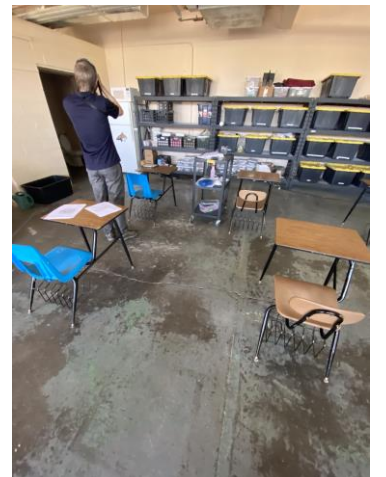
Damaged Classroom Floor

- 1) Mudjack the classroom floor to repair settling and resurface the concrete.
- 2) Replace the fire alarm system with a new, modern fire alarm system.
- 3) Install six new workbench tops
- 4) Demolish old CAT-5 cables and upgrade IT infrastructure
- 5) Open up wall directly next to classroom with big window
- 6) Demo the second wall past this one above^
- 7) Ceiling tile replacements throughout

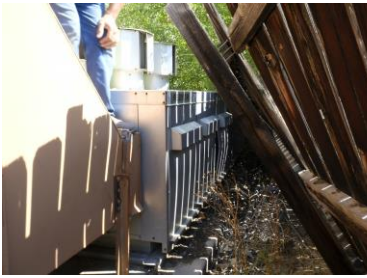
A failed make-up air unit.

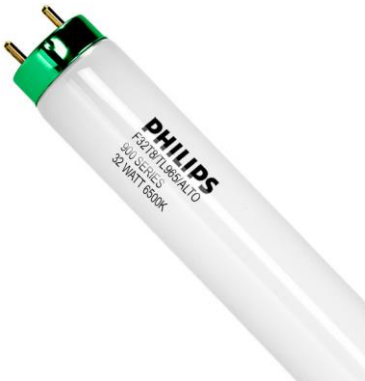
The majority of the building is illuminated by 40-Watt T-12 linear fluorescent lighting. The light fixtures are in fair condition but are using an excessive amount of electricity and have passed their expected service life. Modern LED equivalents of linear fluorescents lights only consume 12 Watts. Additionally, LED lights generally last twice as long as equivalent fluorescent bulbs. The school already upgraded the gymnasium fixtures to efficient LEDs. The rest of the facility should be upgraded to LEDs to reduce energy and maintenance costs.

The majority of the building is illuminated by inefficient linear fluorescent lamps. The entire building needs to be upgraded to high-efficiency LEDs.

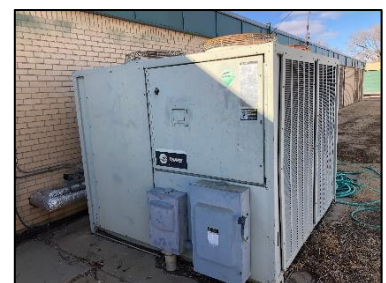
The chiller serving the air handling equipment is 24 years old and due to be retired or replaced.

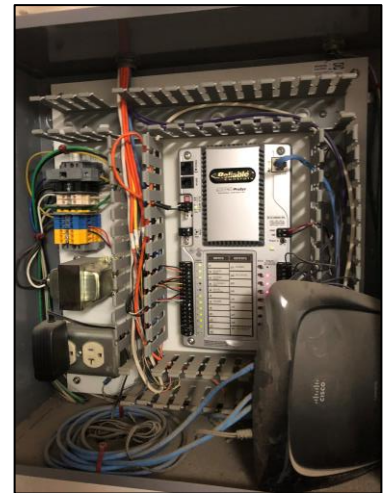
The Reliable Controls system serving the 1967 equipment is broken and needs to be replaced.

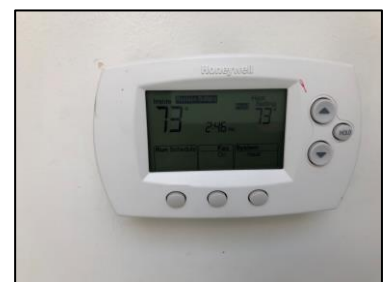
Individual thermostats control the rooftop units that condition the 1998 wing. The maintenance staff cannot bulk edit schedules and setpoints, which makes it difficult to run the equipment efficiently.

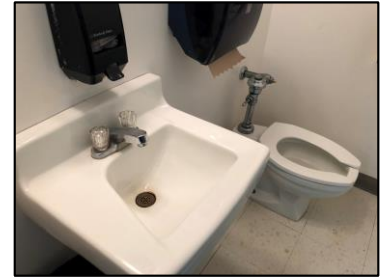
The existing plumbing fixtures are in poor condition and consume an excessive amount of water relative to modern fixtures.

Domestic water lines should be treated and cleaned to remove as much of the hard water buildup as possible. The circulation pumps at each site should be replaced with properly sized pumps, and booster pumps should be added on the longest runs of the domestic water lines. To prevent future hard water buildup, water softening systems should be implemented at each site. Finally, the domestic hot water heater at the Ag Shop should be replaced with a high-efficiency gas fired hot water heater.

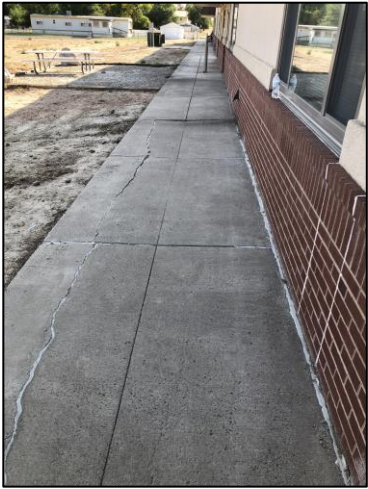
There is sidewalk settling and cracking with signs of poor drainage.

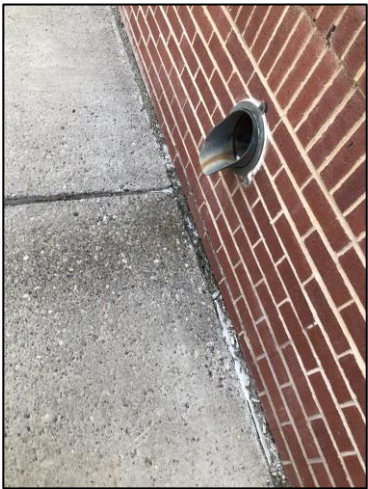
A typical building drainage example, which is poorly sloped providing uncontrolled drainage.

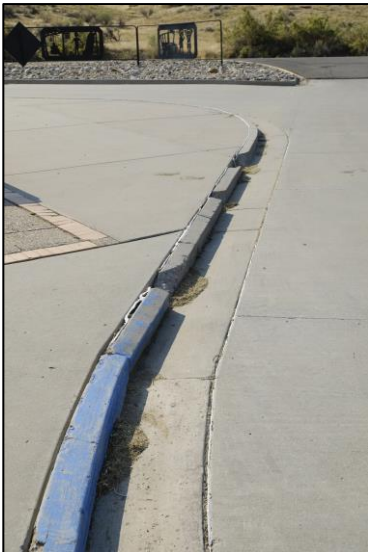
This shows a damaged section of a curb that needs repairing.

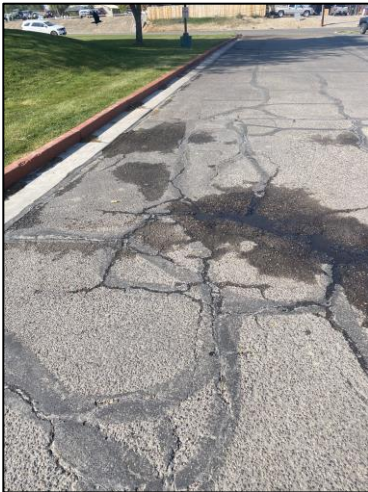
A damaged and cracked parking lot.

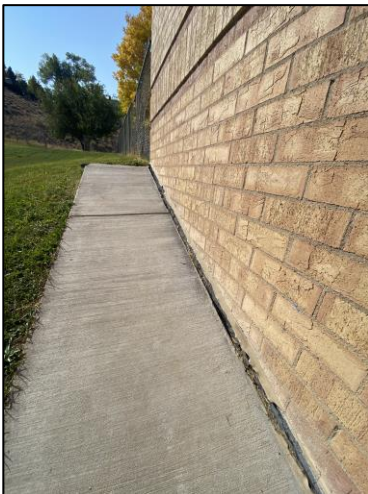
Signs of settling in perimeter sidewalks.
