Facility Infrastructure Safety & Repairs

Lakeview Junior
High School

Prairieview
Elementary School

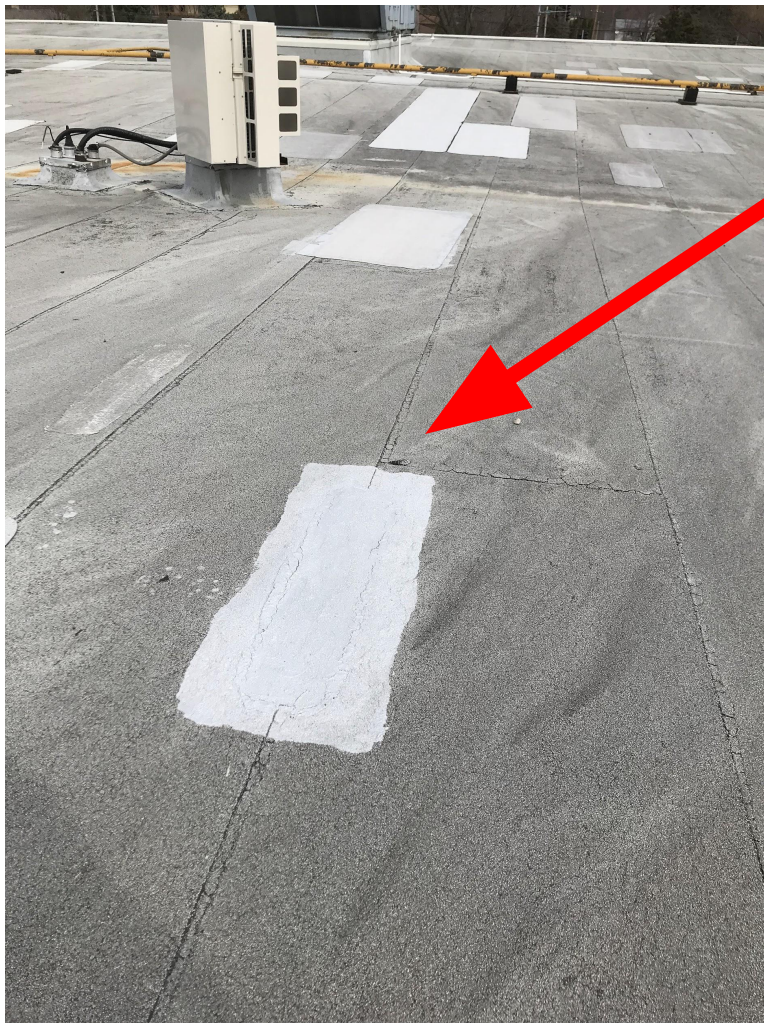
On the Left-
see patches that
have been made-
varying shades of
silver/gray.

On the Right-
see the darker
sections where the
silver/gray color is
wearing thin- this
shows the bare
rubber of the roof
membrane.

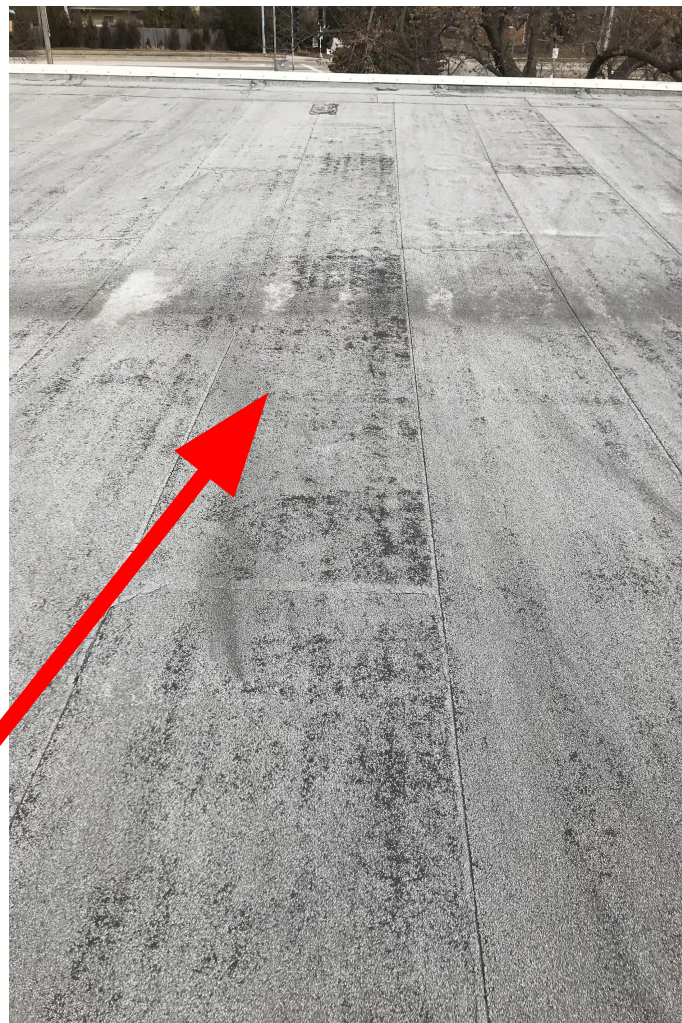
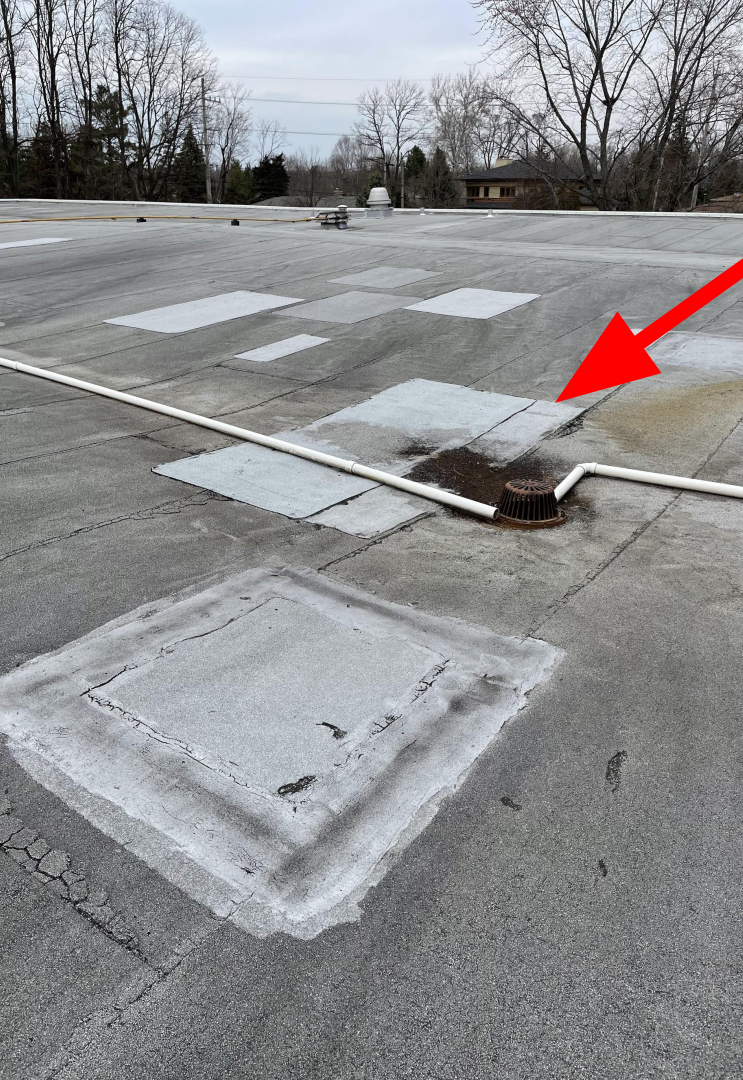
On the Left-
some larger
patch areas and
a roof drain.

On the Right-
heavily degraded
section of surface
coating.

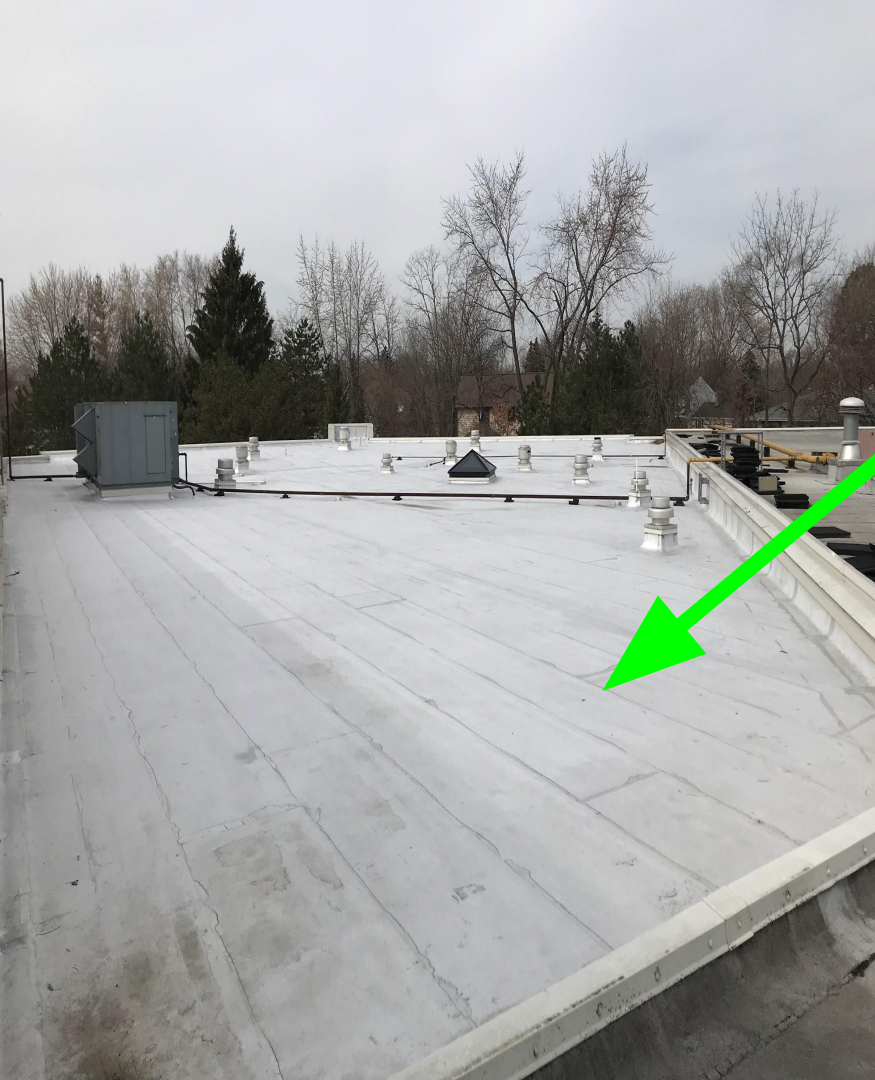
Newly
replaced
section 4 & 5.
Summer 2021

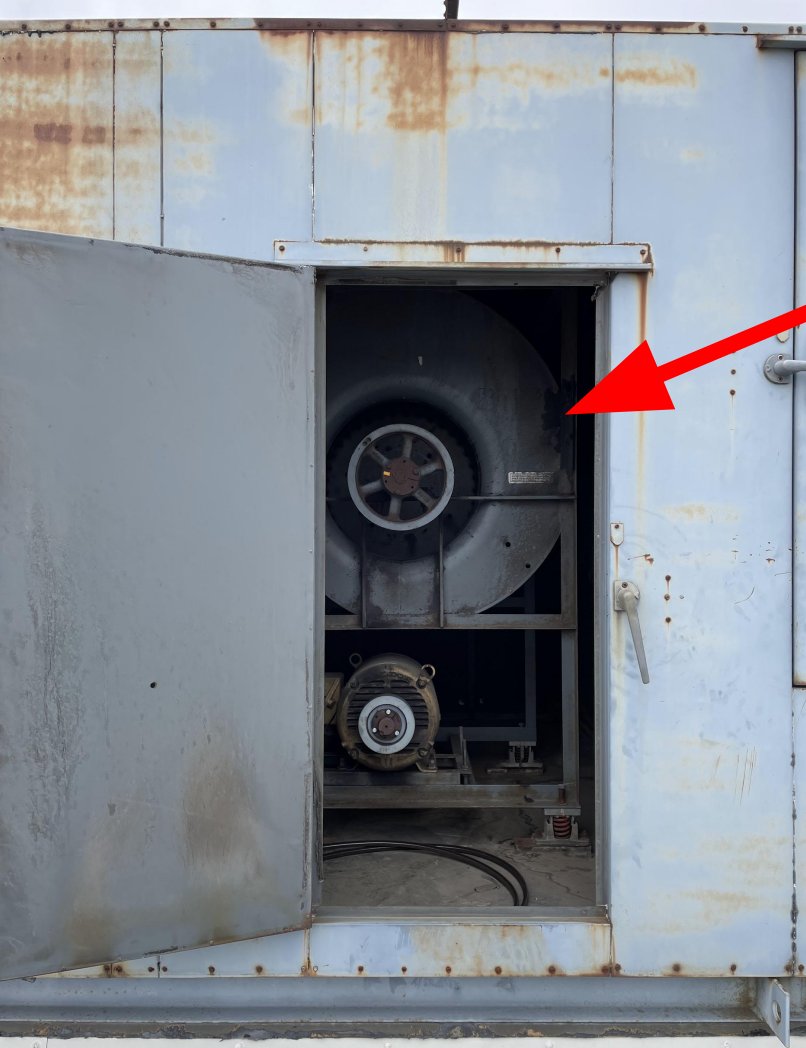
Fan Cage Assembly

- Rusting structures of blower fan cages.
- All repairs of any structural part is no longer available- requiring welding/fabrication.
- Quarterly belt changes

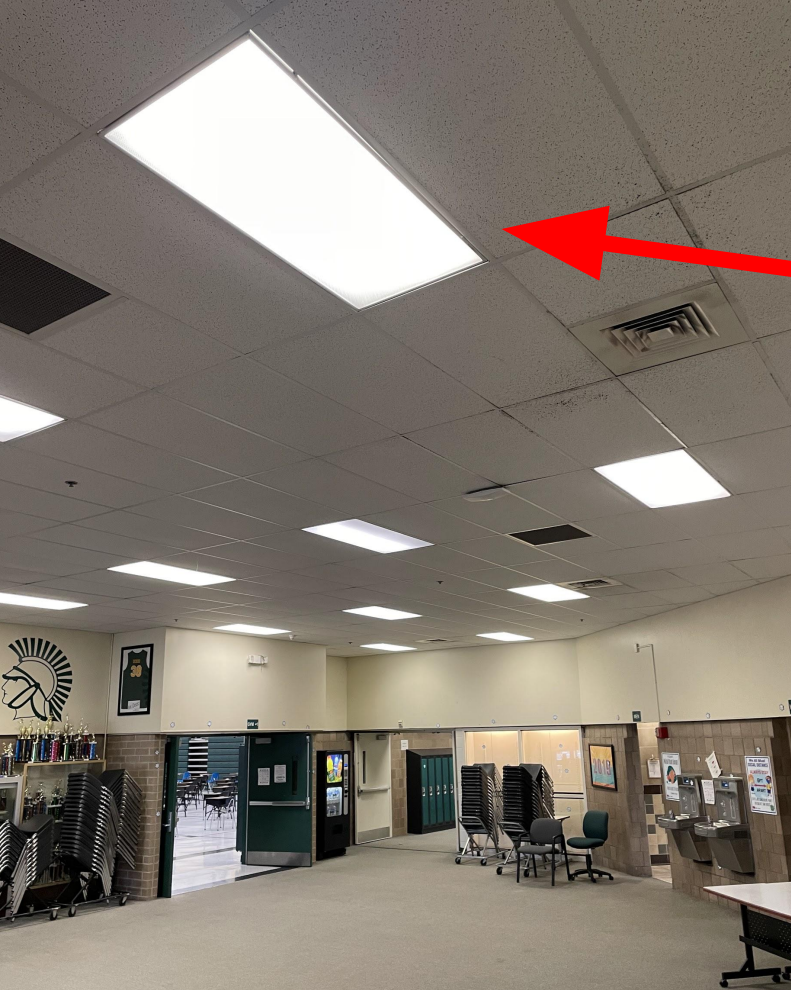
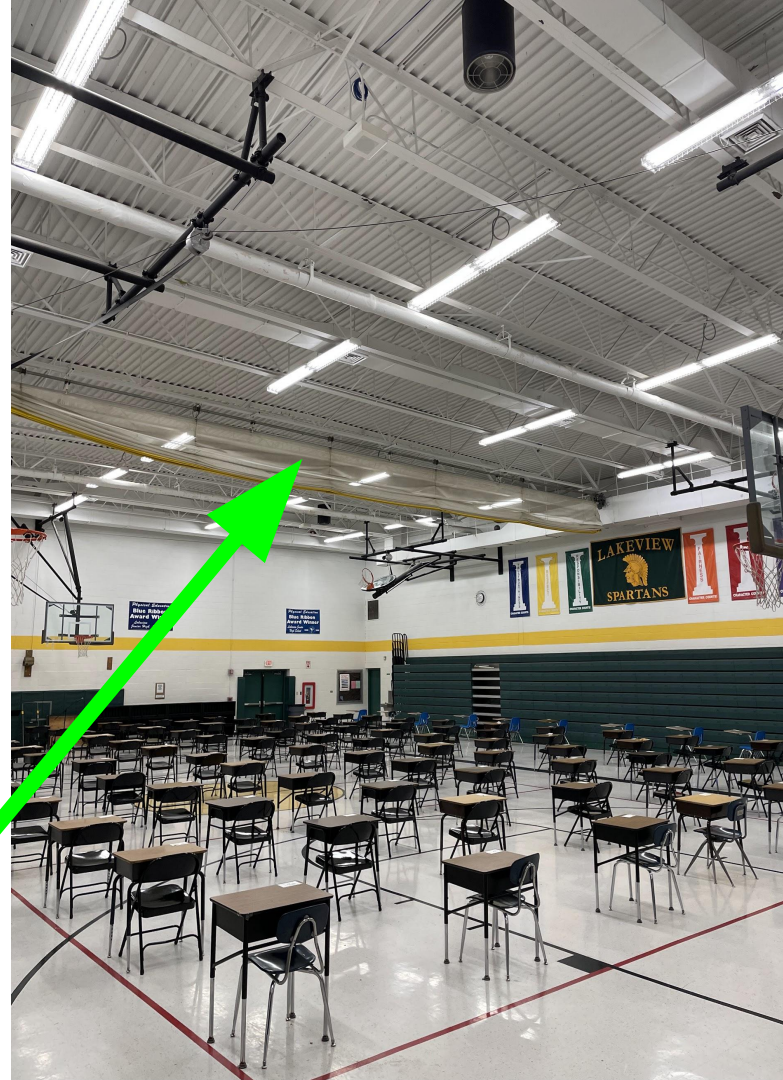
On the Left-
Halogen T5
lighting.
(majority of
Lakeview).

**On The
Right-**
LED
upgraded
lighting.(done
in house)

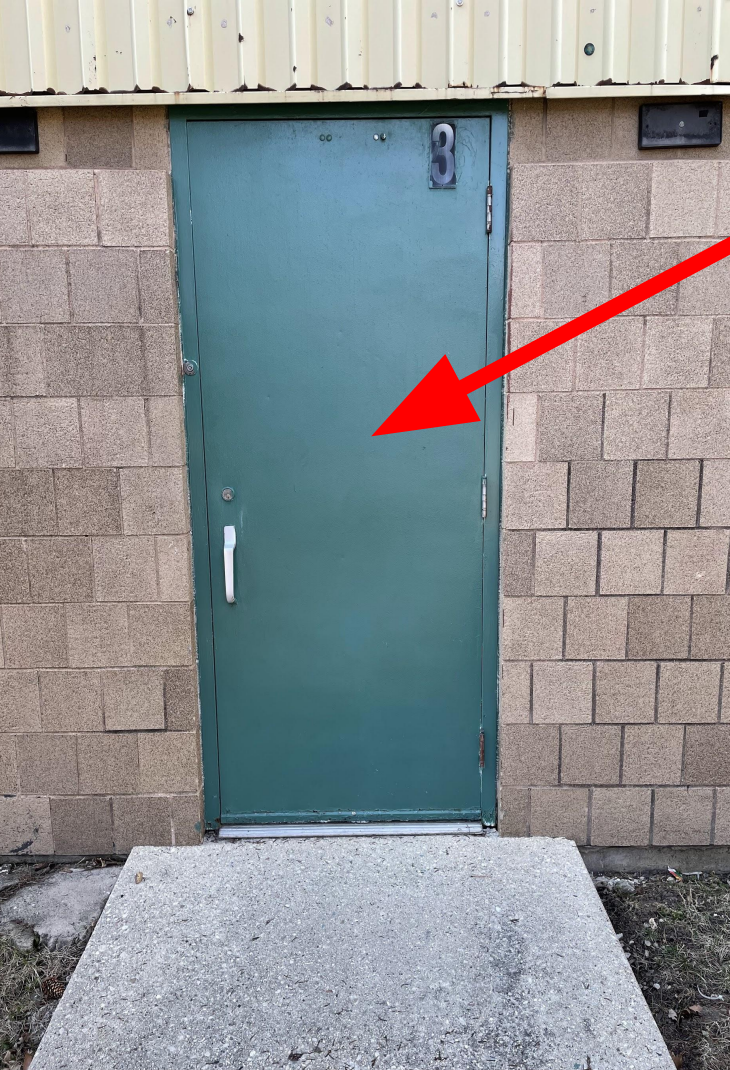
On the Left-
an original exterior
door.

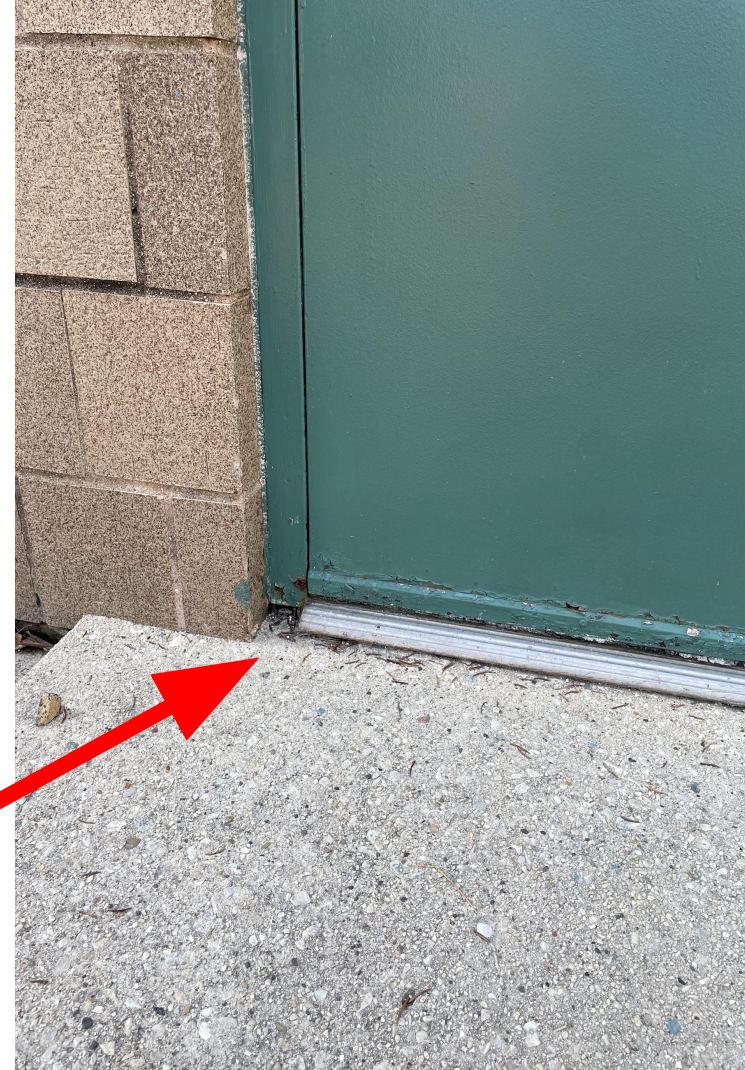
On the Right-
signs of rotting of the
door frame.

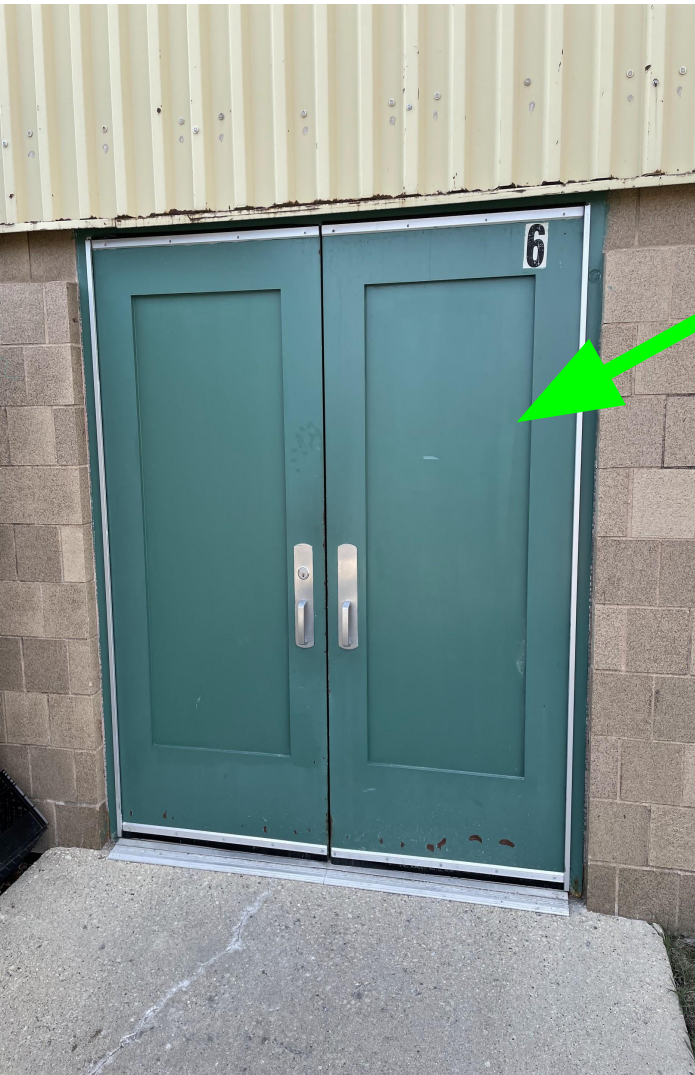
On the Left-
example of
repurposed older
doors. Removed
glass, welded
steel plate to use
as Gym exit
doors.(Done in
house)

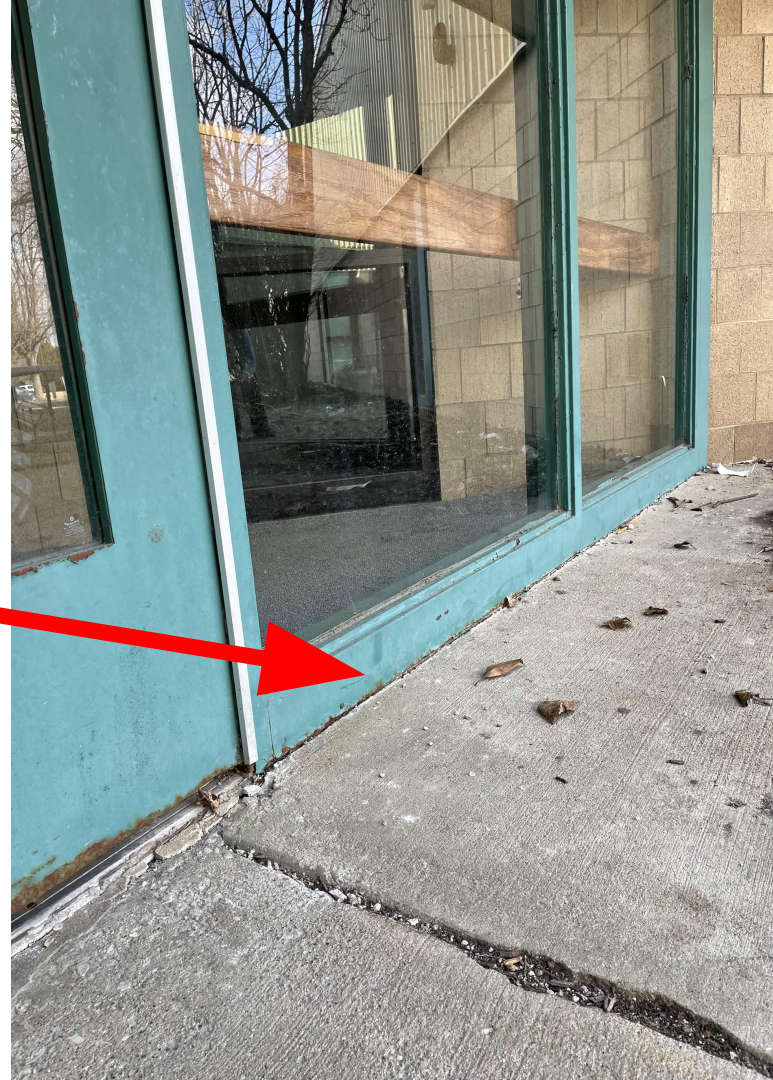
On the Right- many
original windows &
frames are also in
need of attention.

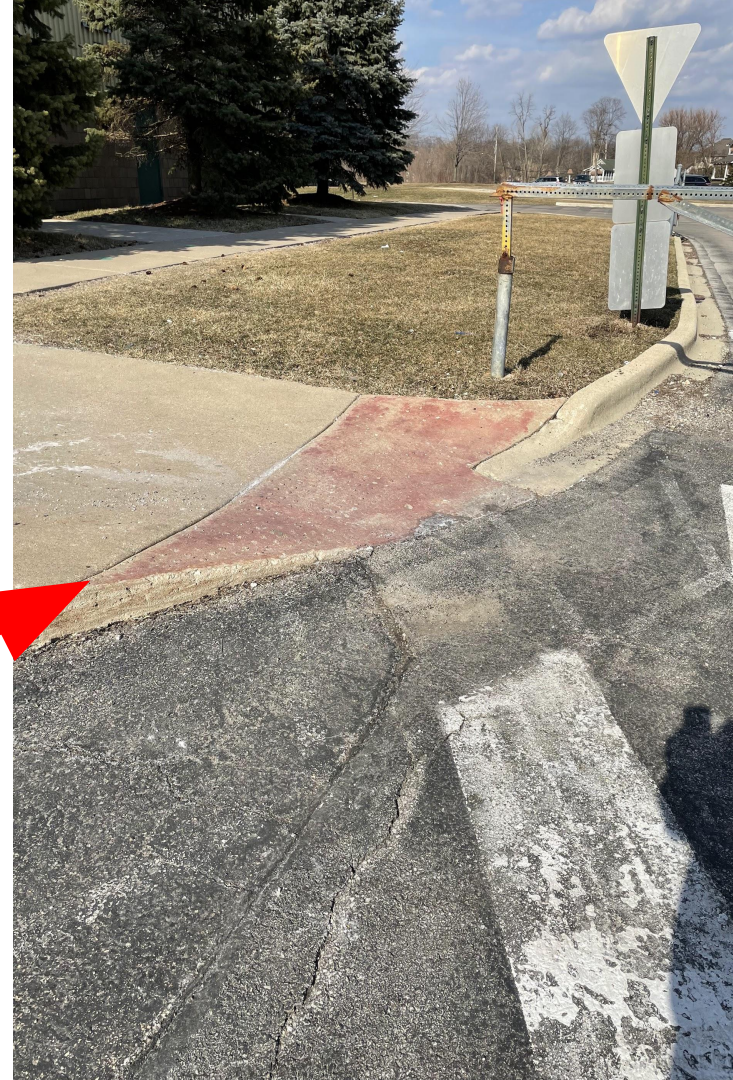
On the Right-
example of an
insufficient sized
access ramp W/out
current ADA pad.

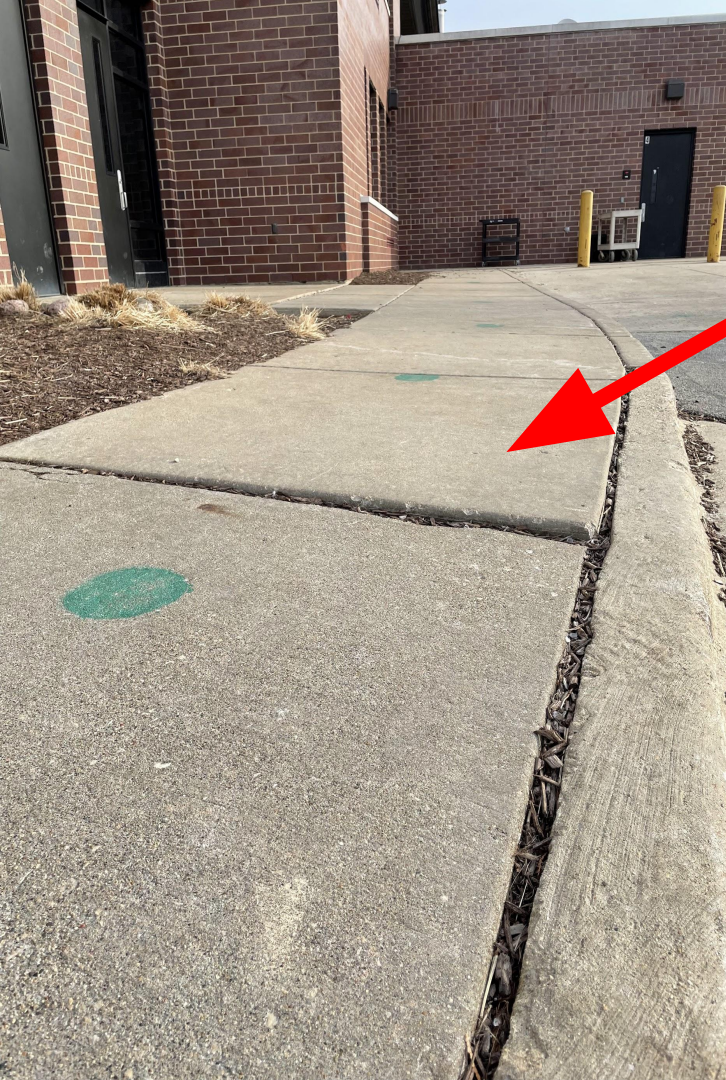
On the Left-
example of height
differences at
Prairieview.

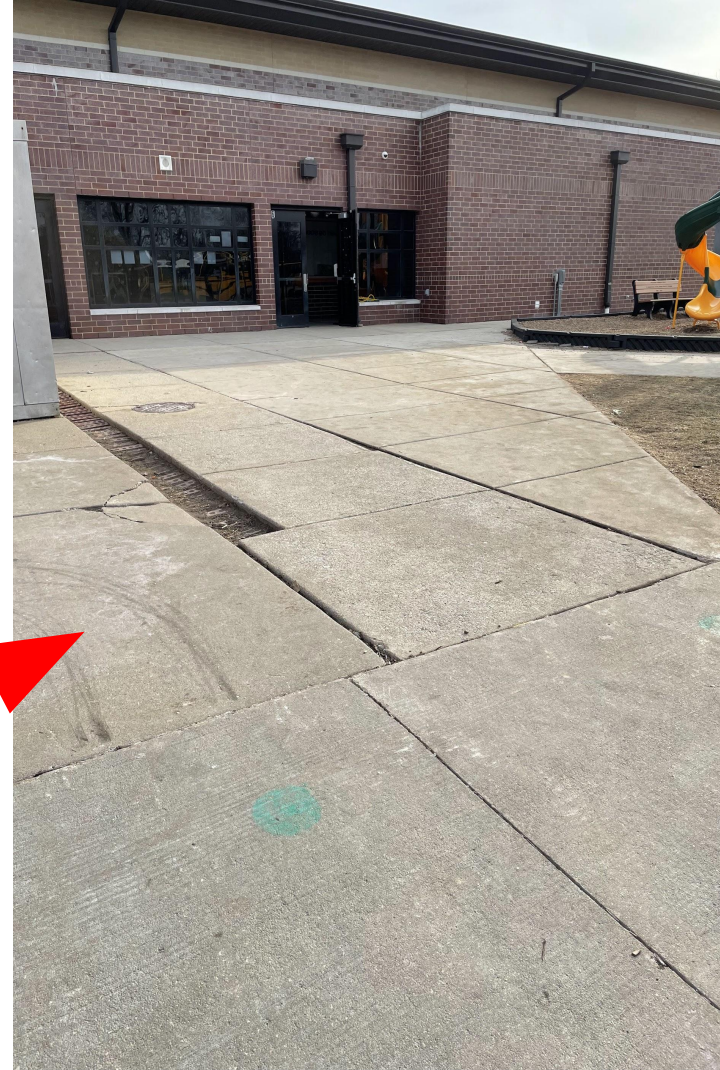
On the Right-
example of height
differences at
Prairieview.

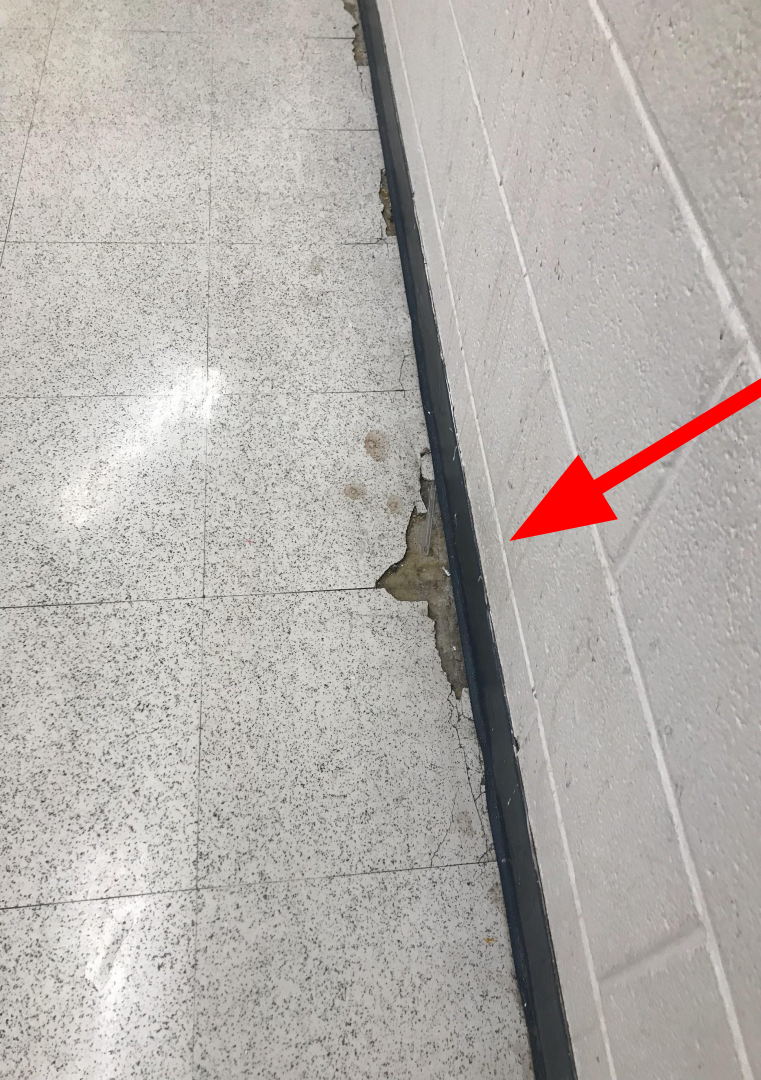
Prairieview
cracked floor tiles.

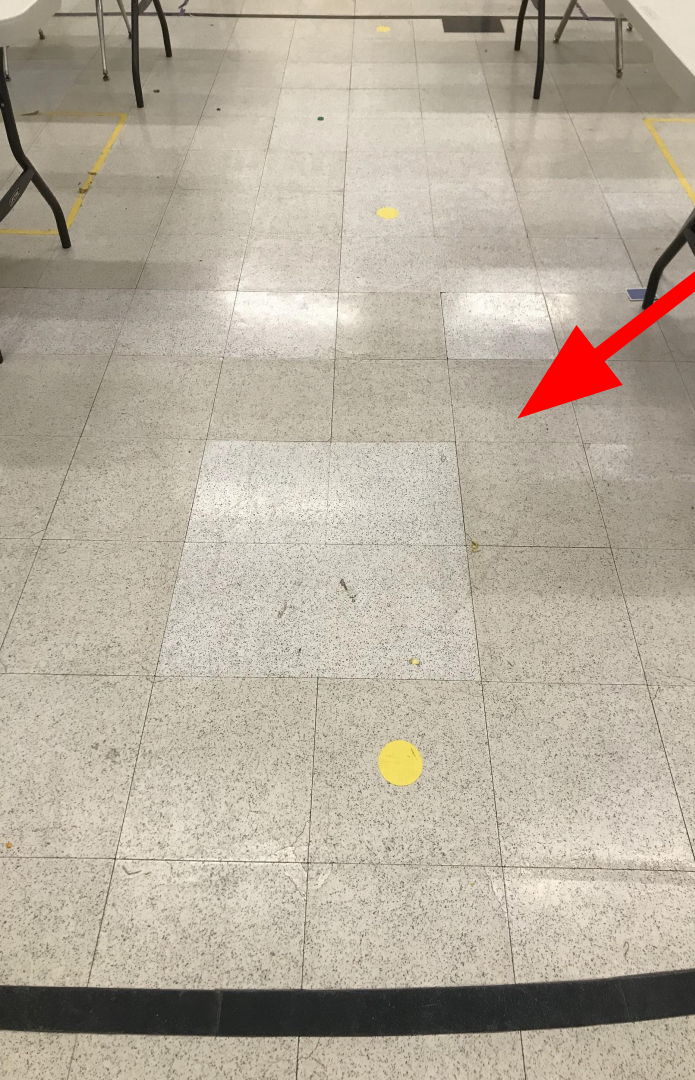
On the Left-
Prairieview example of
replaced tile pieces
(by color brightness).

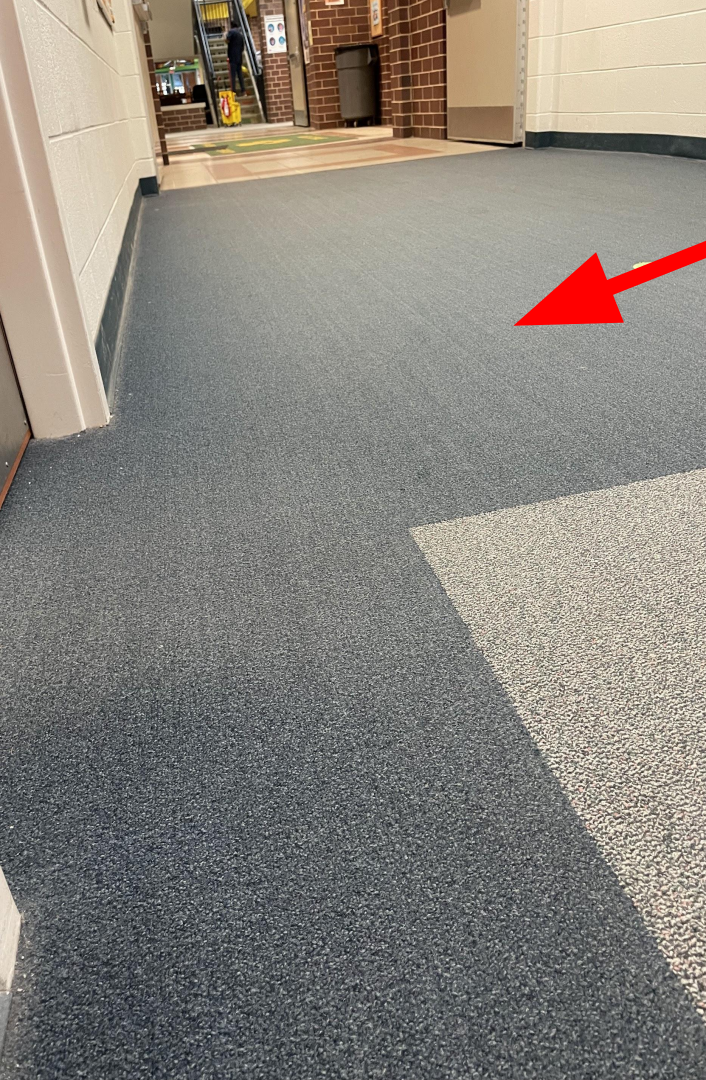
On the Left-
Prairieview carpeting
example.
Original- 22 years.

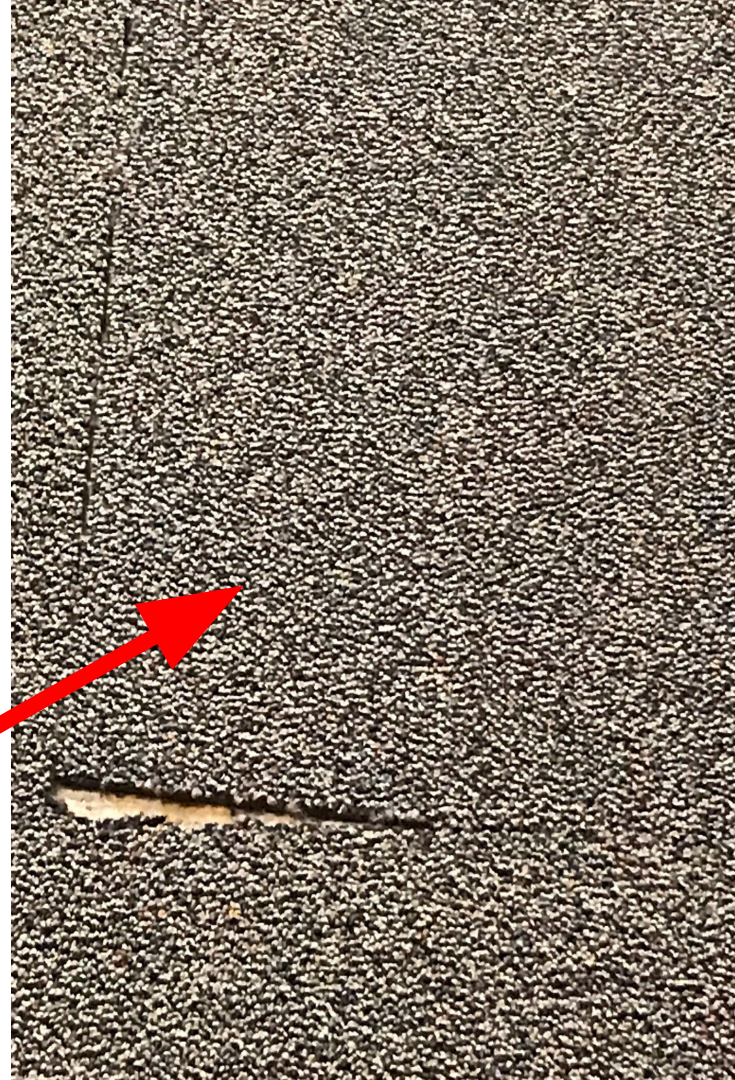
On the Right-
Prairieview Carpeting
example.
Original- 22 years.

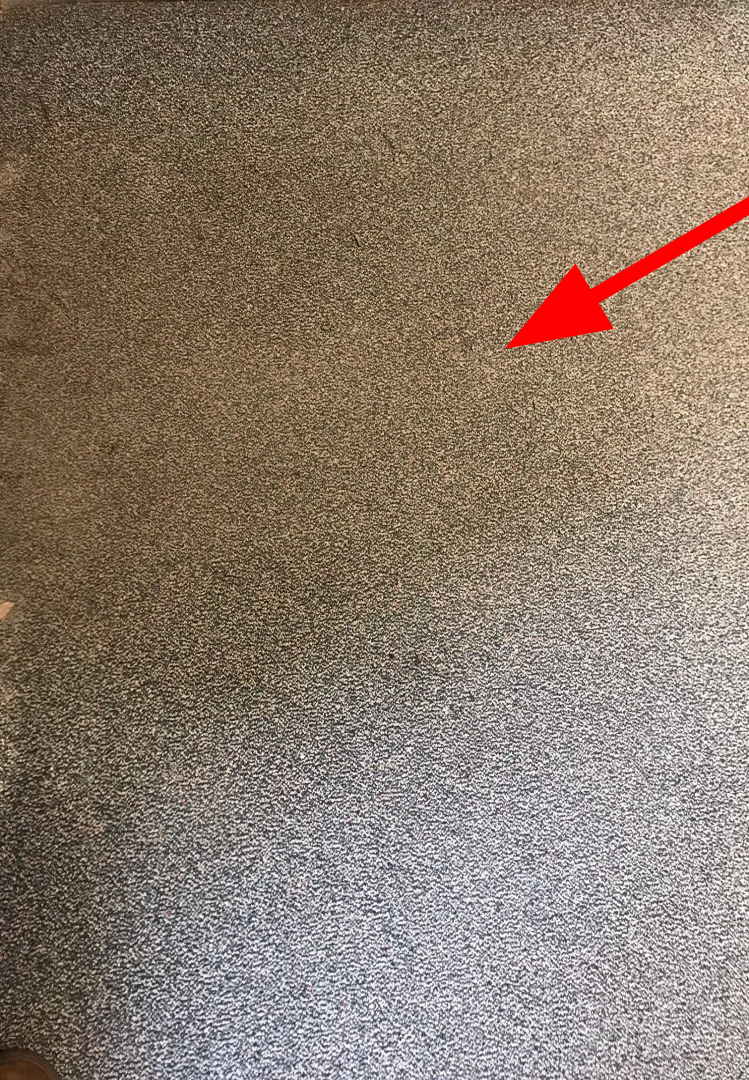
On the Left-
Prairieview carpeting

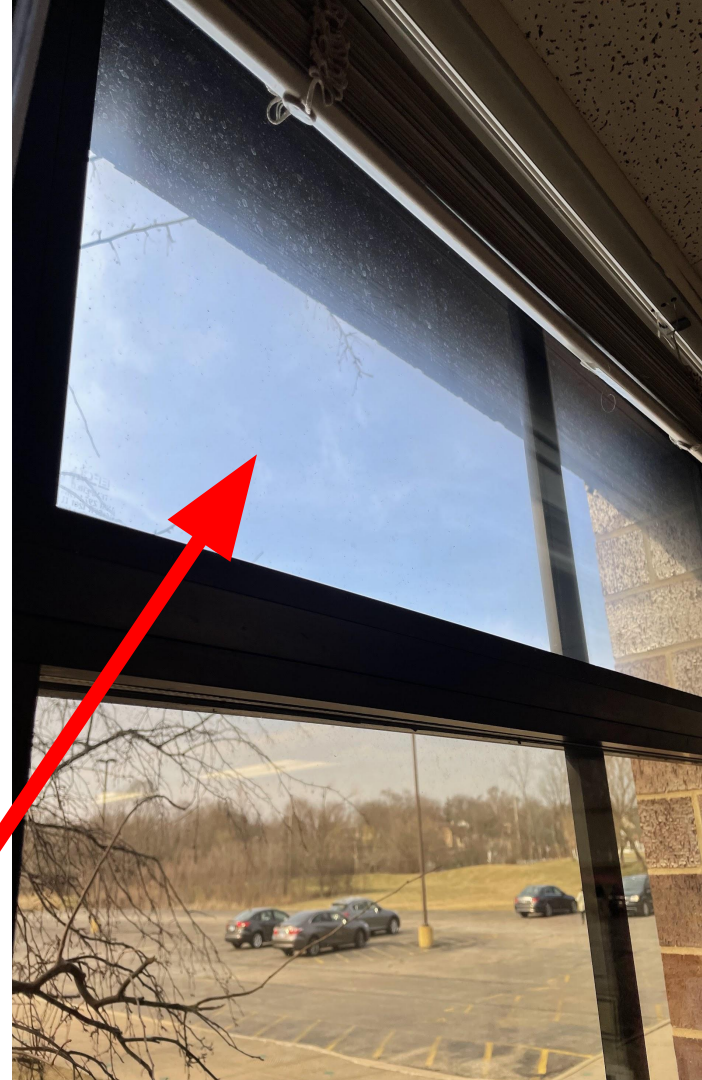
Parking Lot
lighting
examples

Rusting base

Missing head
