# Barrington

# Facility Condition Assessment

June 2017

Barrington - Barrington High School

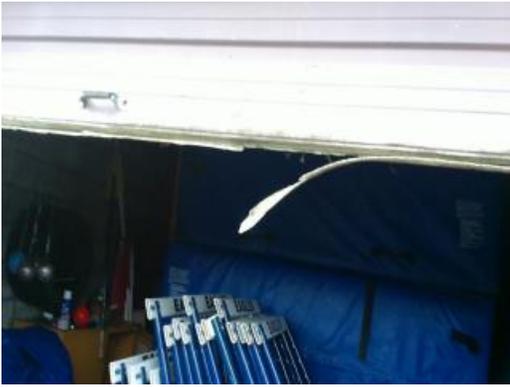
Building 03 - Soffit Damage

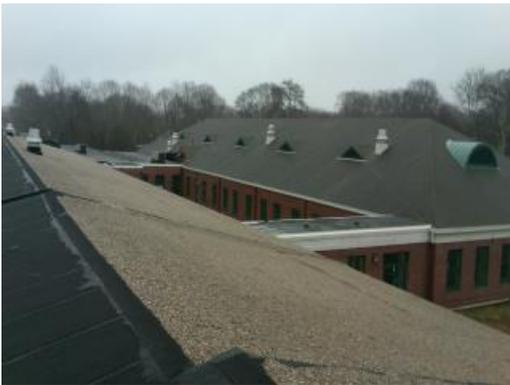
Main Building - Roof Exhausts

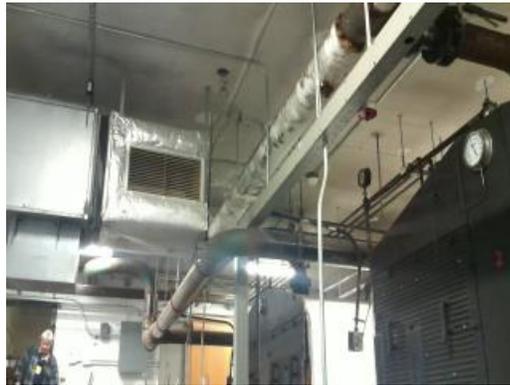
Main Building - Damaged Insulation

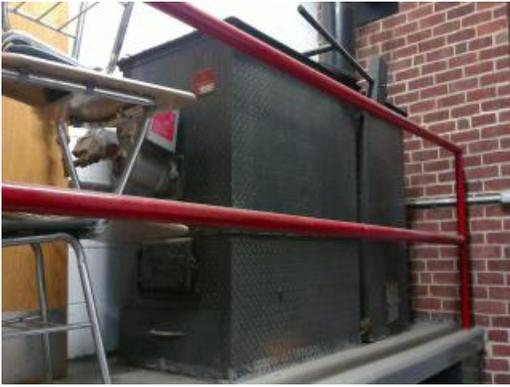
Main Building - Abandoned Incinerator

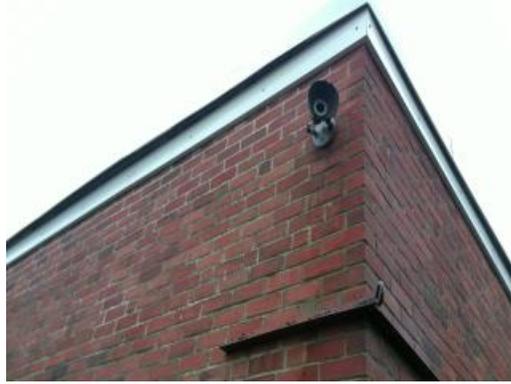
Main Building - Damaged Building Mounted Lighting

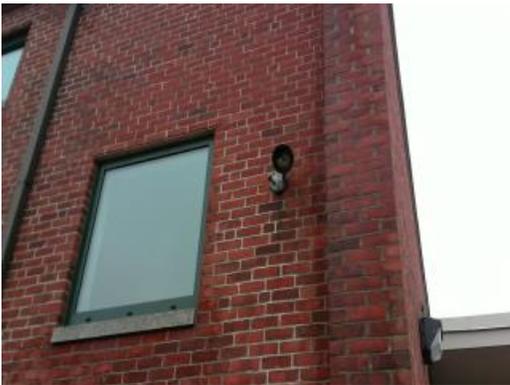
Main Building - Damaged Building Mounted Lighting

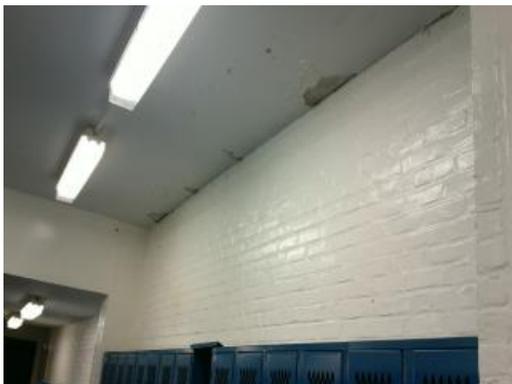
Main Building - Damaged Plaster Ceiling

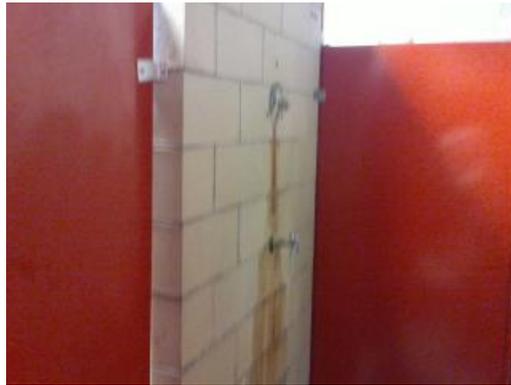
Leaking Shower Fixture

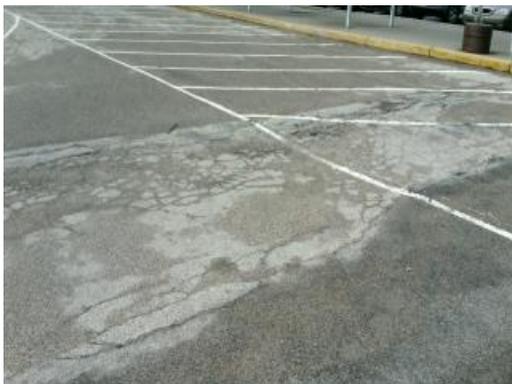
Cracked And Worn Asphalt

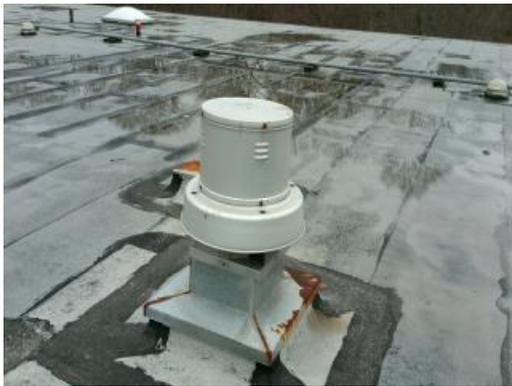
Patched Roofing

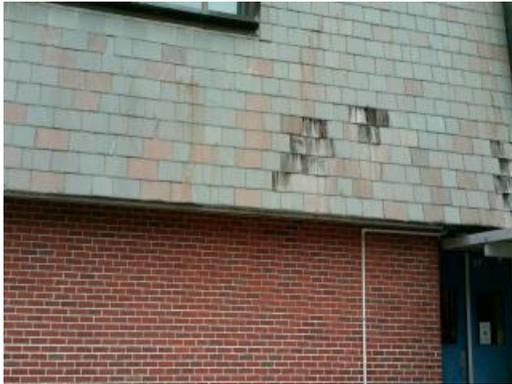
Damaged Exterior Wall

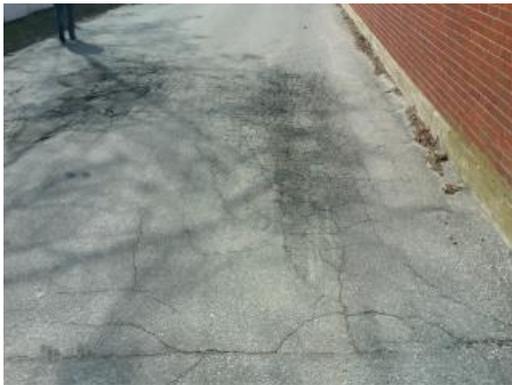
Cracking Asphalt Roadway Pavement

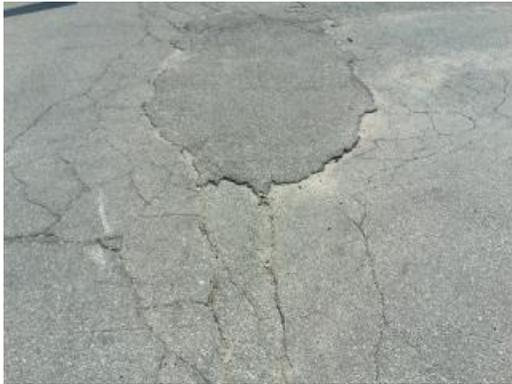
Damaged Parking Lot Paving

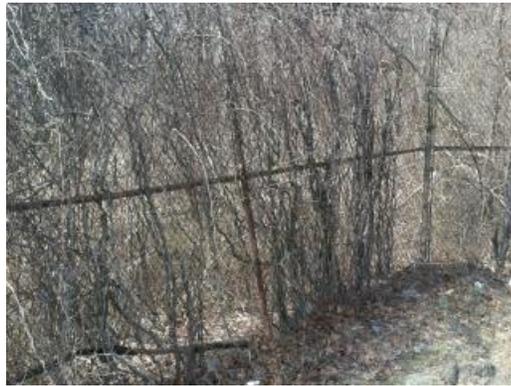
Rusted Fence Falling Over

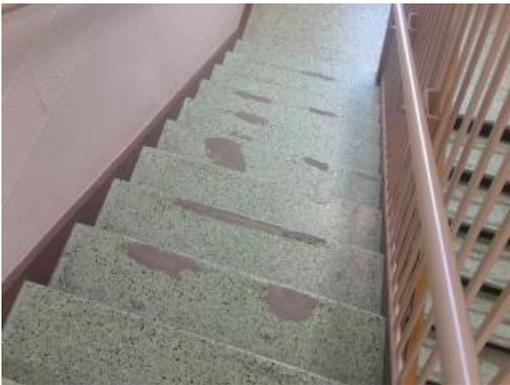
Stairs Missing Treads

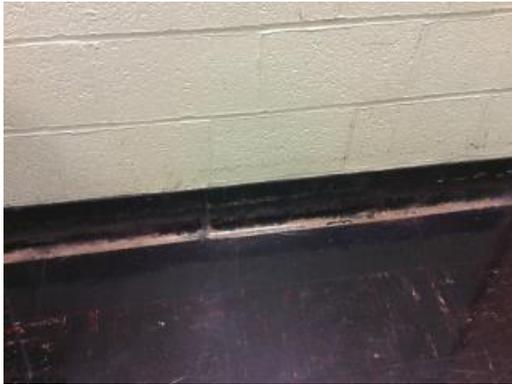
Damaged Vinyl Cove Base

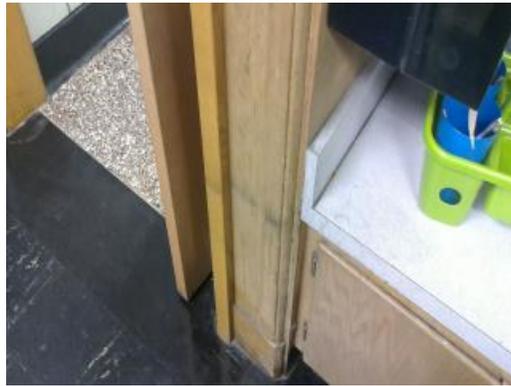
Worn Wood Panel In Classroom

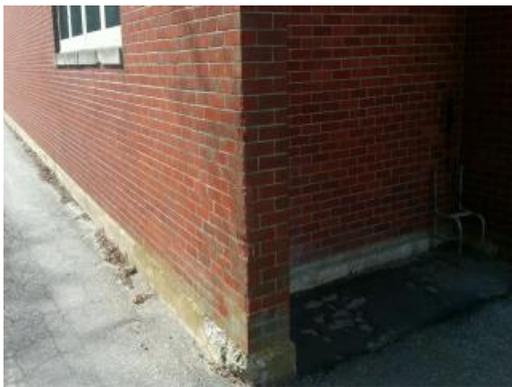
Damaged Exterior Brick Wall

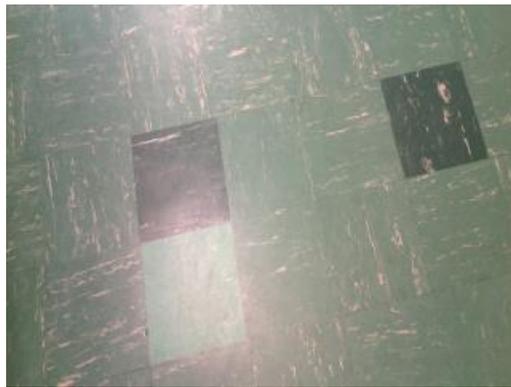
Worn VCT Flooring

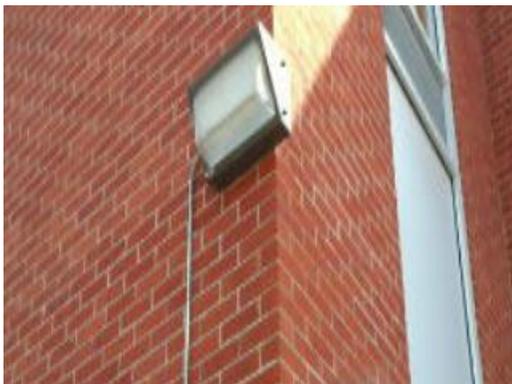
Aged Building Lights

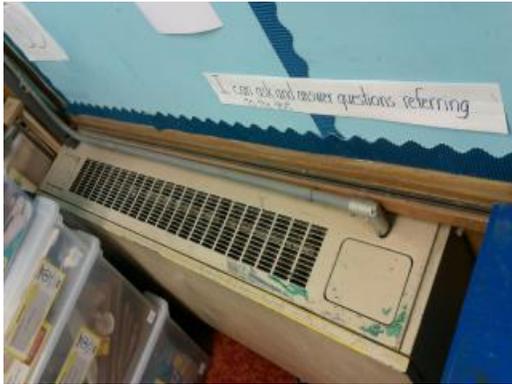
Worn Cabinet Unit Heater

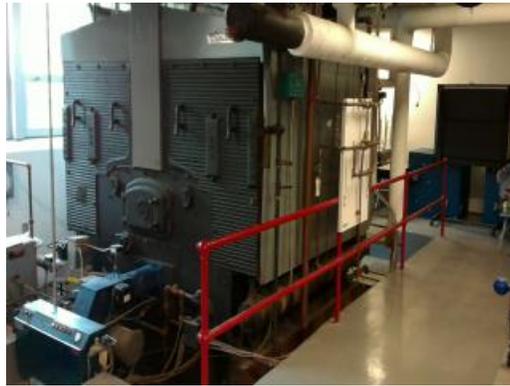
Aged Boiler

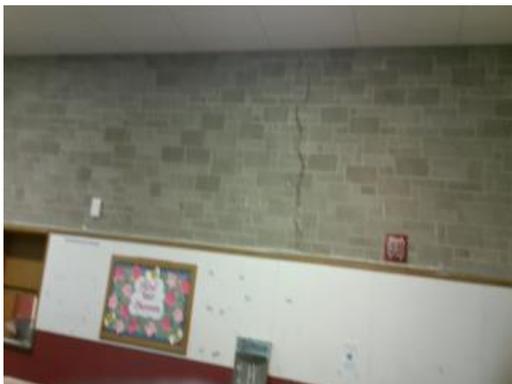
Cracked Wall

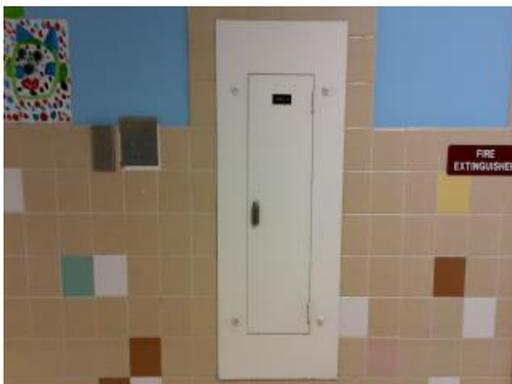
Panel With Damaged Door
