Investment Grade Energy Audit

Boothbay Region High & Elementary Schools

Boothbay Harbor, ME

May 2, 2018

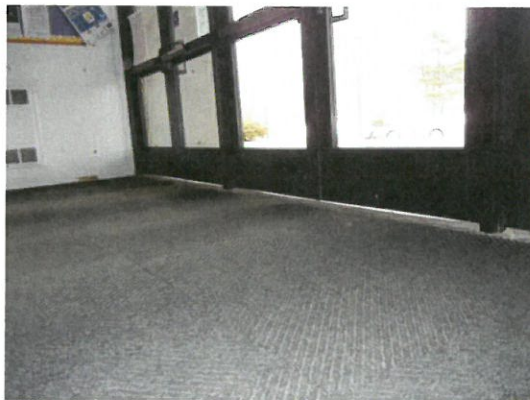
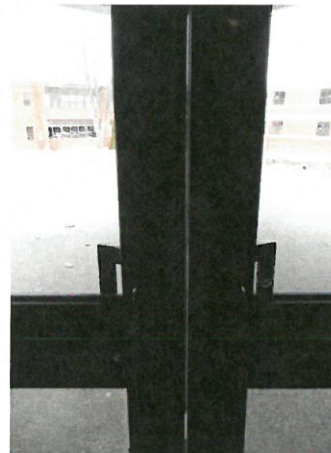
Examples of Door Weatherstripping Missing/Inadequate

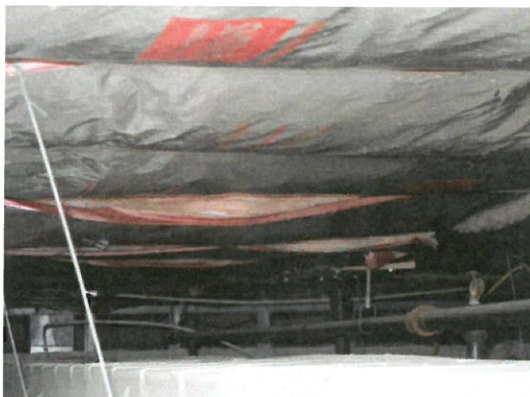
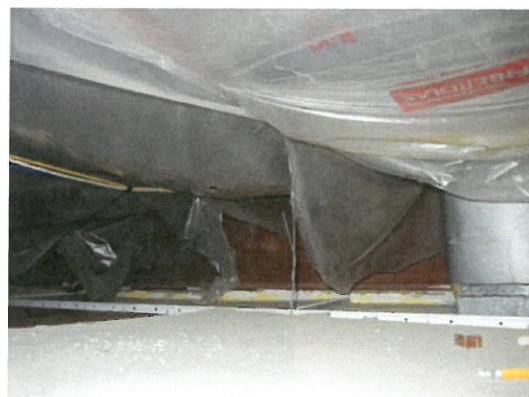
Attic Insulation Inadequate/Missing in Areas

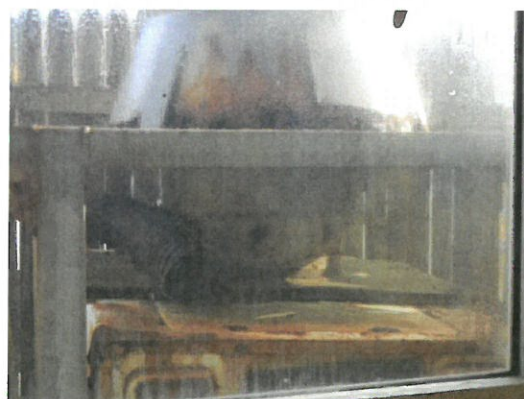
heat loss and improved window appearance. The following windows were identified as being in need of pane replacement due to broken thermal breaks/seals.

Typical Window with Failed Thermal Breaks/Seals

- b. Replace 35 existing window pane units (427 Sq Ft) which have failed or defective seals, with new units. New units shall have maximum U value of 0.57 (R 1.75).

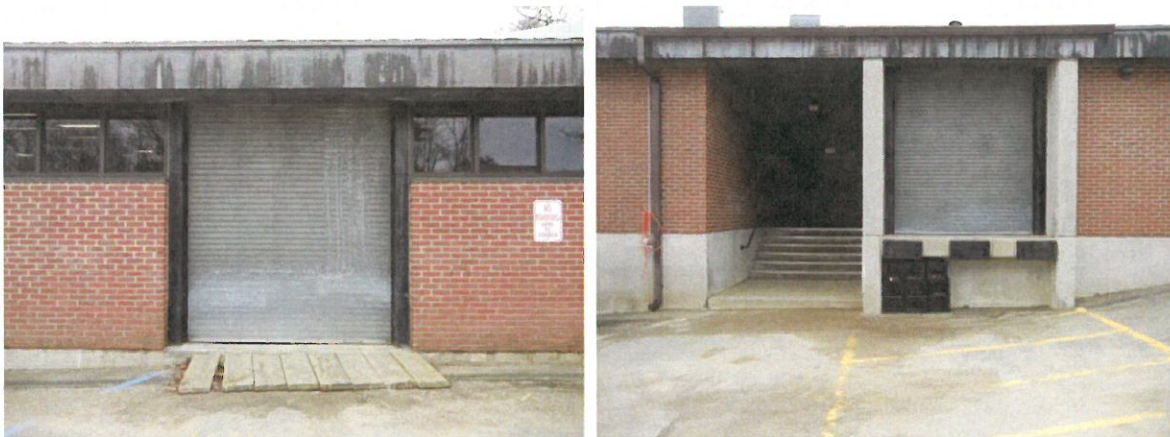
- a. The Elementary School has 2 overhead metal roll-up doors which are original (1975 vintage) and which have little to no insulation value. Replace these two overhead doors with new insulated roll-up overhead doors. New overhead doors shall have minimum R value of R 4.23.

*Overhead Doors to be Replaced*

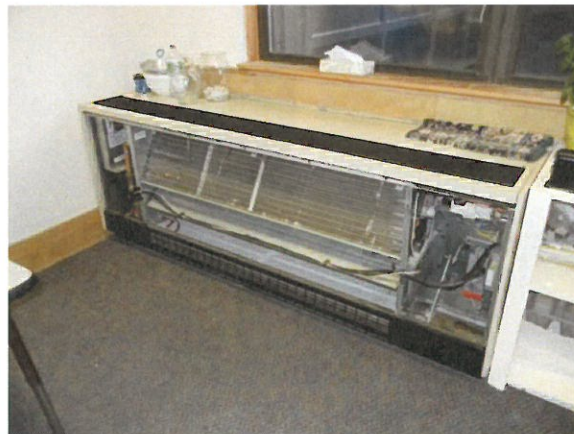
*Existing Unit Ventilator*

- a. 14 unit ventilators have face & bypass dampers, and no control valves on the hot water coils. This allows potential overheating in spring and fall when the boiler/pumps are ON and the units are in full bypass mode. Add automatic control valves and associated controls to these 14 unit ventilators. When OAT is < 40 deg F, full flow through coils and used F & BP dampers for control. When OAT > 40 deg F, all airflow through coil and use ACV's for control.

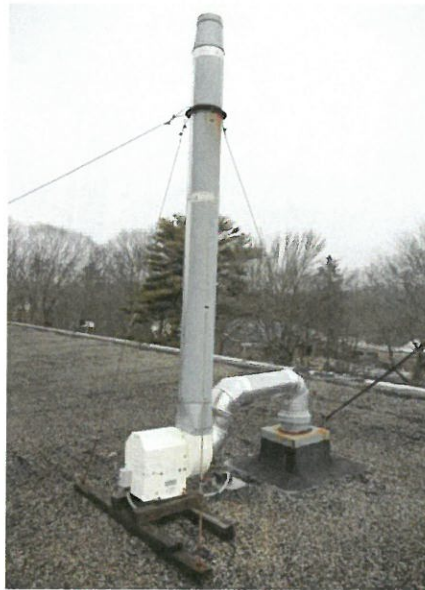
Existing Fume Hood Exhaust Fan

- a. The existing fume hood exhaust fan has no gravity backdraft damper. This allows air to gravity flow out of the fan whenever the exhaust fan is OFF. Provide a gravity backdraft damper, to prevent gravity airflow when the fan is OFF.

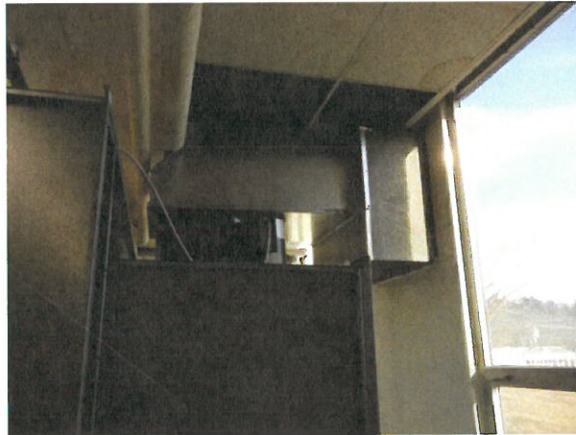
Paint Spray Exhaust System's Existing Damper

- a. The paint spray booth's exhaust system has a damper located near the exhaust louver at the wall. This damper is manually operated by the shop teacher. The teacher manually shuts this damper when the paint spray exhaust fan is OFF, but the damper is of poor quality and it has no blade or jamb seals, which allows cold outdoor air to dump back into the paint spray booth and into the shop.
- b. Replace the existing manually operated damper with a new low leakage damper that has blade and jamb seals. Provide a motorized damper actuator, interlocked with the exhaust fan, so that the damper will automatically close when the exhaust fan is turned OFF and automatically open when the exhaust fan is turned ON.
- c. Provide duct wrap insulation between the new damper and the exhaust louver, to reduce heat loss to the cold section of duct.

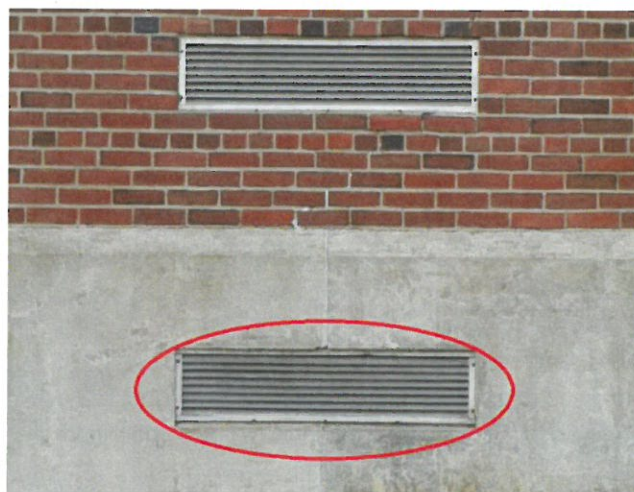
Crawl Space Louver (Circled in Red)

- a. Each of the 2 basement crawl spaces has a wall louver at the exterior foundation wall. The purpose of this louver is to provide passive control of humidity in the crawl spaces. The crawl spaces were dry during our surveys, and typically crawl spaces are dry in the winter. Summer is typically when humidity control in crawl spaces might be required. The open louvers in the winter allow cold air to enter the crawl spaces, and that increases heat loss through the floor of the occupied spaces above.
- b. Provide duct sleeves and motorized dampers at the two wall louvers. Provide a humidistat in each of the 2 crawl spaces. Use the humidistats to control the motorized dampers based on crawl space humidity. This will allow the dampers to close in the winter, which will reduce heat loss through the floors above.

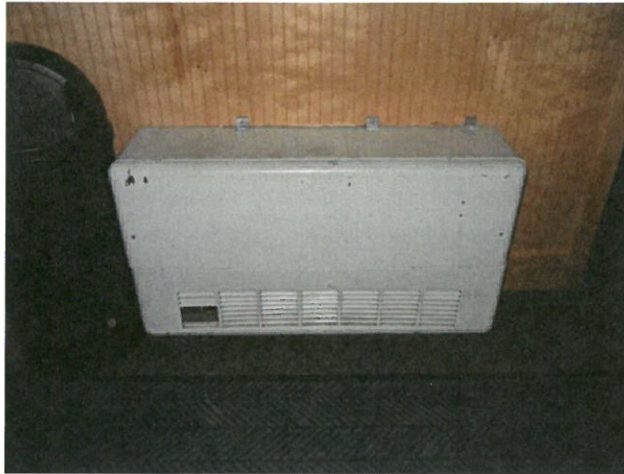
Existing Cabinet Heater in Main Lobby

- a. The 1950's vintage cabinet heater in the Main Lobby is in poor condition. The service technician has indicated that the fan in this unit has not worked for years. As this is the main entrance with significant cold air infiltration, this unit is important in maintaining a comfortable environment.

- b. Replace the existing cabinet heater with a new, appropriately sized unit.

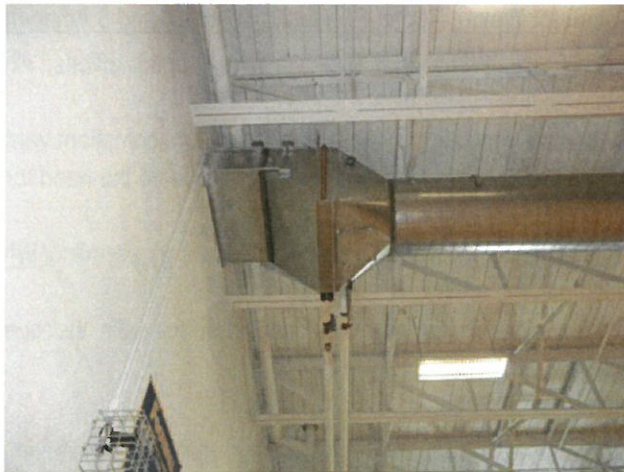
Gymnasium Duct Heating Coil

- a. The Gymnasium air handling unit's heating coil, which is in the exposed supply duct in the Gym, has an access door on the discharge side of the coil, but no access door on the inlet side of the coil where vacuuming needs to be performed.
- b. Provide a new access door on the inlet side of the coil, and vacuum clean the coil.

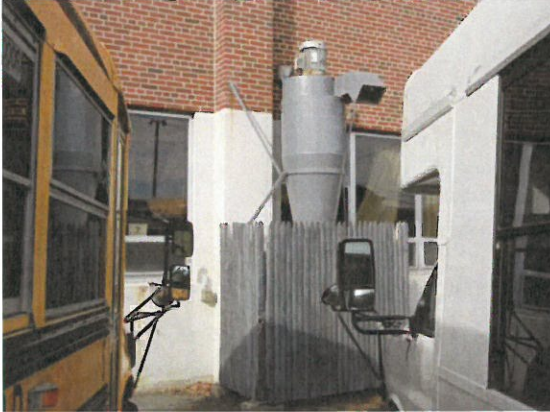
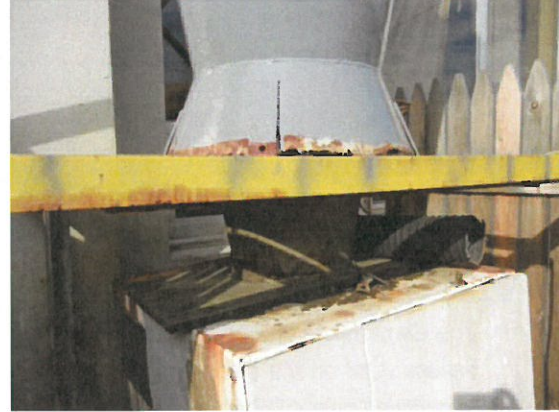
Gymnasium Duct Heating Coil

- a. The outdoor sawdust collector cyclone unit is in very poor condition. It is nearly completely rusted out at the base. In addition, the sawdust collector does not have an after-filter unit, so fine dust, which is a known carcinogen, is blown outdoors.
- b. The ductwork in the Wood Shop is not of proper quality and construction for a sawdust collection system. In addition, the system does not have an explosion backdraft damper.
- c. Base Solution:
 - 1) Replace the cyclone unit with a new, appropriately sized cyclone unit.
 - 2) Provide a new motor starter.
 - 3) Provide a new after-filter unit, to capture fine dust particles.
 - 4) Remove the existing fencing and provide new fencing.

- 5) Provide a new concrete pad.
- d. Optional Solution:
 - 1) Provide all scope listed above in Base Solution, and include the following:
 - 2) Provide a variable frequency drive in lieu of a motor starter, for soft start and balancing of the new unit.
 - 3) Provide an explosion backdraft damper in the main duct.
 - 4) Replace existing sawdust collection system ductwork with new ductwork that is designed for sawdust collection systems (clamped joints).

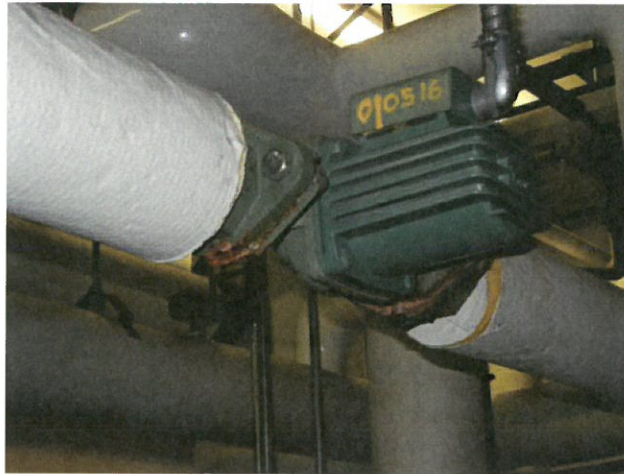
Existing Jockey Pump

- a. There have been issues with cracked boiler sections in recent years. Although we believe that it is a factory quality control issue, we continue to take steps to protect the boilers. One step that has been suggested by our service technician is to increase the sizes of the boiler jockey pumps, to provide additional protection from low return water.
- b. Replace the existing 45 GPM jockey pumps with new 100 GPM jockey pumps.

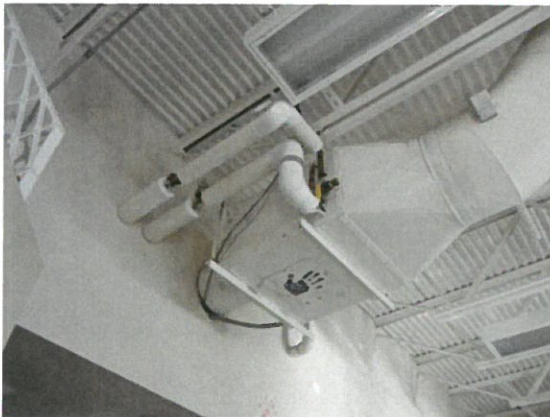
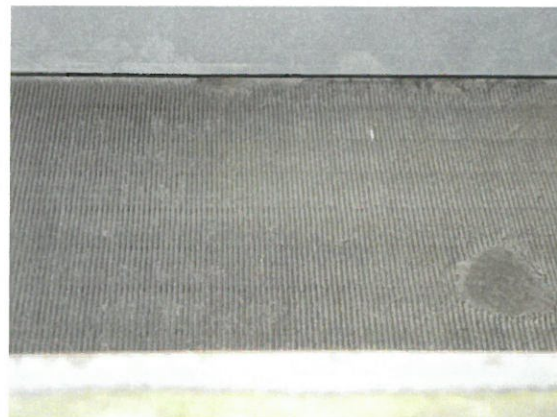
Typical VAV Box Heating Coil (This Coil Located in Art Room)

- a. There are 18 VAV boxes associated with HV-1. These VAV boxes have heating coils, and our surveys revealed that the heating coils have signs of dust and debris partially clogging the coils.
- b. Vacuum clean the 18 VAV box heating coils.

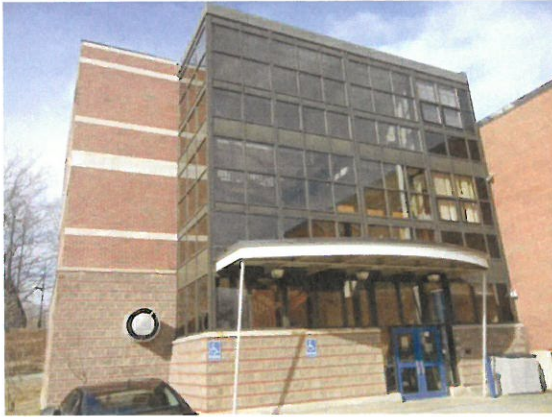
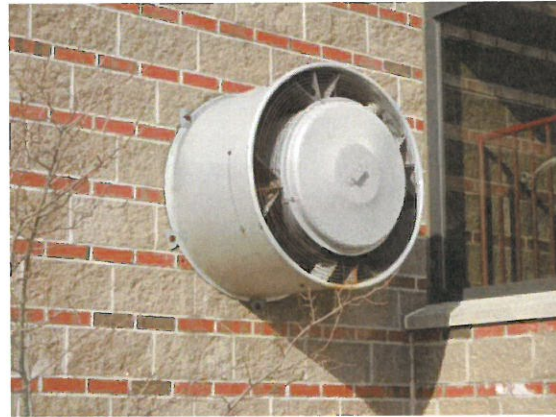
Art Room's Wall Mounted Exhaust Fan

- a. The owner reports that the wall mounted exhaust fan, which serves the kiln hood, leaks water into the building during wind driven rain storms.
- b. Provide a rain hood over the wall mounted exhaust fan.

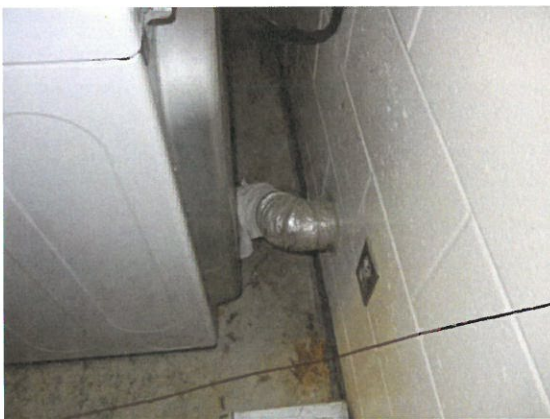
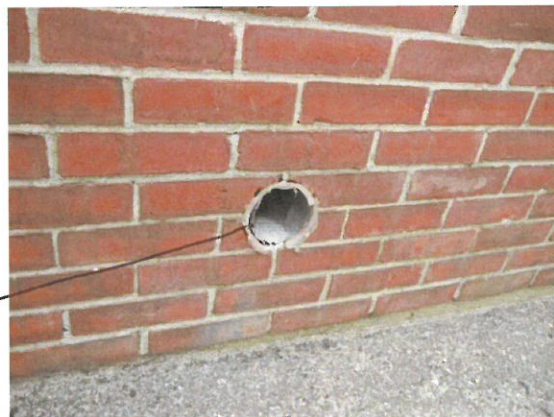
- a. In the Industrial Arts/Maintenance Shop, the dryer vent outlet at the outside wall is missing. This allows cold air to dump into the building through the dryer when it is OFF.
- b. Provide a new backdraft damper on the dryer vent outlet.

Dryer Vent Outlet – Missing Backdraft Damper

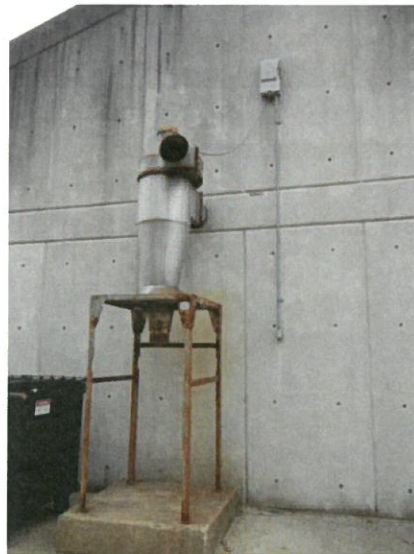
Abandoned Sawdust Collector

- a. In the Industrial Arts/Maintenance Shop, there is an abandoned sawdust collection system, with the sawdust collection cyclone located outdoors. The ductwork for this sawdust collection system is still connected and it terminates outdoors. There is no active backdraft damper in this exhaust system, so warm building air gravity flows out through this ductwork when the exhaust fan is OFF.
- b. Remove the outdoor sawdust collection cyclone, and cap the duct at the exterior wall, to eliminate gravity airflow.
- c. NOTE: The cyclone and its steel framework will be removed, but the concrete base will remain abandoned in place.

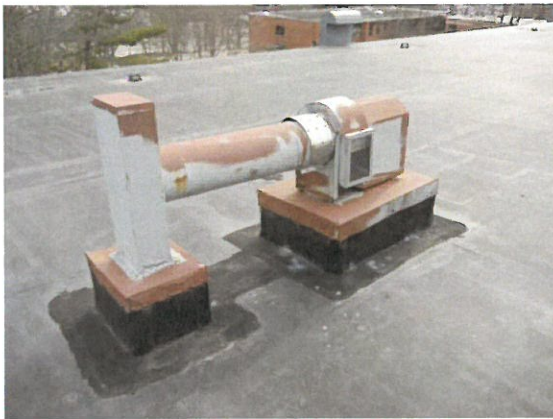
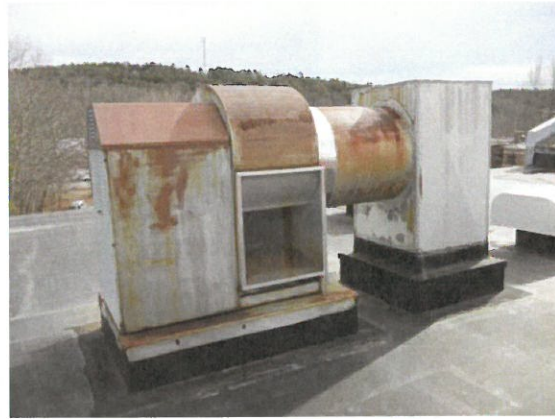
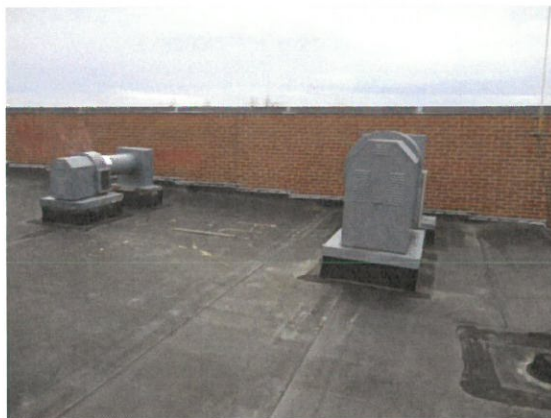
Fan #5, Fan #3, Fan #9 (On Left)

- a. There are 3 rooftop exhaust fans (Fan # 5 – Fume Hood System, Fan # 9 – Dishwasher Exhaust Hood, Fan # 3 – Classroom Exhaust) that have no gravity backdraft dampers, so warm building air gravity flows out through these fans when they are OFF.
- b. Add gravity backdraft dampers to these 3 fans.

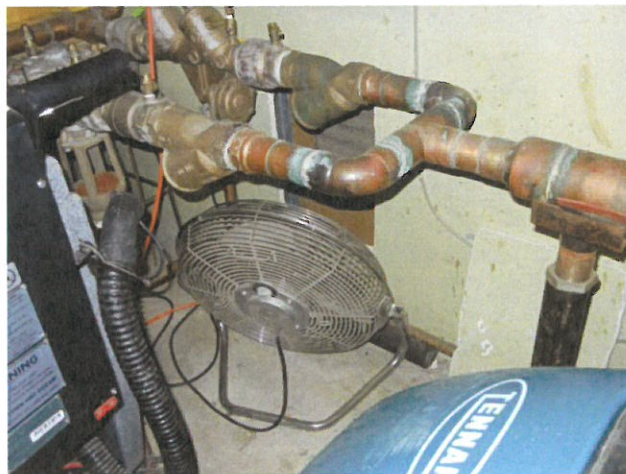
5. Add Transfer Fan System to Transfer Heat From Server Room to Main Entrance:
 - a. The Server Room on the lower level overheats. Small portable fans have been installed to move the heat out of the room. That heat could be beneficially used in the winter, if it could be transferred to the entrance area.
 - b. Provide a new transfer fan system, to transfer warm air from the Server Room to the entrance/lobby area down the hall.

Fan Transferring Heat Out of Server Room

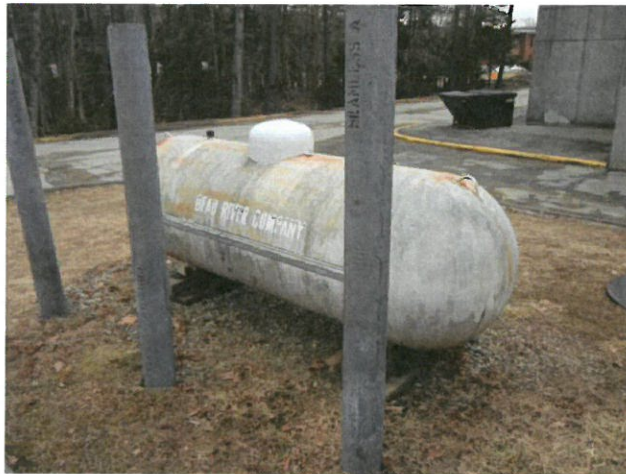
Existing 500 Gallon LP Gas Tank

- c. NOTE: The 500 gallon LP Gas tank may not be of sufficient size to serve the new gas water heater and the emergency generator simultaneously. This should not create a problem, as the boilers are capable of supplying domestic hot water if the emergency generator should be needed for an outage.

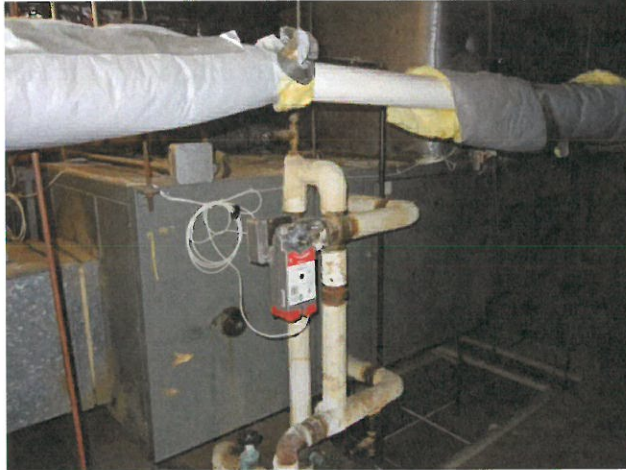
HV-7

- a. The IA/Maintenance Shop's air handling unit (HV-7) was found during our surveys with its outside air damper at 45% open on a cold day (i.e. no need for free cooling) and with no occupancy in the IA/Maintenance Shop.
- b. Provide CO2 controls for HV-7, to reduce outdoor air as occupancy levels change.

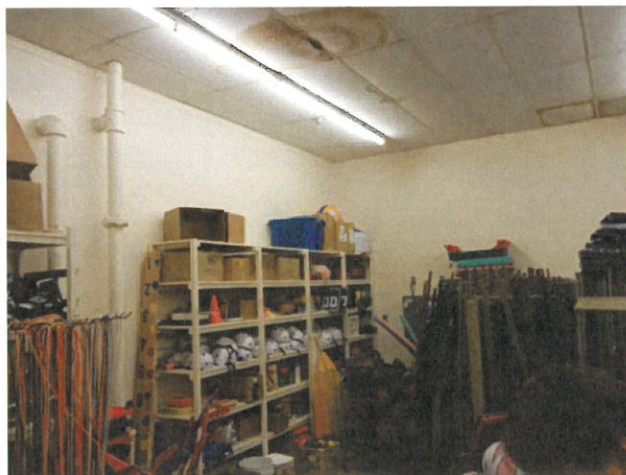
Stage Storage Room

- a. The Stage is used as the Band classroom, and this room has no means of mechanical fresh air ventilation.
- b. Provide a new mechanical ventilation system, to supply code compliant ventilation air to the Band Room/Stage.
 - 1) Locate the new unit in the storage room behind the Stage.
 - 2) Provide new DDC controls for new unit, and interface with the operator workstation and user interface graphics.

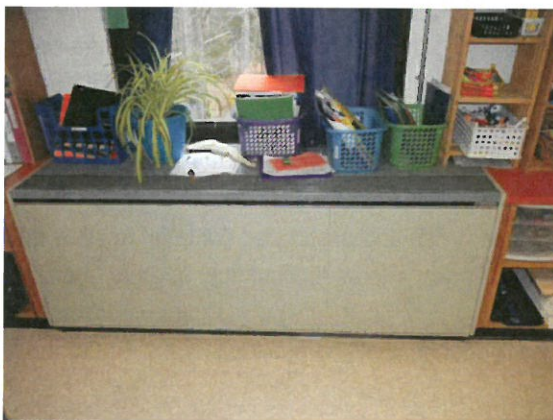
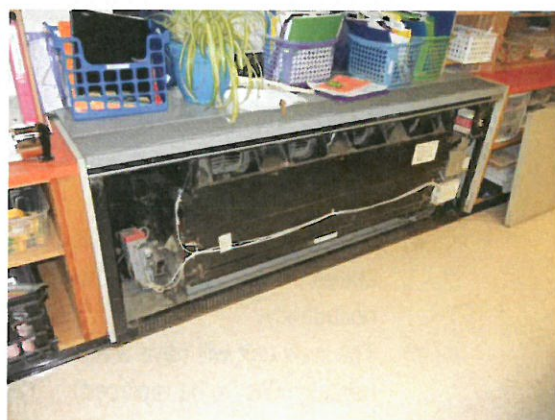
Typical Existing Unit Ventilator

- a. The 36 - 1977 vintage unit ventilators have exceeded their useful service lives. Although the outer cabinets of the units appear to be in generally fair to good condition, the service technician reports that these units have been problematic. Damper blades have been breaking loose from their shafts.

Temporary repairs have been made, but more permanent repairs require the units to be nearly disassembled, which would be very time consuming and costly, so replacement of these units is justified.

- b. Replace the 36 existing unit ventilators with new units.
 - 1) New units will have face & bypass dampers and automatic control valves.
 - 2) Existing units are assumed to have code compliant power feeds. Upgrading of power feeds is excluded.
 - 3) Valves and accessories in the unit ventilator cabinets will be replaced with new.
 - 4) Casework will be modified as required, to accommodate differences in width from existing units to new units.
 - 5) Air and water balancing are included.

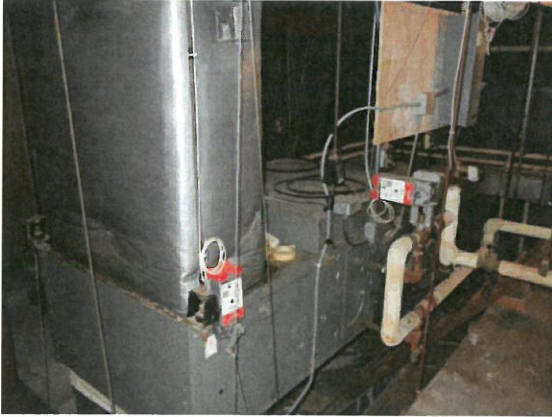
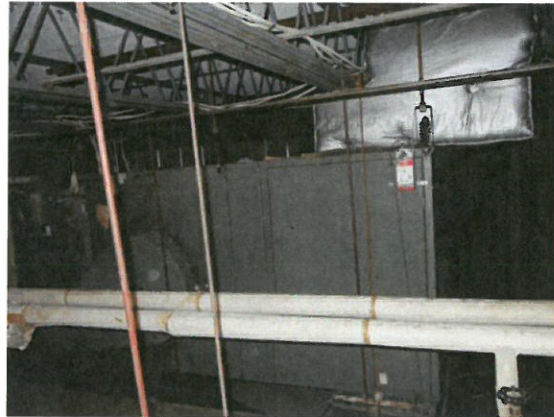
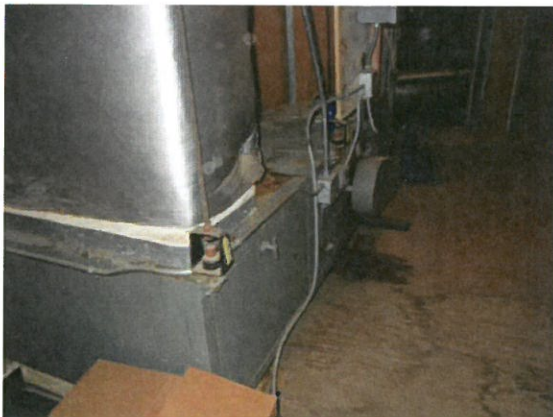
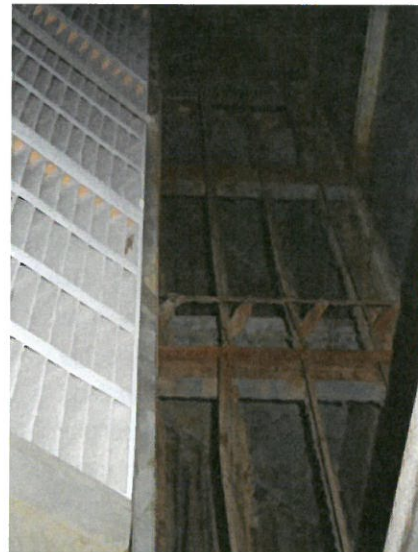
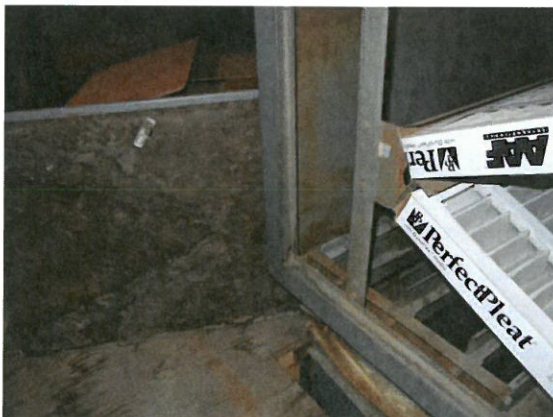
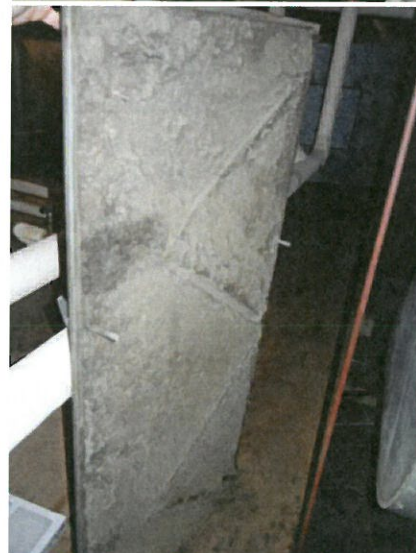
HV-2, HV-3, HV-4

- a. HV-2 (Gymnasium):
 - 1) The Gymnasium air handling unit (HV-2) is original 1977 vintage. The unit has exceeded its useful service life and it is in poor condition. There are no blade or jamb seals on the dampers, the return air damper is bent, the return air duct connection to the bottom of the unit is separated. The unit has exposed fiberboard insulation on the inner surfaces of the unit housing, and that fiberboard liner has become friable and has deteriorated over time, sending fiberglass particles out through the ductwork and into the occupied spaces. The deteriorated fiberboard liner accumulates dirt, dust and is a potential for mold growth.

- 2) The 2 duct mounted heating coils associated with HV-2 are also original 1977 vintage. They have exceeded their useful service lives and they are in poor condition. They are clogged with dust and debris from many years of use.

- b. HV-3 (Locker Rooms):
 - 1) The Locker Room air handling unit (HV-3) is original 1977 vintage. The unit has exceeded its useful service life and it is in poor condition. There are no blade or jamb seals on the dampers. The unit has exposed fiberboard insulation on the inner surfaces of the unit housing, and that fiberboard liner has become friable and has deteriorated over time, sending fiberglass particles out through the ductwork and into the occupied spaces. The deteriorated fiberboard liner accumulates dirt, dust and is a potential for mold growth.

- 2) The 4 duct mounted heating coils associated with HV-3 are also original 1977 vintage. They have exceeded their useful service lives and they are in poor condition. They are clogged with dust and debris from many years of use.

- c) Valves and accessories to be replaced with new.
 - d) Provide water balancing.
- c. HV-4 (Teacher's Lounge):
 - 1) The Teacher's Lounge air handling unit (HV-4) is original 1977 vintage. The unit has exceeded its useful service life and it is in poor condition. There are no blade or jamb seals on the dampers. The unit has exposed fiberboard insulation on the inner surfaces of the unit housing, and that fiberboard liner has become friable and has deteriorated over time, sending fiberglass particles out through the ductwork and into the occupied spaces. The deteriorated fiberboard liner accumulates dirt, dust and is a potential for mold growth.

- 3) Replace HV-2 with a new unit:
 - a) New unit will be double wall construction, with solid interior walls so that exposed fiberboard insulation is eliminated.

- 4) Replace 2 Duct Mounted Heating Coils:
 - a) Replace 2 – 66" x 33" duct mounted heating coils.
 - b) Valves and accessories to be replaced with new.
 - c) Provide water balancing.

- 3) Replace HV-3 with a new unit:
 - a) New unit will be double wall construction, with solid interior walls so that exposed fiberboard insulation is eliminated.

- 4) Replace 4 Duct Mounted Heating Coils:
 - a) Replace 4 duct mounted heating coils (1 – 14" x 12", 1 – 18" x 12", 2 – 6" x 6").
 - b) Provide duct access doors for the new coils.

- 2) Replace HV-4 with a new unit:
 - a) New unit will be a 1,200 CFM unit ventilator.
 - b) Valves and accessories will be replaced with new.
 - c) Air and water balancing of the new unit are included. Air balancing is limited to the unit only; air balancing is not included for the entire ductwork system.

- 3) Expand the mechanical mezzanine platform as required to allow for safe maintenance and service access to the new air handling units and duct heating coils.
- 4) Add safety railing around the perimeter of the platform.

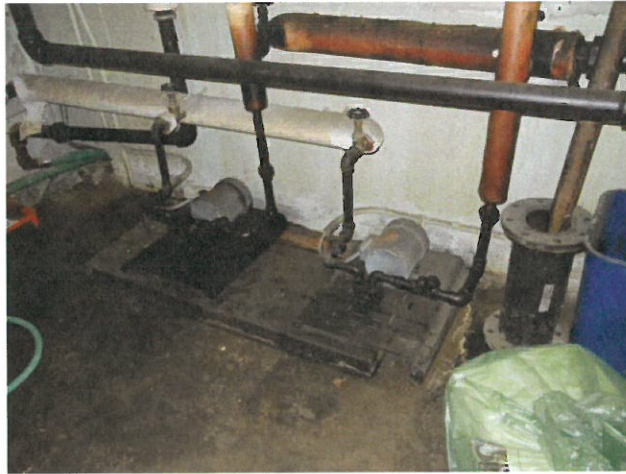
Existing Fuel Oil Transfer Pumps

- a. The existing fuel oil transfer pumps in the boiler room are original 1977 vintage. They have exceeded their useful service lives and they are in fair to poor condition. The existing Cleaver Brooks boilers require these pumps to run continuously during the heating season.
- b. Replace the existing fuel oil transfer pumps with a new fuel oil day tank with duplex pump set. This new system will result in a fuel oil transfer system that cycles on and off to maintain oil level in the day tank, versus the more energy intensive existing pumps which must run 24/7. The Cleaver Brooks boilers will be replaced with new boilers that do not require constant oil flow (scope shown elsewhere in this report).

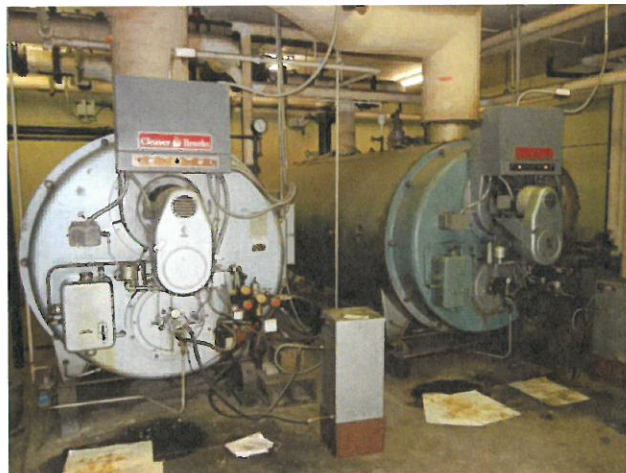
Existing Cleaver Brooks Boilers

- a. The existing Cleaver Brooks boilers are original 1977 vintage. They have exceeded their useful service lives and they are in fair to poor condition.
- b. Replace the existing Cleaver Brooks boilers with new Buderus 3 pass cast iron sectional boilers.
 - 1) Provide new metal chimney liner.
 - 2) Provide new powered combustion air system.
 - 3) Provide new concrete housekeeping pads.
 - 4) Modify boiler room piping so that new boilers inject into the primary heating main.

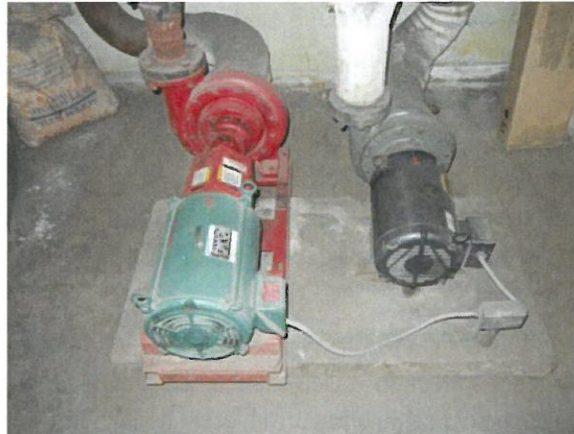
Existing Heating Water Pumps

- a. The existing base mounted heating water pumps are original 1977 vintage. They have exceeded their useful service lives and they are in fair to poor condition.
- b. Replace the existing heating pumps with new base mounted pumps.
 - 1) Extend the concrete housekeeping to accommodate the new pumps.
 - 2) Re-use existing VFD's.
 - 3) Provide water balancing of new pumps.

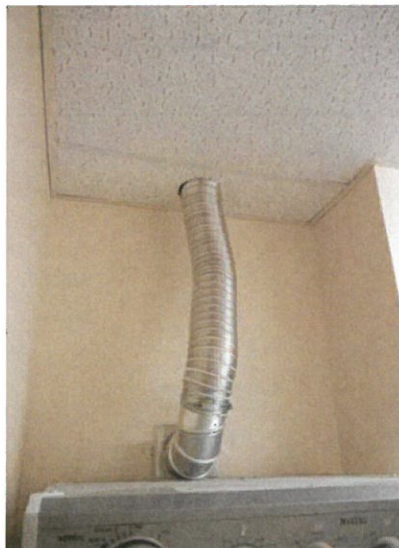
- a. In Room 228, the dryer vent terminates in the cold attic. This is a code violation, and it is not good practice as moist air from the dryer condenses in the cold attic, and that can cause ceiling staining and mold growth.
- b. Extend the dryer vent up through the roof, with a backdraft damper.

Dryer Vent Terminates in Cold Attic

*Re-CD
vent to roof*
