Washington State School Seismic Safety Assessments Project

SEISMIC UPGRADES CONCEPT DESIGN REPORT

Totem Middle School – Main Building

Marysville School District

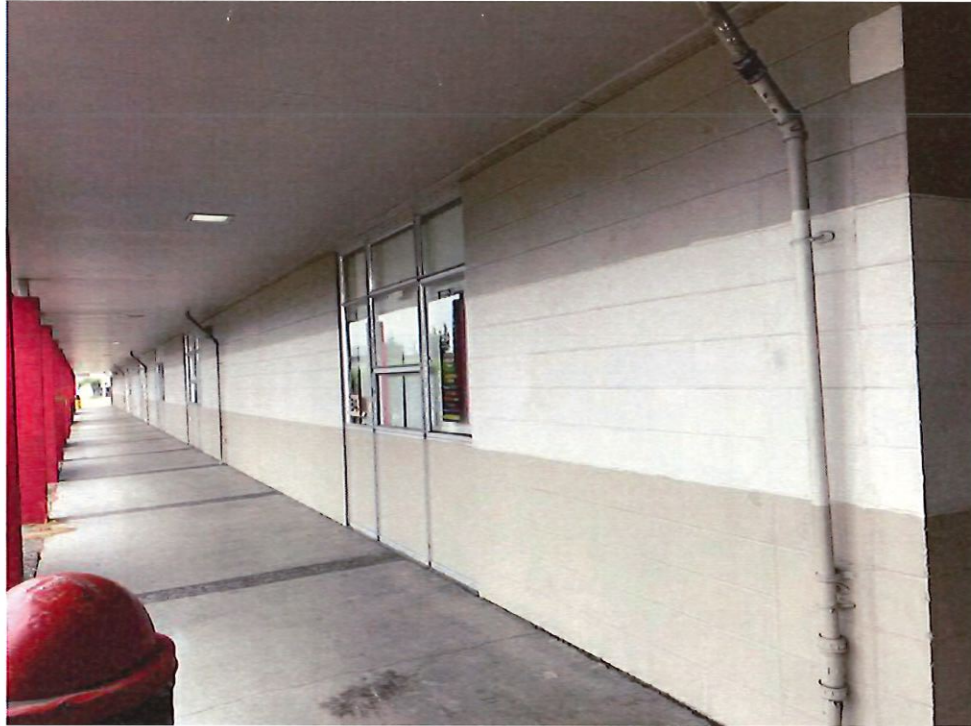
Figure 1-7. South Exterior Wall with Stack Bond Masonry and Exterior Covered Walkway

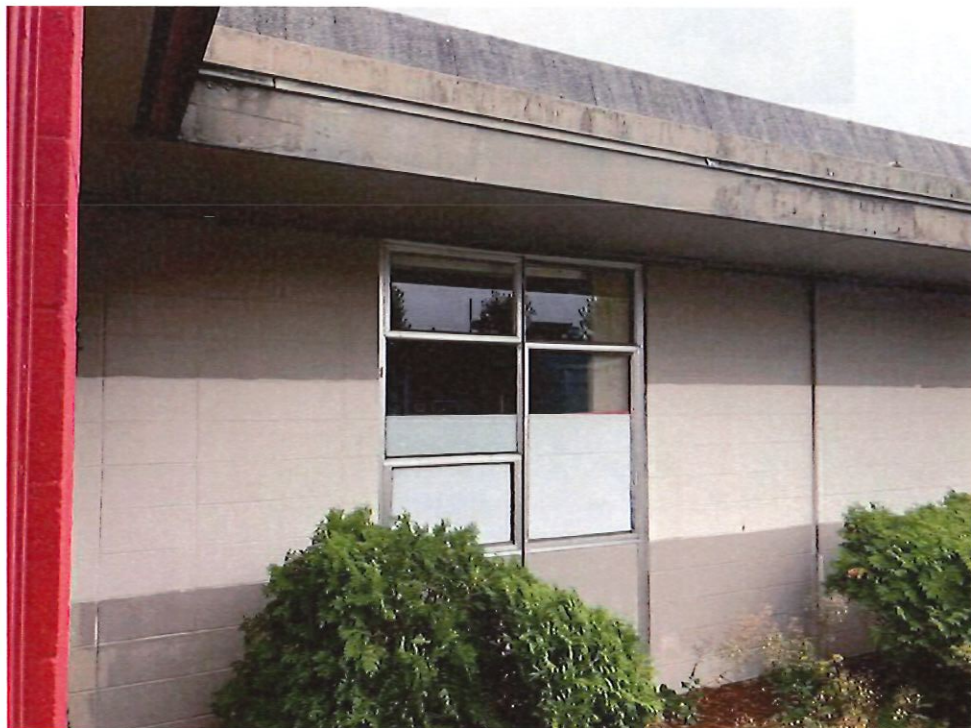
Figure 1-8. North Exterior Wall with Stack Bond Masonry
