# Facility Study

**Chester ISD**

October 2022

GOODWIN • LASITER • STRONG

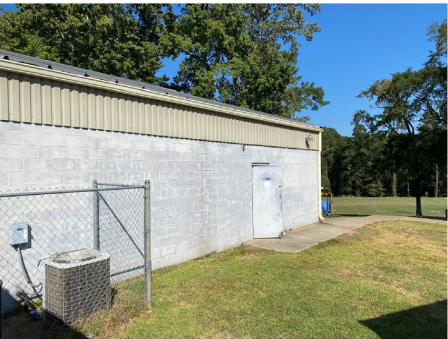
- Exterior is in need of painting
  - Exterior metal panels and roof appear to be in good condition

Conditions of exterior block

- New weight room should be constructed and either attached or a separate facility with view of the stadium.
- Adequate restroom / shower areas
- Attached or separate restrooms for the public
- Area for game officials added
- Expanded storage areas
- Improved coaches' office
- New finishes throughout the interior appropriate for a field house
- Improved safety and security systems upgraded or added
- Laundry area added
- Upgraded mechanical / electrical / plumbing systems replaced
- Painting of the exterior

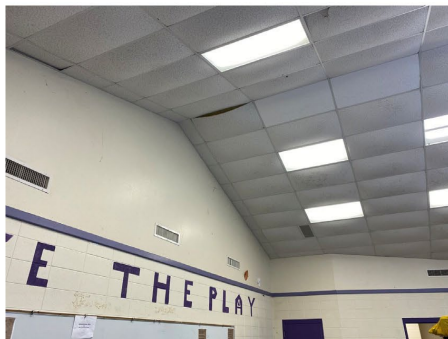
- Field house needs all new finishes on the inside; ceilings, flooring, paint and LED lights
  - Lockers are large and in good condition, but should be refinished; possible replacement of lockers, depending on preference of coaching staff.

Condition of ceilings

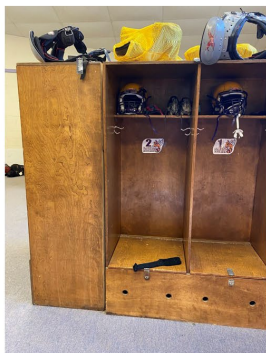
Typical Locker

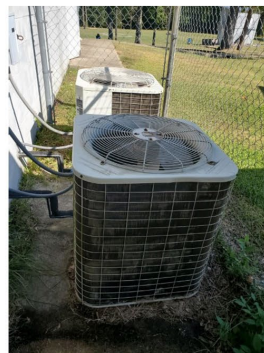
- Sloped metal roof also appears to be in good condition.
- Mechanical Systems –** **Inadequate**
  - The outdoor units appear to be from the early 2000's and are well past service life. The entirety of the HVAC systems will need to be replaced and updated (exhaust fans, indoor & outdoor units).

Field House Outdoor Units

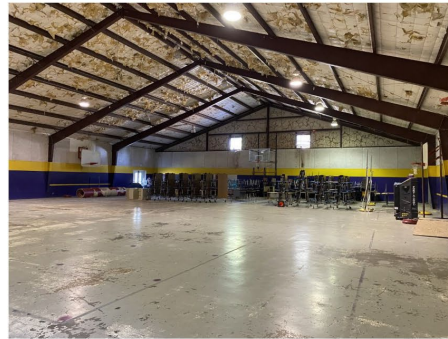
- All finishes are in very poor condition with no gym floor except for definite surface paint.
  - Building insulation is in extremely poor condition
  - Locker room finishes are extremely poor showing visible signs of water damage and rot.

Condition of P.E. Gym Interior & insulation

This facility is in such poor condition it should be stripped down to the frame/foundation and rebuilt to provide a new gym (including new roof) with adequate dressing/locker areas, coaches' office space, adequate storage, all new mechanical / electrical / plumbing systems, insulation, and low maintenance/durable finishes. Also new safety and security systems should be provided.

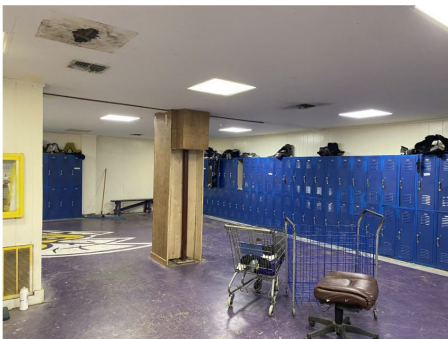
- **Educational Appropriateness and Environment –** **Inadequate**
  - Gym is an appropriate size
  - Locker room area is too small and in extremely poor condition. It does not meet any current plumbing or ADA requirements

View of locker room

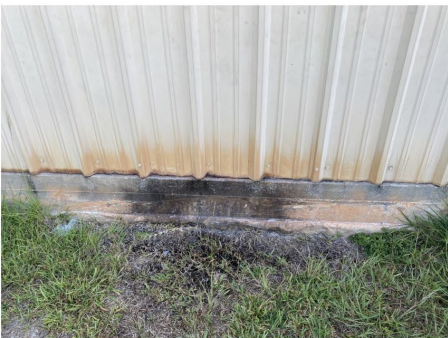
- Exterior metal surfaces are showing signs of paint loss
  - Metal roof system is 35 years old and should be replaced

Rust at P.E. Gym wall panels

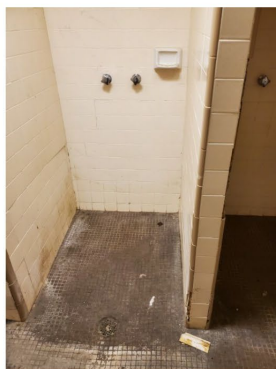
- All interior walls are wood framing and wood surfaces
  - All ceilings are in poor conditions showing signs of roof leaks
  - Restrooms/showers are in poor, and in most cases, are unusable condition

Condition of Locker Room Showers

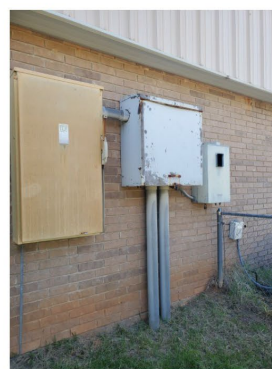
- **Electrical Systems –** **Poor**
  - The electrical systems appear to be in working order but are outdated. The electrical will likely need to be replaced if renovations are to be done. All of the interior and exterior lighting will need to be replaced.

P.E. Gym/Junior High Electrical Service Outdated

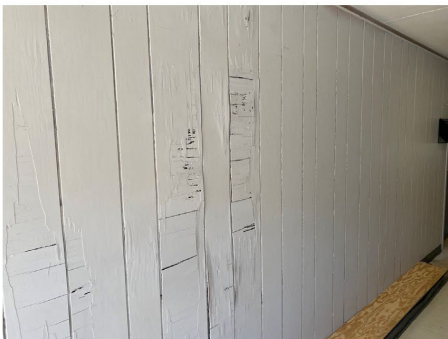
- All interior finishes are in very poor condition with damaged areas in need of repair or replacement
  - All interior walls are wood framing with wood paneling and need replacement

Wall damage at Jr. High

All aspects of this facility are in poor condition and would require extensive remodeling and repair to make it adequate for continued use. It would be best if this building were demolished and the three (3) classrooms become part of a new classroom building, given the cost to update the existing facility in its current condition.

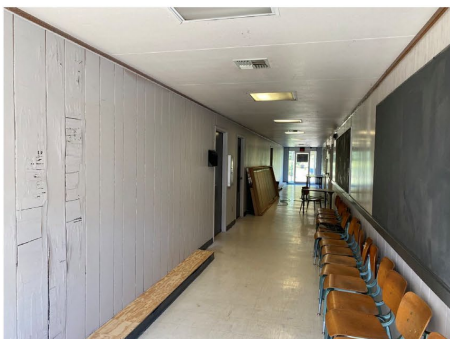
- Wood paneling also creates a dark/claustrophobic atmosphere
  - Hallways are also dark with low ceilings and low levels of lighting
- **Overall Interior and Exterior Appearance -** **Very Inadequate**

Jr. High corridor

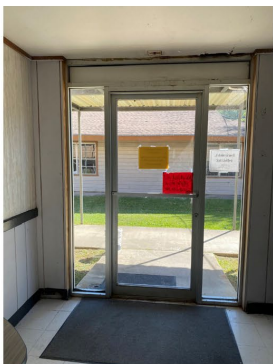
- All ceilings are in poor condition
  - Exterior is in fair condition, but windows need replacement
  - Some areas of mold and rot have been observed throughout the interior

Jr. High Exterior single pane door

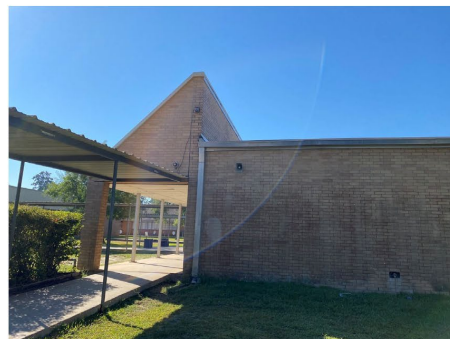
- Structure appears to be in good condition
  - Roof is a modified bitumen roof with a slight slope
  - High sloped parapet at front canopy appears to be in good condition

Elementary porch parapet

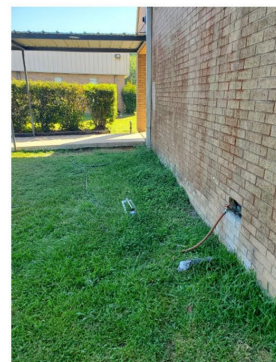
Elementary water hose connection

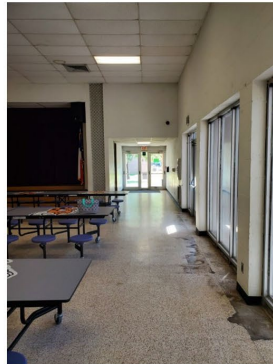
- Fencing is provided around the campus and this building is in the middle of the campus
  - Interior floor tile contains asbestos (according to a recent report) and should be abated and replaced

Damage floor tile

The cafeteria facility especially the dining area and stage, is in good condition with only minor upgrades required. New flooring, paint, new lay-in ceiling, and LED lighting could be recommended. Asbestos abatement, according to a recent report, will be necessary for this facility. A new roof for the building will be required some time in the near future. As far as safety is concerned, an upgraded fire alarm and security system should be installed. Also, the large expanse of glass should be removed and replaced with high glass to provide better safety but allow in natural light. The few cracks in the block walls should also be repaired. The kitchen area is where the most work will be required including all new equipment, new finishes, and an upgraded freezer/cooler. Another consideration would be to enlarge the kitchen area to provide better workflow. The exterior delivery area should be enlarged and improved to provide ease of deliveries.

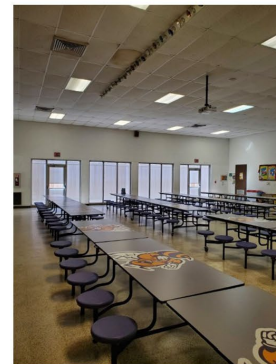
- Condition of the interior finishes down grade the overall appearance of the spaces
  - Facility interiors could be improved with better lighting
  - The existing roof is beginning to show signs of surface loss and may soon require replacement

Low levels of lighting in dining area

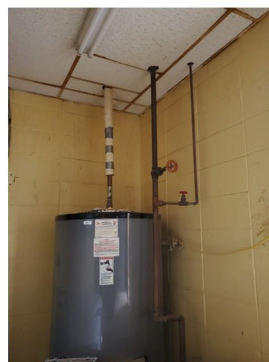
- Plumbing System –** **Inadequate**
  - The 120-gallon electric water heater has a manufacture date of 1994 and will need to be replaced. The water piping appears to be in good condition and no work should be needed. The plumbing fixtures will need to be updated. The kitchen plumbing systems will need to be replaced if renovations are to be done in the kitchen. There is an existing grease trap on the back side of the cafeteria that should not need any work except for a cursory inspection and cleaning to check for any issues.

Cafeteria water heater

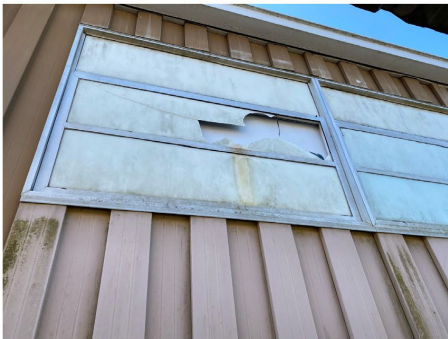
- Old wooden bench seating is out dated and does not provide comfort for spectators
- Locker rooms are generally in poor condition and need a total upgrade
- Exterior metal wall panels are showing some signs of rust, especially near the bottom. These panels may need to be repainted to maintain a good appearance
- Roof is in acceptable condition
- Some exterior window glass is broken

Broken window at gym

The gym itself is in acceptable condition, but the locker rooms need a total renovation and adequate coaches space needs to be provided. Although in good condition the public restrooms are constructed out of wood (as is the High School Wing) and should be rebuilt, if the High School classroom building is torn down. The metal roof would benefit from a membrane overlay and additional insulation and the metal wall panels should be repainted, and the broken window glass replaced. Fire alarm and security system should also be installed.

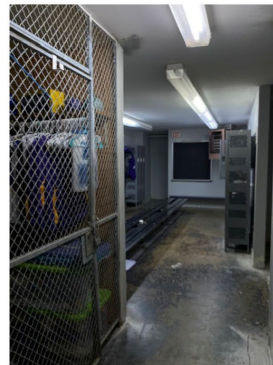
Locker rooms

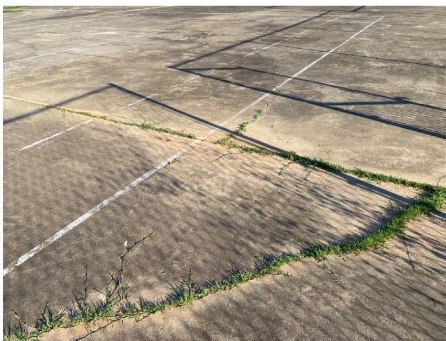
Cracks in court

The existing tennis courts could be cleaned, the cracks repaired, and a new play surface installed. A covered canopy could also be installed, and this area used as a covered play area, if tennis is no longer a desired sport.

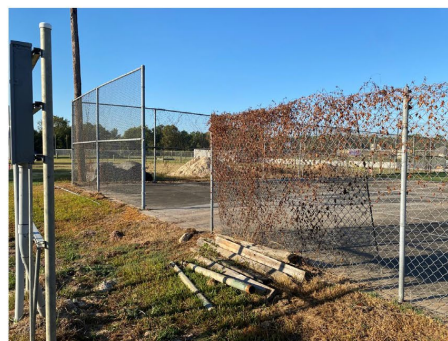
Condition of fencing

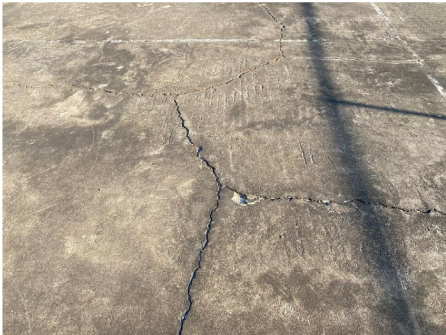
Court cracks and surface wear

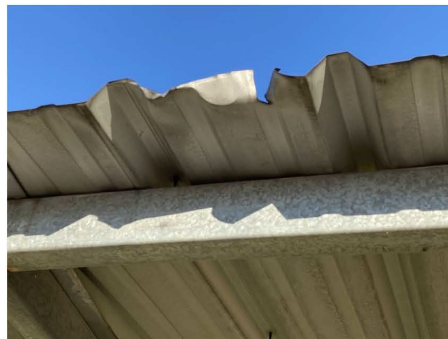
Canopy damage

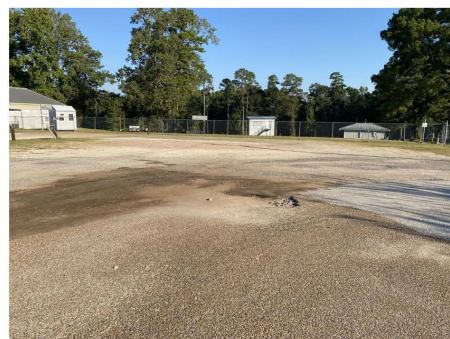
Multiple patches of main parking lot

- All drives and parking should be completed rebuilt/repared because of their poor condition.
