HVAC Infrastructure Assessment - Pender County Schools		
School	Site Visit/Observations	Assessment Report and Appendix A - Final Draft
Topsail Middle School	Completed	Completed
Pender High School	Completed	Final Draft Completed
Surf City Elem School	Completed	Final Draft Completed
Surf City Middle School		
C.F. Pope Elementary (former Burgaw Elementary)	Completed	In Progress
Topsail Elementary School	Completed	In Progress
Malpass Corner Elem School	Completed	In Progress
Burgaw Middle School	Completed	In Progress
Cape Fear Elem School	Completed	In Progress
Cape Fear Middle School		
Heide Trask High School	Completed	In Progress
Topsail High School	Completed	In Progress
West Pender Middle School	Completed	In Progress
North Topsail Elem School	Week of August 8th	September 7th
South Topsail Elementary	Week of August 15th	September 7th
Penderlea School	Week of August 22nd	September 14th
Rocky Point Elem School	Week of August 29th	September 21th

HVAC INFRASTRUCTURE ASSESSMENT TOPSAIL HIGH SCHOOL PENDER COUNTY SCHOOLS

Appendix A – More detailed information found and observed for each HVAC system and area.

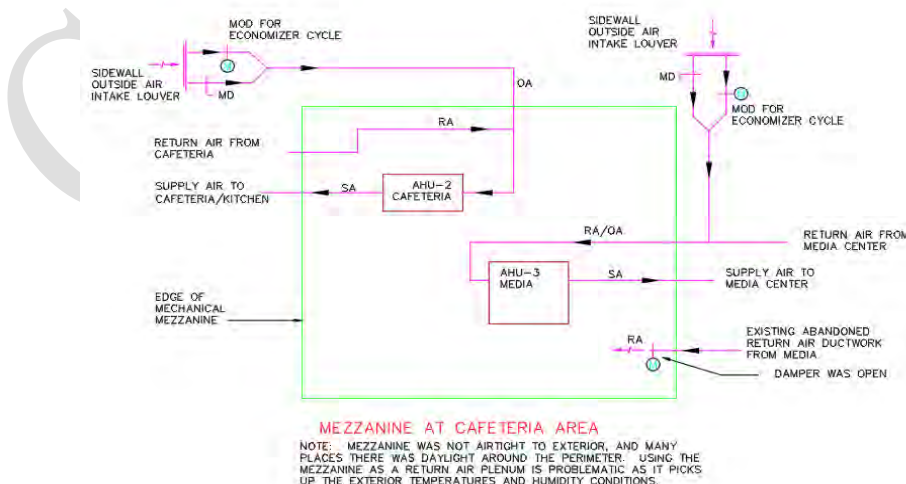
- e. Disconnect switch (good condition)
 - f. 6600 CFM SA scheduled; 1400 CFM OA scheduled with OA economizer.
5. HP-2 (Match with AHU-2):
- a. Trane TWA180DDAA00AR... (4-2018) good condition – heat pump

- b. 460V-3Ph
 - c. R410a Refrigerant
 - d. 60A Heavy duty safety switch – poor condition
 - e. Observed insulation is missing from some exterior refrigerant piping.

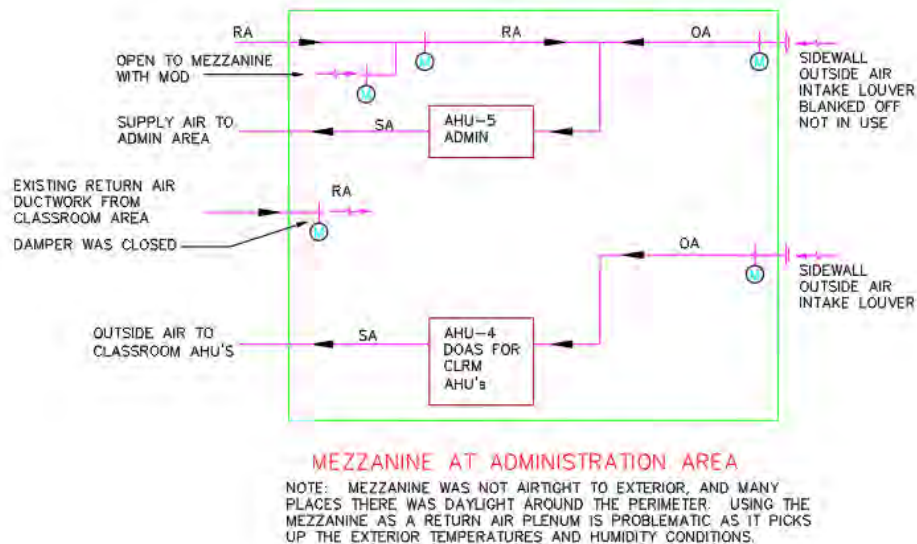
9. HP-4 (Match with AHU-4):

- a. Trane TTA180H400AA (1-2018) good condition – split system a/c
- b. 460V-3Ph
- c. R410a Refrigerant
- d. 30 Amp Heavy Duty Safety Switch – poor condition

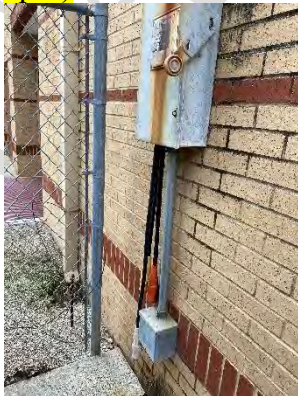
- g. 208V-1ph
 - h. 3.75kW electric heat
 - i. **100A** Sq D disconnect (not listed as HD) good condition

(could it possibly matched with an exterior 100 amp panel what has a generator hook ups?)
