ECM #2 – Building Envelope Upgrades

ECM #3 – Controls & HVAC System Upgrades

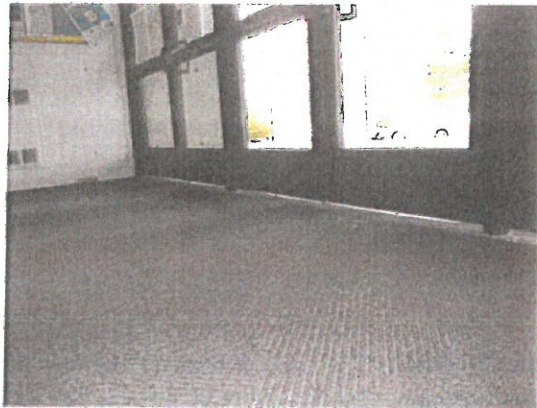
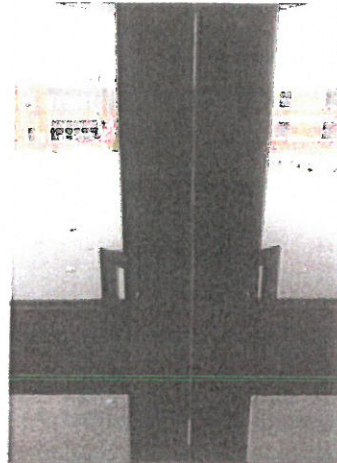
Examples of Door Weatherstripping Missing/Inadequate

1. Base Measures:
 - a. 9 - Single commercial doors to be weather-stripped (3 dark bronze anodized).
 - b. 1 - Single commercial interior boiler room door to be weather-stripped.

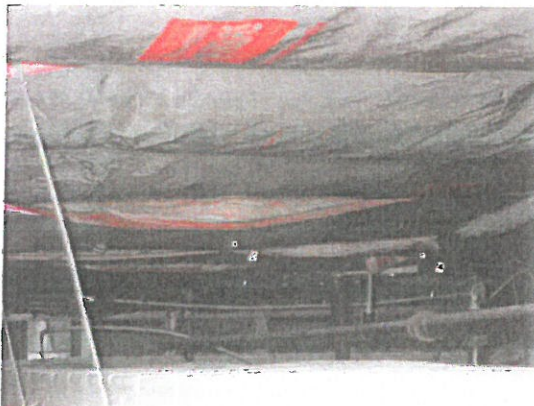
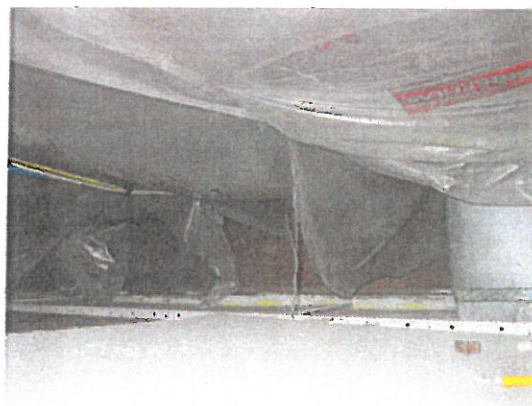
Attic Insulation Inadequate/Missing in Areas

- a. 19,856 - Square feet of existing polyiso board insulation to be sealed at perimeters with 2-component fire rated foam, all foam to be coated with DC315 intumescent paint (approx. 14,891 linear feet).
- b. Option to Increase R Value To ASHRAE Standard of R38: 19,856 - Square feet of cellulose insulation to be added atop existing insulation to achieve an overall R38.

- a. 14,165 - Square feet of 1" Dow Thermax Sheathing to be installed to underside of truss joists and vertical knee-walls (hallways), seams to be sealed with FSK tape and 2-component fire rated foam, all foam to be coated with DC315 intumescent paint (approx. 10,961 linear feet).
- b. Option to Increase R Value to ASHRAE Standard of R38: 14,165 - Square feet of cellulose insulation to be added atop existing insulation to achieve an overall R38.

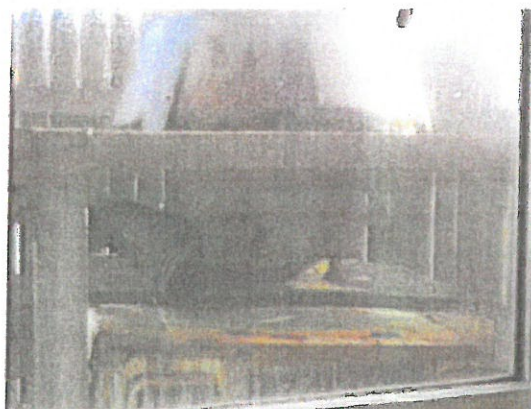
- a. A detailed survey was performed to identify existing windows which have failed or defective thermal breaks/seals between the thermal panes. Failed or defective thermal breaks cause unsightly windows, due to infiltration of water vapor, and more importantly they compromise the thermal integrity of the windows, resulting in additional heat loss. Windows with failed thermal breaks can be repaired by replacing the window panes with new window panes with thermal breaks. This will result in reduced

Typical Window with Failed Thermal Breaks/Seals

- b. Replace 35 existing window pane units (427 Sq Ft) which have failed or defective seals, with new units. New units shall have maximum U value of 0.57 (R 1.75).

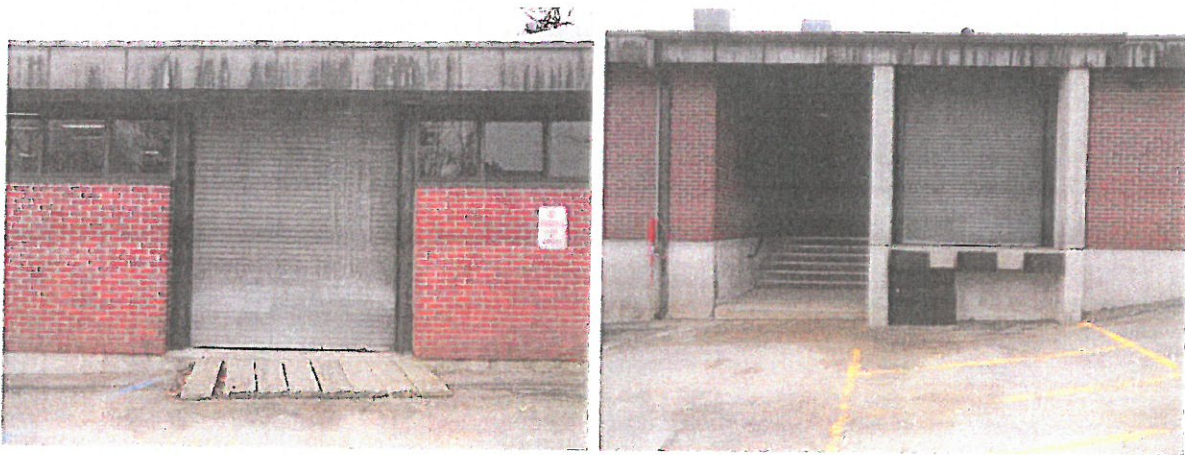
- a. The Elementary School has 2 overhead metal roll-up doors which are original (1975 vintage) and which have little to no insulation value. Replace these two overhead doors with new insulated roll-up overhead doors. New overhead doors shall have minimum R value of R 4.23.

Overhead Doors to be Replaced

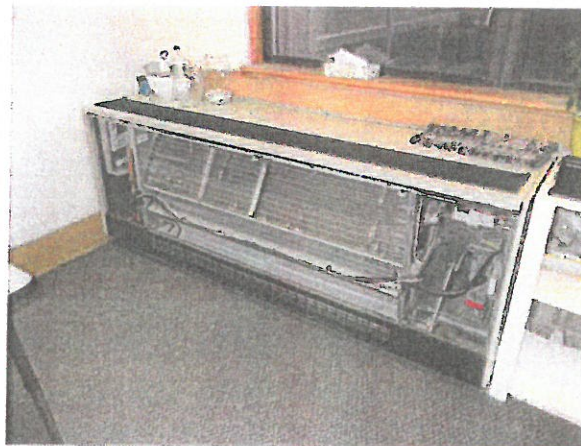
Existing Unit Ventilator

- a. 14 unit ventilators have face & bypass dampers, and no control valves on the hot water coils. This allows potential overheating in spring and fall when the boiler/pumps are ON and the units are in full bypass mode. Add automatic control valves and associated controls to these 14 unit ventilators. When OAT is < 40 deg F, full flow through coils and used F & BP dampers for control. When OAT > 40 deg F, all airflow through coil and use ACV's for control.

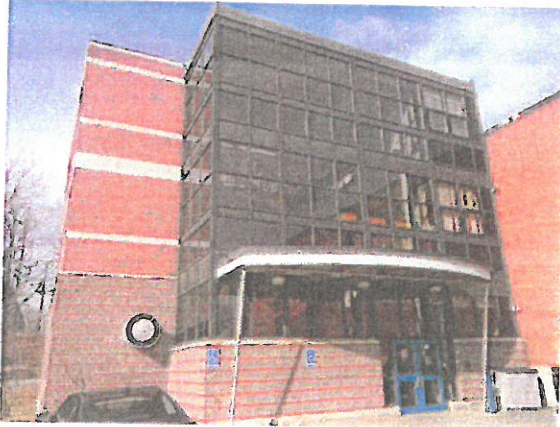
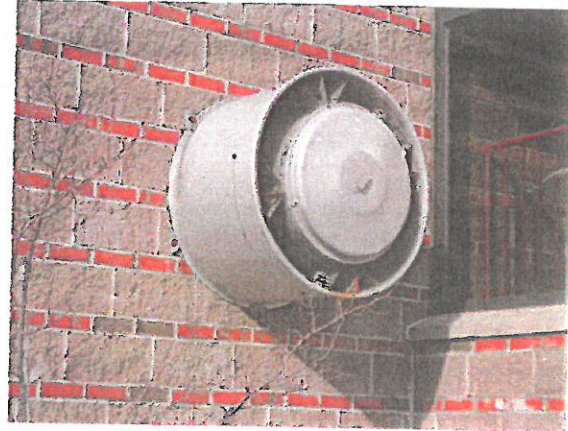
Art Room's Wall Mounted Exhaust Fan

- a. The owner reports that the wall mounted exhaust fan, which serves the kiln hood, leaks water into the building during wind driven rain storms.
- b. Provide a rain hood over the wall mounted exhaust fan.

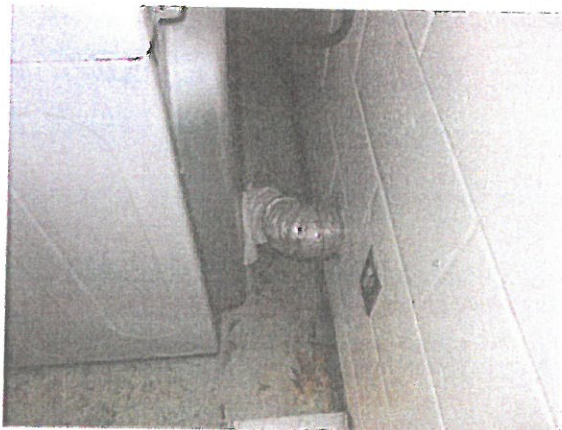
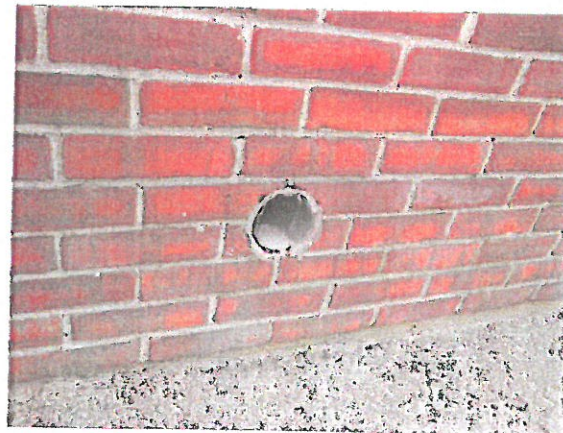
- a. In the Industrial Arts/Maintenance Shop, the dryer vent outlet at the outside wall is missing. This allows cold air to dump into the building through the dryer when it is OFF.
- b. Provide a new backdraft damper on the dryer vent outlet.

Dryer Vent Outlet – Missing Backdraft Damper

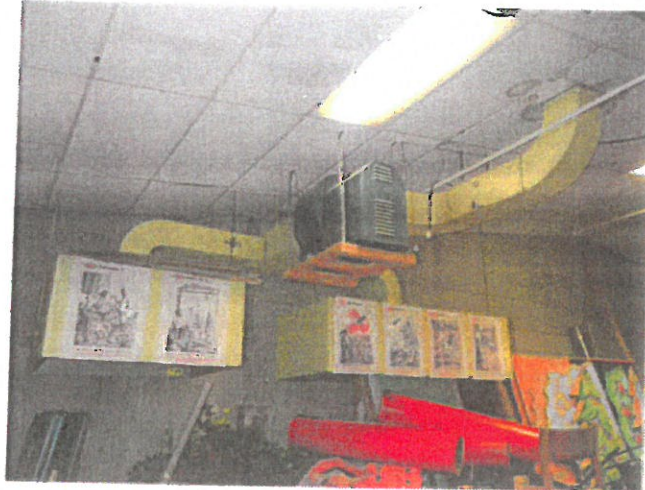
- a. In the Industrial Arts/Maintenance Shop, there are two abandoned yellow exhaust hoods. The ductwork for these hoods is still connected and it terminates outdoors. There is no active backdraft damper in this exhaust system, so warm building air gravity flows out through this ductwork when the exhaust fan is OFF.
- b. Disconnect the ductwork from the two abandoned hoods, and cap the ductwork to eliminate gravity airflow.

Abandoned Exhaust Hoods

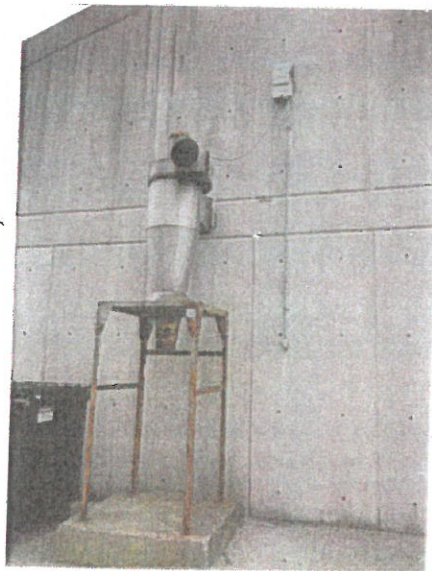
- a. In the Industrial Arts/Maintenance Shop, there is an abandoned sawdust collection system, with the sawdust collection cyclone located outdoors. The ductwork for this sawdust collection system is still connected and it terminates outdoors. There is no active backdraft damper in this exhaust system, so warm building air gravity flows out through this ductwork when the exhaust fan is OFF.
- b. Remove the outdoor sawdust collection cyclone, and cap the duct at the exterior wall, to eliminate gravity airflow.
- c. NOTE: The cyclone and its steel framework will be removed, but the concrete base will remain abandoned in place.

Abandoned Sawdust Collector

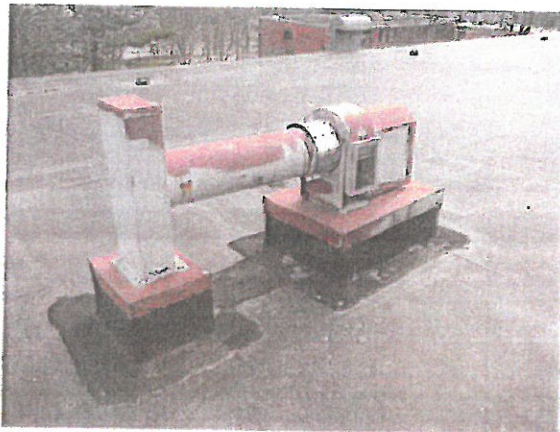
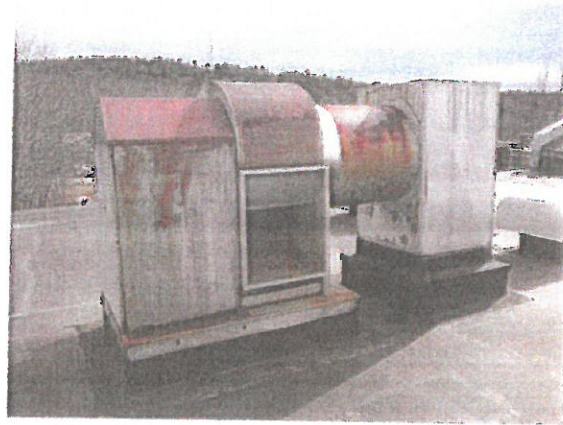
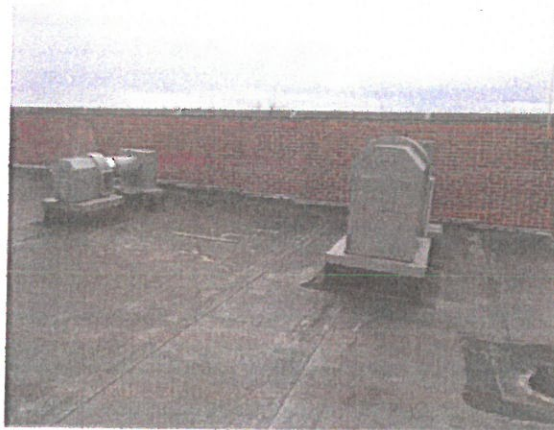
Fan #5, Fan #3, Fan #9 (On Left)

- a. There are 3 rooftop exhaust fans (Fan # 5 – Fume Hood System, Fan # 9 – Dishwasher Exhaust Hood, Fan # 3 – Classroom Exhaust) that have no gravity backdraft dampers, so warm building air gravity flows out through these fans when they are OFF.
- b. Add gravity backdraft dampers to these 3 fans.

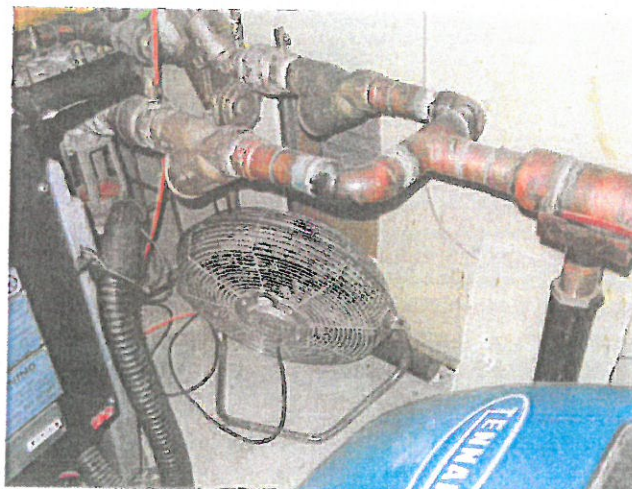
5. Add Transfer Fan System to Transfer Heat From Server Room to Main Entrance:
- The Server Room on the lower level overheats. Small portable fans have been installed to move the heat out of the room. That heat could be beneficially used in the winter, if it could be transferred to the entrance area.
 - Provide a new transfer fan system, to transfer warm air from the Server Room to the entrance/lobby area down the hall.

Fan Transferring Heat Out of Server Room

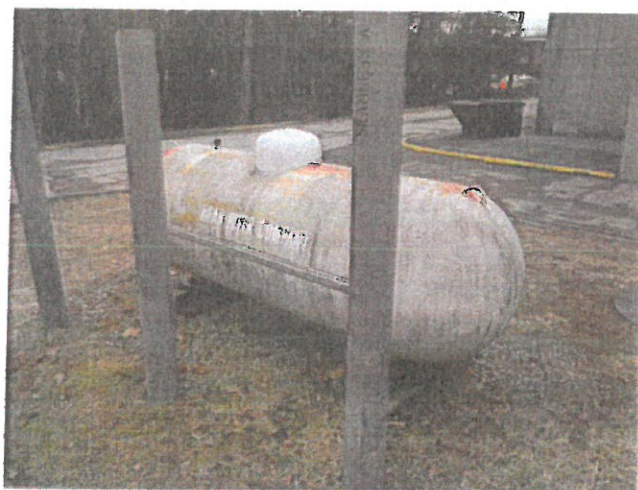
Existing 500 Gallon LP Gas Tank

- c. NOTE: The 500 gallon LP Gas tank may not be of sufficient size to serve the new gas water heater and the emergency generator simultaneously. This should not create a problem, as the boilers are capable of supplying domestic hot water if the emergency generator should be needed for an outage.

- b. As there is an existing 500 gallon LP Gas tank outside the boiler room which serves the emergency generator, provide a new LP Gas water heater to supply domestic hot water for the summer. Serve the new gas water heater from the existing 500 gallon LP Gas tank.

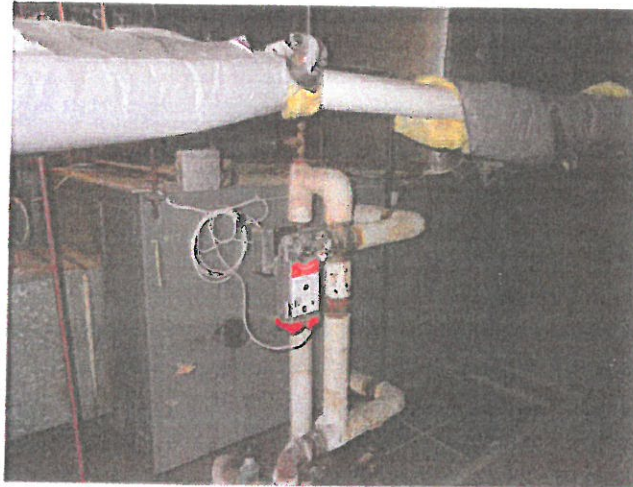
- a. The IA/Maintenance Shop's air handling unit (HV-7) was found during our surveys with its outside air damper at 45% open on a cold day (i.e. no need for free cooling) and with no occupancy in the IA/Maintenance Shop.
- b. Provide CO2 controls for HV-7, to reduce outdoor air as occupancy levels change.

- c) Valves and accessories to be replaced with new.
 - d) Provide water balancing.
- c. HV-7 (IA/Maintenance Shop):
 - 1) The IA/Maintenance Shop air handling unit (HV-7) is original 1977 vintage. The unit has exceeded its useful service life and it is in poor condition. There are no blade or jamb seals on the dampers. The unit has exposed fiberboard insulation on the inner surfaces of the unit housing, and that fiberboard liner has become friable and has deteriorated over time, sending fiberglass particles out through the ductwork and into the occupied spaces. The deteriorated fiberboard liner accumulates dirt, dust and is a potential for mold growth.

- 2) Replace HV-7 with a new unit:
 - a) New unit will be double wall construction, with solid interior walls so that exposed fiberboard insulation is eliminated.

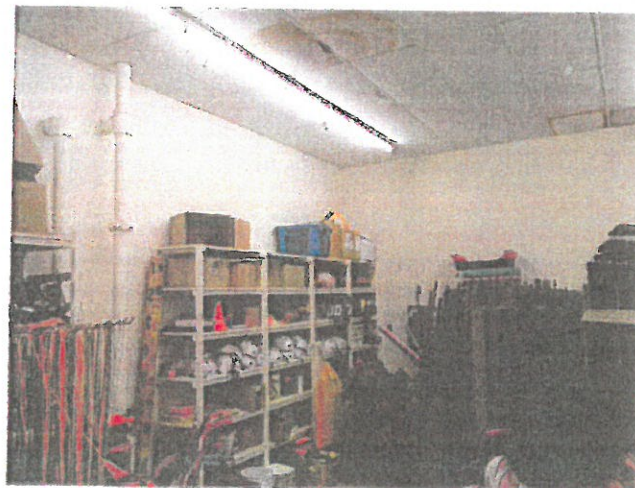
Stage Storage Room

- a. The Stage is used as the Band classroom, and this room has no means of mechanical fresh air ventilation.
- b. Provide a new mechanical ventilation system, to supply code compliant ventilation air to the Band Room/Stage.
 - 1) Locate the new unit in the storage room behind the Stage.
 - 2) Provide new DDC controls for new unit, and interface with the operator workstation and user interface graphics.

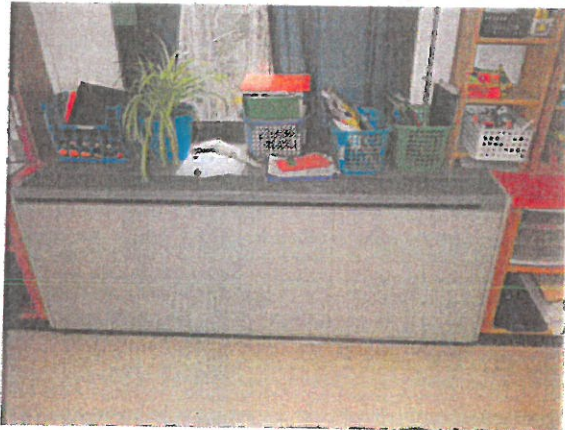
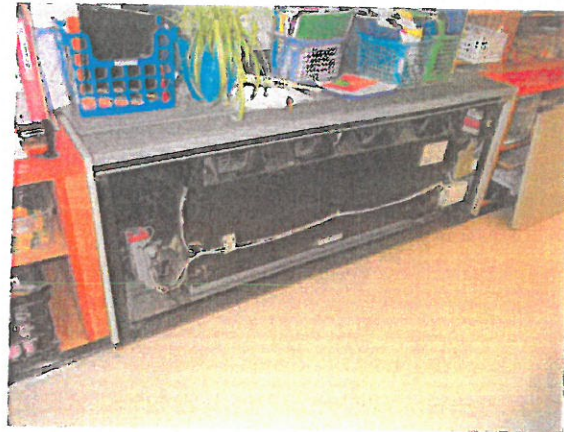
Typical Existing Unit Ventilator

- a. The 36 - 1977 vintage unit ventilators have exceeded their useful service lives. Although the outer cabinets of the units appear to be in generally fair to good condition, the service technician reports that these units have been problematic. Damper blades have been breaking loose from their shafts.

Temporary repairs have been made, but more permanent repairs require the units to be nearly disassembled, which would be very time consuming and costly, so replacement of these units is justified.

- b. Replace the 36 existing unit ventilators with new units.
 - 1) New units will have face & bypass dampers and automatic control valves.
 - 2) Existing units are assumed to have code compliant power feeds. Upgrading of power feeds is excluded.
 - 3) Valves and accessories in the unit ventilator cabinets will be replaced with new.
 - 4) Casework will be modified as required, to accommodate differences in width from existing units to new units.
 - 5) Air and water balancing are included.

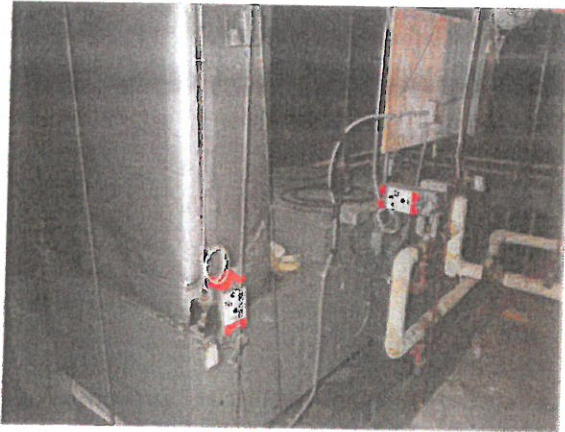
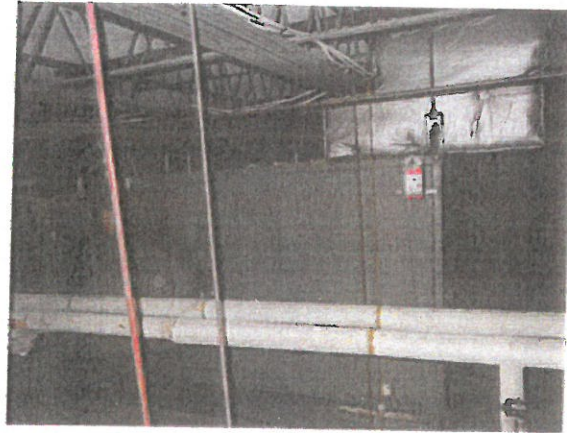
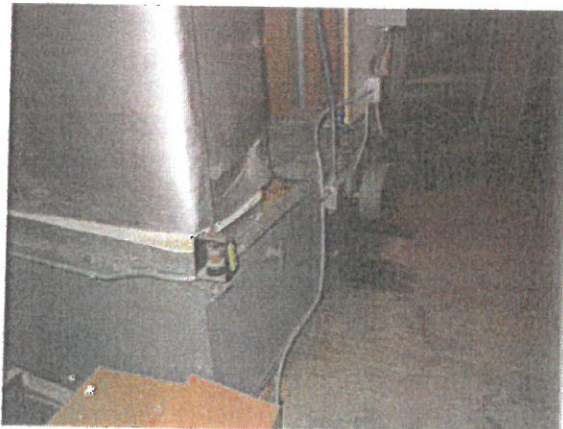
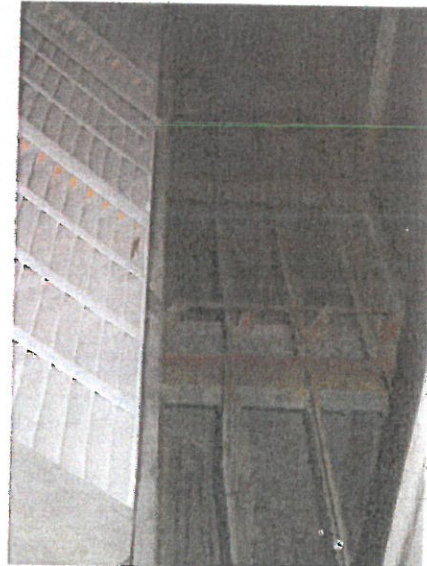
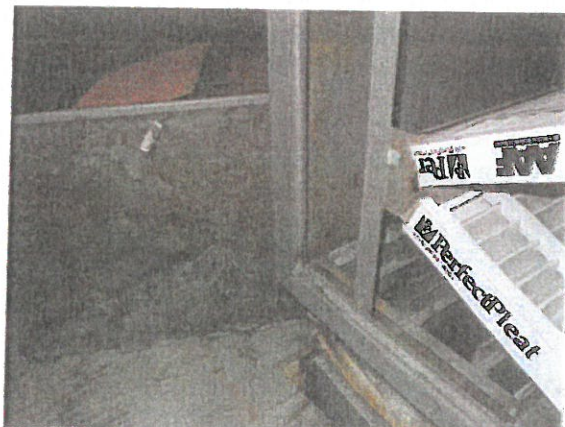
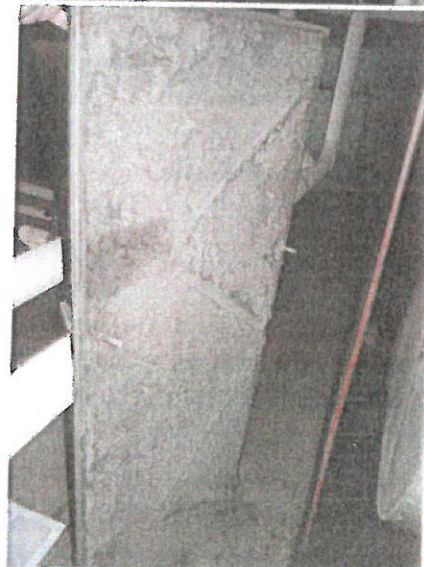
HV-2, HV-3, HV-4

- a. HV-2 (Gymnasium):
 - 1) The Gymnasium air handling unit (HV-2) is original 1977 vintage. The unit has exceeded its useful service life and it is in poor condition. There are no blade or jamb seals on the dampers, the return air damper is bent, the return air duct connection to the bottom of the unit is separated. The unit has exposed fiberboard insulation on the inner surfaces of the unit housing, and that fiberboard liner has become friable and has deteriorated over time, sending fiberglass particles out through the ductwork and into the occupied spaces. The deteriorated fiberboard liner accumulates dirt, dust and is a potential for mold growth.

- 2) The 2 duct mounted heating coils associated with HV-2 are also original 1977 vintage. They have exceeded their useful service lives and they are in poor condition. They are clogged with dust and debris from many years of use.

- b. HV-3 (Locker Rooms):
 - 1) The Locker Room air handling unit (HV-3) is original 1977 vintage. The unit has exceeded its useful service life and it is in poor condition. There are no blade or jamb seals on the dampers. The unit has exposed fiberboard insulation on the inner surfaces of the unit housing, and that fiberboard liner has become friable and has deteriorated over time, sending fiberglass particles out through the ductwork and into the occupied spaces. The deteriorated fiberboard liner accumulates dirt, dust and is a potential for mold growth.

- 2) The 4 duct mounted heating coils associated with HV-3 are also original 1977 vintage. They have exceeded their useful service lives and they are in poor condition. They are clogged with dust and debris from many years of use.

- c) Valves and accessories to be replaced with new.
 - d) Provide water balancing.
- c. HV-4 (Teacher's Lounge):
 - 1) The Teacher's Lounge air handling unit (HV-4) is original 1977 vintage. The unit has exceeded its useful service life and it is in poor condition. There are no blade or jamb seals on the dampers. The unit has exposed fiberboard insulation on the inner surfaces of the unit housing, and that fiberboard liner has become friable and has deteriorated over time, sending fiberglass particles out through the ductwork and into the occupied spaces. The deteriorated fiberboard liner accumulates dirt, dust and is a potential for mold growth.

- 3) Replace HV-2 with a new unit:
 - a) New unit will be double wall construction, with solid interior walls so that exposed fiberboard insulation is eliminated.

- 4) Replace 2 Duct Mounted Heating Coils:
 - a) Replace 2 – 66" x 33" duct mounted heating coils.
 - b) Valves and accessories to be replaced with new.
 - c) Provide water balancing.

- 3) Replace HV-3 with a new unit:
 - a) New unit will be double wall construction, with solid interior walls so that exposed fiberboard insulation is eliminated.

- 4) Replace 4 Duct Mounted Heating Coils:
 - a) Replace 4 duct mounted heating coils (1 – 14" x 12", 1 – 18" x 12", 2 – 6" x 6").
 - b) Provide duct access doors for the new coils.

- 2) Replace HV-4 with a new unit:
 - a) New unit will be a 1,200 CFM unit ventilator.
 - b) Valves and accessories will be replaced with new.
 - c) Air and water balancing of the new unit are included. Air balancing is limited to the unit only; air balancing is not included for the entire ductwork system.

- d. Safety Upgrades to Mechanical Mezzanine:
 - 1) Provide safe access to the mechanical mezzanine where HV-2, HV-3 and HV-4 are located.
 - 2) Add a permanent access ladder in the nearby Janitor's Closet, with an extension of the mechanical mezzanine platform to connect to the new access ladder.

- 3) Expand the mechanical mezzanine platform as required to allow for safe maintenance and service access to the new air handling units and duct heating coils.
- 4) Add safety railing around the perimeter of the platform.

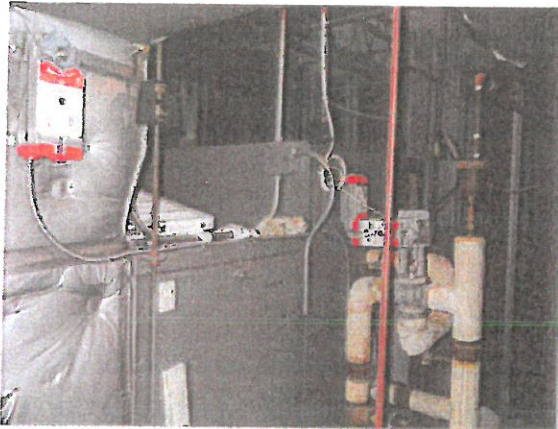
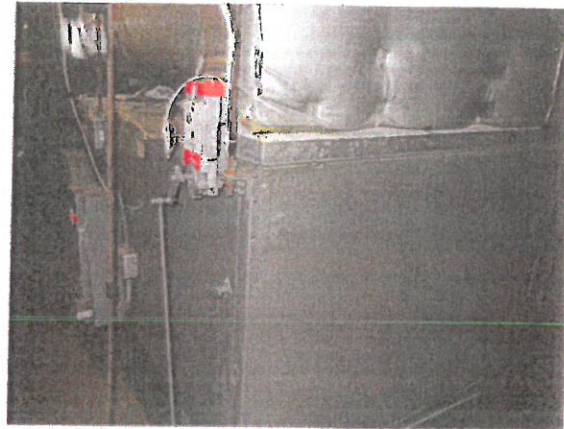
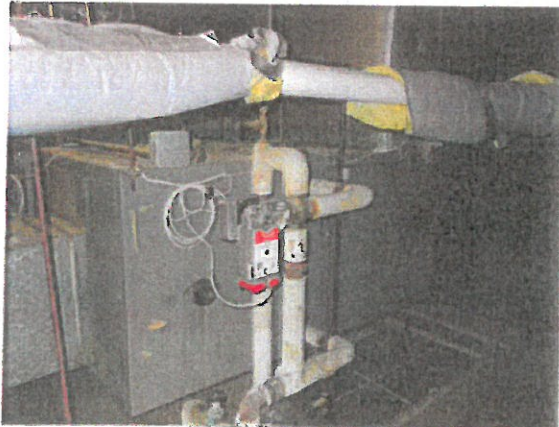
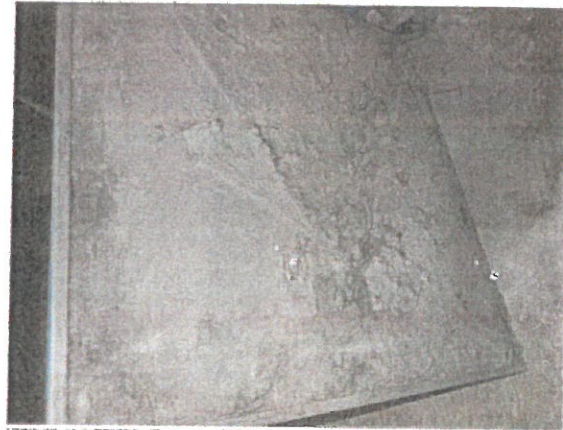
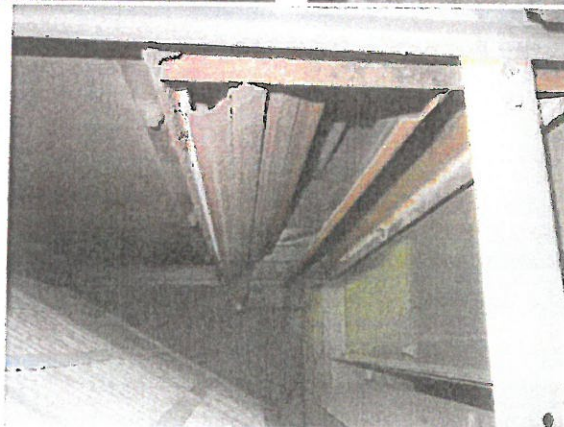
HV-5, HV-6, HV-7

- a. HV-5 (Kitchen):
 - 1) The Kitchen air handling unit (HV-5) is original 1977 vintage. The unit has exceeded its useful service life and it is in poor condition. The unit has exposed fiberboard insulation on the inner surfaces of the unit housing, and that fiberboard liner has become friable and has deteriorated over time, sending fiberglass particles out through the ductwork and into the occupied spaces. The deteriorated fiberboard liner accumulates dirt, dust and is a potential for mold growth.

- b. HV-6 (Music):
 - 1) The Music air handling unit (HV-6) is original 1977 vintage. The unit has exceeded its useful service life and it is in poor condition. There are no blade or jamb seals on the dampers. The unit has exposed fiberboard insulation on the inner surfaces of the unit housing, and that fiberboard liner has become friable and has deteriorated over time, sending fiberglass particles out through the ductwork and into the occupied spaces. The deteriorated fiberboard liner accumulates dirt, dust and is a potential for mold growth.

- 2) The 3 duct mounted heating coils associated with HV-6 are also original 1977 vintage. They have exceeded their useful service lives and they are in poor condition. They are clogged with dust and debris from many years of use.

- 2) Replace HV-5 with a new unit:
 - a) New unit will be double wall construction, with solid interior walls so that exposed fiberboard insulation is eliminated.

- 3) Replace HV-6 with a new unit:
 - a) New unit will be double wall construction, with solid interior walls so that exposed fiberboard insulation is eliminated.

- 4) Replace 3 Duct Mounted Heating Coils:
 - a) Replace 3 duct mounted heating coils (1 – 28" x 18", 1 – 12" x 6", 1 – 30" x 18").
 - b) Provide duct access doors for the new coils.

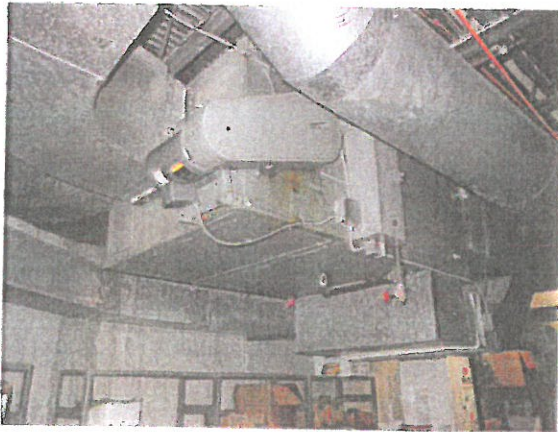
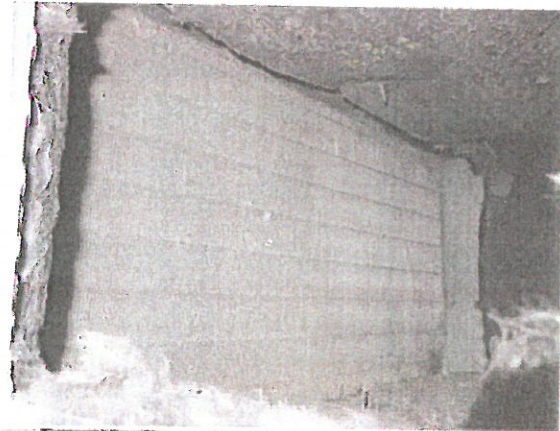
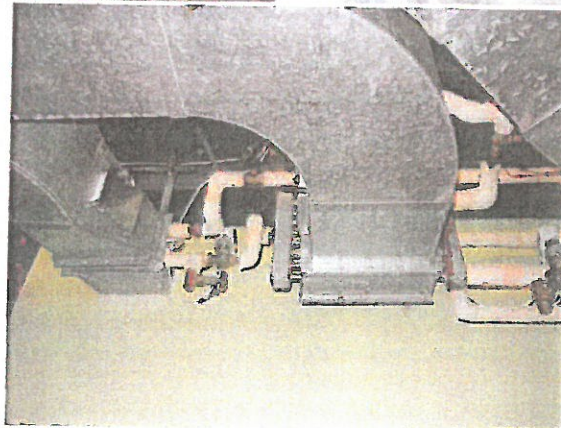
- 1) The Administration air handling unit (HV-1) is original 1977 vintage. The unit has exceeded its useful service life and it is in poor condition. There are no blade or jamb seals on the dampers. The unit has exposed fiberboard insulation on the inner surfaces of the unit housing, and that fiberboard liner has become friable and has deteriorated over time, sending fiberglass particles out through the ductwork and into the occupied spaces. The deteriorated fiberboard liner accumulates dirt, dust and is a potential for mold growth.

- 2) The 4 duct mounted heating coils associated with HV-1 are also original 1977 vintage. They have exceeded their useful service lives and they are in poor condition. They are clogged with dust and debris from many years of use.

- 3) Replace HV-1 with a new unit:
 - a) New unit will be double wall construction, with solid interior walls so that exposed fiberboard insulation is eliminated.

- 4) Replace 4 Duct Mounted Heating Coils:
 - a) Replace 4 duct mounted heating coils (1 – 12" x 6", 1 – 12" x 12", 1 – 14" x 6", 1 – 24" x 12").
 - b) Valves and accessories to be replaced with new.

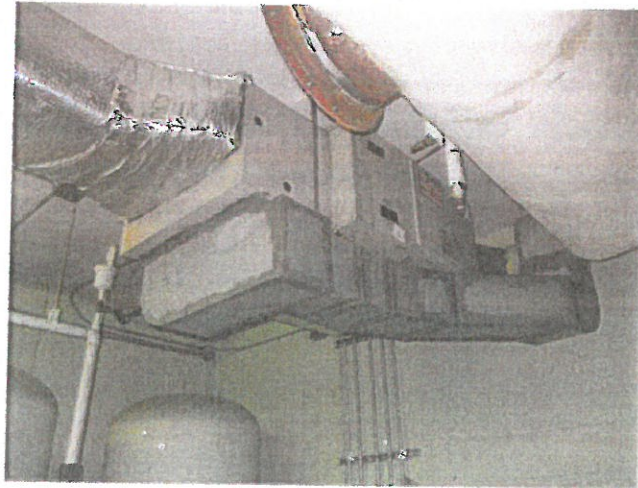
- a. FCU-1 (Computer Lab/Guidance):
 - 1) The Computer Lab/Guidance air handling unit (FC-1) is of unknown age, and it is in fair to poor condition. It appears as though the heating coil in this unit was disconnected, so the unit provides no heat.

- b. Extend Emergency Generator Vent Up Higher:
 - 1) The fresh air intake louver for FCU-1 terminates close to and at approximately the same elevation as the exhaust vent outlet of the emergency generator. This creates a serious danger of potentially drawing in carbon monoxide when the generator runs.

- 2) Replace FCU-1 with a new unit:
 - a) New unit will be a unit ventilator with hot water coil and face & bypass dampers.
 - b) Valves and accessories will be replaced with new.

- 2) Extend the emergency generator exhaust vent up, to an elevation that is a minimum of 10 feet above FCU-1 fresh air intake louver. Brace the emergency generator exhaust vent to the building wall with steel angle support braces.

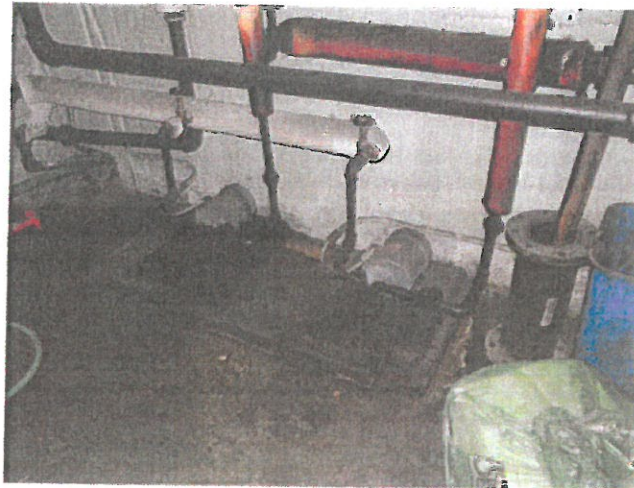
Existing Fuel Oil Transfer Pumps

- a. The existing fuel oil transfer pumps in the boiler room are original 1977 vintage. They have exceeded their useful service lives and they are in fair to poor condition. The existing Cleaver Brooks boilers require these pumps to run continuously during the heating season.
- b. Replace the existing fuel oil transfer pumps with a new fuel oil day tank with duplex pump set. This new system will result in a fuel oil transfer system that cycles on and off to maintain oil level in the day tank, versus the more energy intensive existing pumps which must run 24/7. The Cleaver Brooks boilers will be replaced with new boilers that do not require constant oil flow (scope shown elsewhere in this report).

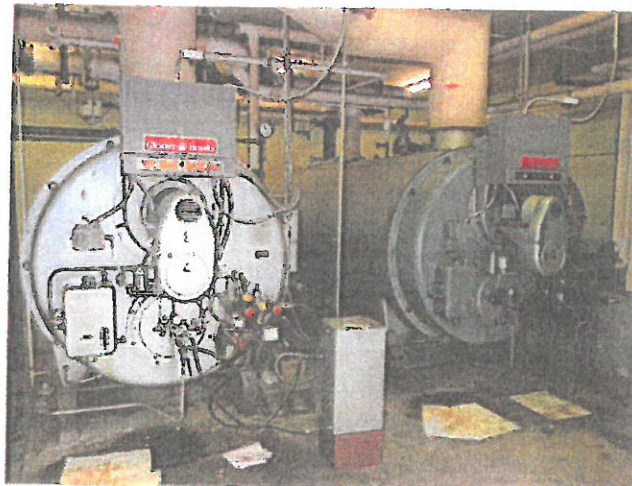
Existing Cleaver Brooks Boilers

- a. The existing Cleaver Brooks boilers are original 1977 vintage. They have exceeded their useful service lives and they are in fair to poor condition.
- b. Replace the existing Cleaver Brooks boilers with new Buderus 3 pass cast iron sectional boilers.
 - 1) Provide new metal chimney liner.
 - 2) Provide new powered combustion air system.
 - 3) Provide new concrete housekeeping pads.
 - 4) Modify boiler room piping so that new boilers inject into the primary heating main.

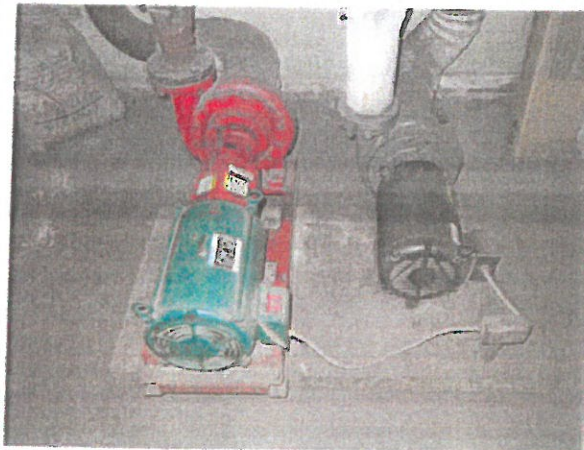
Existing Heating Water Pumps

- a. The existing base mounted heating water pumps are original 1977 vintage. They have exceeded their useful service lives and they are in fair to poor condition.
- b. Replace the existing heating pumps with new base mounted pumps.
 - 1) Extend the concrete housekeeping to accommodate the new pumps.
 - 2) Re-use existing VFD's.
 - 3) Provide water balancing of new pumps.

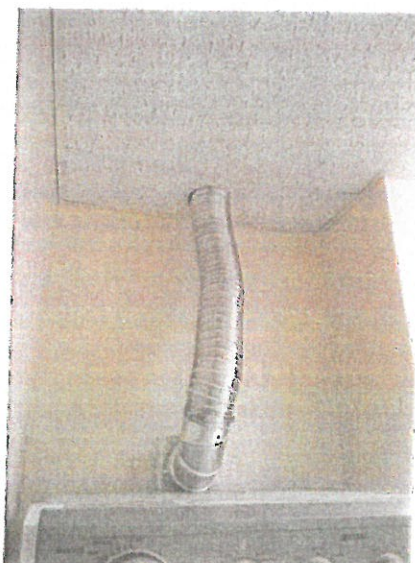
- a. In Room 228, the dryer vent terminates in the cold attic. This is a code violation, and it is not good practice as moist air from the dryer condenses in the cold attic, and that can cause ceiling staining and mold growth.
- b. Extend the dryer vent up through the roof, with a backdraft damper.

Dryer Vent Terminates in Cold Attic
