REPORT OF INSPECTION – FIXED WOOD BLEACHERS

Inspection Date:	Staunton High School	Inspected By:
Facility:	Old Gym	Bill & Courtland
Location:	801 N. Deneen Staunton, IL 62088	Bulte Company
Sent to:	Brian Dustman	Technicians

FIXED WOOD BLEACHER INSPECTION

Job Name: Staunton High School Location: Old Gym Contact: Brian Dustman Bleacher Manufacturer: Type & Size: Fixed Wood Rise/Tread: 17" / 24" Approximate Age: Original	Date of Inspection: 10-3-18 Inspection by: Bill & Courtland

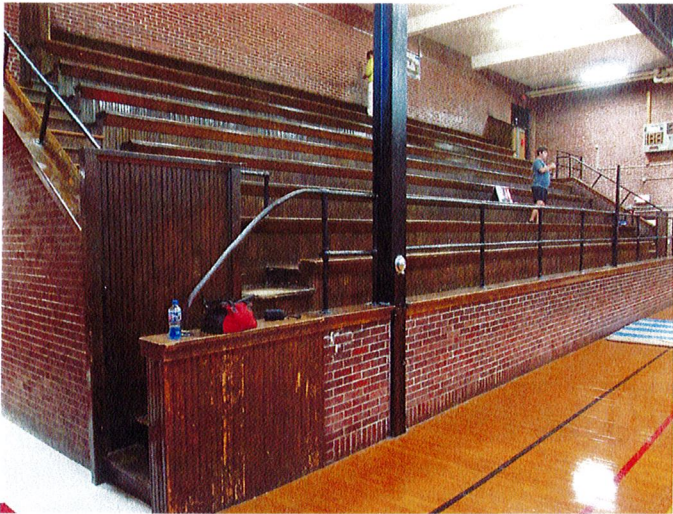
Open railing at the front walkway is a fall hazard. Narrow entry steps and no handrail.

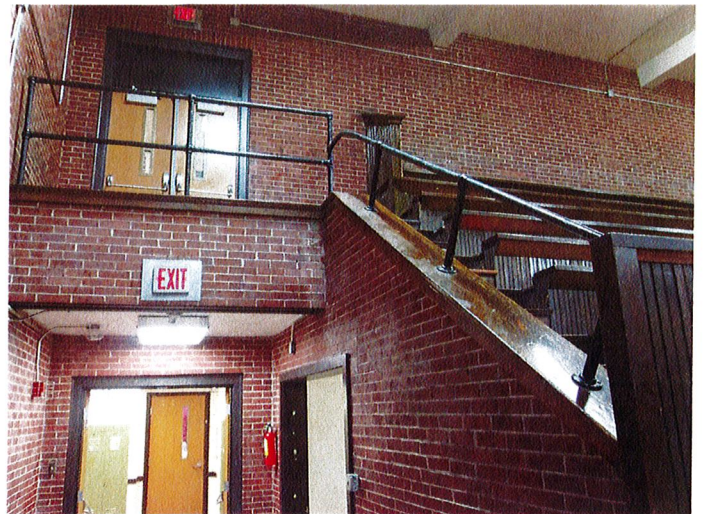
Open railing at the upper walkway. Side rail is not 42" h and is open. Steps are too narrow.

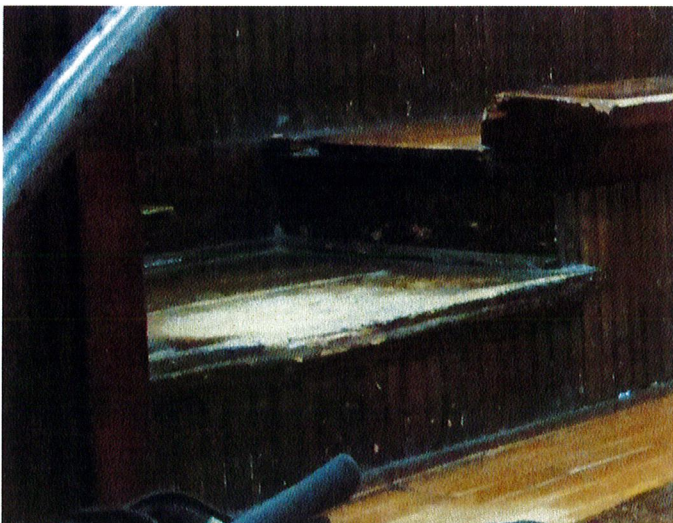
Front edge of steps worn down and no tread tape—slip hazard.

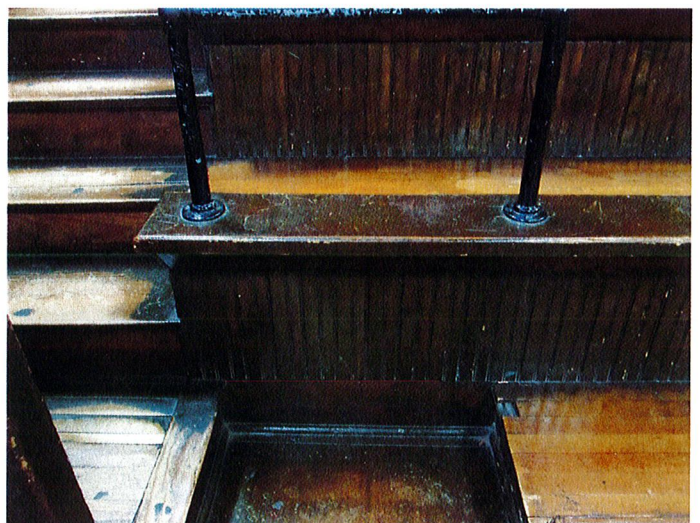
Front row/walkway drops - trip /fall hazard. Worn front edges of steps—slip hazard.

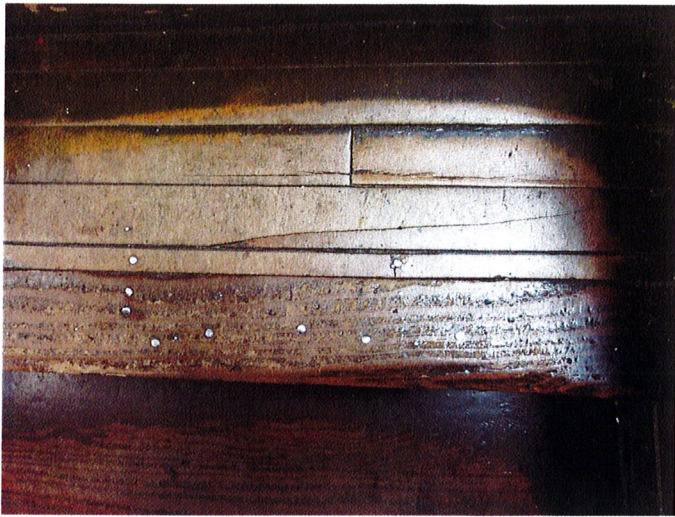
Stair tread needing replacement.

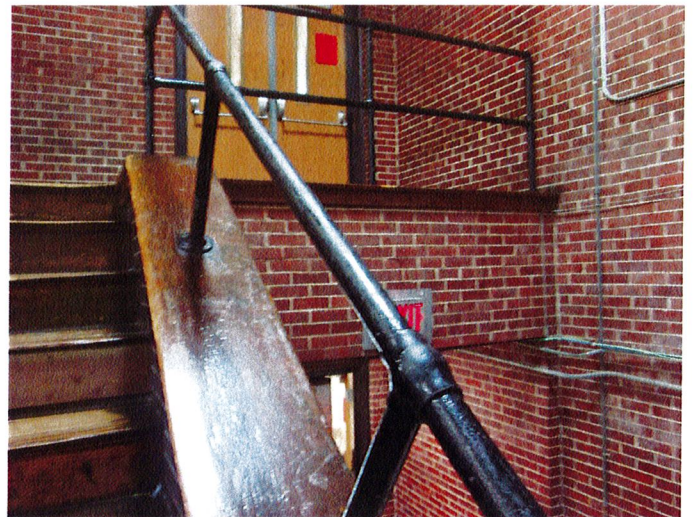
Open rails are a fall hazard .

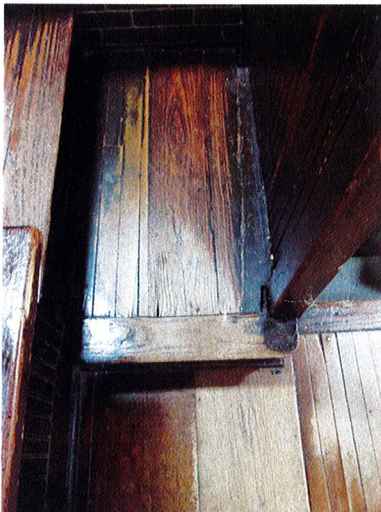
Narrow stair landing and worn step nosing.

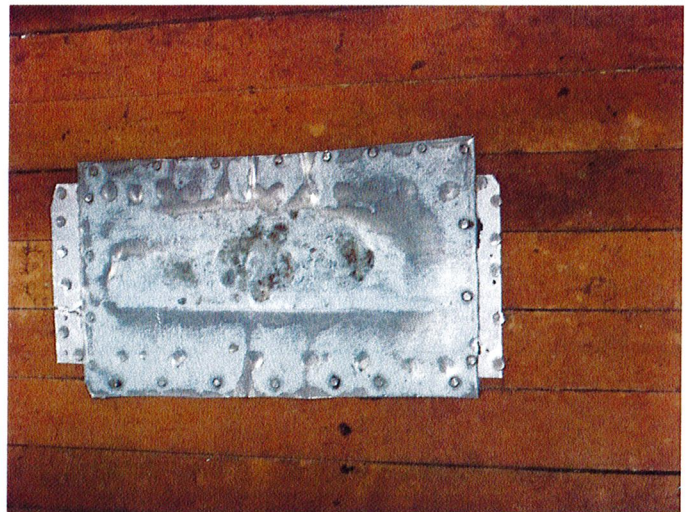
Floor patch is a trip hazard and is not stable.

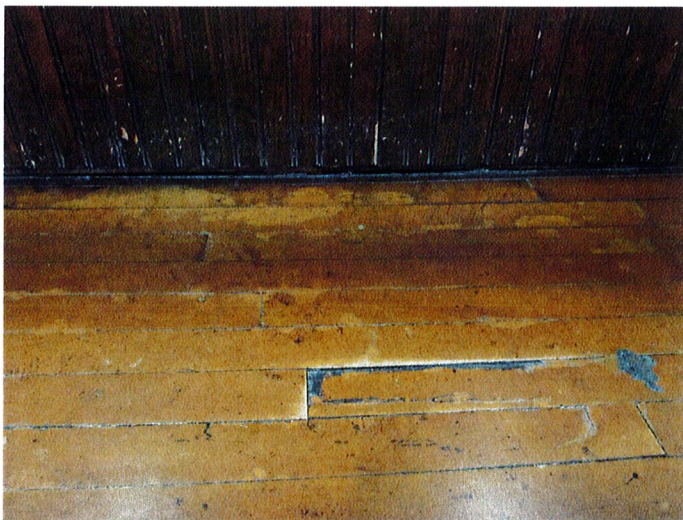
Sinking floor board patch and poor understructure support.

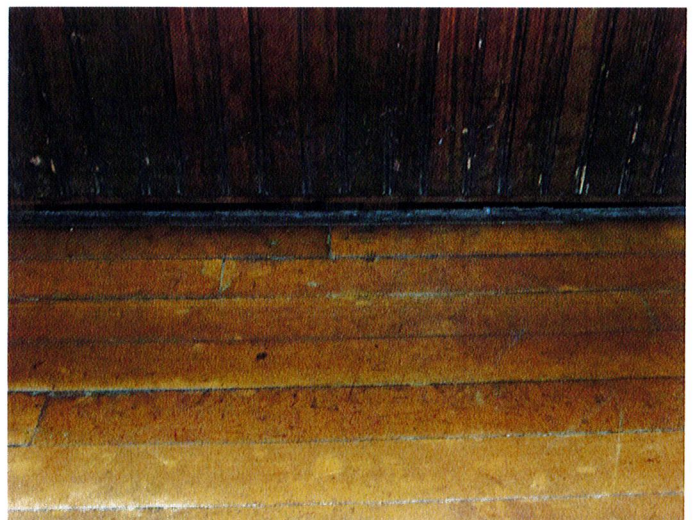
Walkway floor understructure is failing and the floor is sagging.

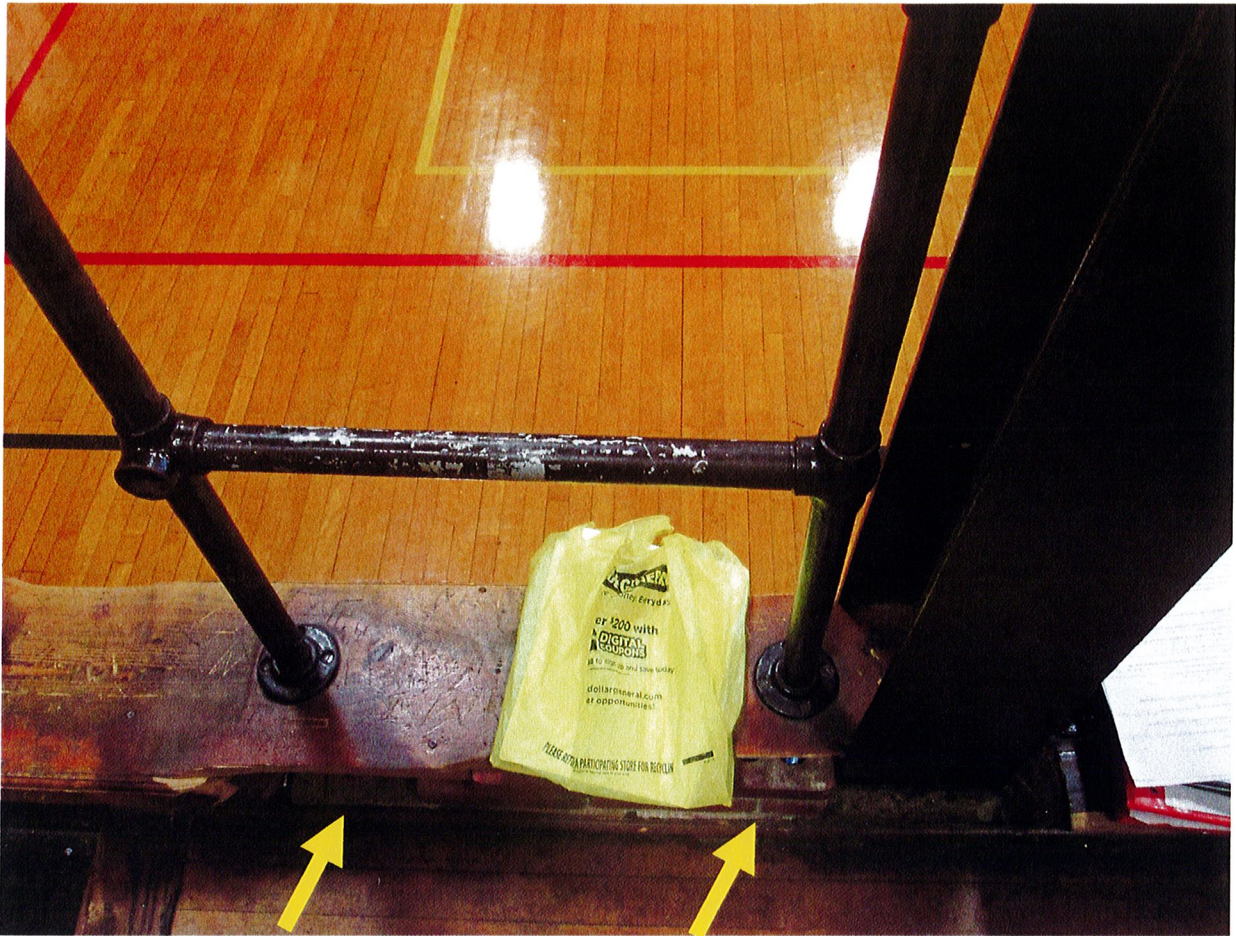
8. The walkway step transition has an intermediate step that creates a depressed section in the walkway. This is an unsafe trip/fall hazard.
9. The front partition at the walkway has a sill plate that is cracked and has exposed sharp wood edges, concrete and bricks which are unsafe. This cap must be repaired and enclosed.

Broken and exposed understructure with sharp edges on wood, bricks and concrete along the front walkway is a safety hazard.
