Seismic Evaluation

Siuslaw School District 97J Lane County, Oregon

January, 2019

January 2019 Project No: G-1182-17

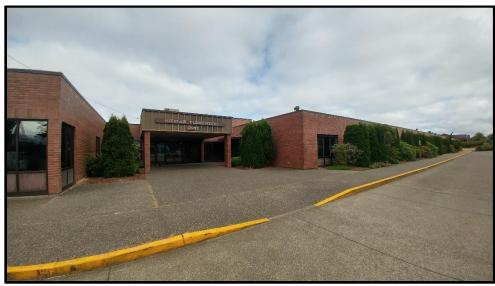
Figure 1: Siuslaw Elementary School

• 1965 Original Classroom Building Area A [PC1/W2]: Seismic Hazard - High

- S1. The roof diaphragms in all buildings are not properly attached to walls for in-plane loading.
- S2. Wood framed shear walls lack adequate shear capacity for prescribed seismic forces
- S3. Wood framed shear walls are not properly attached to the foundation.
- S4. Unblocked plywood diaphragm span exceeds 40 feet.
- S5. The precast concrete tilt up walls and masonry walls are not properly attached to the roof for out-of-plane loading.
- S6. The precast concrete tilt up walls and masonry walls are not properly attached to the roof for in-plane loading.
- S7. Precast concrete tilt up walls are not properly attached to foundation elements for transfer of in-plane forces.
- S8. Connection configuration between diaphragm and wall induces cross-grain bending in wood ledgers.

- S9. Hold down devices are not present to counter over-turning forces at ends of wood framed shear walls.
- S10. The site is located within a high liquefaction risk zone per DOGAMI HAZVU map (further geotechnical evaluation required to determine extent of hazard).

- S3. Provide new anchorage hardware at wood framed shear walls for transfer of seismic forces to foundation elements.
- S4. Provide new interior shear walls at strategic locations and re-nail existing plywood sheathing at roof to provide adequate shear capacity.

- S7. Provide new connection hardware at the bottom of precast concrete tilt up walls to foundation elements for transfer of in-plane forces.
- S8. Provide new out-of-plane connection hardware where wood ledgers are present at concrete tilt-up panels and CMU walls.

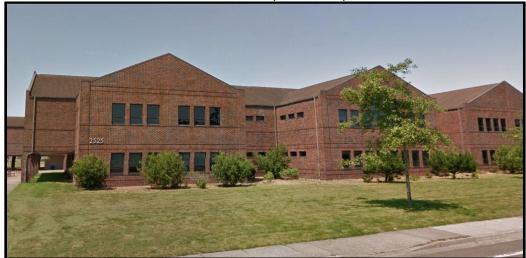
Figure 2: Siuslaw Middle School

• 2000 Original School Building [S1a/PC1]: Seismic Hazard – Low

The gravity resisting system was found to be in good general condition based on the visual observations performed.

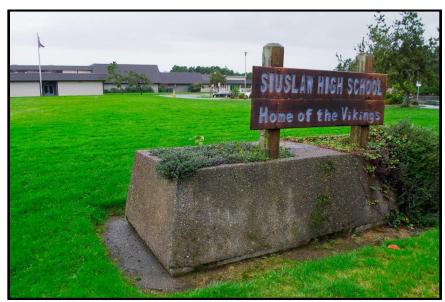
Figure 3: Siuslaw High School

1968 Original School Building [PC1/W2]: Seismic Hazard - High

- S1. The roof diaphragms in all buildings are not properly attached to walls for in-plane loading.
- S2. The precast concrete tilt up walls are not properly attached to the roof and mezzanine framing for out-of-plane loading.
- S3. Areas of partial height concrete tilt-up panel wall with wood framed walls above create a hinge condition.
- S4. Gypsum sheathed wood framed shear walls lack adequate shear capacity for prescribed seismic forces.
- S5. Unblocked plywood diaphragm span exceeds 40 feet.
- S6. Hold down devices are not present to counter over-turning forces at ends of wood framed shear walls.
- S7. Wood framed shear walls are not properly attached to the foundation.
- S8. The site is located within a high liquefaction risk zone per DOGAMI HAZVU map (further geotechnical evaluation required to determine extent of hazard).

- S3. At partial height concrete tilt-up panels provide new steel columns and out-of-plane connection hardware to resolve hinge condition.
- S4. Provide new plywood sheathing at strategic gypsum sheathed shear walls to provide adequate in-plane shear capacity.

- S5. Provide new plywood shear walls at strategic locations to reduce diaphragm span and re-nail existing roof and mezzanine diaphragm sheathing.
- S6. Provide new hold down devices at ends of new shear walls for transfer of overturning forces to foundation elements.
