Limited Asbestos Survey Report

**W.D. WILLIAMS ELEMENTARY SCHOOL
ROOF SURVEY
161 BEE TREE ROAD
SWANNANOVA, NORTH CAROLINA**

August 31, 2017

Terracon Project No. 86177171

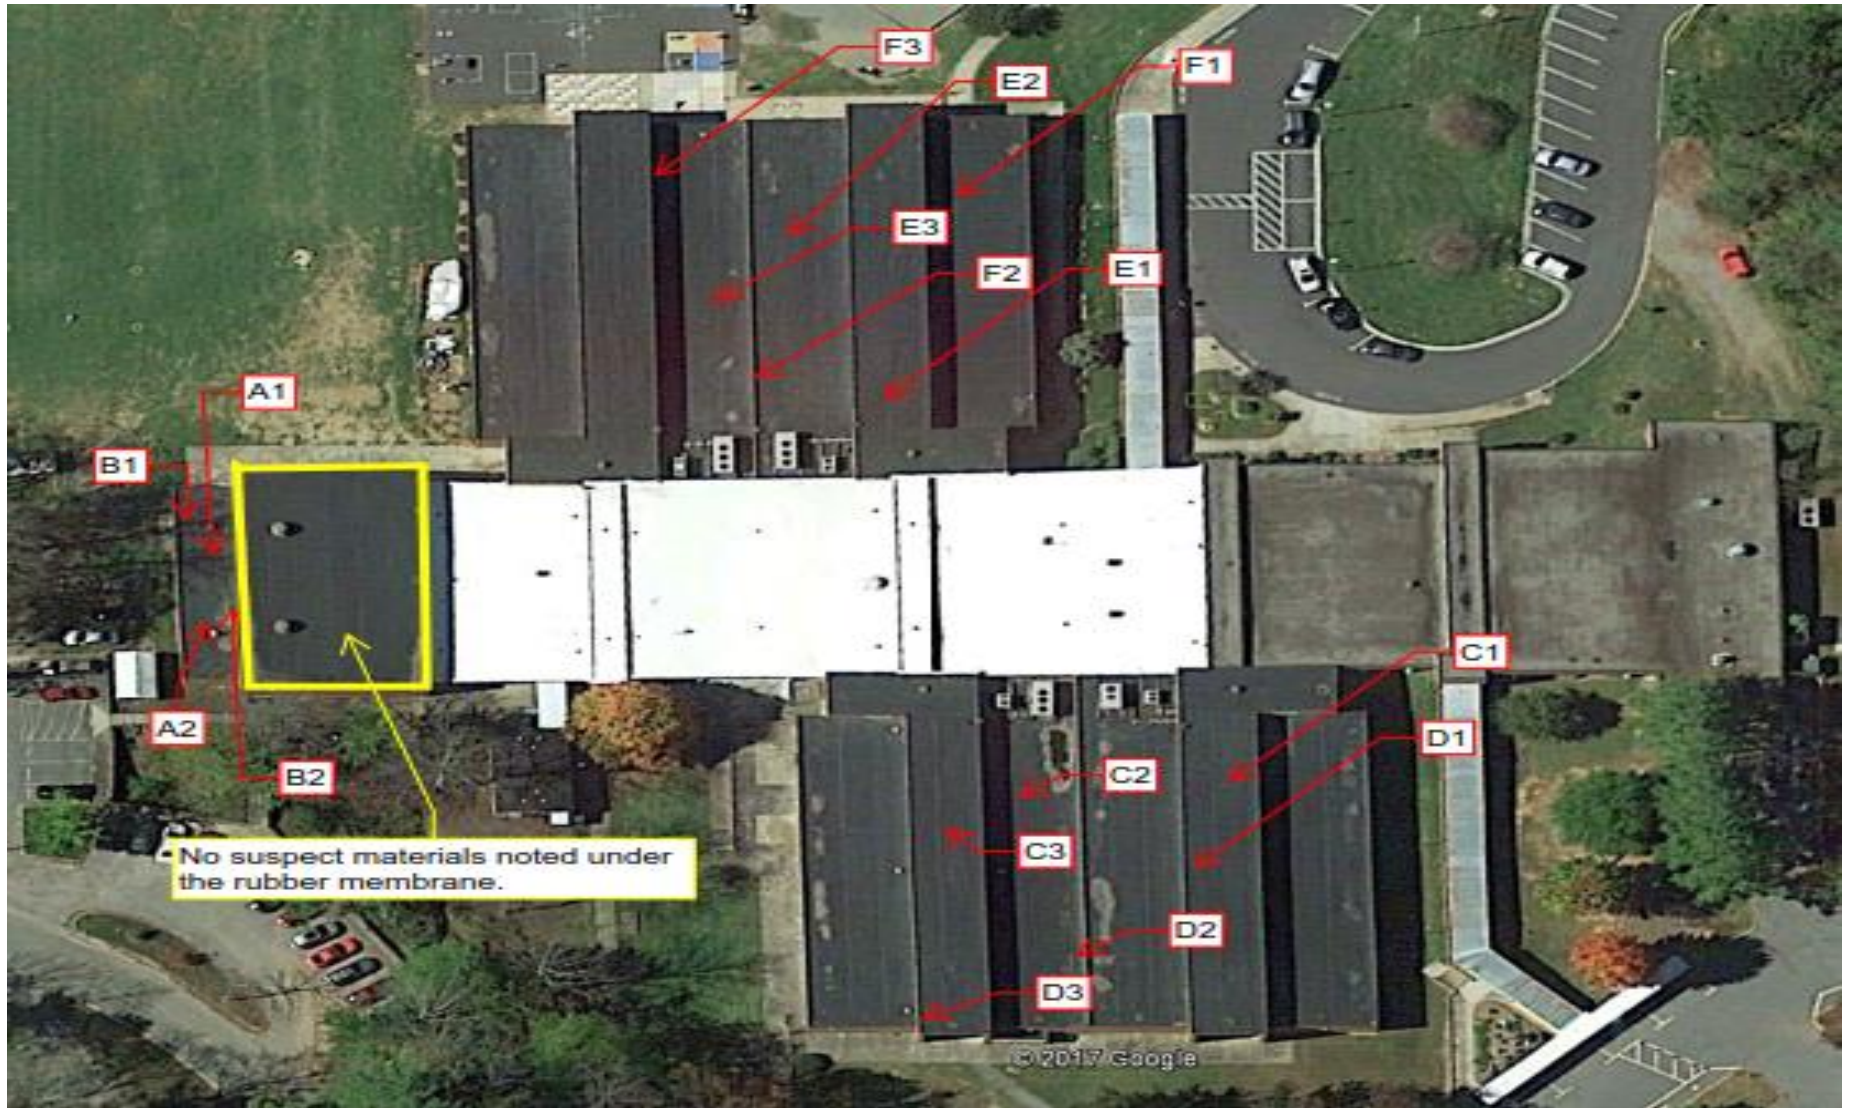
APPENDIX A
FIGURE 1

A total of sixteen (16) bulk samples were collected from the roof areas. A general layout of the roof systems with sample locations are included as Figure 1 in Appendix A. Sample descriptions, locations, analytical results, classification and estimated quantities are summarized in Table 1 in Appendix B. Asbestos laboratory analytical reports are included in Appendix C and photographs are provided in Appendix E.

Sample locations are approximated.

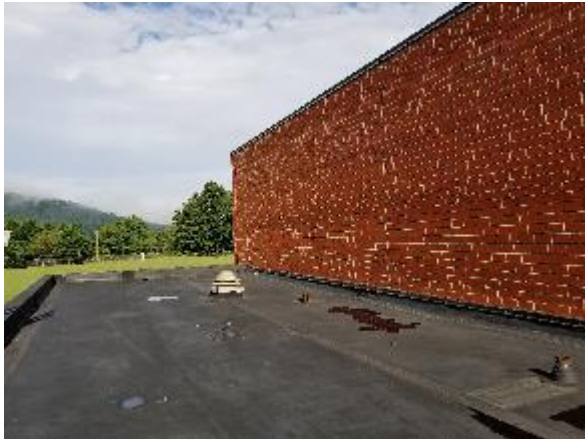
Photo #1 View of the roof over the locker room.

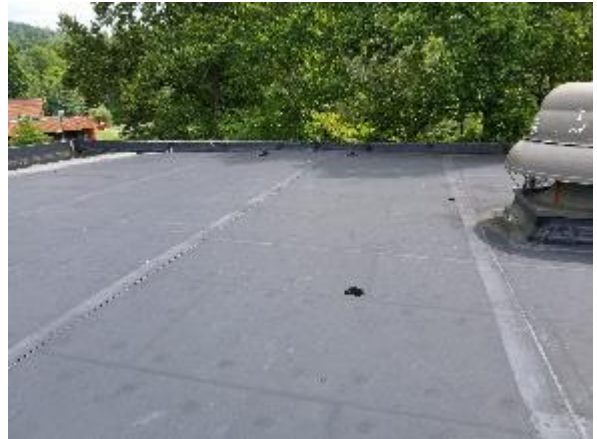
The high bay gym roof is a sloped roof with a rubber membrane over wood fiber board and a Tectum® backer board that covers approximately 5,100 SF. It was noted that no suspect materials were observed on the high bay gym roof at the time of this survey.

Photo #2 View of the roof over the high bay gym.

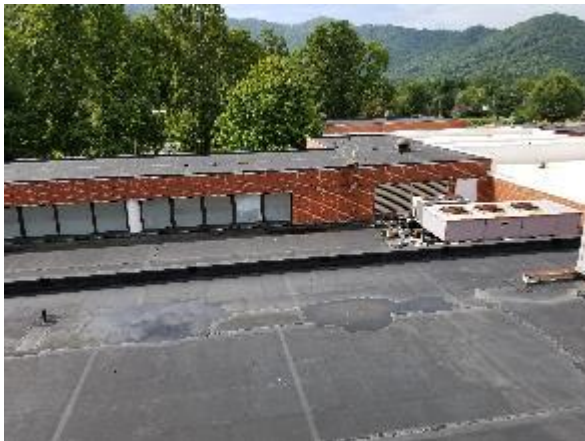
Photo #3 View of the roof system over the eastern portion of the building.

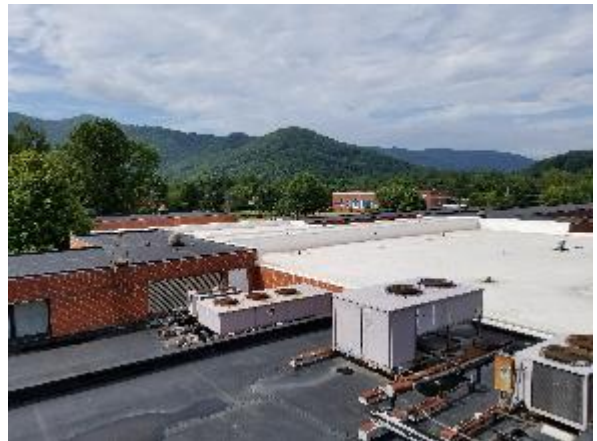
Photo #4 View of the center roof section (not in scope) and the western roof sections.

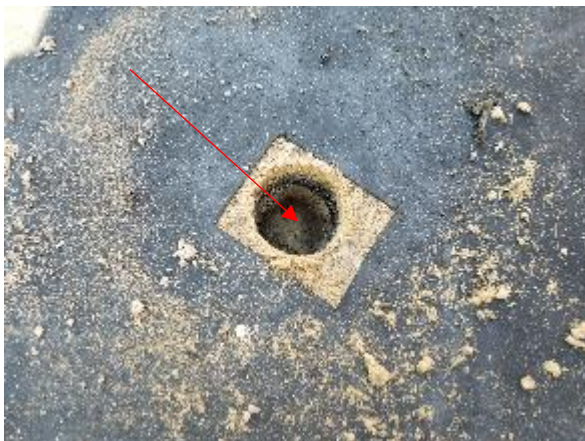
| Sample Number | Analysis Method | Analytical Results | Sample Description | Sample Description | Homogeneous Area | Classification | Friable / Non-Friable | Current Condition | Potential for Disturbance | Estimated Quantity |
|---|---|---|---|--|---|---|---|---|---|---|
| A1 | PLM | NAD | Locker Room Roof | Built-Up Roofing under a Rubber Membrane | A | Miscellaneous | Non-Friable | Good | LPD | 1,450 SF |

Photo #5 View of built-up roofing (HA-A) on the locker room roof.

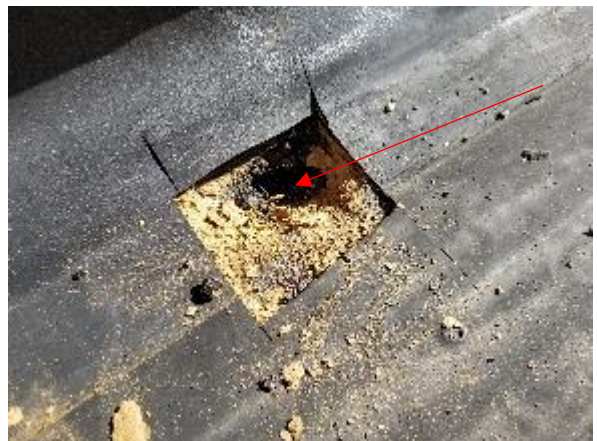
| Sample Number | Analysis Method | Analytical Results | Sample Description | Sample Description | Homogeneous Area | Classification | Friable / Non-Friable | Current Condition | Potential for Disturbance | Estimated Quantity |
|---|---|---|---|--|---|---|---|---|---|---|
| B1 | PLM | NAD | Locker Room Roof | Wall Flashing under a Rubber Membrane | B | Miscellaneous | Non-Friable | Good | LPD | 290 SF |

Photo #6 View of wall flashing (HA-B) on the locker room roof.

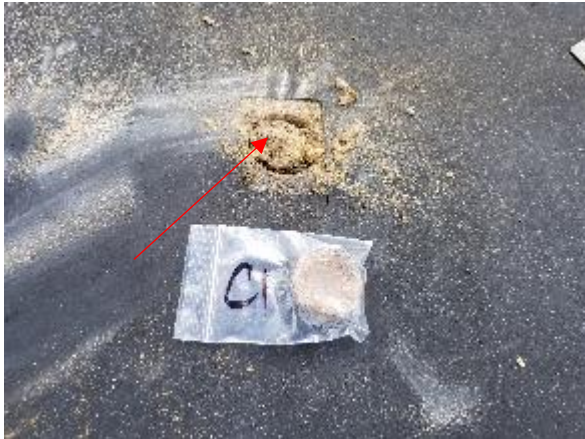
- Built-up roofing (20% chrysotile) on the eastern rubberized roof sections;
- Wall Flashing (10% chrysotile) on the eastern rubberized roof sections;
- Built-up roofing (10% chrysotile) on the western rubberized roof sections; and,
- Wall Flashing (10% chrysotile) on the western rubberized roof sections.

| Sample Number | Analysis Method | Analytical Results | Sample Description | Sample Description | Homogeneous Area | Classification | Friable / Non-Friable | Current Condition | Potential for Disturbance | Estimated Quantity |
|---|---|---|---|--|---|---|---|---|---|---|
| C1 | PLM | 20% Chrysotile | Eastern Rubberized Roof Sections | Built-Up Roofing under a Rubber Membrane | C | Miscellaneous | Category I Non-Friable | Good | LPD | 23,875 SF |
| E1 | PLM | 10% Chrysotile | Western Rubberized Roof Sections | Built-Up Roofing under a Rubber Membrane | E | Miscellaneous | Category I Non-Friable | Good | LPD | 23,875 SF |

Photo #7 View of built-up roofing (HA-C, same as HA-E) on the eastern roof sections.

Terracon recommends the identified ACM (materials containing greater than 1% asbestos) be removed prior to disturbance by a North Carolina licensed asbestos contractor in accordance with 10A NCAC 41C.0600 and applicable OSHA regulations.

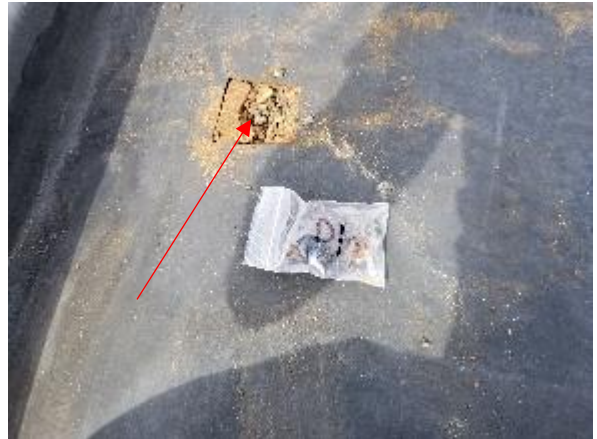
| Sample Number | Analysis Method | Analytical Results | Sample Description | Sample Description | Homogeneous Area | Classification | Friable / Non-Friable | Current Condition | Potential for Disturbance | Estimated Quantity |
|---|---|---|---|--|---|---|---|---|---|---|
| D1 | PLM | 10% Chrysotile | Eastern Rubberized Roof Sections | Wall Flashing under a Rubber Membrane | D | Miscellaneous | Category I Non-Friable | Good | LPD | 3,150 SF |
| F1 | PLM | 10% Chrysotile | Western Rubberized Roof Sections | Wall Flashing under a Rubber Membrane | F | Miscellaneous | Category I Non-Friable | Good | LPD | 3,150 SF |

Photo #8 View of built-up roofing (HA-D, same as HA-F) on the eastern roof sections.

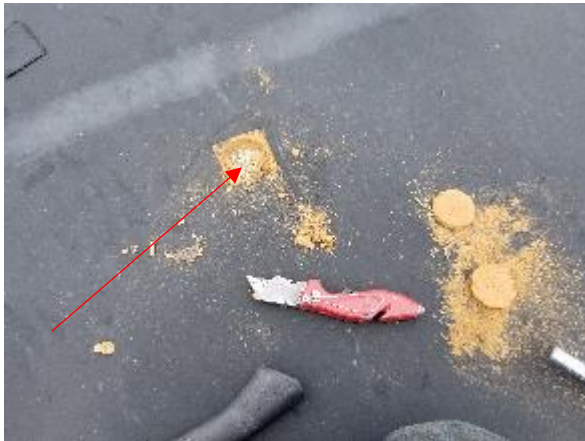
Photo #9 View of non-suspect roof materials (wood-fiber insulation and Tectum®) on the high-bay gym roof.
