RSU #1
MORSE HIGH SCHOOL STUDY
Bath, Maine
PROJECT No. 13558

May 6, 2013

FINAL DRAFT

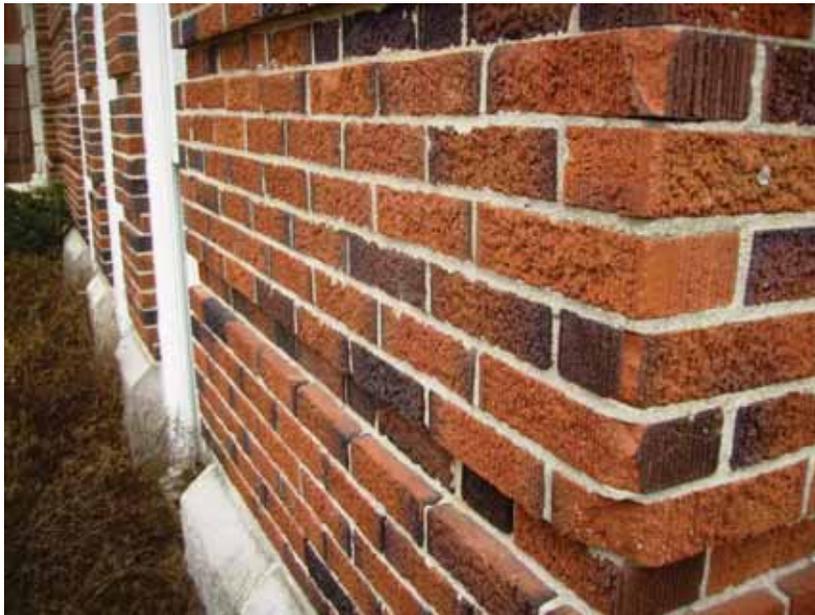
The original 1928 building was constructed of brick that has a high level of porosity leading to moisture migration through the wall and plaster deterioration and efflorescence on interior walls. S.W. Cole has performed a funnel test on the brick and demonstrated that the wall readily absorbs moisture. In order to prevent continual migration of moisture through the walls, sealing the

Exterior brickwork, 1928 building.

brickwork on the original building needs to be part of a periodic maintenance program, with resealing occurring approximately every two years. The interior walls, in particular around some exterior windows, need to be patched and painted.

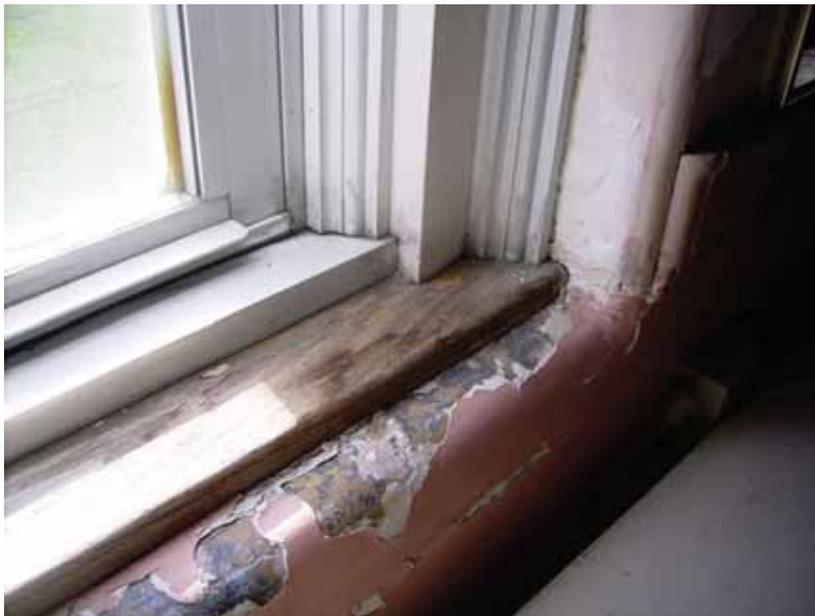
Moisture damage at interior window.

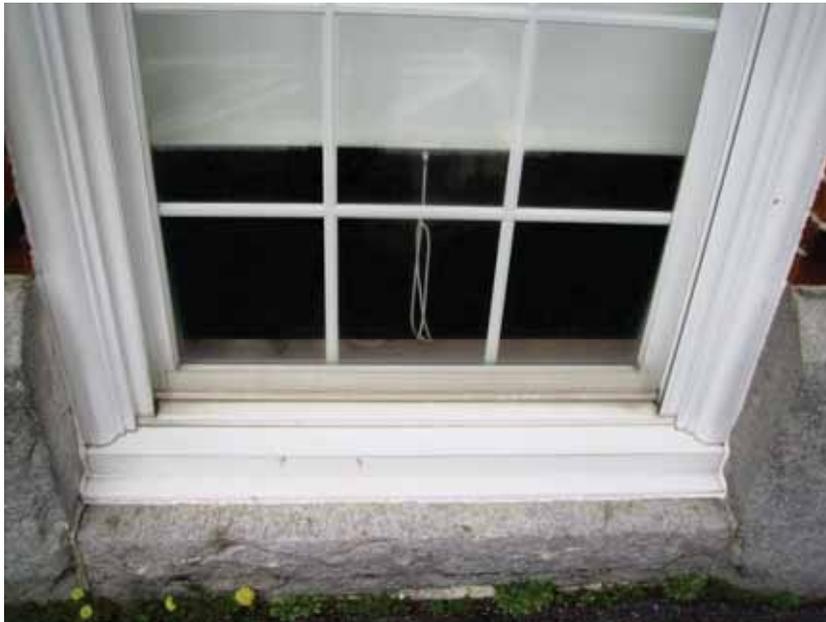
Vinyl replacement windows in the original building are compromised and not sealing well, resulting in energy loss and also contributing to moisture issues at the interior surfaces around windows. The 172 windows in the original building should be replaced in the near future.

Vinyl window at 1928 building.

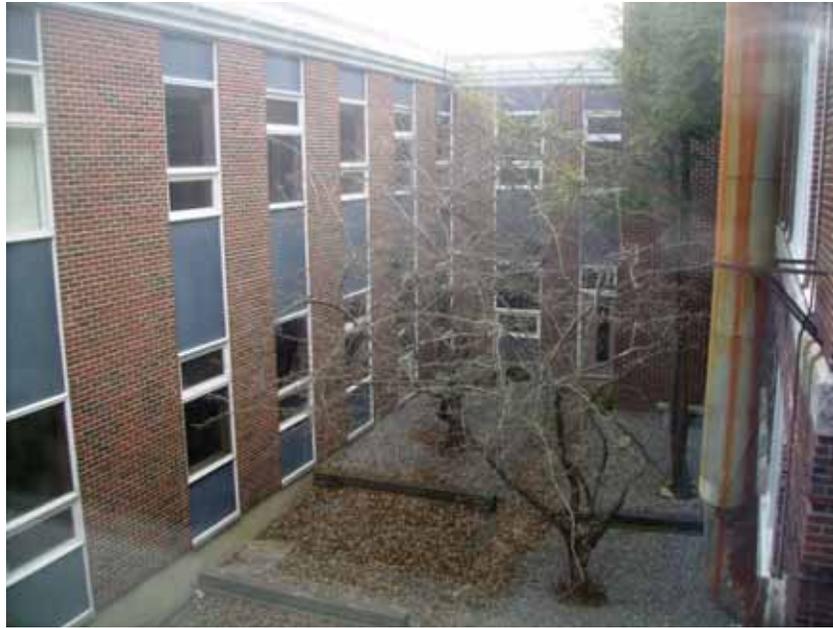
The fiberglass fascia panels that were installed as part of the 1968 addition have periodically loosened and fallen off the façade. Many have been replaced. There are still a number of them needing replacement, primarily in the courtyard area.

Blue fiberglass panels at interior courtyard.

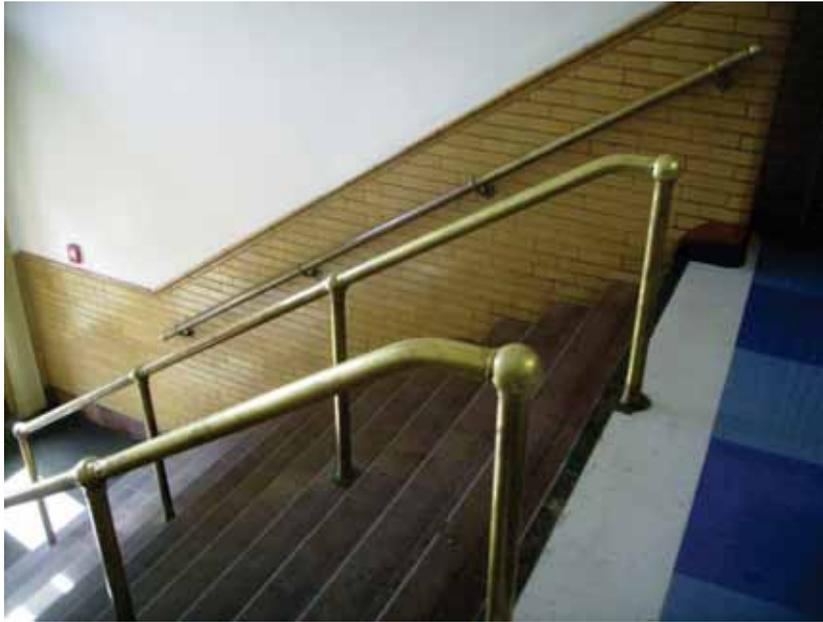
Stairs in many areas do not meet current codes or accessibility requirements, such as tread and riser dimensions, guardrails, handrails and fire separation for egress stairs. The only portion with a sprinkler system is the 1995 addition. Elevators allow access to all levels except the 1928 building

Stairs and rails at original main entrance, 1928 building.

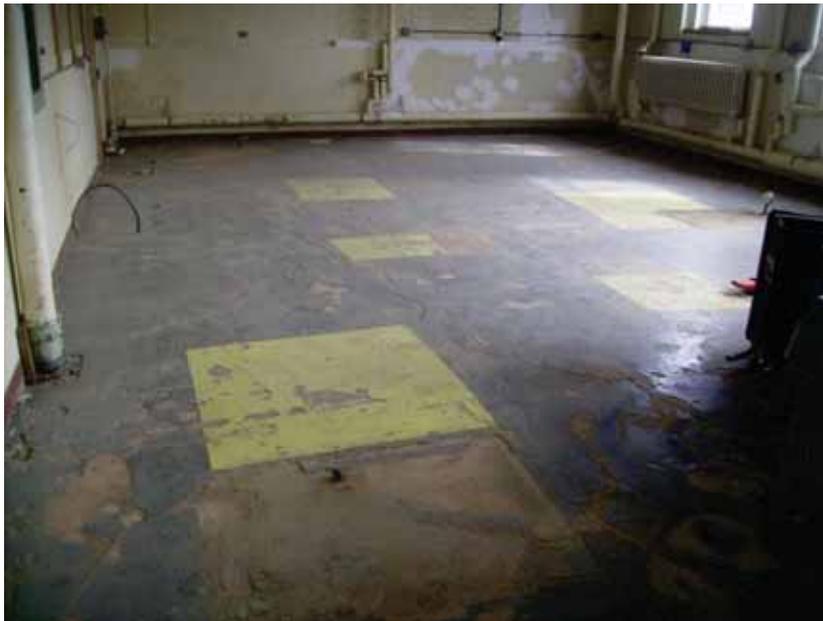
Carpentry shop on ground level with uneven floor slab

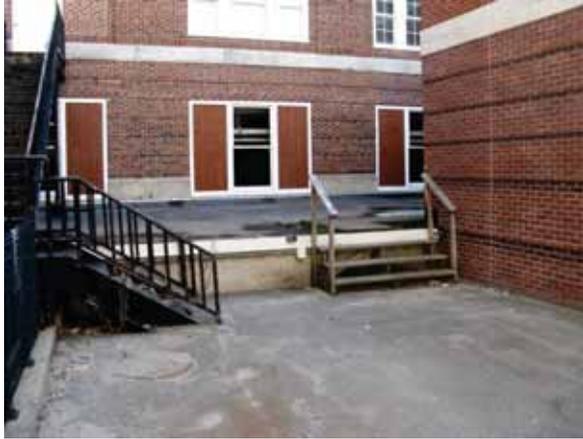
Photo 1 - Boiler Room Roof

The roof over the existing Boiler Room (Photo 1) is surrounded by adjacent higher roof on three sides. Per the current building code requirements, this roof should be able to support substantial amounts of drifting snow. The drift provisions in the building codes only date back to the mid-1970's. The roof structure over the Boiler Room appears to date back to the original building construction, long before the mid-1970's.

It is not clear from the available data that the roof over the Boiler Room has ever been reviewed to ensure that it has sufficient capacity to support the modern building code snow load provisions, including those related to drifting snow. Our recommendation is that this roof should be reviewed to see if it has adequate capacity. We cannot know till such a study is performed, but it is likely that this roof will be found to be inadequate.

We have carried an allowance of \$25,000 in this report to upgrade this roof structure. This figure represents a guess on our part, and will need to be adjusted based on the study results. Upgrading, or replacing, this roof structure may be disruptive to the school environment, as it is likely that there are many items (pipes, ducts, etc.) that are suspended from these joists that may need to be removed, or temporarily supported, while the reinforcing activities are performed.

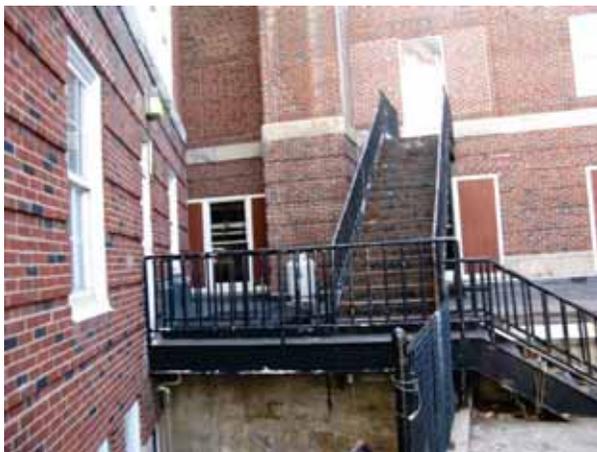
Photo 2 - Exterior Steel Stair

There is an outdoor stair off to one side of the Boiler Room roof (Photo 2) that shows significant signs of rusting. Some repair work has been attempted for areas of the stair railing system. It is likely that this stair will need to be replaced in the near future. We recommend carrying an allowance of \$20,000 for the replacement of this stair.

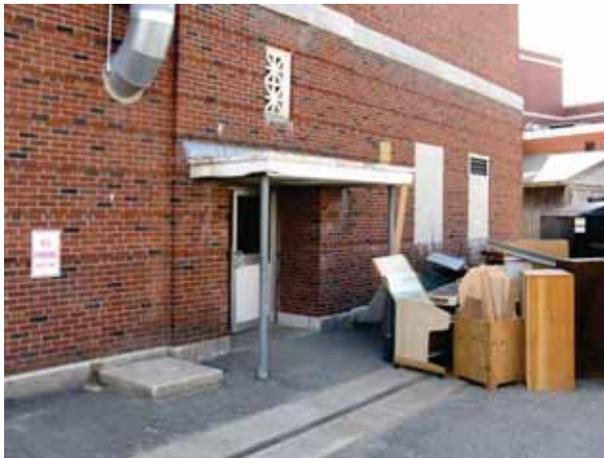
Photo 3 - Covered Entry Roof

There is a covered roof at an entry over a back door to the school facility (Photo 3). This roof shows significant signs of degradation from exposure, and perhaps from snow falling on it from the adjacent high roof. It is likely that this roof will need to be removed, or replaced in the near future. We recommend carrying an allowance of \$5,000 for the replacement of this roof.

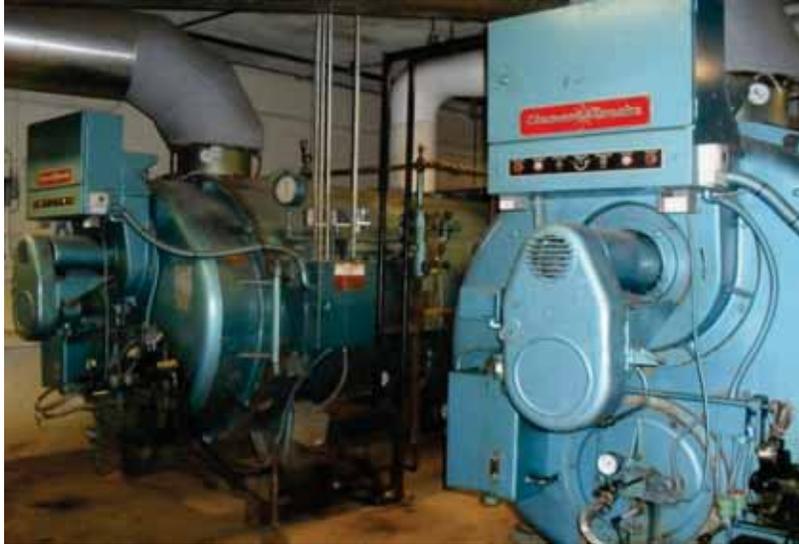
Figure 1 - Existing Steam Boilers

The main boiler room houses two Cleaver Brooks, fire tube low pressure steam boilers. The boiler model numbers are CB-101-150. The input capacity of each of these boilers is 6,277 mbh. The number 2 oil fired boilers are 27 years old. They were re-tubed six or seven years ago. This re-tubing process is common to be performed on boilers of their age. As long as they are properly maintained and treated it should allow the boilers to provide dependable service for many years to come. Low pressure steam boilers are required to be opened up on both the fire side and the water side annually. They need to be blown down on a regular basis and require boiler feed water chemical treatment to extend the life of the boiler and minimize the effect of oxygen in the fill water. The boilers are fed with number 2 fuel oil from an above ground 8,000 gallon steel oil tank. The tank is located in a building above and adjacent to the boiler room. Oil is drawn directly from the storage tank to each oil burner by dedicated oil pumps mounted on each individual boiler.

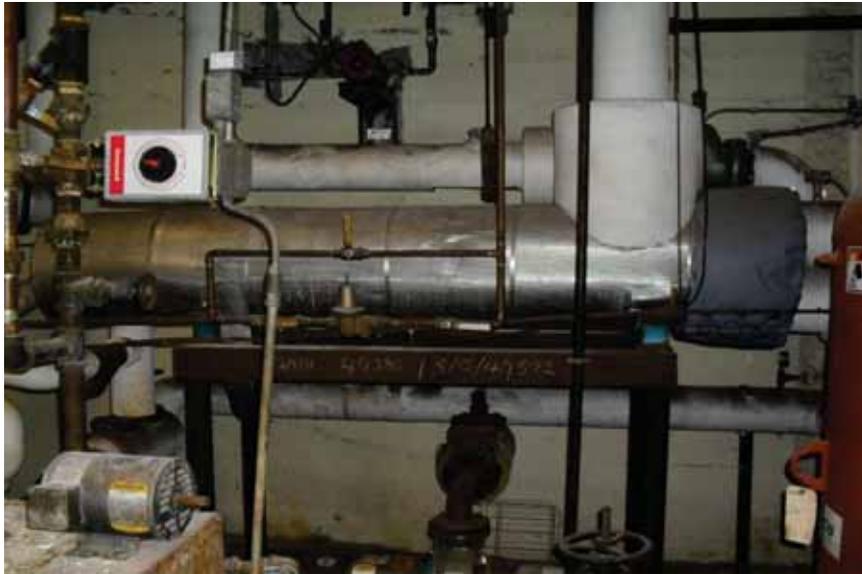
Figure 2 – Steam to Water Heat Exchanger

The low pressure steam to hot water heat exchanger which feeds heating hot water to the 1968 wing is original to the construction of this addition. It is controlled by a 1/3 – 2/3 steam control valve arrangement. The two base mounted pumps also appear to be original to the 1968 addition. These pumps are constant volume pumps that are simply on or off depending on system demand.

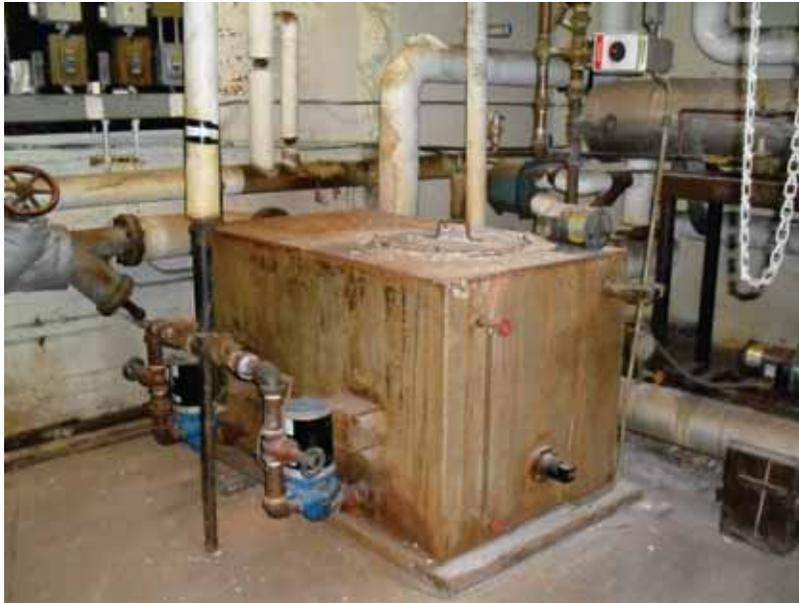
Figure 4 - Original Condensate Receiver Tank/Pumps

The original steel condensate receiver tank is currently in use. However, the condensate pumps have been replaced within the past several years and are in good condition. The tank is currently un-insulated and releases a significant amount of heat into the boiler room.

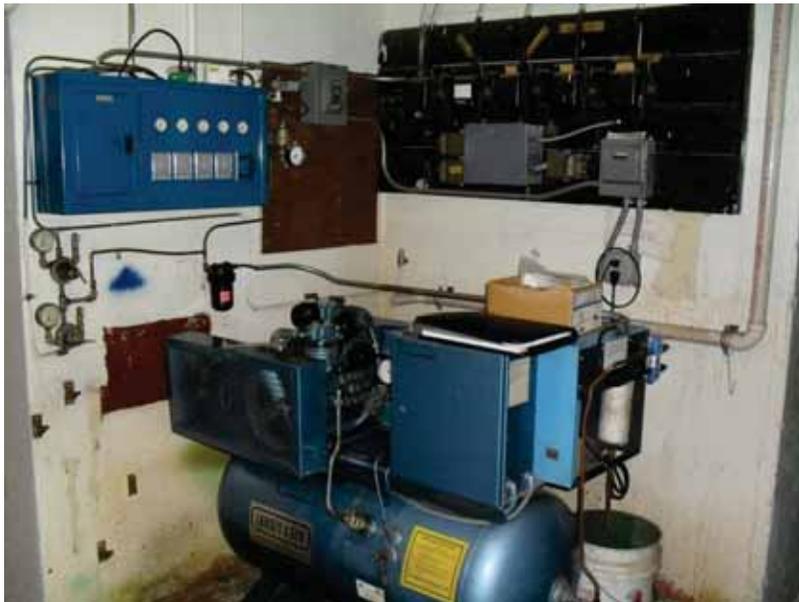
Figure 5 - Temperature Controls Air Compressor and Central Control Panel

The temperature controls pneumatic air compressor appears to be relatively new and is in good shape. It is difficult, however, to determine the condition of the thousands of feet of existing pneumatic tubing that currently runs throughout the facility. As with all pneumatic control systems

that remain in use today, we recommend they be replaced with state of the art Direct Digital Control (DDC) systems as soon as possible and as funding allows.

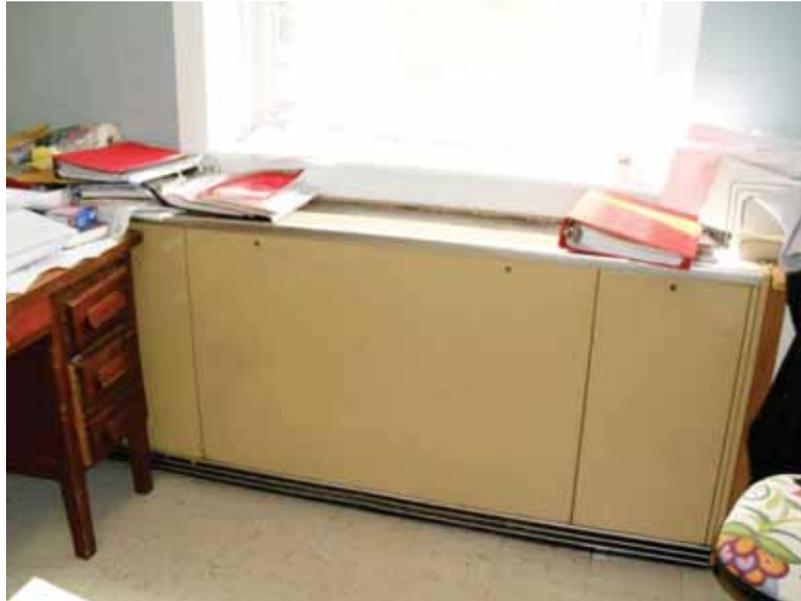
Figure 6- Typical Classroom Unit Ventilator

The unit ventilator indicated above is one of three different age vintages located throughout the facility. This type is original to the 1968 building. There are a few significantly older types UV's and a number of UV's that are newer than the one shown. All of the newest units appear to be in good condition. The unit types shown appear to be in fair condition and the original UV's are well past their expected life span and should be considered for replacement.

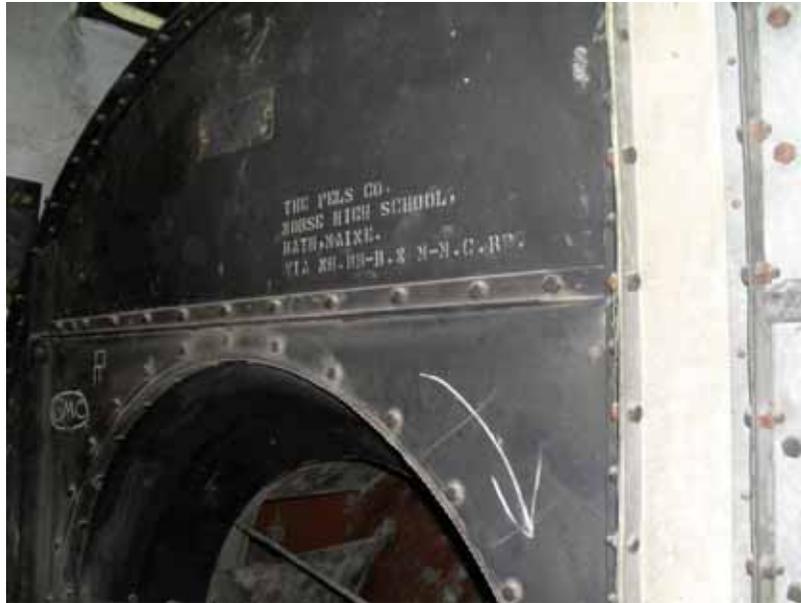
Figure 7 - Ventilation Fan Serving Auditorium

The auditorium ventilation is provided by a large single backward curved centrifugal fan located in a plenum room above the stage area. Within the plenum located on the return wall is a large steam coil that actually heats the air coming back to the fan room. The air is then drawn in through the inlet bell of the fan, then distributed to the space below. The coil is not protected with adequate filtration. This fan appears to be an original mechanical component of the building's construction. The current arrangement of this fan causes significant concern for safety of the individuals who have access to this room. The fan has no inlet guard or fan belt guards in place. The wall mounted steam coil is also completely exposed within the room and poses a risk for burns, as it has no protective guard around it.

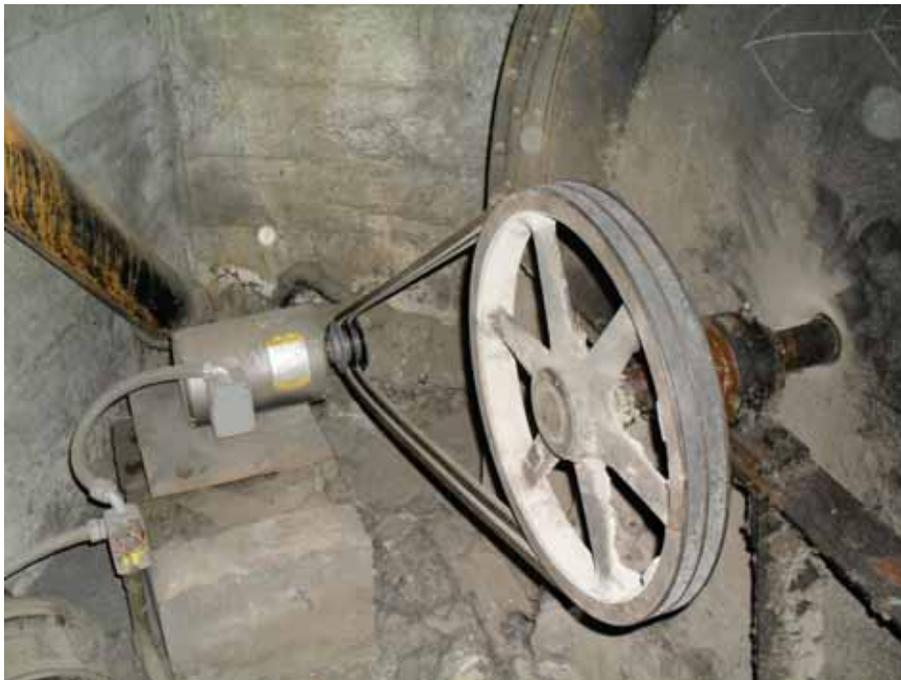
Figure 9 - Unprotected Fan Belt/Pulley

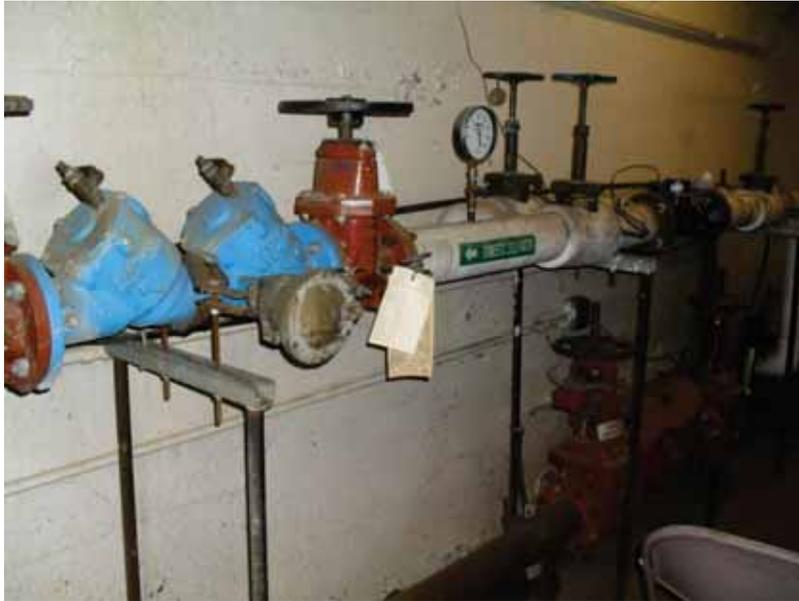
Figure 10 - Main Water Entrance

The 4 inch primary water entrance is located in the boiler room. It is separated from the 4 inch sprinkler entrance which is located within a foot or so. The water entrance is provided with a double backflow preventer and a 2 inch electronic water meter. From indications on the pressure gauge located upstream of the double backflow preventer, it appears that entering water pressures are running approximately 75 psig.

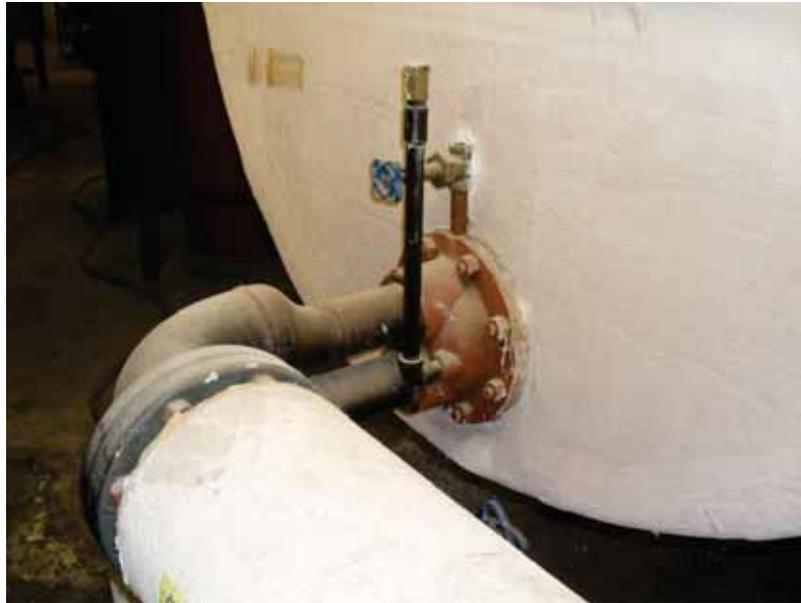
Figure 12 - Domestic Hot Water Tank Boiler Piping

The domestic hot water for the facility is provided by the primary boilers feeding a 1,800 gallon storage tank equipped with an indirect coil inserted in the bottom of the tank as indicated in Figure 12. This tank was installed in 1995 and appears to be in good condition.

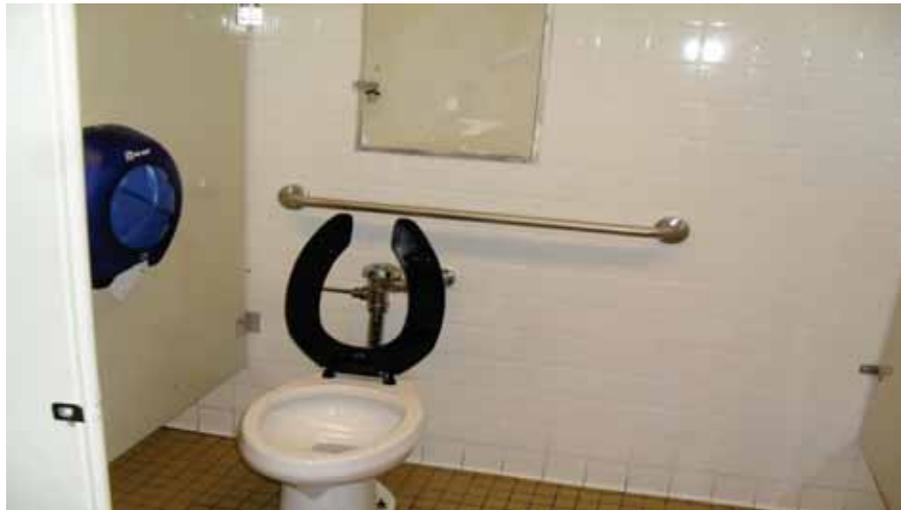
Figure 13 - Typical Floor Mounted Water Closet

It appears that most of the plumbing fixtures are original to their respective building additions. None of the water closets or urinals are low flow fixtures, however, it is reported that a majority of the flush valves have been replaced within the last several years. Other than the fact that the fixtures are not of the low flow design type, they appear to be in good condition.

The water closets and urinals currently serving the facility are not currently low water volume flushing fixtures. Even though a significant number of the flush-o-meters have been replaced, the fixtures remain high water volume fixtures. We would recommend replacing all of the water closets and urinals with low flush fixtures. Just one existing water closet, if replaced, would go from using over 3 gallons per flush to 1.6 gallons per flush. Urinals would go from over 1 gallon per flush to 1/2 gallon or less per flush. Seeing this significant water consumption difference in just one fixture indicates the potential for high levels of water conservation, if this recommendation is implemented. Our opinion of probable costs for the fixture replacements would be approximately \$1,500 per fixture. Flush-o-meters for water closets and urinals that were replaced within the past three or four years can be reused. However, they would need to be retrofitted with new replacement diaphragm kits to match the fixtures' lower flow rates.

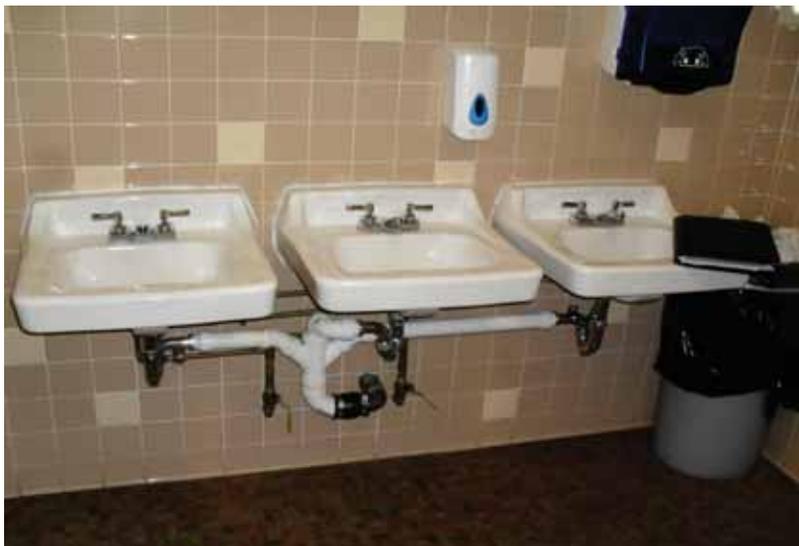
Figure 15 - Typical Lavatory Bank

Wall hung lavatories appear to be original to the building additions in which they were installed. Faucets are lever type and are not of low flow design. They appear in relatively good shape, although most do not meet the ADA requirements.

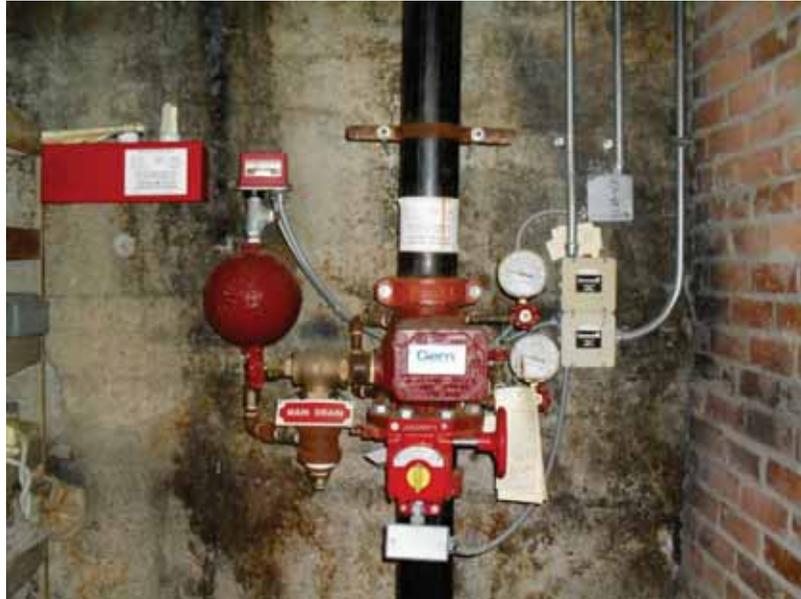
Figure 16 - Sprinkler Entrance

The building has a relatively up to date wet sprinkler system installed throughout. The entrance size is 4 inch. The system is maintained by Eastern Fire of Auburn, Maine. All inspections appear to be current and intact.

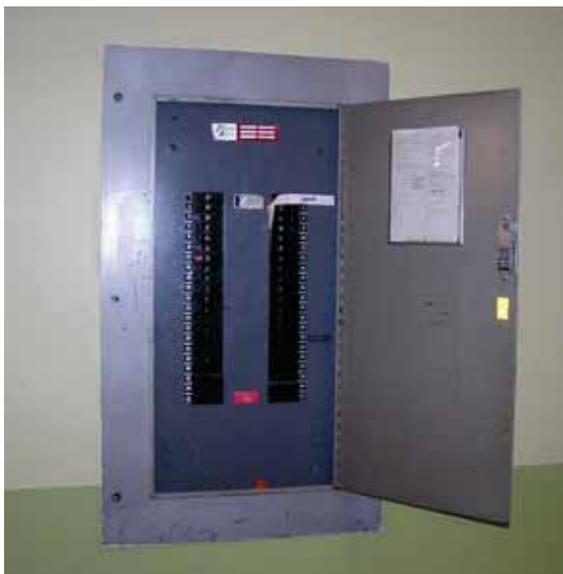
Typical Frank Adam Branch Panel

The branch panels are a mixture of manufacturers. Frank Adam, General Electric, and Siemens were all observed in the building. The Frank Adam panels appear original to the building. Several of the Frank Adam panels have been gutted and replaced with Siemens internal components. There is a lack of spare branch circuit breakers in the Frank Adam panelboards. Parts are difficult if not impossible to obtain since the panels are no longer manufactured. There are numerous extension cords used in the classrooms some with plug strips.

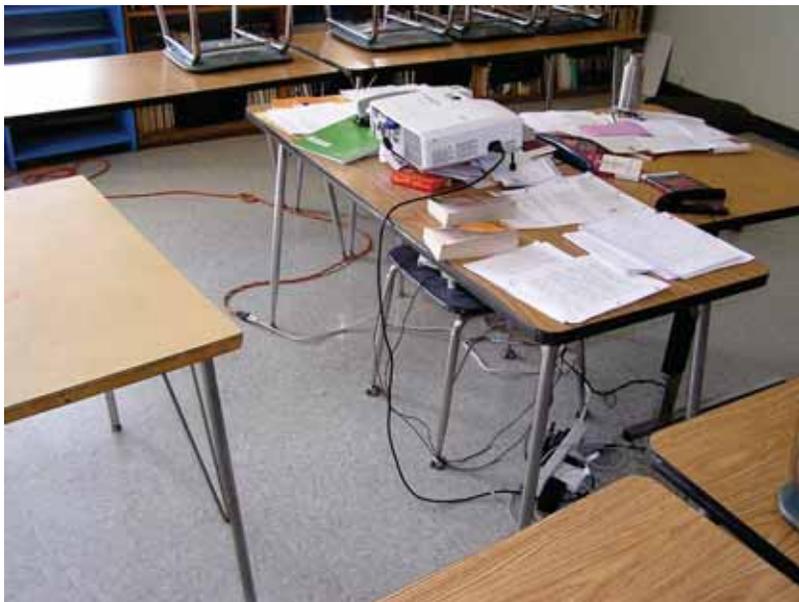
Extension Cord Used as Permanent Power

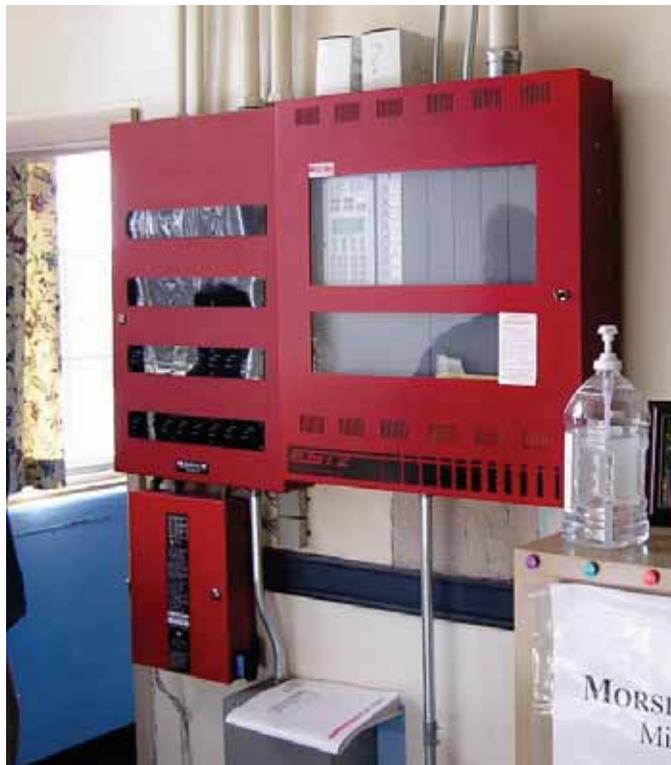
Fire Alarm Control Panel

The fire alarm system is an EST Panel serviced by R.B.Allen. The control panel was installed around 2006 with upgrade to EST devices and appliance a couple of years later, around 2008. Strobes were installed in bathrooms, corridors, gymnasiums, and the auditorium. The gymnasiums and the auditorium do not have voice notification. The auditorium seats about 700 people. The classrooms do not have strobes. Many of the pullstations have been lowered to ADA height. Several pullstations in the original building are mounted above the chair rail at 56.5 inches above finished floor.

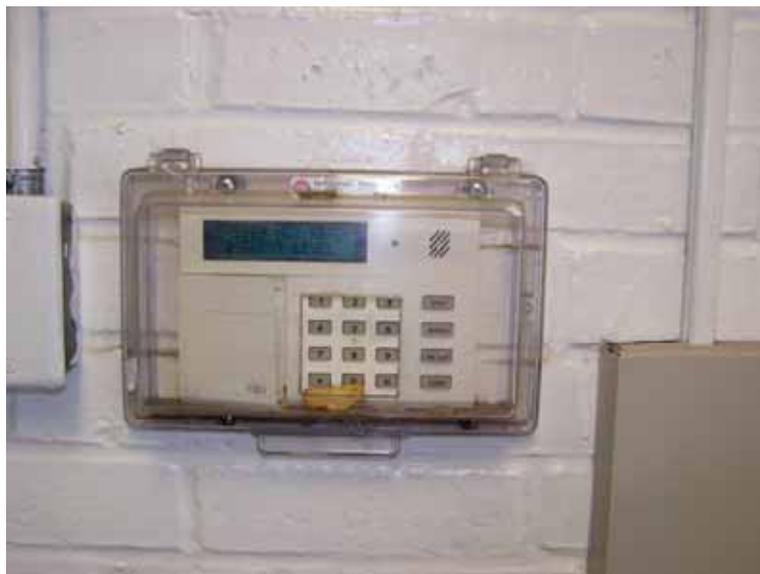
IDS Keypad

The IDS system has been reported as not functional. Windows are sometimes left open. There have been many brass keys handed out that have not been returned.
