DATE: January 8, 2020
FROM: Roger Raymond, Facilities Manager
SUBJECT: Indoor Air Quality Assessment – December 2019

INDOOR AIR QUALITY ASSESSMENT

**Sutton Elementary School
407 Boston Road
Sutton, Massachusetts**

Prepared by:
Massachusetts Department of Public Health
Bureau of Environmental Health
Indoor Air Quality Program
December 2019

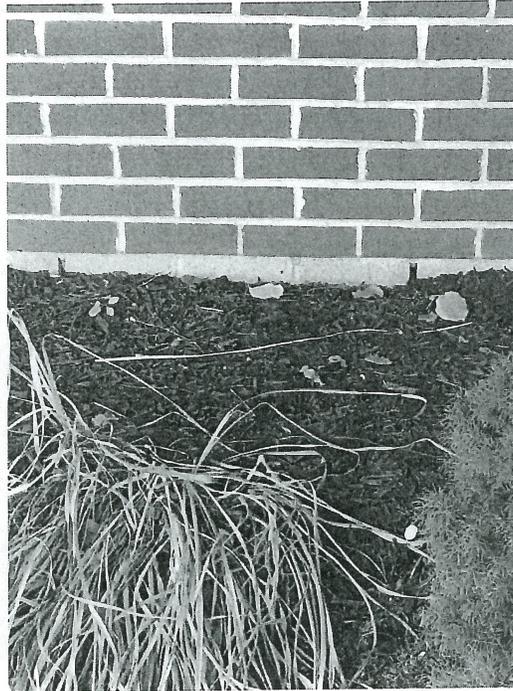
Picture 1

Mulch against exterior walls, burying weep holes

RESPONSE: The leaves/debris and mulch will be removed from the weep holes on the building.

10. Clear accumulated leaves/debris and mulch from weep holes/against building.
11. Repoint brickwork as needed.
12. Repair/replace sealant for wall joints.

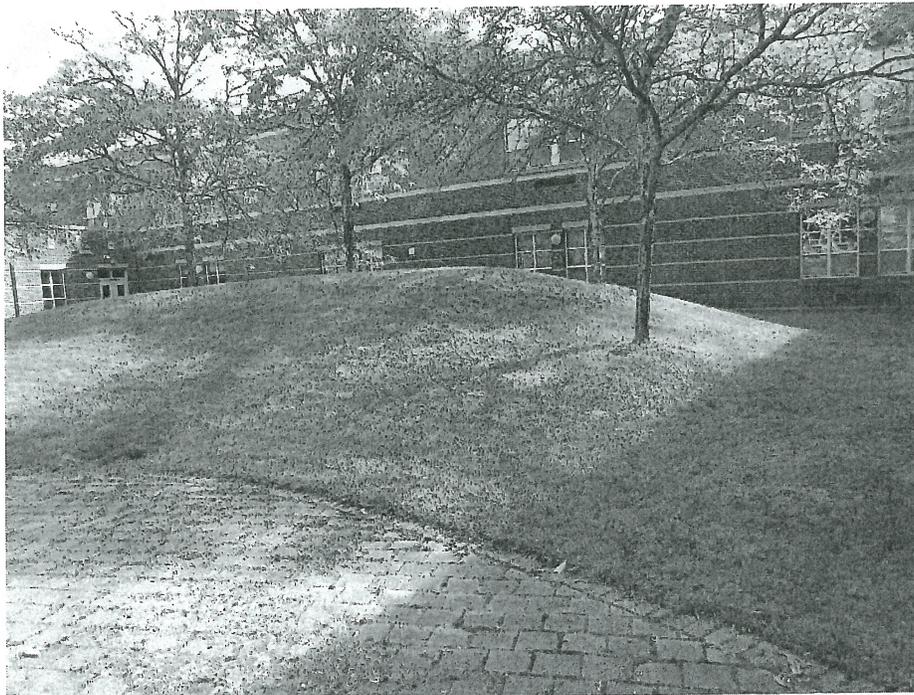
Picture 2

Hill topped by trees in courtyard

1. Consider completely removing trees from the enclosed courtyard.

2. Examine the feasibility of removing the hill in the enclosed courtyard and re-grading the soils to form a bowl-like configuration to promote water drainage away from exterior courtyard walls.

RESPONSE: The school is presently looking at getting a quote to remove the courtyard hill.

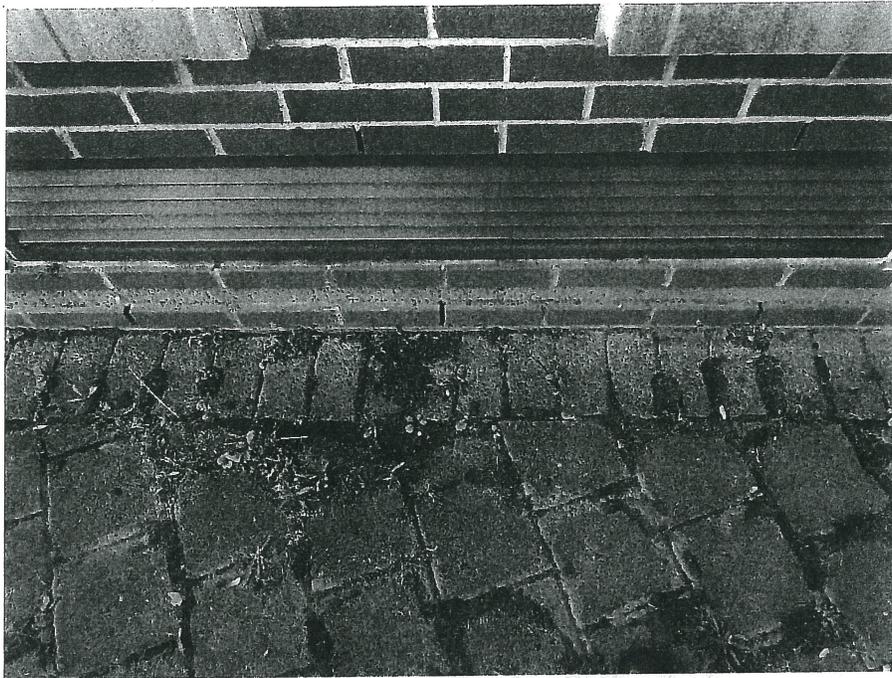
Picture 3

Moss growth indicates heavy and chronic dampening of brick and soil (Note univent fresh air intake above dampened area)

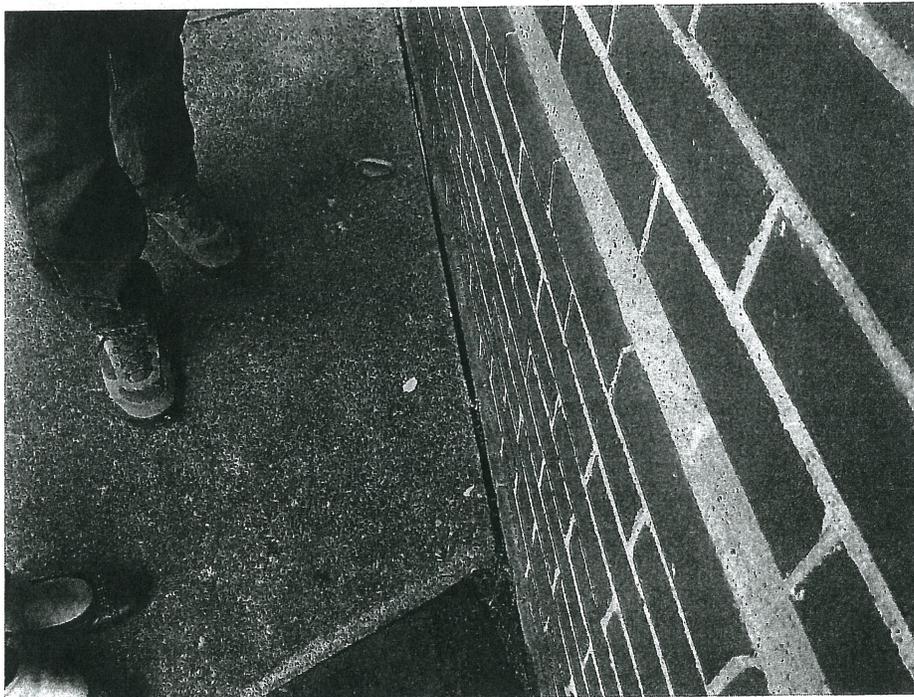
Picture 4

Areas of wall in the courtyard appear to be missing sealant (Picture 4). Sealant is used to prevent water penetration through seams in walls or adjacent dissimilar building materials (e.g., brick and cement). Without continuous sealant, water may enter through the gap in exterior walls.

Seam missing sealant

RESPONSE: We will repair the joint sealant on the walls.

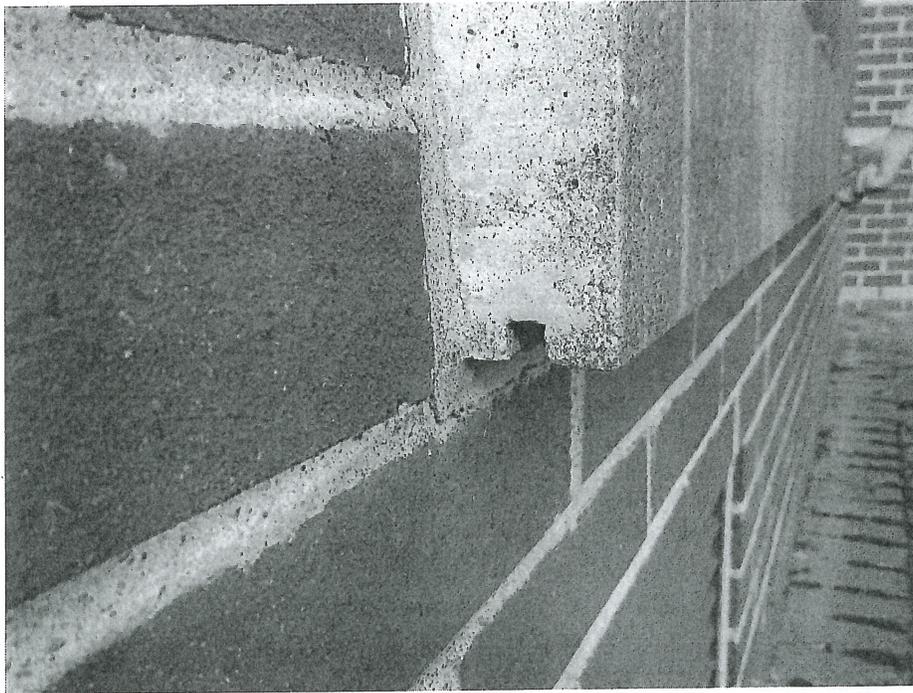
Picture 5

Some windows appear to have filled in drip grooves (Pictures 5 and 6). The purpose of a drip groove is to prevent water from accumulating in the joint of the underside of the window and exterior wall. Without a drip groove, water may penetrate through this joint to cause moistening of adjacent interior walls.

Windowsill drip groove

RESPONSE: All drip edges on the window sills will be checked to allow correct shedding of water.

13. Repair flashing to maintain a continuous drainage plain for exterior walls.
14. Repair drip grooves in the exterior of windowsills, or otherwise outfit sills with the ability to shed water.

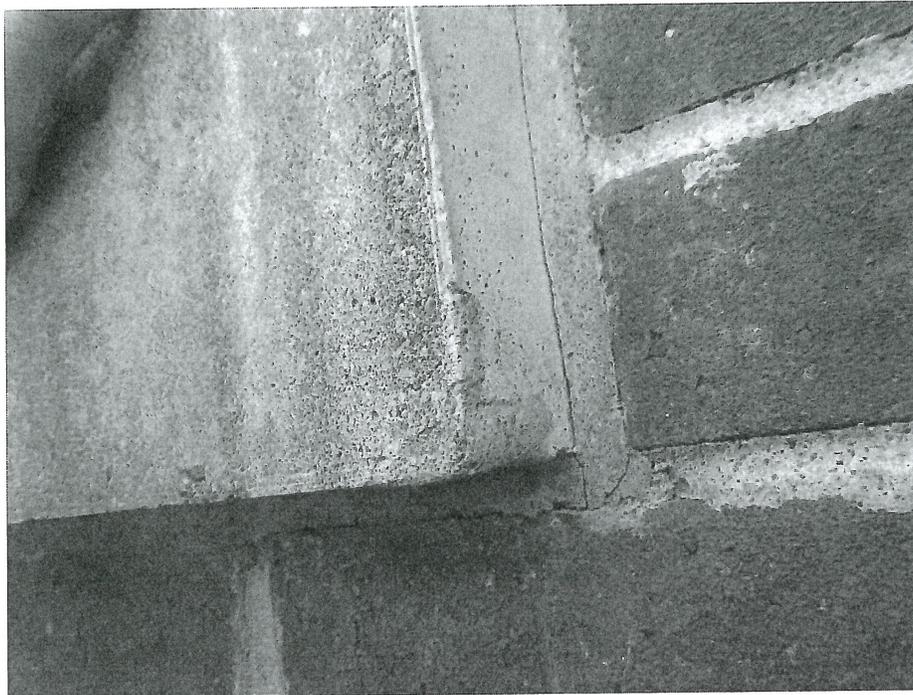
Picture 6

Sill with missing or filled-in window sill drip groove

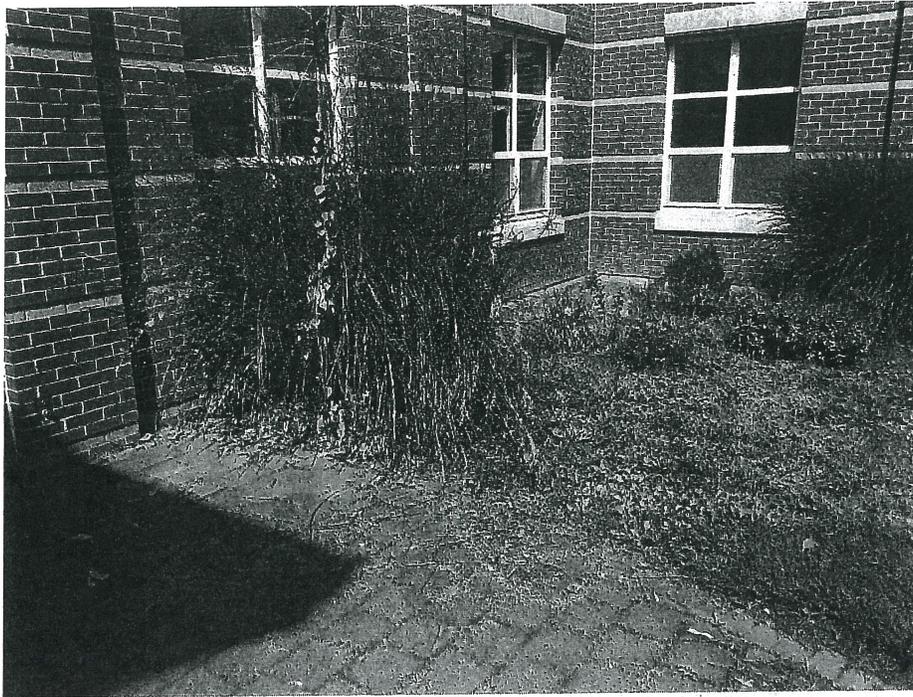
Picture 7

Plants in contact with exterior wall

RESPONSE: Weeds and clinging plants will be removed from the brick walls as weather permits. We are planning to remove the trees during the winter.

8. Trim outdoor plants/shrubs etc. to five feet away from the foundation and away from air intakes.
9. Remove clinging plants from exterior brick. Trim trees/ branches from close proximity to walls.
