DIECK ELEMENTARY

DIECK ROAD ELEMENTARY SCHOOL

2239 Van Vleet Road, Swartz Creek

DIECK ELEMENTARY
ROOF CONDITION REPORT

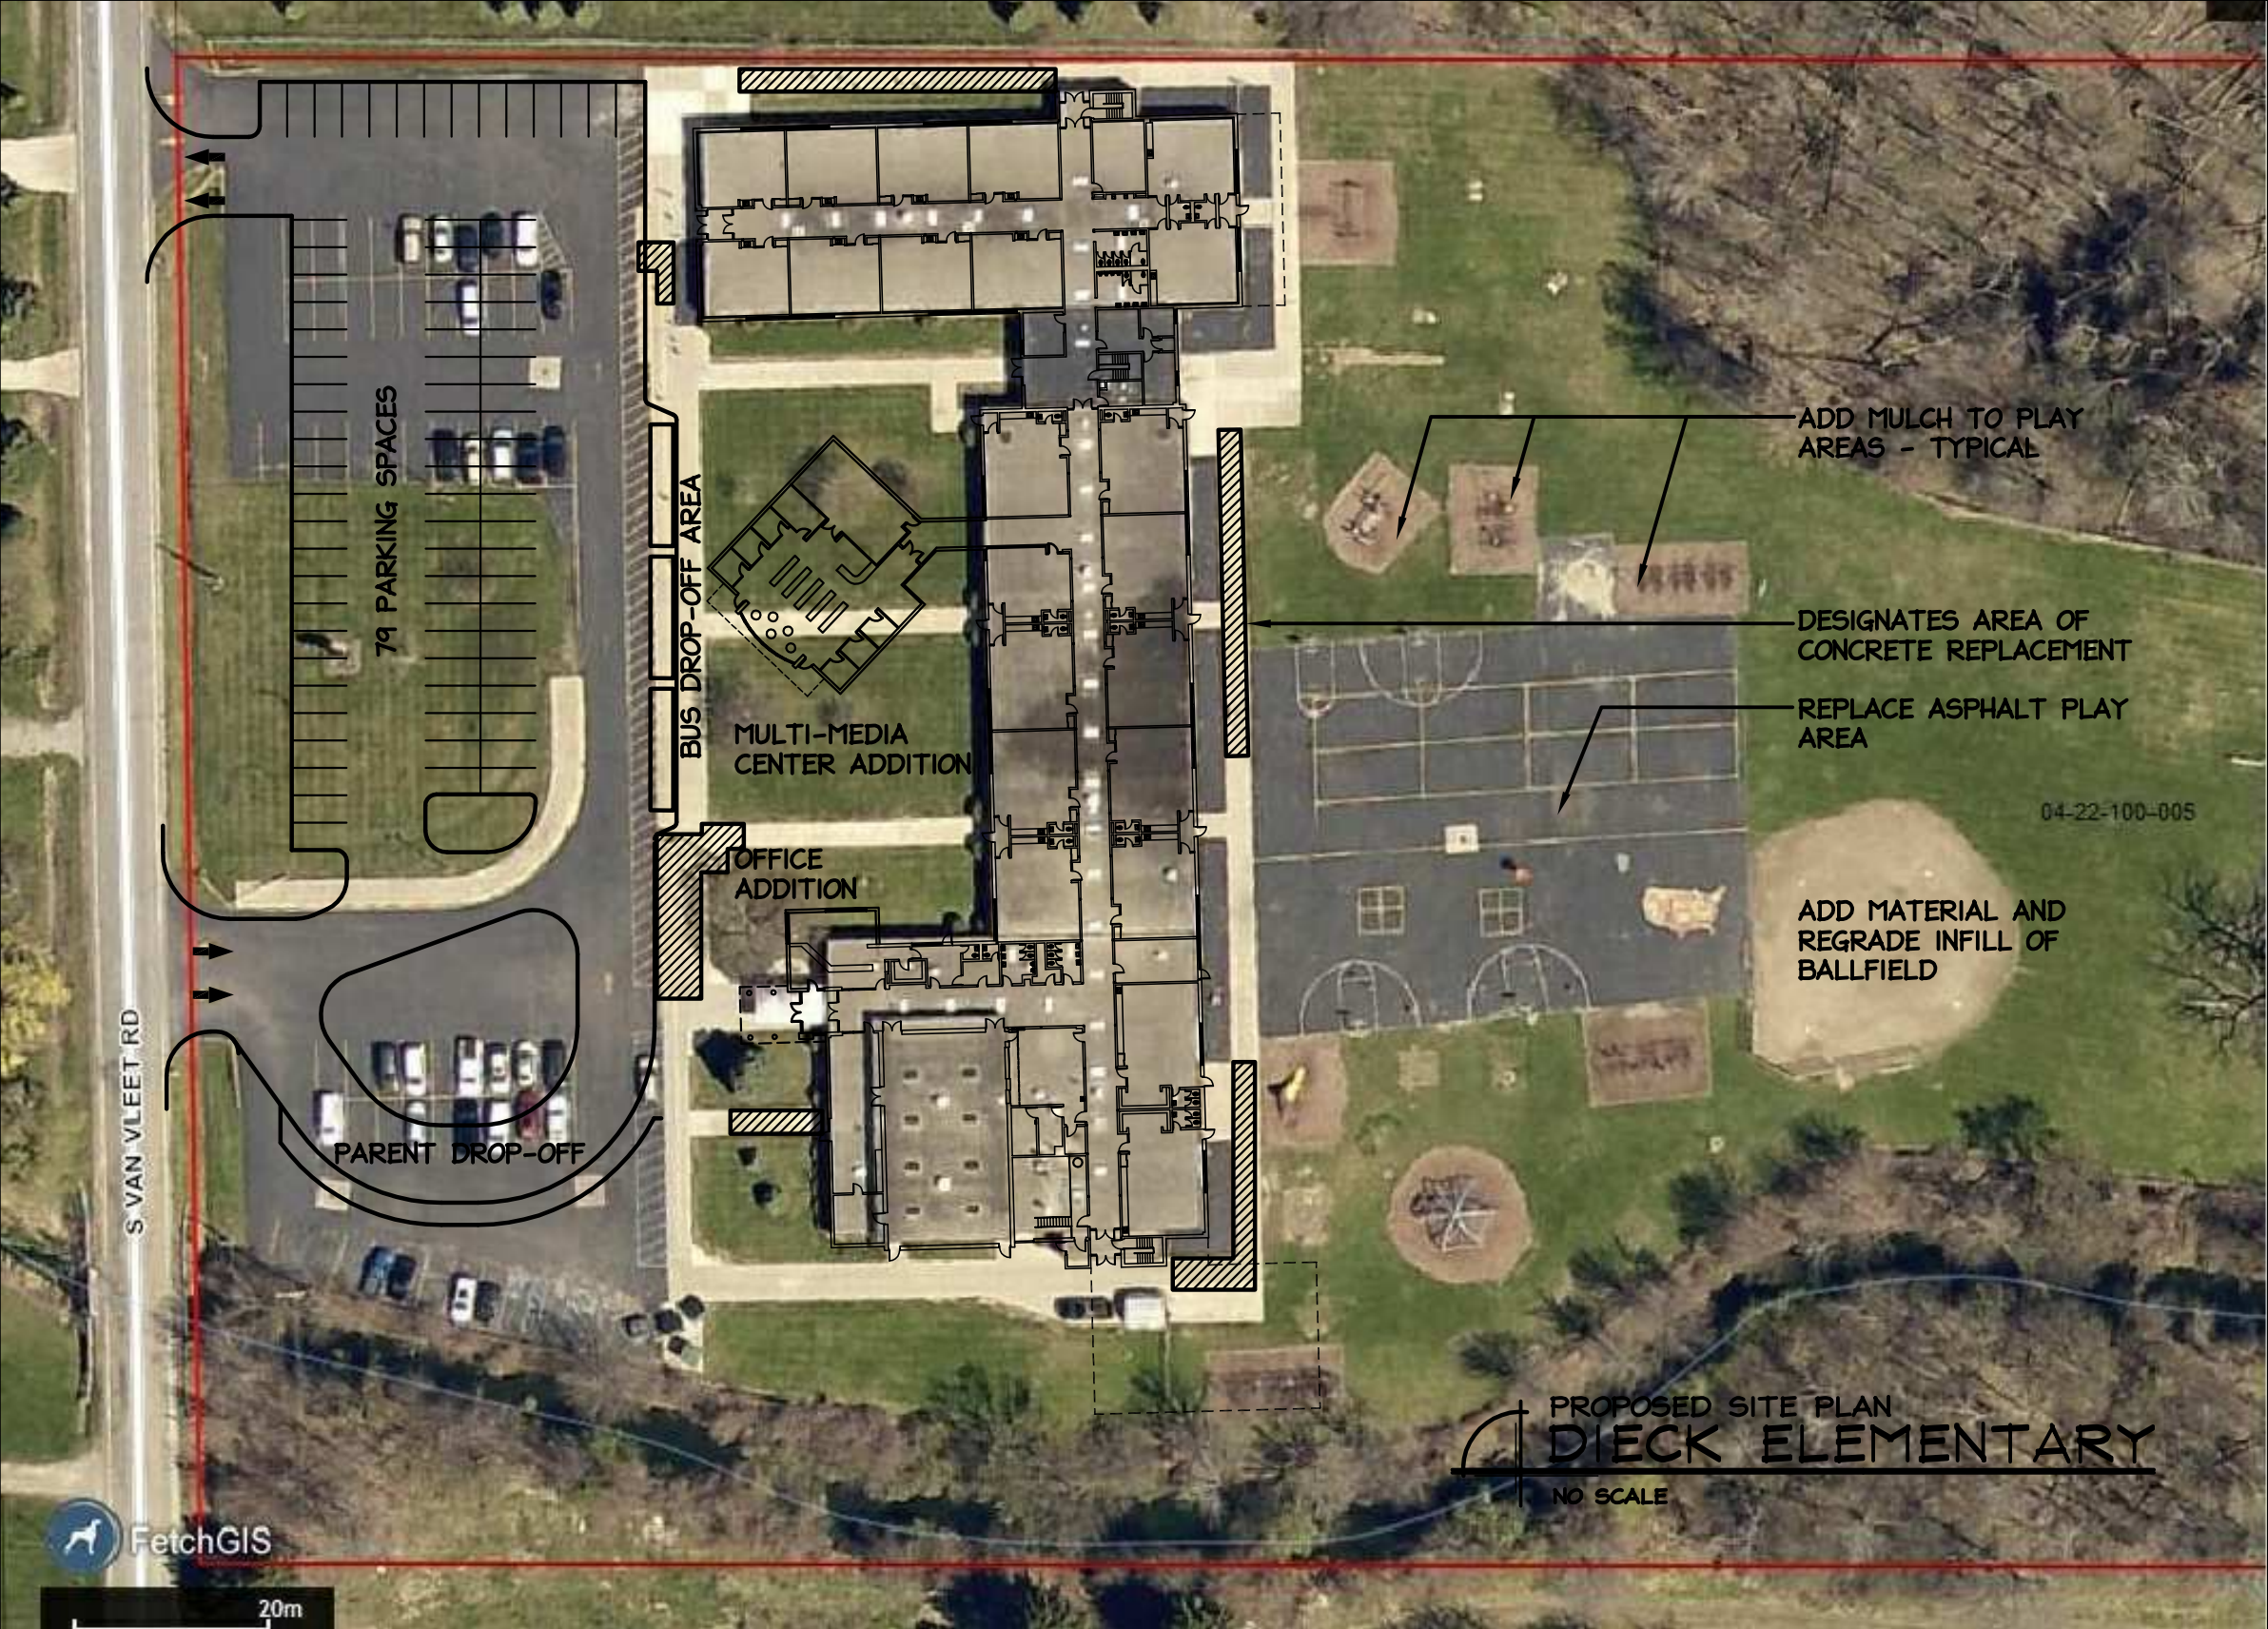
- Asphalt paved basketball court area. In very bad condition. It should be pulverized, re-graded and re-paved.
- (1) ballfield with fenced backstop. Overall in fair condition.
- Asphalt Pavement: Overall in poor condition. All parking lots and drives should be pulverized and re-paved with additional drainage catch basins added.
- Concrete Sidewalks: Overall in fairly good condition with most areas showing some surface spalding. Areas that are broken and uneven need to be replaced. The district may consider reducing the number of walks, especially walks from classroom doors.
- Site Lighting: Two (2) headed poles located on the north edge of southwest parking lot.
- Landscaping: Generally consists of lawn area with some major trees. Most of the foundation plantings (shrubbery at entry doors) is overgrown and should be removed.

DESIGNATES AREA OF CONCRETE REPLACEMENT

REPLACE ASPHALT PLAY AREA

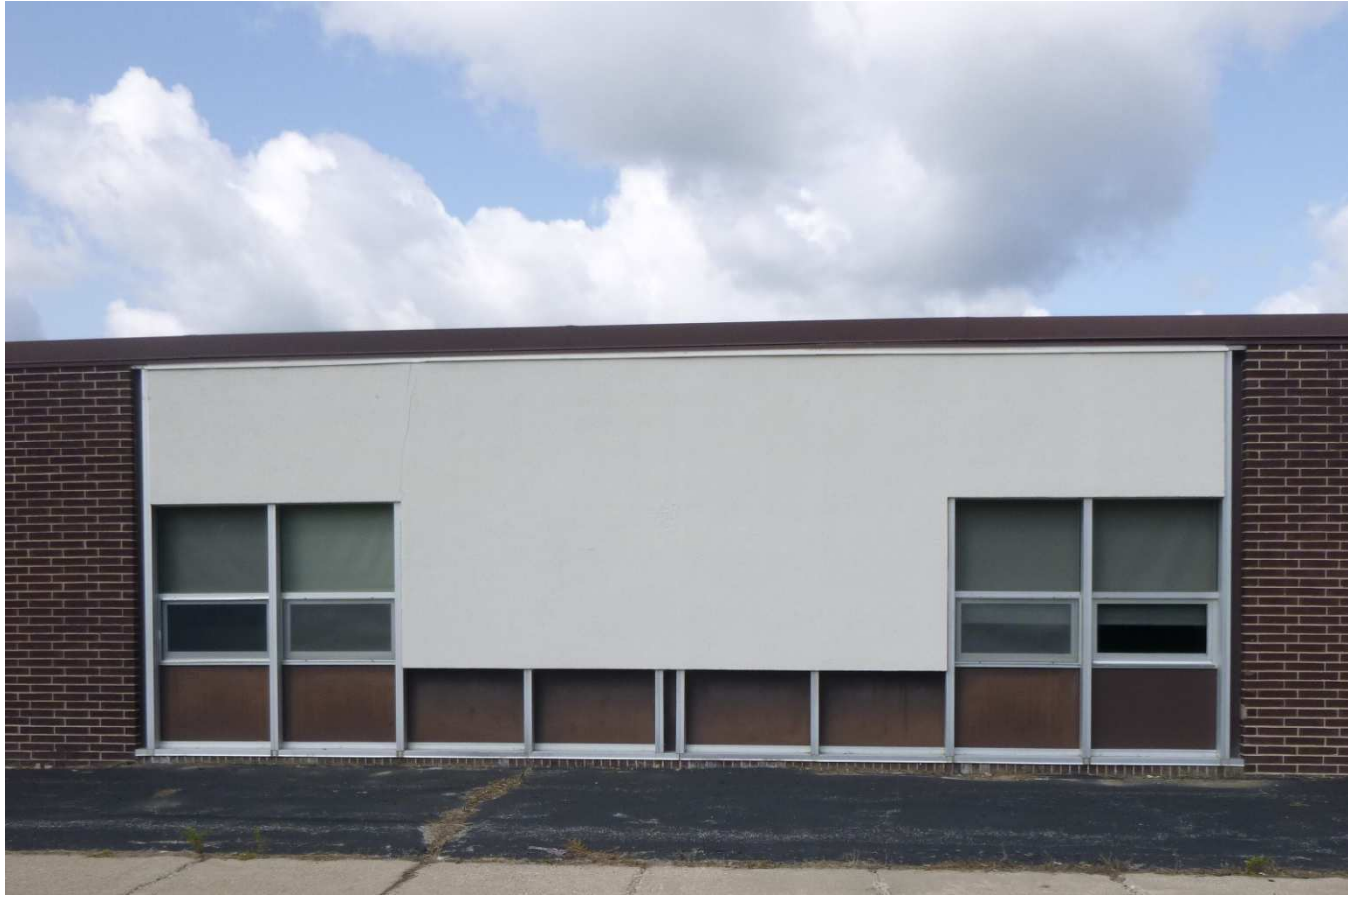
Existing

- Window Sash: Is original and consists of non-thermally broken aluminum framing with single glass glazing. Some areas of the sash have been covered over with EIFS (exterior insulation finish system). The sash are drafty and allow a great deal of heat gain from the sun. All sash should be replaced with new windows and wall infill.

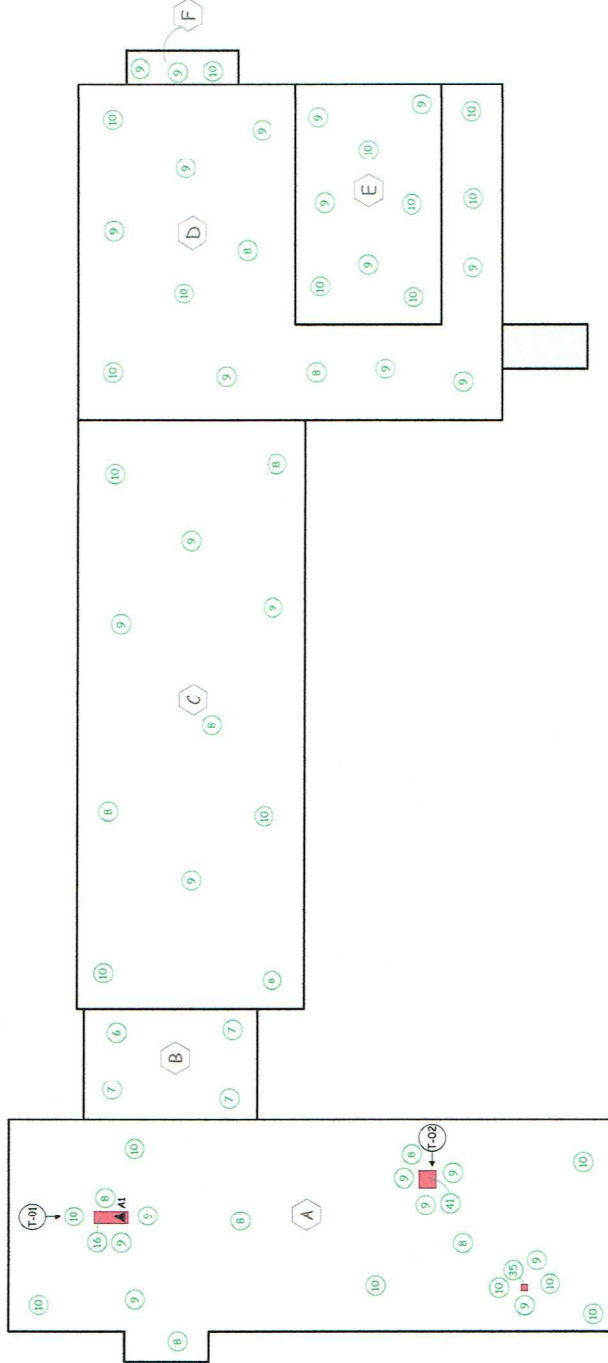
ROOF PLAN
SCALE: AS SHOWN

ROOF AREA DATA			
ROOF AREA	SIZE (S.F.)	WET (S.F.)	% WET
A	11,502	69	0.60%
B	1,683	0	0.00%
C	11,792	0	0.00%
D	9,322	0	0.00%
E	3,053	0	0.00%
F	330	0	0.00%
TOTALS	37,682	69	0.18%
