# ELMS ROAD ELEMENTARY

**3259 Elms Road, Swartz Creek, Michigan**

## **ELMS ROAD ELEMENTARY SCHOOL**

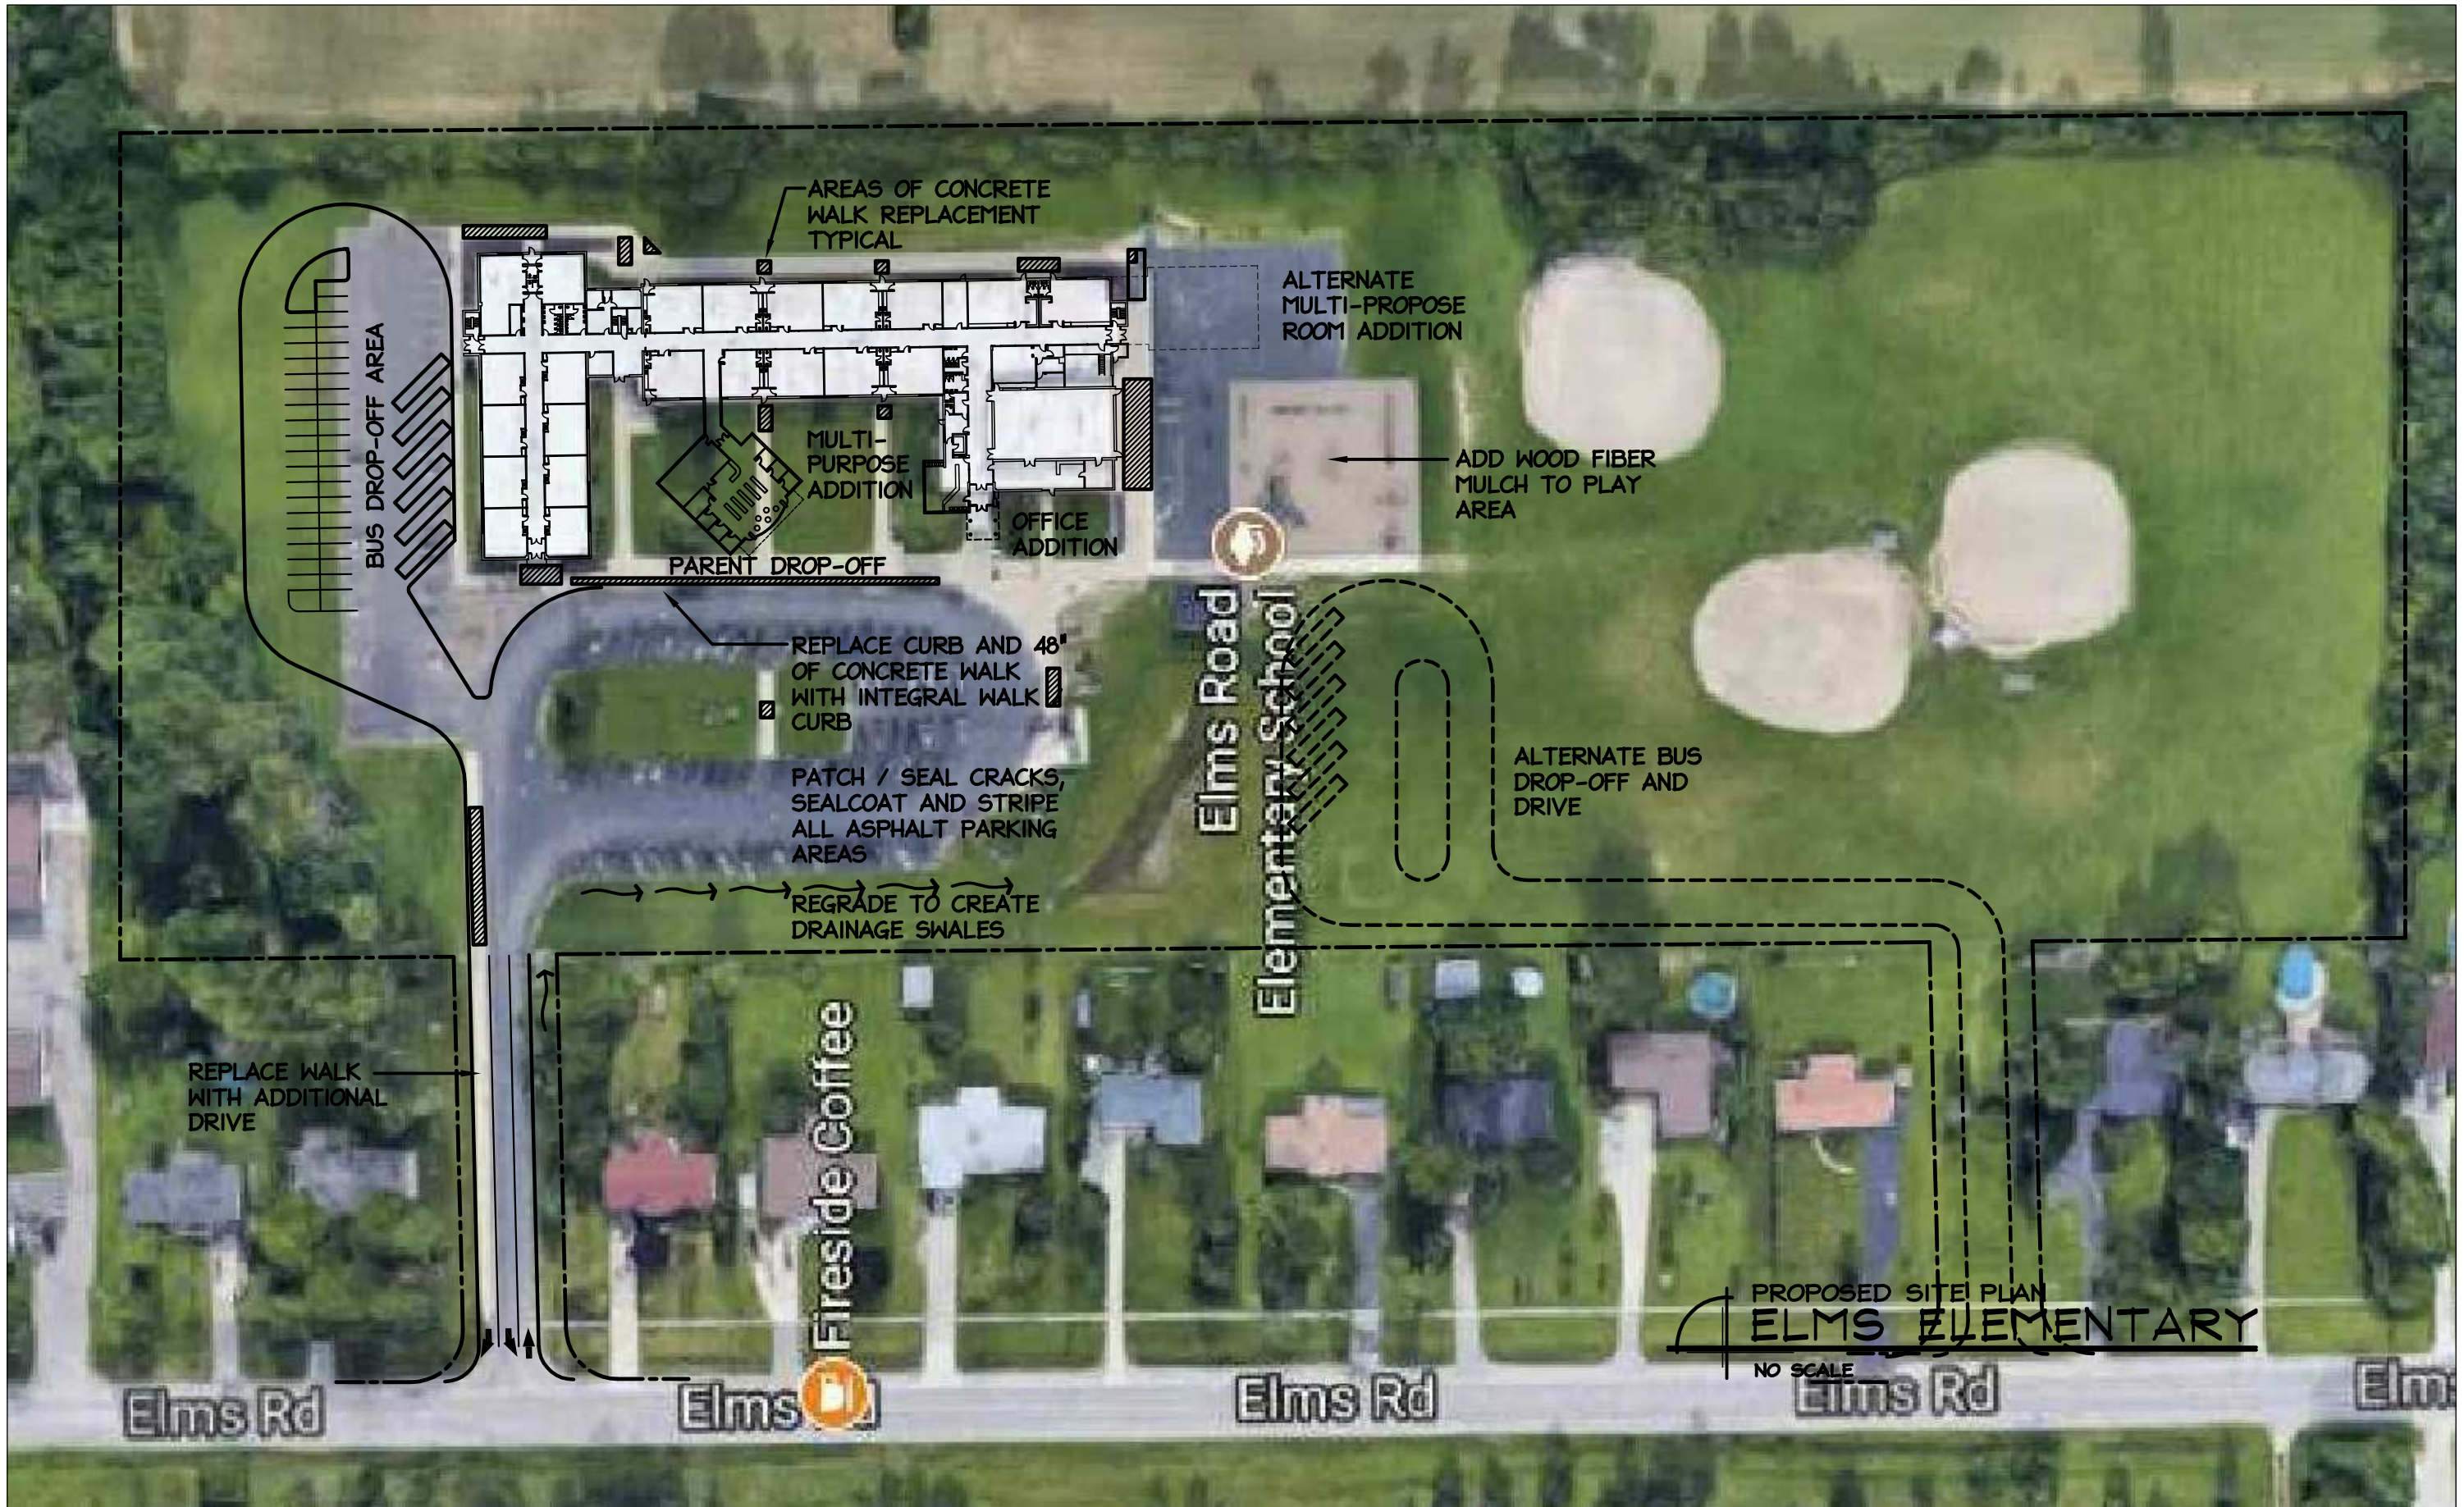
- Concrete Sidewalks: Overall in fairly good condition with most areas showing some surface spalding. Areas that are broken and uneven need to be replaced. The district may consider reducing the number of walks, especially walks from classroom doors.

AREAS OF CONCRETE WALK REPLACEMENT TYPICAL

REPLACE CURB AND 48" OF CONCRETE WALK WITH INTEGRAL WALK CURB

PATCH / SEAL CRACKS, SEALCOAT AND STRIPE ALL ASPHALT PARKING AREAS

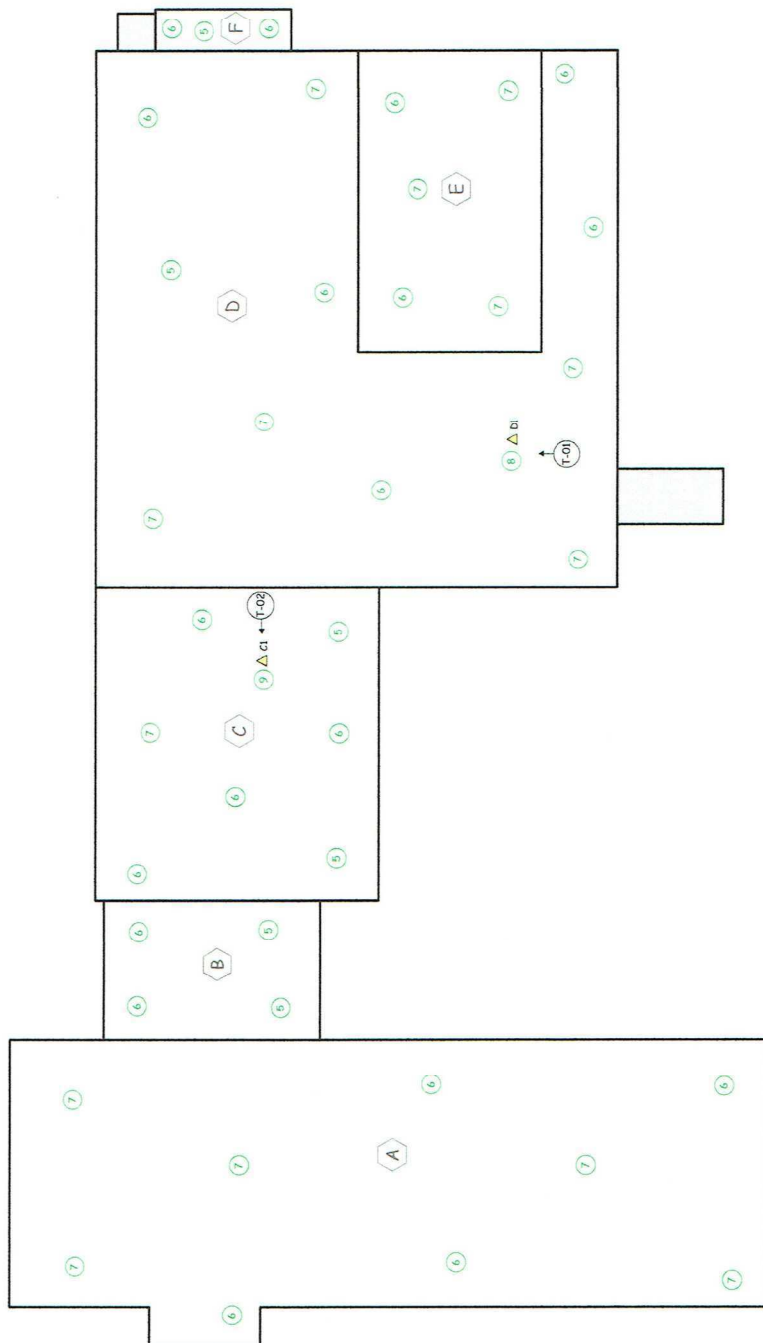
ROOF PLAN  
Scale: 1/8" = 1'-0"

ROOF AREA DATA			
ROOF AREA	SIZE (S.F.)	WET (S.F.)	% WET
A	11,690	0	0.00%
B	1,683	0	0.00%
C	5,025	0	0.00%
D	12,568	0	0.00%
E	3,083	0	0.00%
F	320	0	0.00%
<b>TOTALS</b>	<b>34,339</b>	<b>0</b>	<b>0.00%</b>

ROOF CORE CUT		CONSTRUCTION DATA	
AREA NUMBER	DENSITY READING	MOISTURE READING	CONSTRUCTION
C	C1	9	1 1/2" POLYISO/CANADATE INSULATION
			BUILT-UP-ROOF WITH GRAVEL
			1 1/2" POLYISO/CANADATE INSULATION
			METAL DECK
D	D1	8	SINGLE PLY (WHITE) ROOF SYSTEM
			1 1/2" POLYISO/CANADATE INSULATION
			BUILT-UP-ROOF WITH GRAVEL
			1 1/2" POLYISO/CANADATE INSULATION
			METAL DECK
