# MORRISH ELEMENTARY

**5055 Maple Avenue, Swartz Creek, Michigan**

**MORRISH ELEMENTARY**  
**ROOF CONDITION REPORT**

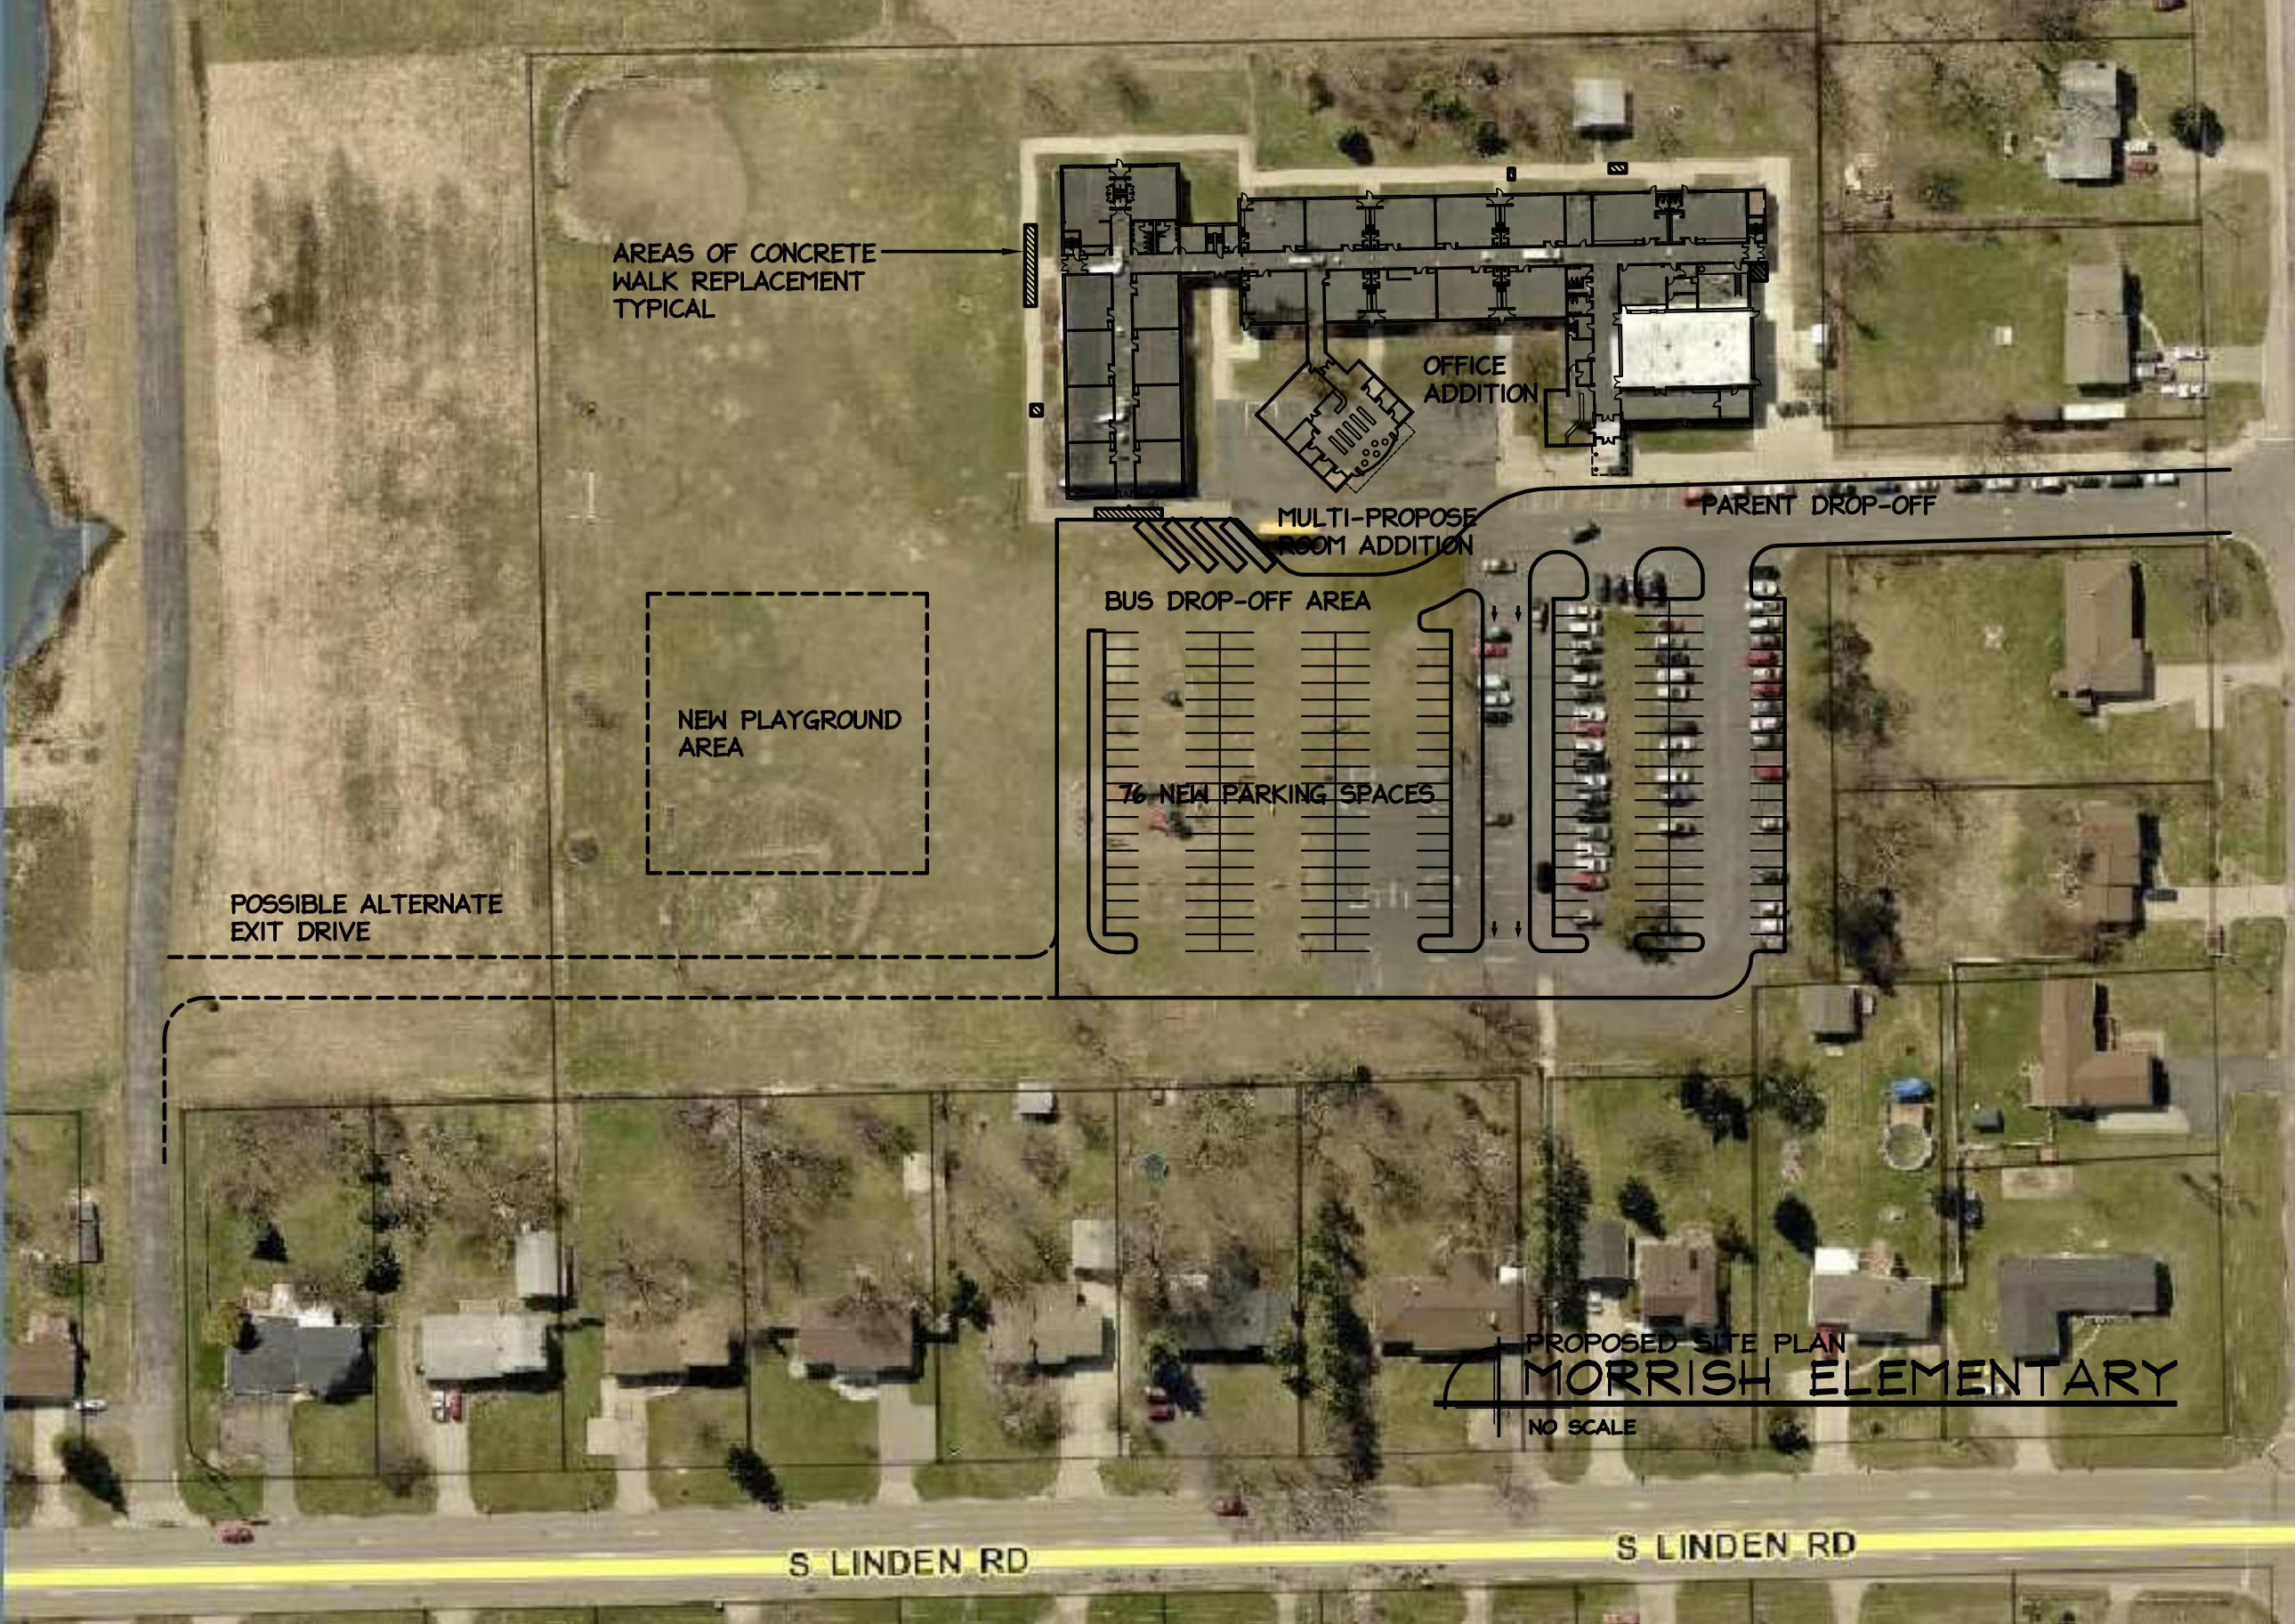
AREAS OF CONCRETE WALK REPLACEMENT TYPICAL

<b>Proposed Site Work:</b>	<b>Quantity of Work:</b>	<b>Estimate of Cost:</b>
Concrete Walk Replacement	750 sq feet	\$ 7,500.00
Reconstruct Classroom Exit Door Stoops for ADA Compliance	9 Exits (650 sq feet)	\$ 31,500.00
Asphalt Pavement Replacement (Between walks and building)	800 sq feet	\$ 4,800.00
Reconstruct and Expand Parking Lot with new Bus and Parent Drop-off	106,000 sq feet	\$ 582,340.00
New Concrete Walk at New Parent Drop-off	3,000 sq feet	\$ 30,000.00
Additional Drive to Church Entry	12,500 sq feet	\$ 33,125.00
Install Site Lighting	8 poles / 20 building	\$ 55,000.00
Reconstruct Paved Play Area	18,000 sq feet	\$ 59,000.00
Relocated Playground Area		\$ 120,000.00
Replace Older Play Structures	Lump Sum	\$ 80,000.00
Add Mulch to Playground	200 cubic yards	\$ 9,000.00
<b>Total Opinion of Probable Cost of Site Work:</b>		<b>\$1,012,265.00</b>

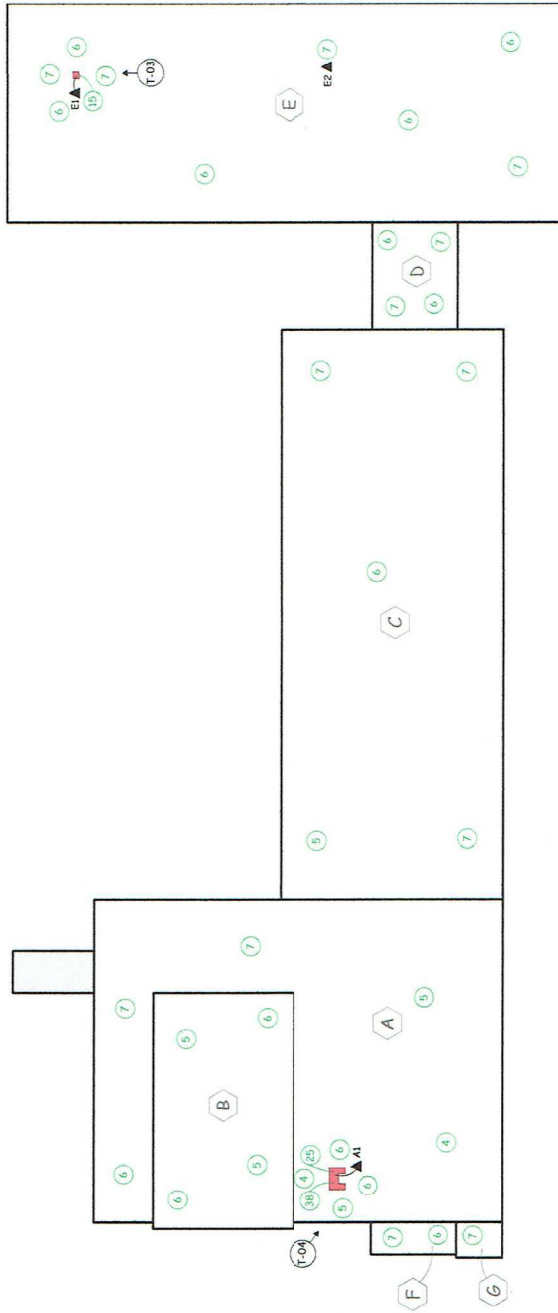
N ROOF PLAN  
SCALE: 1/8" = 1'-0"

The low slope roof areas A, C, D, E, F & G are covered with single ply EPDM (rubber) membranes over insulation on a metal deck. They are estimated to be 10+ years old and have three (3) reported active leaks. They are in fair condition with minor ponding in some areas. Housekeeping, maintenance and repairs are required. These areas appear to be viable candidates for long term repair and restoration procedures.

The low sloped roof area B is covered with a mechanically attached single ply PVC (thermoplastic) membrane. It is estimated to be less than 10 years old. The roof area is in fair condition with minor ponding. Housekeeping, maintenance and repairs are required.

All roof areas should be placed under a yearly inspection, preventive maintenance and reporting process to extend roof life cycles, minimize disruptions/risks, and lower facility costs. Regular inspections, preventive maintenance, repair/restoration procedures can double the life cycles of well designed and installed roof systems at 1/2 to 1/3 the cost of removal and replacement.
