# SYRING ELEMENTARY

**5300 Oakview Drive, Swartz Creek, Michigan**

## **SYRING ELEMENTARY SCHOOL**

**SYRING ELEMENTARY  
ROOF CONDITION REPORT**

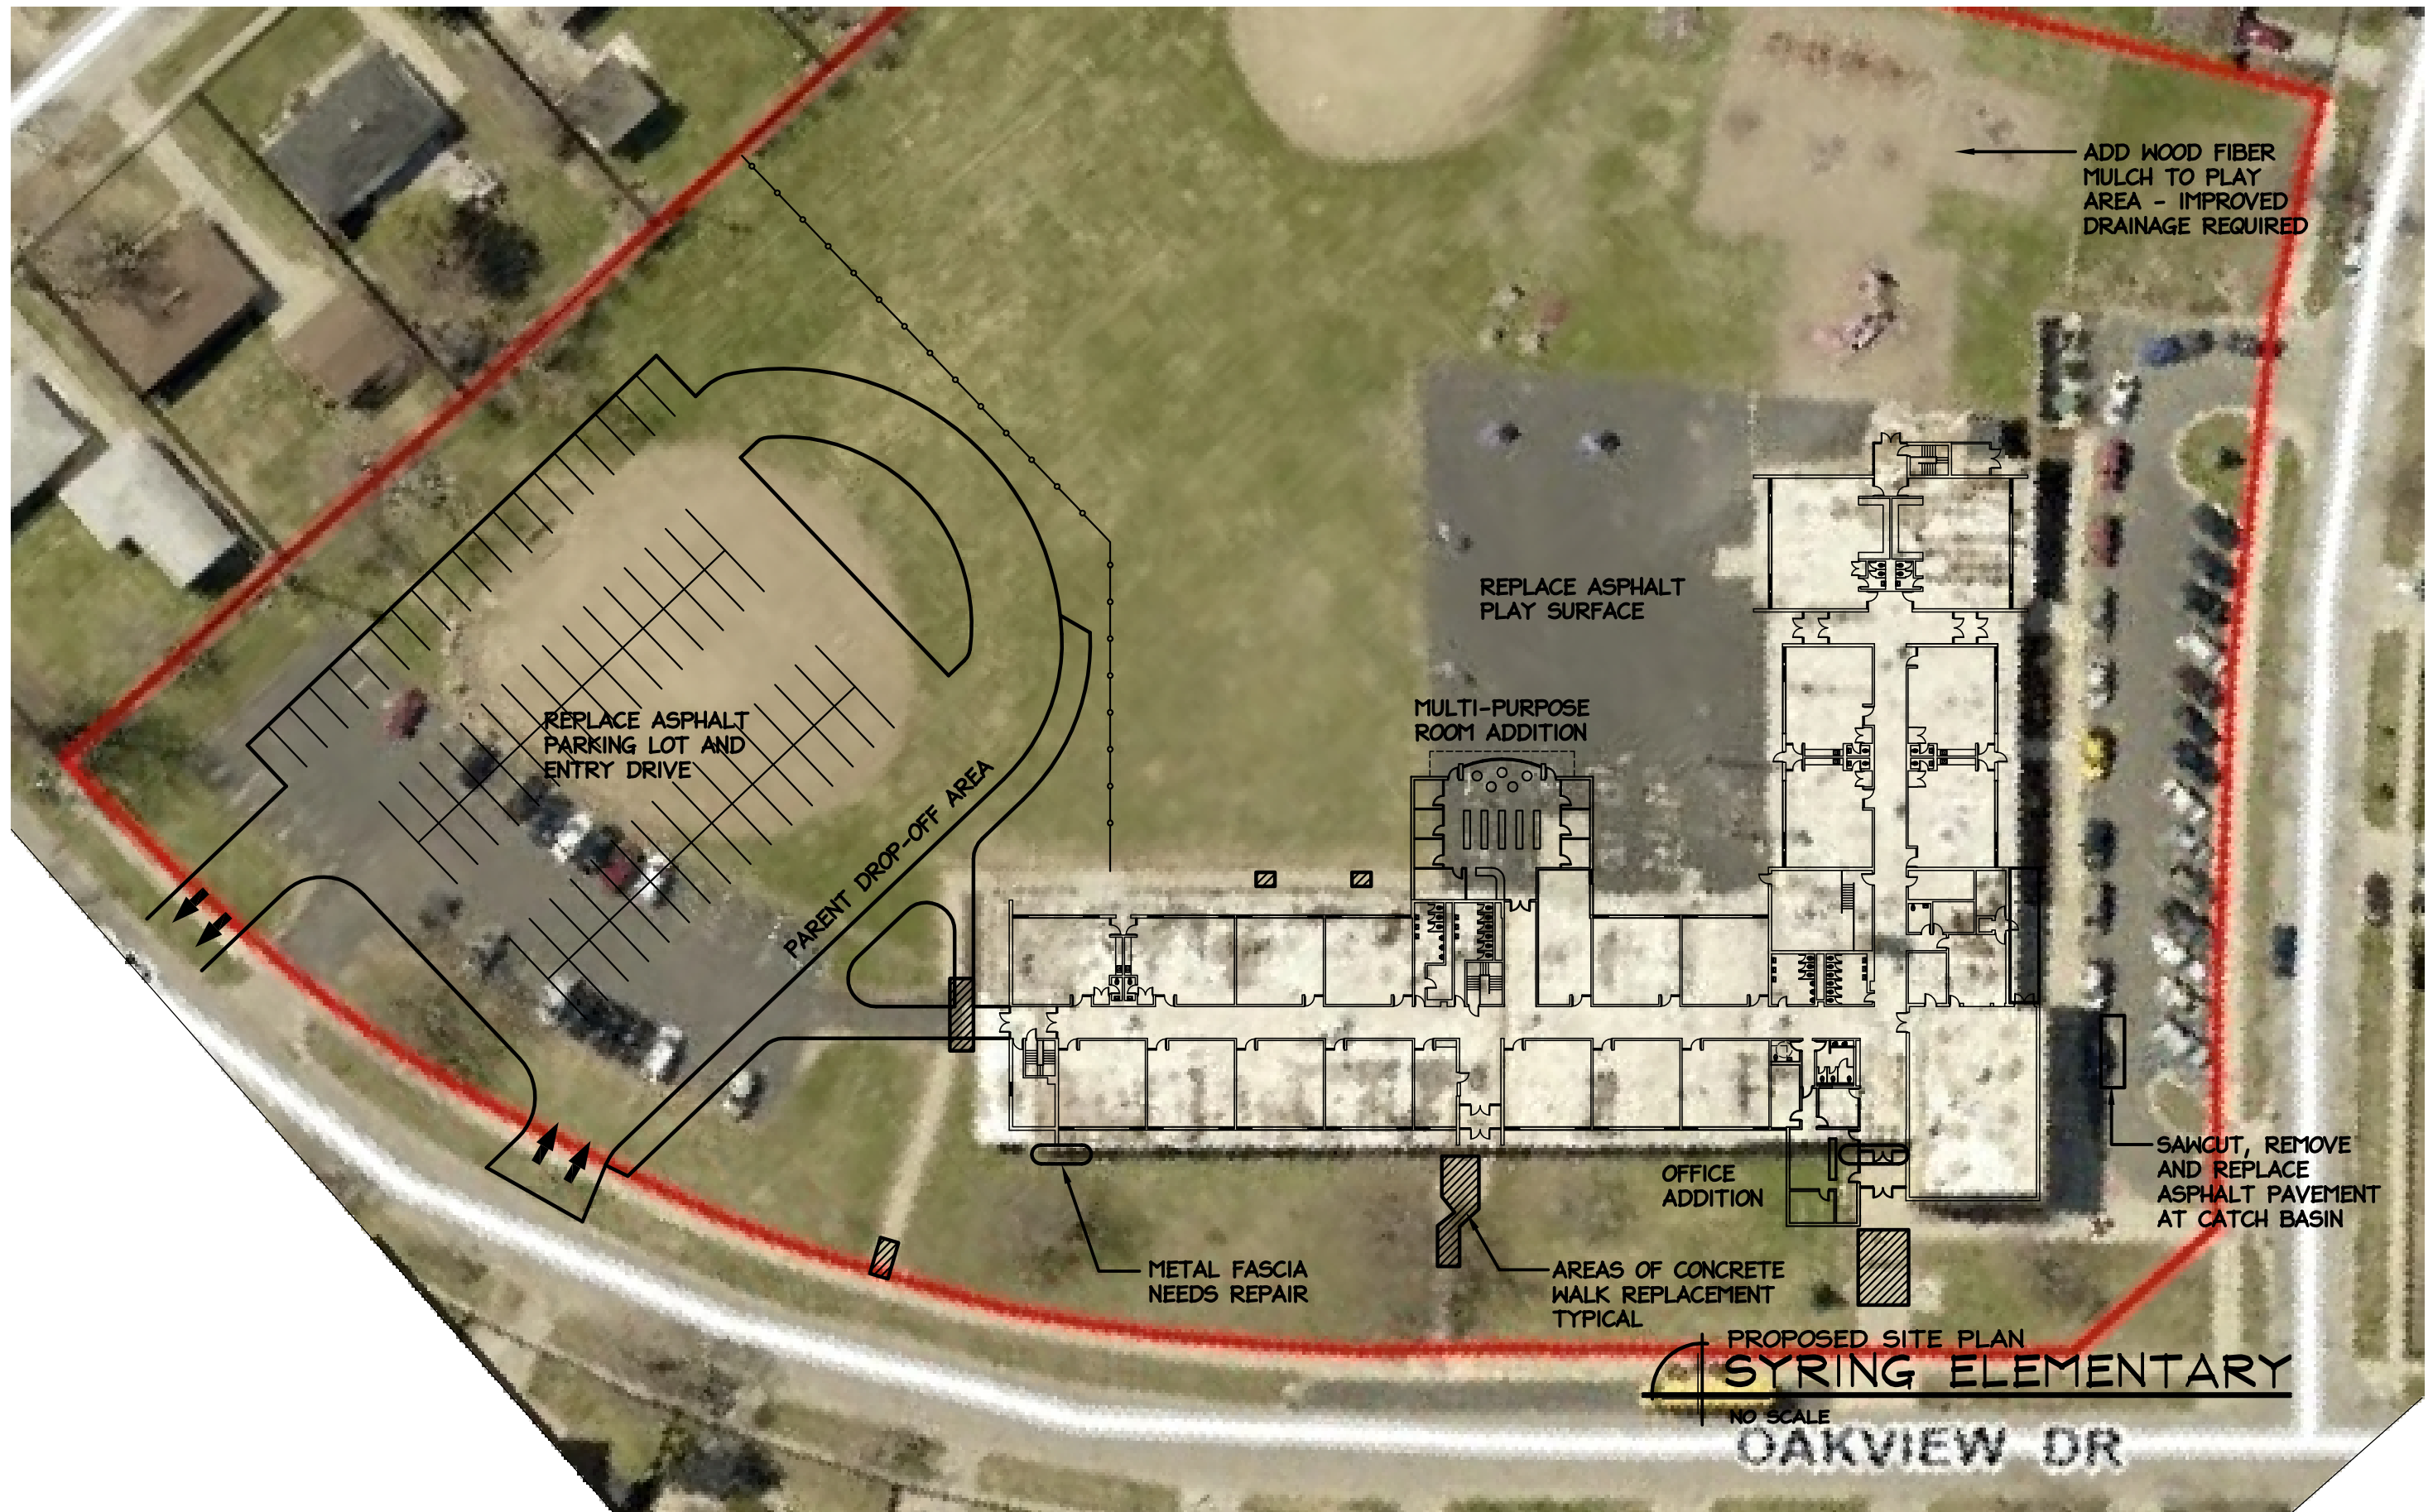
PROPOSED SITE PLAN  
**SYRING ELEMENTARY**  
NO SCALE  
**OAKVIEW DR**

← ADD WOOD FIBER MULCH TO PLAY AREA - IMPROVED DRAINAGE REQUIRED

METAL FASCIA NEEDS REPAIR

AREAS OF CONCRETE WALK REPLACEMENT TYPICAL

REPLACE ASPHALT PARKING LOT AND ENTRY DRIVE

REPLACE ASPHALT PLAY SURFACE

SAWCUT, REMOVE AND REPLACE ASPHALT PAVEMENT AT CATCH BASIN

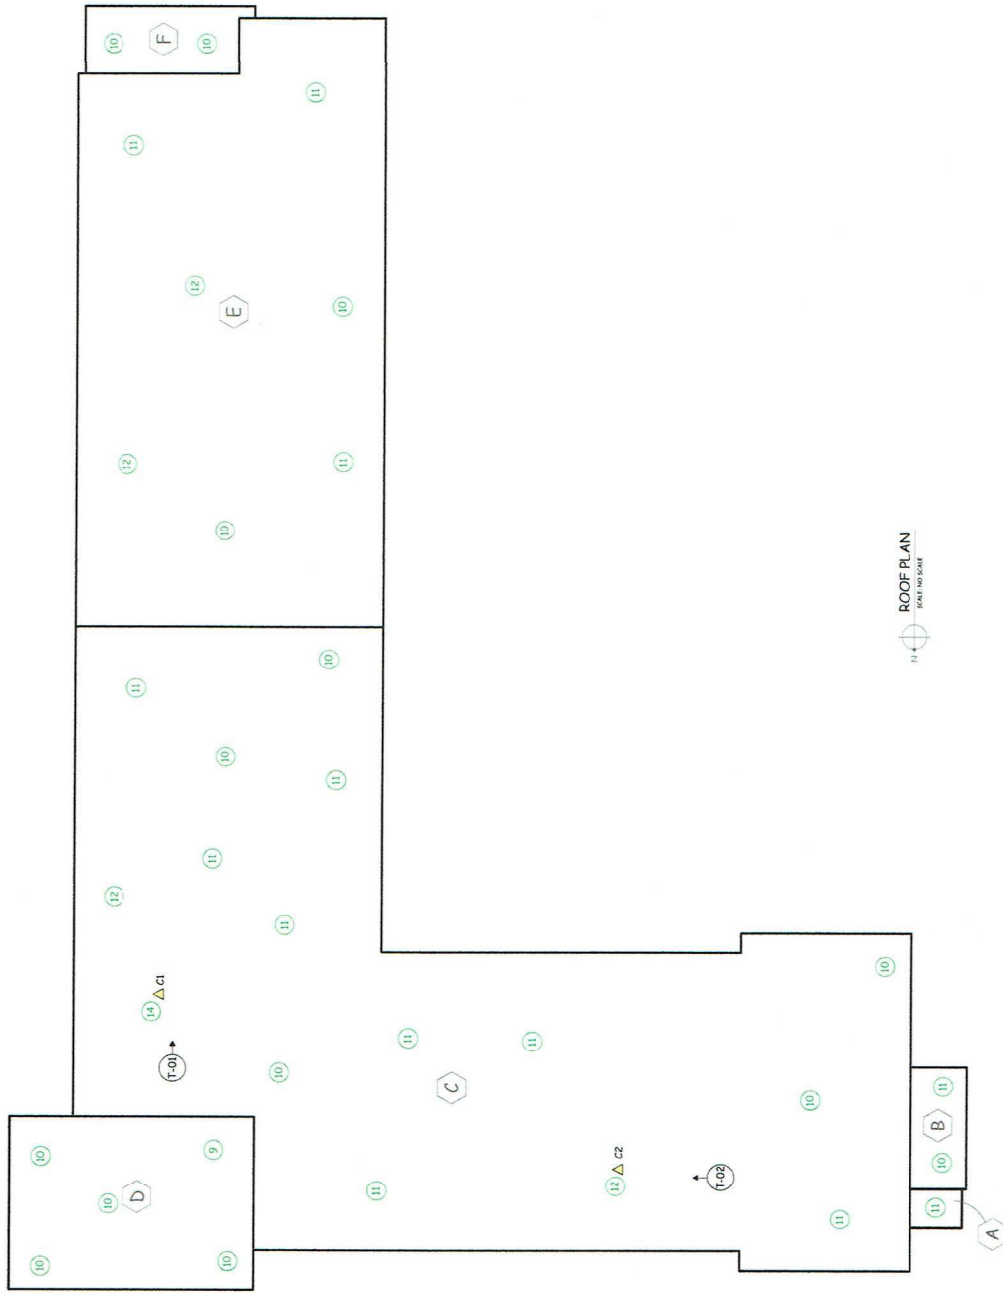
SWARTZ CREEK COMMUNITY SCHOOLS SYRING ELEMENTARY SWARTZ CREEK, MI 48473	PROJECT NO: 09-100008 DRAWING NO: E.A.M. DATE: 8/19/2004
		E

The low sloped roof areas A, B, C, D, E & F are covered with mechanically attached single ply PVC (thermoplastic) membranes over insulation over gravel built-up roof membrane over insulation over another gravel built-up roof membrane on a Tectum deck. The core samples showed three (3) roof systems on the building. This is in violation of building codes. They are estimated to be 10 + years old and had two (2) reported active leak areas. They are in fair to poor condition with several ponding areas which need to be monitored. I would recommend budgeting for removal and replacement of these systems within the next 1 to 5 years.

ROOF AREA DATA			
ROOF AREA	SIZE (S.F.)	WET (S.F.)	% WET
A	130	0	0.00%
B	434	0	0.00%
C	21,530	0	0.00%
D	2,728	0	0.00%
E	11,438	0	0.00%
F	675	0	0.00%
<b>TOTALS</b>	<b>36,935</b>	<b>0</b>	<b>0.00%</b>

All roof areas should be placed under a yearly inspection, preventive maintenance and reporting process to extend roof life cycles, minimize disruptions/risks, and lower facility costs. Regular inspections, preventive maintenance, repair/restoration procedures can double the life cycles of well designed and installed roof systems at 1/2 to 1/3 the cost of removal and replacement.
