Crow-Applegate-Lorane School District No. 66  
Educational Facility Master Plan & Facility  
Assessment  
June, 2016

**FACILITIES ASSESSMENT - DEFICIENCIES AND RECOMMENDATIONS - JANUARY 30, 2016**

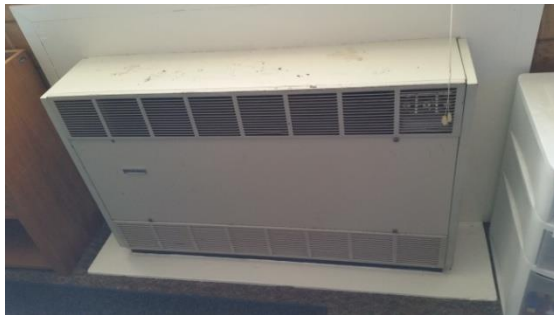
Heating for most classrooms in the school is provided by individual unit ventilator consoles with electric heat. The console units were installed in the early 1980s and are beyond their normal expected service life. A few rooms have newer electric baseboard heaters, and a few rooms have electric wall heaters. Corridors have larger recessed electric cabinet unit heaters. The district office has a new LG through the wall air conditioner. The Gym is heated by three suspended unit heaters and a fan coil system located under the stage. Locker Rooms have small suspended electric unit heaters. Below the Stage/Cafeteria is a large storage room with one suspended electric unit heater and one wall heater.

Figure 1: Unit Ventilator Console

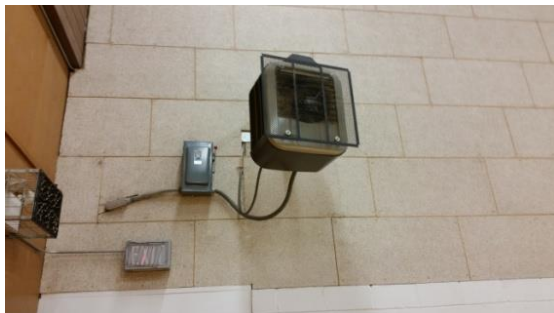
Figure 2: Electric Unit Heater in Gym

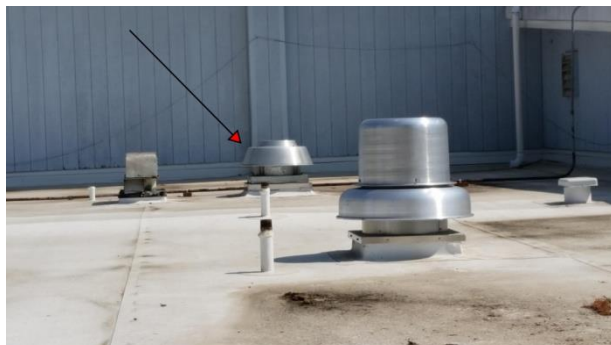
east wall. Several rooms with exhaust fans, mainly the Kitchen and Gym, do not have a means of makeup air. A converted classroom at the southwest corner of the building has food storage freezers and refrigerators. These units generate heat, which is dealt with by a window exhaust fan that operates continuously.

*Figure 3: New Kitchen Exhaust Fans*

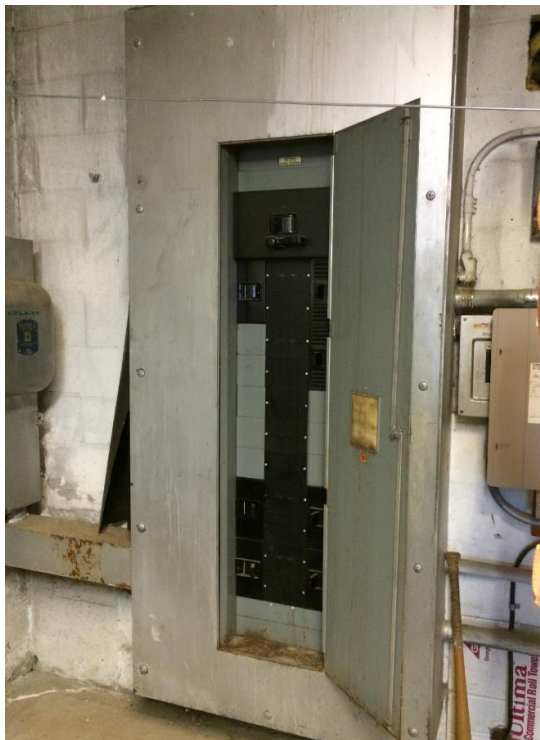
Service #1, general lighting and receptacles metered service #61934 is 120/240-volt, 1-phase, 3-wire, and is served overhead from a pole mounted service transformer across the street from the main school entrance. The service entrance equipment appears to be original and in poor to fair condition at best. Nameplate information is missing from the main service switchboard, but it appears to be either 600-amp or 800-amp rated equipment.

Figure 5: Service #1 120/240V Switchboard at Electrical/Storage Room

| No. | School | Category | Priority Source | Item | Qty | Units | Unit Price (\$) | Const. Cost (\$) | With Soft Cost (1.45%) | Notes |
|---|---|---|---|--|---|---|---|---|---|---|
| 52 | Main Bldg | Maint | 5 | • Service #1: Replace with a new 800-amp 120/240-volt 1-phase service equipment. Remove overhead service and install underground service lateral with utility termination cabinet and meter located on the exterior wall outside of the electrical room. Coordinate with utility company for new service provisions and removal of overhead. | 1 | lot | 55,000 | 55,000 | 79,750 | |

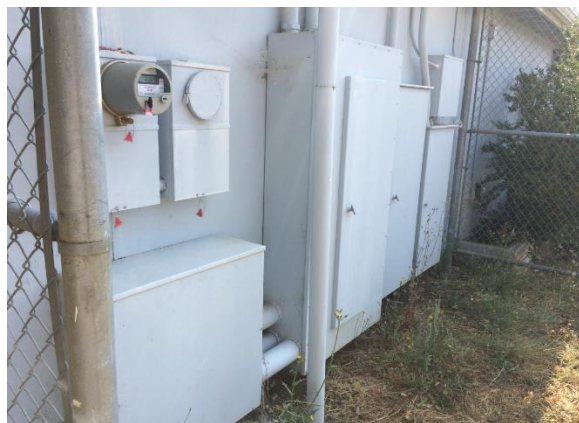
Service #2, mechanical equipment metered service #50187 is 277/480-volt, 3-phase, 4-wire, and is served underground from pad mounted service transformers at the rear of the school building. The service entrance equipment appears to be original and in fair to good condition. Nameplate information is missing from the main service switchboard, but appears to be 800-amp rated equipment.

Figure 6: Service #2 277/480V Equipment at Building Exterior

| No. | School | Category | Priority Source | Item | Qty | Units | Unit Price (\$) | Const. Cost (\$) | With Soft Cost (1.45%) | Notes |
|---|---|---|---|--|---|---|---|---|---|---|
| 53 | Main Bldg | Safety | 5 | • Service #2: Test distribution circuit breakers by current injection method and replace failed, as needed. Torque check of feeder terminations. Test (Megger) feeder conductors to panelboards. Visually inspect internal bussing for signs of corrosion. De-energize and clean interior of dust and debris. Check supply houses for circuit breaker and hardware availability. | 1 | lot | 20,000 | 20,000 | 29,000 | |

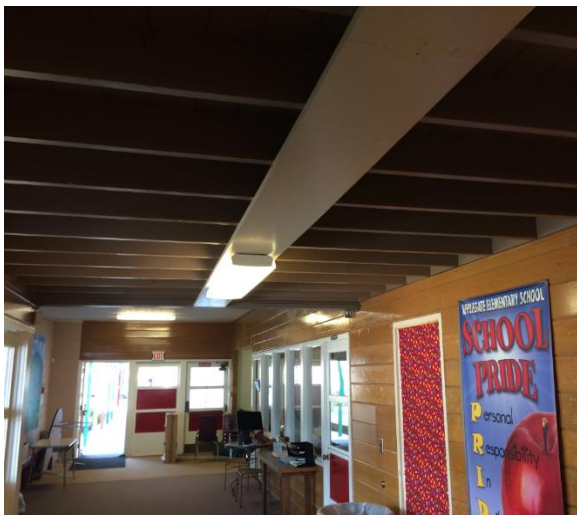
Figure 8: Surface Wrap in Corridor

Building interior lighting consists mostly of lensed T-8 linear fluorescent luminaires in corridors, classrooms, and support spaces. Some smaller spaces have compact fluorescent and incandescent lighting. All areas appear to be controlled by manual switches only.

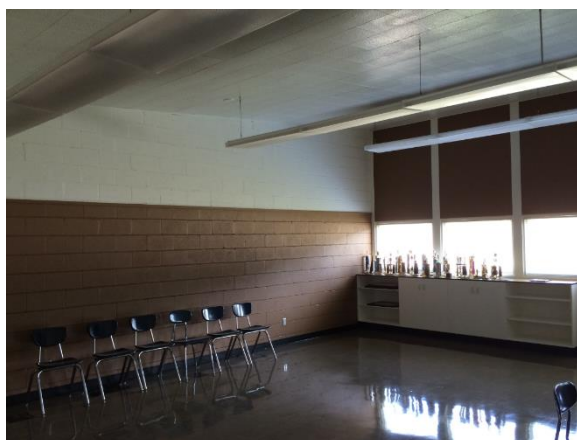
Figure 9: Linear fluorescent pendants at classroom.

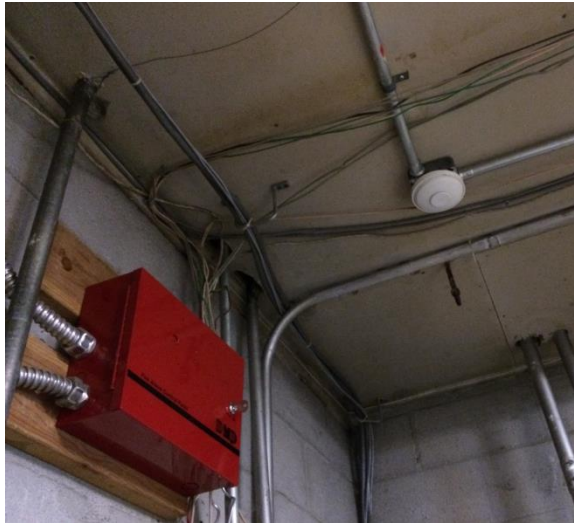
The fire alarm system consists of a fire alarm control panel located near Service #1 in the electrical/storage room. The panel is manufactured by Digital Monitoring Products, installed around 2008. Area smoke detection is provided at main corridors and select rooms, with manual pull station at main office and near exits. Notification appliance coverage is limited to audible devices only, with no visual strobe coverage. The auto-dialer has malfunctioned in the past and is currently deactivated due to false dial-outs.

Figure 10: Existing Fire Alarm Control Panel in Electrical/Storage Room

Provide new fire alarm/sprinkler monitoring system with voice evacuation/alarm communication and visual strobe notification, with approved dial-out equipment to central monitoring station.

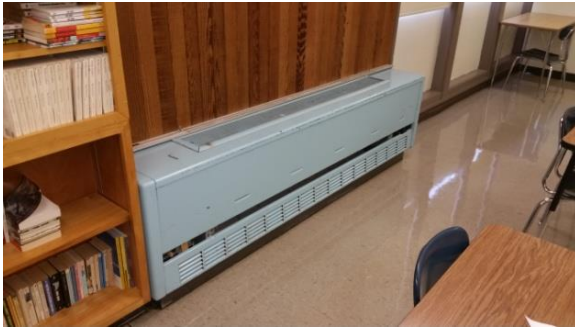
Figure 13: Older Unit Ventilator Console

Heating for most classrooms is produced by individual unit ventilator consoles with electric heat and through the wall connections for outside air ventilation. Most consoles have been replaced over the years as units fail, with only a one original construction consoles still in service.

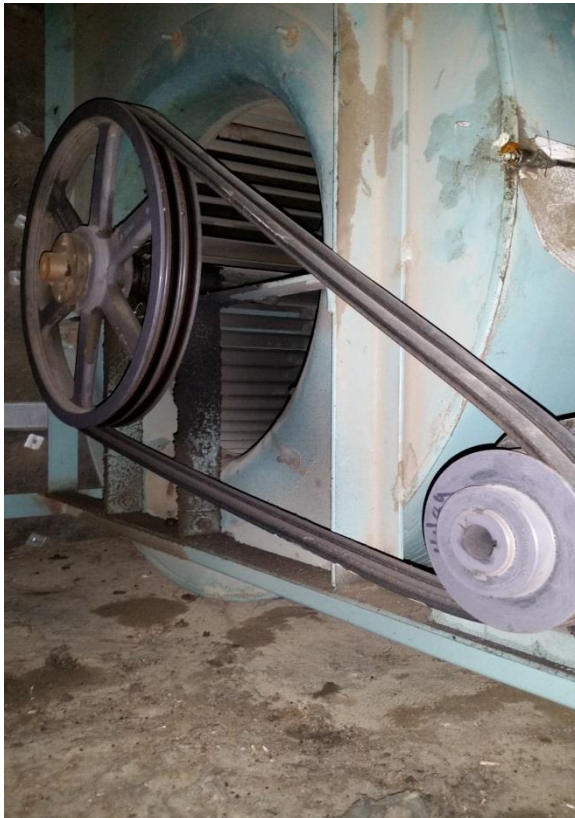
Figure 14: Gym Heating and Ventilation Unit

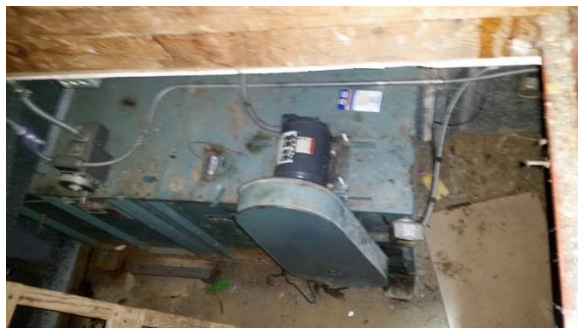
There is also a large forced air unit located in a pit below the stage. These units appear to be 1975 vintage, and although functional are beyond their expected service life.

*Figure 15: Stage Pit Forced Air Fan Unit*

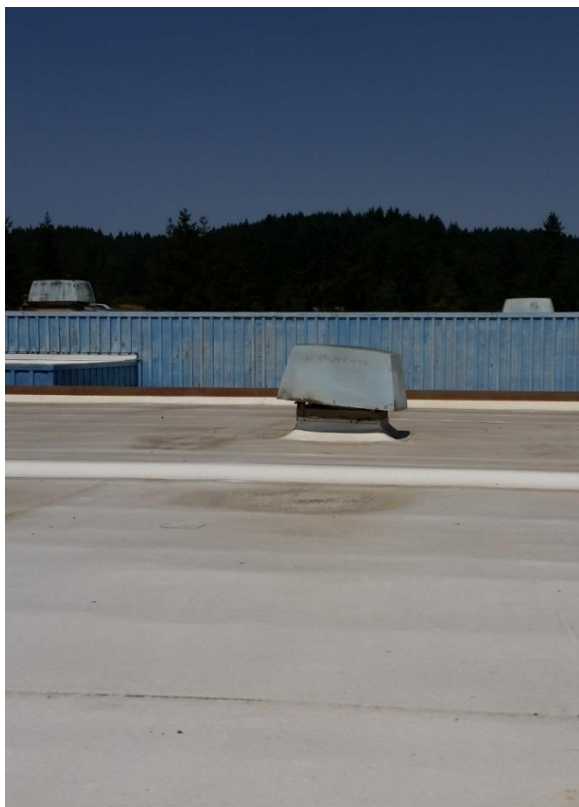
Exhaust fans located on the roof appear to be original equipment and are starting fail with cover frames rusting. Exhaust grilles in the locker shower areas are badly rusted. Condition of connecting ductwork not established.

*Figure 16: Several Roof Exhaust Fans. The near unit with a broken cover support.*

| No. | School | Category | Priority Source | Item | Qty | Units | Unit Price (\$) | Const. Cost (\$) | With Soft Cost (1.45%) | Notes |
|---|---|---|---|--|---|---|---|---|---|---|
| 28 | Main Bldg | Maint | 3 | • Replace all roof exhaust fans | 17 | ea | 3,000 | 51,000 | 73,950 | |

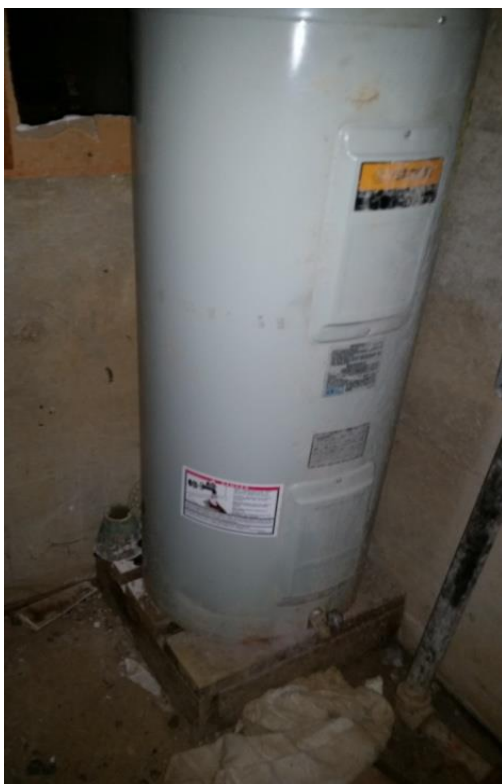
*Figure 18: Water Heater in Stage Pit without Seismic Bracing*

| No. | School | Category | Priority Source | Item | Qty | Units | Unit Price (\$) | Const. Cost (\$) | With Soft Cost (1.45%) | Notes |
|---|---|---|---|---|---|---|---|---|---|---|
| 49 | Main Bldg | Safety | 5 | • Replace water heater in mechanical pit and seismically brace | 1 | ea | 2,000 | 2,000 | 2,900 | |

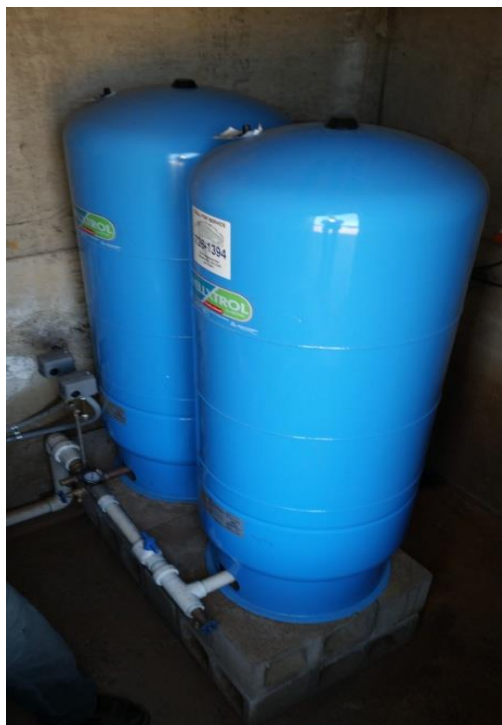
Domestic water piping is new in the boiler room around the new water heaters, although most of the distribution piping is older galvanized pipe. The school has a well for its source of domestic water. The pumps are located in a pump house to the northwest of the main building. Two new pressure tanks are in the pump house and do not have seismic bracing.

*Figure 19: Pump House Pressure Tanks without Seismic Bracing*

- Replace the water heater in the mechanical pit and seismically brace.
- Replace existing galvanized water distribution piping.
- Seismically brace pressure tanks in pump house.
- Replace older fixtures with new low flow fixtures.
- Relocate Science classroom emergency eye wash.

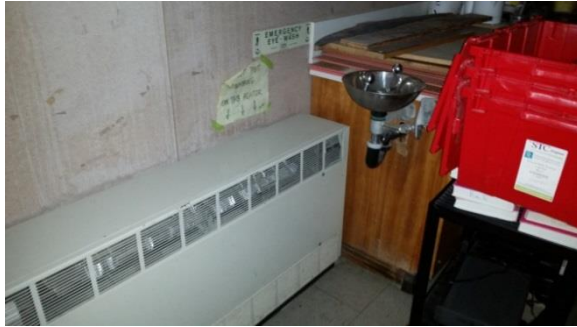
The Science classroom has an emergency eye wash that may splash on the electric unit ventilator console.

*Figure 20: Science Room Emergency Eyewash Close to an Electric Unit Ventilator Console.*

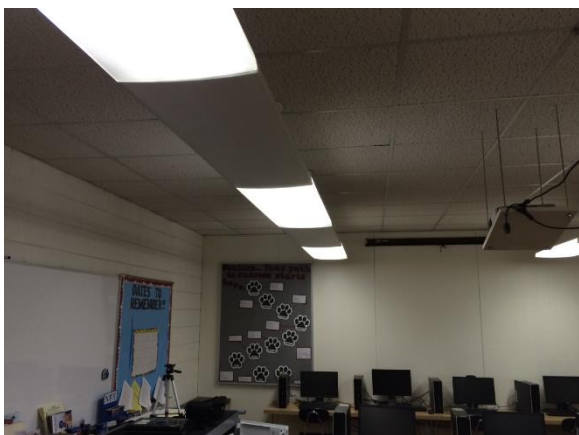
Building interior lighting consists mostly of lensed T-8 linear fluorescent luminaires in corridors, classrooms and support spaces. Some smaller spaces have compact fluorescent and incandescent lighting. All areas appear to be controlled by manual switches only.

Figure 24: Linear Fluorescent Pendants at Computer Lab Classroom

| No. | School | Category | Priority Source | Item | Qty | Units | Unit Price (\$) | Const. Cost (\$) | With Soft Cost (1.45%) | Notes |
|---|---|---|---|--|---|---|---|---|---|---|
| 12 | Main Bldg | Maint | 1 | • Replace existing fluorescent acrylic linear pendant luminaires with new – classrooms, support areas, cafeteria | 1 | lot | 75,000 | 75,000 | 108,750 | |

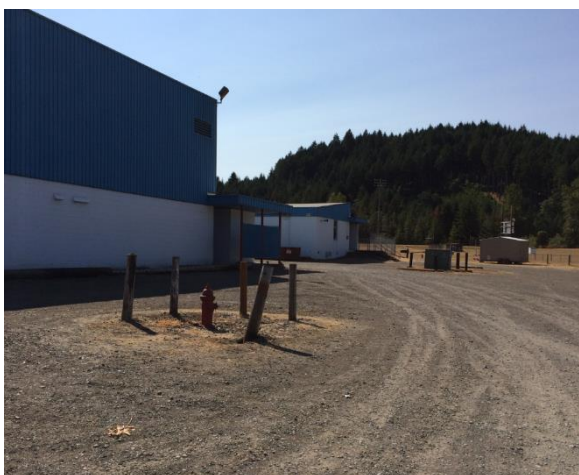
Figure 25: Floodlight Lighting at East End of Building and Driveway

| No. | School | Category | Priority Source | Item | Qty | Units | Unit Price (\$) | Const. Cost (\$) | With Soft Cost (1.45%) | Notes |
|---|---|---|---|--|---|---|---|---|---|---|
| 30 | Main Bldg | Maint | 3 | <ul style="list-style-type: none"> <li>Remove flood lights where coverage is aimed at parking and driveways. Provide new exterior pole mounted area lighting and pathway lighting to replace flood lights removed.</li> </ul> | 1 | lot | 20,000 | 20,000 | 29,000 | |

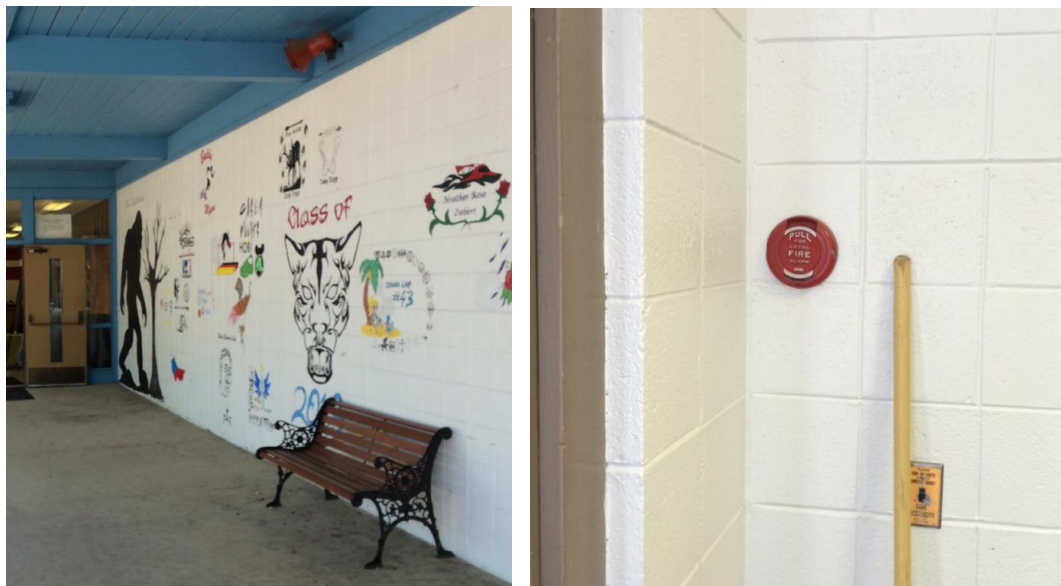
The fire alarm system consists of an old manual system with pull stations, and bells with several loud sirens for notification, with no visual strobe coverage. The District has expressed a concern with the annunciating sirens being excessively loud and that some devices have been physically muffled, disconnected or deactivated.

Figure 26: Fire Alarm Siren and Pull Station

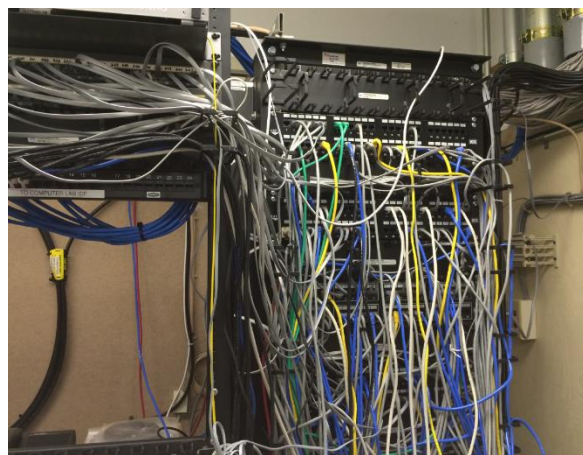
Figure 27: MDF Equipment at Computer Lab Classroom

| No. | School | Category | Priority Source | Item | Qty | Units | Unit Price (\$) | Const. Cost (\$) | With Soft Cost (1.45%) | Notes |
|---|---|---|---|---|---|---|---|---|---|---|
| 62 | Main Bldg | Maint | 5 | • Replace horizontal copper cabling and upgrade to CAT 6. 3 drops per classroom. | 1 | lot | 15,000 | 15,000 | 21,750 | |
