TOTAL ROOF MANAGEMENT

SUBJECT: ROOF ASSESSMENT REPORT FOR RINCON VALLEY UNION SCHOOL DISTRICT (RVUSD)

RINCON VALLEY UNION SCHOOL DISTRICT

ROOF ASSESSMENT REPORT

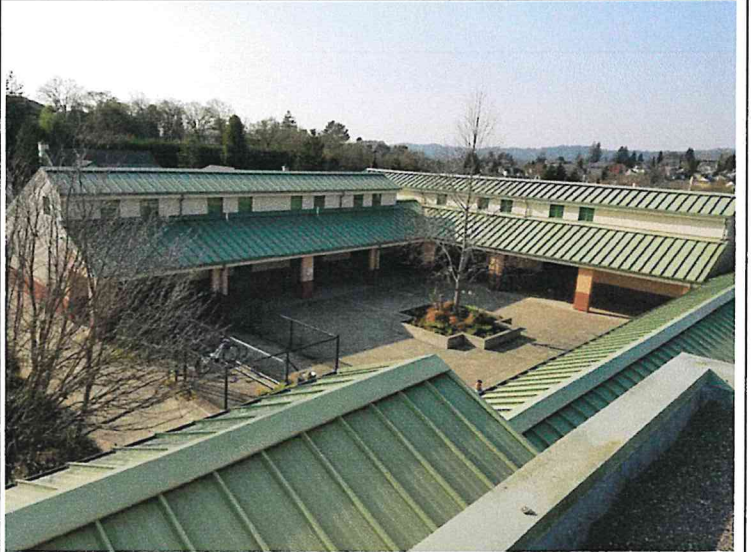
Photo 3

Panoramic view of standing seam metal roof systems at Austin Creek Elementary School. There were no reported roof leaks in the standing seam metal roof systems but there are, however, very bad gutter leaks caused by deteriorated / rusted gutters that are integral with the metal roof systems. (Photos 12, 13 & 14 show the deteriorated / rusted gutters.)

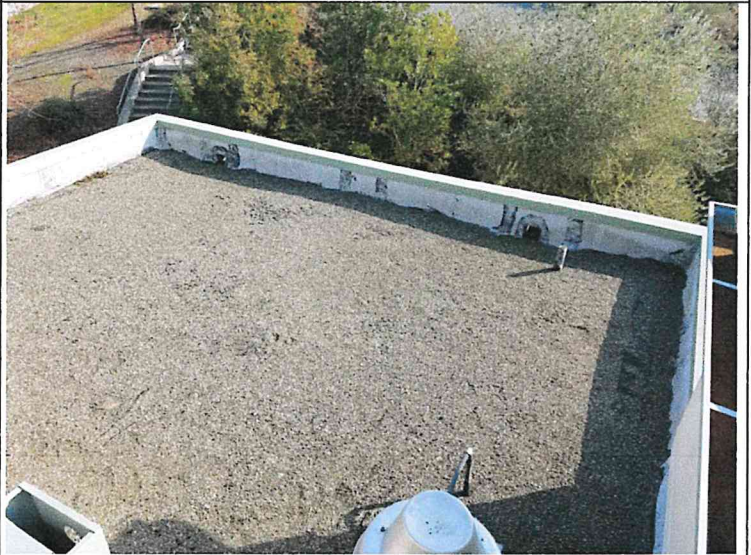
Photo 8

Panoramic view of a roof deck with gravel surfaced built-up roofing. While there are minor roof anomalies on the gravel surfaced roofs throughout the campus there were no reported roof leaks.

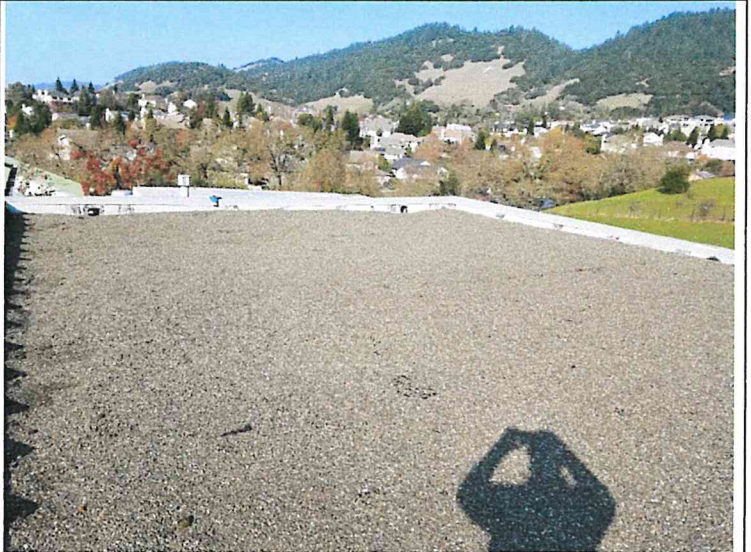
Photo 9

Panoramic view of a roof deck with gravel surfaced built-up roofing. While there are minor roof anomalies on the gravel surfaced roofs throughout the campus there were no reported roof leaks.

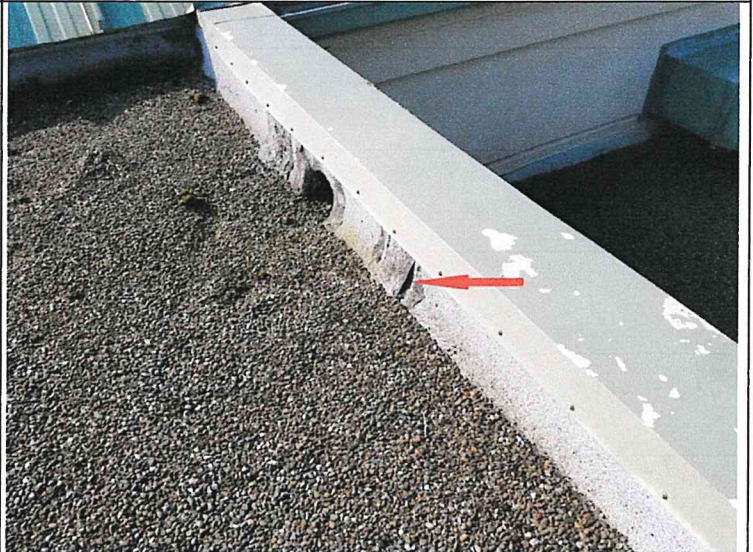
Photo 11

The indicator arrow is pointing at an opening in the seam of the base flashing on the short parapet wall separating two(2) roof decks. This minor flashing anomaly should be repaired as soon as it is feasible to do so. (Note: This membrane flashing anomaly is present on other roof decks in random locations on this campus.)

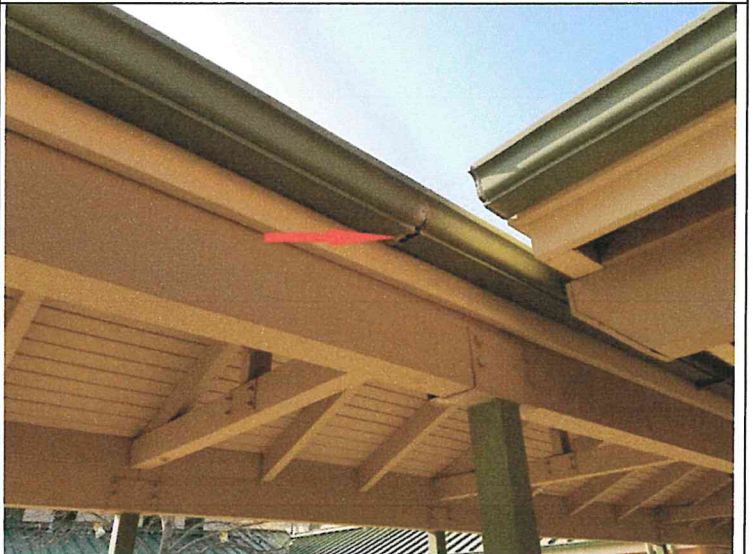
Photo 12

The indicator arrow is pointing a seam between two(2) lengths of gutter. The deteriorated solder joint is now rusted.

1. Remove and replace the badly deteriorated gutters as soon as possible.
2. Repair the flashing membrane anomalies as soon as possible.

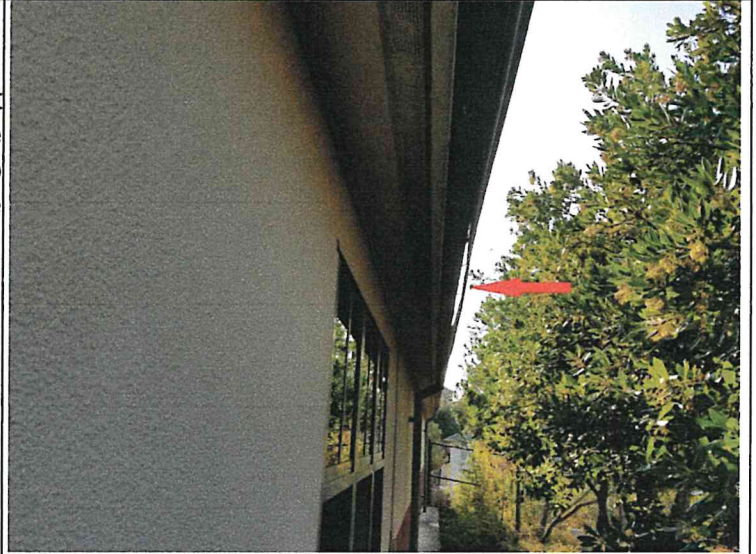
The indicator arrow is pointing at a length of gutter that is so badly rusted / deteriorated that you can see daylight through the bottom of the gutter. Needless to say the gutter is no longer functional and should be replaced as soon as it is feasible to do so.

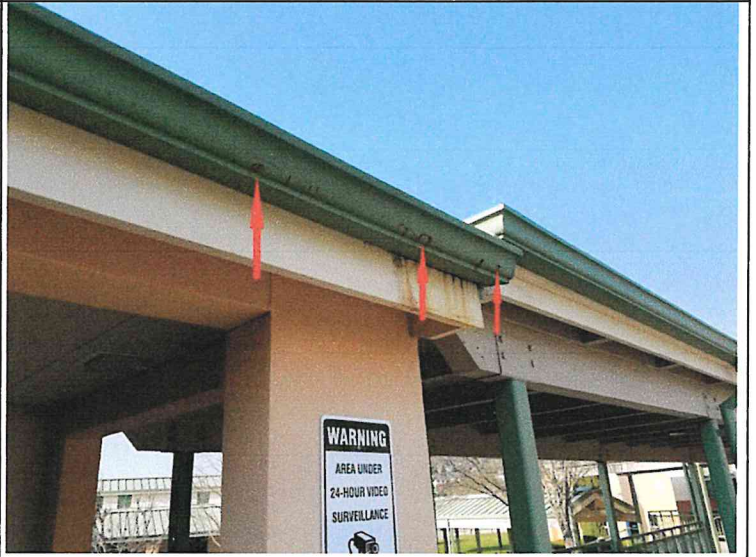
Photo 14

The indicator arrows are pointing at areas of a gutter length that is rusted so badly drainage water from the roof deck passes through the sheet metal gutter and stains the wood fascia.

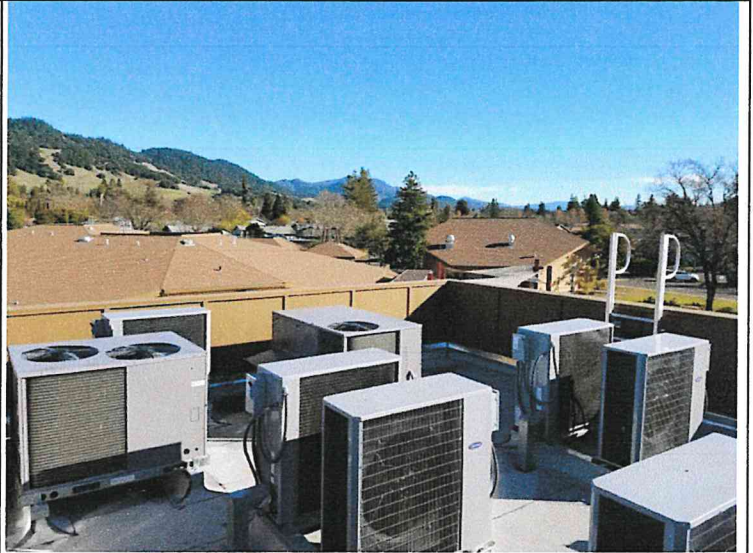
Photo 5 shows the mechanical equipment well on the new construction complex and built-up roofing. (Note: A leak into the interior space directly below this equipment well was reported and there was a stained ceiling tile but the leak may not be roof related; a follow-up investigation is required.)

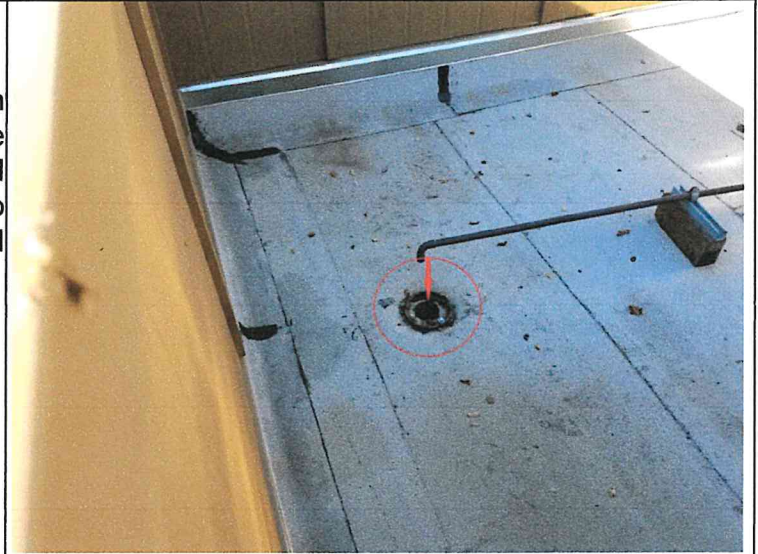
The circle and indicator arrow point-out a roof drain with a bolt missing on the drain ring which minimizes the pressure seal on the flashing membranes that extend into and beneath the drain ring; the strainer is also missing from the drain assembly. This condition should be repaired as soon as possible.

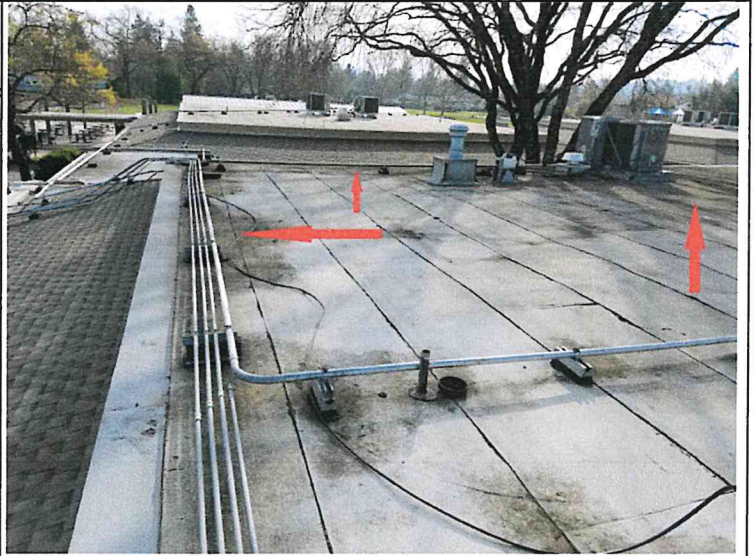
Photo 3

Panoramic view of the mineral surfaced built-up roof system on the School Office building. Note the indicator arrows pointing at the various stained / watermarked areas on the surface of this roof deck indicating the presence of ponding water during inclement weather; this is a typical condition on low sloped roof decks.

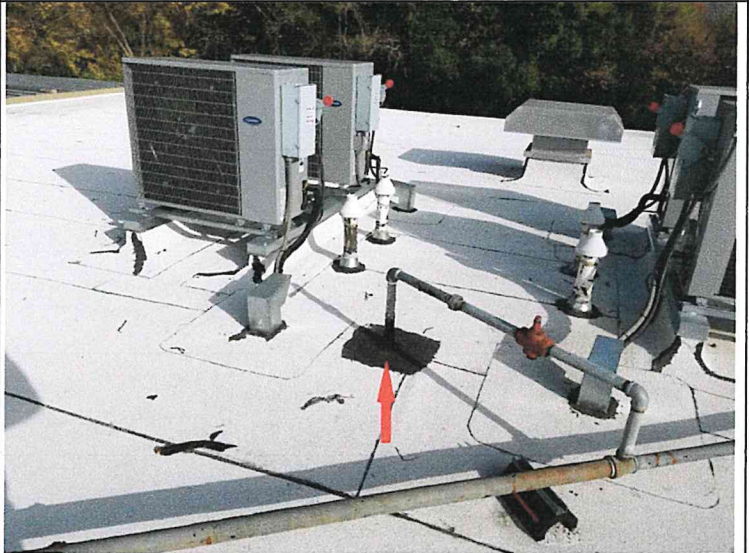
Photo 8

The indicator arrow is pointing a gas line penetration through the roof surface that is not properly flashed with flashing membranes. Additionally, it's not clear whether this roof penetration has a roof jack or if the sleeve of the roof jack is simply very short and not properly capped. This condition should be repaired as soon as it is feasible to do so.

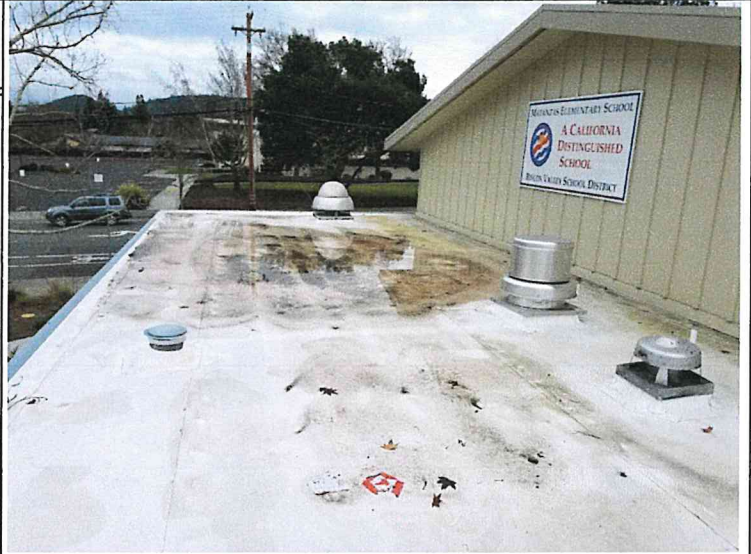
The single ply roof membrane shown in Photo #1 (Thermoplastic Olefin) has the largest portion of the roofing on this campus. Note in Photo #1 the standing or ponding water on top of the thermoplastic Olefin which causes premature degradation of the membrane.

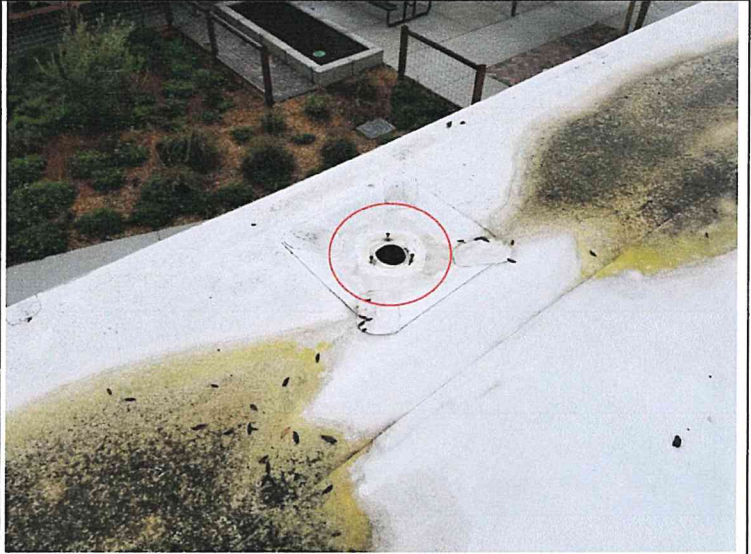
Photo 2

Inside the red circle in Photo #2 is a roof drain without a drain ring or strainer. Note the small bolts around the drain normally tighten the roof membrane under the drain ring holding it tight to the substrate and "squeezing" the membrane so no water can find its way under the membrane and into the interior space(s.) Also note the ponding water left & right of the drain which, again, is a typical condition at the roof perimeter of wood framed buildings. (Roof drains are usually located where they're supported by the building structure while the plywood sheeting making-up the roof deck spans the roof joists and can deflect / sag over time resulting in the roof deck being lower in spots than the roof drain.)

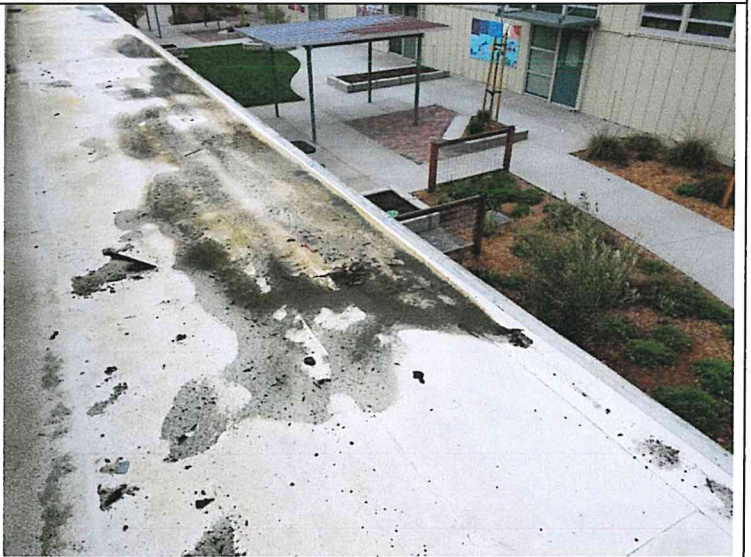
Photo 3

Photo #3 shows the roof deck of a walkway canopy with ponding water at the perimeter edge of the roof. Also note the dark gray color of the sediment at the bottom of the water which, I believe, is ash from the October 2017 firestorm. (Note: I did not see damage to any of the roof systems or roof membranes at this campus that made me suspect the damage was caused by last year's firestorm.)

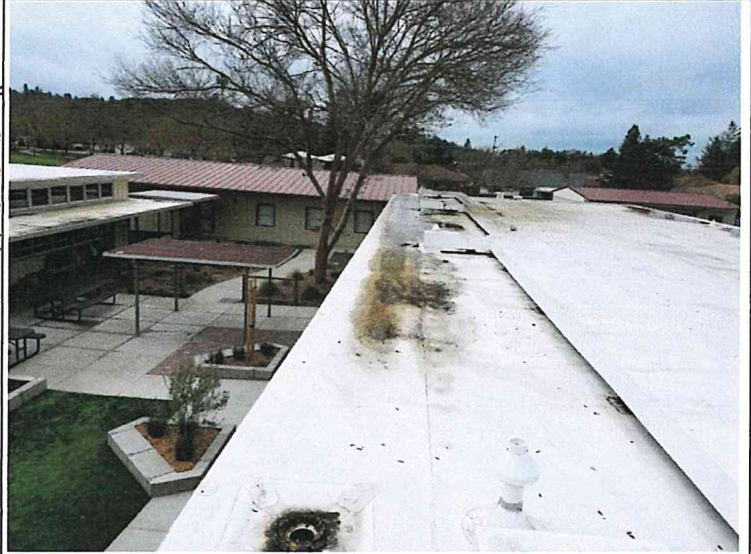
Panoramic view of the thermoplastic single ply roof system on the south side of Classroom Wing 2 (middle classroom wing.) Note the ponding water at the perimeter edge of the roof deck. Also note that the drain in the foreground has a drain ring but does not have a strainer.

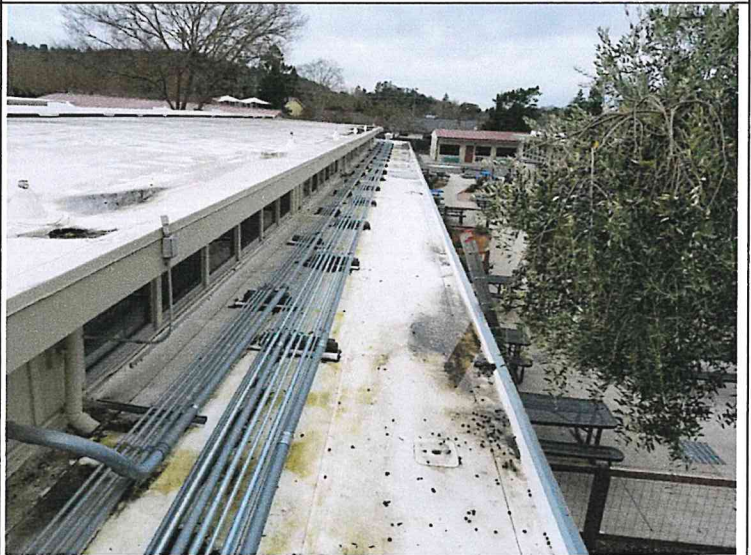
Photo 5

Panoramic view of the thermoplastic single ply roof system on the north side of Classroom Wing 2 including the walkway canopy contiguous with the classroom wing. Note the substantial conduit run down the walkway canopy as well as the ponding water conditions.

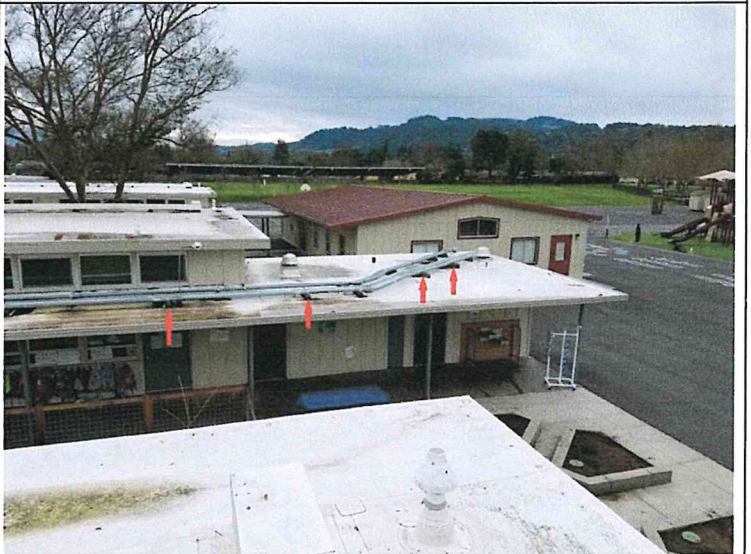
Photo 6

Panoramic view of the west end of Classroom Wing 2 and the walkway canopy roof deck that transitions to the roof deck over the restrooms. The indicator arrows are pointing at the "sleeper supports" for the conduit runs which are pieces of 4" x 4" lumber that have little membrane protection or cushioning beneath them and pose a of damaging the thermoplastic membrane. This condition should be corrected as soon as possible.

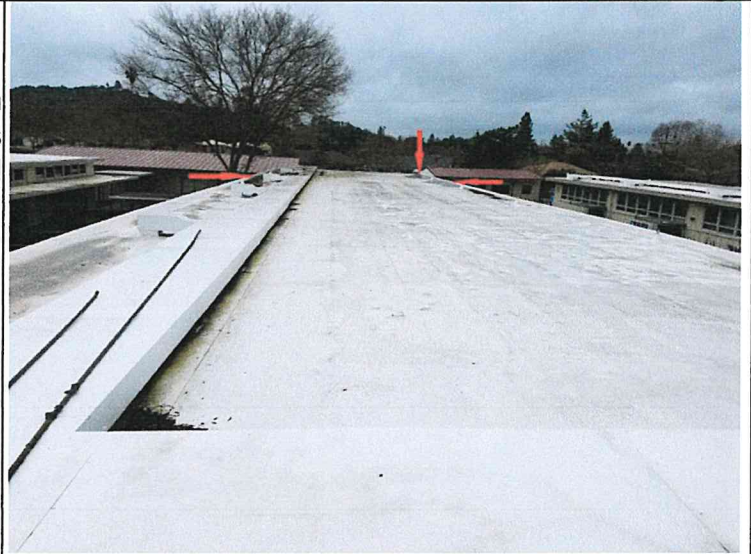
Panoramic view of the thermoplastic roof system down the center of Classroom Wing 2. The indicator arrows are pointing at severe ponding areas at the south and north perimeter edges of the roof deck.

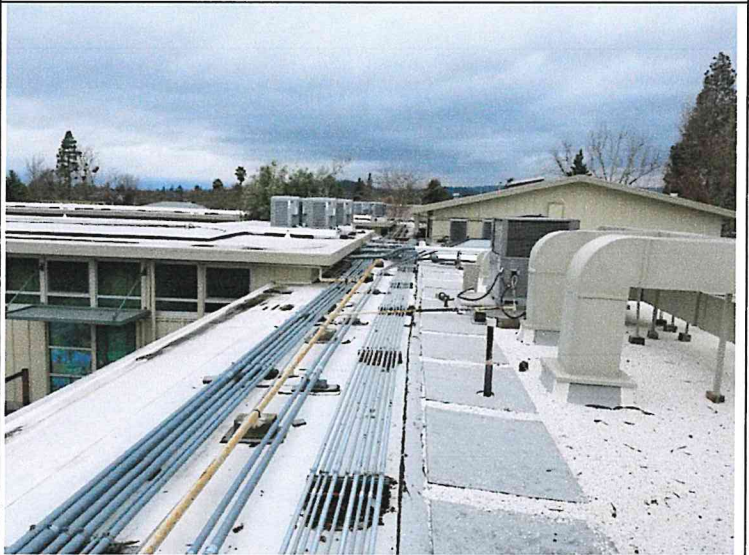
Panoramic view of the walkway canopy roof deck that runs north & south connecting all of the classroom wings, school office and M/U Building. Note the significant conduit runs down the middle of the walkway canopy as well as the gravel surfaced built-up roof system on the immediate right of the walkway canopy. (The gravel surfaced built-up roof was installed in the summer of 2016 so it's very new.)

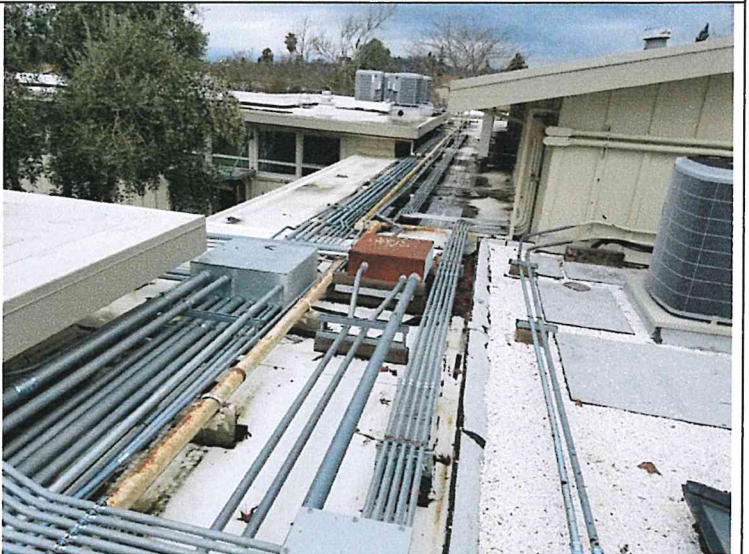
Photo 12

Photo #12 shows another view of the north / south walkway canopy from a different vantage point. The electrical conduit (and gas line) presents a **very** severe roof maintenance / roof replacement issue. The school office is immediately to the right, one(1) step up from the walkway canopy.

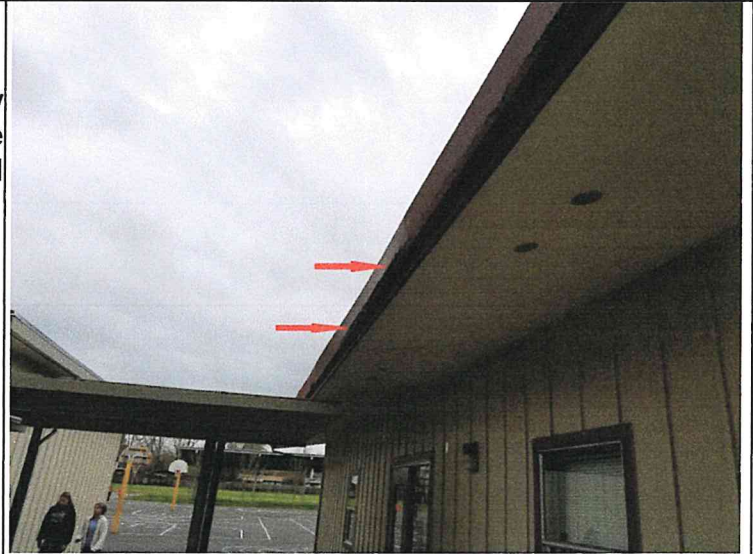
The indicator arrows are pointing at the very badly rusted and deteriorated gutter on the east side of the Library/Media Building. The gutter should be removed and replaced as soon as it is feasible to do so.

1. Replace the deteriorated gutter on the Library / Media Building.
2. Plan for the roof rehabilitations of the mineral surfaced built-up roofing and the thermoplastic single ply roofing.

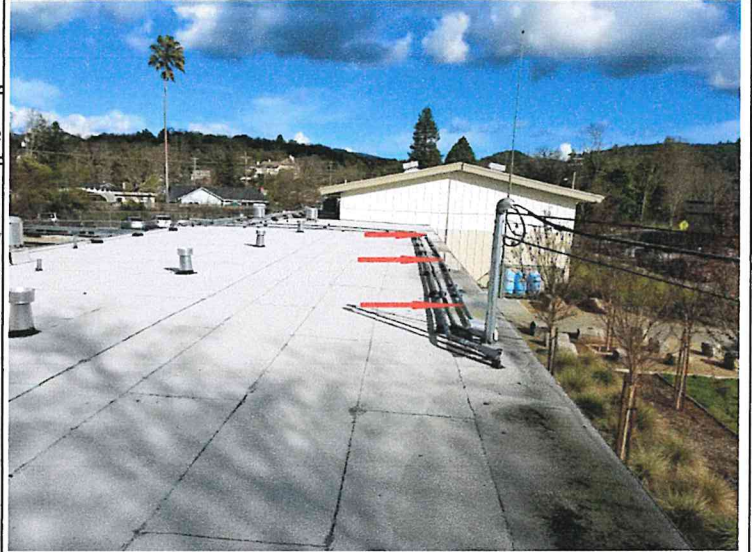
Panoramic view of the mineral surfaced built-up roof system on the School Office Complex. Note the indicator arrows pointing at ponding water along the roof perimeter on the south side of the building. Ponding water at the roof perimeters and over the walkway canopies is a typical condition at this campus during the inclement weather season.

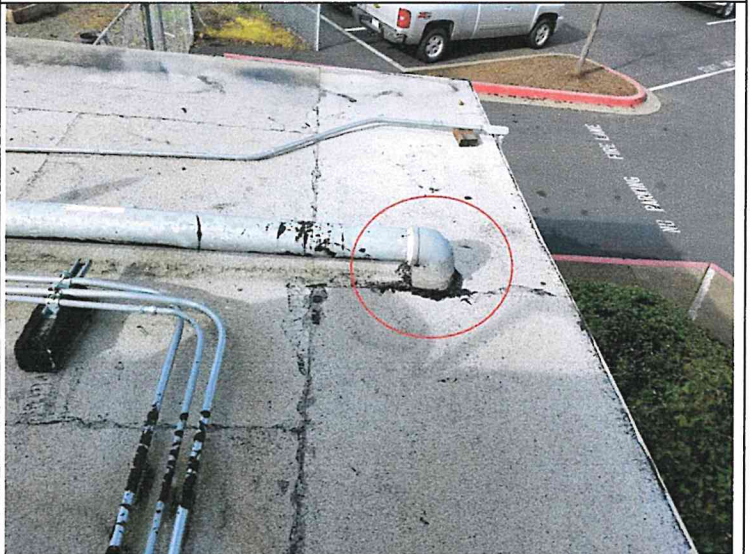
Photo 3

Inside the red circle you'll see a gas line penetration through the roof system that does not have the proper height for a roof jack to be properly installed & flashed to permanently seal the penetration. At this time water is prevented from entering the interior space by the asphalt roof mastic around the penetration. This condition should be repaired as soon as it is feasible to do so.

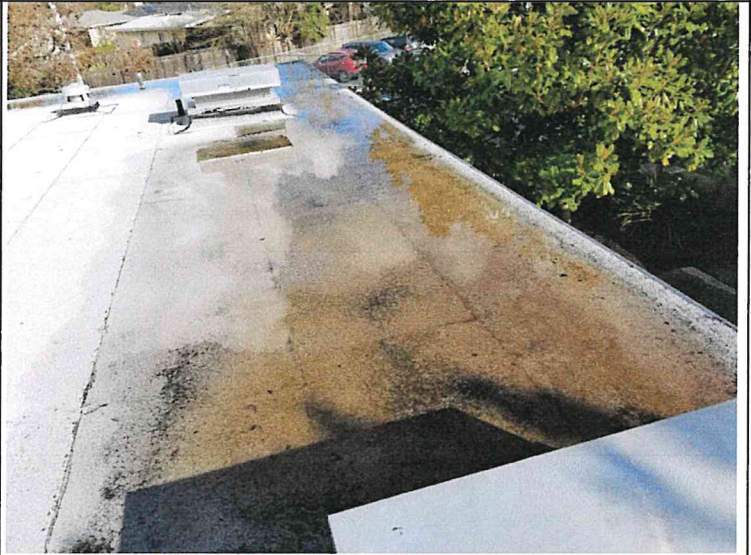
Photo 11 shows the southeast corner of Classroom Wing 2. Note the severe ponding water condition on the south perimeter of the roof deck.

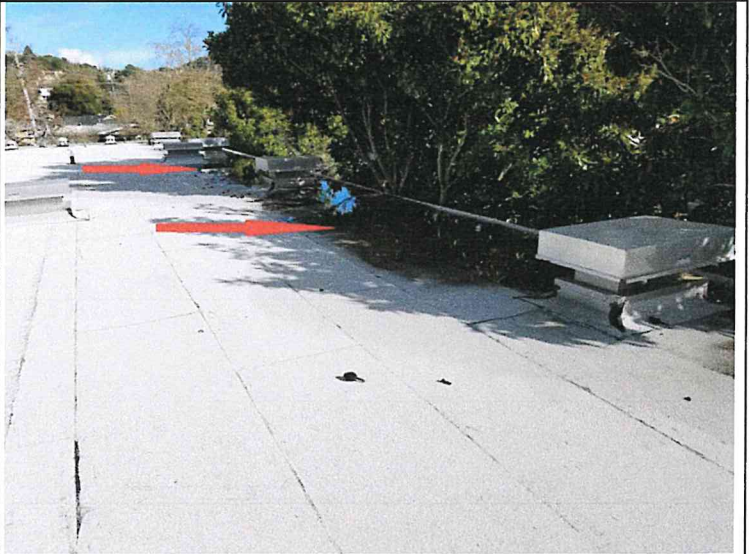
Photo 12 also shows the south perimeter edge of the roof deck on Classroom Wing 2 but is taken approximately 60 feet further to the west in order to show that the ponding water condition is severe virtually the whole length of the classroom building. The indicator arrows point at severe ponding water conditions.
