# Oakridge Junior/Senior High

## Findings

AHERA  
ASBESTOS INSPECTION  
FOR

OAKRIDGE HIGH SCHOOL

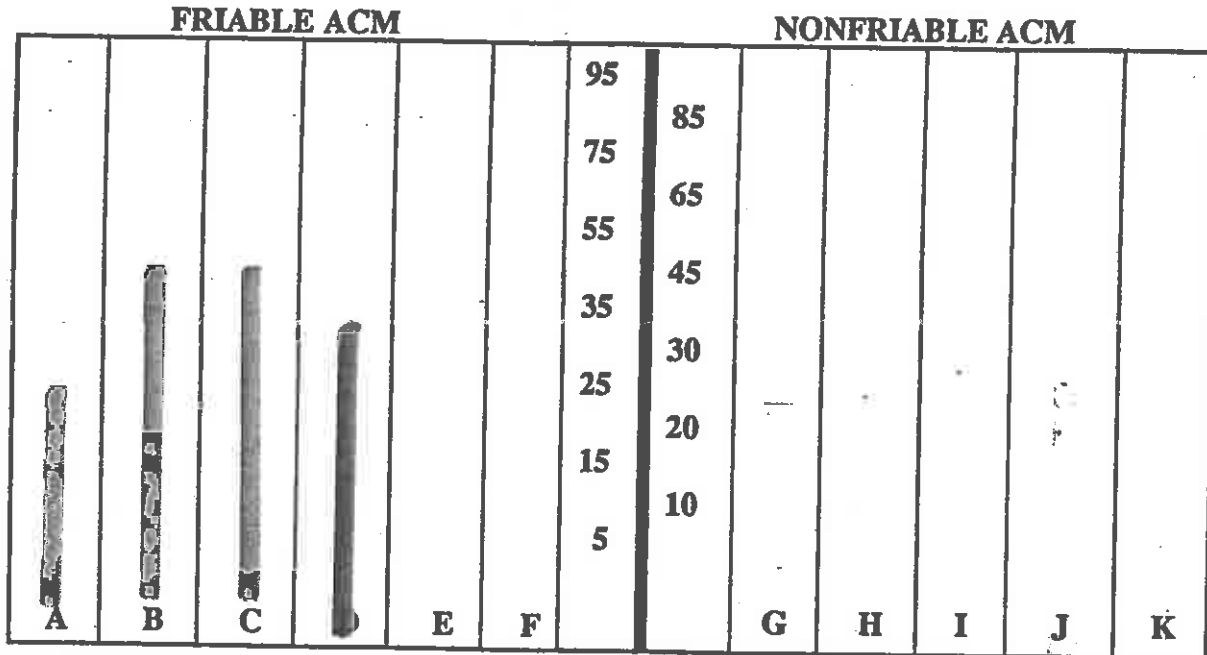
OAKRIDGE HIGH SCHOOL  
HAZARD ASSESSMENT OVERVIEW

This hazard assessment overview is designed to provide a comparison of the friable and nonfriable hazards that actually exist within the facility. The chart is rated from 5 points (the lowest hazard) to 95 points (the highest hazard). The chart also distinguishes between friable ACM and nonfriable ACM.

A.	Thermal: Boiler room, pipe covering	24.0
B.	Thermal: Pipe covering (wood shop)	44.4
C.	Thermal: Domestic water line joints (wood shop)	44.4
D.	Thermal: Pipe Covering	31.2
E.		
F.

G.	9"X9" Floor tiles	22.18
H.	12x12 Floor tiles	24.2
I.	MISC - Transons/Transite	28.8
J.	MISC - Transite/Kitchen & Rm. 104	26.2
K.

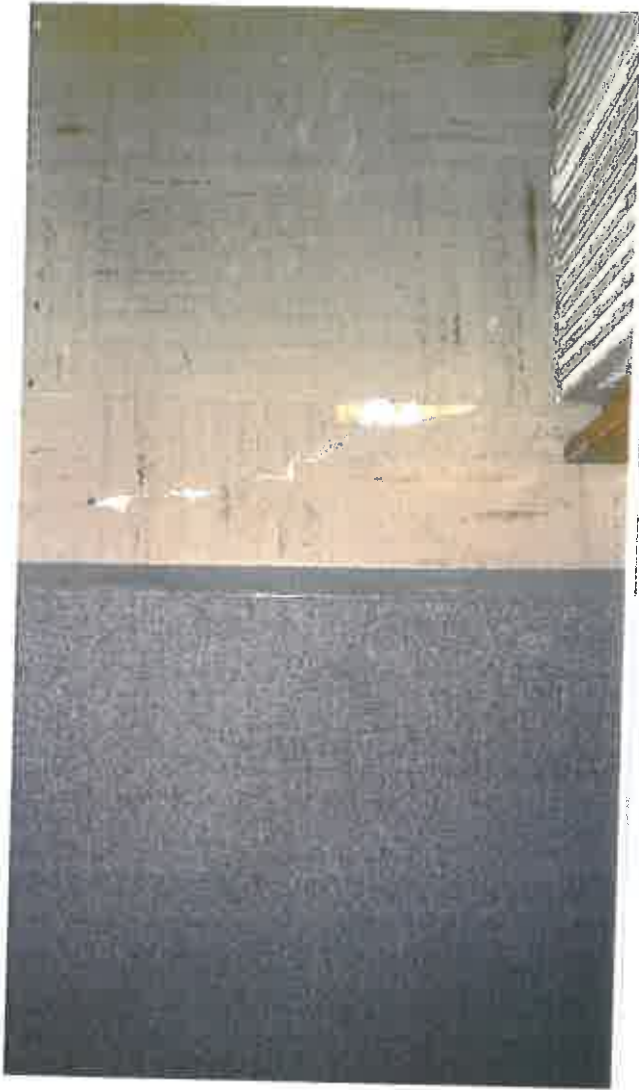
H3

Most of the 9x9 tiles are in good condition with exception of a few broken tiles in the library. (H3) The rest of the 9x9 tiles are in small storage rooms throughout the school are in good condition and very few staff members come in contact with them.(see H4 for locations)

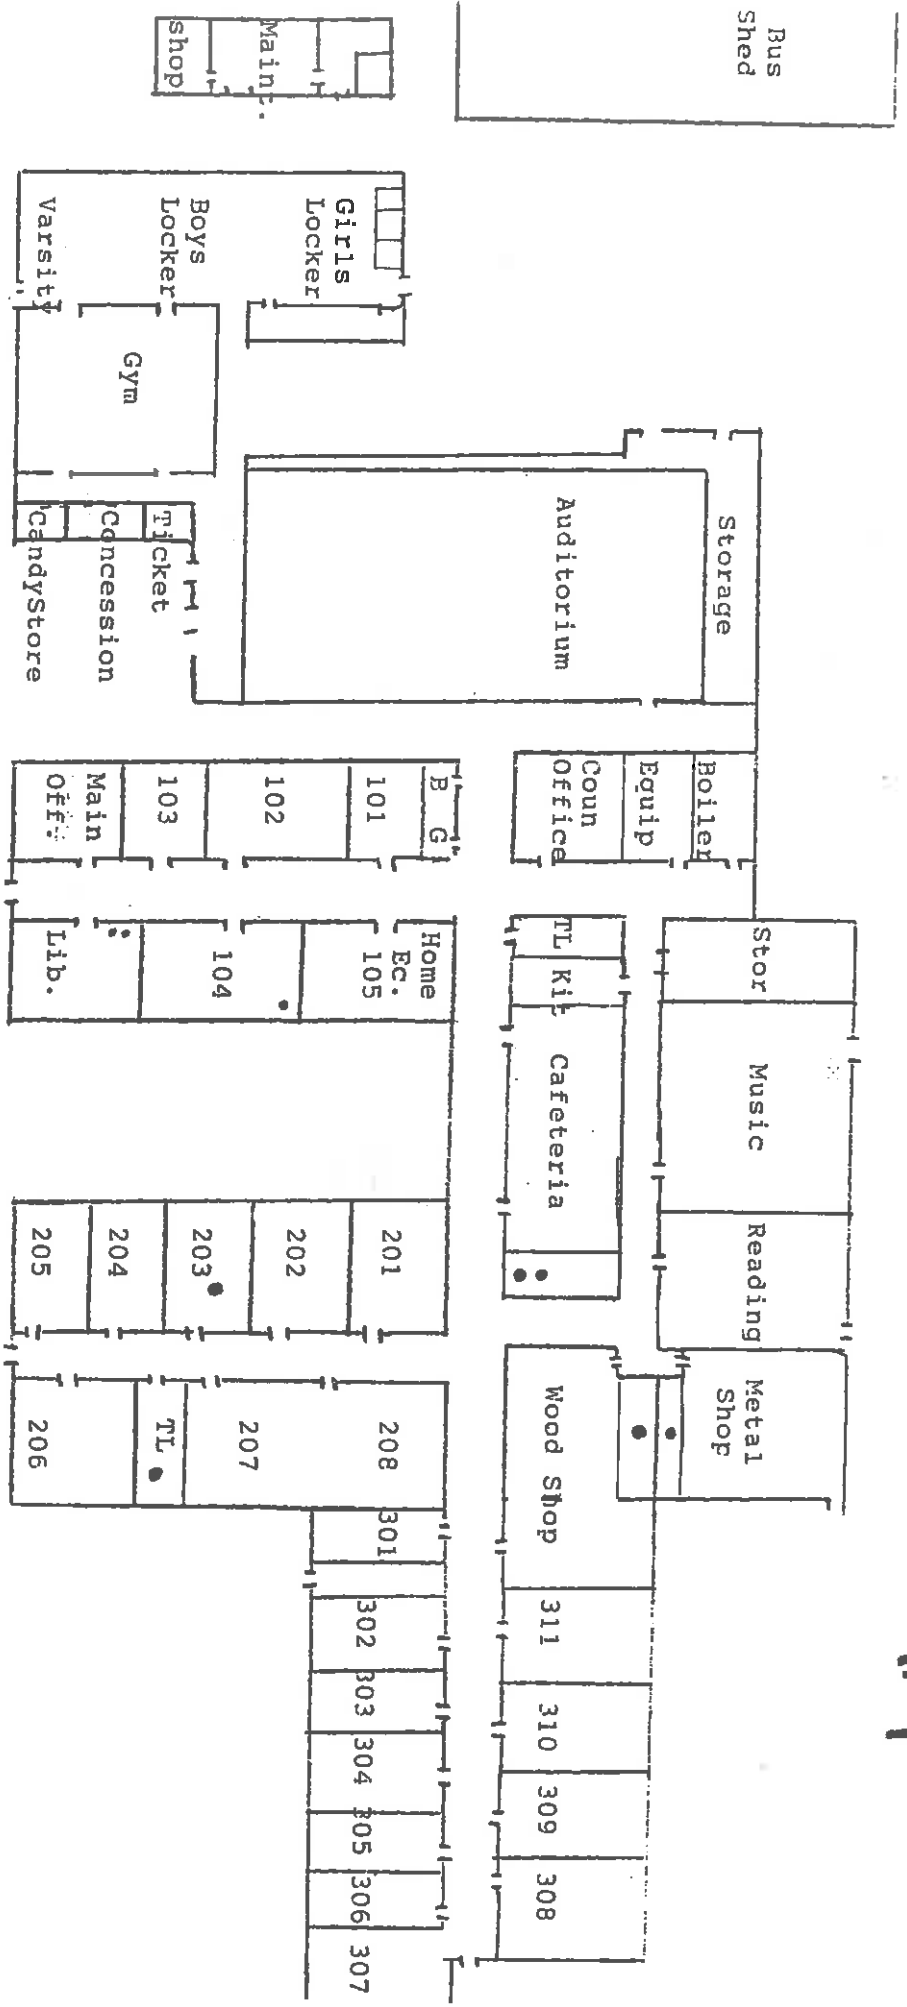
**OAKRIDGE HIGH SCHOOL**

12"X12" Floor Tiles

● 9"X9" Floor Tiles

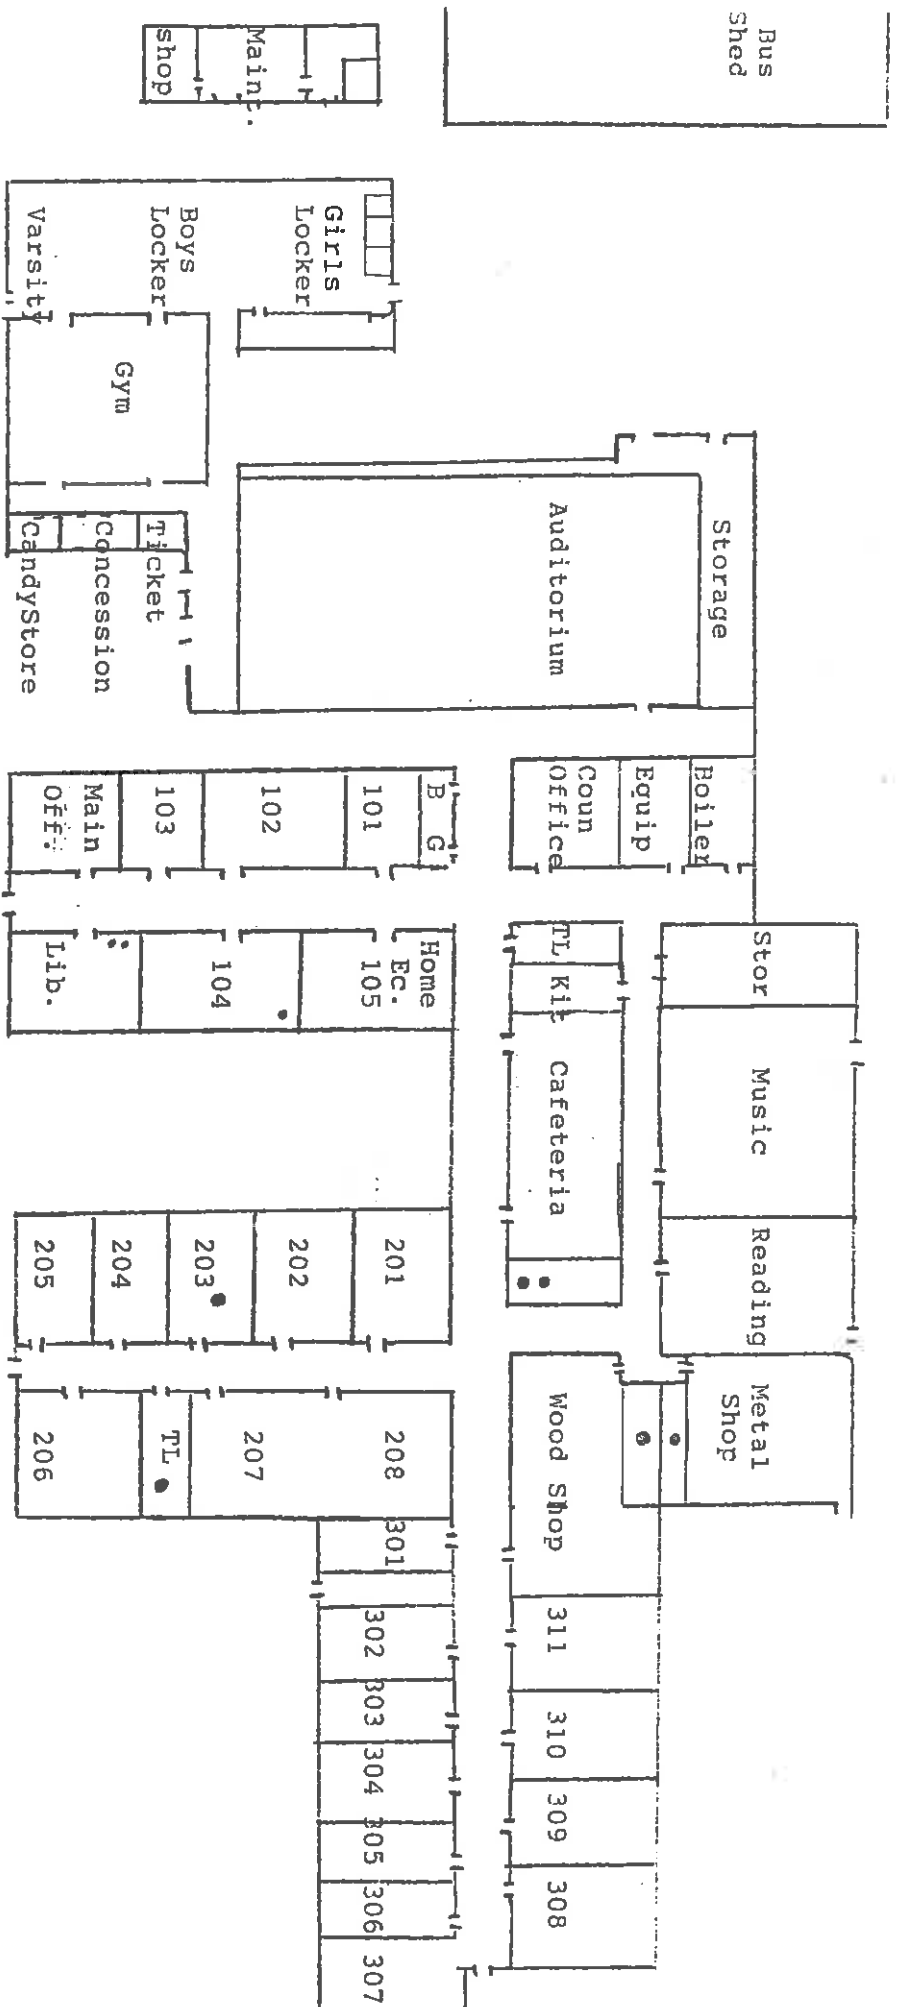
# OAKRIDGE HIGH SCHOOL

12"X12" Floor Tiles

● 9"X9" Floor Tiles
