Kermit ISD
Facilities Assessment
February, 2019

Executive Summary

Kermit Independent School District requested a facilities assessment by the Texas Association of School Boards Facilities Services program. The purpose of the facilities assessment was to measure the quality and educational effectiveness of school facilities, to understand the existing conditions and operational links of the systems and building components, and to provide the basis for a long-range facility plan.

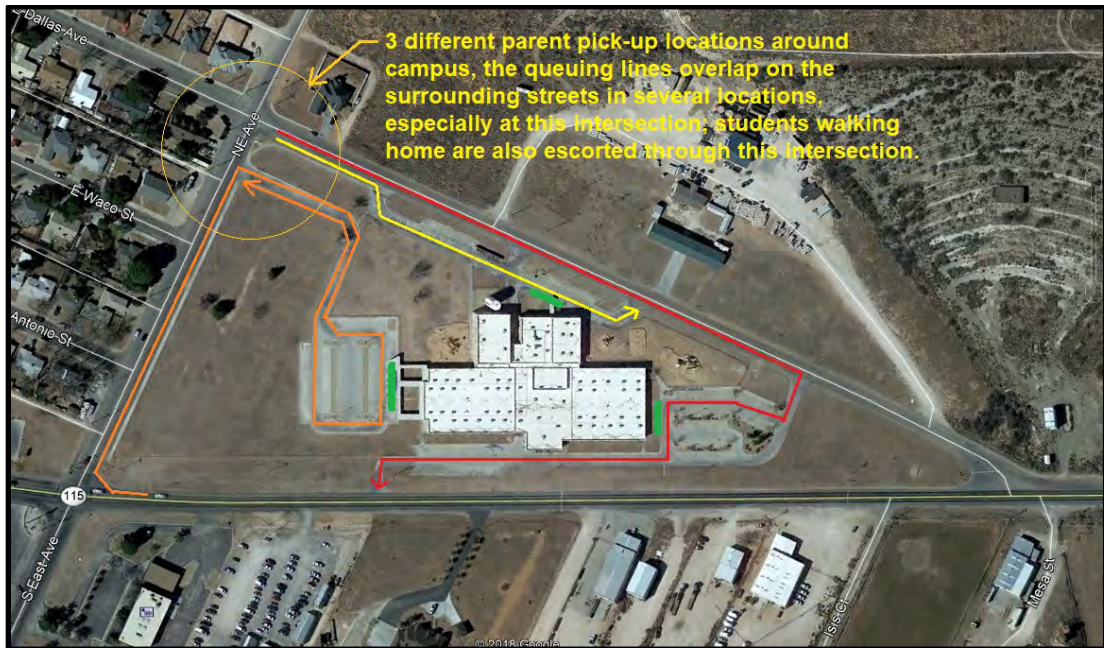
3.1 Student Loading Areas

- Bus loading for drop-off and pick-up generally moves smoothly. Afternoon bus pick-up traffic takes approximately 5 minutes to disperse.
- Parent loading for afternoon pick-up takes place at three different pick-up locations; parent vehicles at all three pick-up lines back up onto adjacent streets with some adjacent lines parallel on the streets, and one line backed up onto Highway 115 at peak volume; however, most vehicles appeared to be aware and respectful of the expected vehicle patterns which resulted in a generally smooth process. Afternoon parent traffic took approximately 25 minutes to disperse, due primarily to the high volume of cars (very few students are bus riders). Some students that are walking home or to waiting cars in the residential area do cross vehicles that are in the student pick-up lines; staff members assist the walkers to the initial off-campus location.

- The district should consider redesigning the parent/bus loading area to provide a more orderly and safe process; perhaps additional queuing driveways could be provided on campus to help reduce the number of cars that back-up on the adjacent streets and highway.
