La Farge School District 2020 FACILITY ASSESSMENT REPORT

La Farge School District

HSR Associates, Inc.

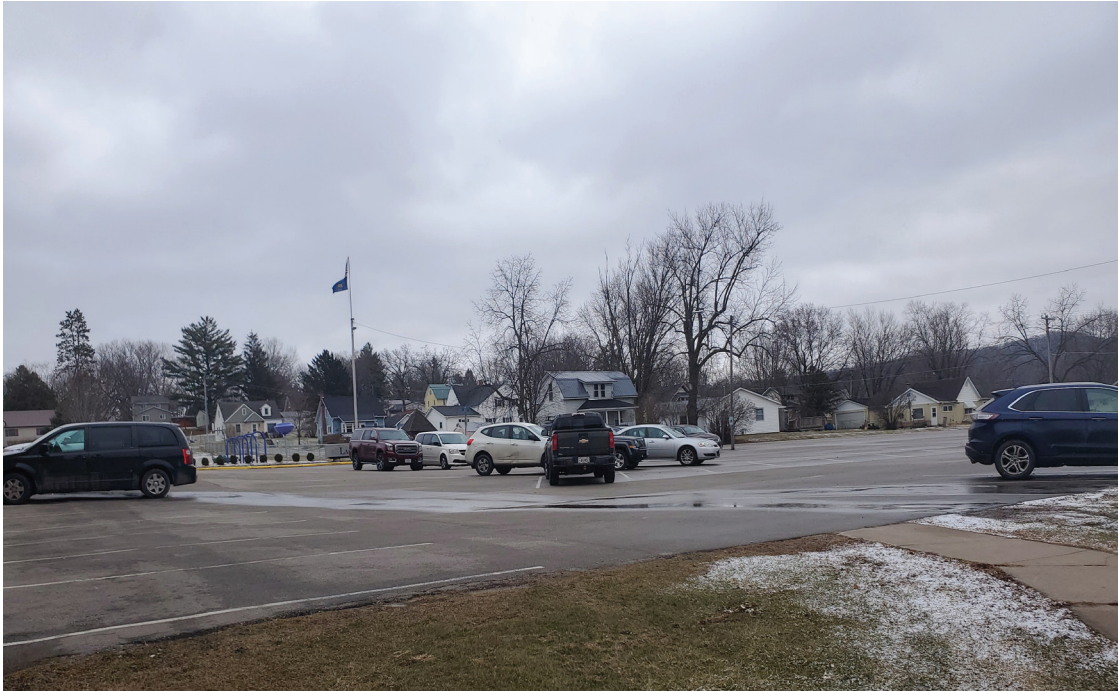
Parking/Traffic Flow

Currently, the vehicle traffic and parking are all south of the building adjacent to the main entry. The staff and visitor share the same entry and exit. The traffic is organized with a one way directional flow. North Silver Street serves as the entry for the site. While most people are used to this flow, it can cause confusion for visitors not familiar with the traffic flow. Also, combining the drop-off and pick-up with the same drive lanes for the parking areas can cause greater congestion. Through on site observation, the traffic flow seems to work for the regular traffic volumes.

The overall parking count on the south is adequate for both staff and students for normal school days. As is the case for many school districts, there is increased pressure for overflow parking for events. The overflow parking is limited for events, and often the street serves these purposes.

As part of long term site planning with limited site area, we would recommend looking at options for further parking lot expansion and site traffic improvements. If adjacent residential properties become available, it is recommended to look at options to procure them over time for future site flexibility.

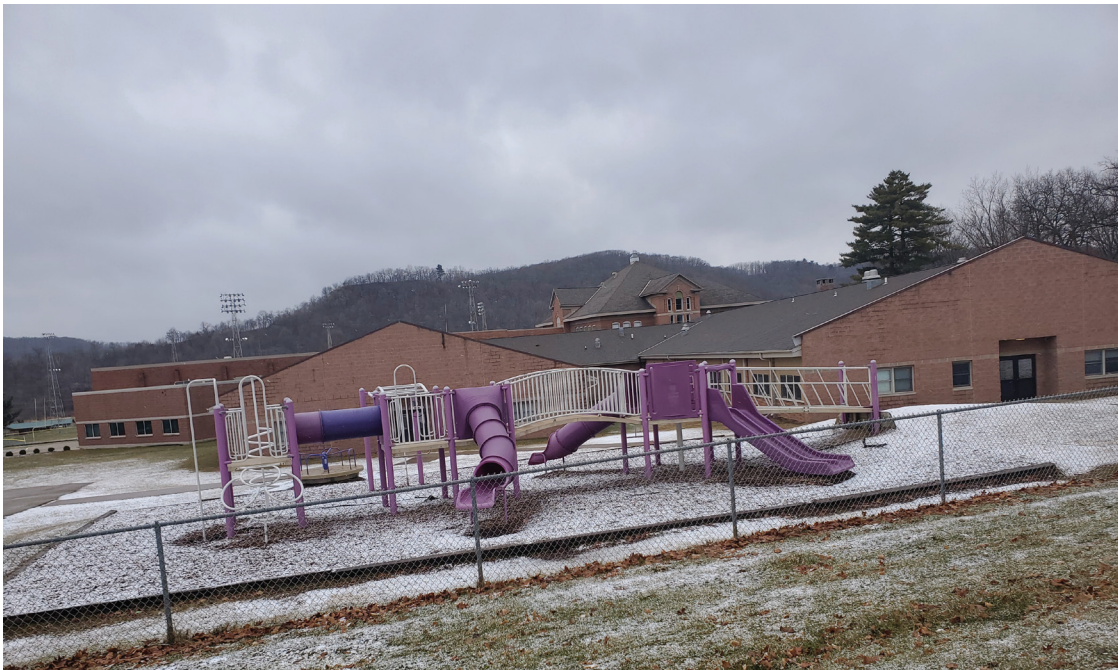
Playground/Green Space

The playground and overall play green space on site are limited. With the additions over the years, the green space has become more limited. Having adequate green play space is critical for development for the young children. If adjacent residential properties become available over time, the addition of more green play space should be evaluated.

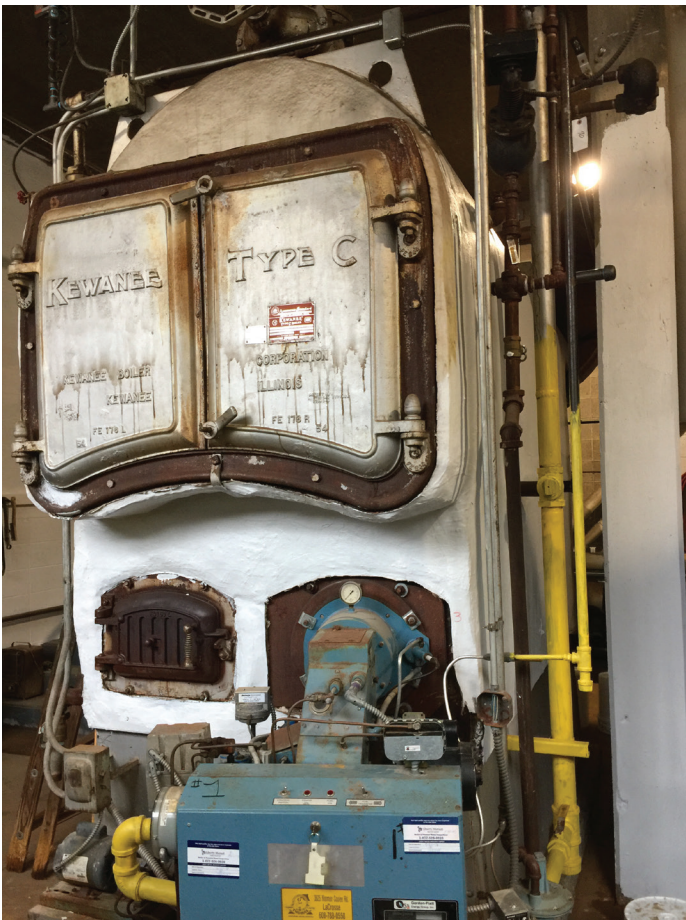
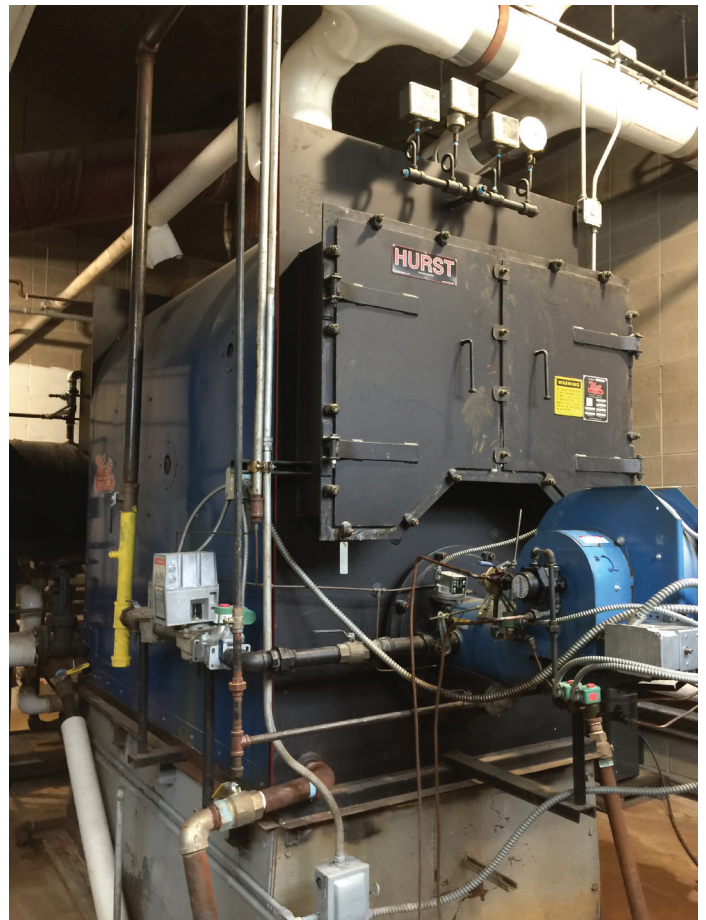
HEATING SYSTEMS

The majority of the school is served by two steam boilers. One is a Kewanee Series 2X gas fired steam boiler that is original to the 1963 building addition. The second boiler was replaced in 2001 and is a Hurst FB505-15-10. The capacity of the boilers is 3,089,00 BTUH for the 1963 Kewanee and 3,485,00 BTUH for the 2001 Hurst. The Kewanee boiler is starting to fail as some of the tubes have been replaced or capped. The Kewanee boiler is beyond its expected useful service life and is used primarily as a backup boiler and on really cold days when necessary. Estimated service life is projected to be approximately 25-30 years for this type of boiler. Efficiency of the boiler is around 65-70%. The burners are dual fuel, natural gas and fuel oil. Utilizing interruptible natural gas isn't as big of a savings in operational costs as compared to firm gas rate as in previous years. Steam is distributed in piping running through tunnels below the floor. Condensate lines are also located in the tunnel and condensate pumps return the condensate to the boiler feed tank. Steam pressure is 5-10 psig. The steam and condensate piping are original to the 1963 building and are showing their age with leaks. There is a portion of steam pipe from the tunnels of the 1963 building addition to the original 1901 building that is direct buried with no access. These pipes have leaks which are not accessible to repair. Steam was previously utilized to heat domestic hot water in the storage tank. The steam heated domestic hot water system has since been abandoned and replaced with separate domestic hot water heaters.

Replacement of the existing steam and hot water boilers with new high efficient condensing boilers. With the new technology available today that wasn't available when these systems were installed, it is possible to achieve better efficiencies. Condensing boilers allow efficiencies in the +90% when hot water temperatures permit. New hot water piping shall be run overhead to provide better access for service. Steam and condensate piping should be removed as the insulation may likely contain asbestos.

The steam boilers supply steam directly to a portion of the existing building for heating and ventilation purposes. These air handling units should be replaced and that portion of the building converted to hot water heating. The entire steam system including boilers, piping, coils, and condensate pumps shall be removed. The existing tunnel system shall be abandoned with the new heating system because there are water and maintenance access issues with the tunnels.

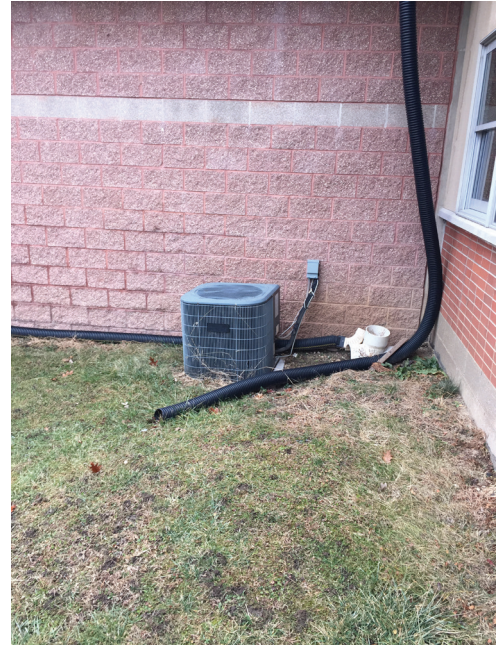
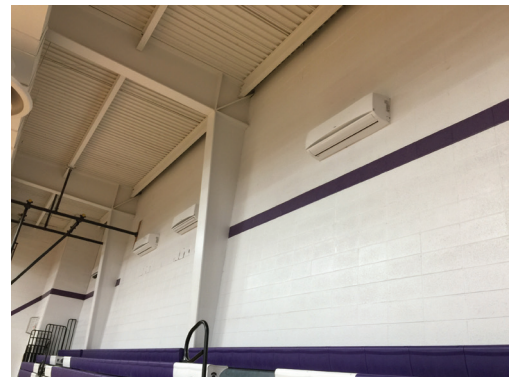
COOLING SYSTEMS

Most of the building is not air conditioned. The library and AV/Library Storage have A-coils mounted on the discharge of the furnaces that serve them. The condensing units sit on grade just outside the building. The condensing units and coils are Luxaire using R-410A refrigerant.

The gym has (4) 3-ton minisplits mounted above the bleachers. The condensing units are located on the roof using R-410A refrigerant. Typically minisplits perform well for spot cooling applications. During summer, these minisplits will have a hard time keeping up with bringing in warm/humid outside air for code required ventilation when the gym is occupied.

For the gym and kitchen cooling, cooling would be better served being tied into the main air handling units (gym) and makeup air units (kitchen). This way, outdoor air is pre-conditioned before it enters the space, mitigating humidity issues and having better temperature control during the summer.

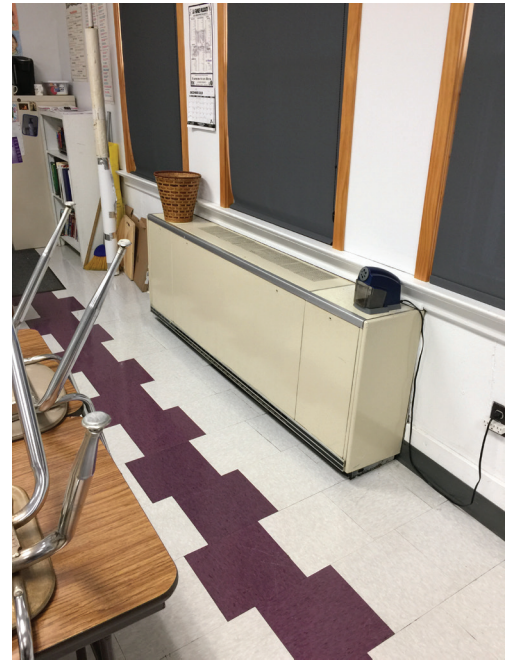
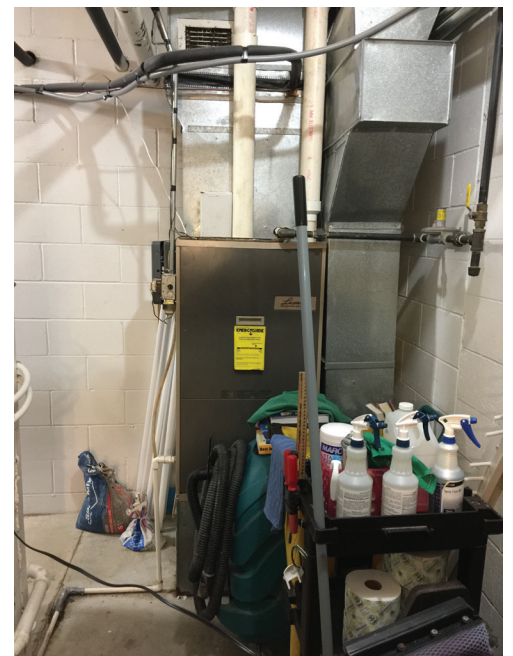
VENTILATION SYSTEMS

The majority of the existing building including the 1963 addition have steam unit ventilators installed on an exterior wall. The unit ventilators consist of a filter, a steam heating coil, a fan, outdoor and return dampers. All of these components require service in the Classroom which is disruptive to teaching. The noise from the unit ventilators is also disruptive to teaching. With the age of most of these unit ventilators being from the 1963 addition, these units are well beyond their useful service life.

A portion of the school has the original air handling units with the steam coils that should be replaced with units with hot water coils and cooling, if desired. The areas involved are the Gym and Old Gym/Cafeteria. Locker rooms, shop areas and music have horizontal type steam unit ventilators mounted up high at the ceiling level.

In the 1996 addition, the corridor space is being used as a return path for the furnaces. This is not allowed by code anymore because of life safety issues. If we are doing extensive work to this area, work will have to be done to resolve the problem and bring this up to code standards. If no major work is done in this area, code updates would not be required.

All of the existing exhaust fans in the building should be evaluated and replaced during this upgrade. Many of these fans are original and beyond their useful service life. Replacing the fans will improve exhaust flow and overall function of the systems. The existing dust collector and welding exhaust system should be replaced with the upgrade in these spaces. The dust collector appears not to be functioning properly. If the system is modified, there are some code deficiencies with this system that will need to be addressed.

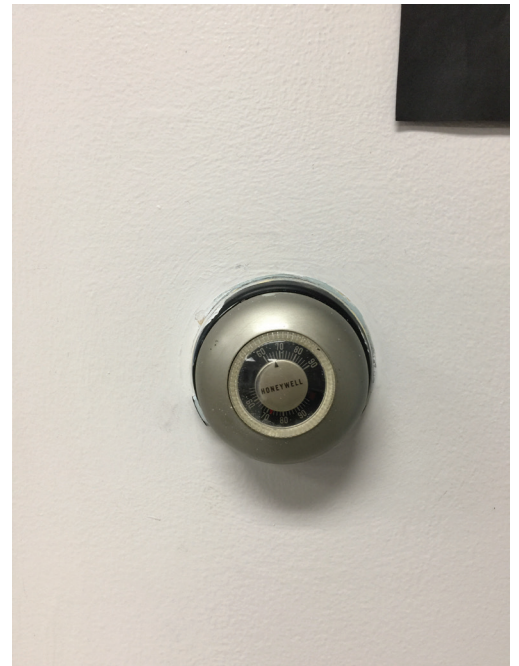
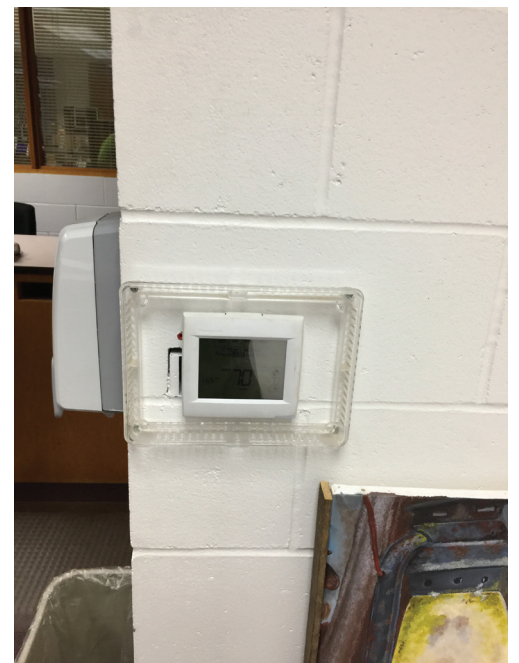
CONTROL SYSTEMS

The majority of the school is served by pneumatic controllers or standalone electric thermostats. Much of the existing building have outdated controls, and temperature control is an issue with the steam heat.

Recommend converting the entire building to a central building automation system with direct digital controls (DDC). DDC controls are more reliable, precise, provide feedback relative to the controller position and can be trended for troubleshooting. When building automation systems and direct digital controls are combined, it allows for automated control of the temperature and ventilation throughout the facility. For example, the system can adjust temperatures in spaces based on season, occupancy, time of day, or day of week to reduce energy consumption. The system can also reduce the amount of outside air being brought into the building during unoccupied times thus saving on heating or cooling that air. They can adjust boiler supply water temperatures based on outside air temperature, which works well for condensing boilers in shoulder months. This system also has the capabilities to send out alarms for break downs, failures, and hazards that many times lead to costly situations being avoided. Pneumatic controls require a lot of continual calibration and maintenance to maintain accuracy.

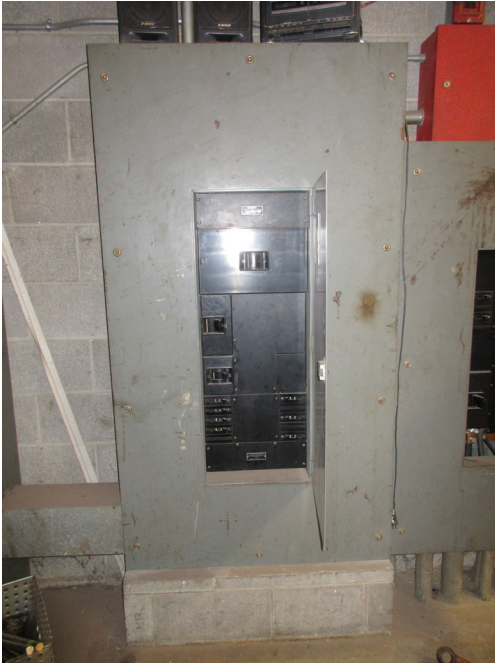
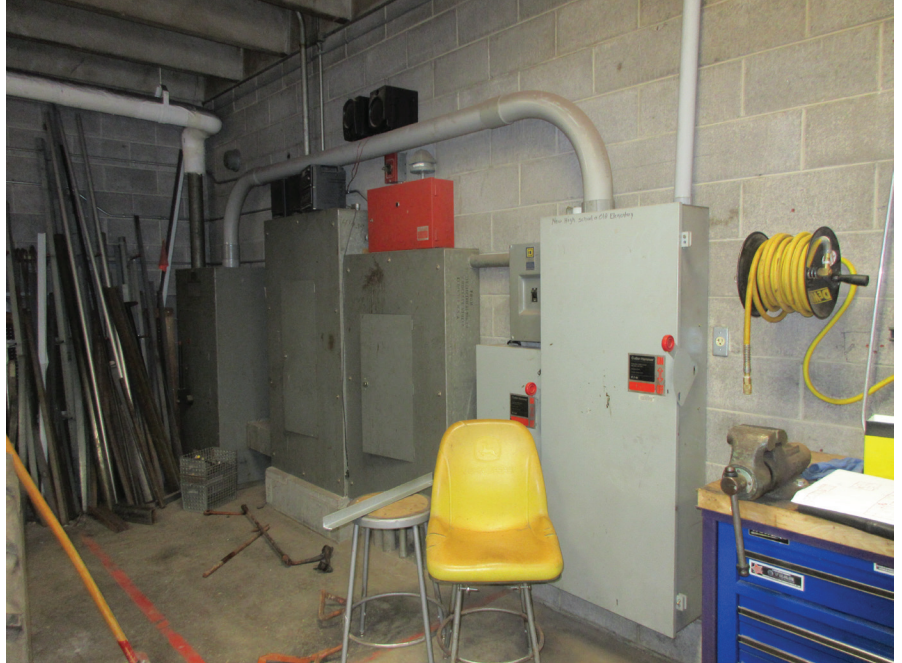
Building Service Entrance and Primary Distribution Equipment

The electrical service to this building is 120/240volt, 1-phase, 3 wire. The service is underground to the building from a nearby power pole. The building has a 1200 amp service panel with main breaker. The equipment is older 1961 Kinney type with safety switches feeding subsequent additions and remodel areas.

The current service is 1200 amps, 120/240 volt, 1 phase. Current service is undersized for any large additions or implication of mechanical cooling systems. Replace existing electric service with new 480 volt, 3 phase, 4 wire Service.

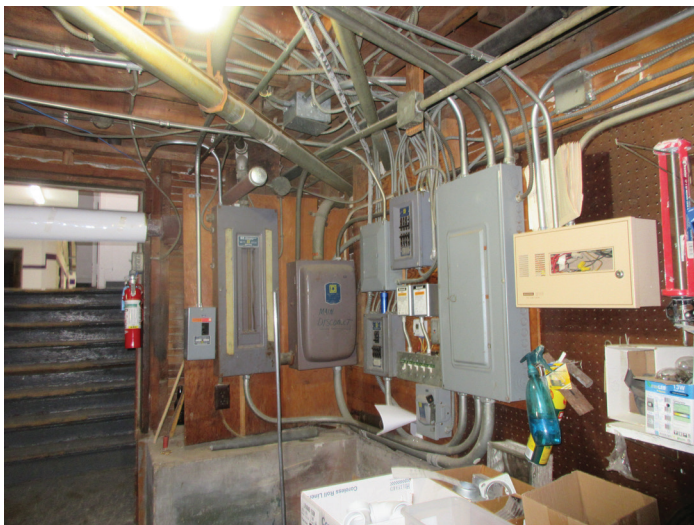
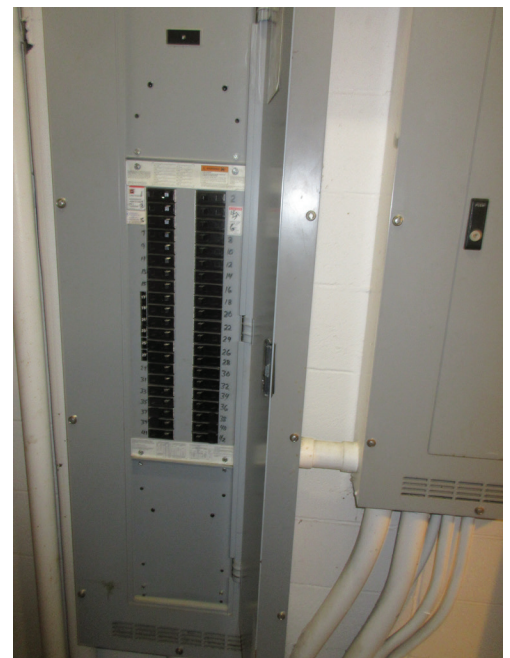
Secondary Power Distribution

Secondary power distribution is comprised of Kinney, Cutler-Hammer and Square D electric panel boards. Generally, the panels have little or no space for additional circuit breakers.

Conduits in the older portion of the building's basement have conduits and flexible metal raceways with extensive rusting.

Replace all wiring and devices that are original to the 1901 building and 1936 addition.

Replace older type Kinney panel boards and feeders throughout the older portions of the building (approx. 1963 and before).

Replace 1 phase panel boards in areas that will be remodeled with new 3 phase boards.

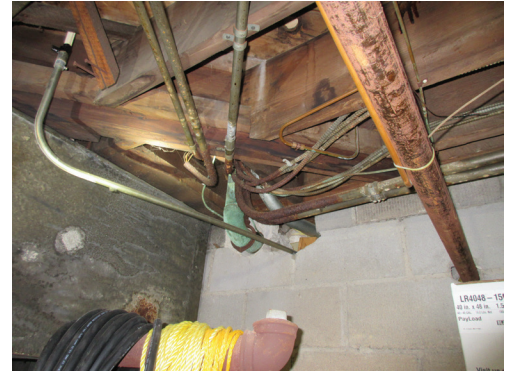
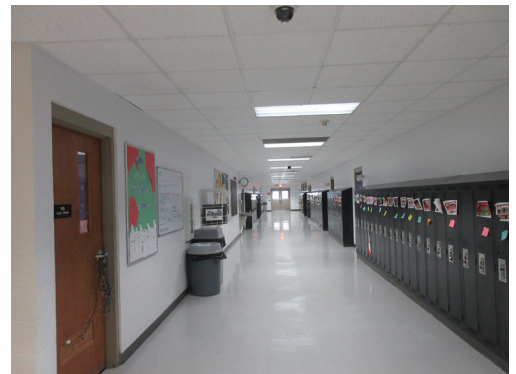
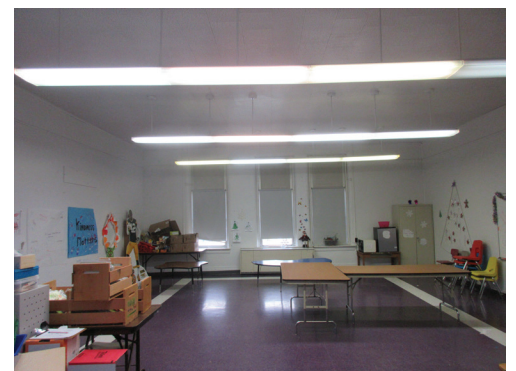
Building Lighting

Corridor lighting is composed of 2'x4' recessed light fixtures with LED replacement tube lamps in most areas. Original building has surface fluorescent lighting with (old) T12 lamps.

Replace all existing fluorescent lighting fixtures with LED fixtures.
