# Cody-Kilgore Unified Schools

## General Facility, Mechanical and Electrical Facilities Assessment

*May 2017*

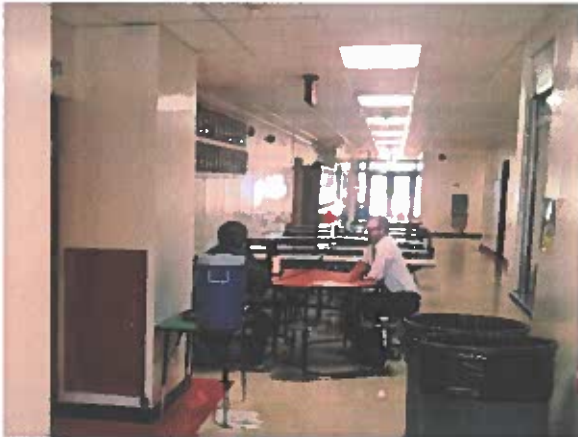
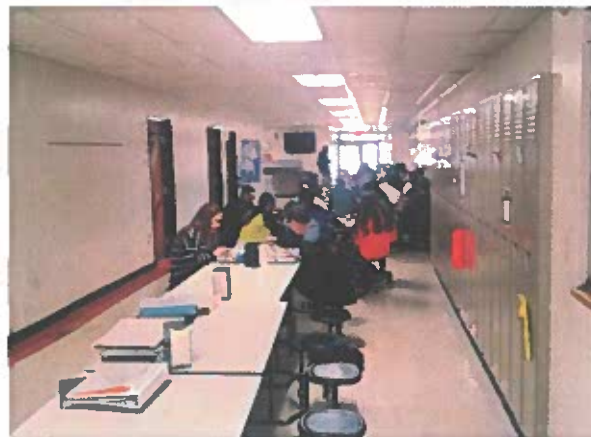
Another area that violated the exiting width is the cafeteria when the tables are in the area. When the tables are pushed up against the wall as shown in the first picture below, the created aisle is to be 6'-0" wide. With the current tables used the aisle is just under 6'-0" (easy solve – shorter tables). The second picture shows where the cafeteria gets narrower, the tables running with the aisles. In this scenario, both aisles are required to be 6'-0" wide. Both aisles do not meet this requirement.

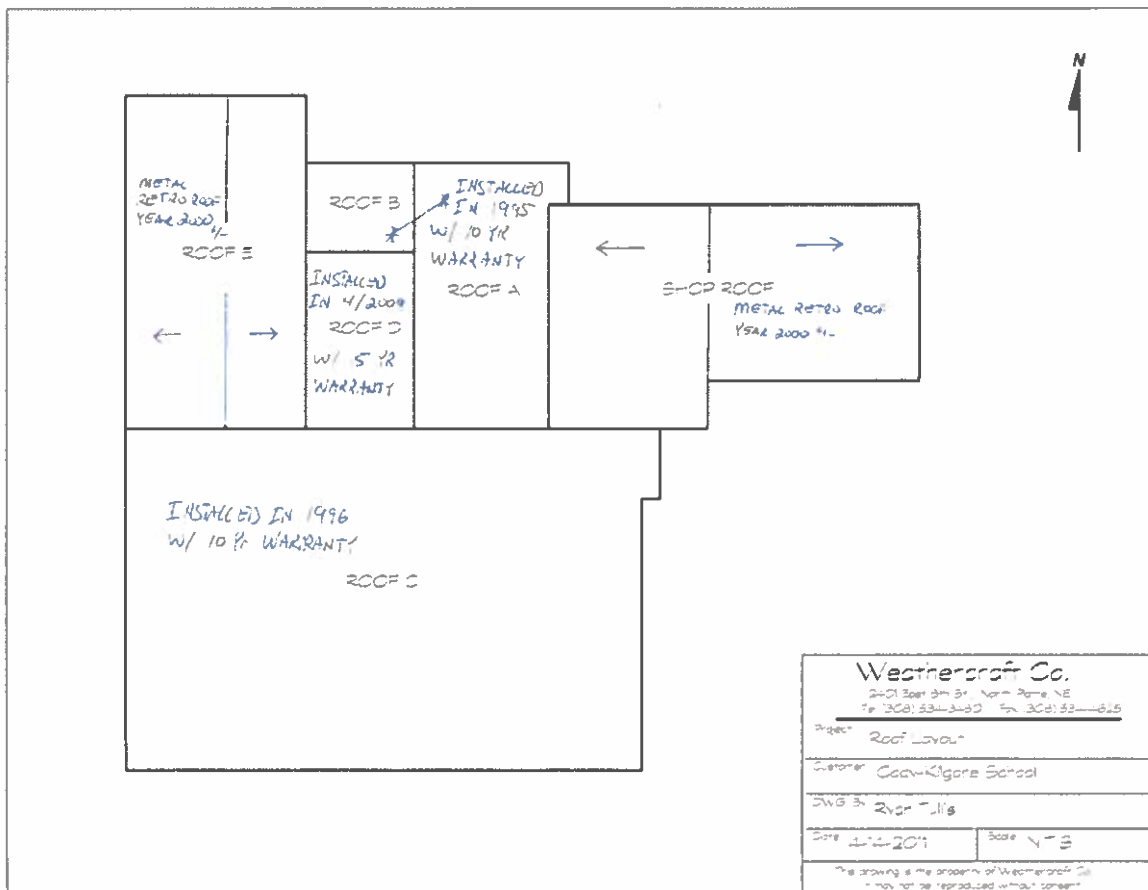
Roof C is a built-up roofing system that is 11 years over its warranty. This area is in the most need of repair and has had recent work completed along the west side.

Roof D is also a built-up system and still has 7 years of warranty remaining. This roof area appears to be in good condition.

Roof E & the Shop Roof are Alert "retro-fit" metal roof that appear to be in good shape. The extent of the warranty for these two areas is unknown.

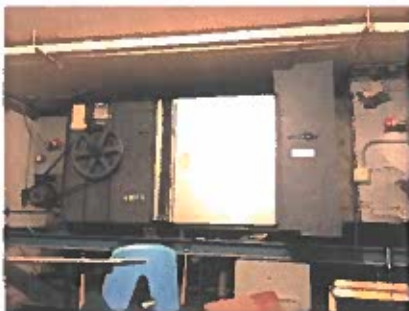
Photo 1

The building is served by 2 Trane horizontal air handling units (AHUs) located in a mezzanine mechanical room (photo 1). One (1) of the AHUs is dedicated to the gymnasium and the other serves the remainder of the school. Each unit has an electric resistance heating coil and no means of mechanical cooling. The units are original to the building and appear to be in marginal condition.

The school is primarily served by two large air handling units with zone reheat coils and no means of mechanical cooling. The units are in marginal condition and it is recommended that the units are upgraded and mechanical cooling is added.

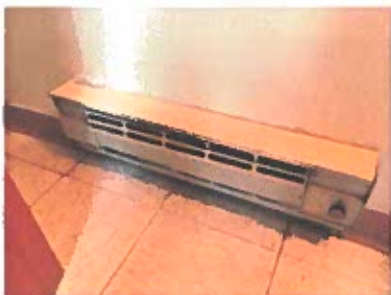
Photo 4

Electric baseboard heaters (photo 4) are also tied to the thermostats in the rooms to provide supplemental heating. The baseboard heaters appear to be in marginal condition and the controls were not reliable.

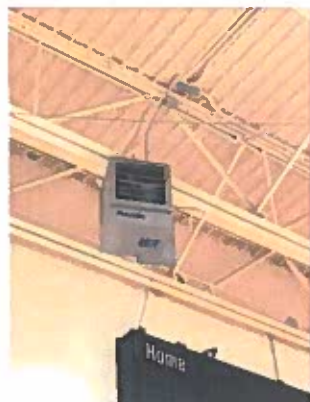
Photo 5

Electric unit heaters are installed in the gym and shop to provide supplemental heating. The unit heaters in the gym appear to be in acceptable condition (photo 5). The unit heaters in the shop appear to be in marginal condition.

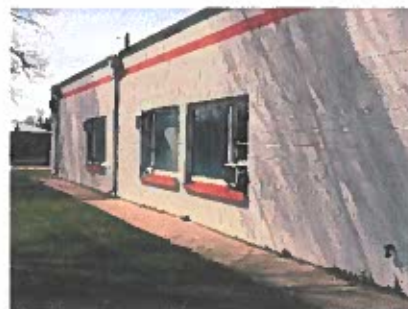
Photo 6

Window air conditioners (photo 6) have been installed in some rooms around the perimeter of the facility. These units are noisy, inefficient, and can overload existing electrical circuits.

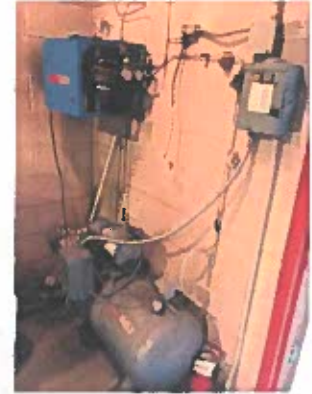
Photo 7

The facility has a pneumatic control system (photo 7) to control the HVAC system. Pneumatic control systems are an obsolete technology and difficult to maintain and repair. The existing control system is in poor condition and is not reliable.

It is recommended that a new direct digital control (DDC) building management system (BMS) is installed to serve the entire school. All existing equipment to remain would be retrofit with new controls.

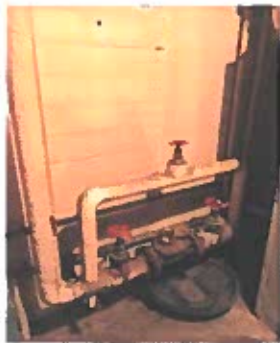
Photo 8

A 3" domestic water service (photo 8) enters the building in the north mechanical room. The service is metered but does not have a backflow prevention device. The main isolation valve appears to be corroded and in poor condition. The other valves appear to be in acceptable condition.

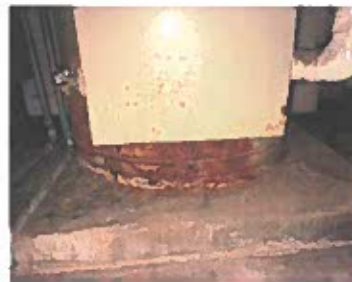
Photo 10

Domestic hot water is generated by a pair of A.O. Smith electric tank style water heaters (photo 9). Each water heater is rated at 45 kW and has 120 gallons of storage capacity. The water heaters are in poor condition and are showing significant signs of corrosion (photo 10) on the outer tank shells.

The plumbing systems are in generally good condition. However, it is recommended that the water heaters are replaced and restrooms and locker rooms are renovated to meet current ADA standards.

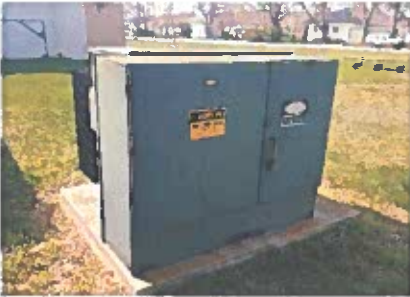
Photo 17

The building is currently serviced from a pad mount transformer (photo 17) located on the north side of the building. The building has 2 service laterals (photo 18) that are metered on the north face of the facility. The 2 service laterals entering the building appear to be (1) at 1200A, 480Y277v 3p 4w and (1) at 400A, 480Y/277v 3p 4w.

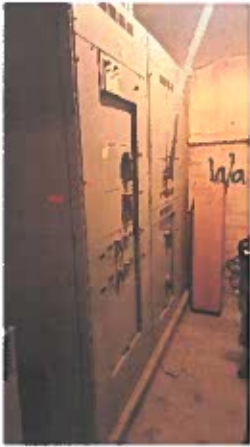
Photo 19

The electrical services enter the building within the main electrical room located just off of the shop area. The 1200A service terminates in a multi-section switchboard (photo 19). This switchboard appeared to feed most components in the building. A board of this size is required to have ground fault protection and it did appear this was present. The overall condition of this board was average. The board is definitely aged and it appears new parts are no longer available in the industry. In addition to parts not being available, the main service disconnect within this board is a 1200A bolted pressure switch (photo 20). Bolted pressure switches are a type of disconnect that require regular maintenance and where regular maintenance has not been provided the switch can be problematic if required to be moved to the off position. In many cases once turned off, the switch will not reengage to restore power.

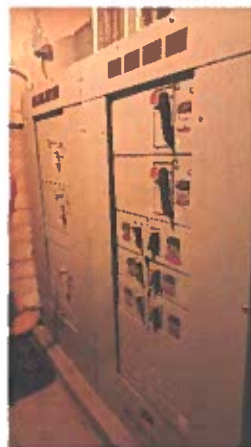
Photo 21

The second electrical service (photo 21) enters the building within the same electrical room within a 400A 2 section distribution panel. This board appears to be of the same vintage as the other service. The condition is again average and parts are likely no longer available.

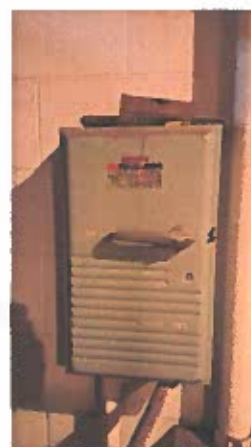
Photo 22

Other building distribution (photo 22) was reviewed as a part of this assessment and generally most equipment are aged beyond their useful life and parts are no longer available. There are cases where new panels have been added such as the kitchen but generally most areas within the school are operating off of outdated equipment unable to be expanded or modified.

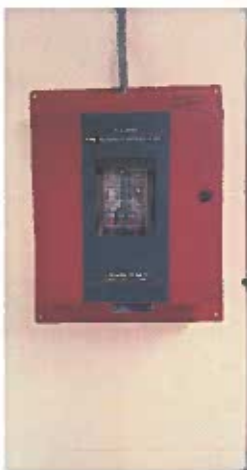
Photo 23

The building does currently have a Spectronics SA400 zoned fire alarm system (photo 23) in place. Areas were reviewed for general device coverage and it appeared that in most cases the necessary smoke detection was in place but egress paths could utilize more visual device coverage. The system did appear to be in good condition and has some expansion capabilities. If a large construction or expansion project were to take place within the facility it would be recommended to update the fire alarm system to a fully addressable system with devices provided in compliance with today's standards.

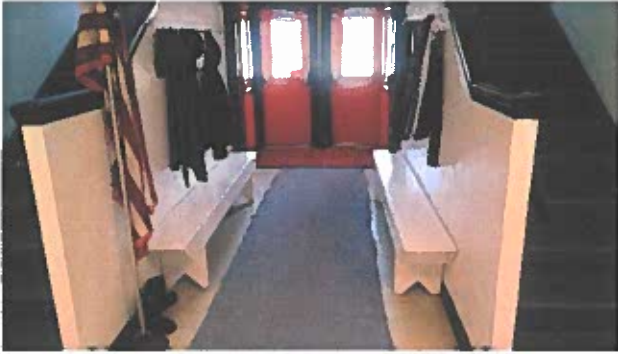
The entrances into all the building on this campus do not comply with ADA. The door at the main building are too narrow in the current configuration meet the required exiting width for Life Safety or clear passage width for ADA. Once in the building, all toilet rooms do not meet ADA. The access to the dining area at the stage or in the gymnasium area do not meet ADA passage requirements.

Entrance into Main School Building

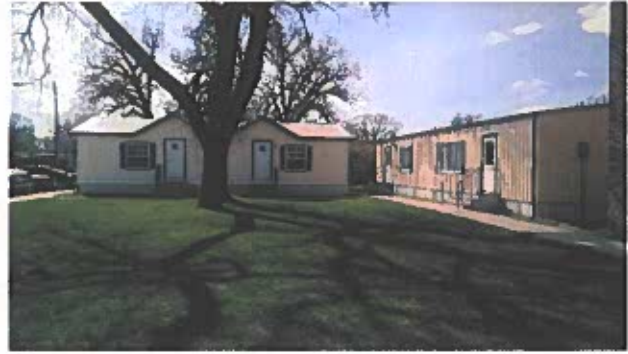
Stair access only to both portable buildings

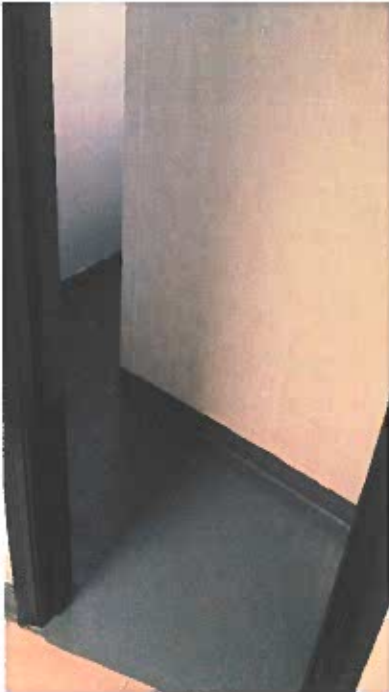
Access into toilet rooms

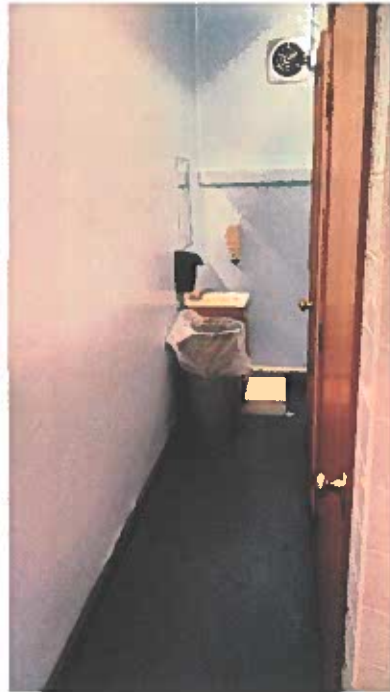
Passage in toilet Rooms

50% of  
toilet  
to Room  
occupancy

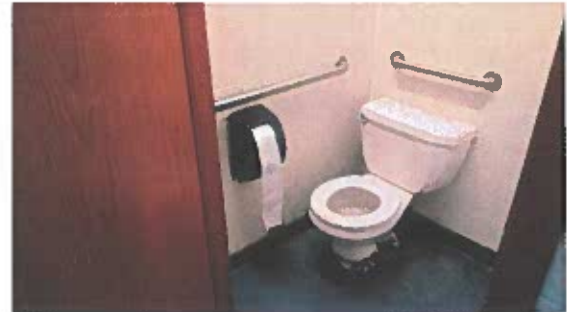
ADA toilet stalls do not meet space requirements

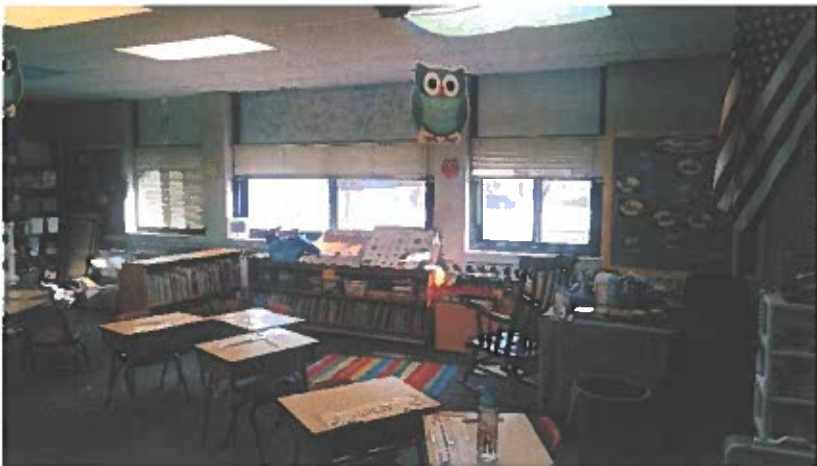
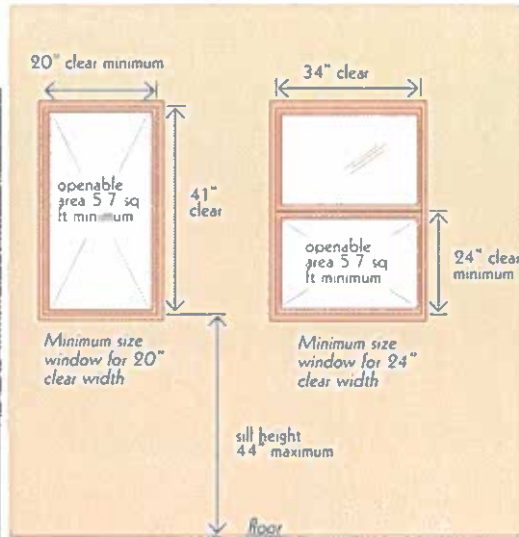
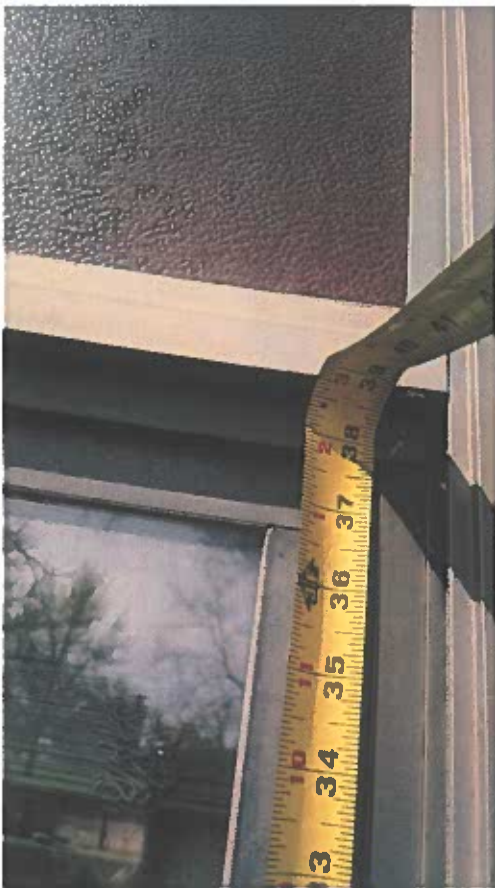
The Windows for Rescue required in each classroom Per section 15.2.11.1 of the 2000 Edition of the Life Safety Code, is to be unobstructed in front of the designated rescue window, have a maximum height of 44" from the floor to the window sill and have no more than 54" from the floor to any latch device. The window opening requirements are 41.2" in clear opening height and greater than 20" in clear opening width. This is not the case in most of the classrooms. There is space within the old window opening to place a tall enough window unit to meet code.

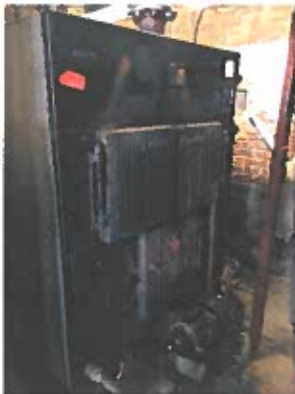
Photo 11

The building is heated by a fuel-oil fired American Standard steam boiler (photo 11) rated at 1,376 MBH output. The boiler appears to be poor condition. An underground fuel-oil storage tank is installed just west of the school adjacent to the main boiler room. Fuel-oil supply and return piping is routed below grade into the boiler room.

The existing steam boiler system is in poor condition. An entirely new HVAC system with mechanical cooling is recommended.

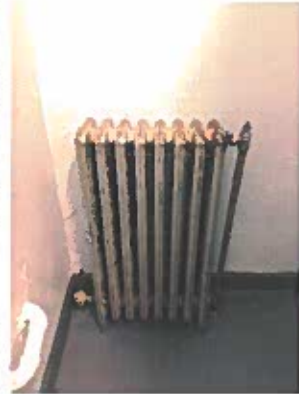
Photo 12

Cast iron steam radiators (photo 12) and steam fintube heaters are located throughout the building to heat the individual spaces. All of this equipment is aged and in poor condition.

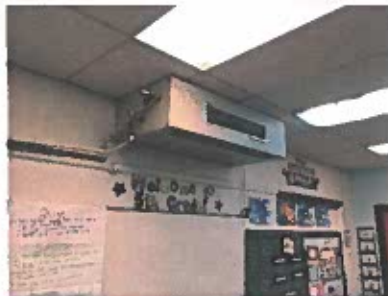
Photo 13

A fan coil unit (photo 13) was installed in the fifth-grade classroom to replace the original heating equipment. This unit appeared to be in acceptable condition.

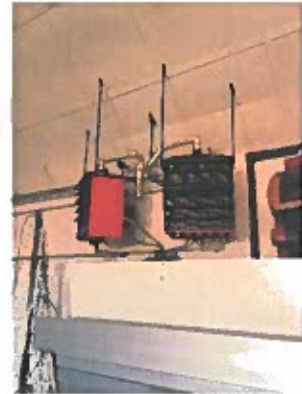
Photo 14

Steam and electric unit heaters are installed in the gym/cafeteria (photo 14) and appear to be in acceptable condition.

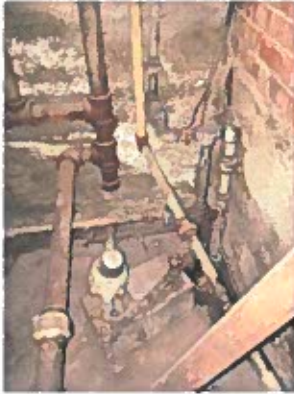
Photo 15

A 1" (approximate) domestic water service (photo 15) enters the building in the main boiler room. The service is metered but does not have a backflow prevention device. The main valves and piping appear to be corroded and in poor condition.

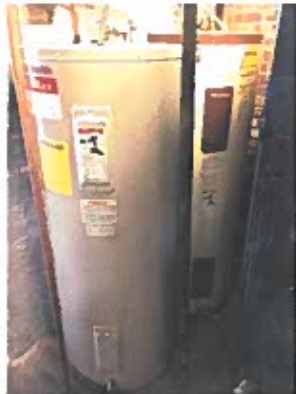
Photo 16

Domestic hot water (photo 16) is generated by a pair of electric tank style water heaters. Each water heater is rated at 4.5 kW and appears to be in acceptable condition.

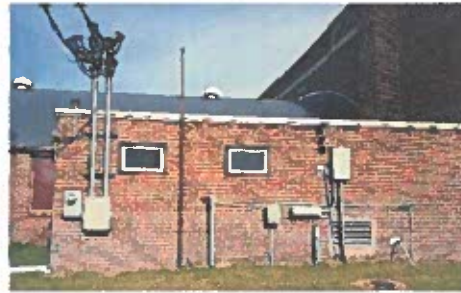
Photo 25

The electrical service serving the Elementary School enters the building from overhead distribution located on the NW corner of the school (photo 25). The lateral is provided overhead and enters the school through a series of weatherheads. The transformer configuration is a High Leg Delta service meaning only the A and C phase can be utilized for secondary voltage connections. On several occasions in the industry we have seen the B phase be incorrectly connected causing damage to building components and even injury to workers. If the High Leg Delta service is to remain in the school we would recommend improving the labeling of the "High Leg" to ensure the protection of persons and property.

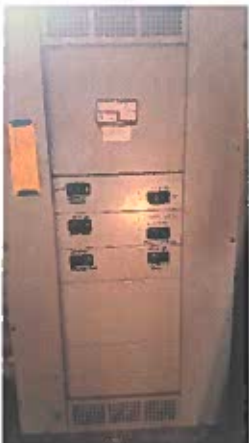
Photo 26

The electrical service enters the building within a main 1000A 3 phase 4 wire 240/120v (Delta) electrical panel (photo 26) located within a combination electrical/mechanical room just off the cafeteria. The panel appears to have been installed in 1995. The panel is in good condition and has approximately 10 years of useful life remaining in the current condition of the school. If a major renovation were to take place in the school, the recommendation would be to replace the service and main panel with an electrical service that would eliminate the High Leg.

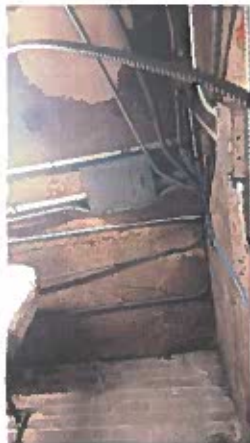
Photo 27

Some additional safety items identified within the electrical distribution systems include an electrical panel mounted to the ceiling (photo 27) within the main electrical/mechanical room and some Edison base fused panels (photo 28) located throughout the building. The Edison base fused panel pose a risk due to when fuses are removed, live bussing is exposed in the panel.

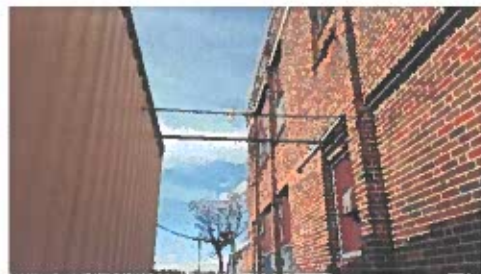
Conduits not Supported – Photo 29 – Not in Main Text

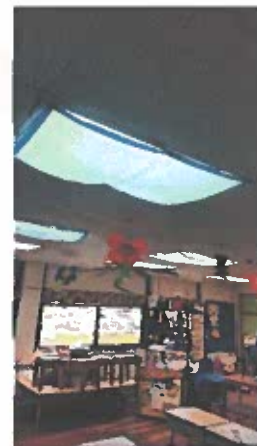
Photo 30

The existing lighting within the building is comprised of a mix of incandescent, high pressure sodium, and T12 fluorescent technologies. As a whole, the majority of the lighting within the building is beyond its useful life and should be replaced. In addition to the light fixtures being beyond their useful life, generally most of the lighting within the building is 30% or more, less energy efficient than today's LED light fixtures and far more glaring which was evident with some classrooms where shielding has been provided over the lights (photo 30).

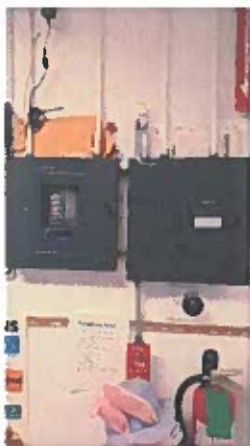
Main Fire Alarm  
Control Panel

The building does currently have a Notifier SFP-400B zoned fire alarm system in place. Areas were reviewed for general device coverage and it appeared that in most cases the necessary smoke detection was in place but egress paths could utilize more visual device coverage. The system did appear to be in good condition and has some expansion capabilities. If a large construction project were to take place within the facility or a building addition added, it would be recommended to update the fire alarm system to a fully addressable system with devices provided in compliance with today's standards.
