Prepared for:

Cape Elizabeth Schools

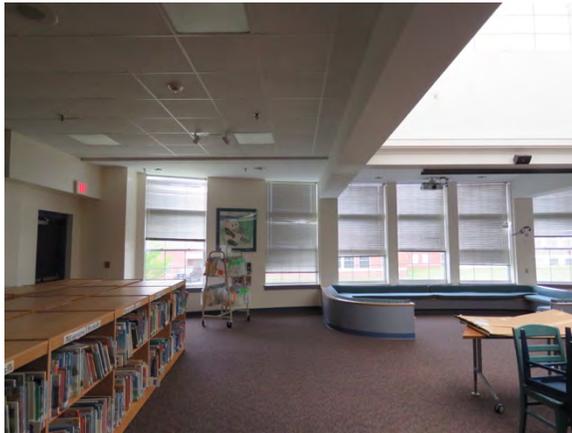
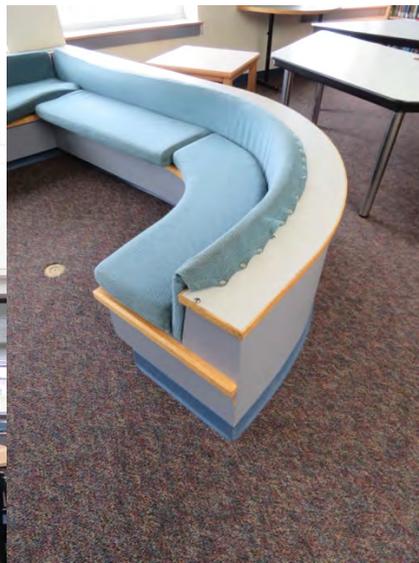
- a. Although well maintained, millwork seating is showing standard wear and tear and does not allow for flexibility in usage.

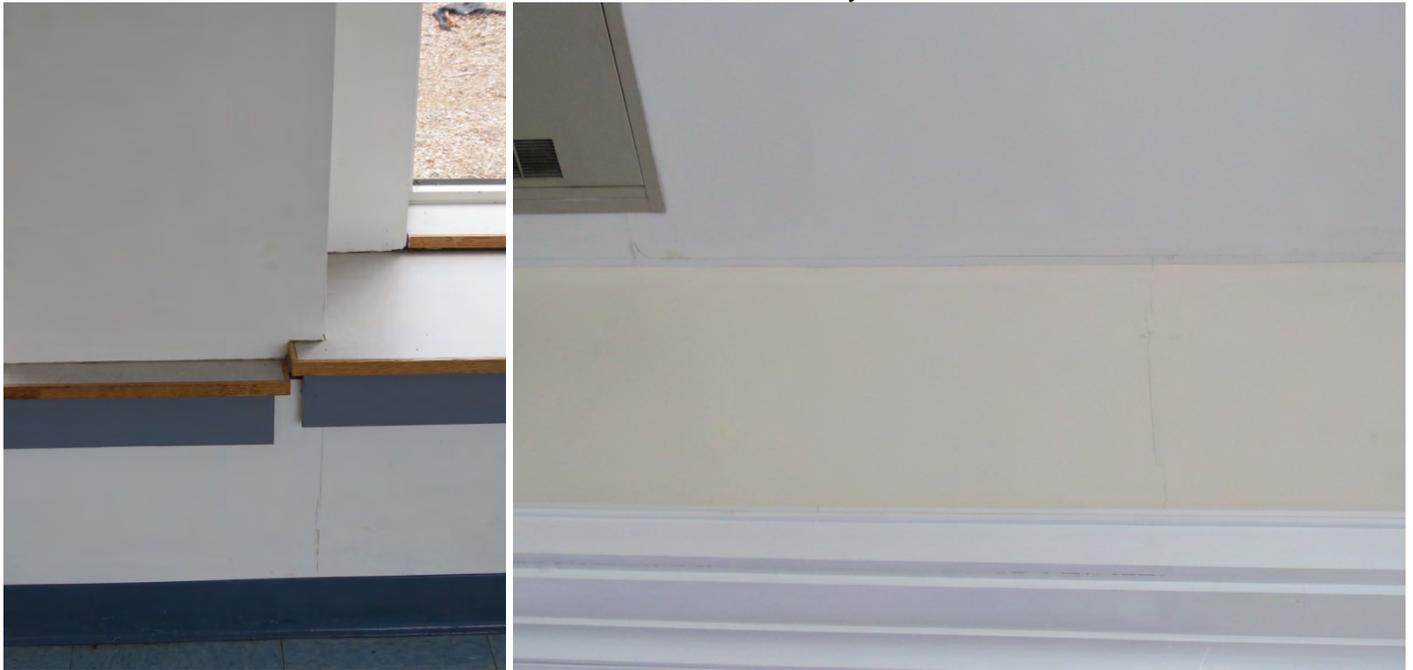
- a. Stress cracks observed at B110 corridor and D104 western entry wall.

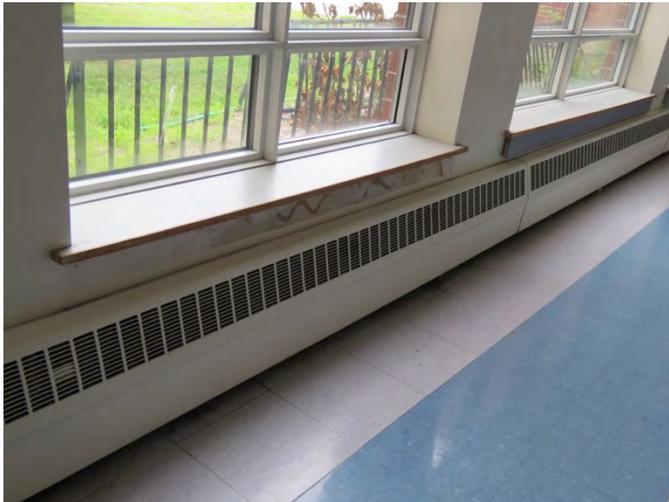
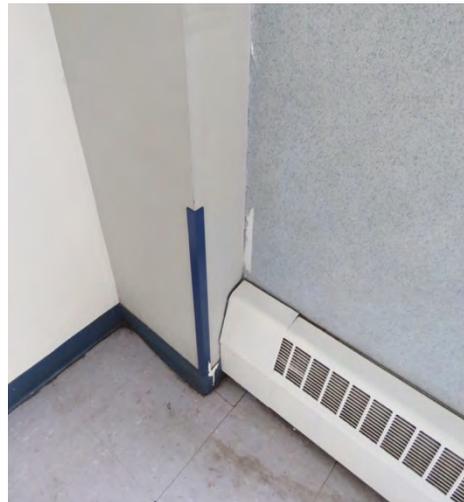
# Water Damage at Window Frame

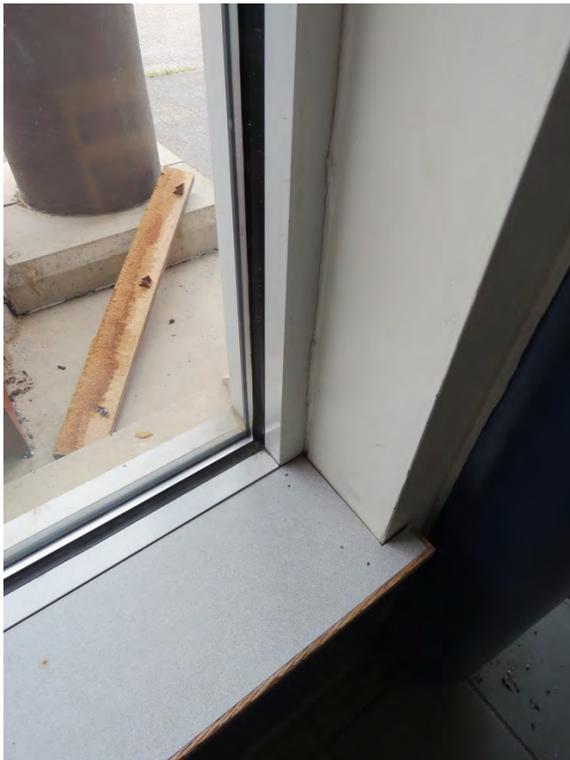
Window adjacent to entry doors at Pond Cove Entry D104

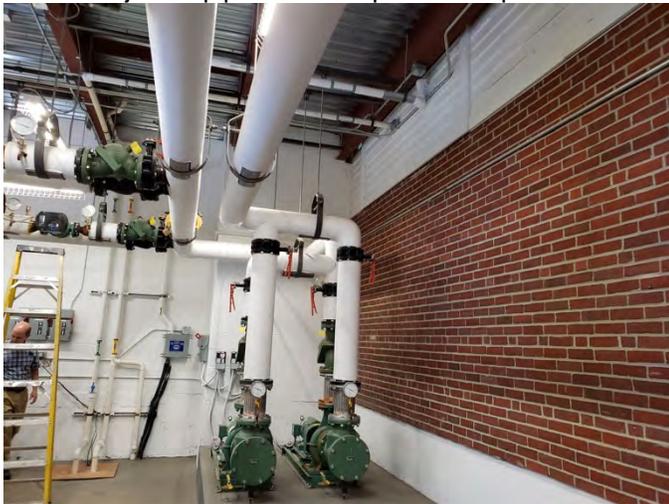
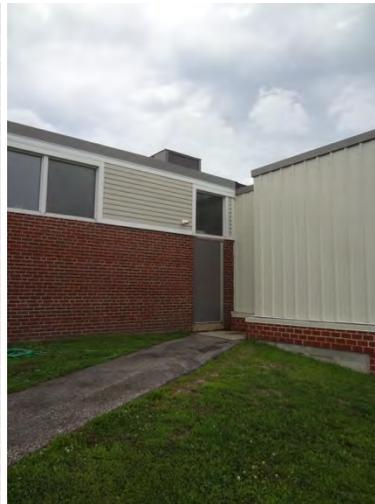
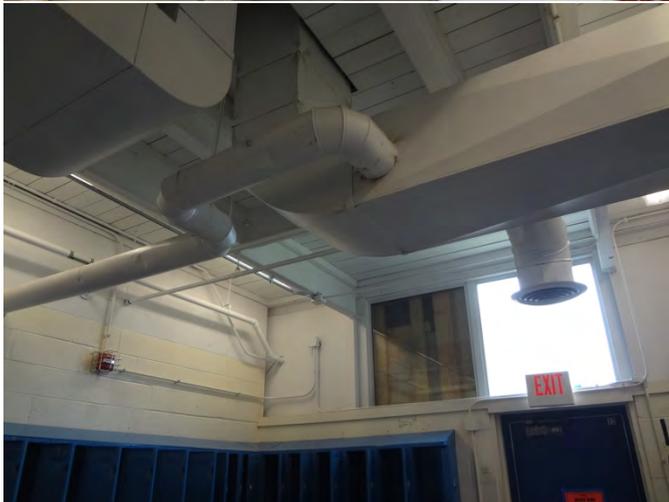
Locker room is not separated from Boiler Room with a rated assembly. Studs are visible through the glass from the Locker Room side; glass is visible from the boiler room as evidence that wall does not extend to deck behind steel beam. Adjacent pipe mains require firestop.

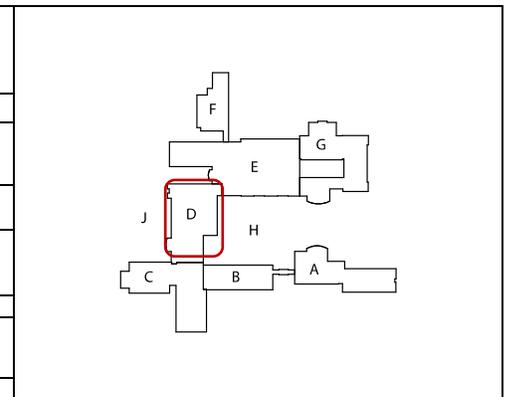
## EXISTING CONDITIONS

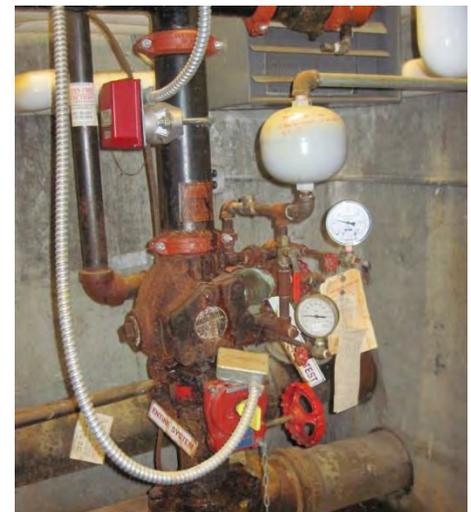
The existing incoming service and riser pipe supplying the sprinkler system appear to be in serviceable condition.

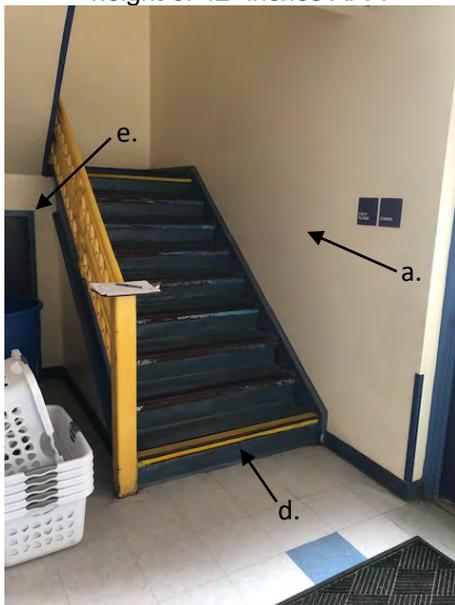
- f. Replace handrail with handrail meeting required graspability. Augment existing guards with additional railing at height of 42" inches AFF.

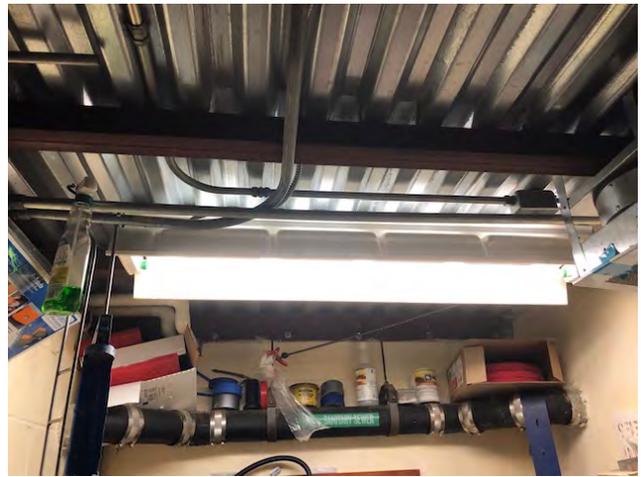
Ceiling of Janitor's Closet C117

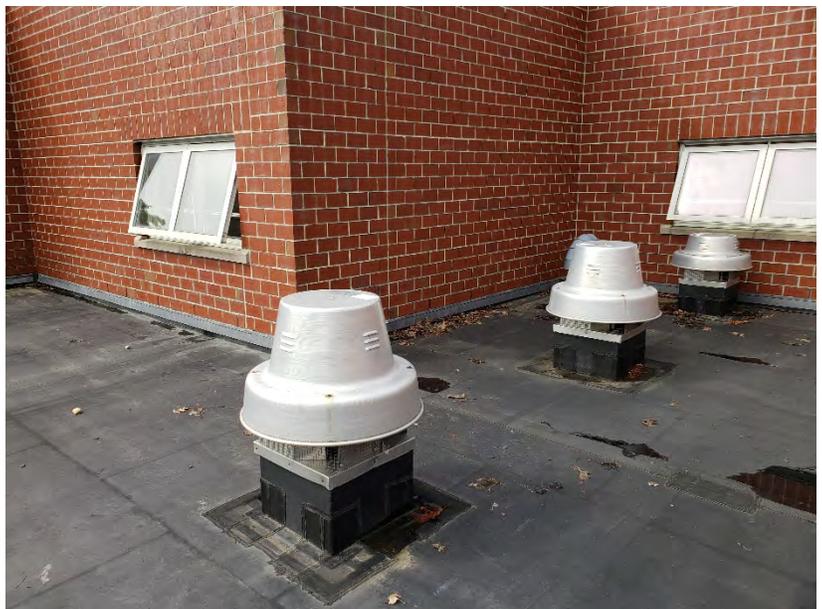
Relocate these three exhaust fans to meet code required separation distances such that they are greater than ten feet from the roof edge as well as operable windows and HVAC intakes including IH-1 and AHU-1 located on the same roof. IH-1 is to be replaced and relocated under work item E-ROOF-M-1015.

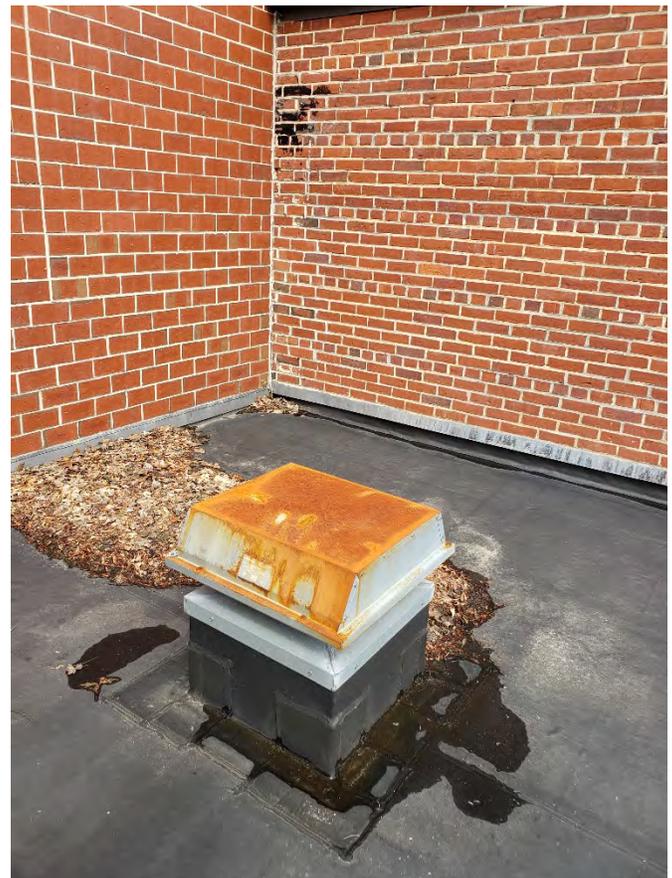
Replace IH-1 in kind, with the exception that an aluminum top is recommended to help minimize rust. Relocate IH-1 such that it is a minimum of ten feet from all exhaust fans as well as ten feet from the roof edge. Coordinate relocation of IH-1 closely with relocation of EF-1, EF-2, and EF-4 on the same roof, which are to be relocated under work item E-ROOF-M-1014. These are the minimum separation distances as required by code.

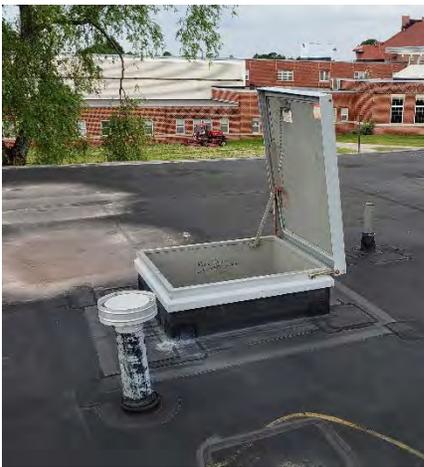
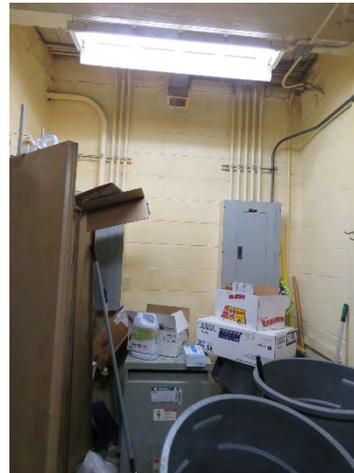
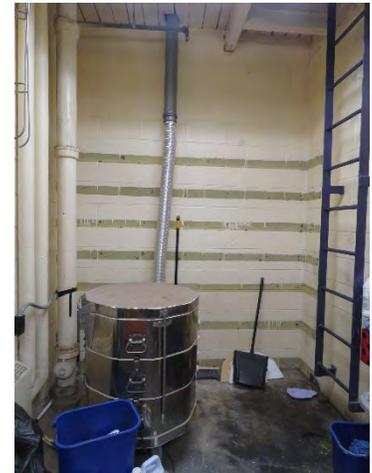
Kiln is located in a janitor's closet, which also houses electrical power panels and transformer, as well as janitorial services and the ladder to a roof hatch. The room is inconveniently remote from Art Room A128, and is not a suitable space for use by teachers and students due to the other services in the room. The room also has minimal ventilation which was suitable only for the janitorial use, and does not appear to be sized for the kiln heat or the transformer.

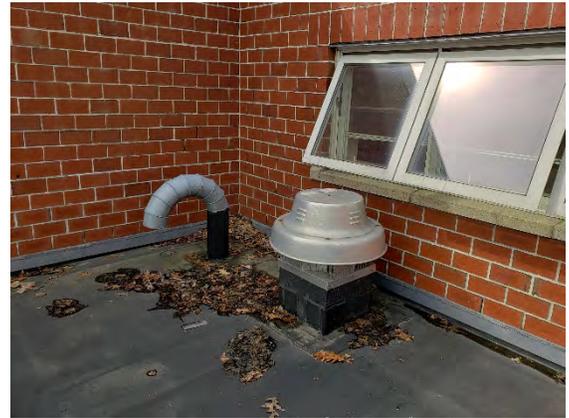
Unidentified gooseneck is too close to operable windows, and is close to exhaust fan.

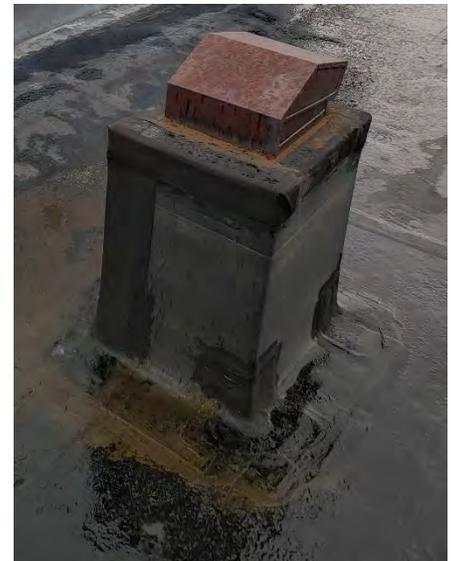
Replace Elementary School EF-7 roof jack with an aluminum air relief roof hood designed for installation on a flat roof.

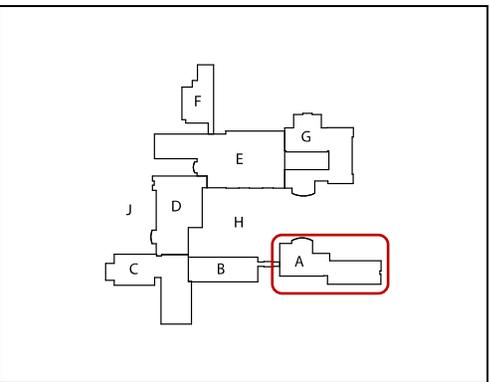
Priority	Cost			
	\$\$			
Coordination by Discipline				
<input checked="" type="checkbox"/>	<input checked="" type="checkbox"/>	<input checked="" type="checkbox"/>	<input type="checkbox"/>	<input type="checkbox"/>
A	M	E	P	FP
<input checked="" type="checkbox"/>	<input type="checkbox"/>	<input type="checkbox"/>	<input type="checkbox"/>	<input type="checkbox"/>
S	LS	SC	BE	C

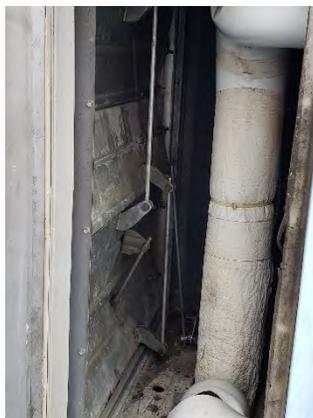
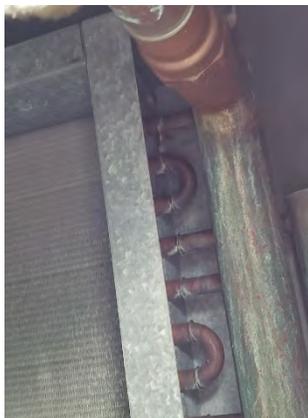
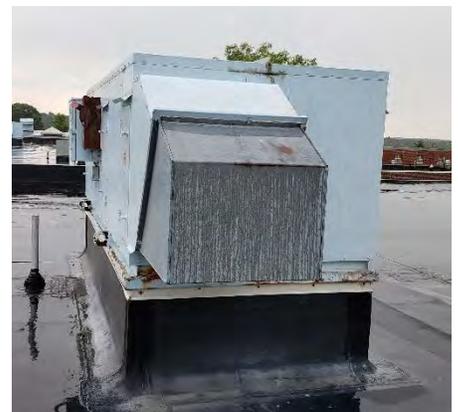
Coil pipes inside unit are corroding. Unit is old and beyond its expected useful life. Intake hood has retrofitted extension. Base and other components are rusted. Control dampers are faulty.

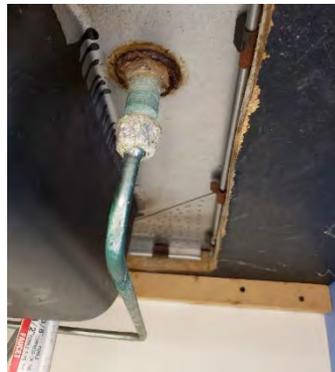
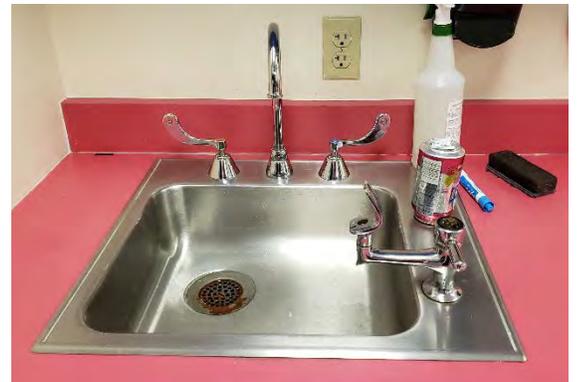
Sink bubblers are in varying conditions of repair, corrosion, and looseness in connection to the sinks. They are generally aged and were built before the recent Federal law requiring lead-free construction in plumbing water components.

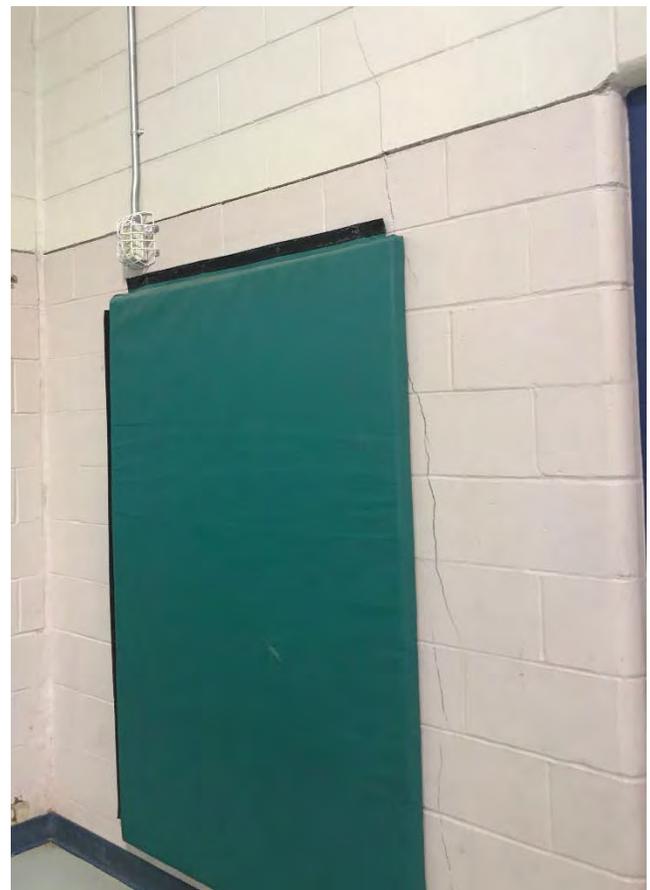
# Replace Kindergarten Wing Intake Hood

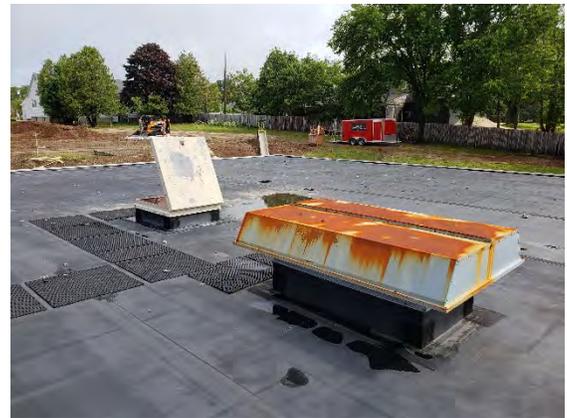
The westernmost large intake hood on the kindergarten roof, labeled IH-1 (duplicate numbering) is rusted. The existing hood is a Carnes model GIGB02404820EY 05, serial number 830242 002, installed in October 2004.

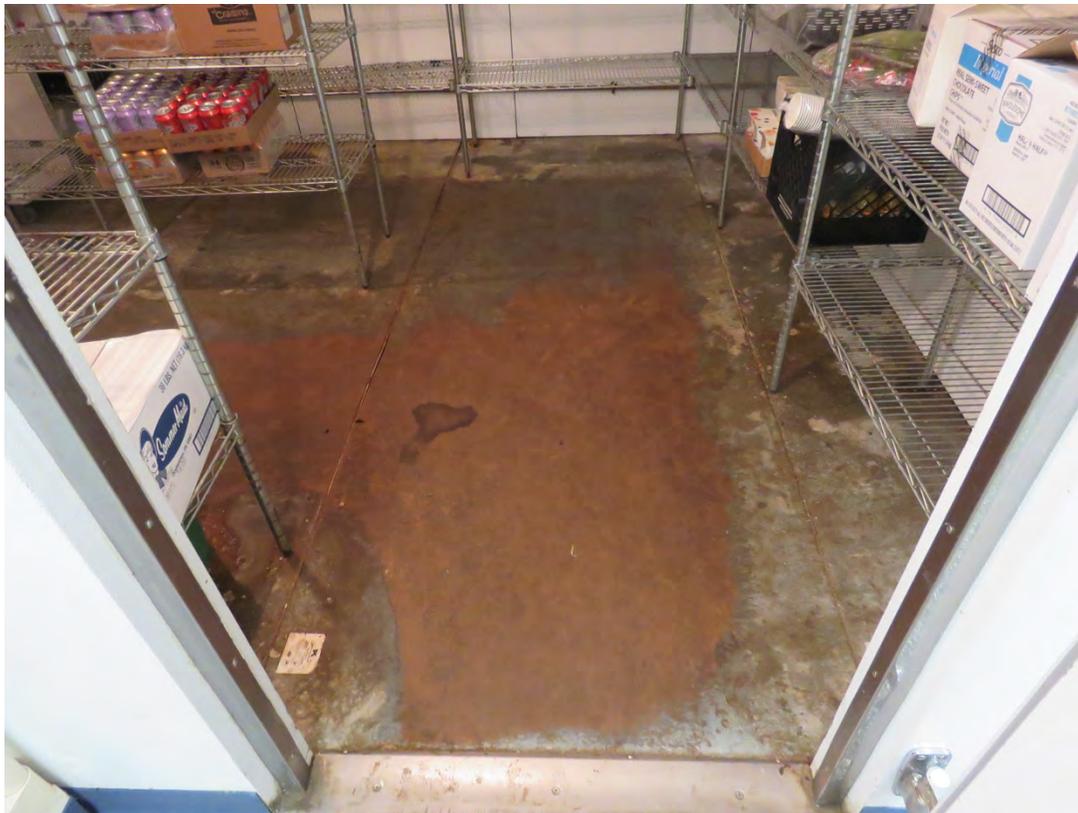
Kitchen cooler floor

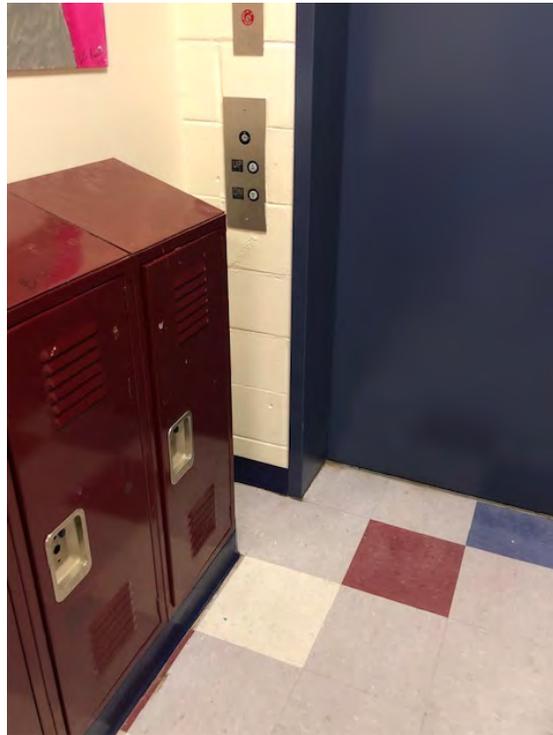
- Remove lockers to provide clear area of 48 inches in front of elevator call buttons.

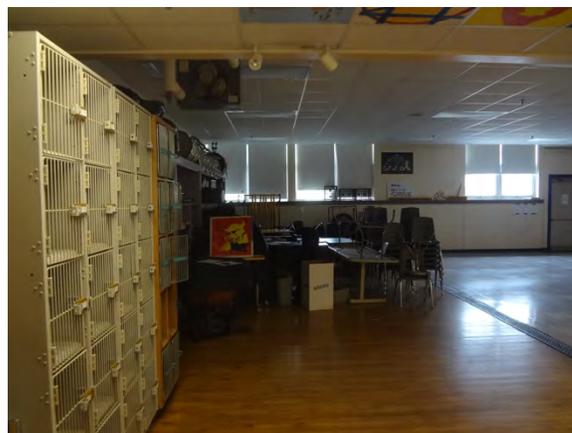
Band room storage (left side) is inadequate.

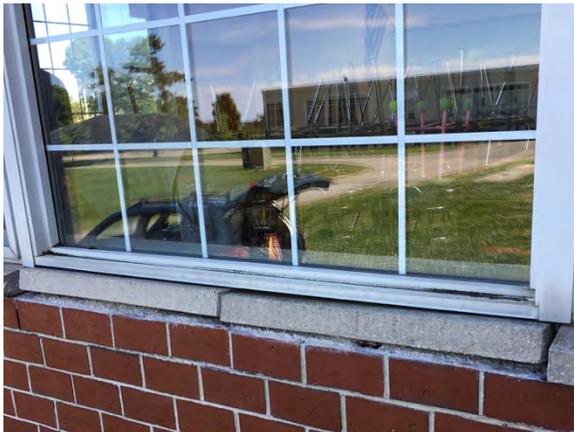
Dislodged precast window sills

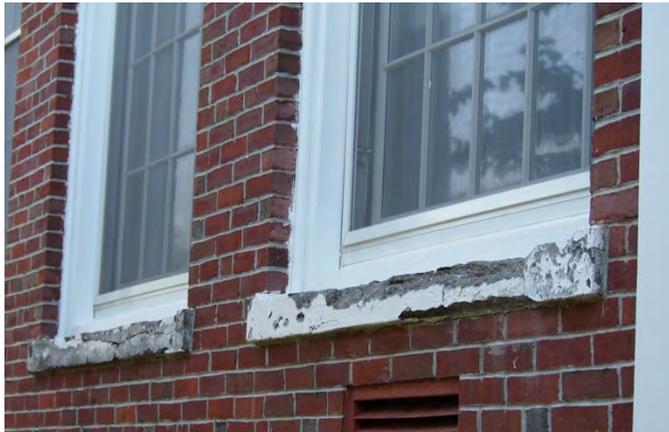
Deteriorating cast stone sills

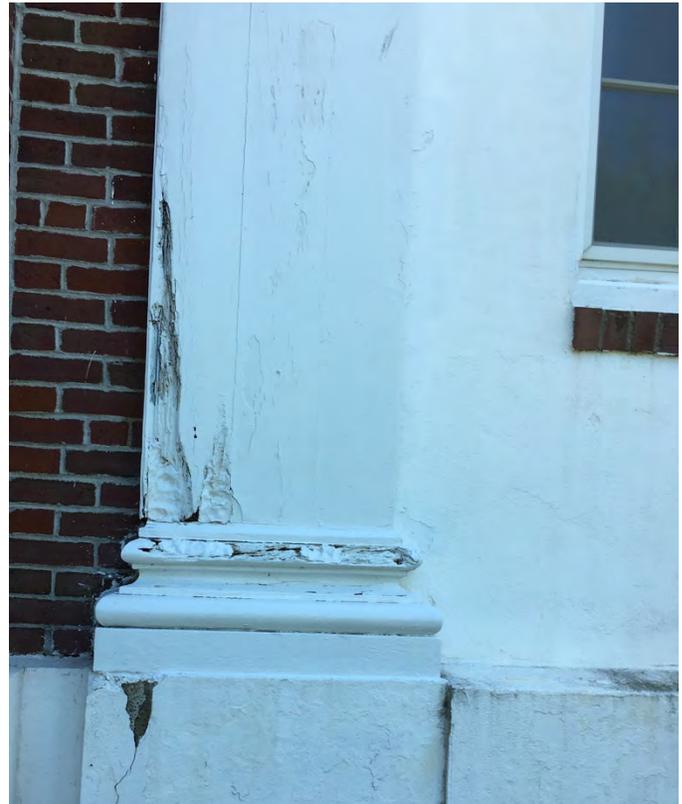
Spalling concrete at foundation and wood rot

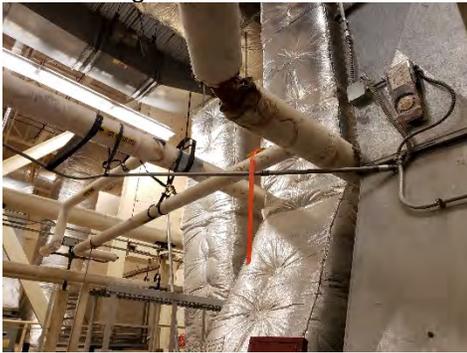
The existing conduits in the mechanical room do not have independent supports required by the electrical code.

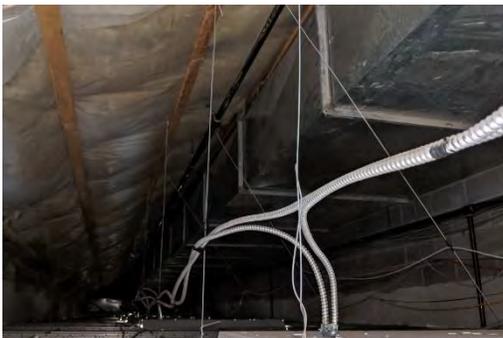
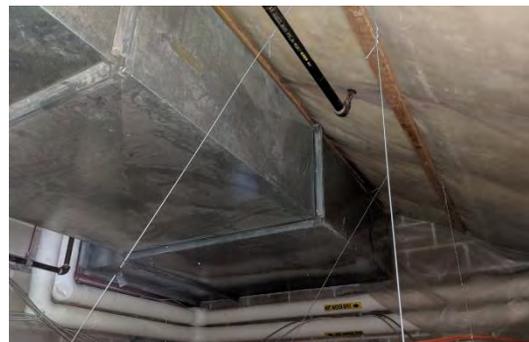
The roof deck above the ceiling in this corridor is sloped and the ceiling space is divided by an HVAC duct. the currently installed sprinklers are installed at the low side of the roof deck slope and obstructed by the HVAC duct.

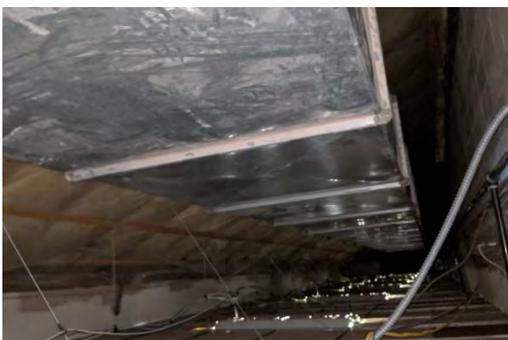
Install an additional line of sprinklers at the upper elevation of the roof pitch on the other side of the duct obstruction as required by NFPA 13.

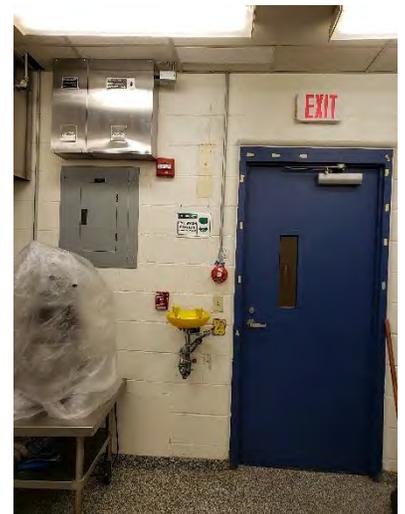
Kitchen hood fire suppression system manual pull is located only a few feet from the hood, not at least 10 feet as required by the building Code.

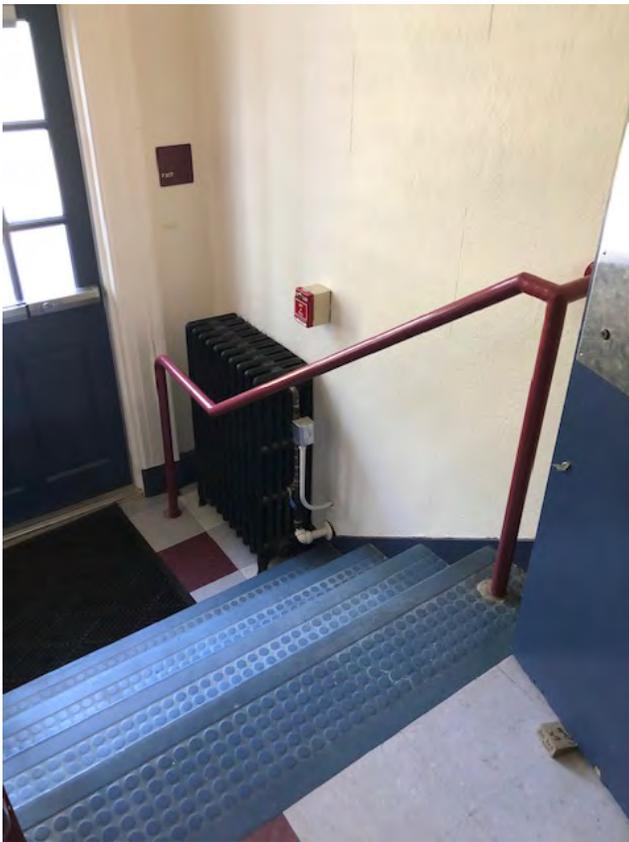
While technically the railing is in violation of life safety code, exiting width is determined by width of paired doors at top and bottom of stairs. Proper configuration of railing would require the elimination of the existing radiator.

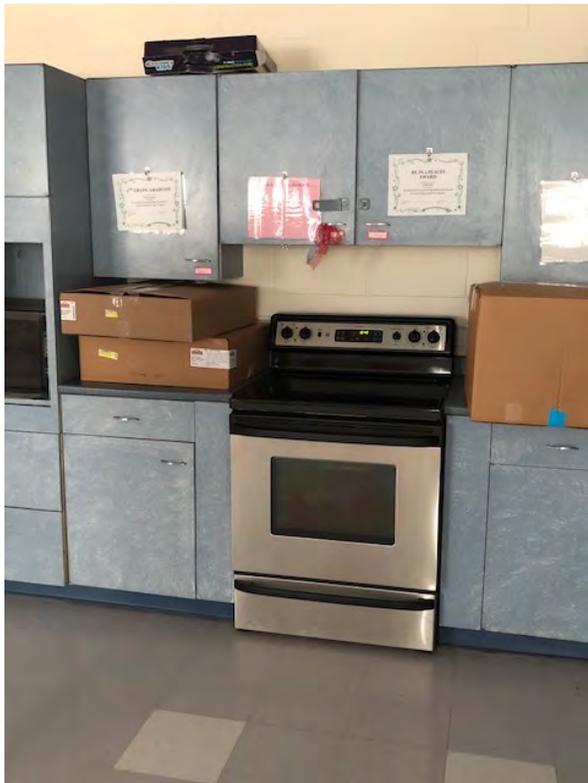
Range lacks an NFPA compliant exhaust and suppression hood

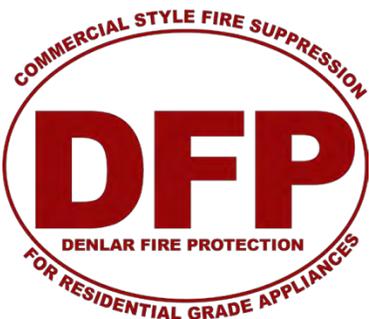
# Replace EF-7 Roof Cap

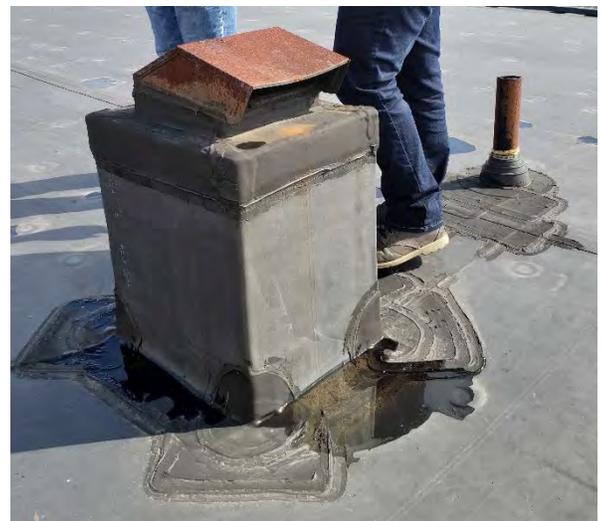
Replace roof jack with an aluminum air relief roof hood designed for installation on a flat roof.

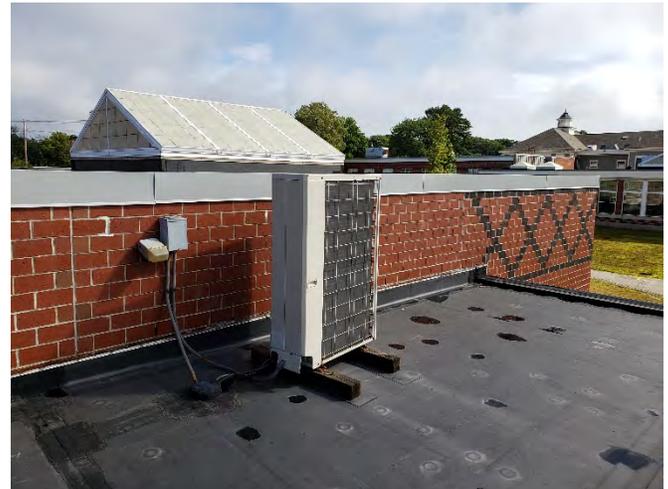
Replace refrigerant piping insulation on all roof mounted condensing units, and provide PVC jacketing to protect and extend the useful life of the insulation. Provide stands to suspend condensing units at least 14 inches above the roof surface to maintain clearance above snow. Affix stand to both condensing unit and roof. Flash roof connection points to prevent water infiltration.

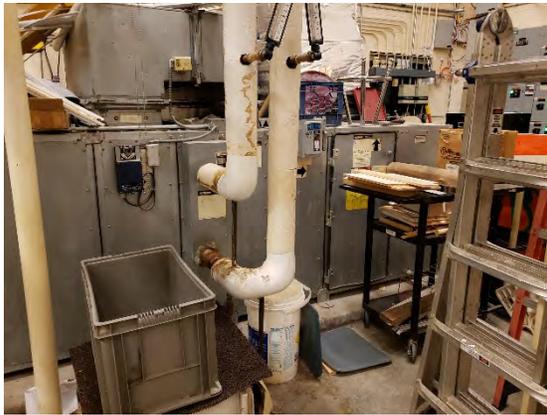
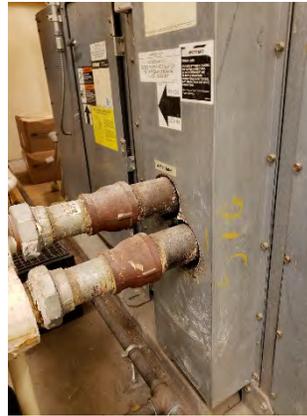
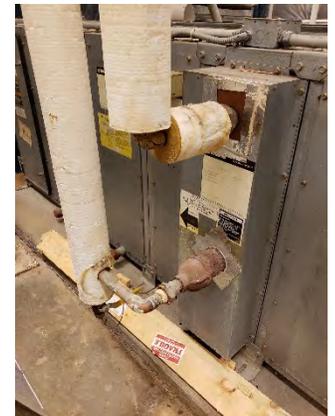
AHU-5, 6, and 7 are nearing the end of their useful life. Outwardly visible signs include rust, leaking and corroded control valves and piping. Typically at this age inner components are wearing out as well. In general it appears that the exhaust and relief for these systems is located elsewhere rather than in this mechanical room.

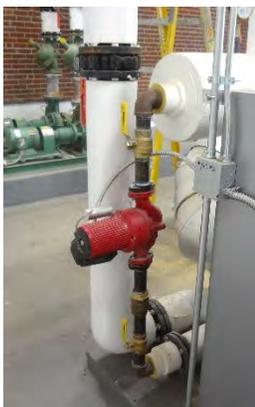
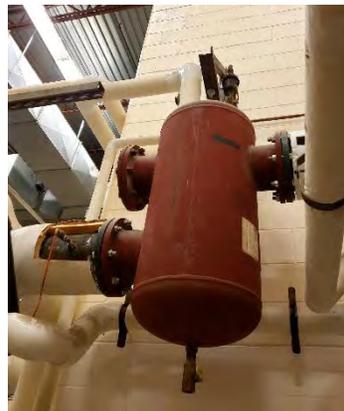
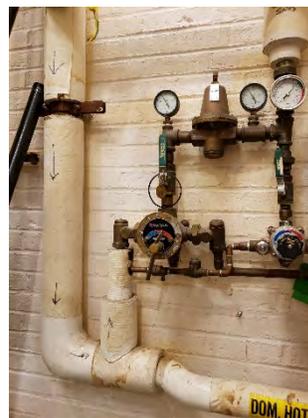
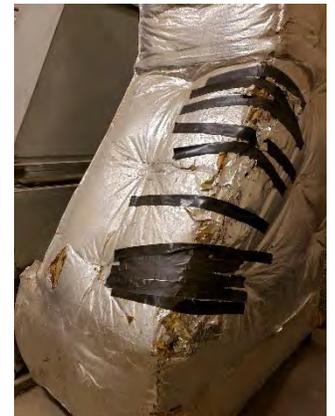
**Equipment:** Many items of equipment such as piping air separators, and large piping bodies such as valves, strainers, and pump suction diffusers, both hot for heating and plumbing and cold for plumbing water, are missing their insulation. This results in excessive heat in these rooms, heating fuel and solar water heating energy waste, and sweating and damage on the cold items. This condition applies to the former boiler room and its associated basement level space, and extensively in the new boiler room.

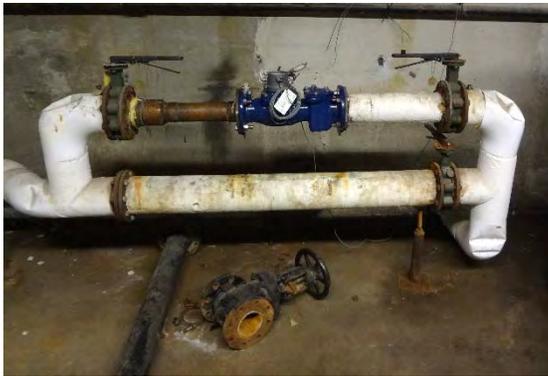
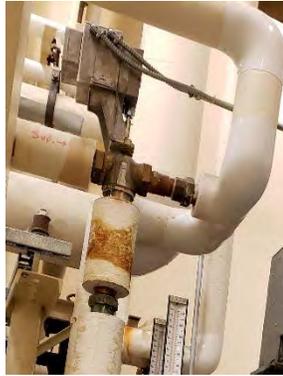
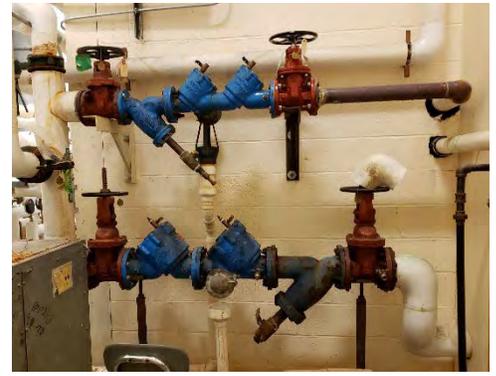
Heating control valves and other valves are aged and leaking. Plumbing cold water valves are old and externally rusted from condensation (sweating). Associated unions and flanges are also rusted or corroded.

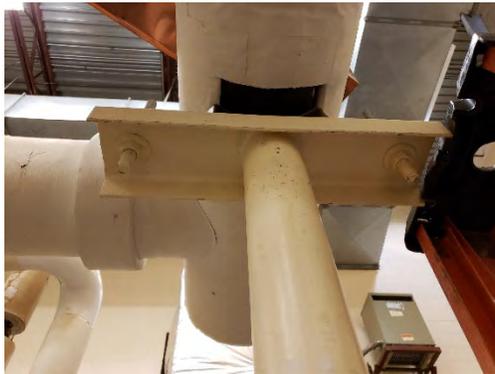
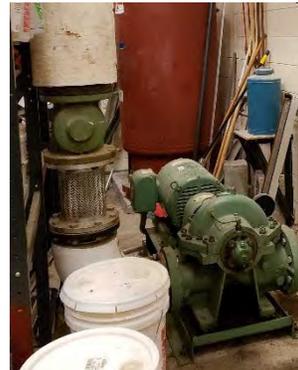
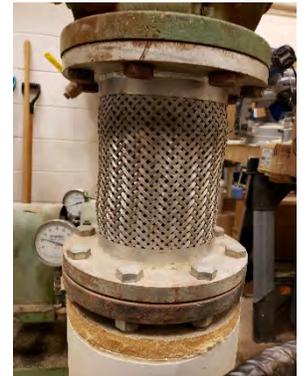
The discharge pipes from the pumps are centrally supported by a floor-mounted structural steel stand, which supports the piping header several feet from the individual risers at the pumps. This support location allows the weight of this large piping to bear on the flexible connectors, as well as transferring some weight to the pumps. This compresses and visibly deforms the flexible connectors, which reduces their ability to isolate pump vibration from the piping as well as their ability to accommodate piping expansion due to heating. Bearing weight is also bad for the pumps.

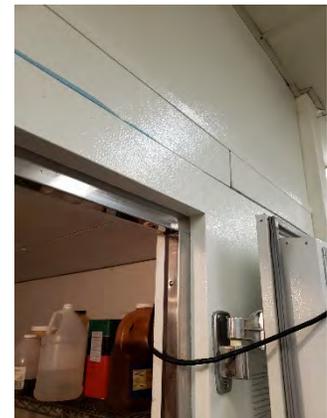
Air handling unit AHU-4 which serves the kitchen area is located above the hard ceilings of the walk-in freezer and cooler. To access the unit for service, workers must remove the wall panels from the top of the walk-ins to above the kitchen area's drop tile ceiling, then climb a stepladder and crawl onto the walk-in ceiling. This inhibits frequent routine service such as filter changes, and makes repairs difficult and time-consuming. The unit was not accessed for viewing as part of this report, but it is presumed to be of a similar advanced age to other AHUs in the building.

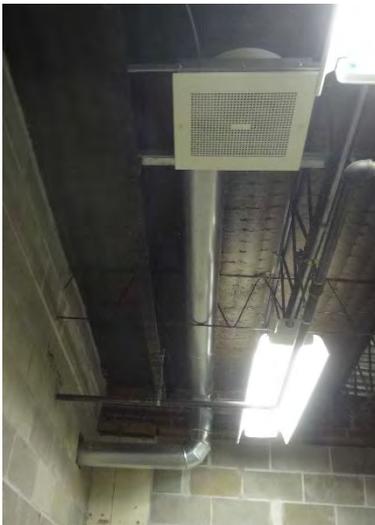
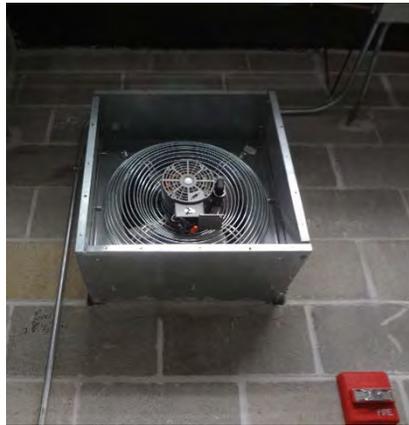
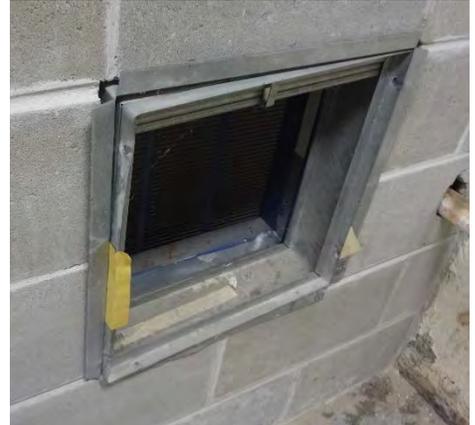
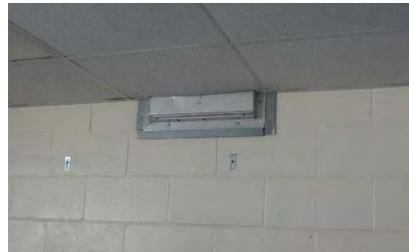
The room has a low opening through the CMU wall to the adjacent room which has a fire damper that is roughly set in the opening rather than being fastened. A room cooling propeller fan is ducted through that same wall with a backdraft damper on the discharge, and the damper has been disrupted by a ceiling grid run across it in the adjacent room. Another fan is duct-mounted within the machine room. The walls have penetrations with unsealed openings.

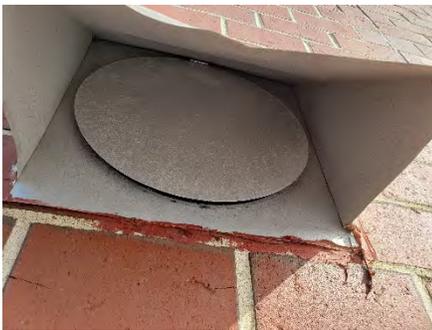
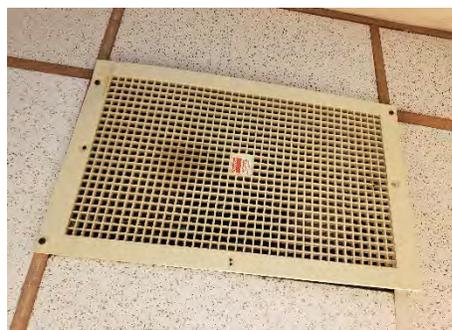
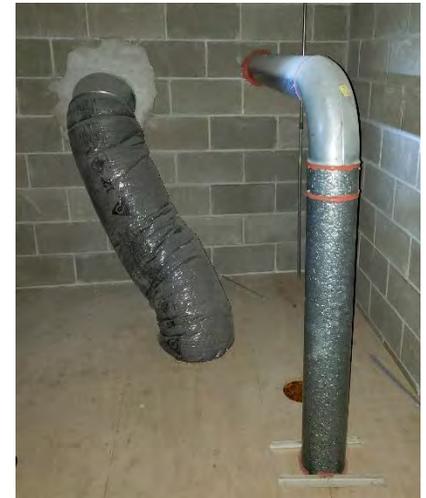
The room has a ceiling-mounted exhaust fan with integral ceiling inlet grille. The fan is supported by the suspended ceiling grid, lacking supports to the structure. The duct includes a long run of flexible duct which is restrictive due to its rough interior and tendency to collapse and kink. The exterior wall discharge cap has a heavy backdraft flapper which further restricts airflow.

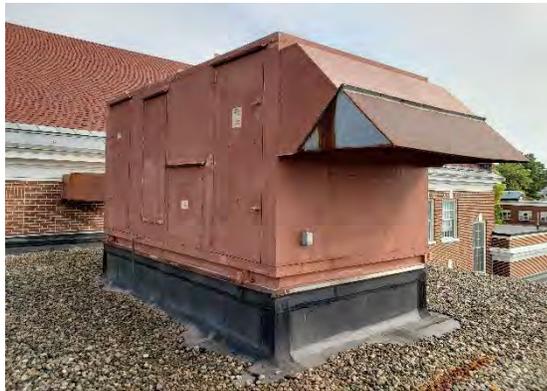
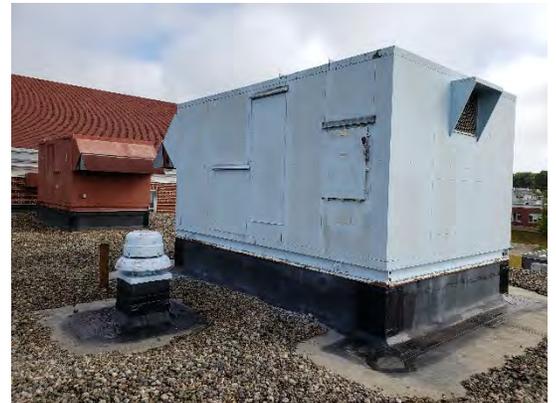
HRU-8 and 9 are existing roof-mounted Z-Pack heat recovery units that appear to have been installed in 1994, and are at or near the end of their useful life. Exteriors are rusted and have been repainted. HRU-9 duct into sidewall of building is also due for replacement.

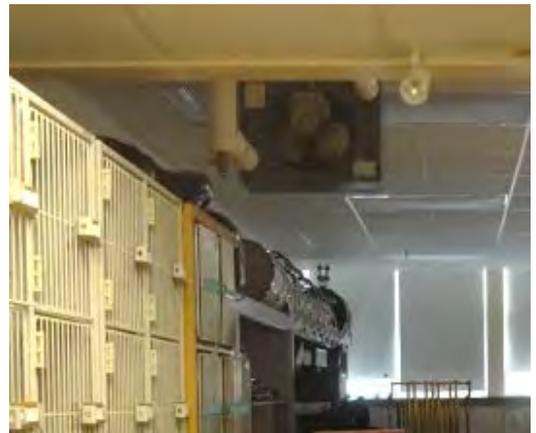
Unit heaters hung at ceiling are too loud.

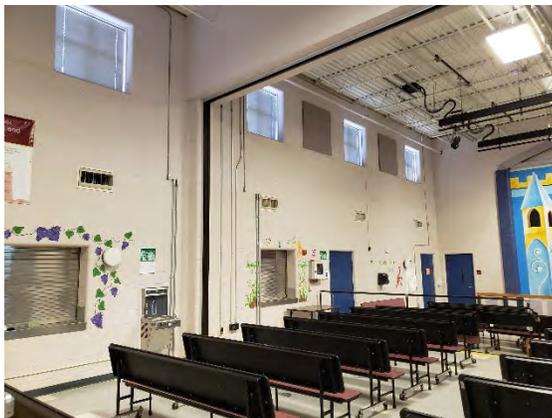
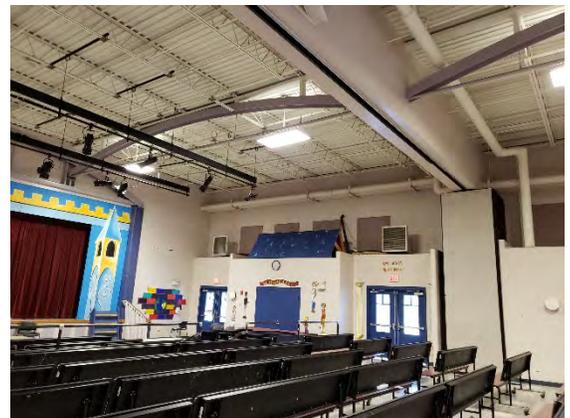
Ventilation supply seems poor and ineffectively distributed per discussion with maintenance staff and user complaints. Air conditioning may be needed, pending airflow and space temperatures resulting from improved ventilation airflow.

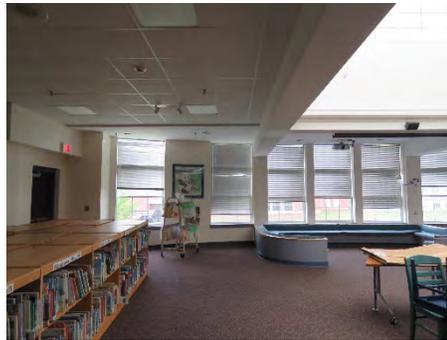
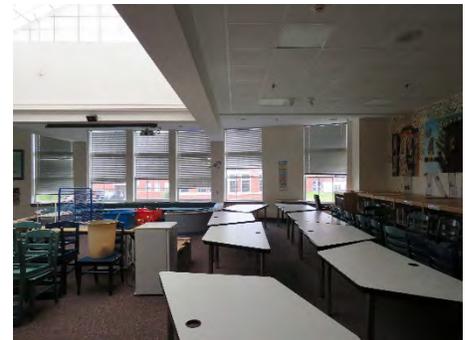
Cooling and airflows are reported by users to be insufficient. Room has a lot of glass, skylight, and added loads from electronics.

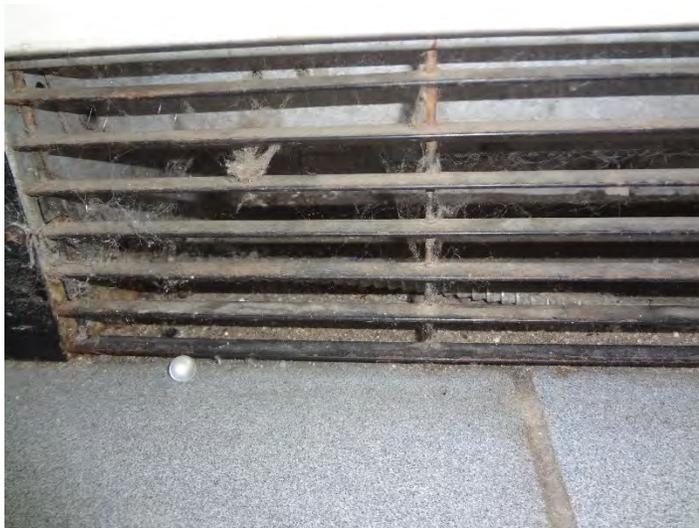
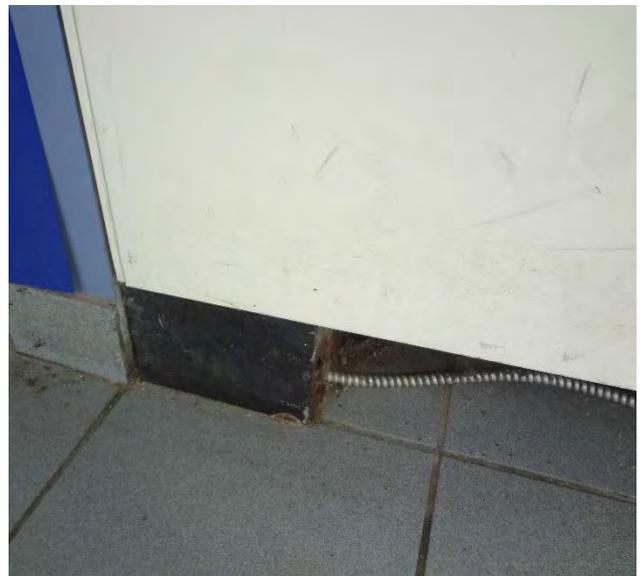
In Entry D116, the 2 cabinet unit heaters CUH-10 on both sides of the entry doors are plugged with dirt and debris, and rusted from moisture and floor cleaning. Bottom protective grille is missing from one heater.

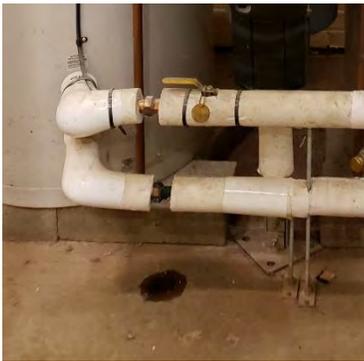
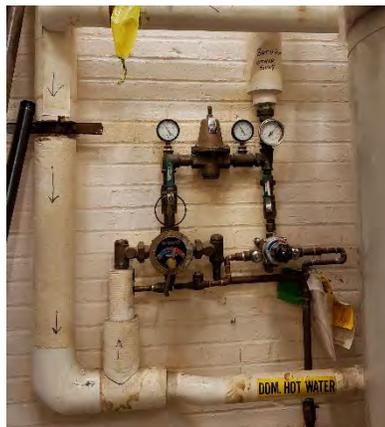
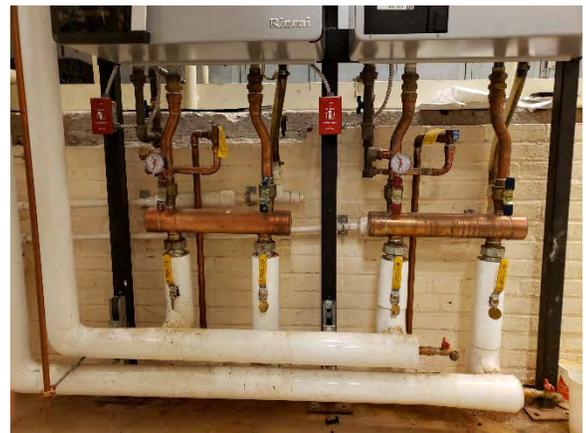
Condensate drain neutralizer cartridges for the Rinnai gas-fired instantaneous water heaters are not removable, and so likely haven't been serviced since installation; marble neutralizer chips are likely used up; cast iron floor drainage piping possibly corroded by untreated acidic condensate. Solar water tank piping has a failed union. Thermostatic mixing valves for domestic hot water supply show significant age, predating the solar and gas water heating, and likely contain some lead because they predate current lead-free regulations.

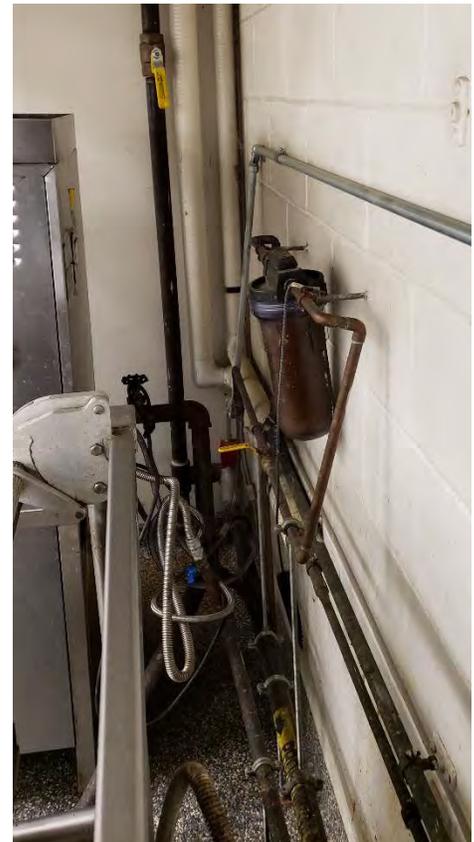
Replace exposed corroded natural gas and domestic hot and cold-water piping throughout kitchen. Provide flexible braided hose connections at equipment for ease of connection. Replace valves, filters, and filter cartridges in kind.

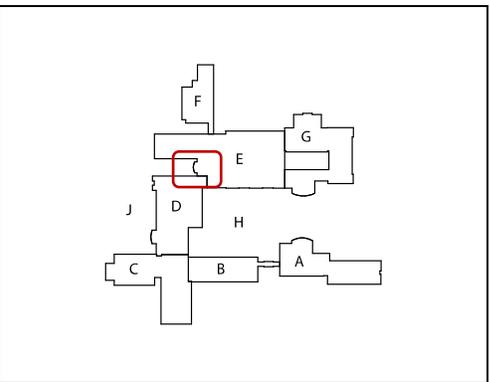
## EXISTING CONDITIONS
