Prepared for:

Cape Elizabeth Schools

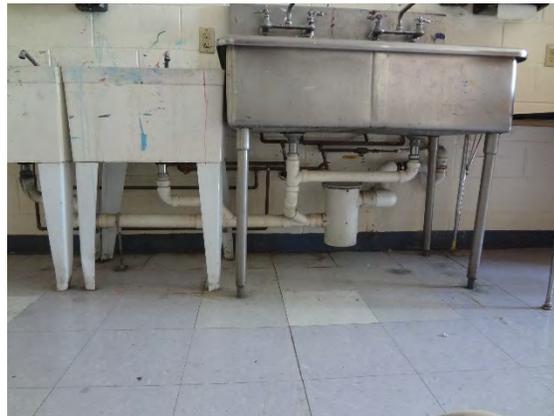
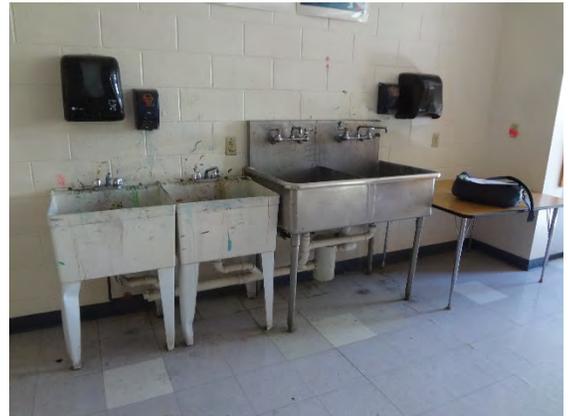
Sinks have deep bowls, rim heights, leg spacing, pipe routing, and floor-mounted pipe supports which do not conform to ADA accessibility guidelines. Two of the sinks are plastic laundry-tray type which appear to have been added later; they are lower than the older stainless steel sinks. The sinks share a plaster trap and wall sanitary pipe connection; the bottoms of the plastic sinks are at about the height of the wall pipe connection which inhibits draining. The faucets on the plastic sinks have short non-ADA handles, and hose-thread outlets without vacuum breakers to prevent cross-contamination.

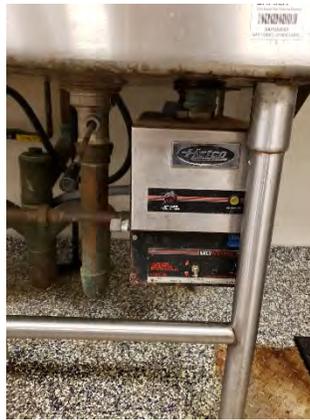
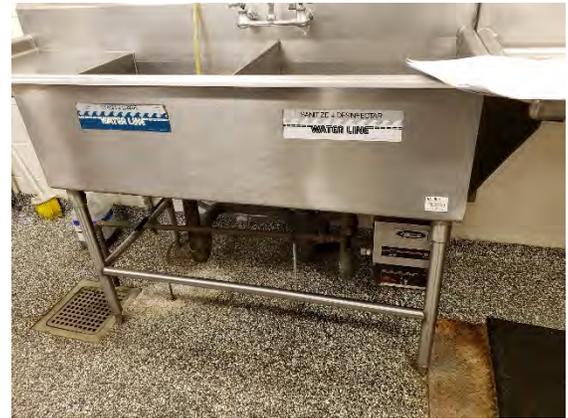
Kitchen sinks do not provide proper separation of dishwashing and other unsanitary functions from food preparation such as washing vegetables to be served uncooked. The single 2-bay lacks indirect waste and is piped directly to the sanitary system. Warewashing sink booster heater is beyond its expected useful life; there doesn't appear to be an alternative such as a chemical sanitizing system.

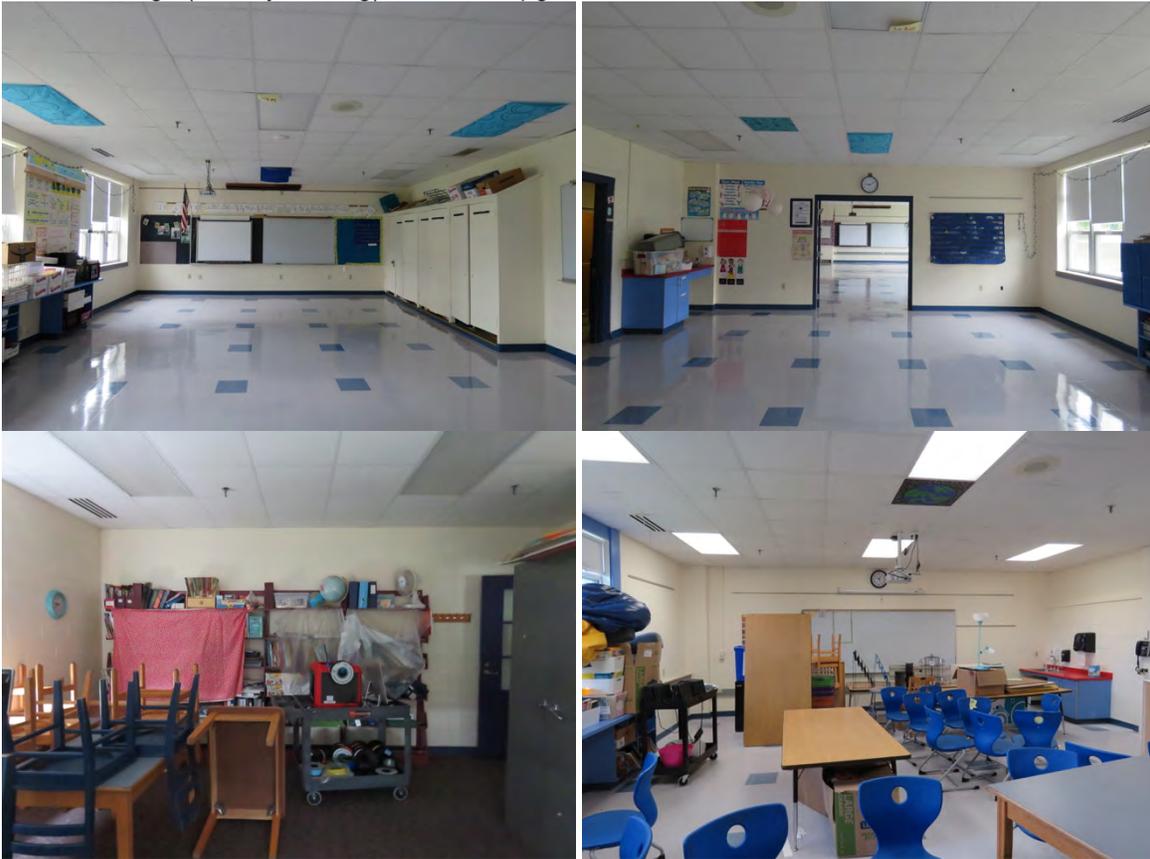
- Classrooms are well maintained, but finishes and fixtures are worn, dated, or require extensive amount of maintenance or are inefficient.
- Millwork is worn and feels dated. Many units are missing components. In some locations, shelving is extremely bowed or doors are miss-aligned.
- Some furnishings (notably seating) has been upgraded in some classrooms.

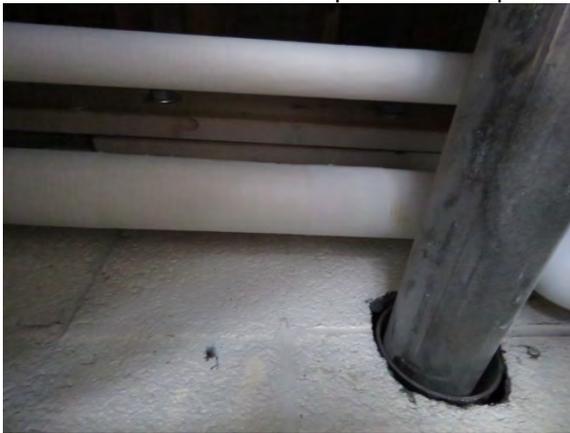
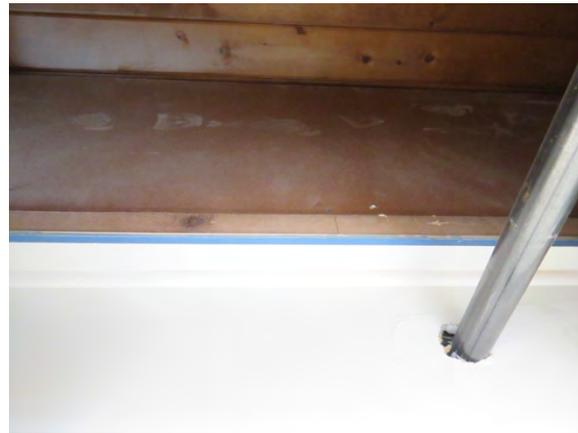
- a. Sealant appears missing at some conduit penetrations above ACT ceiling. In some cases this happens at corridor walls where smoke separation is required.

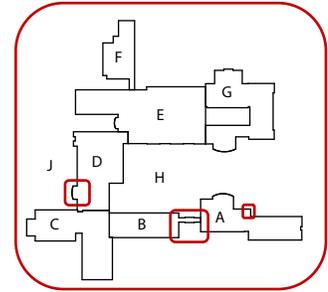
## EXISTING CONDITIONS

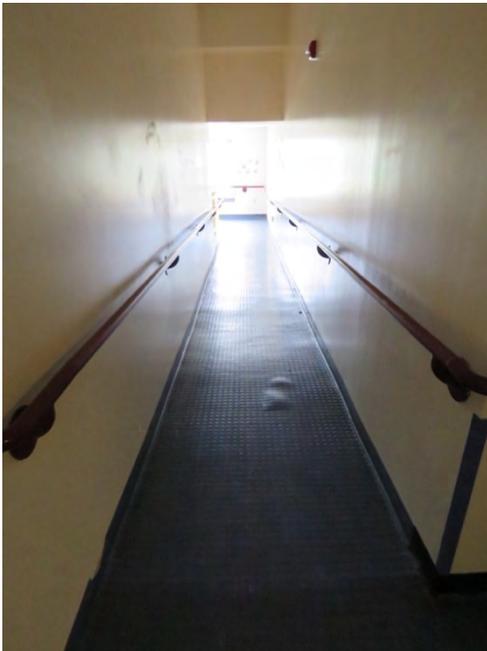
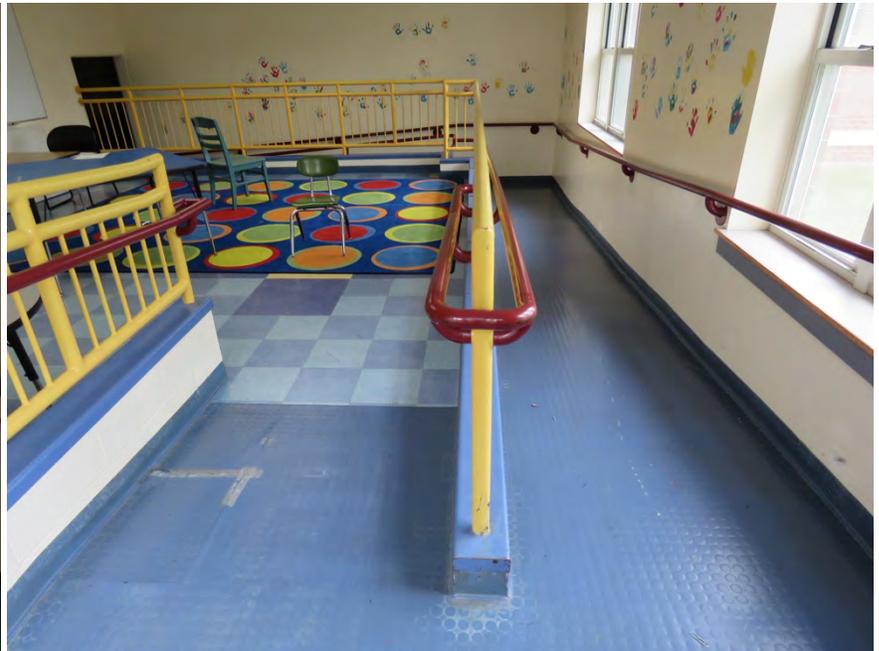
## Cape Elizabeth Schools Needs Assessment

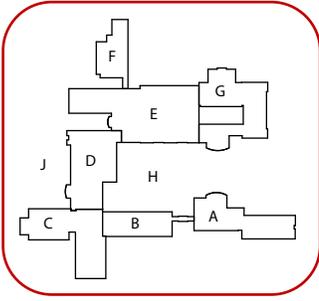
## EXISTING CONDITIONS

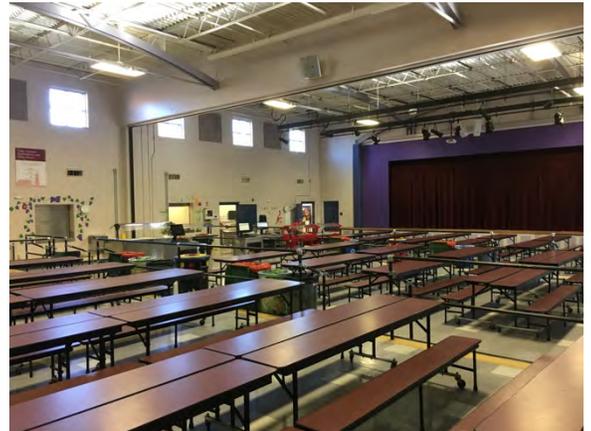
- Control booth
- Catwalks
- 600-650 fixed seats
- Green room
- Classrooms
- Dressing rooms
- Stage storage
- Offices

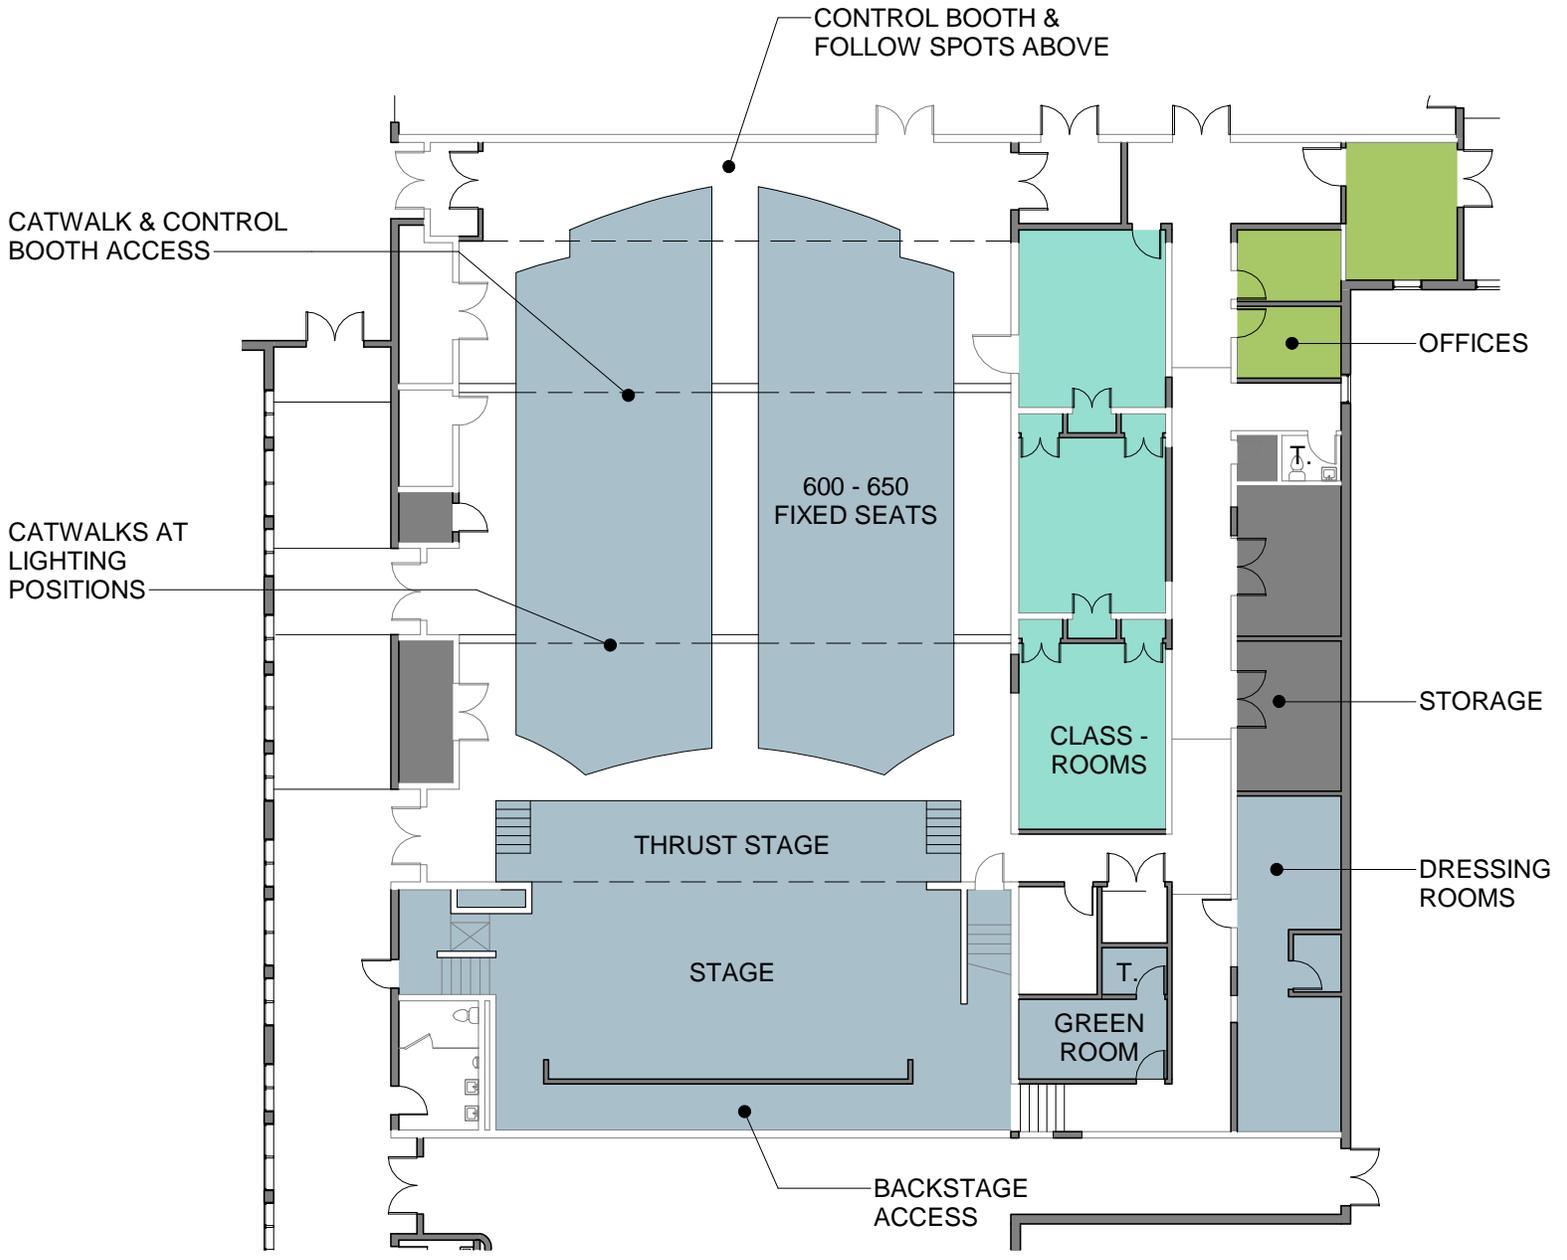
# New Cafeteria and Kitchen

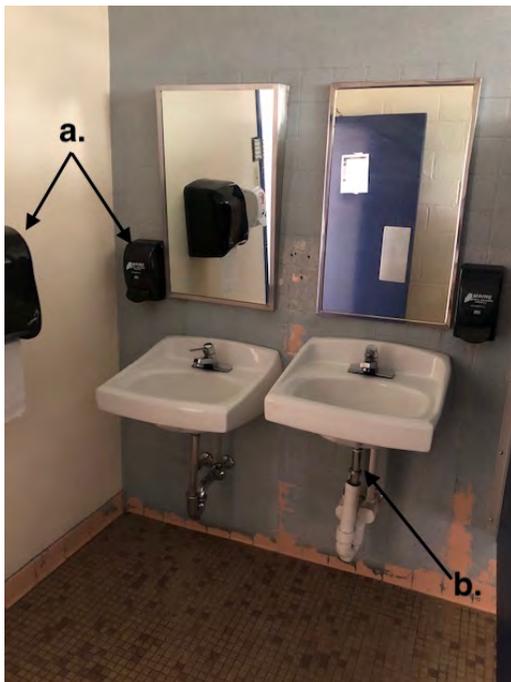
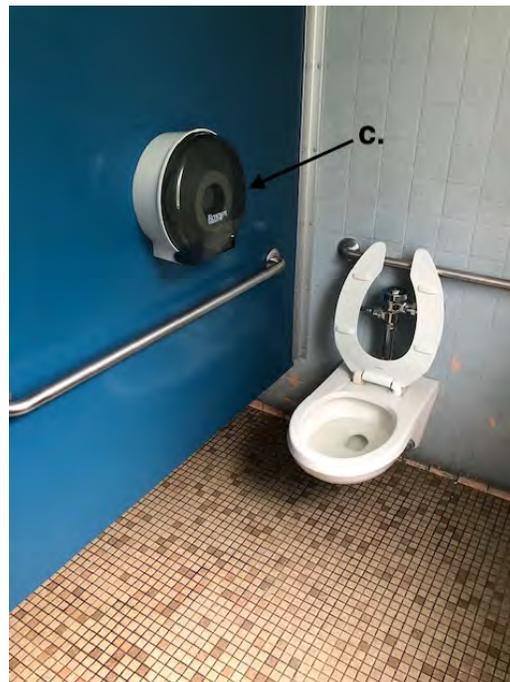
# ACCESSIBLE MOUNTING HEIGHTS for VARIOUS SCHOOL AGE STUDENTS

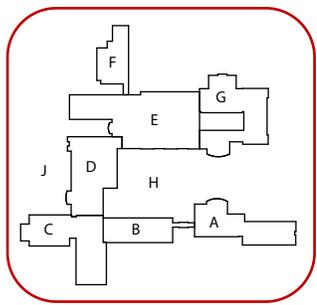
## EXISTING CONDITIONS

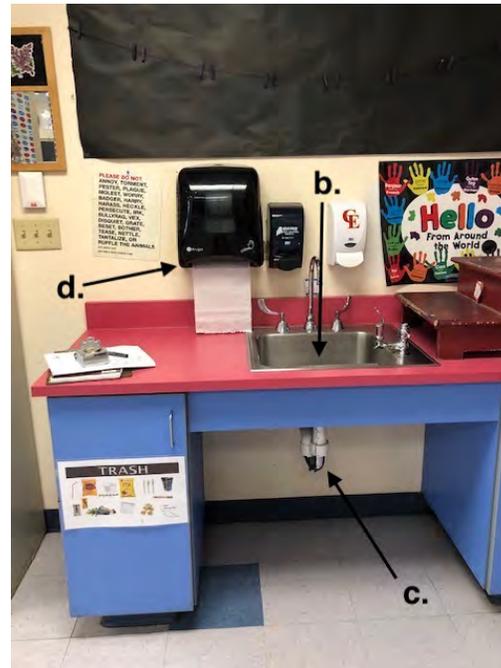
Example non-ADA compliant classroom sink, E109

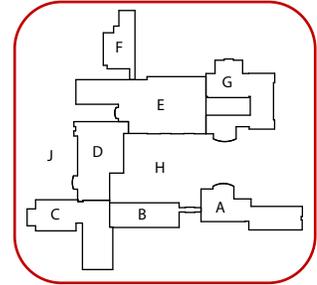
## EXISTING CONDITIONS

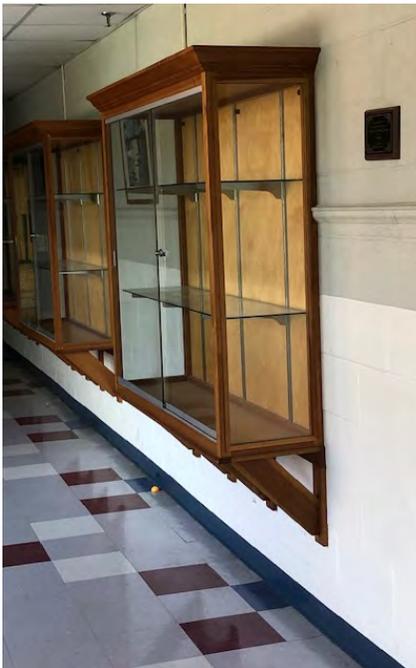
Corridor D117  
Display cases protrude beyond ADA limits

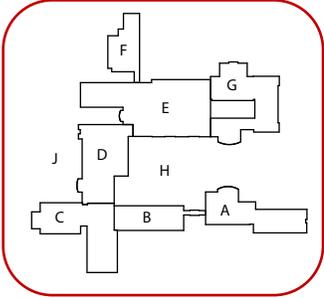
**EXISTING CONDITIONS**

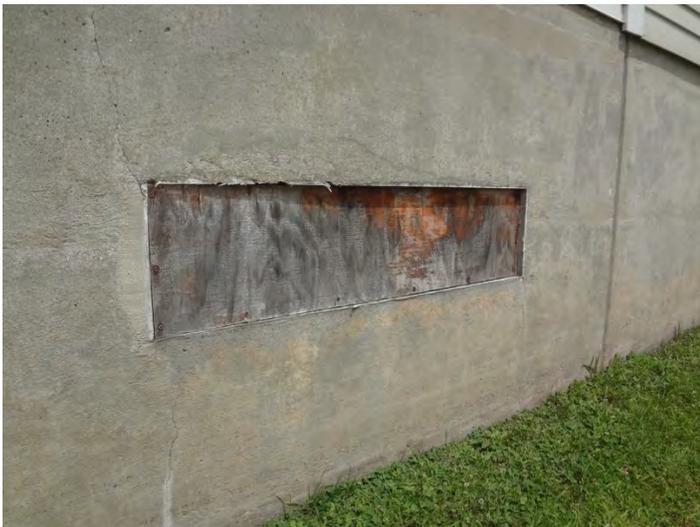
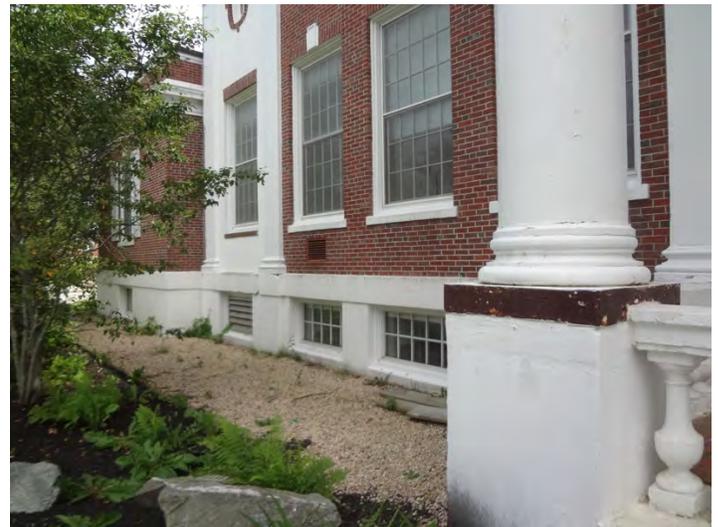
# Roof Improvements and Repairs

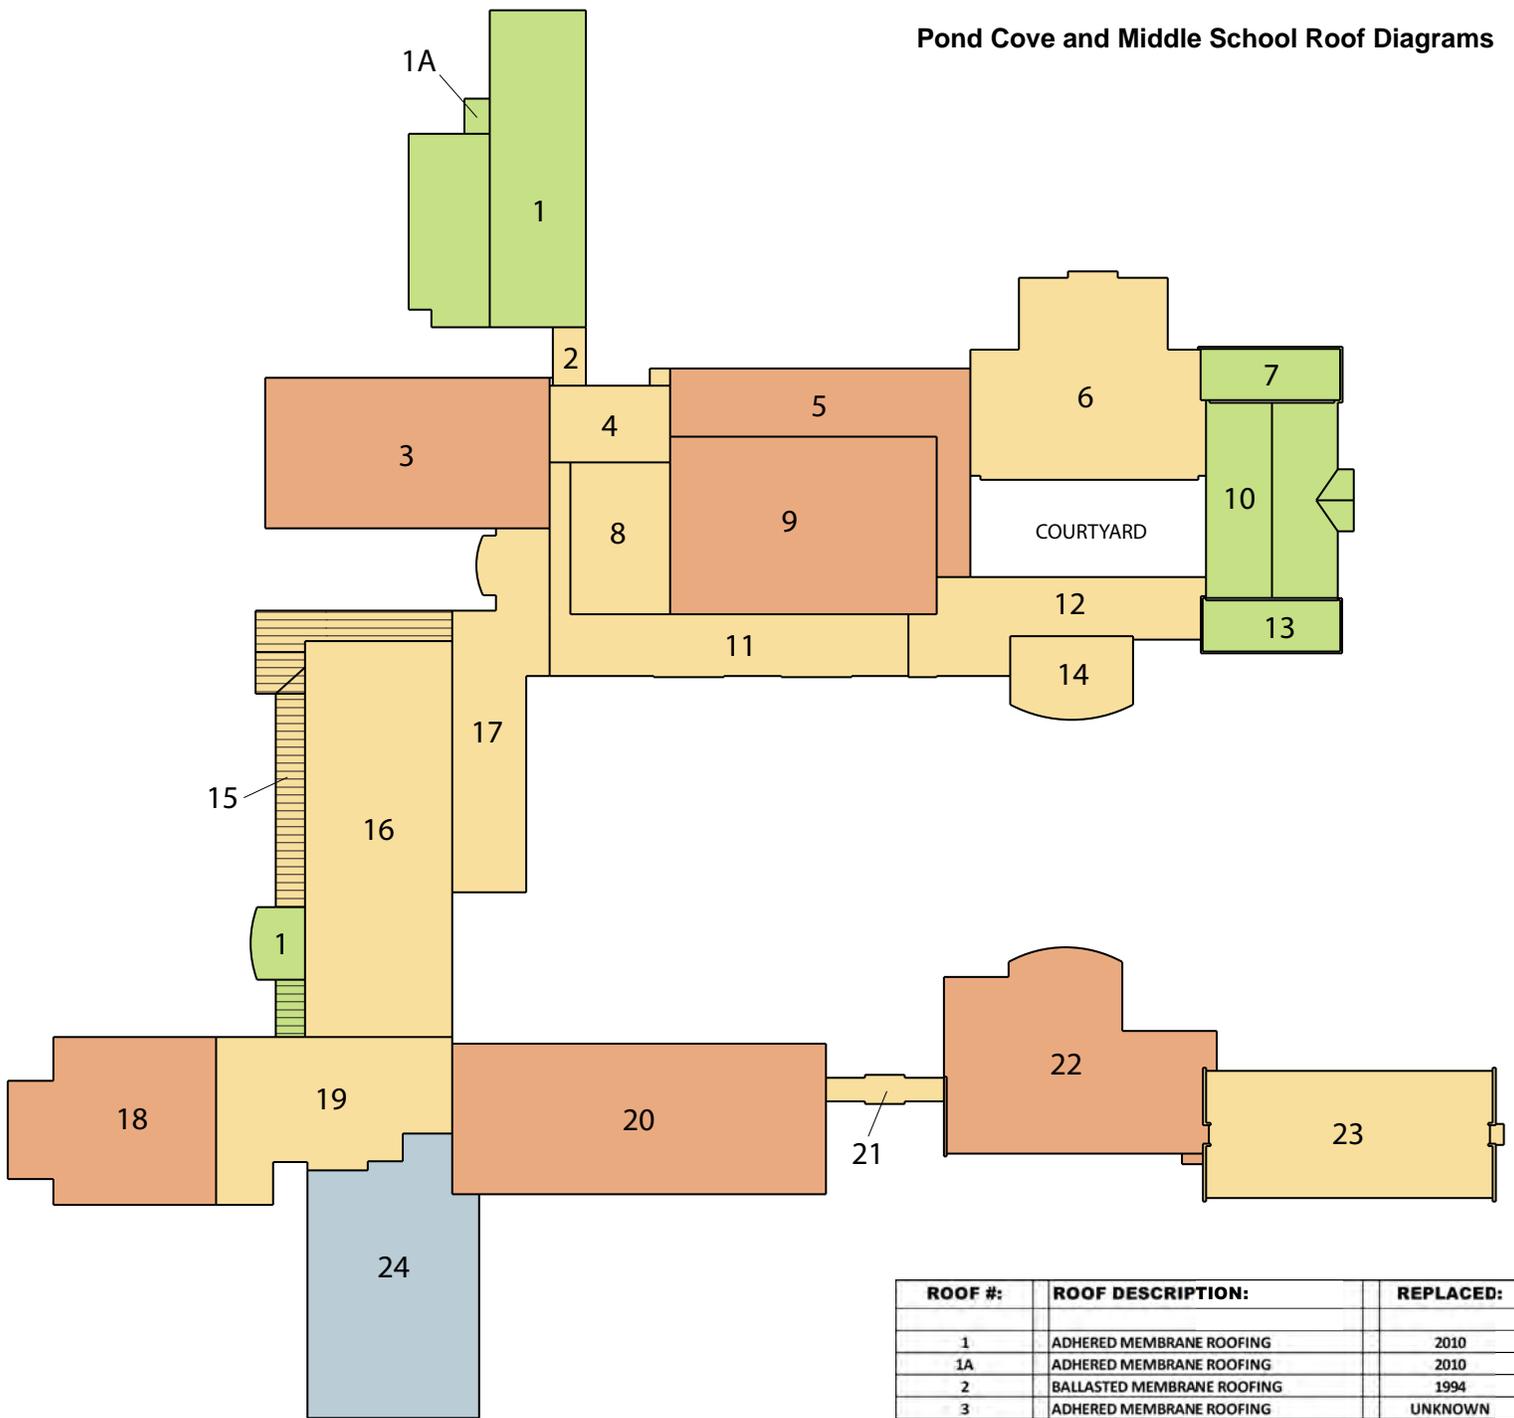
# Pond Cove and Middle School Roof Diagrams

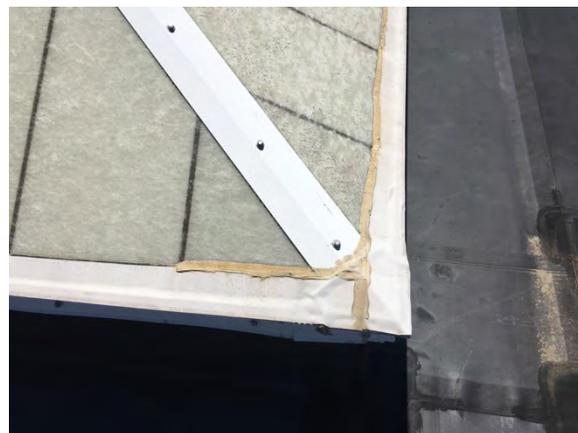
EPDM flashing tape and sealant to stop leakage

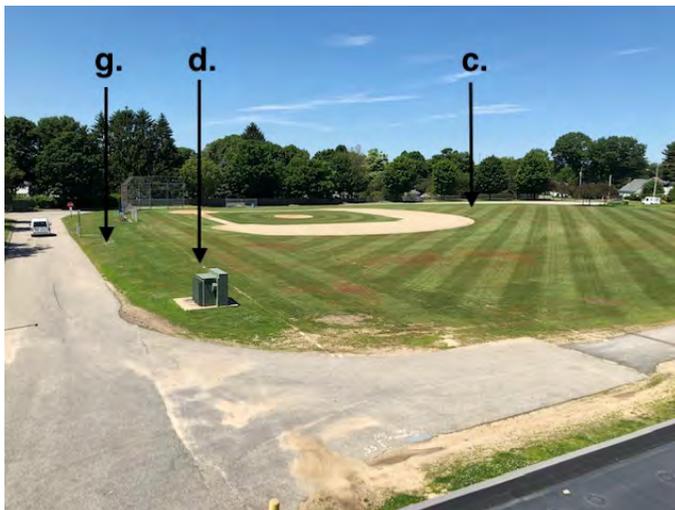
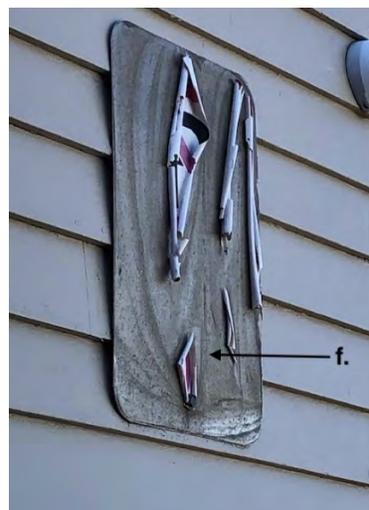
Exterior Middle School Site Work

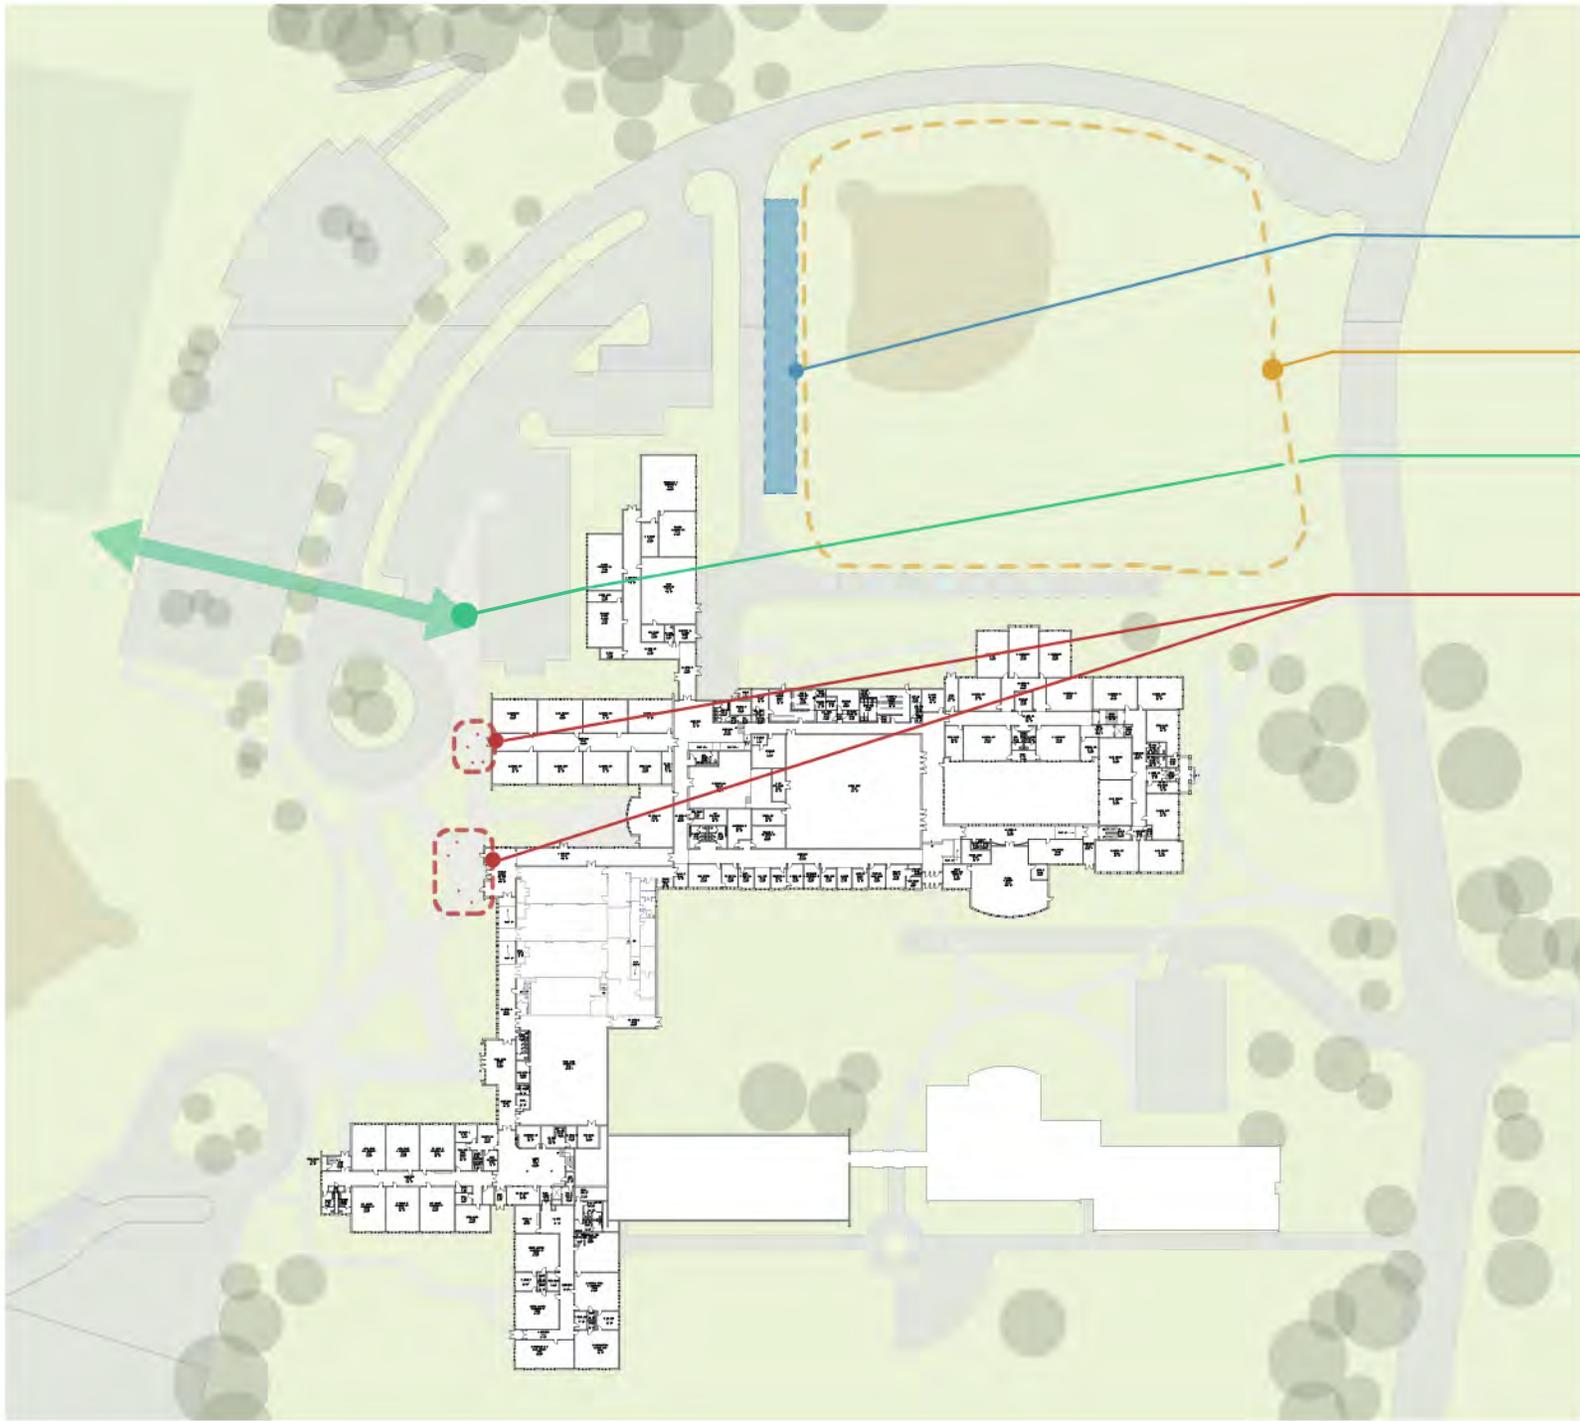
g additional parking

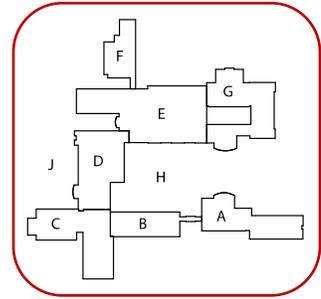
## EXISTING CONDITIONS

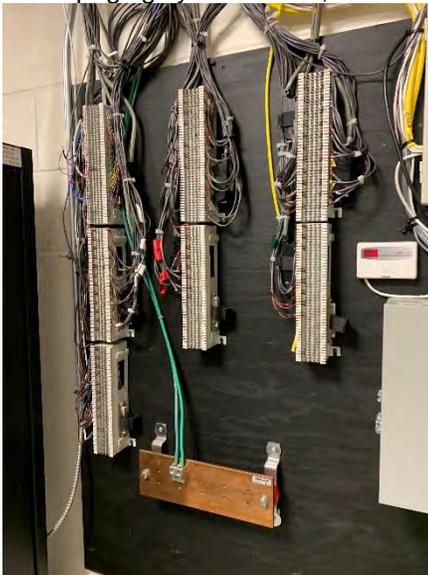
The existing phone system is an analog system, that is outdated, and not all locations have handsets. The intelligibility of the paging system is low, and the system is aging.

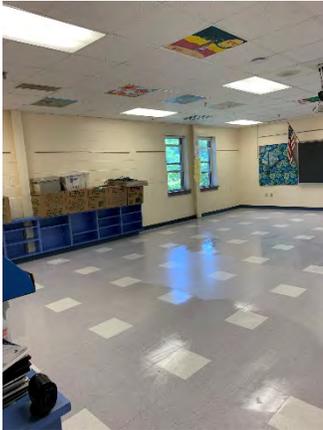
The classrooms typically have 2x4 recessed fluorescent fixtures with three or four lamps. Controls consist of a combination of one level, two level and three level switching with local switches. The multiple level of lighting provides for reduced energy consumption. Lighting levels appear to be adequate. Occupancy sensors were not present, and no form of automatic off for classroom lighting is present.

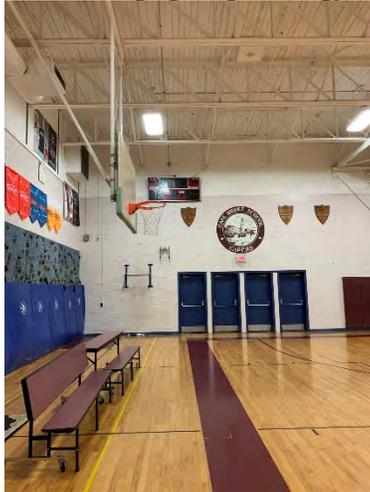
The existing lighting in the gymnasium is T5 lighting, with local controls.

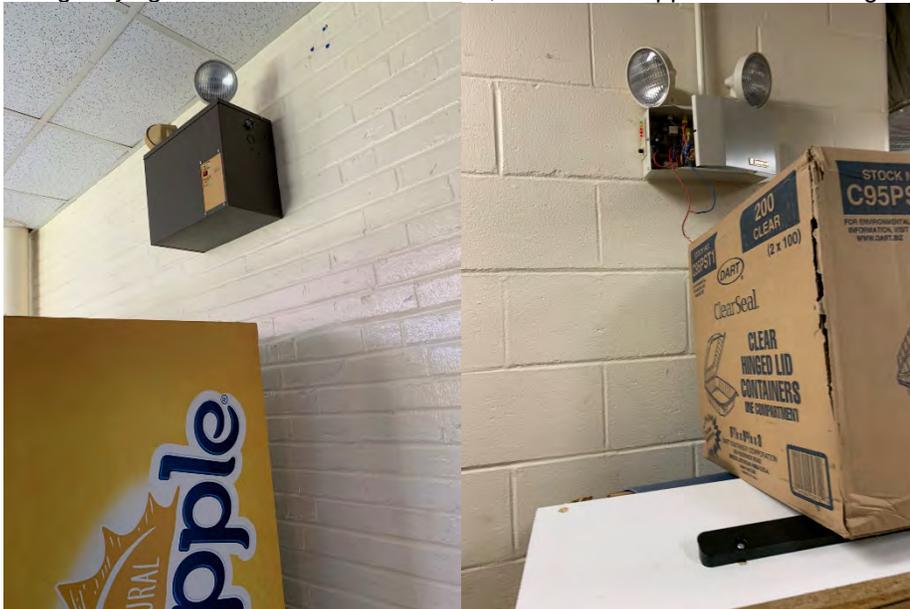
The existing emergency lighting are older style, and consist of a combination of self contained battery units, remote dual and single heads. The single heads do not meet current code for egress lighting. It does not appear that there is adequate coverage, to meet the 1 fc requirement from NFPA 101, and not all exit doors have an exterior egress emergency light. In a number of instances, the fixtures appear to be damaged.

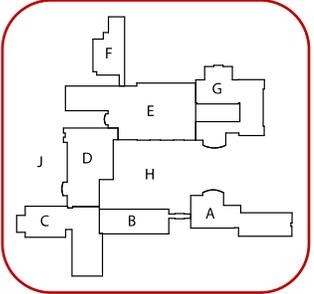
## EXISTING CONDITIONS

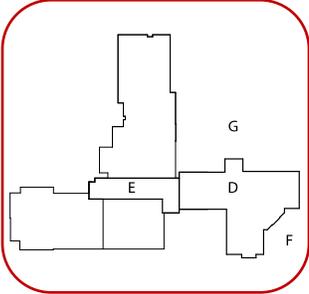
## EXISTING CONDITIONS

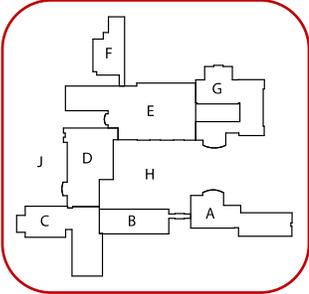
## EXISTING CONDITIONS

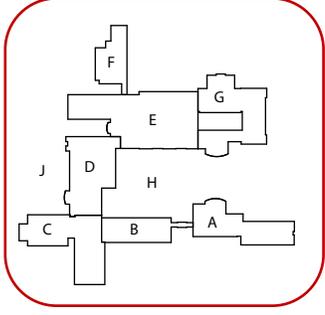
## EXISTING CONDITIONS

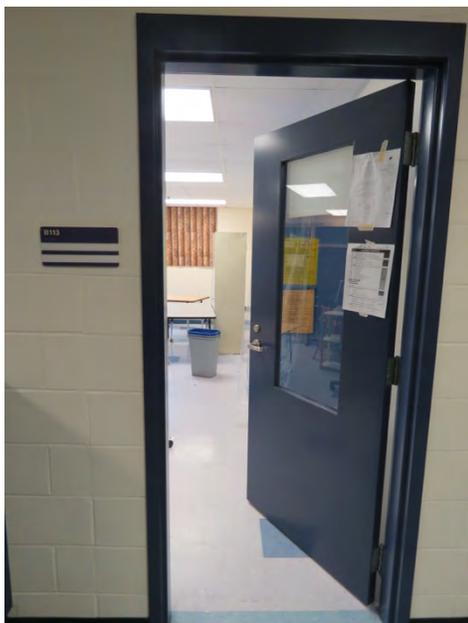
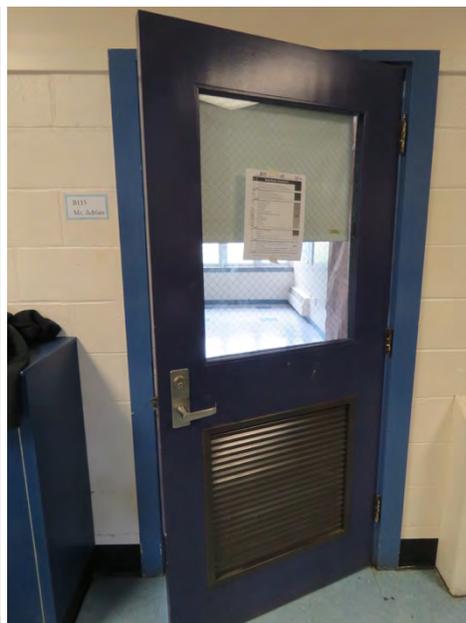
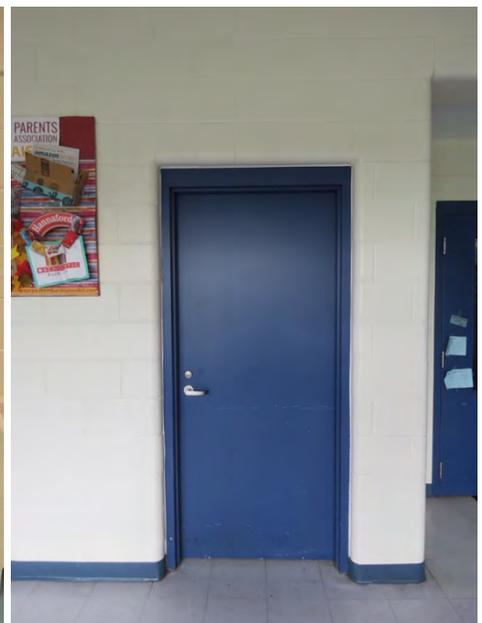
# Cape Elizabeth Schools Needs Assessment

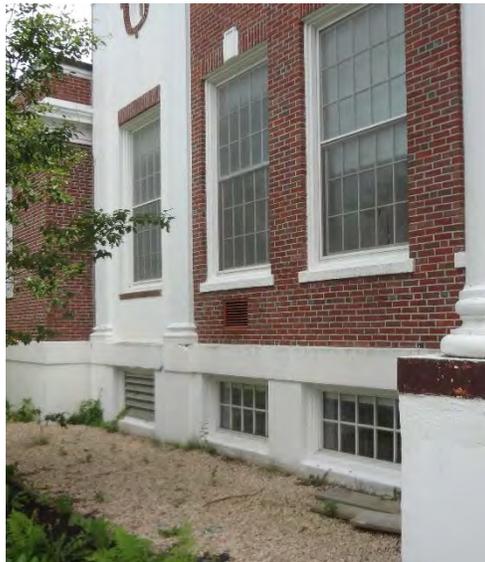
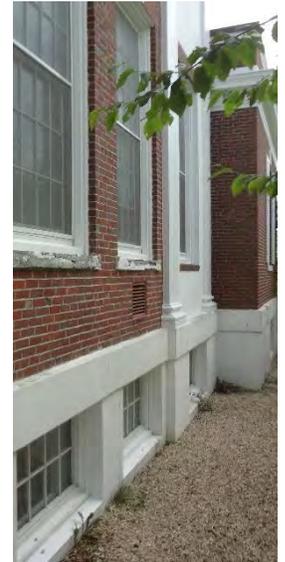
To meet the intent of the Maine Department of Education's Public School Standards & Guidelines for New School Construction & Major Renovation Projects, provide burglar bars in low openings to prevent entry.

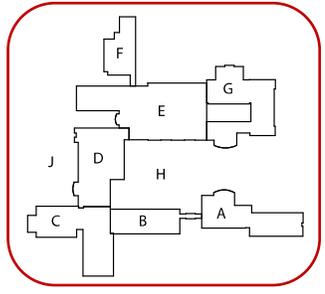
## EXISTING CONDITIONS

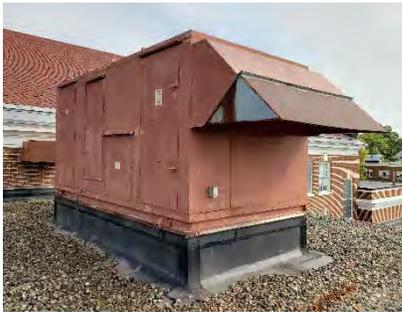
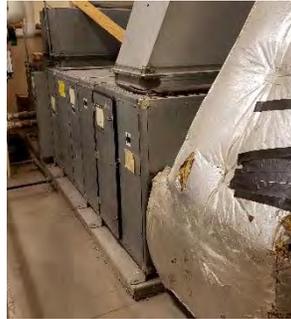
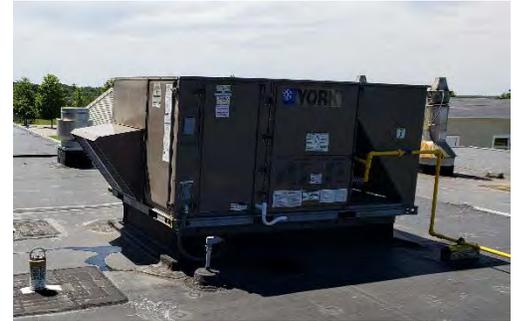
There are several roof-mounted 100%-outside-air heat-recovery units (HRUs) with built-in heat recovery to transfer sensible (dry) heat from exhaust air to incoming ventilation air; these are old and in need of replacement as discussed in a related work item. There are also various ages of indoor air handling units (AHUs) and gas-fired rooftop units (RTUs) which provide mixed air at less than 100% outside air; these do not have any recovery.

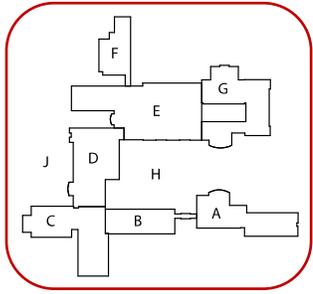
## EXISTING CONDITIONS

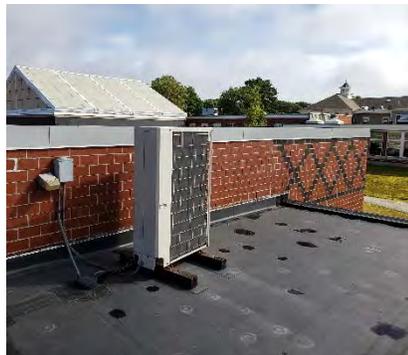
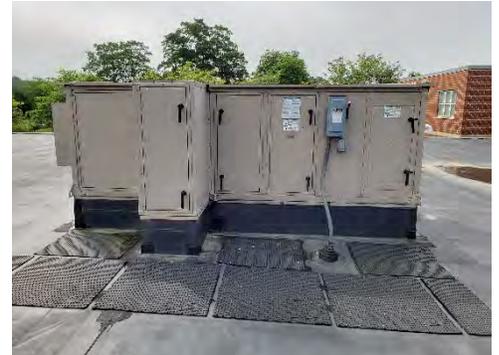
Most of the rooms used by students do not have air conditioning or dehumidification. Summer school and similar programs for children and others are a growing need and interest in the community. Summer weather has trended hotter and more humid in recent years. In addition to the comfort concerns, uncontrolled humidity can damage building materials and other items, and can potentially cause mold issues, which affect both building occupants and materials. The Maine Department of Education Public School Standards and Guidelines for New School Construction & Major Renovation Projects requires or recommends air conditioning in spaces used year-round such as auditoriums, and spaces needed for summer school programs. It also recommends (as a premium) dehumidification systems for summer use in general areas, and specialized dehumidification systems for gymnasiums with wood floors.

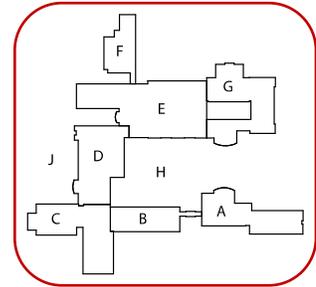
## EXISTING CONDITIONS

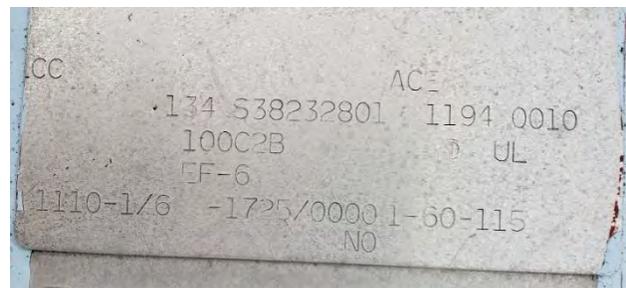
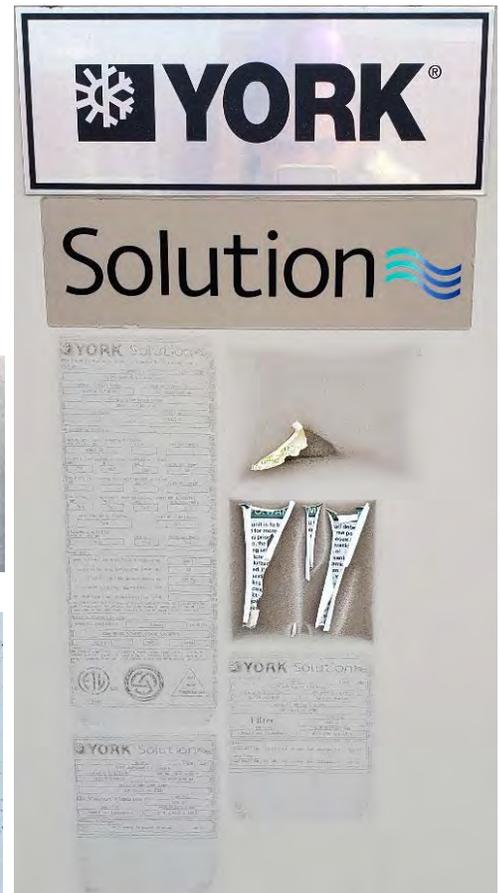
Provide a building-wide mechanical equipment numbering scheme such that no two items receive the same number. Provide riveted engraved acrylic nameplates affixed to each piece of equipment bearing the unit number, make, model, serial number, and general performance. Install nameplates such that dismantling of equipment is not necessary to view the nameplate in full. Recommend including all pieces of HVAC equipment including unit ventilators, exhaust fans, unit heaters, air handling units, and any other piece of equipment serving the HVAC systems. Such a system will provide clarity for ease of maintenance and will allow for a comprehensive operations and maintenance database.

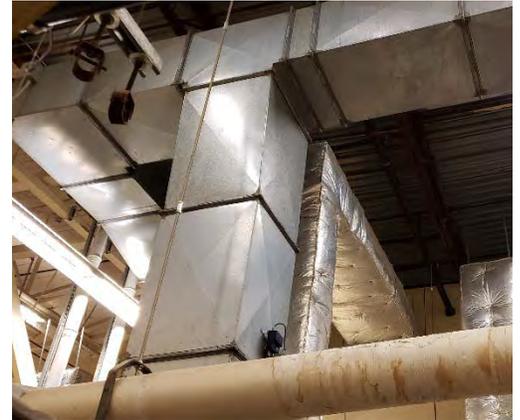
Older ductwork has its original seam and joint sealant, which was not always applied to the level required by today's Codes. Sealants harden and deteriorate as they age, leading to increased leakage both into and out of the ductwork. Leaking ducts waste energy, and because air leaks out where it isn't wanted, reduce ventilation effectiveness where it is wanted, and cause improper pressure relationships in the building. The leaks can also result in a replacement air handling unit being unable to perform as designed, when airflows are measured at the rooms where the air is needed.

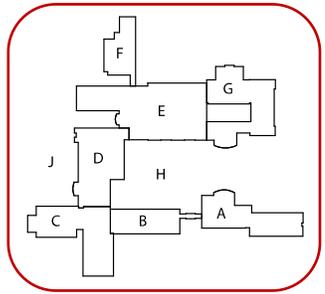
## EXISTING CONDITIONS

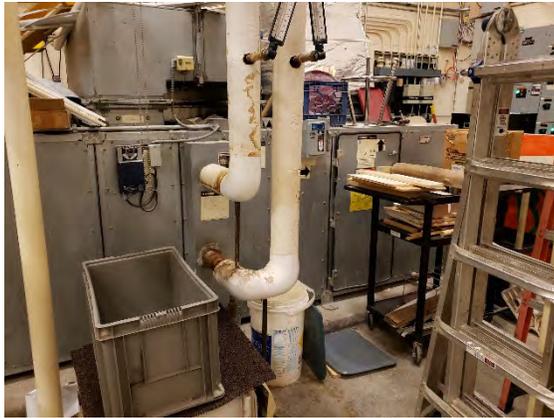
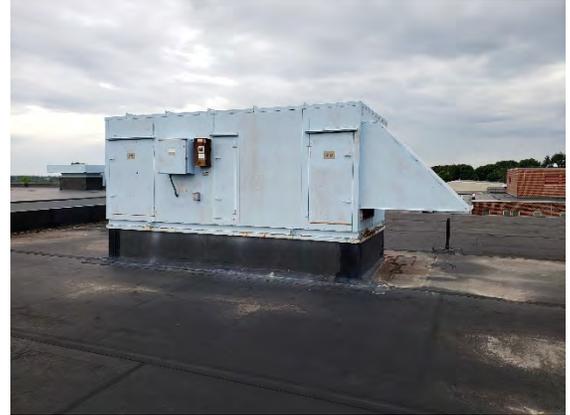
Existing ventilation systems were designed to meet ventilation codes in use during original design and construction. Codes and other standards have increased their requirements and recommendations for quantities of outside air supply, and requirements for good distribution of the air for ventilation effectiveness.

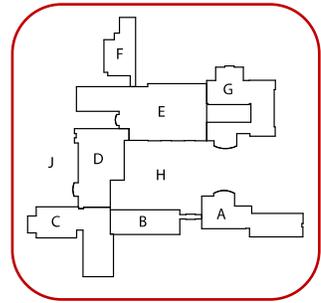
## EXISTING CONDITIONS

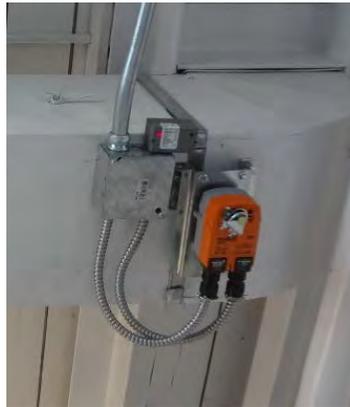
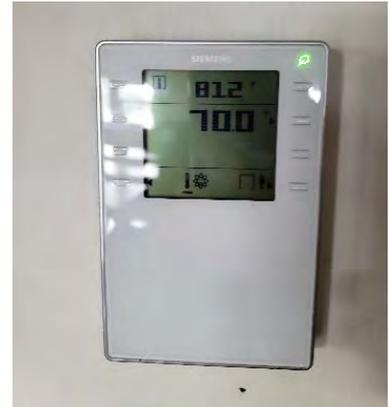
Commissioning is a process of testing systems to demonstrate that they operate as designed. Control sequences are confirmed by direct observation of items such as control valves and dampers.

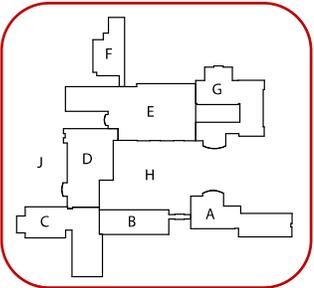
Priority	Cost				
	\$\$\$				
Coordination by Discipline					
<input type="checkbox"/>	<input checked="" type="checkbox"/>		<input checked="" type="checkbox"/>	<input type="checkbox"/>	<input type="checkbox"/>
A	M		E	P	FP
<input type="checkbox"/>	<input type="checkbox"/>		<input type="checkbox"/>	<input type="checkbox"/>	<input type="checkbox"/>
S	LS	SC	BE	C

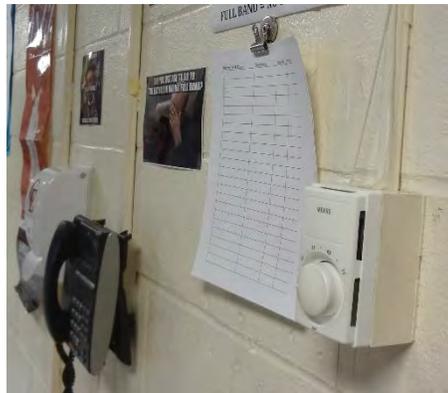
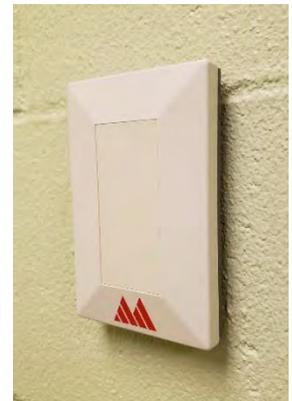
The Maine Department of Education Public School Standards and Guidelines for New School Construction & Major Renovation Projects lists as “required or recommended” individual room controls, including the use of operable windows. Most of the existing occupied rooms have operable windows. In the rooms that have DDC (direct digital control) room temperature control, most of the wall-mounted sensors have blank covers with no occupant-accessible settings. Occupants may want to adjust the sensors’ temperature setpoints to coordinate with their use of the space and the windows, as well as their personal comfort needs.

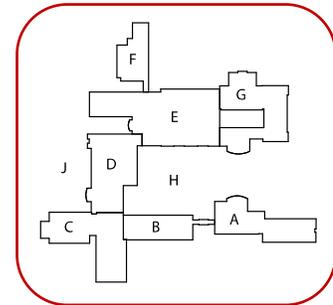
## EXISTING CONDITIONS

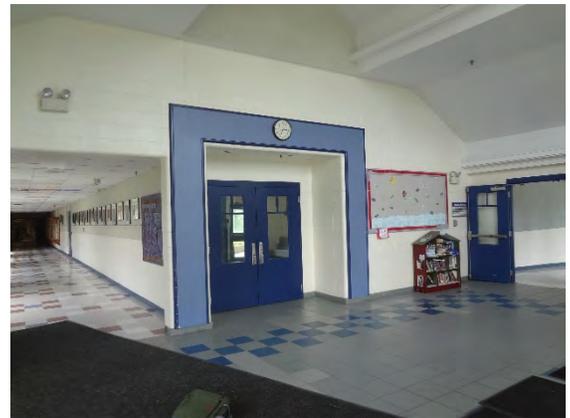
Several of the corridors and lobbies lack ventilation supply outlets, or have few outlets which are poorly distributed. Examples include the Middle School entry lobby, and long corridors with a single short linear diffuser aimed downward.

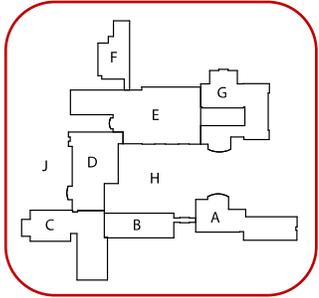
## EXISTING CONDITIONS

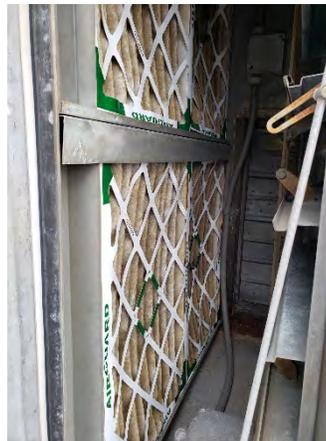
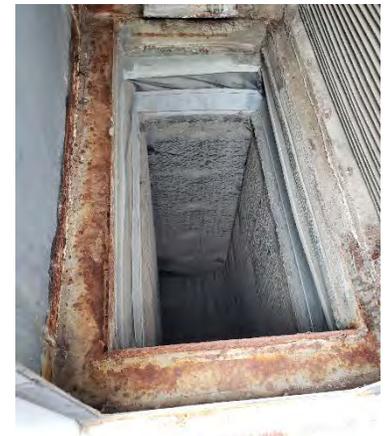
Heavy dust buildup is seen inside ductwork near rooftop air handling and heat recovery units. Filters in these units receive a lot of dust and pollen, and because of imperfect fit and some overloading they allow some air to bypass unfiltered. Dust buildup is also seen at terminal inlet and outlet grilles and diffusers. Schools bring in large amounts of outdoor air which bears humidity as well as outdoor contaminants such as dust and pollen, and have large dense populations of people who generate dust and other contaminants. Ducts can store these contaminants and distribute them to the occupants, and in some conditions such as high humidity the dirty duct surfaces can promote unhealthy biological growth. Periodic duct cleaning has become standard practice in many schools and other buildings, to promote healthy indoor air quality (IAQ).

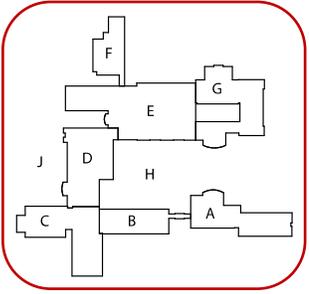
## EXISTING CONDITIONS

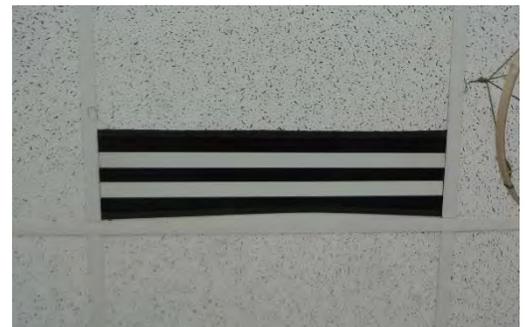
Some air diffusers, grilles, and registers have damage. Most remain functional to deliver the air.
