Prepared for:

Cape Elizabeth Schools

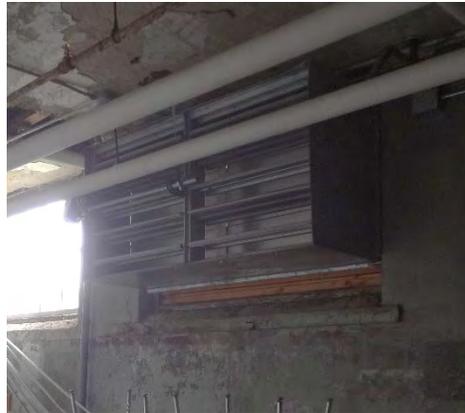
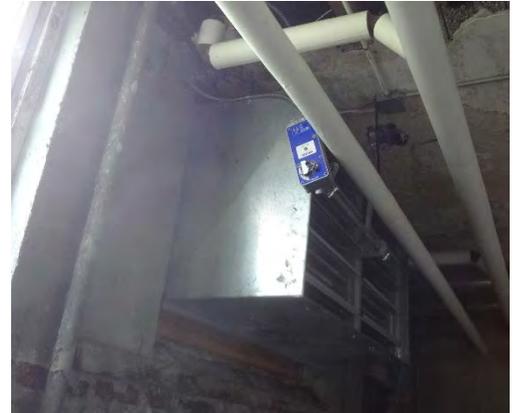
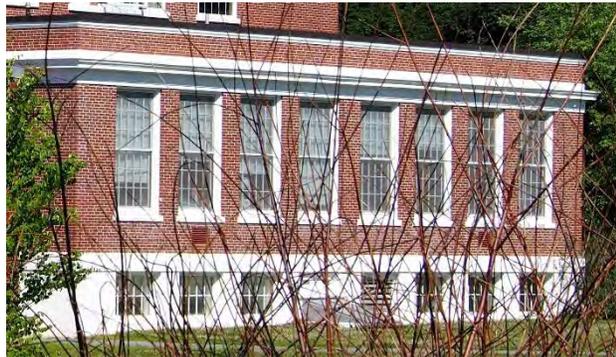
Remove the duct, damper, and outdoor louver. Provide architectural infill of the opening with insulation, or a window to match the adjacent one.

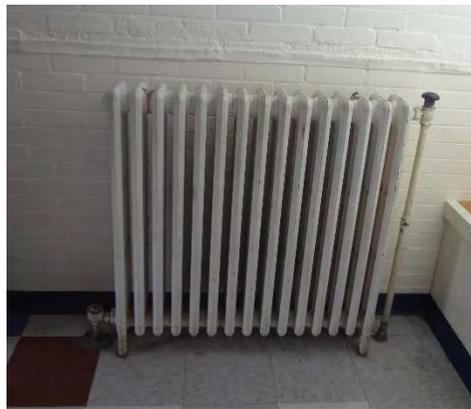
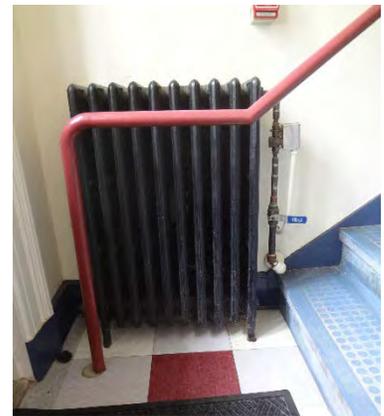
Cast iron radiators are original to the 1934 portion of the building. The outer surfaces of the radiators and their piping are exposed to the students' touch. The hot water supply temperature might typically be 180 degrees F or up to 200 F. OSHA limits surface temperatures to 140 F (by indirect reference to ASTM C1055), in a zone up to 7 feet above the floor in occupied and service spaces. A general industry consensus is that surface temperatures above 111 F can burn with a long enough contact time, and a surface temperature of 140 F can only be touched by a healthy adult for 5 seconds before a serious burn occurs (these temperatures and times have not been independently verified by the Engineer). Children, the elderly, and the physically or mentally impaired, can be more susceptible to burns, or unable to pull themselves away quickly enough.

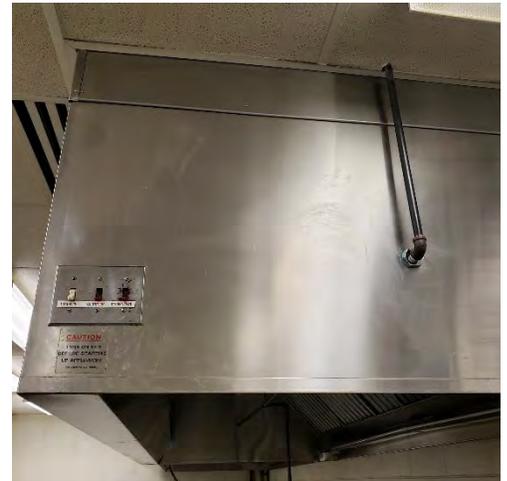
The switches for the kitchen hood's lights, supply fan, and exhaust fan are mounted on the end of the hood well over 6 feet above the floor. It appears that the hood fan operation is not interlocked with cooking operation as is required by current Codes. There is a sticker cautioning users to turn on the fan before starting up appliances, which is not in sight from the user's cooking position.

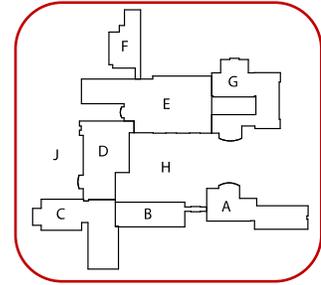
## EXISTING CONDITIONS

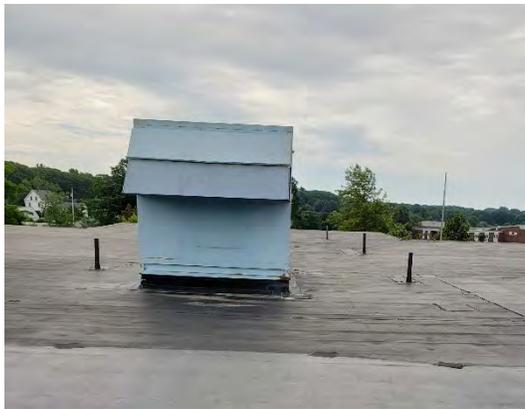
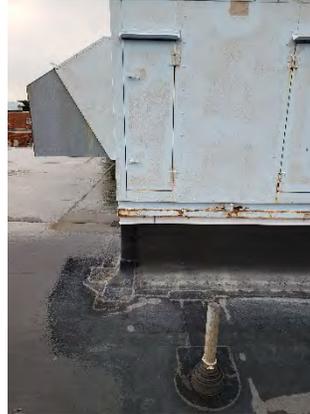
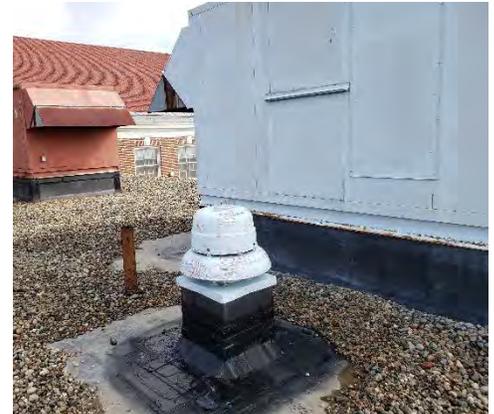
Several plumbing vent pipes through roof are less than the Code-required minimum of 10 feet from air intakes, or from other potential air inlets such as operable windows. Most of these pipes appear to have been existing when many of the rooftop air handling units were added in the 1994 era remodel.

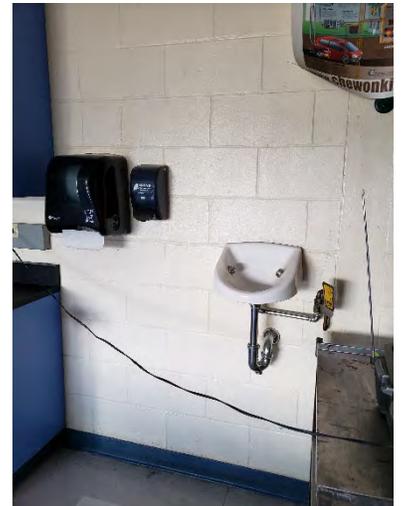
Provide at each middle school science classroom a plumbed combination emergency unit with eyewash or eye/face wash and shower, and provide a floor drain and piping. Provide floor drains at any existing showers that do not have drains. Provide at each janitor closet or space utilizing chemicals an emergency eyewash or eye/face wash, which may be plumbed or self-contained ("portable") type. Provide ADA accessibility where applicable, and replace any existing emergency fixtures which do not have adequate accessibility for the location. Provide replacement emergency fixtures to meet ADA accessibility including at Kitchen D131. Provide tepid water supplies to plumbed emergency fixtures, including existing ones which have only cold water; do not downgrade these locations to non-plumbed type.

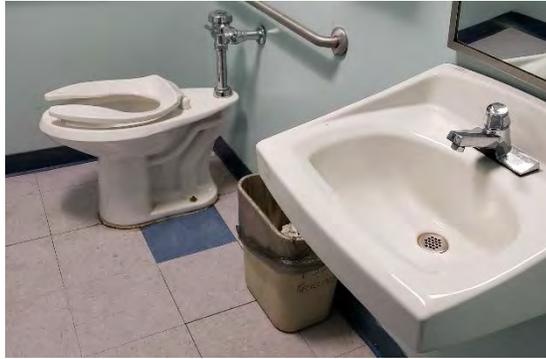
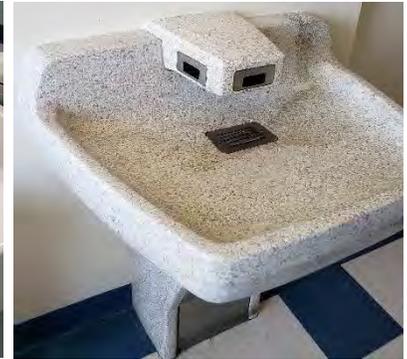
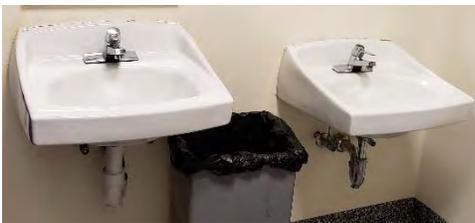
Provide 70 hard-wired automatic flushometers for toilets and 13 hard-wired automatic flushometers for urinals, and 64 hard-wired automatic sensors for lavatories to meet the Maine Department of Education requirements. The hard-wired units provide greater reliability than battery-operated units. Provide fixtures compliant with EPA WaterSense maximum allowable flow rates of 1.28 gpf for toilets, 0.5 gpf for urinals, and 1.5 gpm for lavatories, where feasible. Aerators may be provided at lavatories, and a 15-second automated duration may be utilized. Provide new fixtures where the existing cannot support automatic sensors. In the instance that an automatic sensor is fitted to an existing water closet or urinal, the sensor flow rate must match the fixture flow rate.

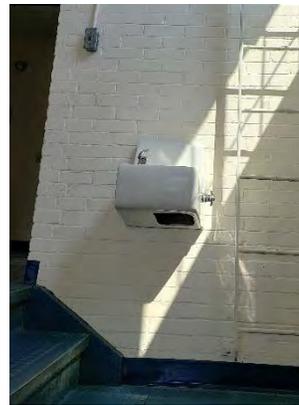
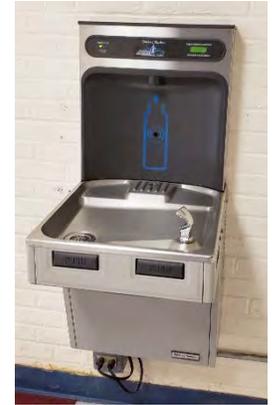
- Lobby C120 – single vinyl with bottle filler, 32"
- Kindergarten Lobby – dual stainless, 32.5" & 38"
- 4<sup>th</sup> Grade Corridor – single vinyl with bottle filler, 32"
- Corridor D117 – single vinyl with bottle filler, 32"
- Cafetorium D114 – single stainless with bottle filler, 33.5"
- Corridor F106 – single stainless, 33.5"
- Corridor E112 – single vinyl with bottle filler, 32.5"
- Corridor E144 – single stainless, 33"
- Corridor G102 – single vinyl with bottle filler, 35"
- Corridor G002 – single stainless, 35"
- Corridor G236 – single vinyl, 33.5"
- Work Area G004 – single vinyl, 33.5"
- Stair G227 top landing – single vitreous china, 29"

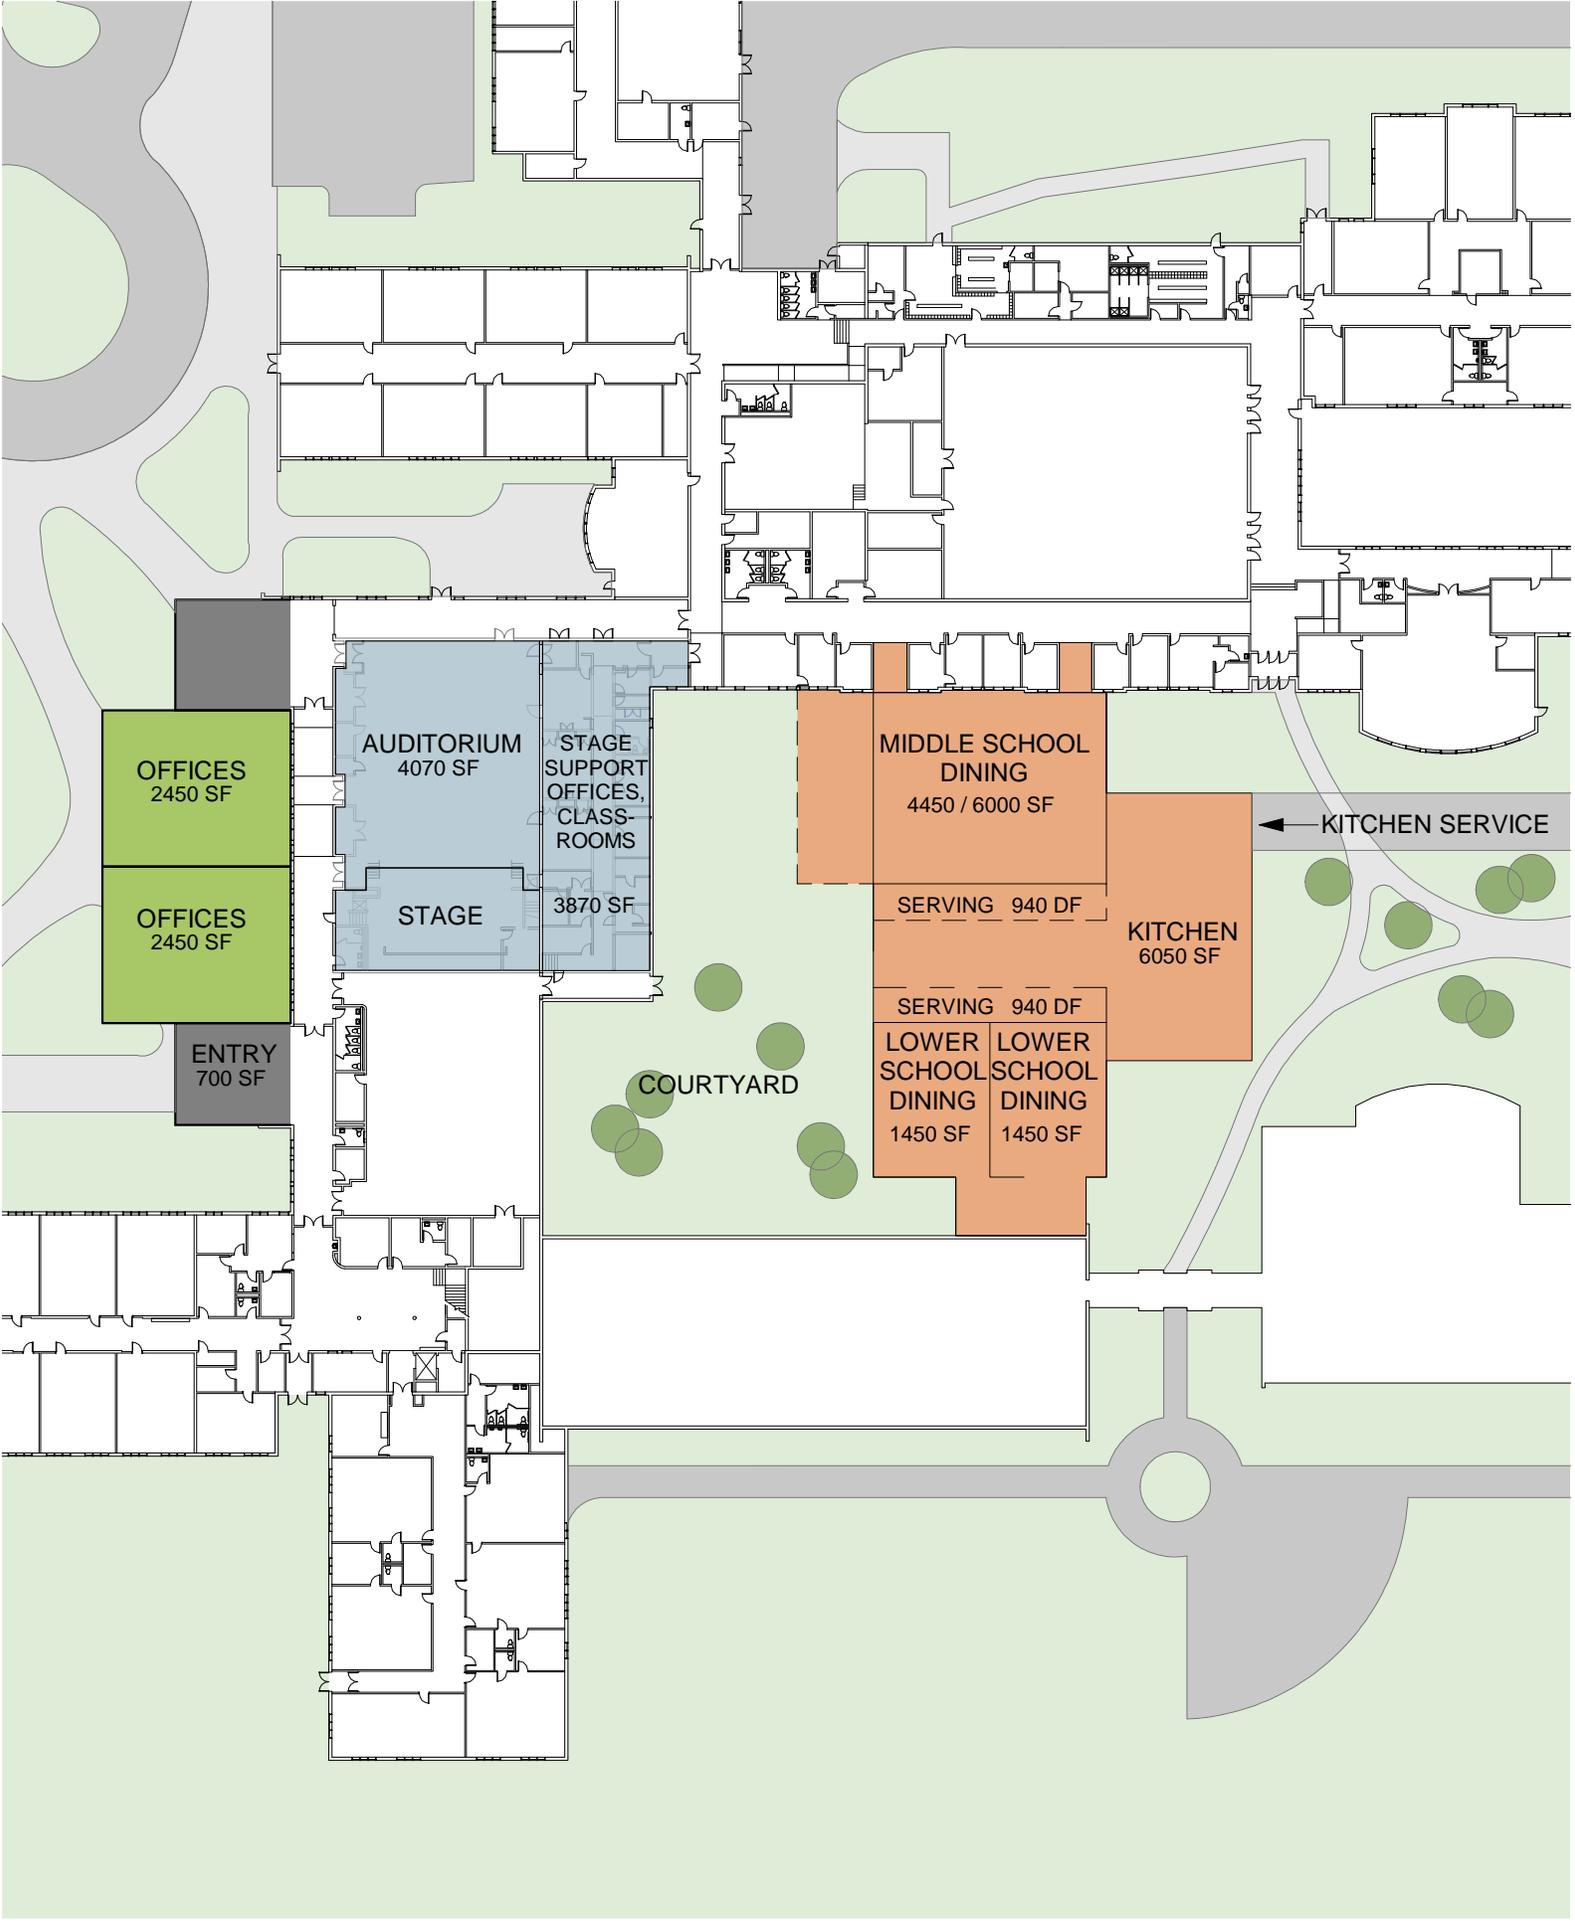
# General Exterior Masonry Repair

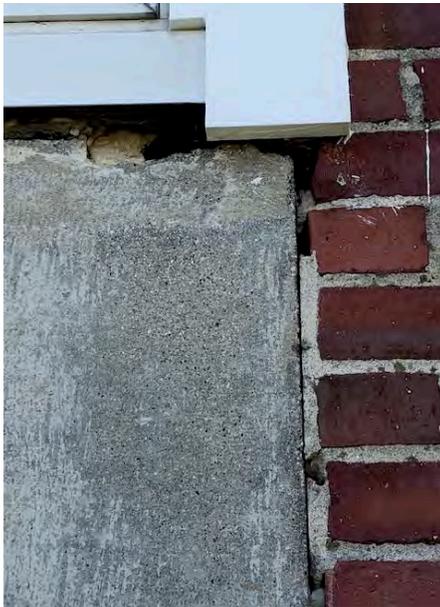
a. Open Mortar joints

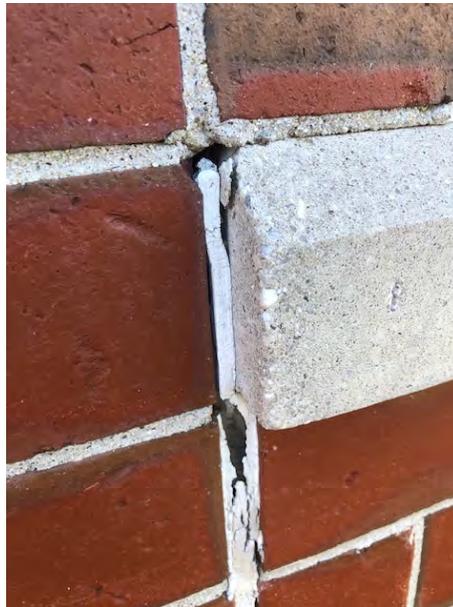
b. Failing soft joints

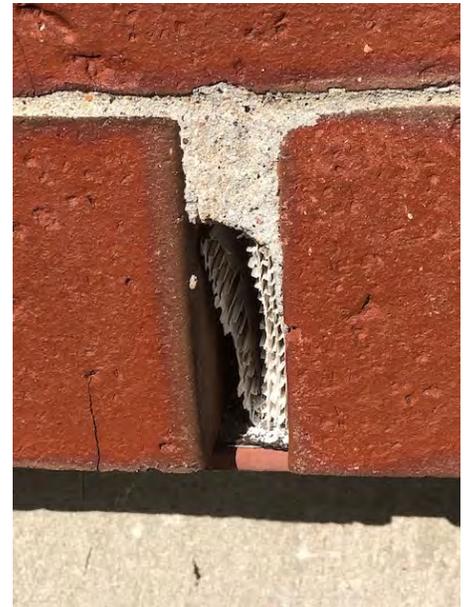
c. Failing masonry weeps

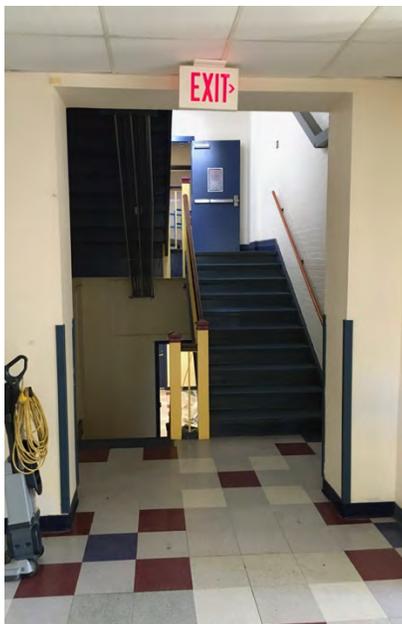
Reinstall rated doors at entrances on each level.

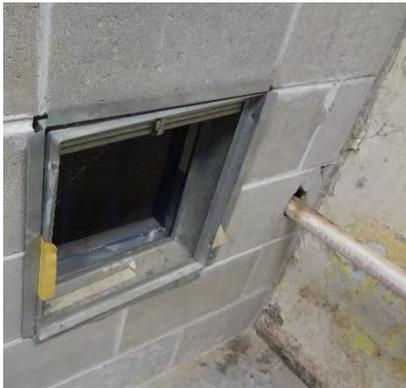
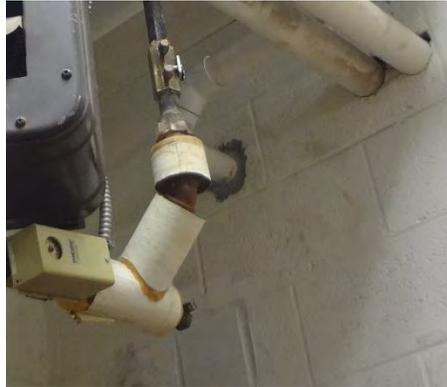
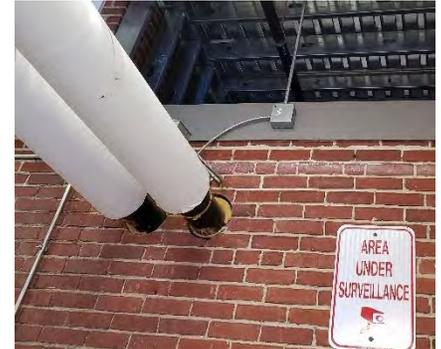
Many walls and floors throughout the building are penetrated by various building systems including, but not limited to, fire protection piping, plumbing systems, HVAC systems, and electrical conduit. Many of these penetrations are not sufficiently firestopped to meet the rating of the assembly being penetrated. Several penetrations are currently firestopped, but insufficiently. There are also several empty openings through walls and floors where building systems once penetrated, but have since been removed.

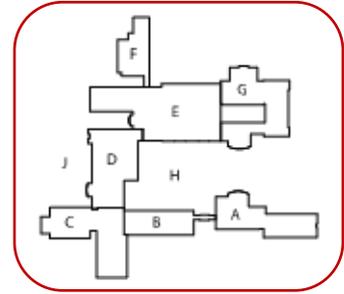
## EXISTING CONDITIONS

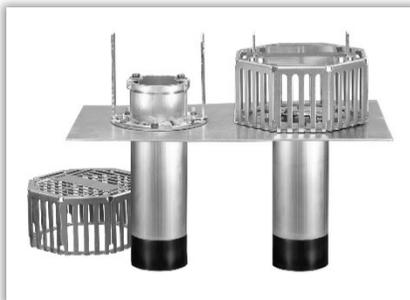
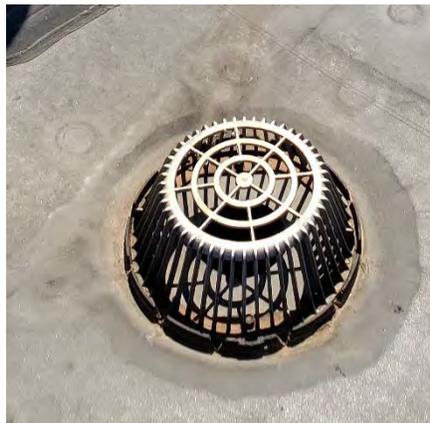
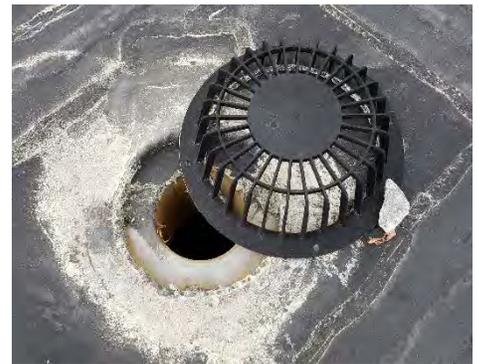
Some of the existing roof drains are a retrofit type typically installed by roofing contractors when they are replacing roof membranes and adding insulation. These generally differ from the retrofit drains used at the High School, but similarly have a flat top plate and a flashing tube that inserts through the existing drain bowl and into the pipe, as well as a low-cost plastic basket that doesn't hold in place well. Roofers also often allow the roof membrane to overlap the drain opening, also restricting water flow, such as the drain on the new boiler room roof.

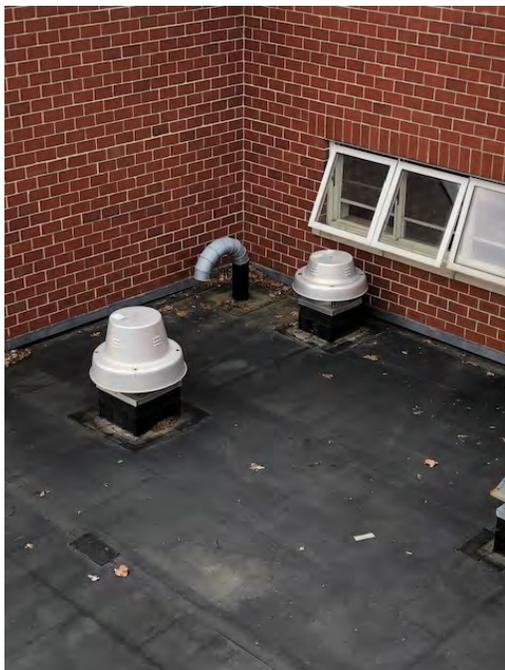
Operable window unit within ten feet of exhaust hood

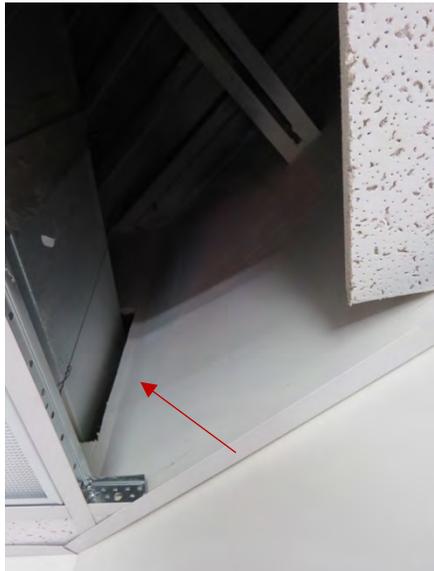
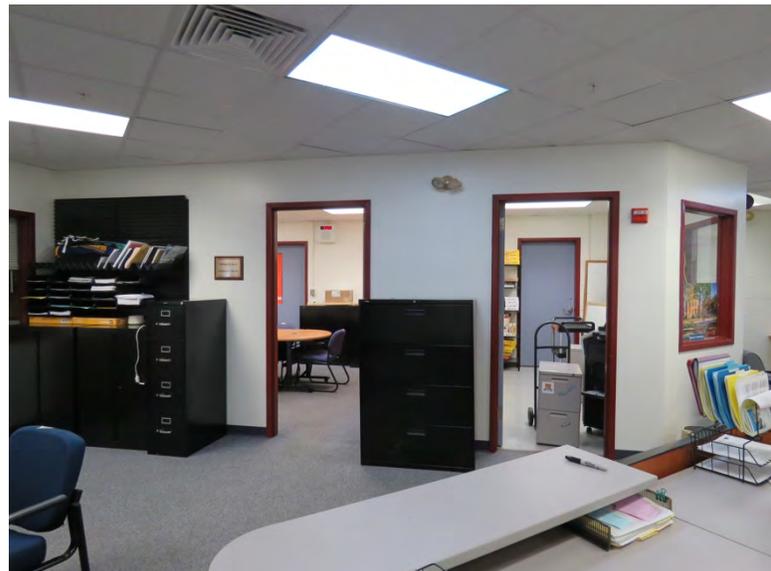
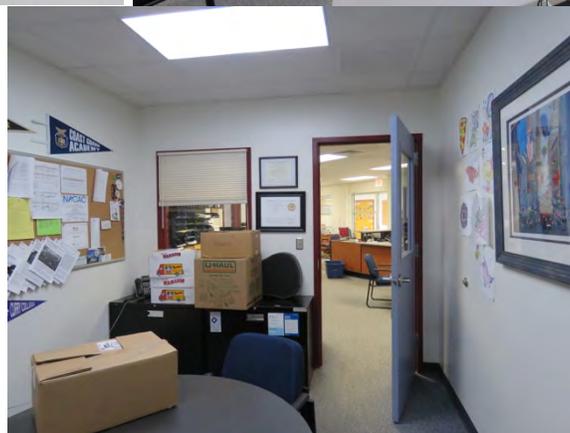
Acoustical privacy issues have been reported in the existing Guidance Counselor Suite, specifically between some offices, the conference room, and general open area. This is a particular concern in this location due to the confidential nature of conversations held. Where observations were made (above the ceiling in room B343), partitions appeared to continue to the deck above. Thru-wall penetrations, however, did not appear to be sealed and likely contribute to noise transfer. It's possible that the layout of the mechanical ducts themselves also contribute to noise transfer, but this was not observed directly.

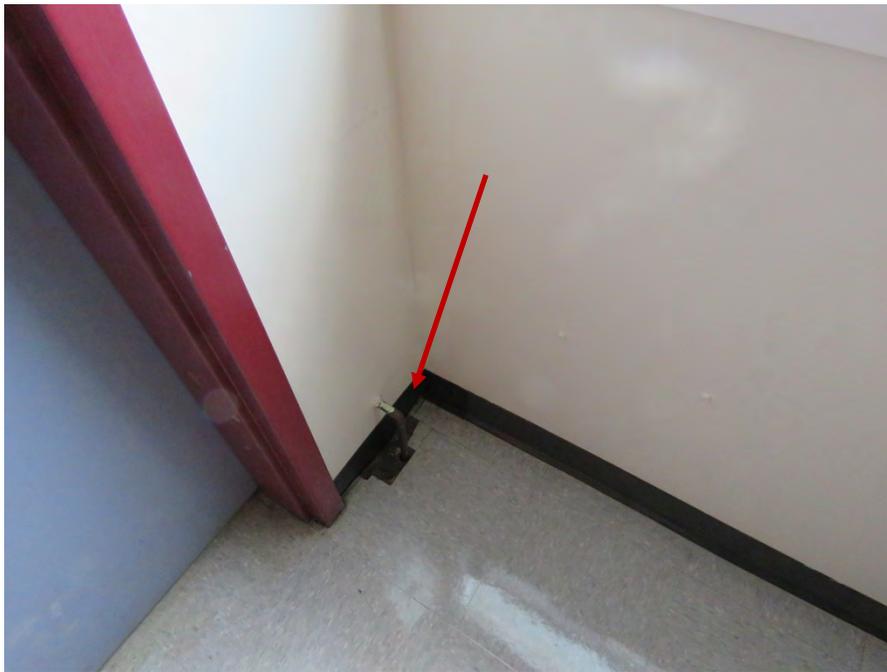
Piping is exposed within classroom 318, leading to the adjacent Prep Room. The engineering team believes this to be a water line.

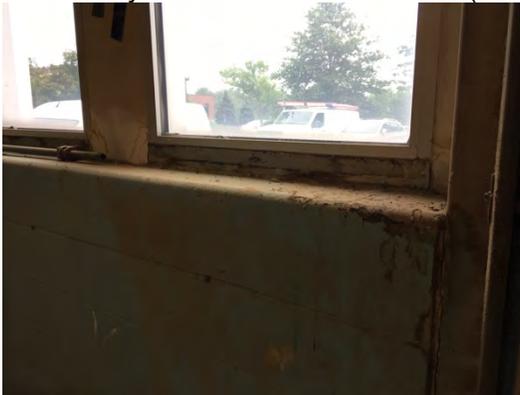
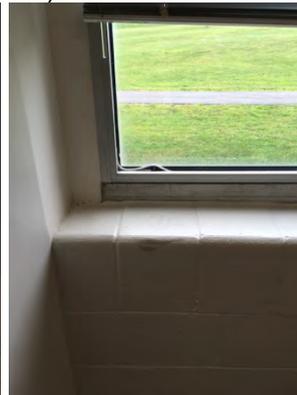
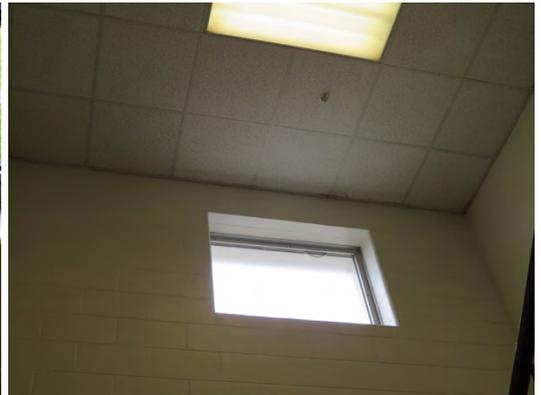
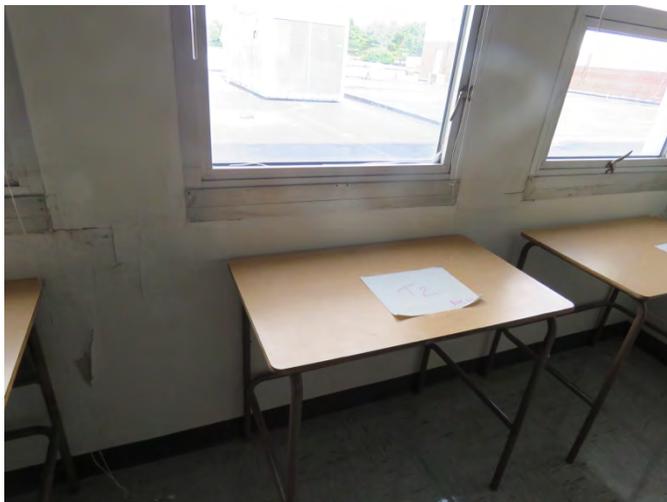
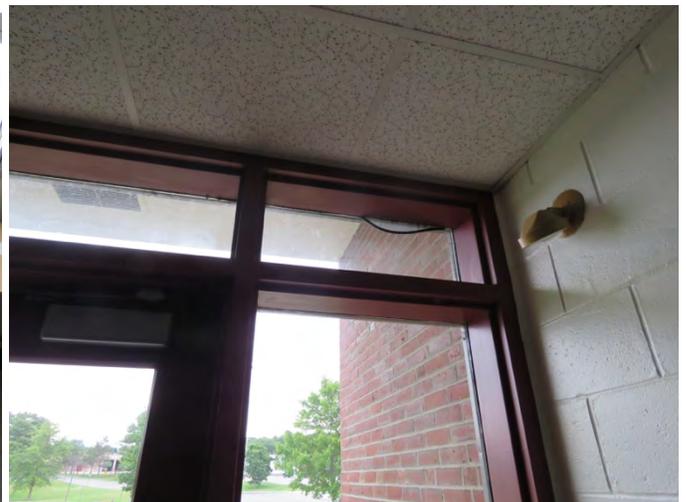
- Wood Lab (C111)
- Ensemble Room (C137)
- Stair 1 Landing
- 2<sup>nd</sup> Floor Classrooms (217,215,214,211)
- Entry Vestibule at Nurse's Office (3<sup>rd</sup> Floor)

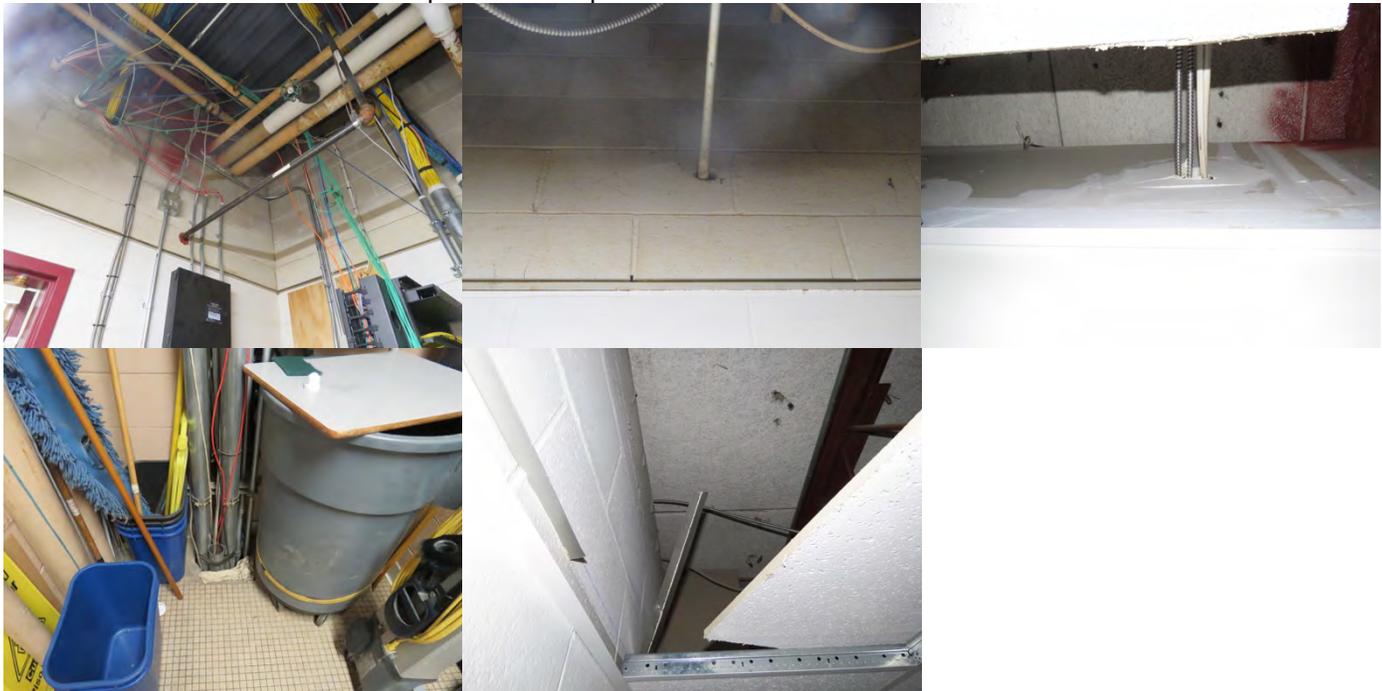
- a. Sealant appears missing at some conduit penetrations above ACT ceiling or at floor conditions. In some locations, ceilings don't exist such as in Janitor's Closets. In some cases, this happens at corridor or storage room walls where smoke separation is required.

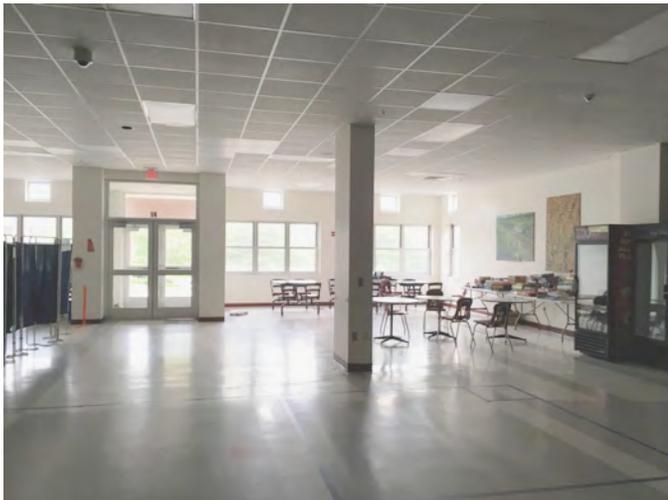
Mostly unused space to the left of the egress doors.

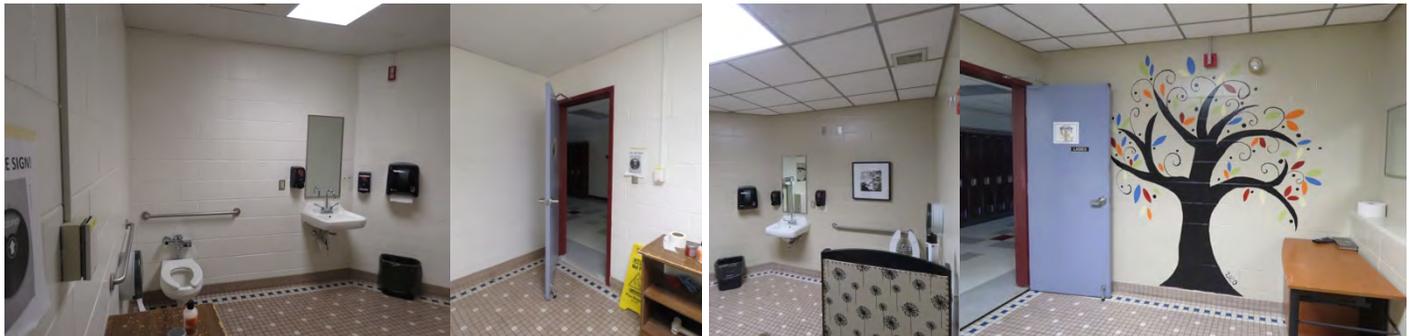
- Ventilation is reportedly inadequate in B332.
- B338 door hardware should allow the door to be locked; An occupancy sign is used to indicate use.
- These are currently labeled for use by faculty only

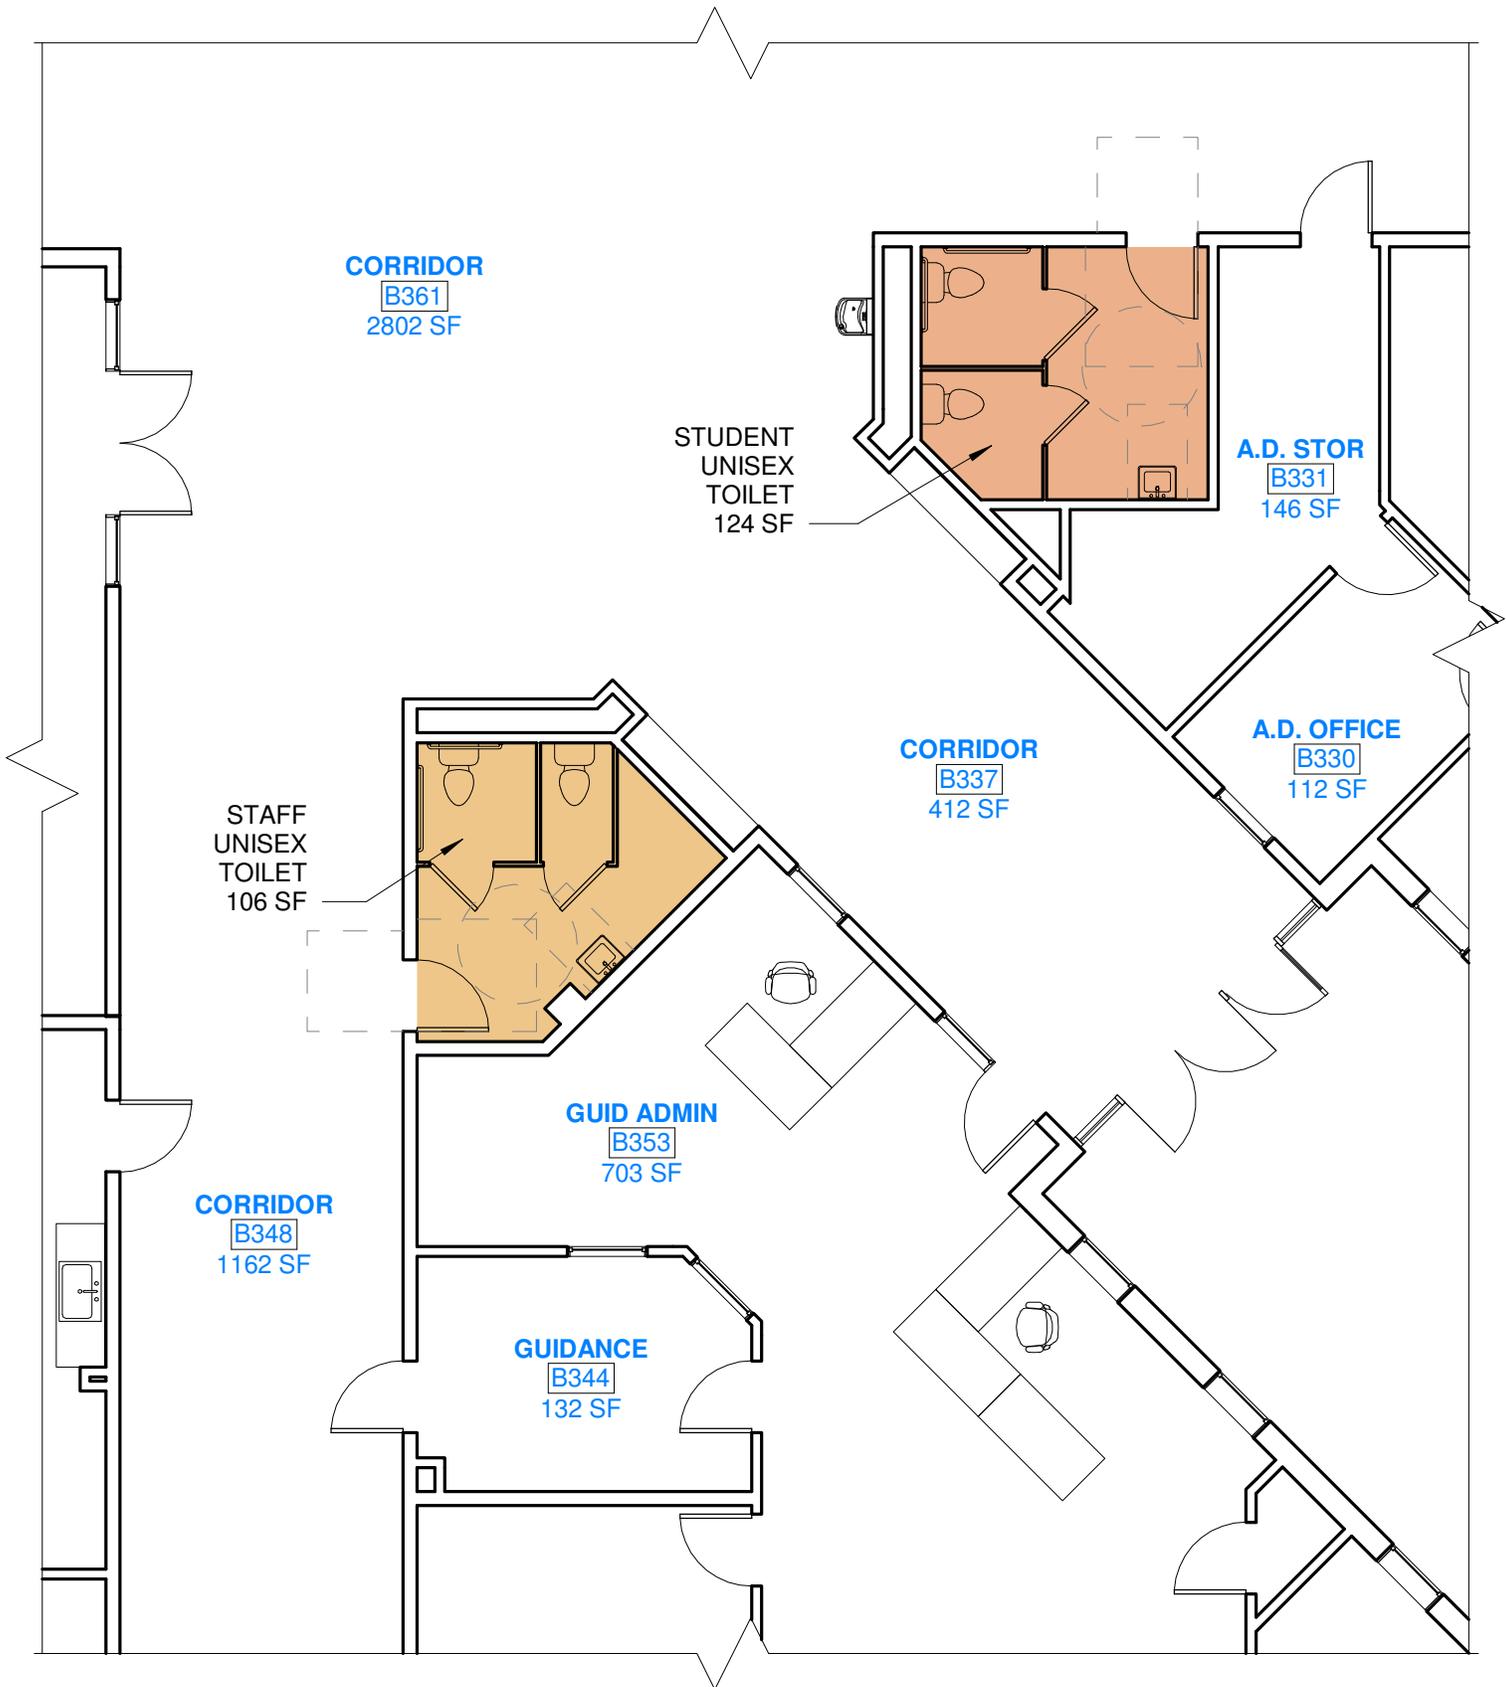
# Door Compliance Issues

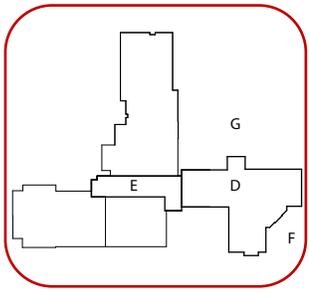
## EXISTING CONDITIONS

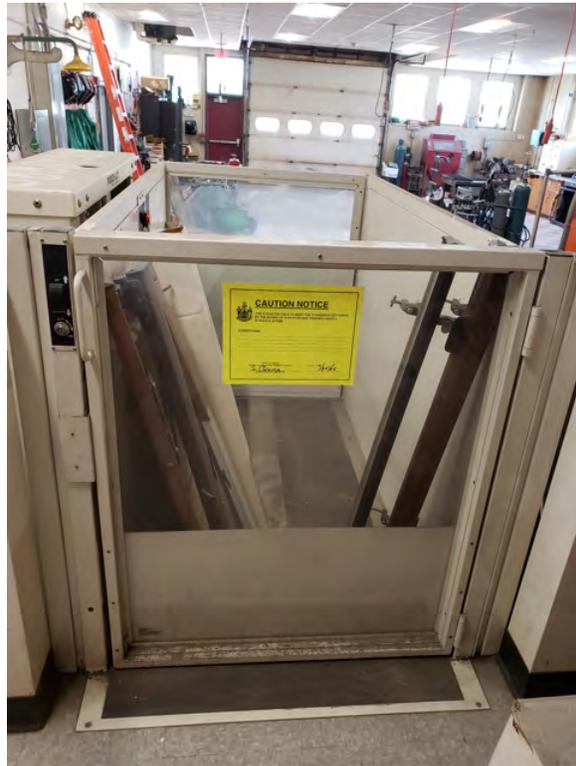
The notice on the lift reads:

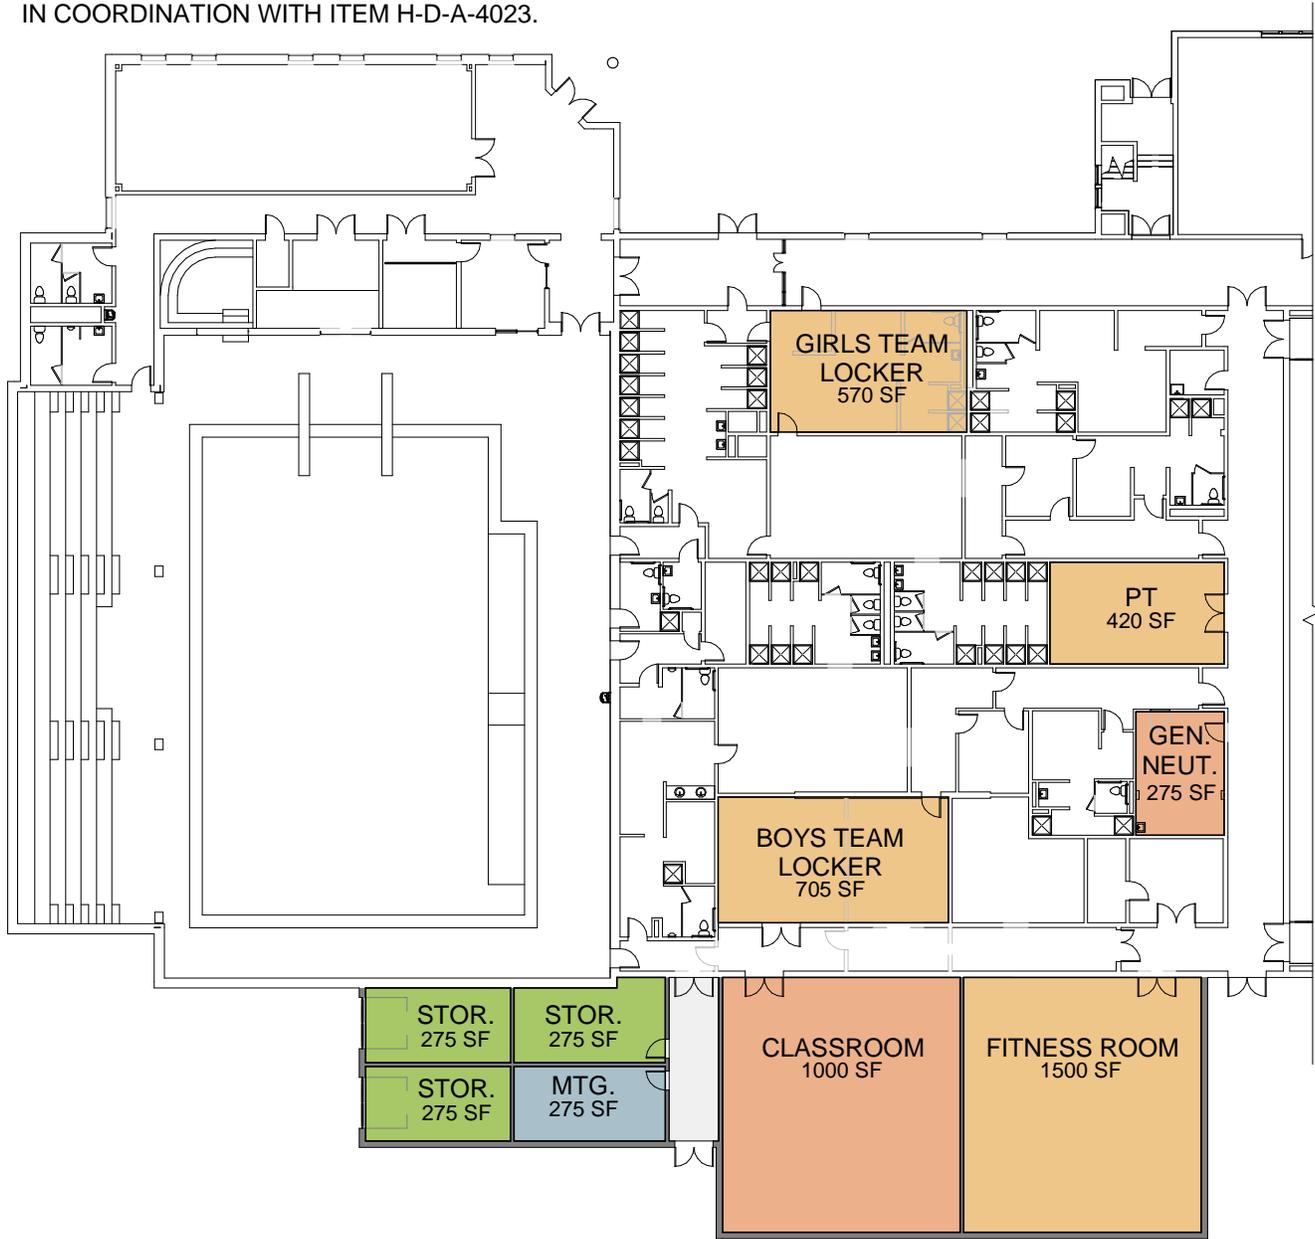
PROPOSED	MENS	WOMENS	
boys shower	325 SF	771 SF	girls pool locker
boys locker	761 SF	68 SF	girls pool entry
boys pool locker	597 SF	43 SF	girls pool single rest.
boys team locker	705 SF	696 SF	girls locker room
PE office	140 SF	442 SF	PE office/coaches
men coaches	276 SF	385 SF	girls shower
pool entry - boys	90 SF	570 SF	girls team locker
	<b>2894 SF</b>	<b>2975 SF</b>

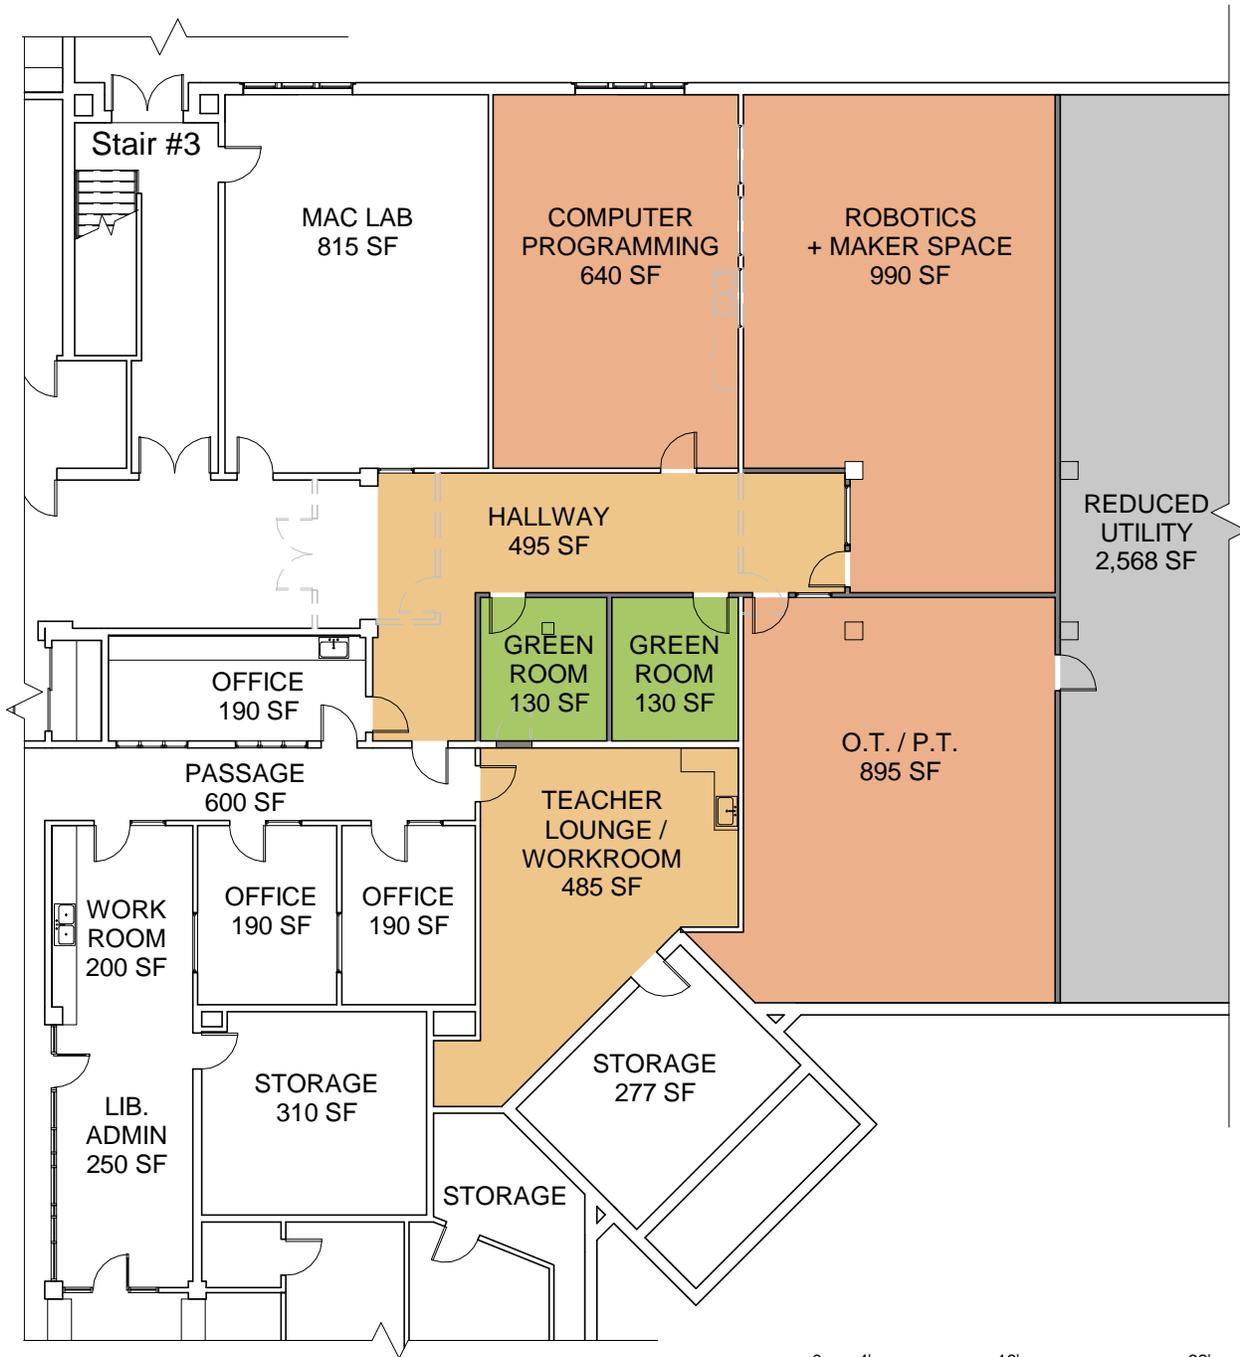
# Nurse's Space Improvements

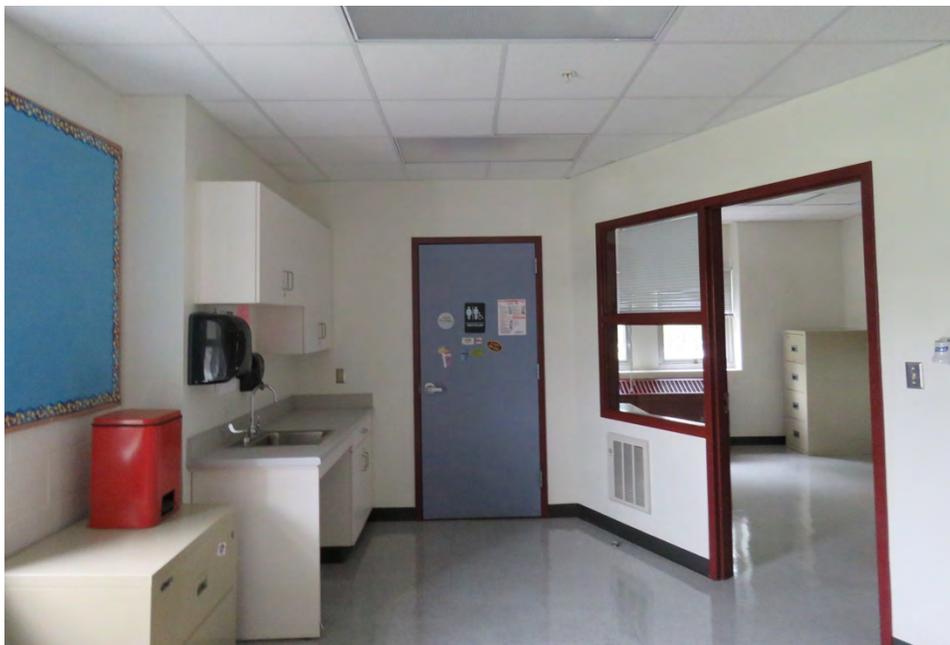
Nurses suite waiting area and office visible through door at right.

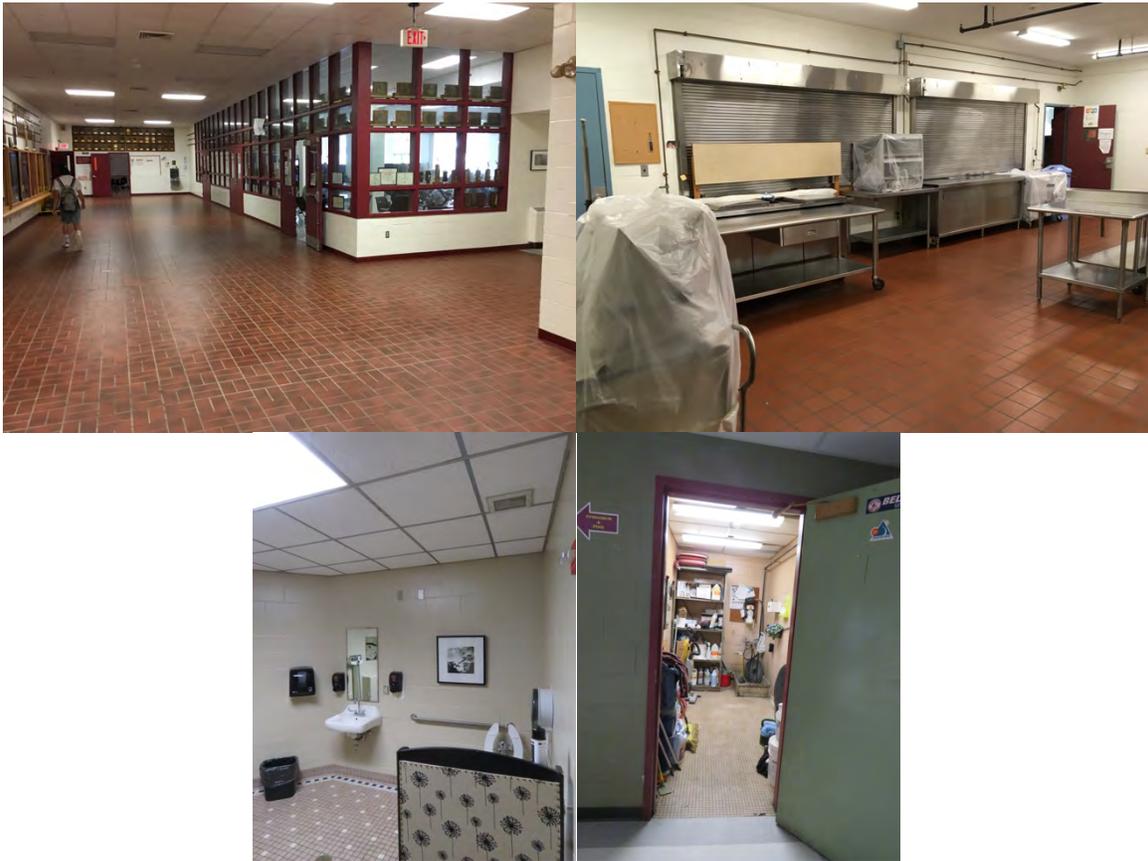
## Cape Elizabeth Schools Needs Assessment
