Prepared for:

Cape Elizabeth Schools

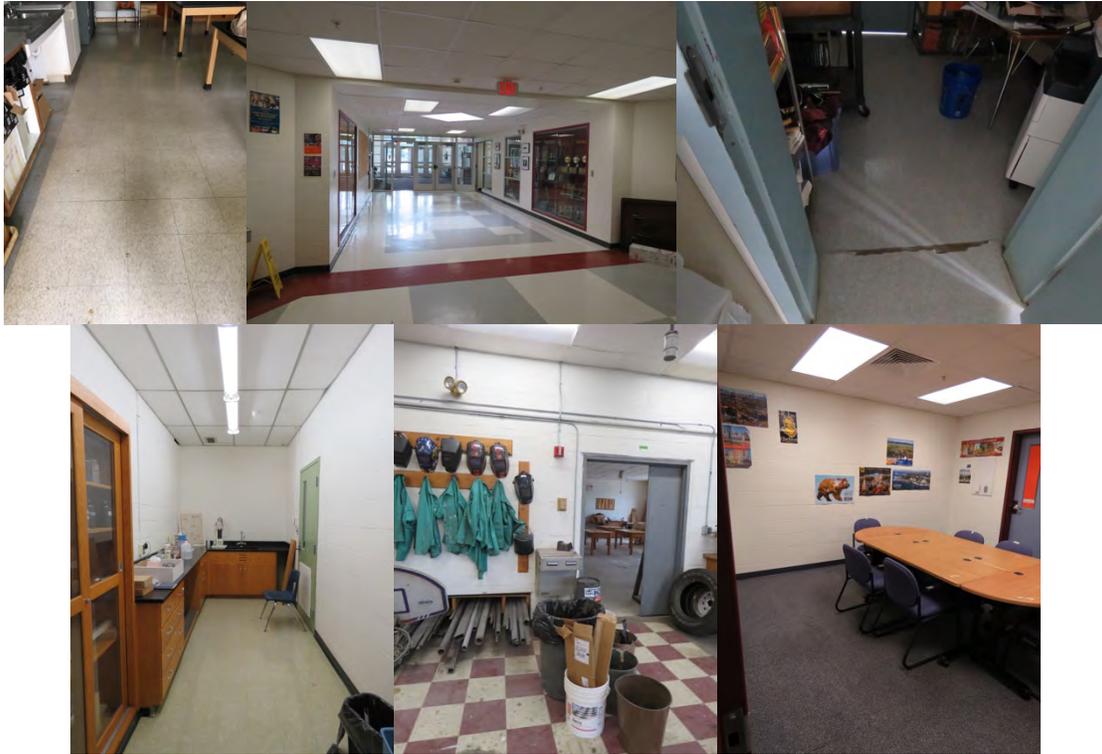
## Cape Elizabeth Schools Needs Assessment

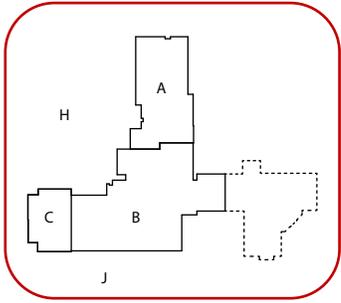
## EXISTING CONDITIONS

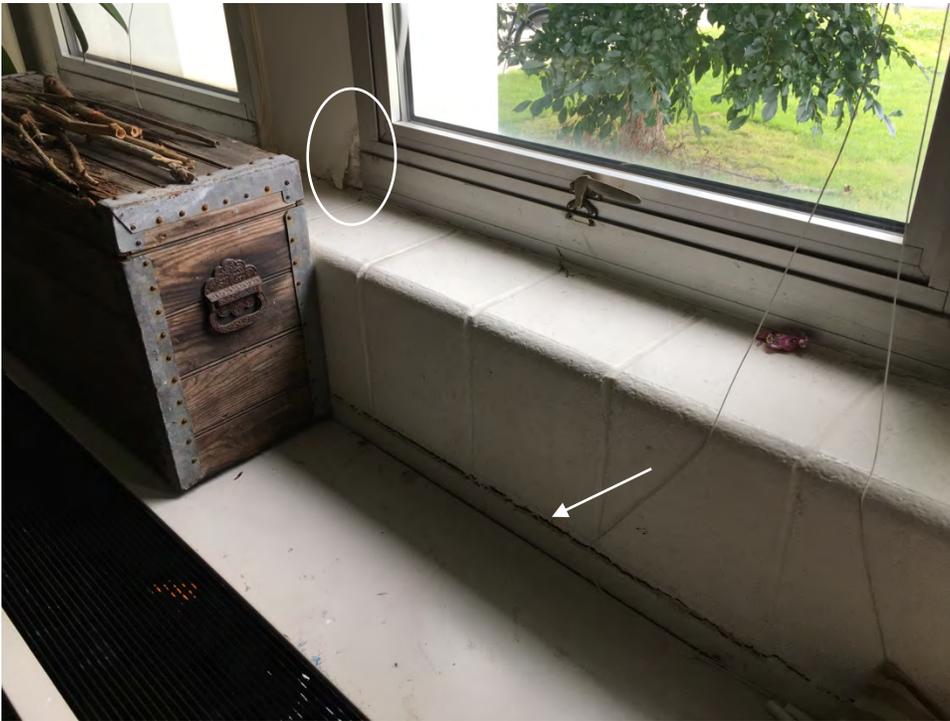
Drywall peeling from moisture infiltration / condensation and CMU cracking.

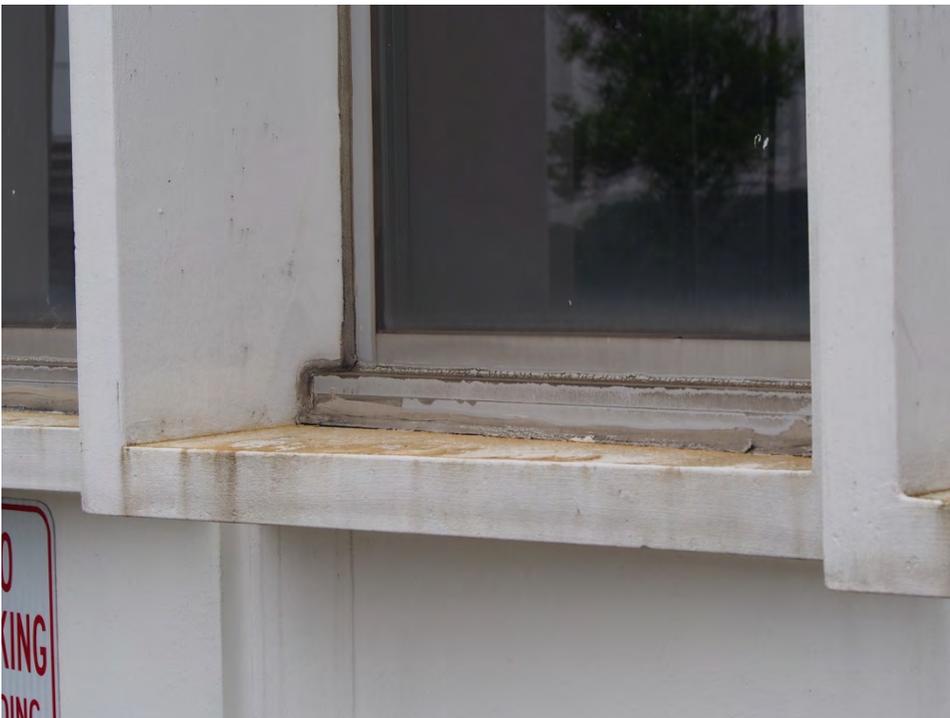
Non-thermally broken aluminum frames set into precast concrete panel are a vessel for condensation to form on the interior surfaces.

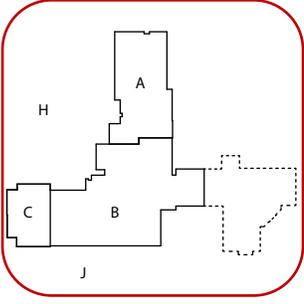
### EXISTING CONDITIONS

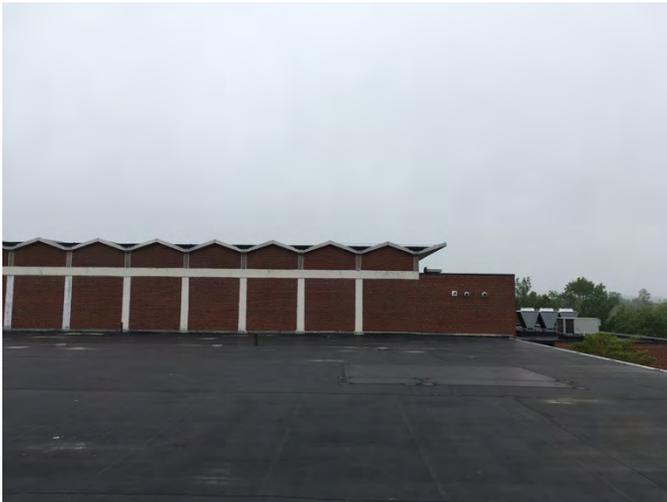
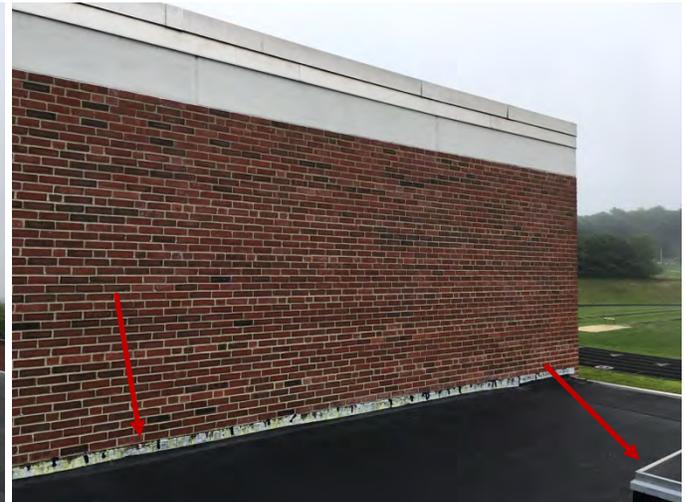
- See Harriman report of 2012 for detailed discussion of roof items. Conditions outlined appear to be largely unchanged.

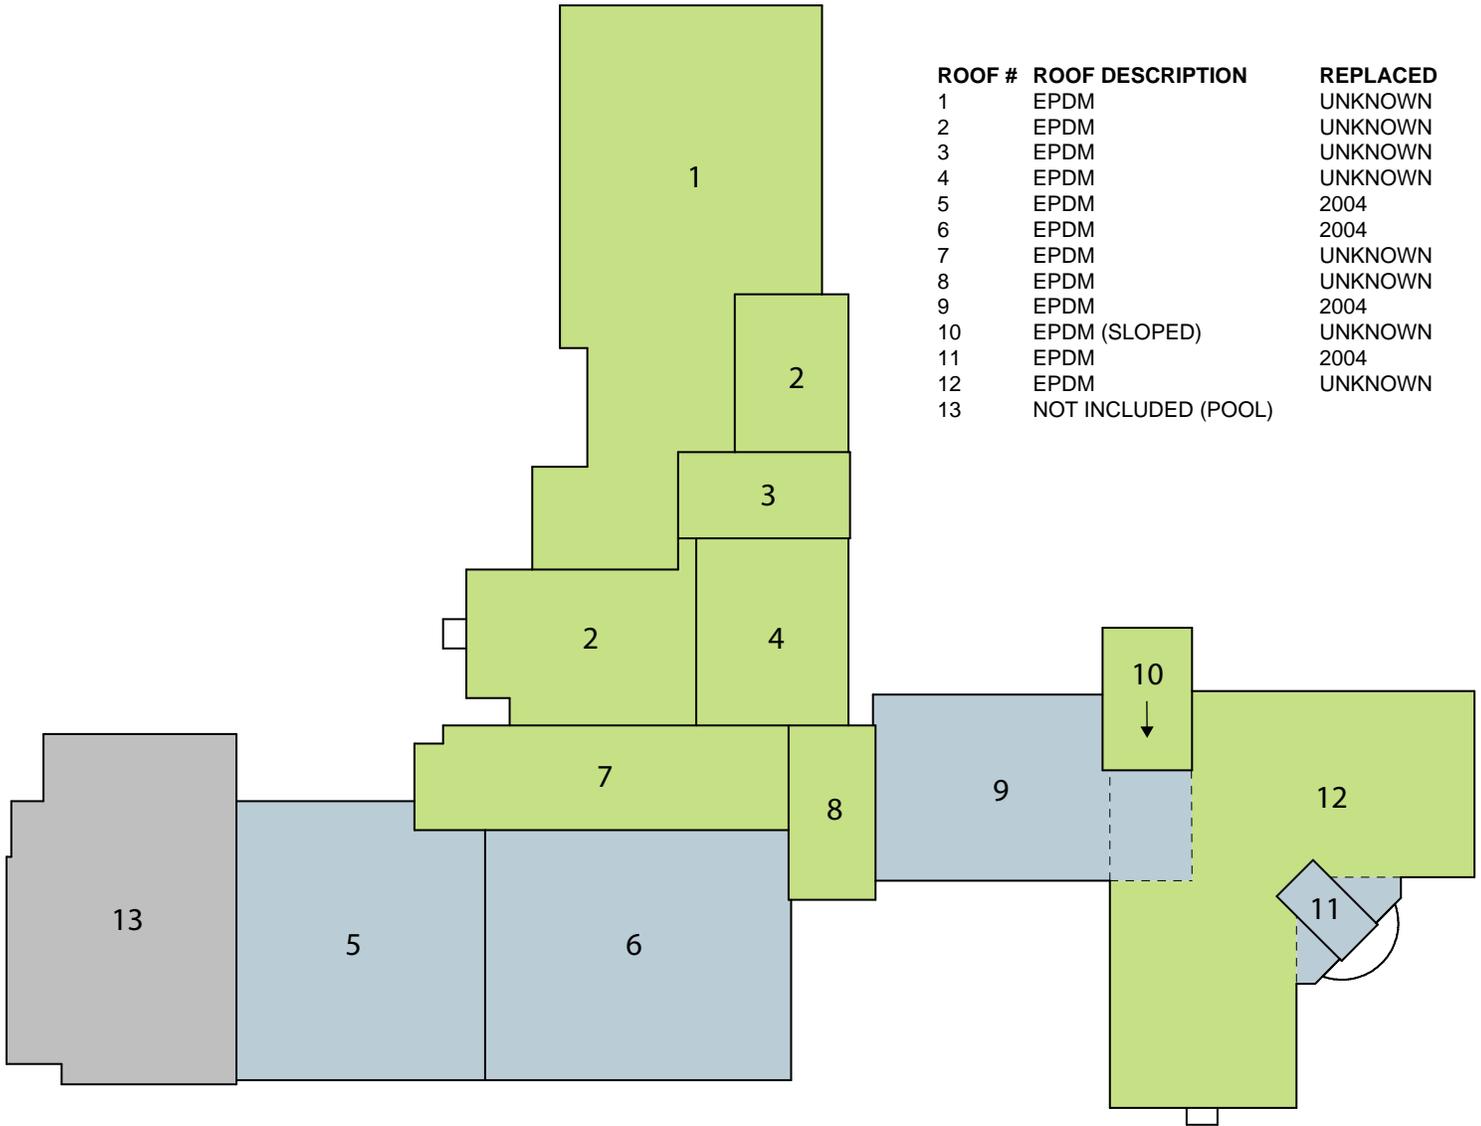
ROOF #	ROOF DESCRIPTION	REPLACED
1	EPDM	UNKNOWN
2	EPDM	UNKNOWN
3	EPDM	UNKNOWN
4	EPDM	UNKNOWN
5	EPDM	2004
6	EPDM	2004
7	EPDM	UNKNOWN
8	EPDM	UNKNOWN
9	EPDM	2004
10	EPDM (SLOPED)	UNKNOWN
11	EPDM	2004
12	EPDM	UNKNOWN
13	NOT INCLUDED (POOL)

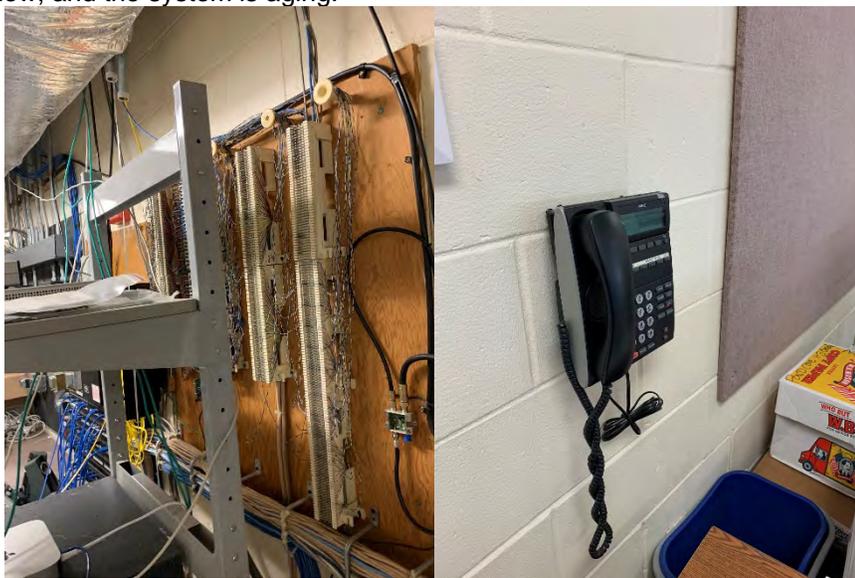
The existing phone system is outdated, and not all locations have handsets. The intelligibility of the paging system is low, and the system is aging.

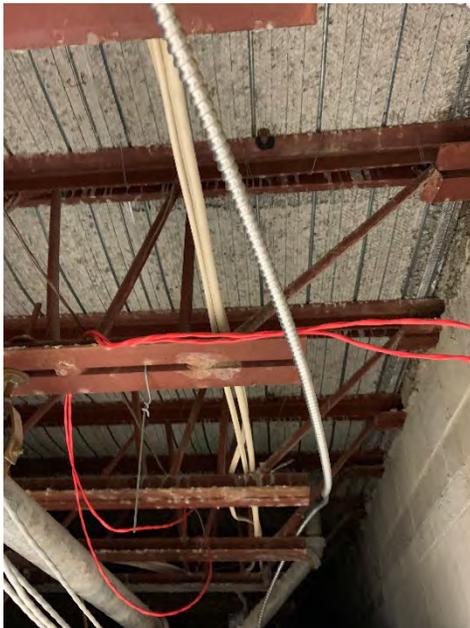
The wiring in the building is a combination of non-metallic (Romex) cabling, MC-cable (metal clad) and wiring in conduit. The current code does not allow NM wiring above SAT ceilings.

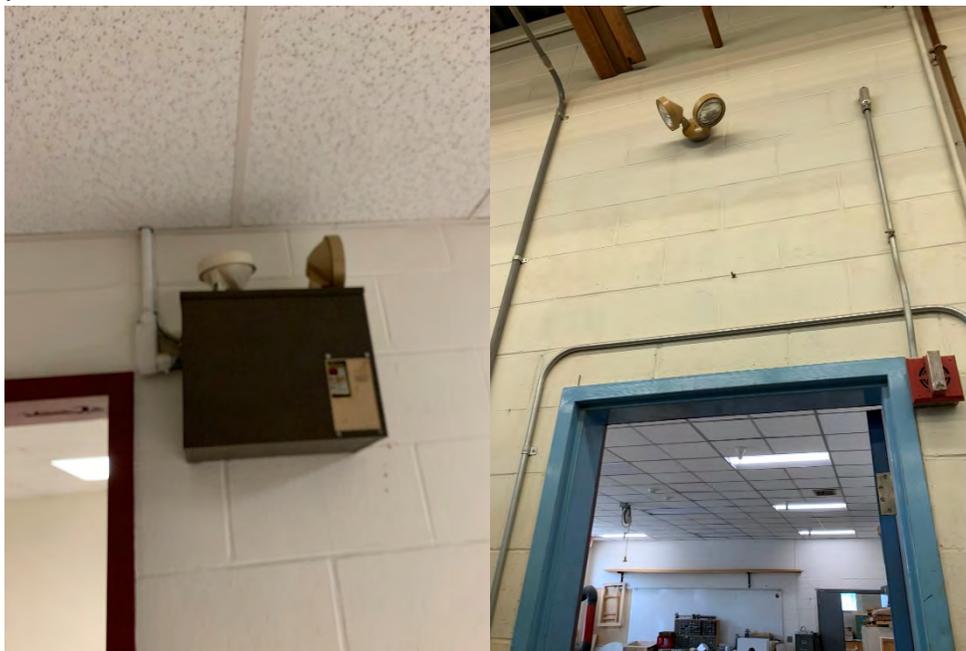
The existing emergency lighting are older style, and consist of a combination of self-contained battery units, remote dual and single heads. The single heads do not meet current code for egress lighting. It does not appear that there is adequate coverage, to meet the 1 fc requirement from NFPA 101, and not all exit doors have an egress emergency light. A number of instances, the fixtures appear to be damaged.

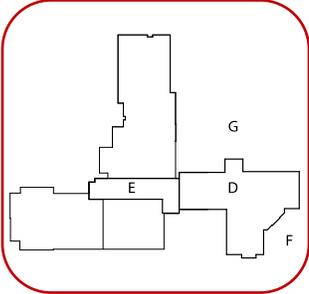
## EXISTING CONDITIONS

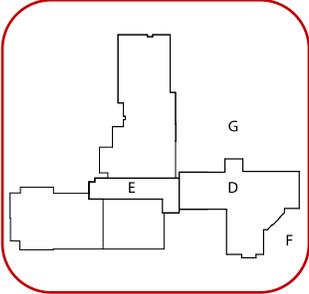
## EXISTING CONDITIONS

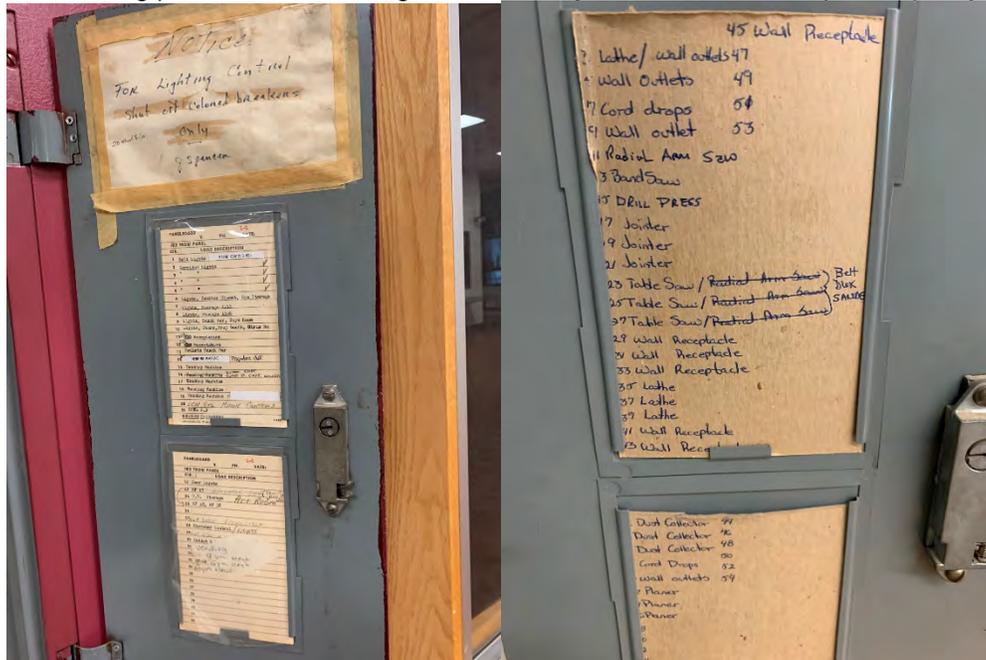
The existing panels located throughout the facility have limited to no spare capacity.

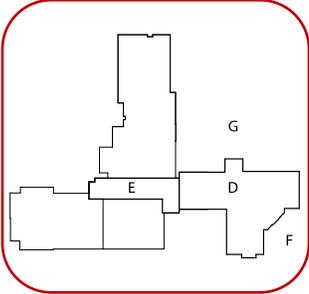
## EXISTING CONDITIONS

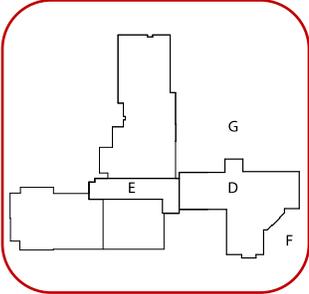
## EXISTING CONDITIONS

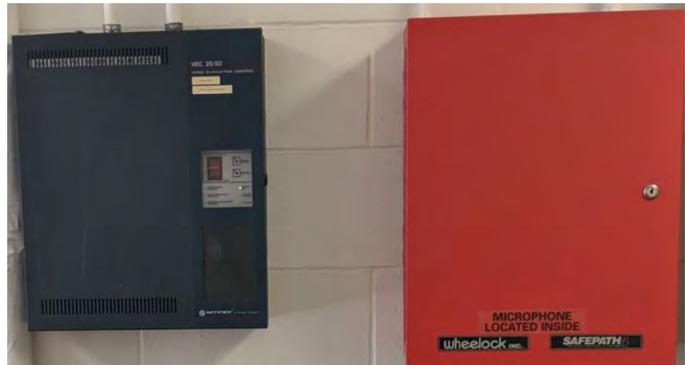
The two voice notification systems additionally appear to be two separate systems, one Notifier and the other Wheelock, serving different areas of the building.

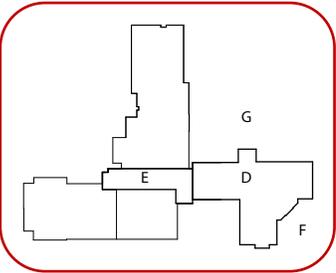
## EXISTING CONDITIONS

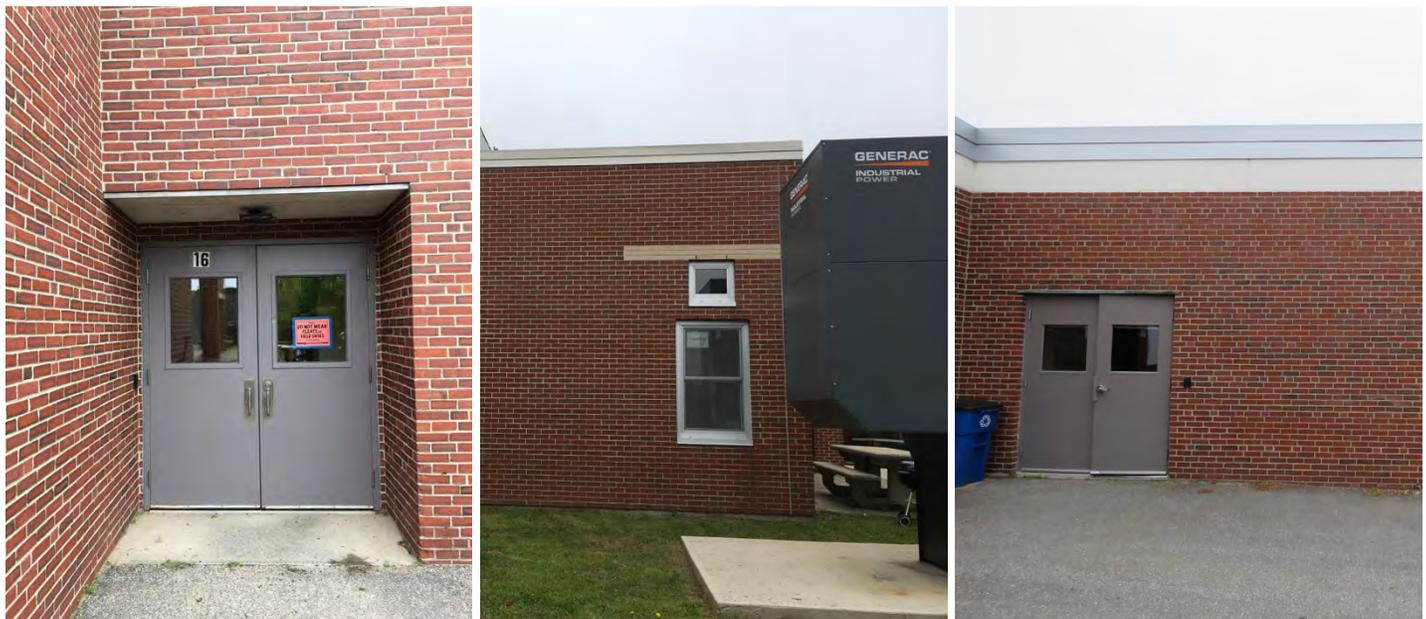
# Cape Elizabeth Schools Needs Assessment

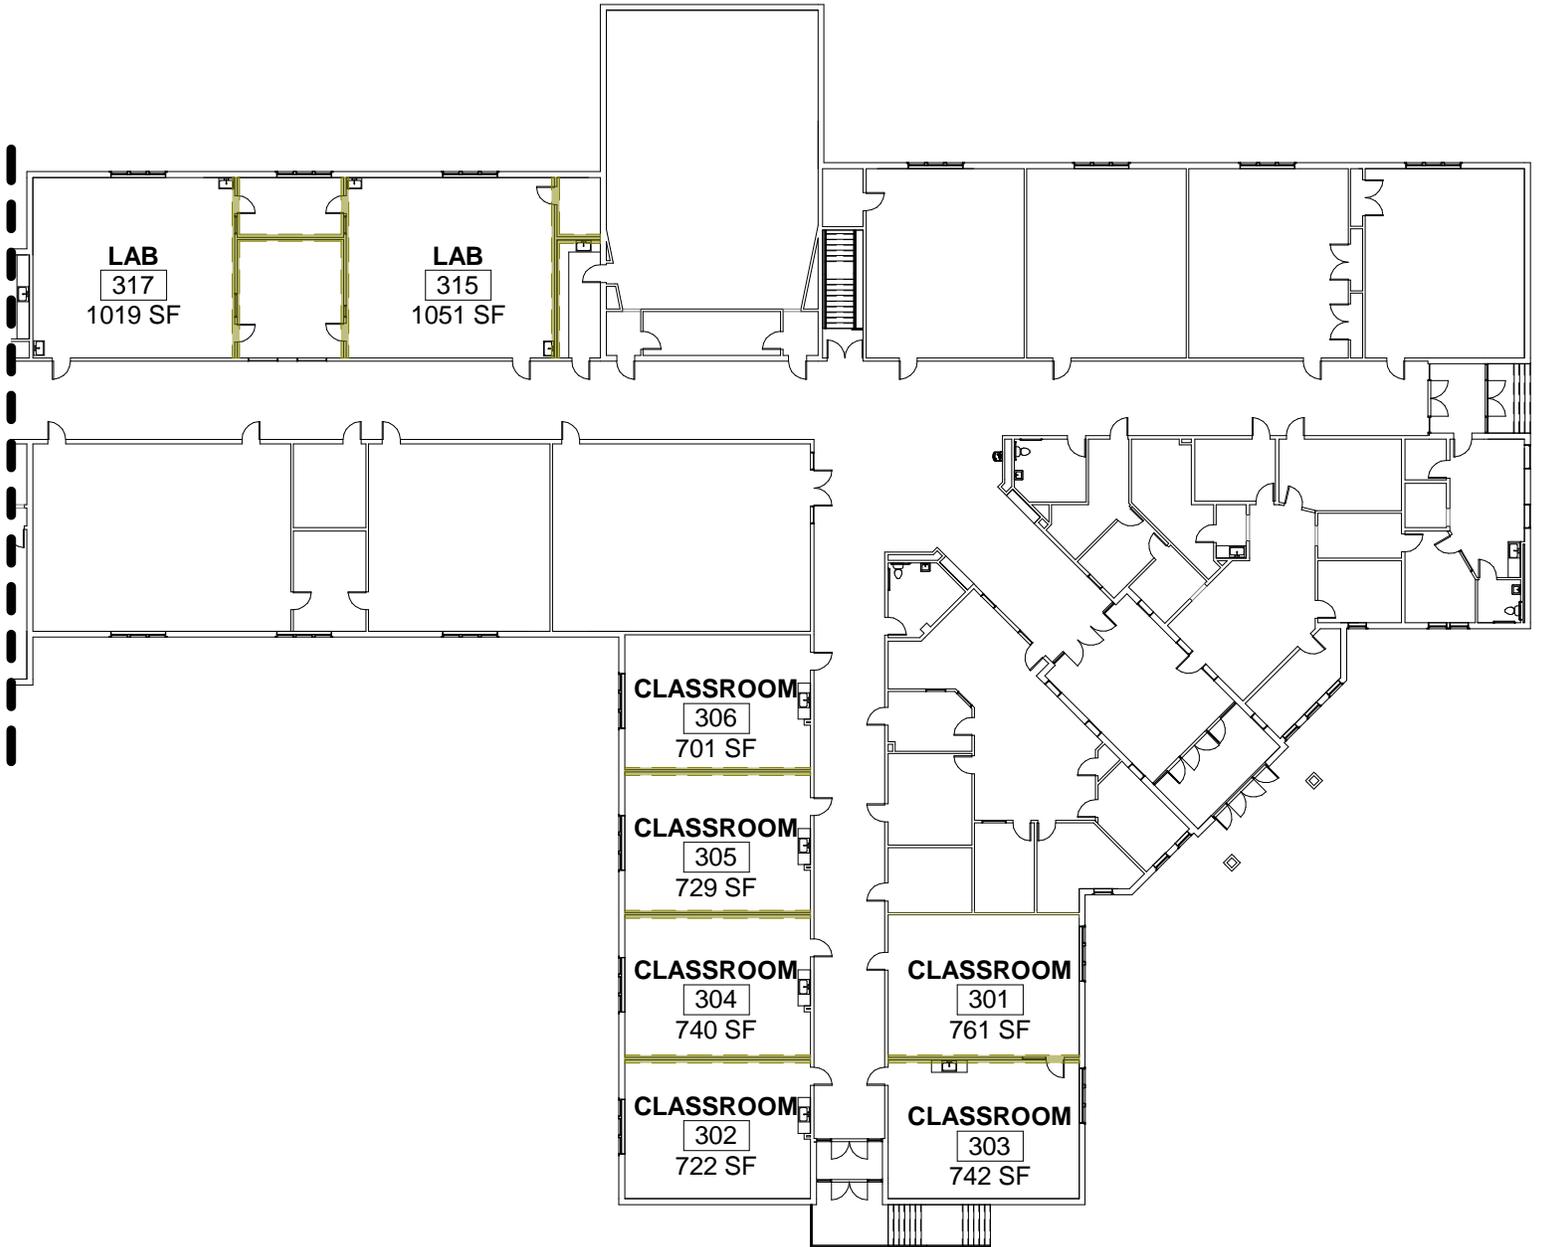
① 3RD FLOOR - D PLAN - DIAGRAM  
 1/32" = 1'-0"

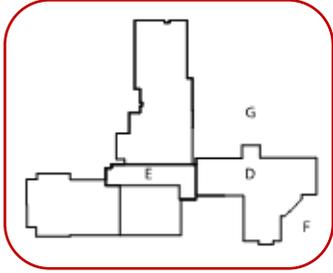
## EXISTING CONDITIONS

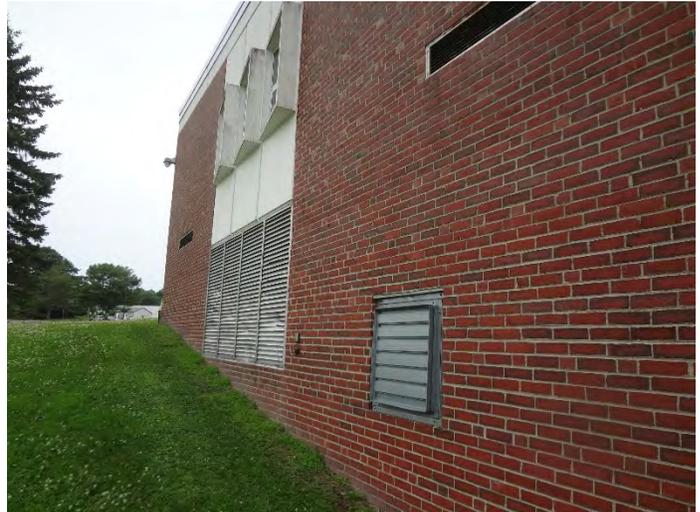
To meet the intent of the Maine Department of Education's Public School Standards & Guidelines for New School Construction & Major Renovation Projects, provide burglar bars in low openings to prevent entry.

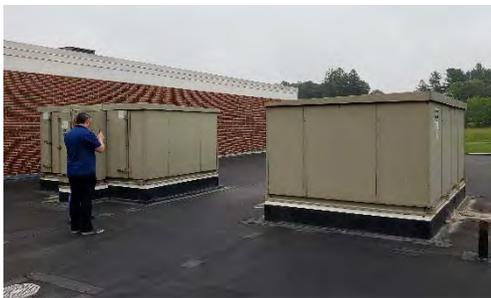
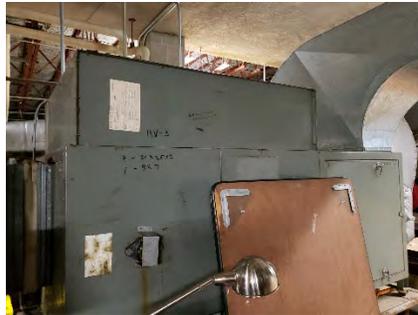
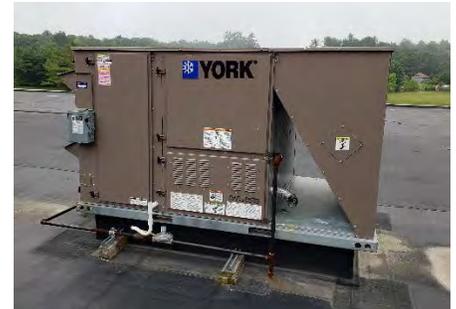
There are various ages of indoor and roof-mounted air handling units (AHUs), gas-fired rooftop units (RTUs), and unit ventilators (UVs), which provide mixed air at less than 100% outside air; these do not have heat or energy recovery.

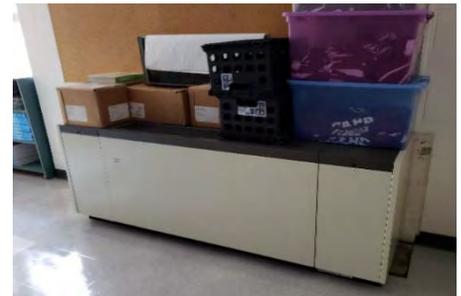
At a minimum as a short-term solution, perform various repairs at each UV, including rust removal and repainting, new grilles, new exterior louvers, new dampers, and re-sealing to wall louvers. A long-term solution would be to provide new UVs, provide relief air systems for rooms where relief is lacking, and rebalance existing relief systems for those that do. Balance outdoor air dampers at each unit ventilator to provide ventilation air per current Code and ASHRAE 62.1 requirements of 10 cfm per person plus 0.12 cfm per square foot.

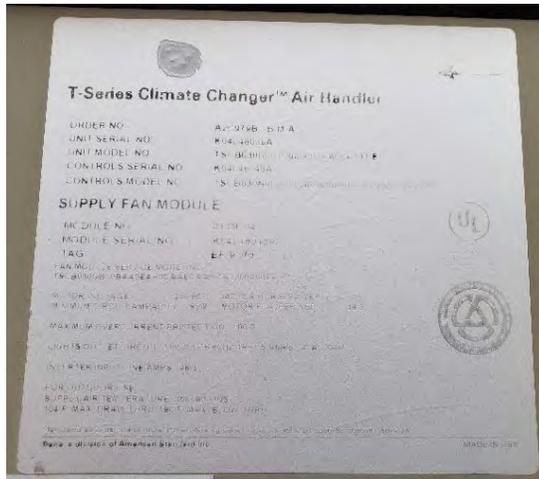
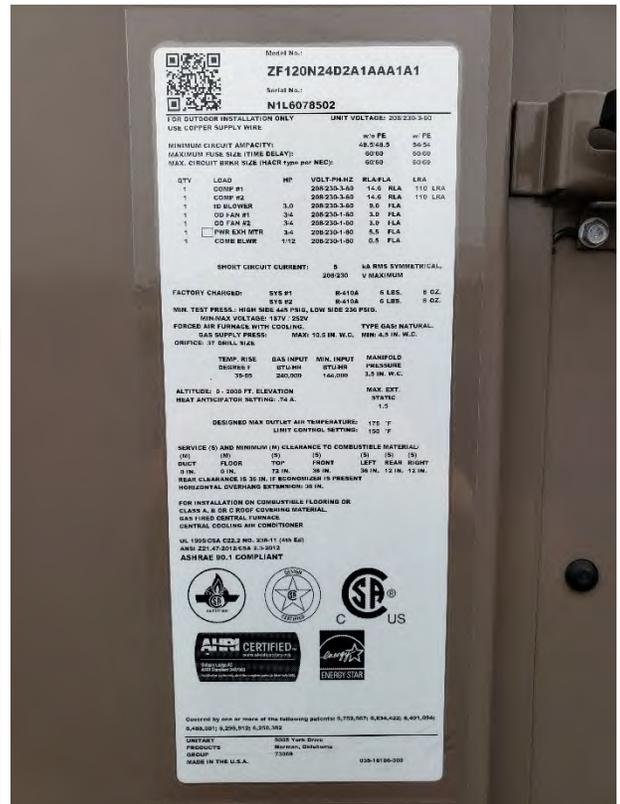
Provide a building-wide mechanical equipment numbering scheme such that no two items receive the same number. Provide riveted engraved acrylic nameplates affixed to each piece of equipment bearing the unit number, make, model, serial number, and general performance. Install nameplates such that dismantling of equipment is not necessary to view the nameplate in full. Recommend including all pieces of HVAC equipment including unit ventilators, exhaust fans, unit heaters, air handling units, and any other piece of equipment serving the HVAC systems.

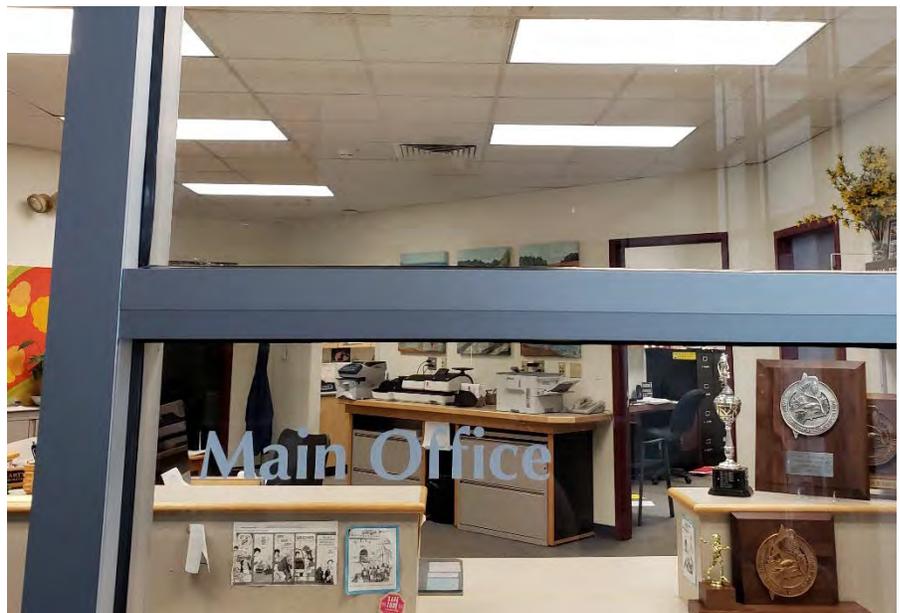
Copiers and printers generally do not have local exhaust to remove fumes and odors, as required by current Codes.

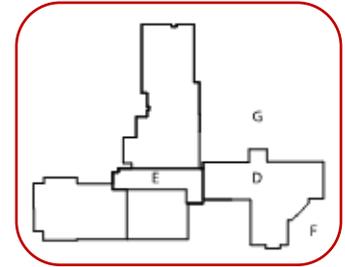
## EXISTING CONDITIONS

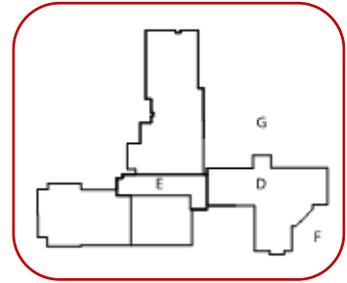
## EXISTING CONDITIONS

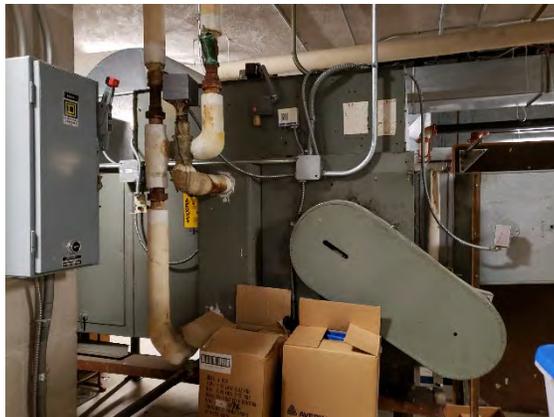
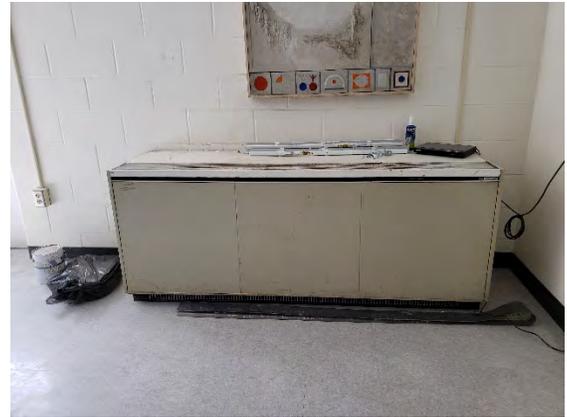
Existing ventilation systems were designed to the ventilation Codes of their time. Codes and other standards have increased their requirements and recommendations for quantities of outside air supply, and requirements for good distribution of the air for ventilation effectiveness.

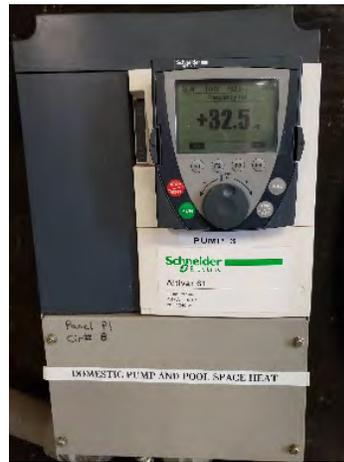
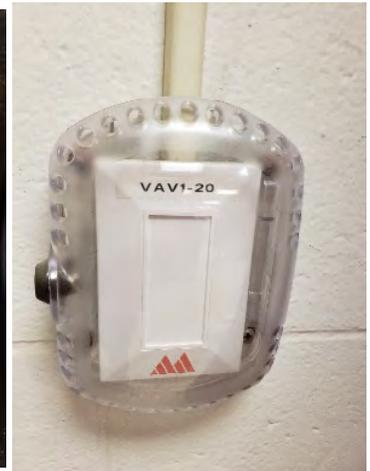
Commissioning is a process of testing systems to demonstrate that they operate as designed. Control sequences are confirmed by direct observation of items such as control valves and dampers.

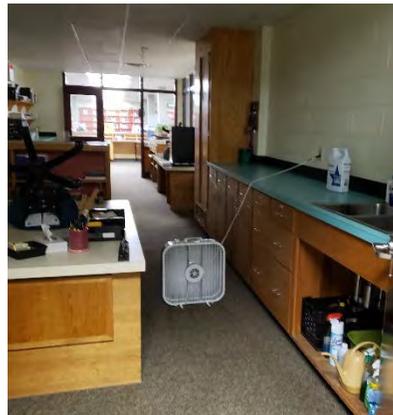
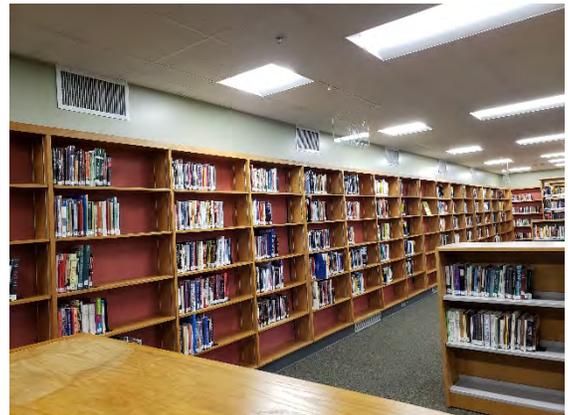
It appears that the cooling is insufficient; as noted in Appendix C, stakeholder meeting notes state that library remains too warm/hot despite having some air circulation. There are ceiling diffusers widely spaced across the library ceiling, but it seems the majority of the air is supplied and returned in the sidewall at one side of this wide, low room. Occupants in the summer were using portable floor fans to provide additional air movement near the people. Several computers were running in the room.

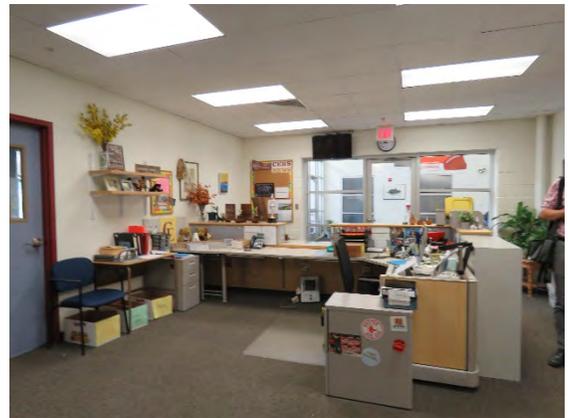
Front office staff report that heating in their rooms is inadequate. Individuals' needs vary, so appropriate zoning of heating is needed.

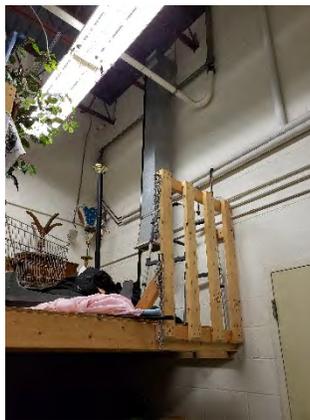
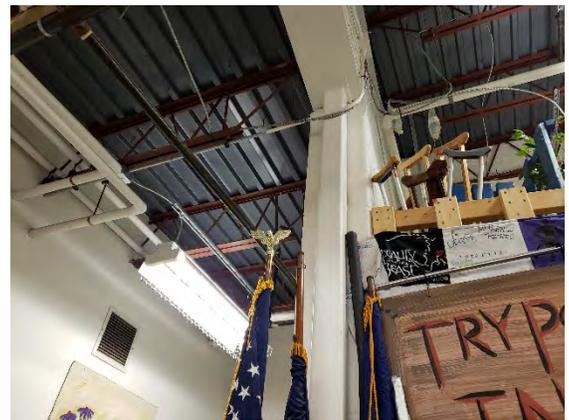
Room lacks HVAC air movement, and has an unpleasant musty, mold-like odor.

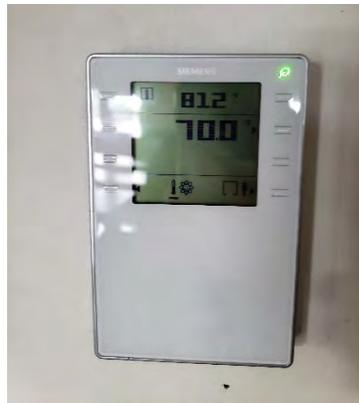
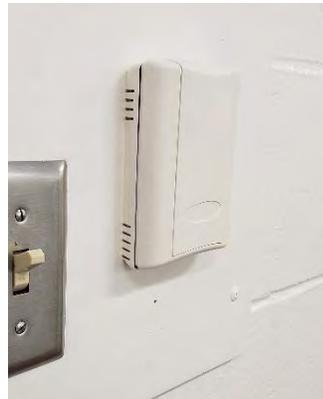
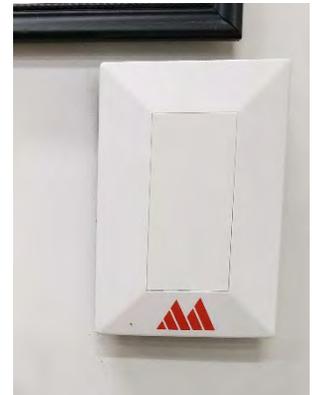
The Maine Department of Education Public School Standards and Guidelines for New School Construction & Major Renovation Projects lists as “required or recommended” individual room controls, including the use of operable windows. Most of the existing occupied rooms have operable windows. In the rooms that have DDC (direct digital control) room temperature control, most of the wall-mounted sensors has blank covers with no occupant-accessible settings. Occupants may want to adjust the sensors’ temperature setpoints to coordinate with their use of the space and the windows, as well as their personal comfort needs.

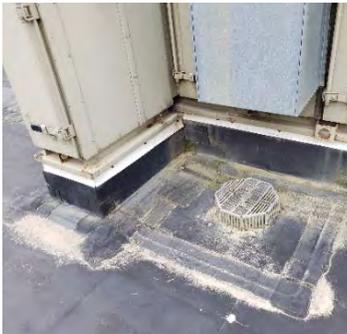
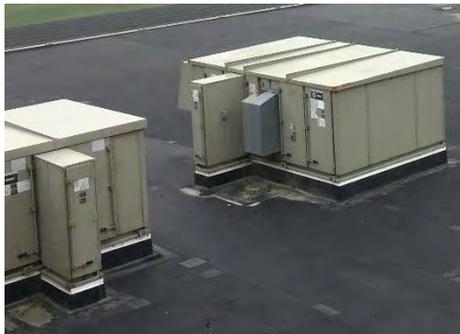
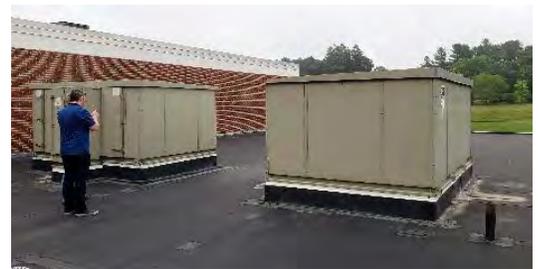
The locker rooms for both the high school and the attached Community Pool share a common ventilation system. As a result, the humidity and odors such as chlorine from the pool enter into the high school locker rooms. The rooftop units AHU-9 and EF-9, built in 1995, are separate units for supply and exhaust. The units have coil piping vestibules; they may have runaround coils for heat recovery.

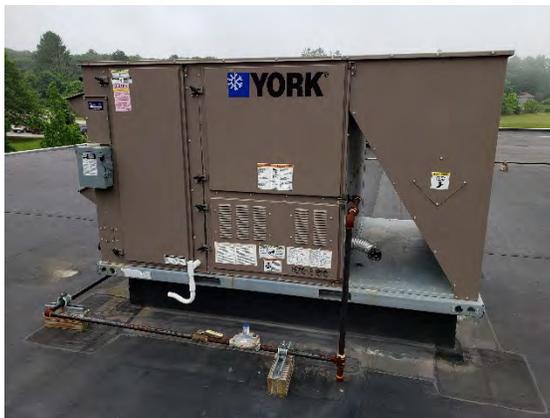
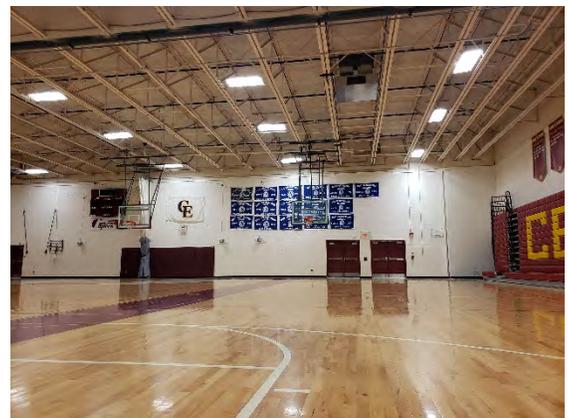
Floors warp seasonally with humidity fluctuations. Rooftop-mounted HVAC systems built in October 2016 are gas-fired packaged rooftop units with air conditioning, but do not provide adequate control of humidity.

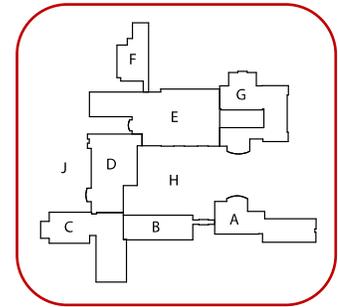
## EXISTING CONDITIONS

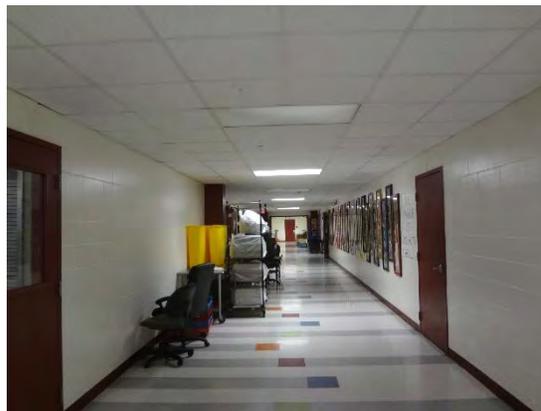
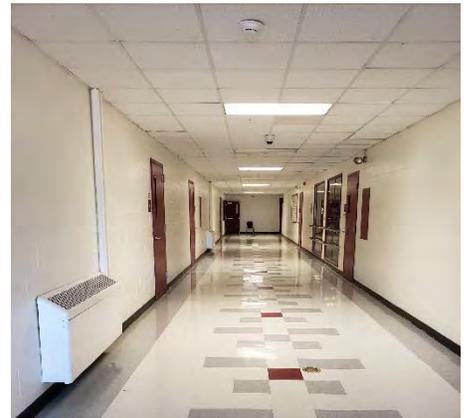
Several of the corridors and lobbies lack ventilation supply outlets, or have few outlets which are poorly distributed.

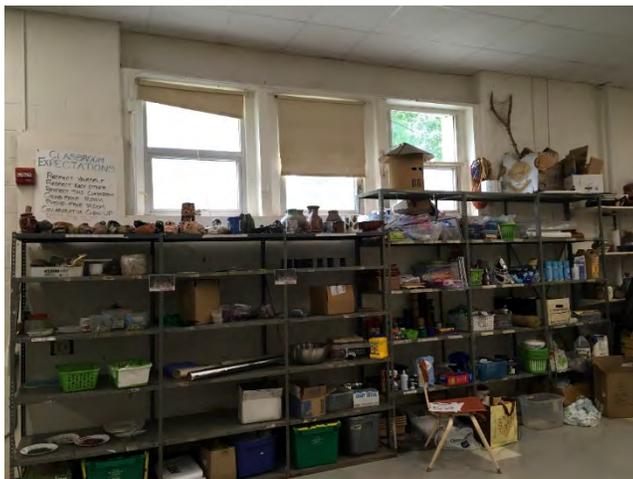
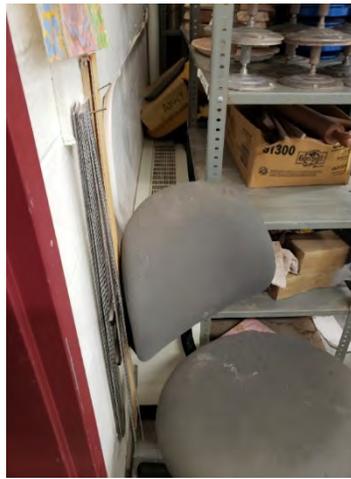
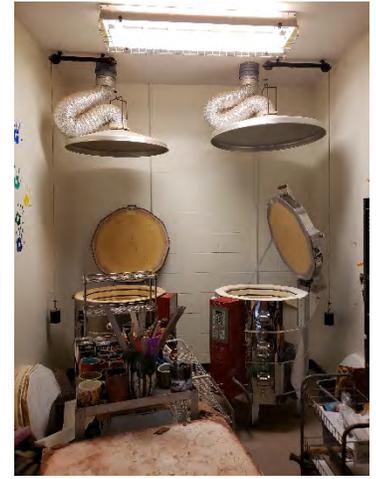
These rooms are used for summer school, but have no air conditioning.

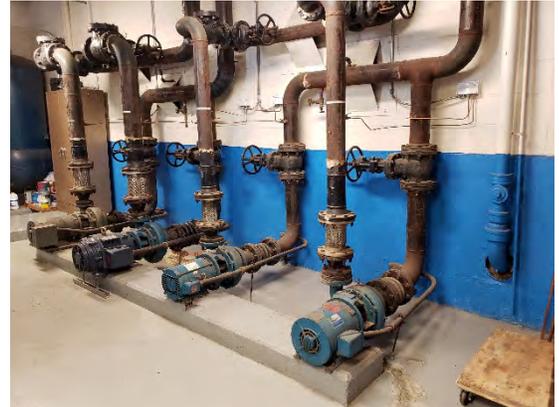
Replace each of four end suction pumps in kind, and replace their flexible piping connectors. Provide supports to take the weight of piping off the flexible connectors, to prevent compressing the connectors and prevent bearing any piping weight on the pumps.

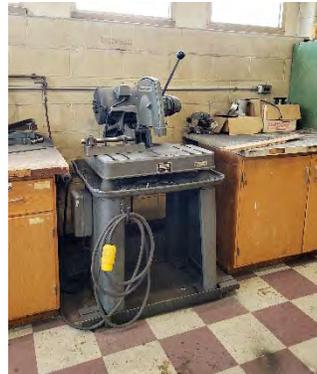
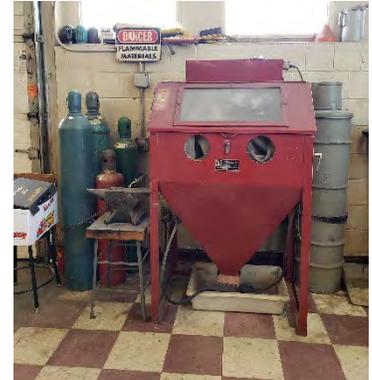
The Metal Lab has metals machining equipment that can produce hazardous dust into the room and the air students breathe. Unlike the Wood Lab, the equipment does not have a dust collection system to capture the dust and filter the air.

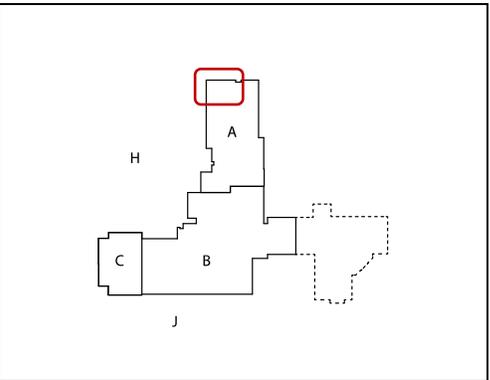
## EXISTING CONDITIONS

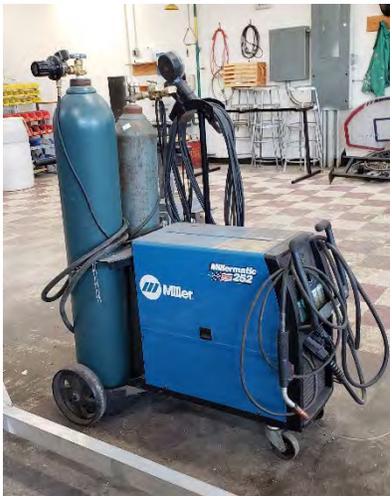
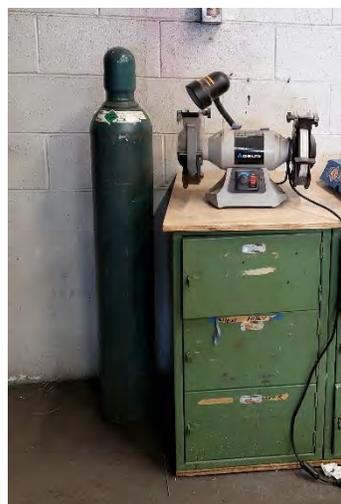
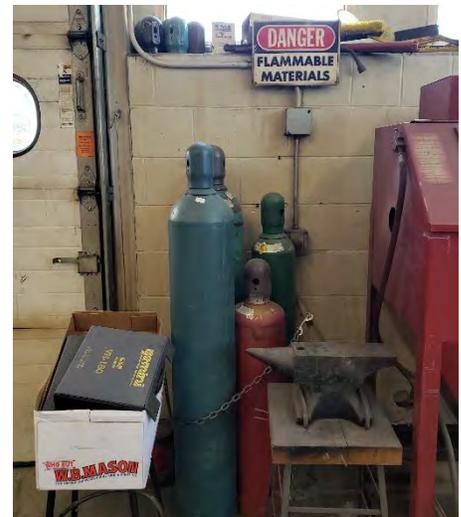
There are several tanks of various compressed gases in various locations throughout the Metal Lab, including Acetylene, Argon, Argon/CO2 blend, Nitrogen, and Oxygen. A group on the wall has a low loose chain. One tank at a bench has no chain. Some are on carts. An overhead door could allow entry of motor vehicles.

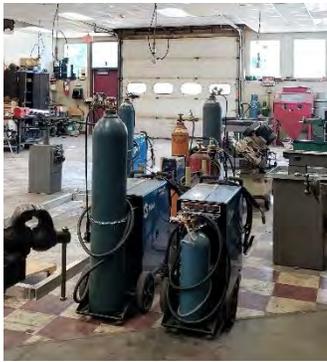
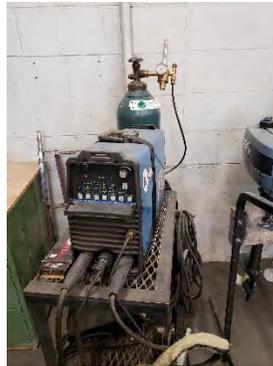
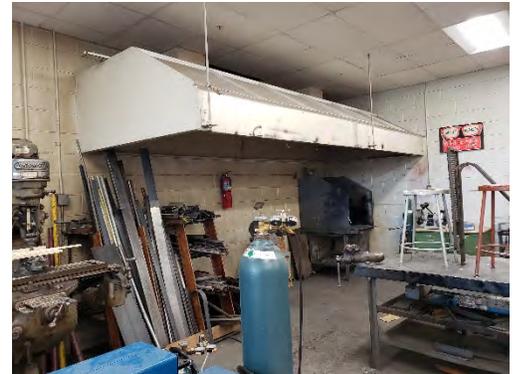
The Metal Lab has metals welding equipment that can produce hazardous fumes into the room and the air students breathe. Unlike the Wood Lab, the equipment does not have a welding exhaust system to capture the fumes and filter the air.

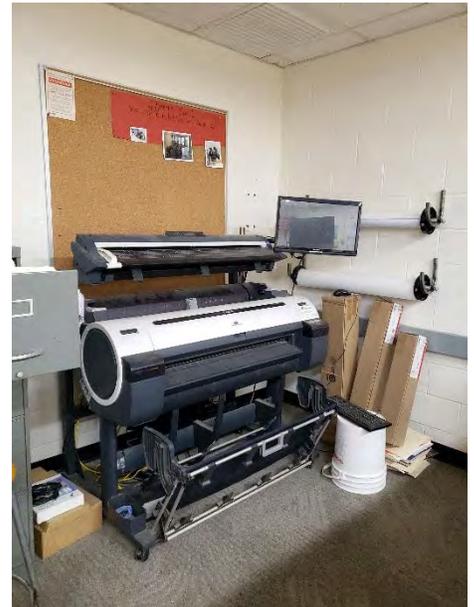
Plotter has no ducted exhaust to it, and partial exhaust via a ceiling grille.

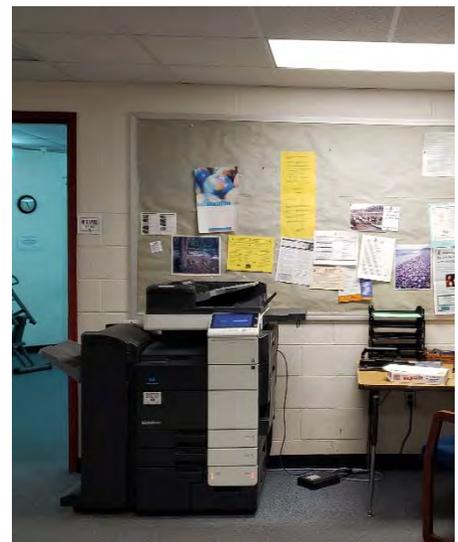
Copiers-printer does not have local exhaust to remove fumes and odors, as required by current Codes.

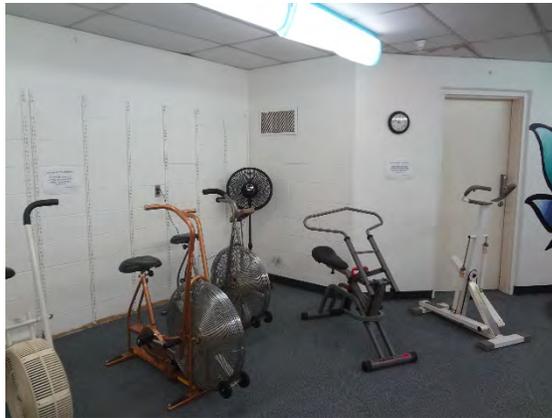
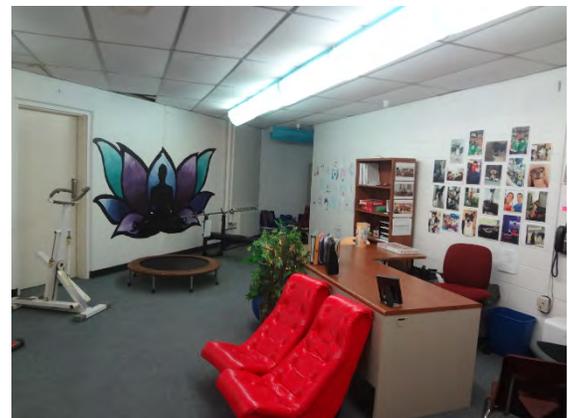
The Green Room which has also been known as Occupational Therapy and Physical Therapy, lacks ventilation. It houses several pieces of exercise equipment. Existing HVAC consists of an exhaust grille, a hydronic heating convactor, and a portable floor fan.

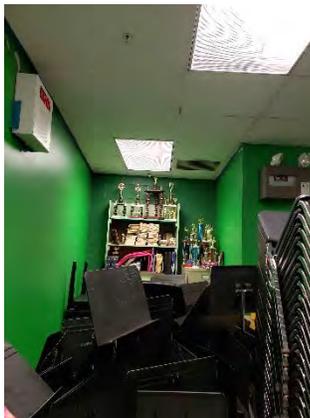
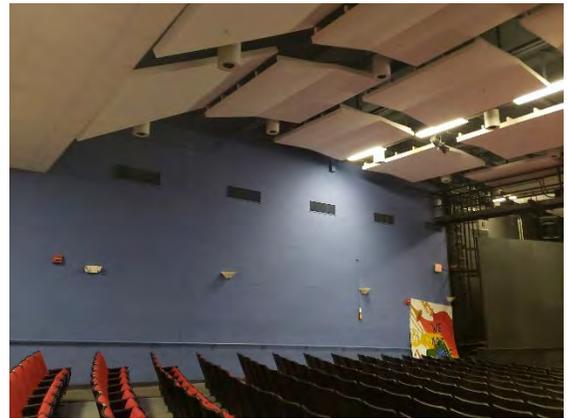
AHU-11 above Stage Prep can be heard rattling loudly; seems to need repairs.

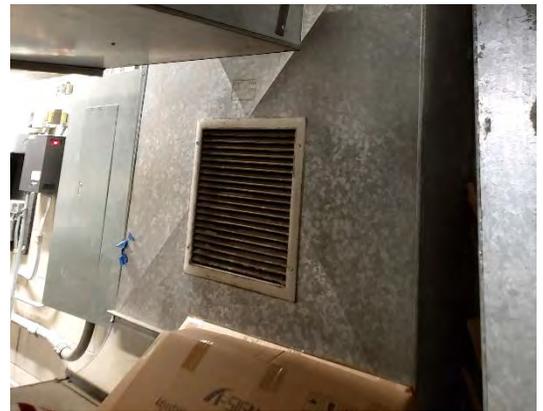
Heavy dust buildup is seen inside ductwork near air handling units. Filters in these units receive a lot of dust and pollen, and because of imperfect fit and some overloading they allow some air to bypass unfiltered. Dust buildup is also seen at terminal inlet and outlet grilles and diffusers. Schools bring in large amounts of outdoor air which bears outdoor contaminants such as dust, pollen, and humidity, and have large dense populations of people who generate dust and other contaminants. Ducts can store these contaminants and distribute them to the occupants, and in some conditions such as high humidity the dirty duct surfaces can promote unhealthy biological growth. Periodic duct cleaning has become standard practice in many schools and other buildings, to promote healthy indoor air quality (IAQ).

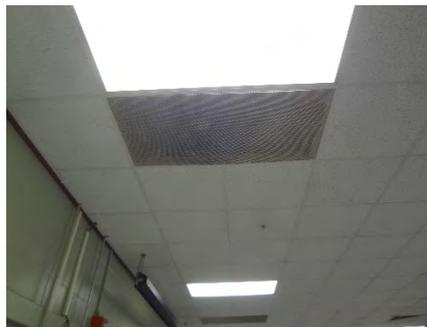
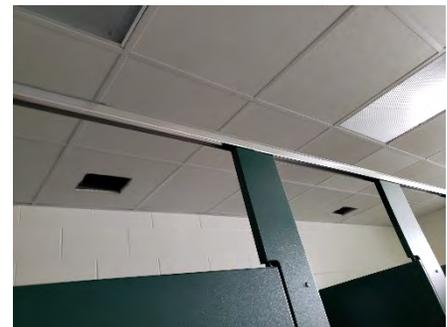
Some air diffusers, grilles, and registers have damage. Most remain functional to deliver the air.
