Prepared for:

Cape Elizabeth Schools

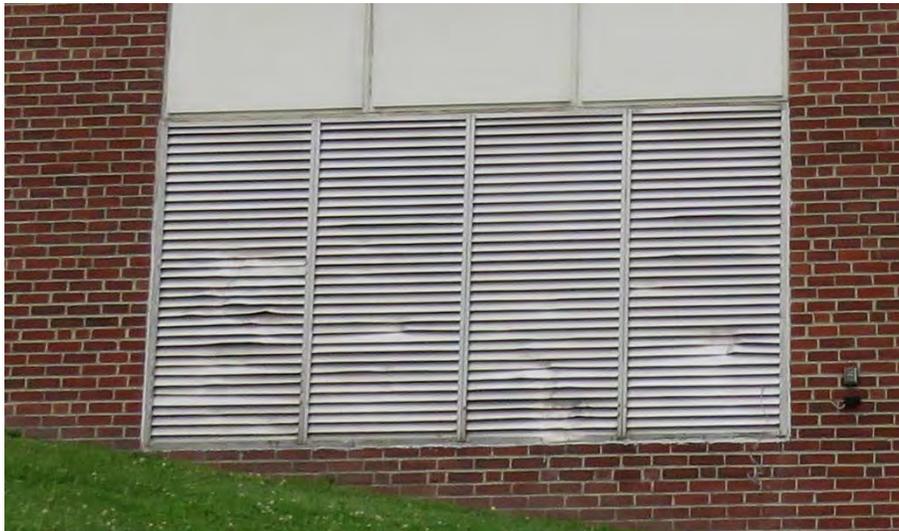
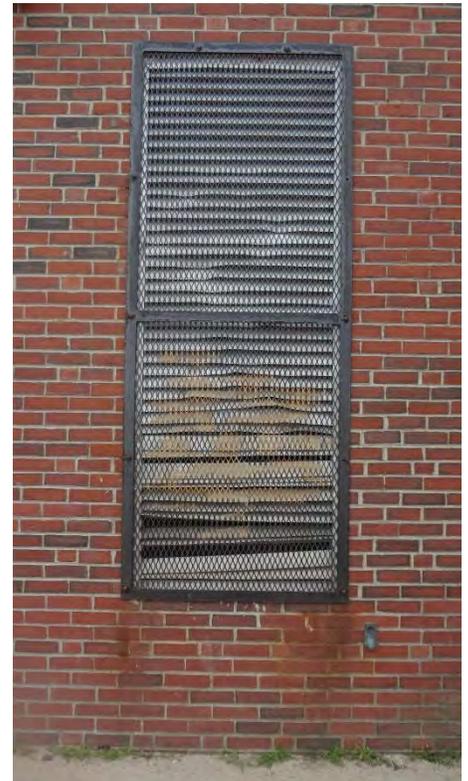
Replace louvers to eliminate existing damage, and potentially reduce future damage.

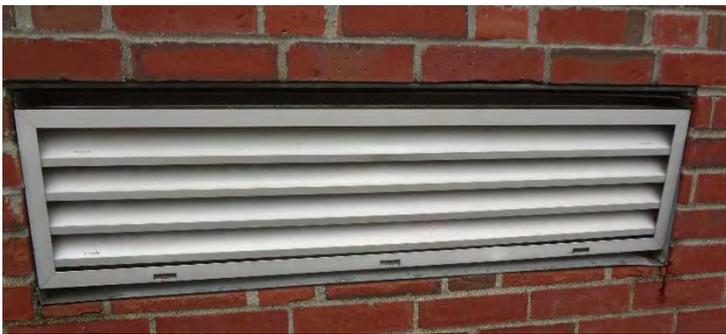
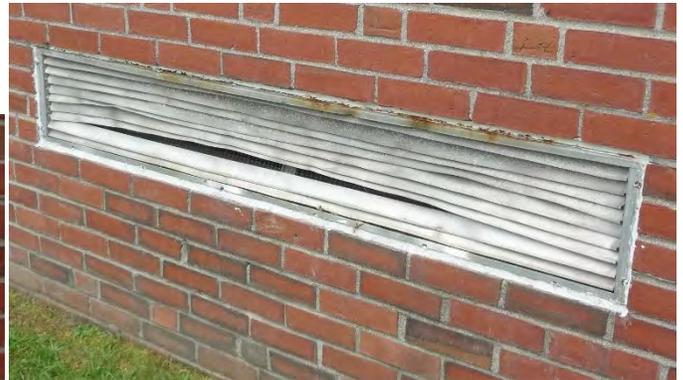
Replace unit ventilators with a more centralized ventilation and heating system, in a related scope of work.

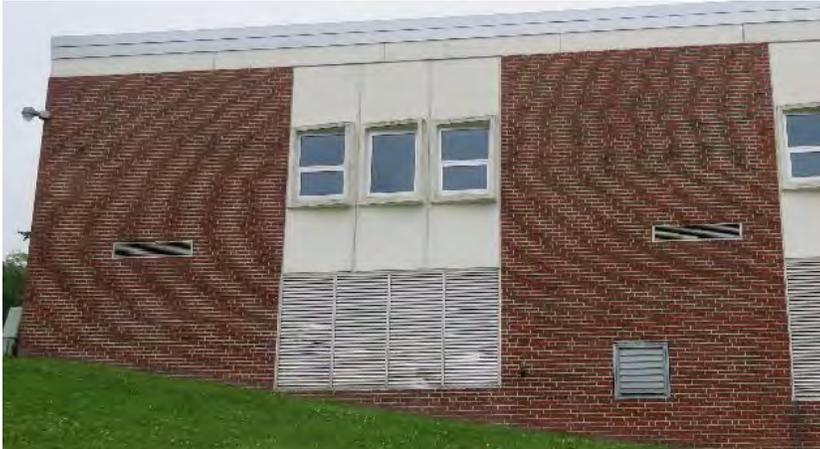
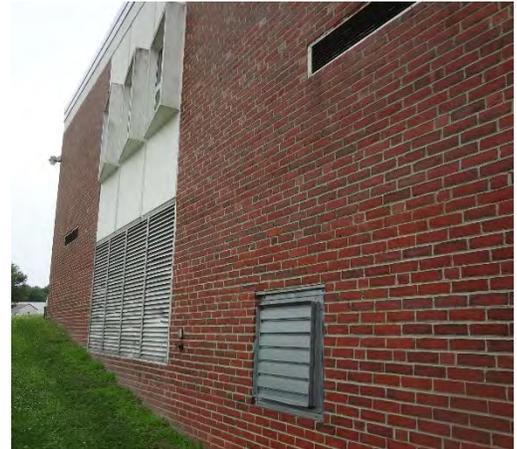
2nd-floor mechanical air handling room’s combined relief/exhaust louver receives both Class 1 (occupied room) relief/exhaust air from the return fan, and Class 2 (potential odors) air from toilet and similar rooms via the main exhaust fan. Such a louver should be 10 feet from fresh air intakes. This louver is about 6 and 8 feet from intake louvers to unit ventilators on the 3rd floor above. Louvers in this area are damaged by student impact such as sports activities, as well as possible vandalism.

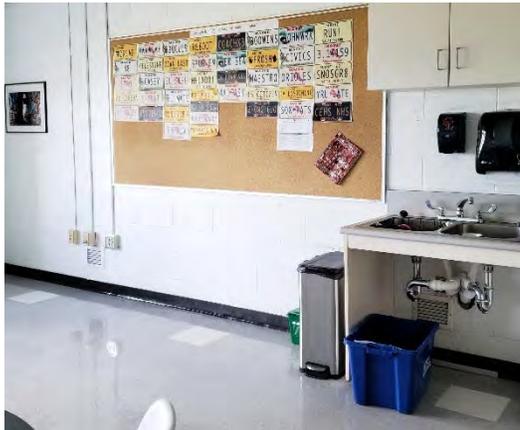
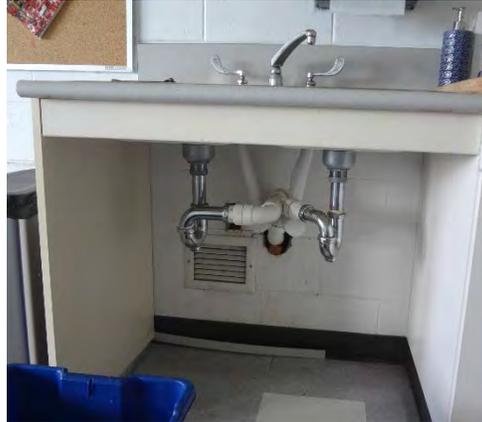
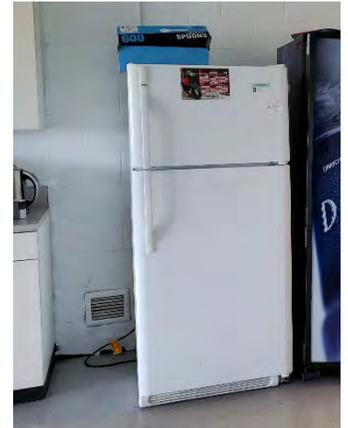
Teacher Lounge B212 has 3 unnecessary low exhaust or return grilles including below the sink and behind the refrigerator. These were made redundant when ceiling return grille was installed under the 2004 design, but are still connected to ducts and may still be pulling air unnecessarily. These are unneeded sound paths to the mechanical room for voice transmission and mechanical equipment noise. They may be restricting occupants' use of the wall space. The ductwork fills space in Mech. Room B216 that could be used for storage.

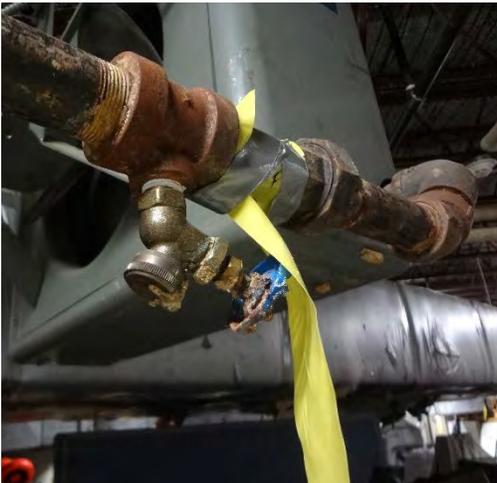
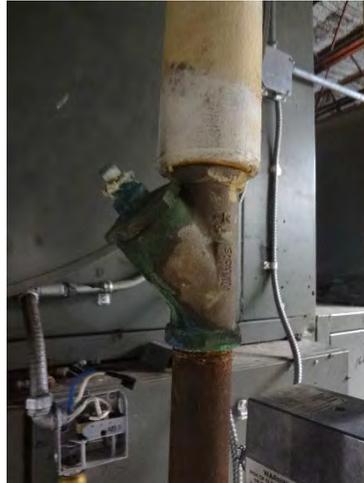
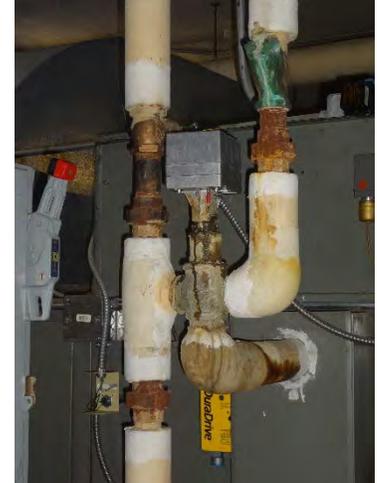
Heating piping has many leaky and corroded valves and unions. Water flow-setting valves are old and obsolete "Illinois" brand valves that may have an adjustment screw but have no way to measure the flow. Many of these items are immediately adjacent to equipment such as air handling unit coils and the unit heater. The piping in general is old, and of unknown internal condition; external rust on some piping fittings may be from past conditions rather than ongoing leakage. Water stains on the floor were only in a few areas, whereas rusty fittings were in many areas.

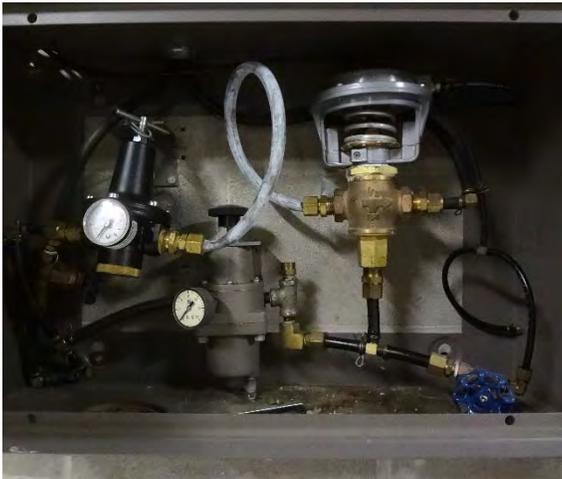
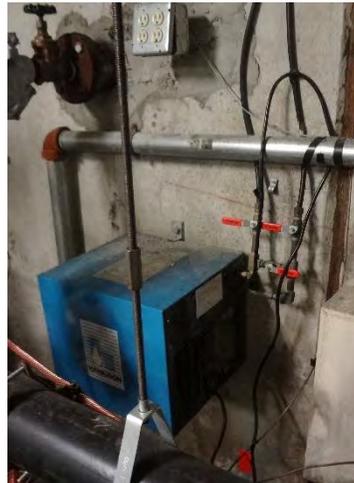
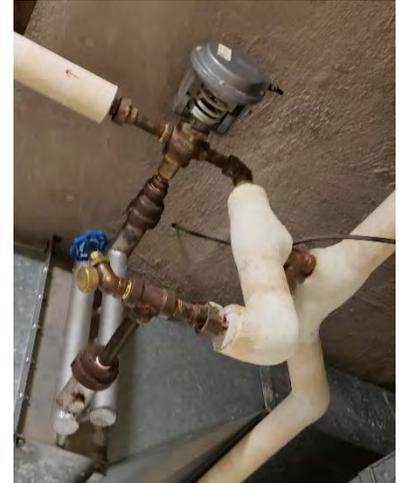
Some of the duct coils have pneumatic control valves which may no longer be operating; one of the pneumatic actuators has its air tubing cut off. Another pneumatic tube runs into the ceiling; it is not obvious where this runs to. There is an abandoned Honeywell pneumatic control panel near the doorway labeled Type W726A Master Oscillator, with a pneumatic pressure regulator and other devices. There is an abandoned pneumatic air dryer and piping station at the water entrance.

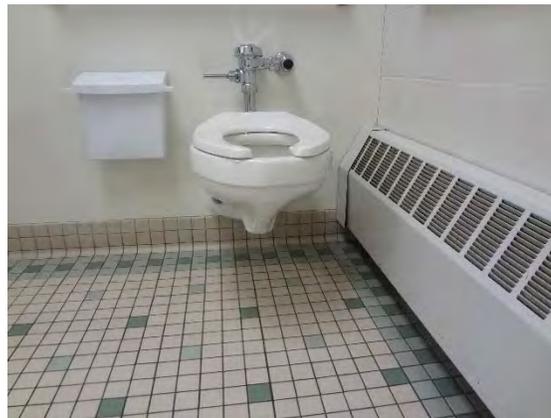
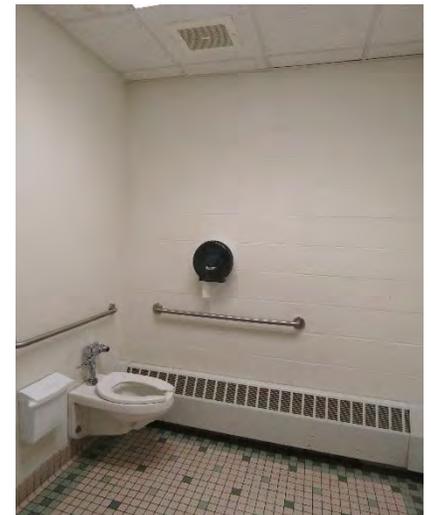
The hydronic fintube radiation heating is mounted on the exterior CMU wall, within the clear space required for ADA wheelchair access to the water closet. This location is also contrary to the requirement to avoid fintube radiation at floor level in toilet rooms, found in the Maine Department of Education Public School Standards and Guidelines for New School Construction & Major Renovation Projects. The hot water piping is fed from the 2nd floor ceiling cavity below, exposed under fintube. The room's ceiling exhaust fan is above the fintube. The interior partitions and furred space behind the water closet are stud type.

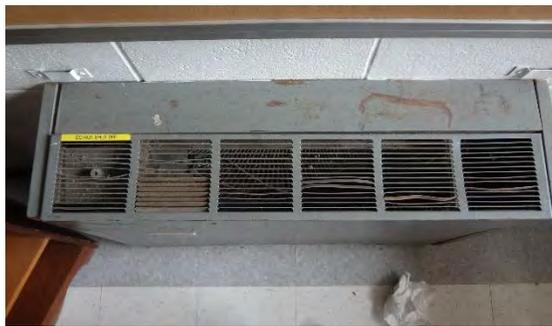
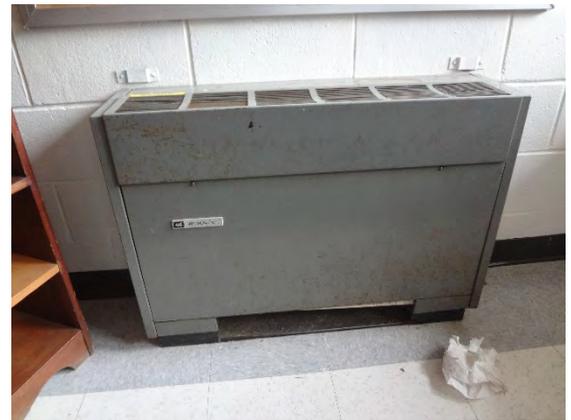
Original AAF Herman Nelson cabinet unit heater is in poor condition; old, dirty, damaged.

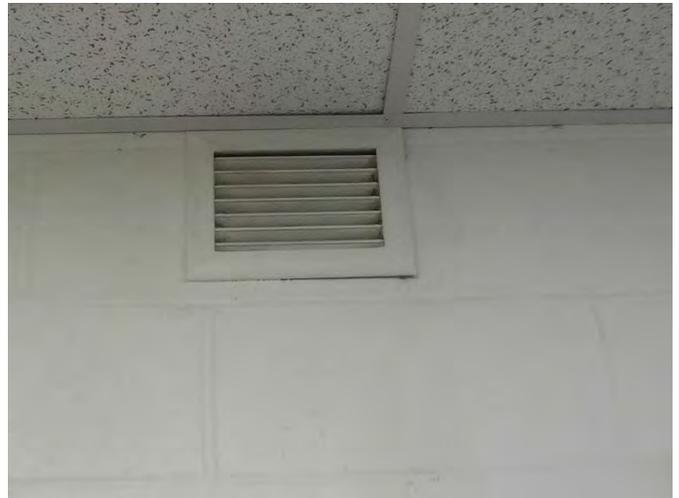
Wall relief grille is undersized at 8"x6" rather than 12"x8" indicated in 2004 design, and smaller than grilles in the adjacent rooms. This can restrict the ability of the room's unit ventilator (UV) to bring in the required minimum outdoor ventilation air, and prevent the UV from increasing the outdoor to provide "economizer" free cooling.

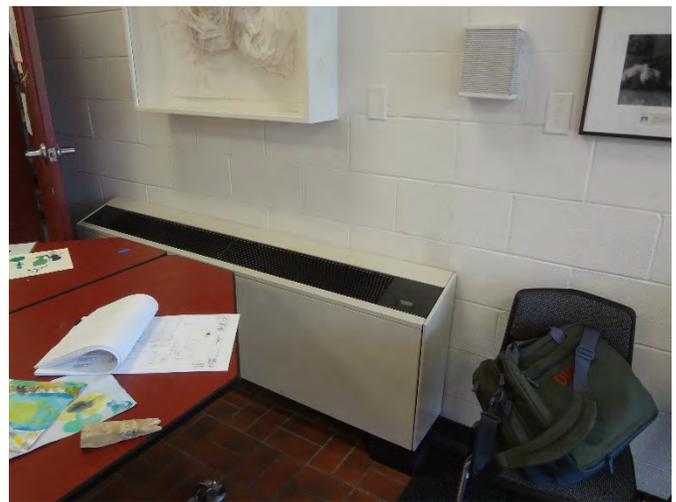
Wall temperature sensor is directly above the cabinet unit heater.

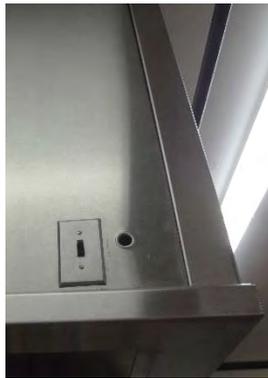
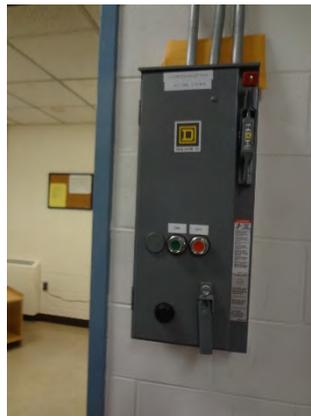
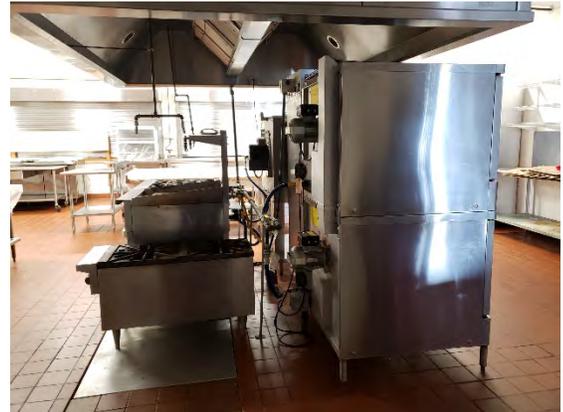
The switch for the kitchen hood's lights is mounted on the front of the hood over 6 feet above the floor. The fan switch is on the wall in the form of start/stop buttons on the motor starter or controller. Control of makeup air, It appears that the hood fan operation is not interlocked with cooking operation as is required by current Codes. The hood's coverage of the existing 2-pot gas burner is marginal and may not meet Codes.

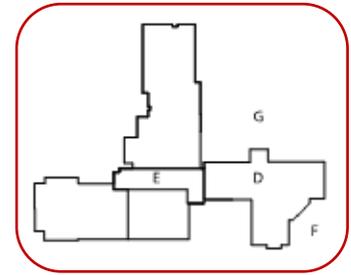
## EXISTING CONDITIONS

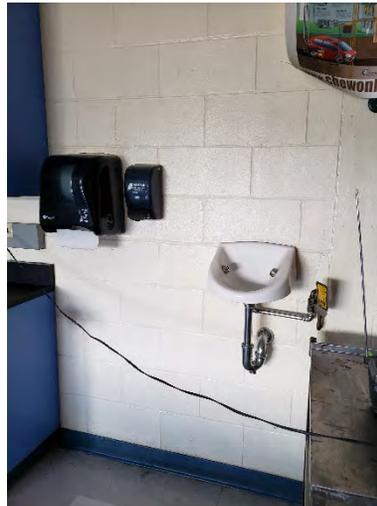
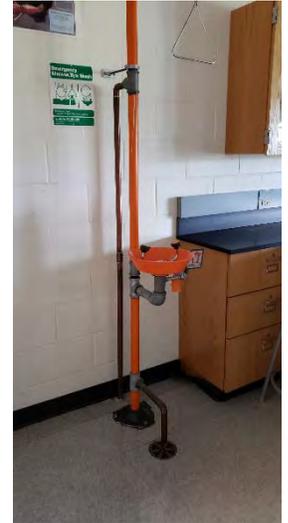
High school science laboratory classrooms do not contain emergency eyewash or shower fixtures. Some janitor spaces utilize self-contained eyewash stations, which may not fully comply with OSHA standards, and clear access isn't being maintained. The Maine Department of Education document *Public School Standards & Guidelines for New School Construction & Major Renovation Projects* requires emergency eyewash and showers for science laboratory classrooms. Where any emergency showers exist they do not all have floor drains, which may inhibit use and testing due to the potential for water damage, and may not have tepid water. Eyewashes are not ADA accessible and have only cold water rather than tepid.

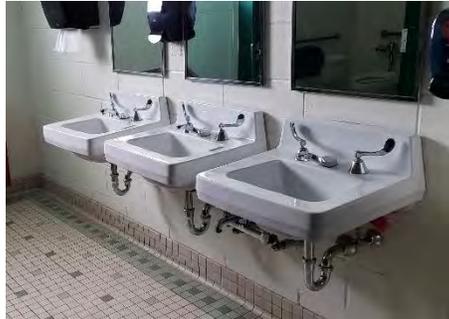
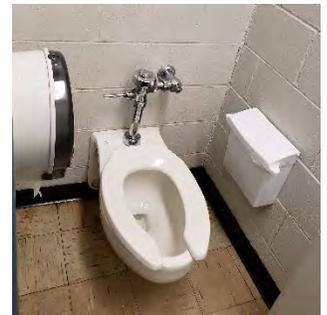
Existing lavatory fixtures are a mixture of automatic and manual operation. Existing fixtures are non-uniform throughout and vary including multi-faucet automatic lavatory stations to individual vitreous china manual lavatories, and toilets vary including both floor and wall-mounted units with both manual and automatic flushometers. However, most plumbing fixtures have manual controls. Some have accessibility issues due to the control design or placement.

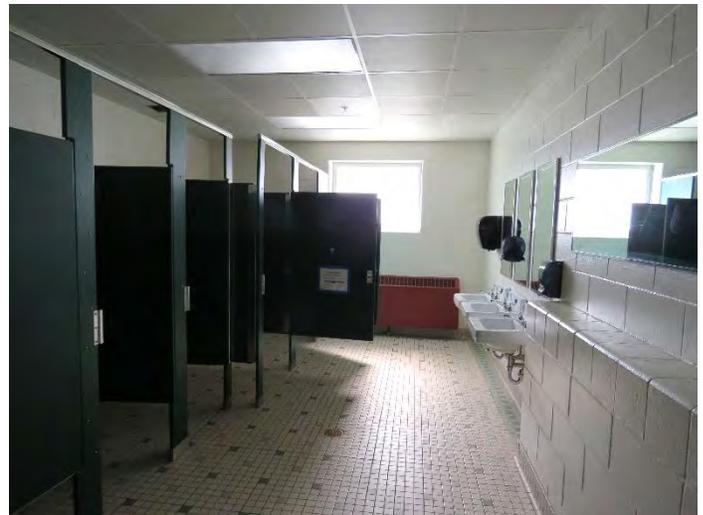
Repair piping to eliminate leaks.

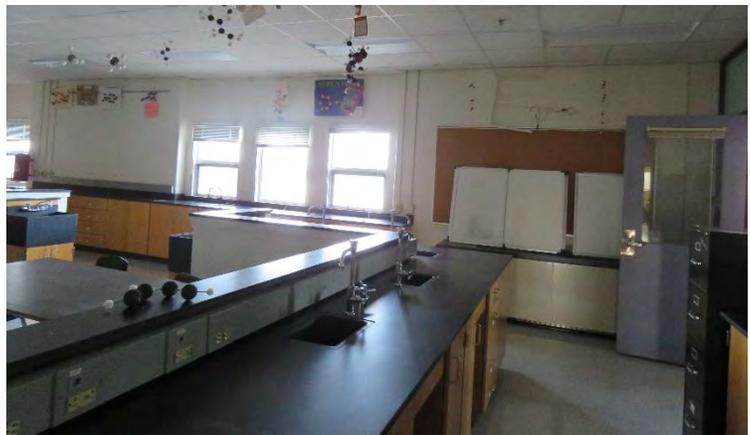
During site investigation, there was no water flowing to the 1st through 3rd floor science classroom sinks. Domestic water to these rooms was reportedly shut off due to leakage. The investigation did not confirm the location of the leak.

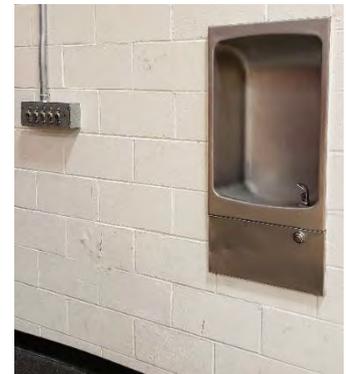
- Metal Lab C100 – single vinyl, 39”
- Boys Locker D114 – single vinyl, 35”
- Girls Locker D122 –single vinyl, 35” (presumed to match boys)
- Gym D103 – single recessed stainless steel, 38”
- Public Foyer A118 – single vinyl with bottle filler, 34.5”
- Cafeteria A123 – dual vinyl, 31” & 35”
- Corridor C124 – dual stainless, 33” & 37”
- 2<sup>nd</sup> Floor D-Wing Central Corridor – single vinyl with bottle filler, 33.5”
- 3<sup>rd</sup> Floor D-Wing Central Corridor – single vinyl with bottle filler, 32”
- 2<sup>nd</sup> Floor E-Wing Corridor – single stainless, 36”
- 3<sup>rd</sup> Floor E-Wing Corridor – dual stainless, 31” & 39”

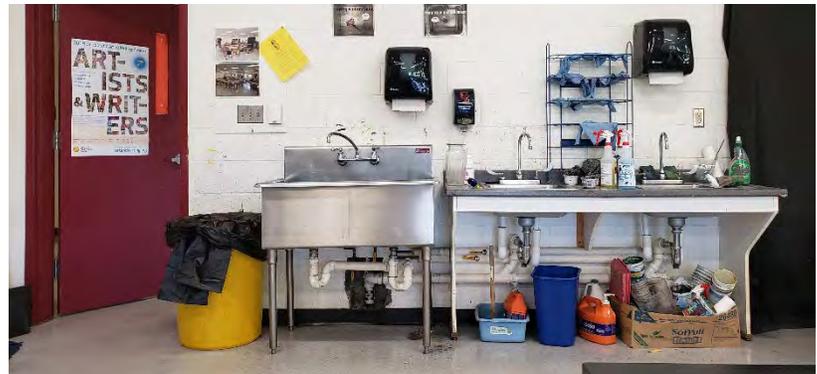
Drawing and Painting Room sinks do not have sediment traps to prevent solids from entering the sanitary waste system.

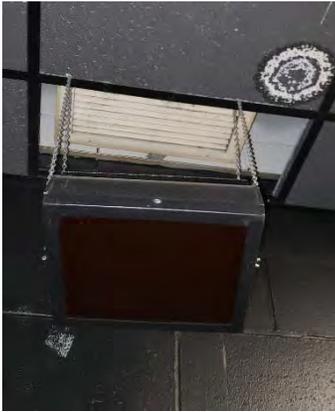
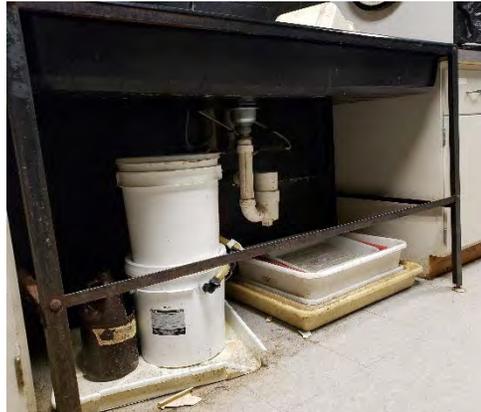
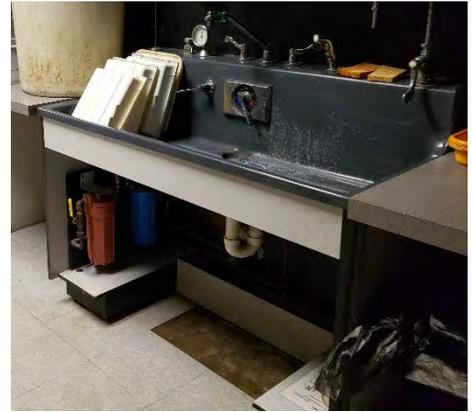
In Darkroom C101, the sinks appear to be made of chemically resistive materials. The drain piping is ordinary PVC and is piped to drain directly into sanitary system without any treatment to neutralize or capture photography chemicals. Developer is typically alkaline; stop bath is typically acidic. One sink has a bucket underneath which is labeled as a silver trap; the bucket has an inlet tube; such waste must be handled and disposed of properly as hazardous waste. Room ventilation was existing prior to the 2004 remodel.

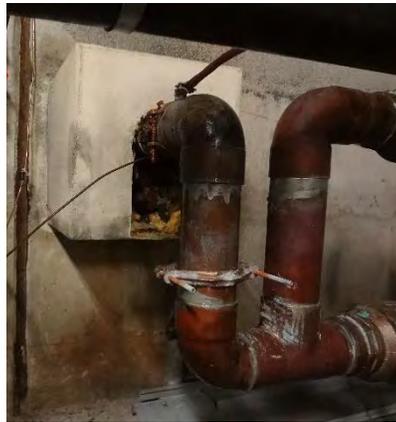
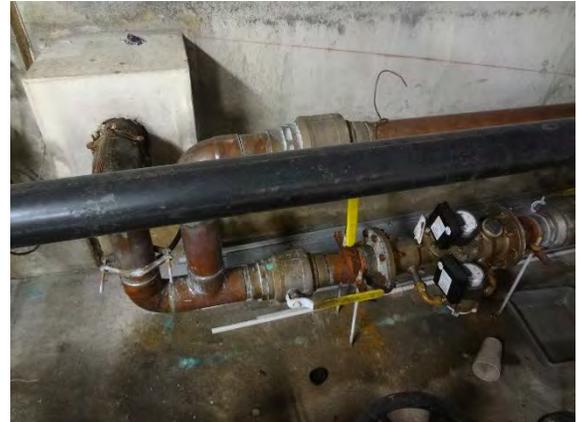
Mechanical Room B216: Domestic cold water piping at entrance meters and BFPs is bare, sweating, and rusting the steel supports with rust running onto floor. Insulate, and replace supports.

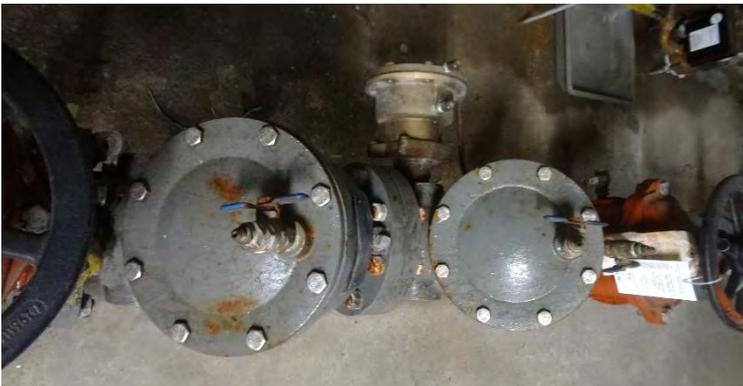
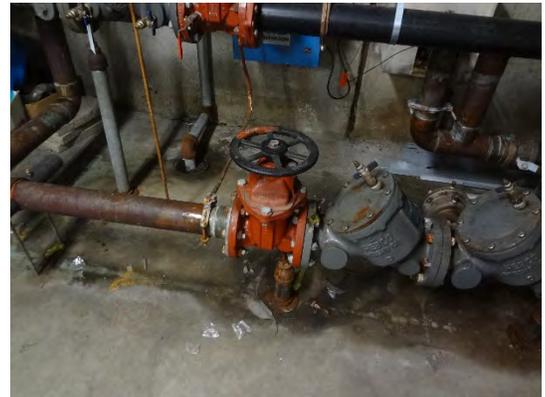
The 4-inch RPZ-type BFP, Febco model 825-YD, lacks sufficient drainage and could flood this and adjacent rooms. The nearby floor drain (FD) and its piping are small, and made smaller by the 2-inch sprinkler drain piped through the grate. There are no protections such as a water-sensing alarm or containment dam. Febco indicates 520 GPM vent discharge at the 80 psi city pressure, and suggests an 8-inch pipe-size FD for this flow, or 6-inch for nearly this flow.

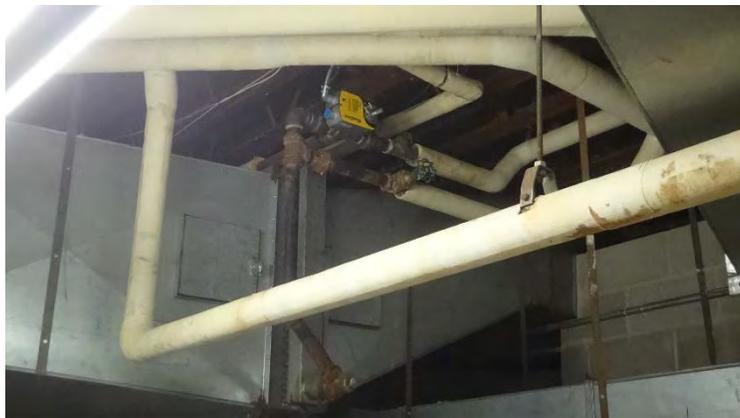
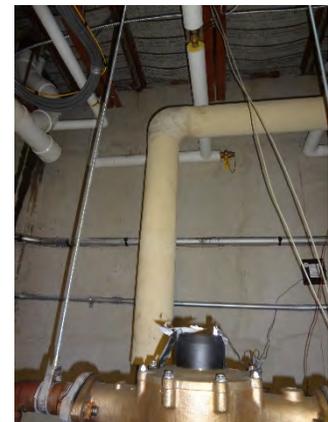
Mechanical Room B216: Overhead plumbing and heating piping in most of this room is insulated with an old canvas jacketing, including on elbows. On the 4" cold water main the elbows have stains suggesting mold or other growth.

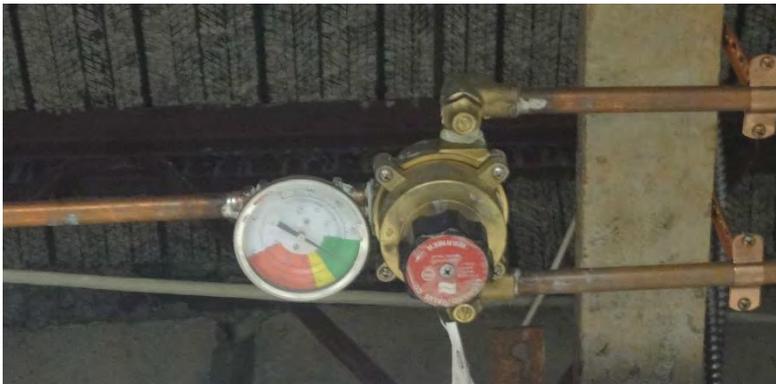
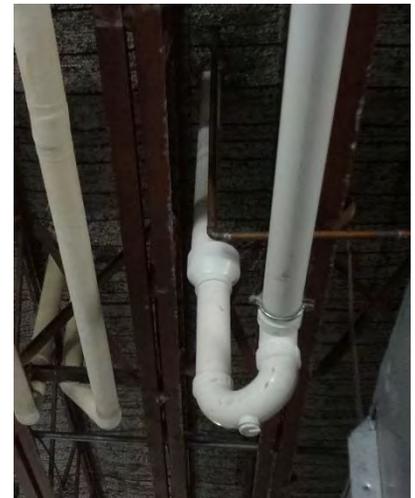
Mechanical Room B216: An emergency eyewash in the nurse's COT room on the 3rd floor has a water mixing valve and an overhead indirect waste standpipe in this room. The hot water piping into the valve lacks recirculated hot water piping to keep the hot water at temperature and not stagnant, and the hot water piping lacks insulation. The indirect waste standpipe serving the eyewash drain lacks a trap primer to protect the trap from drying out, and lacks vent piping.

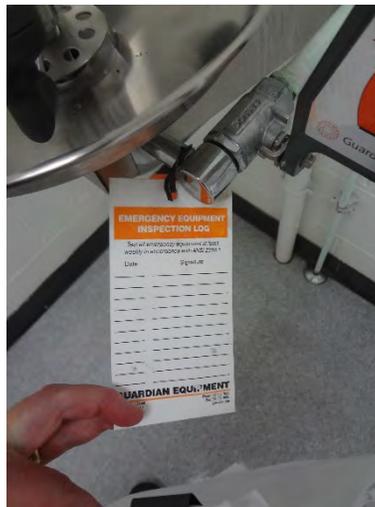
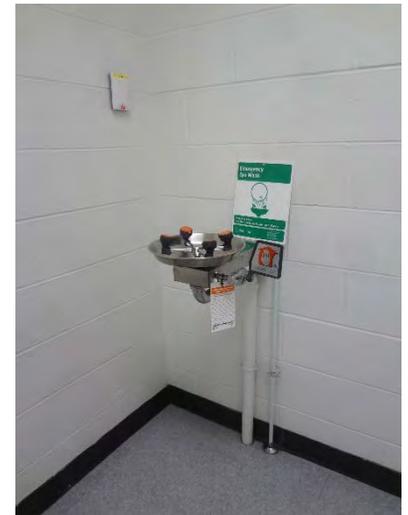
The emergency eyewash has a center hub, off which water splashes onto the floor when the water is run. The eyewash appears clean and little used but may not comply with ADA accessibility requirements. The weekly inspection hang-tag has not been filled out, so frequency of past testing is unknown. The PVC drain and 1/2" tepid water down thru the floor lack sleeves and firestop.

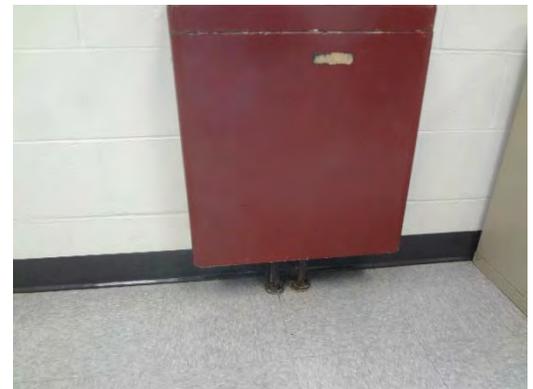
The convectors in this area of the building are aged and have been painted more than once. The heating water down thru the floor lack sleeves and firestop. The room is above the 2nd-floor mechanical and storage room.

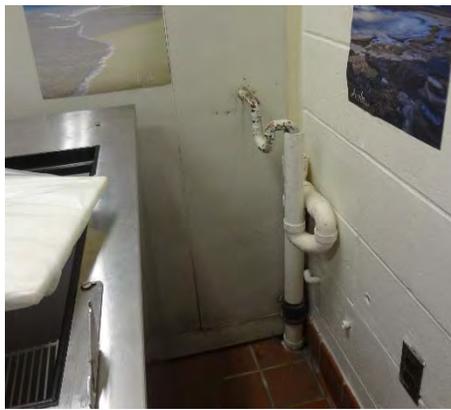
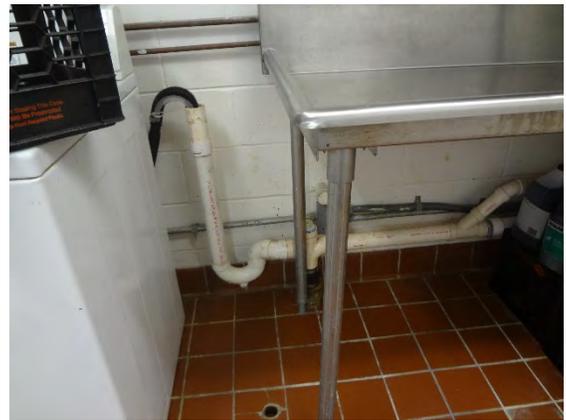
Washing machine standpipe, dishwasher drain, and walk-in freezer standpipe lack venting.

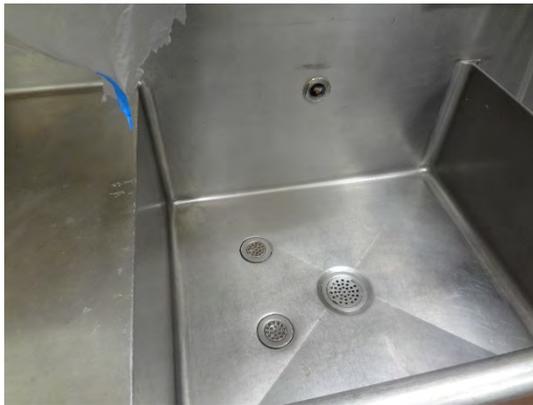
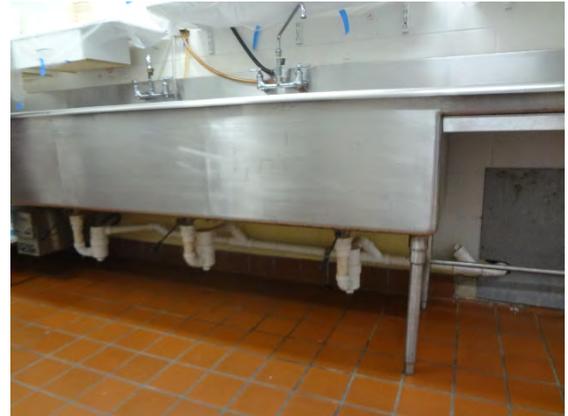
Kitchen sinks do not provide proper separation of dishwashing and other unsanitary functions from food preparation such as washing vegetables to be served uncooked. The single 3-bay lacks indirect waste and is piped directly to the sanitary system. The electric sink booster heater for warewashing sanitation appears to be out of use with plugged-up supply and return connections at the bottom of the sink, but there doesn't appear to be an alternative such as a chemical sanitizing system. The bowl with the booster heater is missing its overflow outlet fitting.

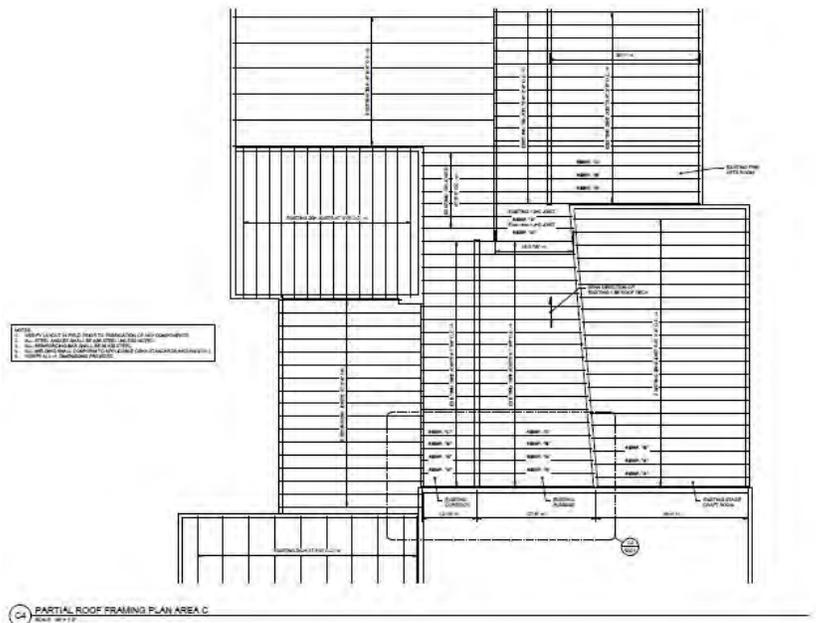
# Security: Weak Points

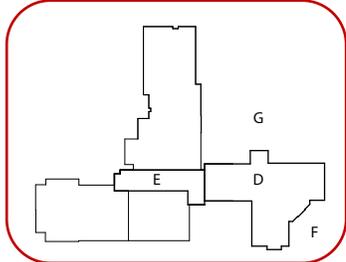
### EXISTING CONDITIONS

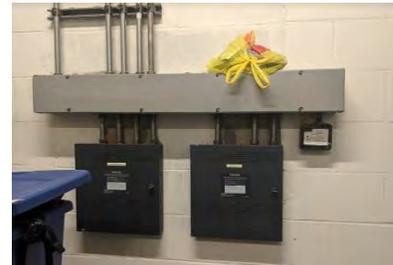
Not all areas with fire alarm control equipment installed in normally unoccupied areas, such as electrical closets, are provided with smoke detection as required by NFPA 72.

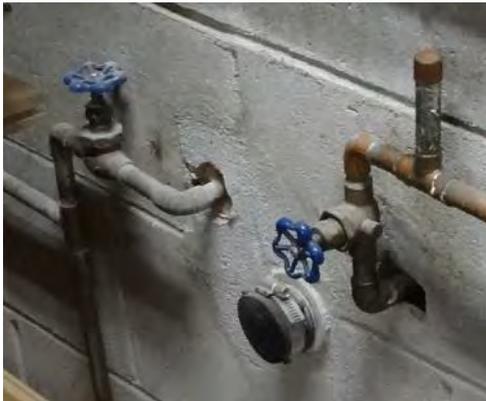
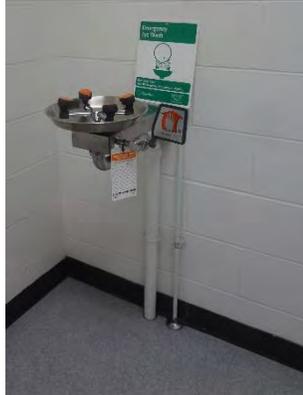
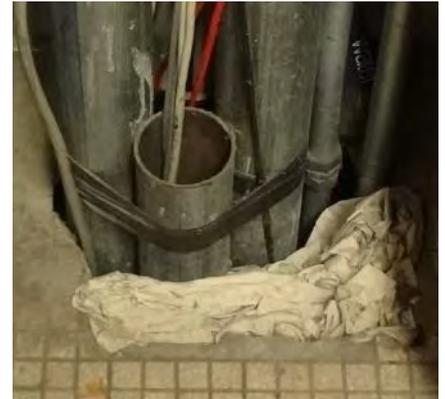
Many walls and floors throughout the building are penetrated by various building systems including, but not limited to, fire protection piping, plumbing systems, HVAC systems, and electrical conduit. Many of these penetrations are not sufficiently firestopped to meet the rating of the assembly being penetrated. Several penetrations are currently firestopped, but insufficiently. There are also several empty openings through walls and floors where building systems once penetrated, but have since been removed.

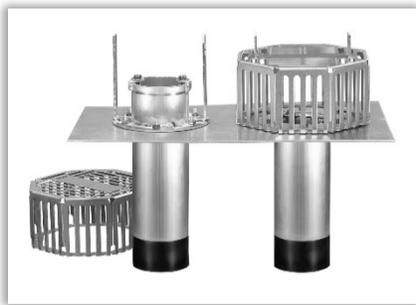
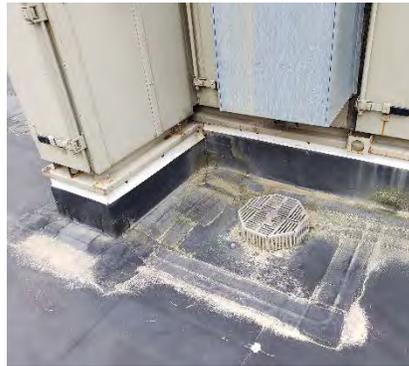
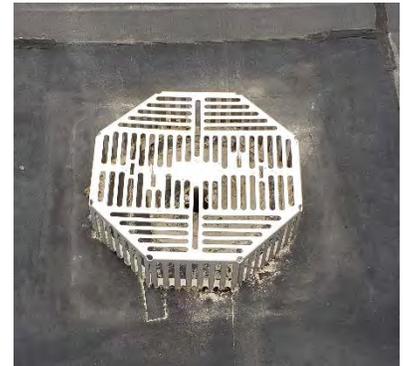
Some of the existing roof drains, such as above the Gymnasium, are a retrofit type typically installed by roofing contractors when they are replacing roof membranes and adding insulation. They have a flat plate, and a tube that inserts through the existing drain bowl and into the pipe. Roofers also often allow the roof membrane to overlap the drain opening, further restricting water flow.

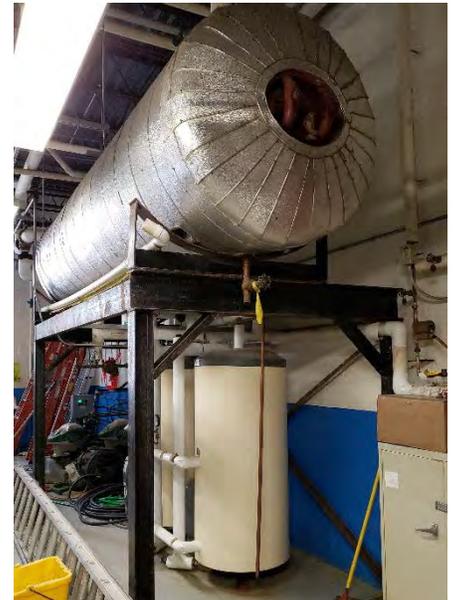
Existing hot water tank in the boiler room shows signs of leakage. Unit may require resizing for current and future building demand.

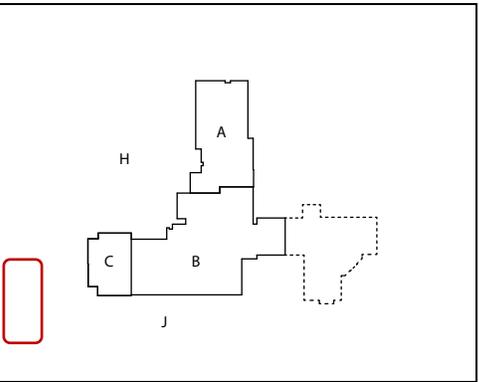
**EXISTING CONDITIONS**

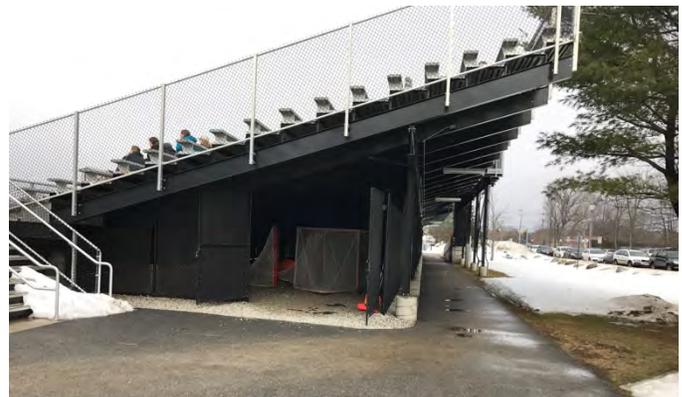
Example of covered storage from Bates College.

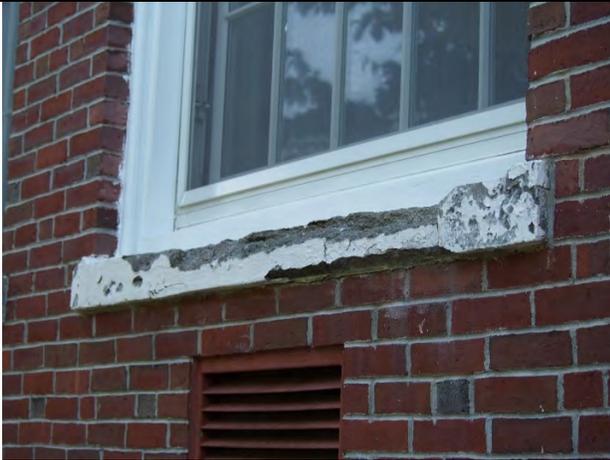
*Figure A1: 1934 Building – Cast Stone Sill Damage (EM)*

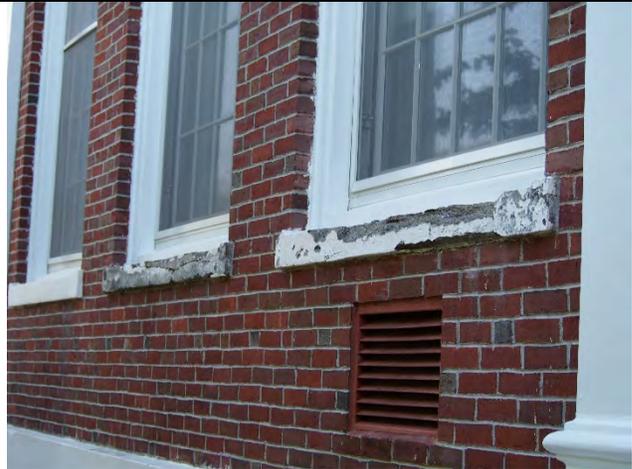
*Figure A2: 1934 Building – Cast Stone Sill Damage (EM)*

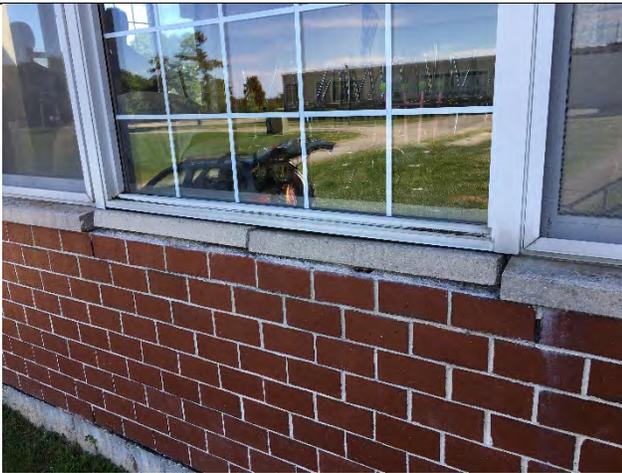
*Figure A3: Failing Precast Window Sill (EM)*

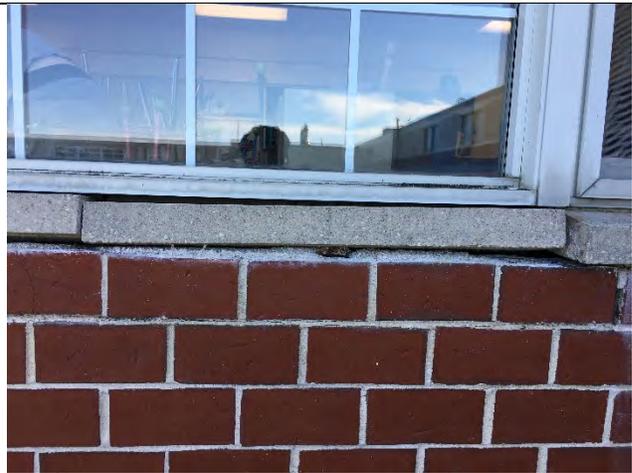
*Figure A4: Failing Precast Window Sill (EM)*

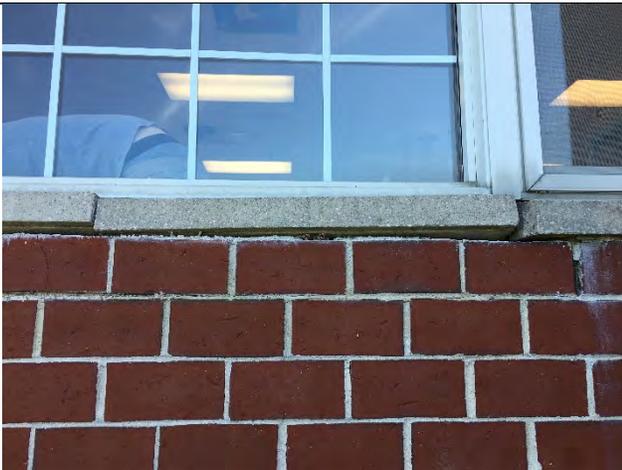
*Figure A5: Failing Precast Window Sill (EM)*

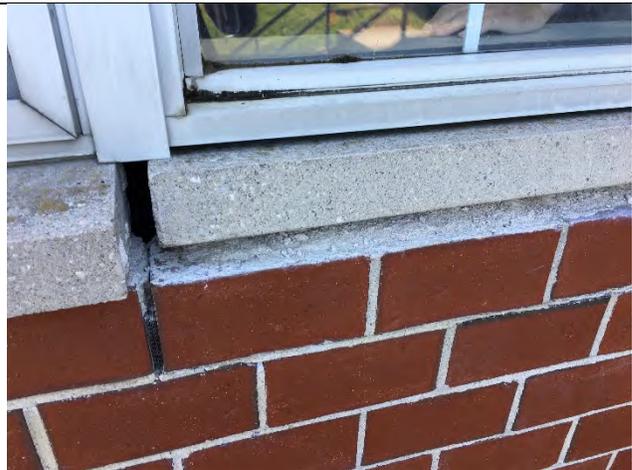
*Figure A6: Failing Precast Window Sill (EM)*

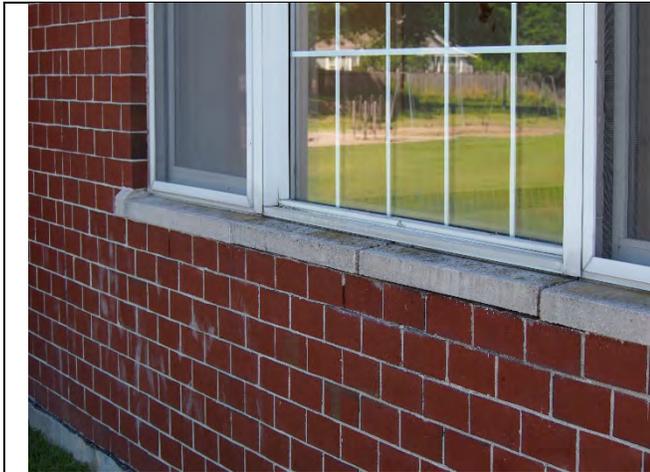
*Figure A7: Failing Precast Window Sill (EM)*

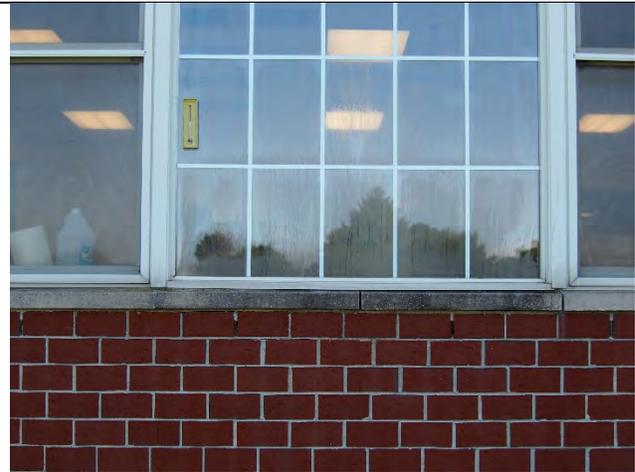
*Figure A8: Failing Precast Window Sill (EM)*

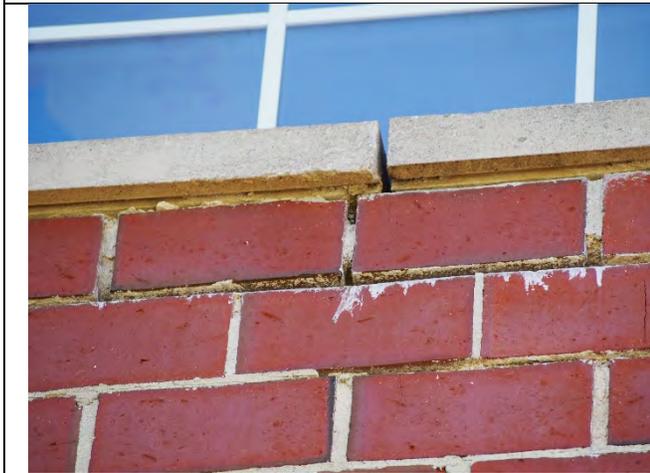
*Figure A9: Failing Precast Window Sill (EM)*

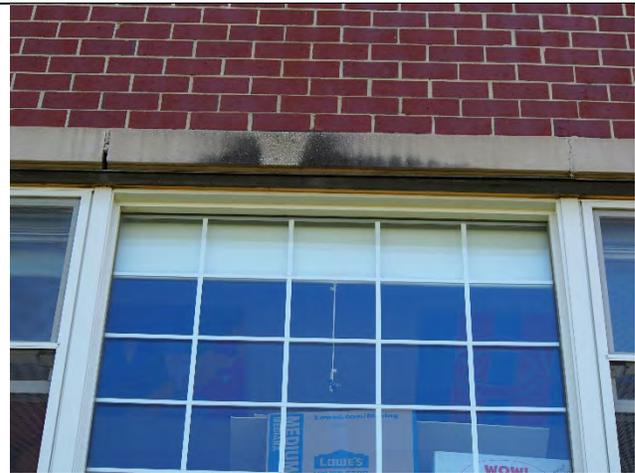
*Figure A10: Failing Joints at Precast Window Head (EM)*

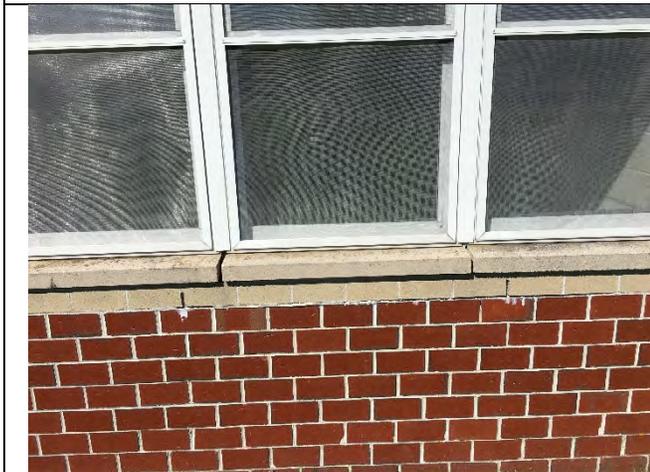
*Figure A11: Failing Precast Window Sill (EM)*

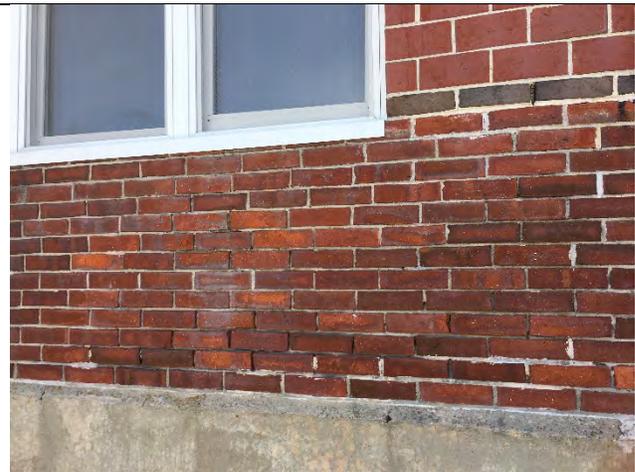
*Figure A12: Brick Needs Repointing (EM)*

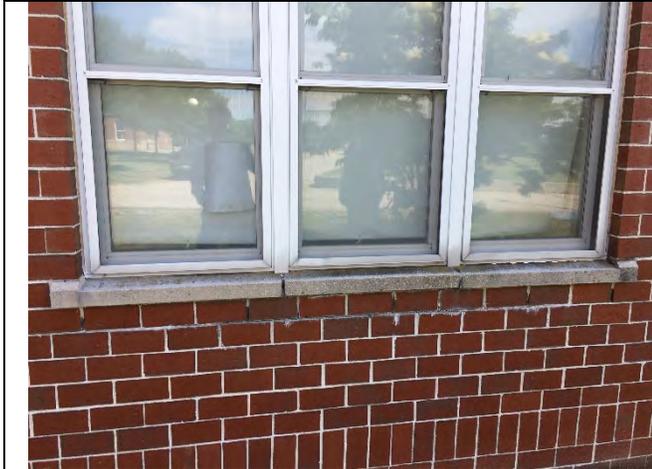
*Figure A13: Water Spall and Masonry Damage at Window Sill (EM)*

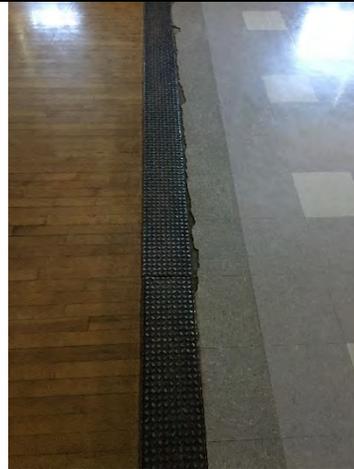
*Figure A14: Flooring Damage at Band Room (EM)*

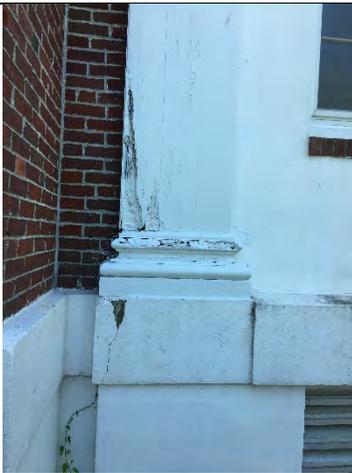
*Figure A15: 1934 Building – Exterior Wood Rot (EM)*

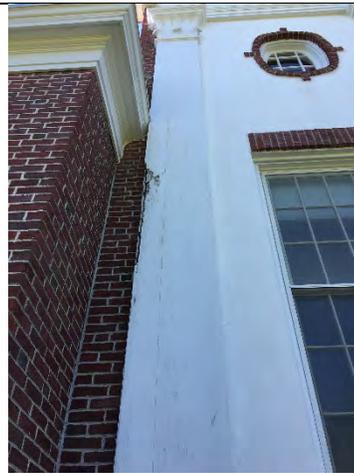
*Figure A16: 1934 Building – Exterior Wood Rot (EM)*

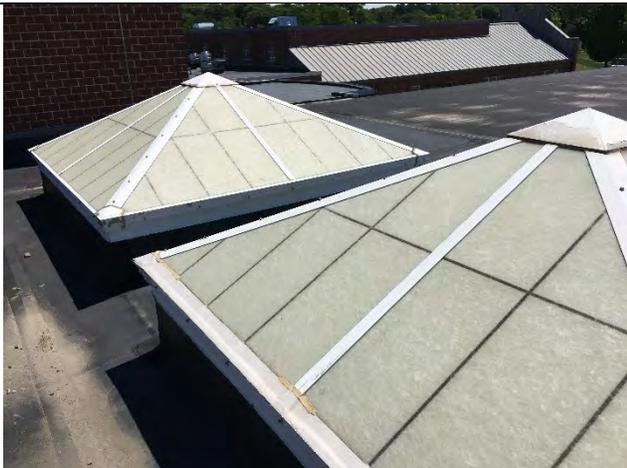
*Figure A17: Skylight Conditions Issues (EM)*

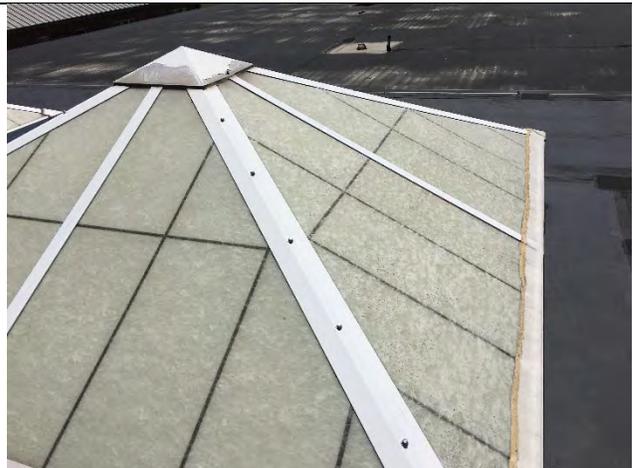
*Figure A18: Skylight Conditions Issues (EM)*

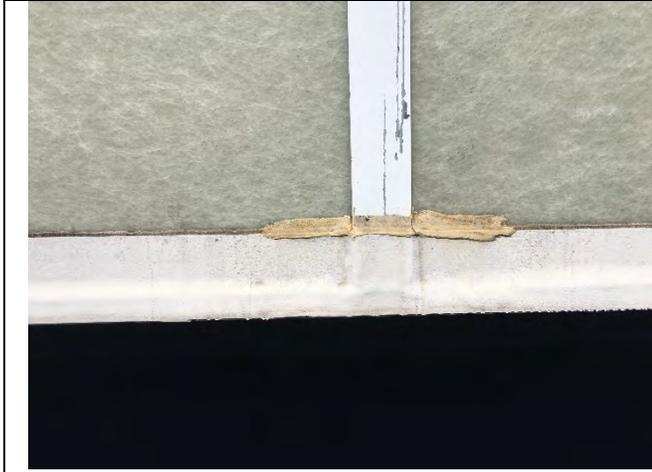
*Figure A19: Skylight Conditions Issues (EM)*

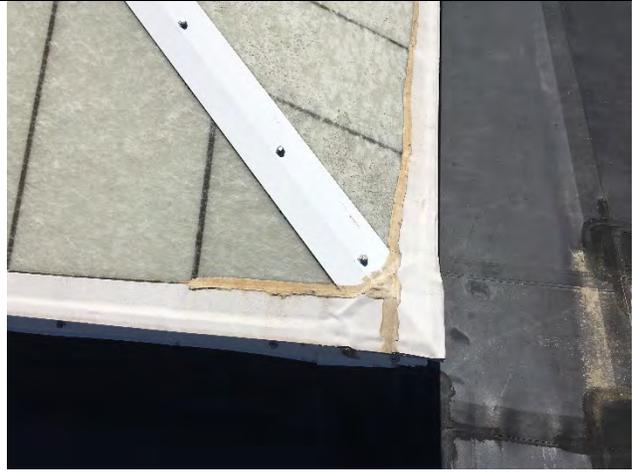
*Figure A20: Skylight Conditions Issues (EM)*

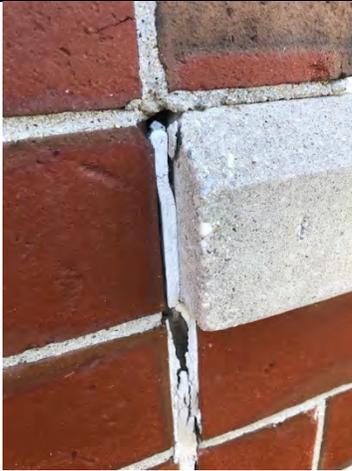
*Figure A21: Sealant Issues at Window Sill (EM)*
