Prepared for:

Cape Elizabeth Schools

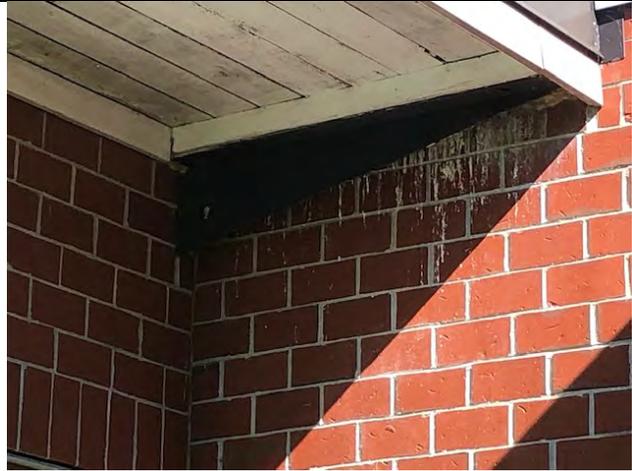
*Figure A22: Exterior Wall Condition (EM)*

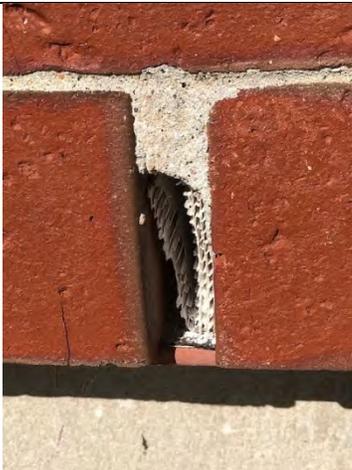
*Figure A23: Degraded Masonry Weep (EM)*

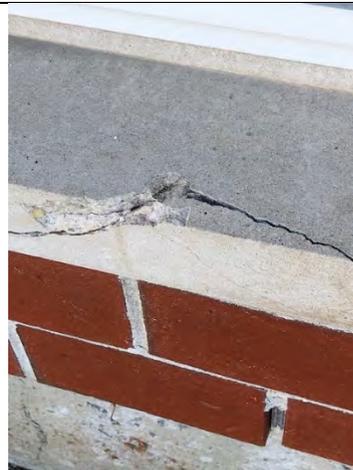
*Figure A24: Crack at Precast Window Sill (EM)*

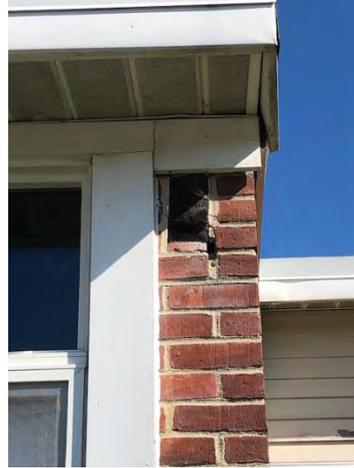
*Figure A26: Missing Mortar at Brick/Wood Intersection (EM)*

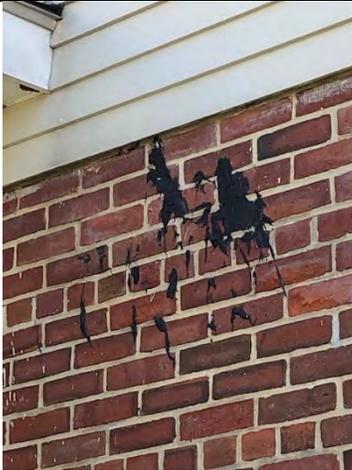
*Figure A27: Exterior Wall Mastic Staining (EM)*

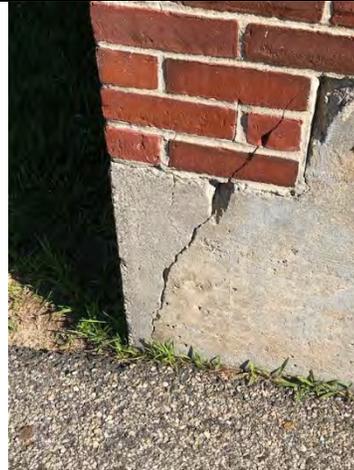
*Figure A28: Crack at Concrete Foundation and Brick (EM)*

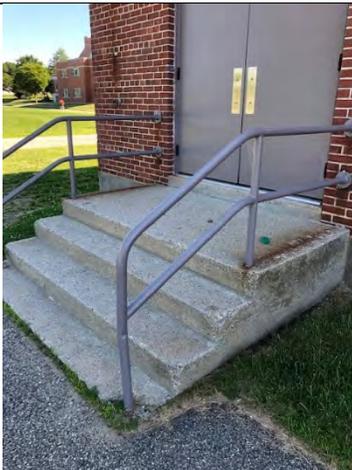
*Figure A29: Non-Compliant Egress Door (EM)*

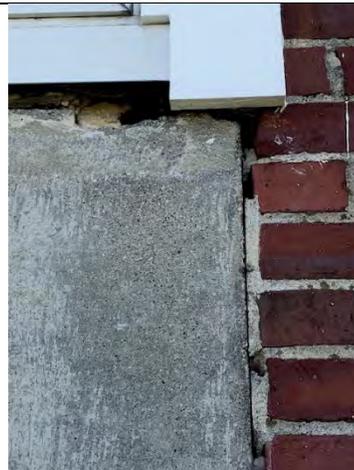
*Figure A30: Missing Mortar at Brick/Concrete Intersection (EM)*

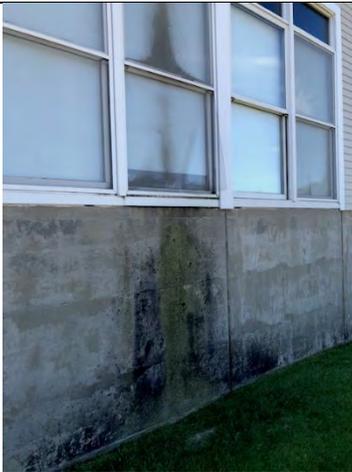
Figure A31: Water Staining and Biological Growth below Window (EM)

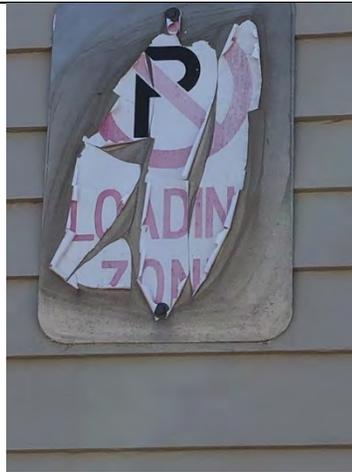
Figure A32: Damaged Sign (EM)

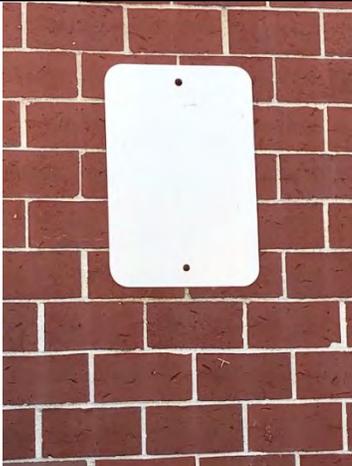
Figure A33: Sun Damaged Sign (EM)

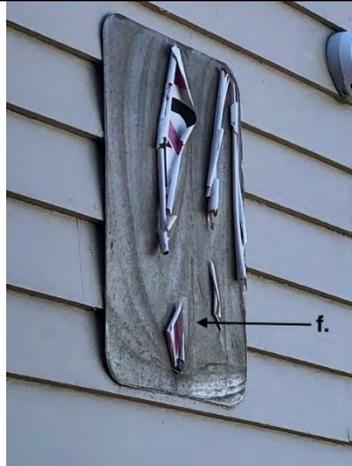
Figure A34: Damaged Sign (EM)

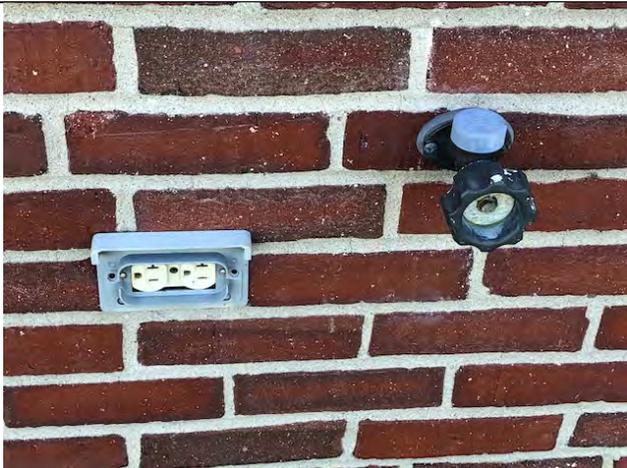
Figure A35: Exposed Outlet (non-GFCI) (EM)

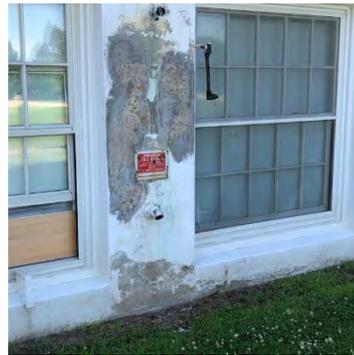
*Figure A40: 1934 Building – Exterior Wall Condition (EM)*

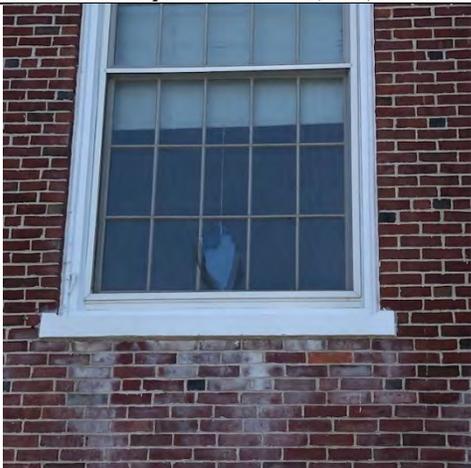
*Figure A41: 1934 Building – Exterior Wall Water Staining (EM)*

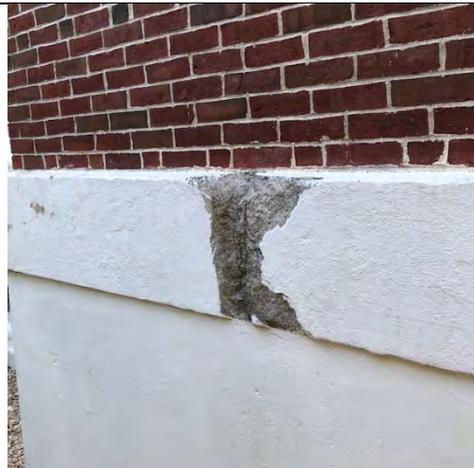
*Figure A42: 1934 Building – Spalled Concrete at Foundation (EM)*

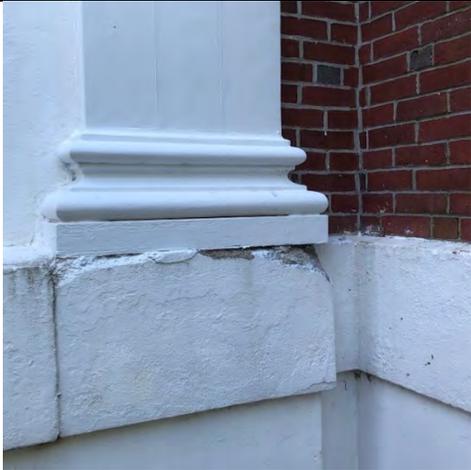
*Figure A43: 1934 Building – Spalled Concrete at (EM) Foundation*

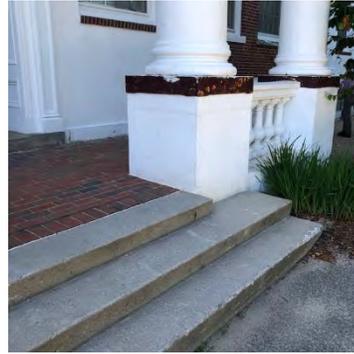
*Figure A44: 1934 Building – Rusted Column Bases (EM)*

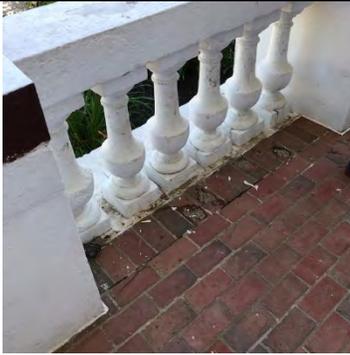
*Figure A45: 1934 Building – Cracked Brick Paving (EM)*

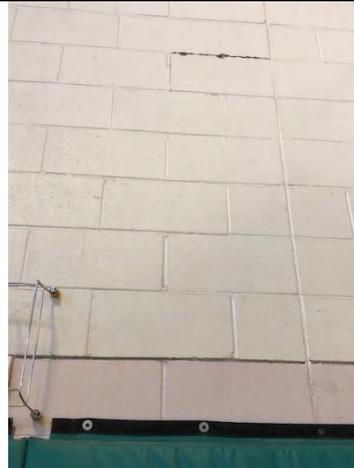
*Figure A46: CMU Cracks at Gymnasium (EM)*

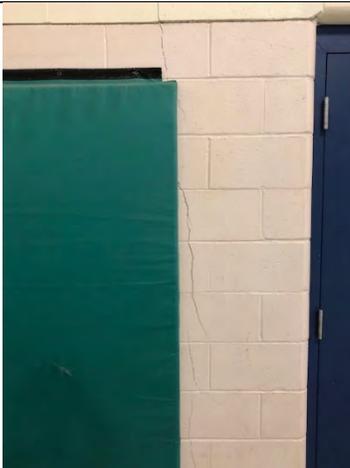
*Figure A47: CMU Cracks at Gymnasium (EM)*

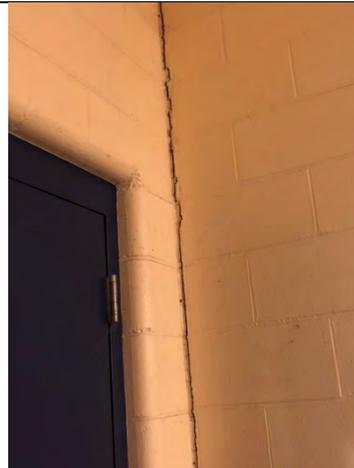
*Figure A48: CMU Cracks at Gymnasium (EM)*

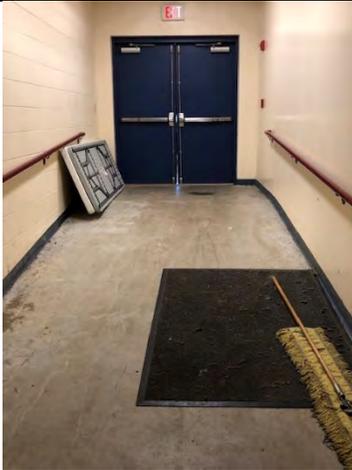
*Figure A49: Weatherstripping at Door #20 (EM)*

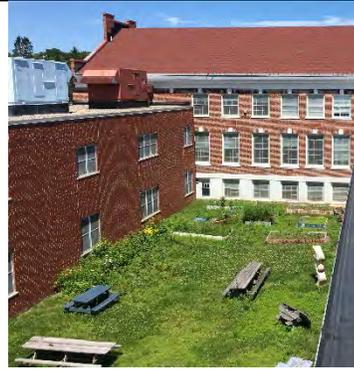
Figure A86: Courtyard without Compliant Egress, Conditions Issues (EM)

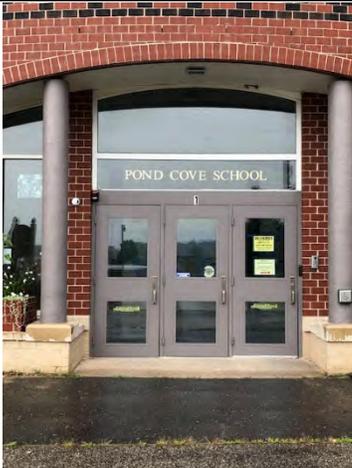
Figure A87: Door #1 (EM)

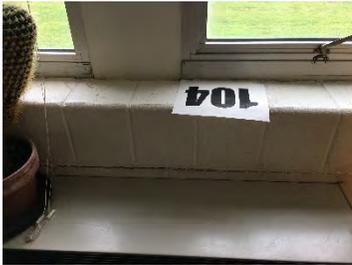
*Figure A111: CMU Crack at Window Sill (H)*

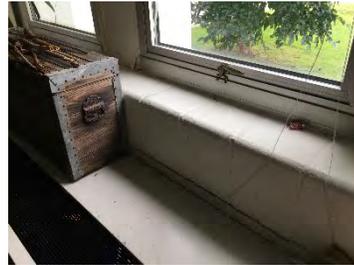
*Figure A112: CMU Crack at Window Sill (H)*

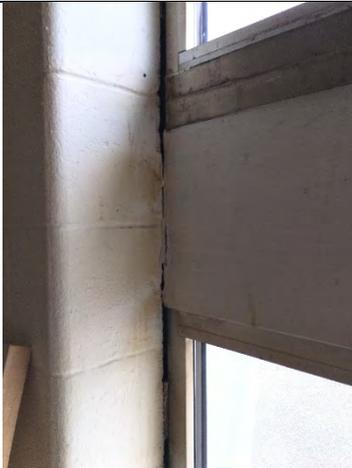
*Figure A113: Interior Finish Issues at Precast Wall System (H)*

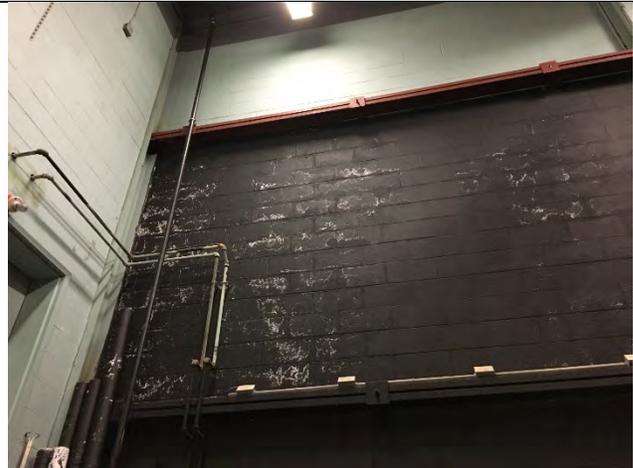
*Figure A114: Efflorescence Stains on Interior wall (H)*

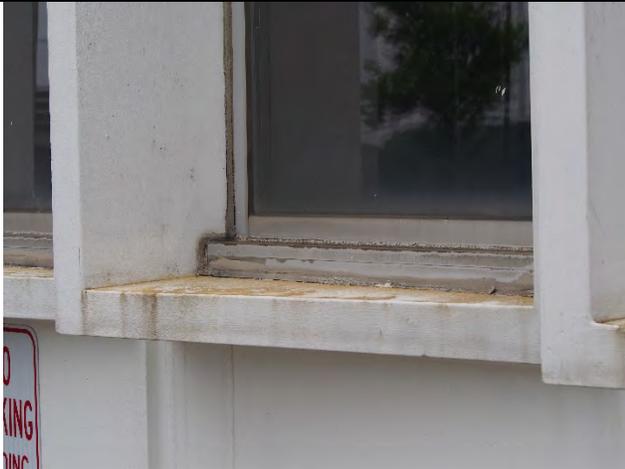
*Figure A115: Precast Window System Sill (H)*

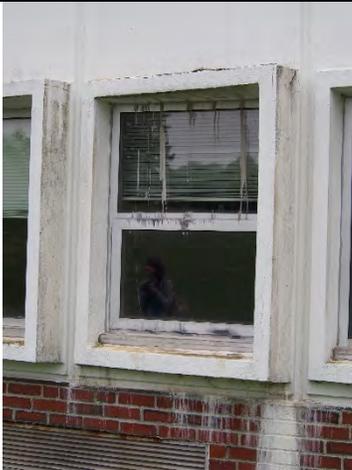
*Figure A117: Moisture Issues at Precast Window System (H)*

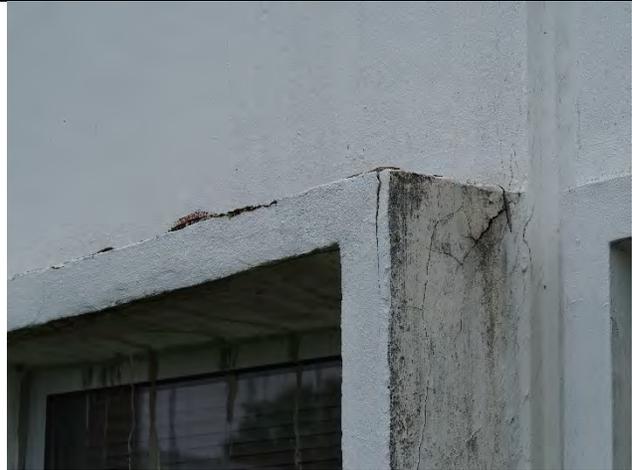
*Figure A118: Moisture Issues at Precast Window System (H)*

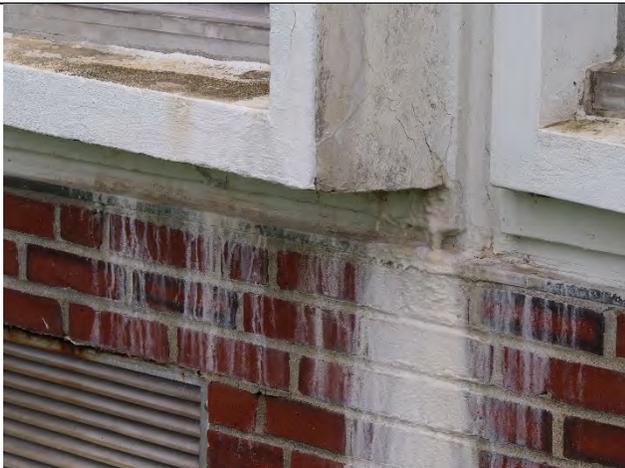
*Figure A119: Moisture Issues at Precast Window System (H)*

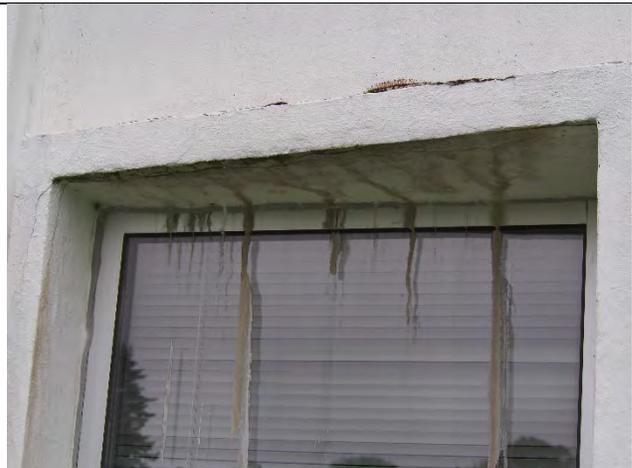
*Figure A120: Moisture Issues at Precast Window System (H)*

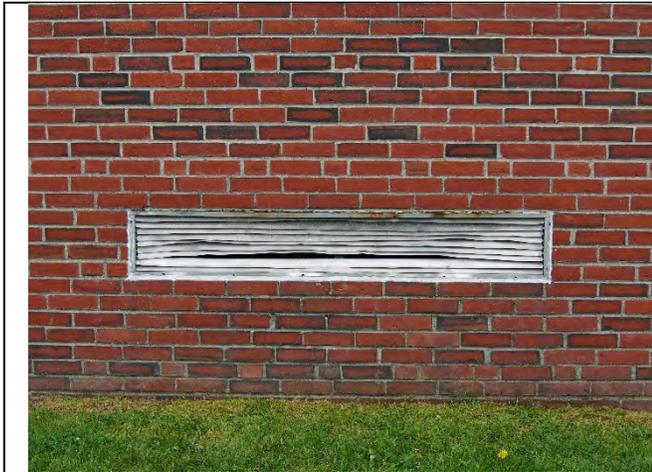
*Figure A121: Abandoned and Damaged Wall Louver (H)*

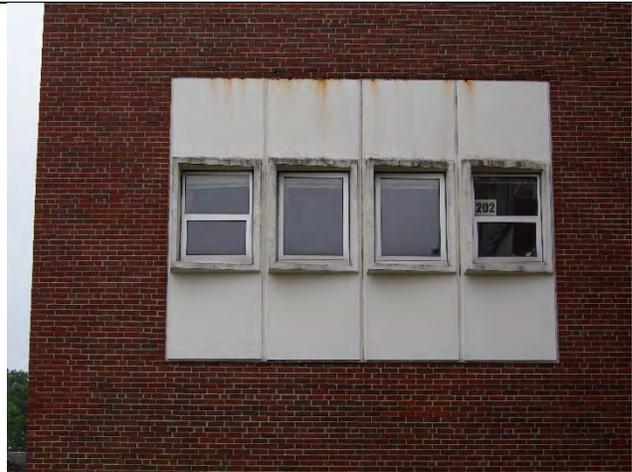
*Figure A122: Rust Stains at Precast Window System (H)*

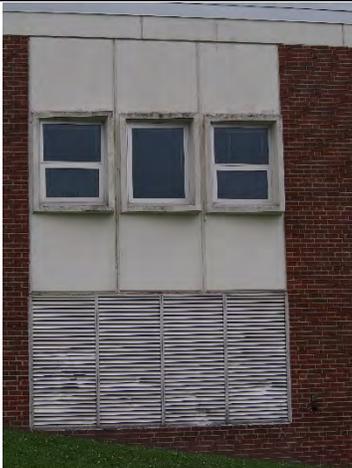
*Figure A123: Precast Window System with Abandoned and Damaged Wall Louver (H)*

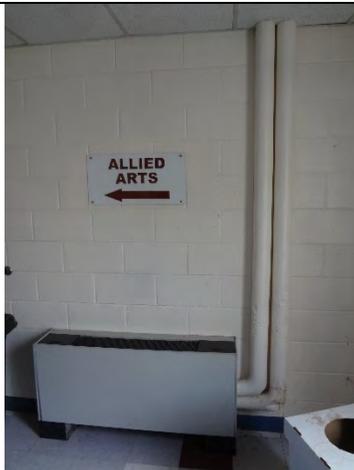
Figure H5: Clean & Repair Cabinet Unit Heaters (M)

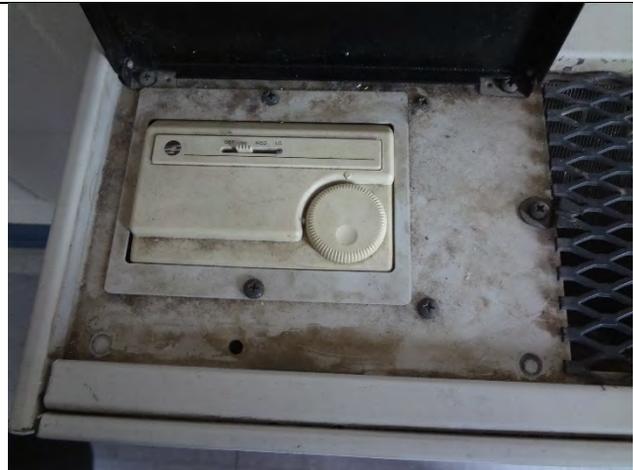
Figure H6: Clean & Repair Cabinet Unit Heaters (M)

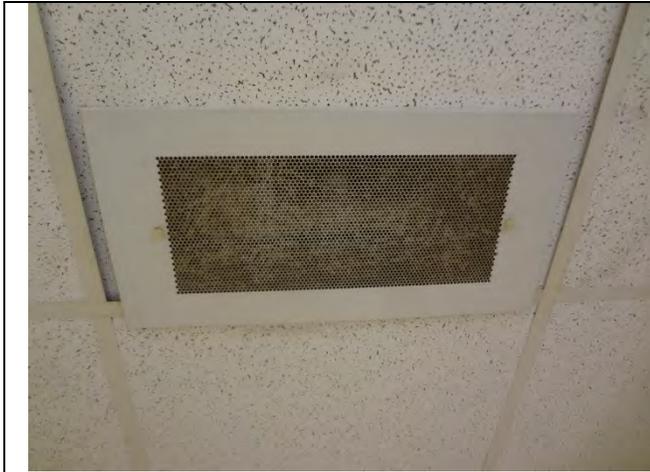
Figure H7: Clean and Support Fan (M)

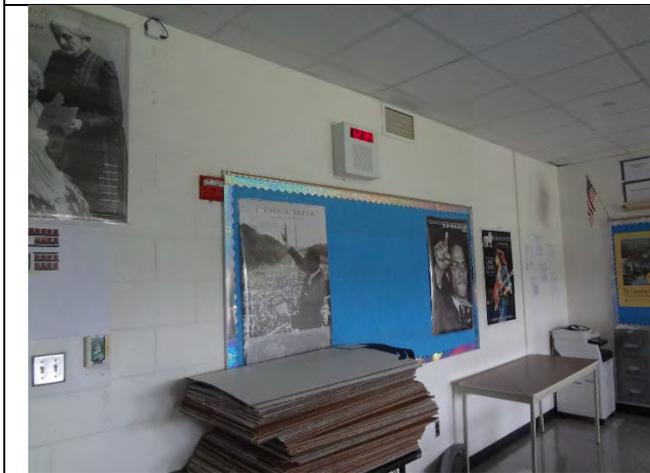
Figure H9: Broken Temperature Sensor (H)

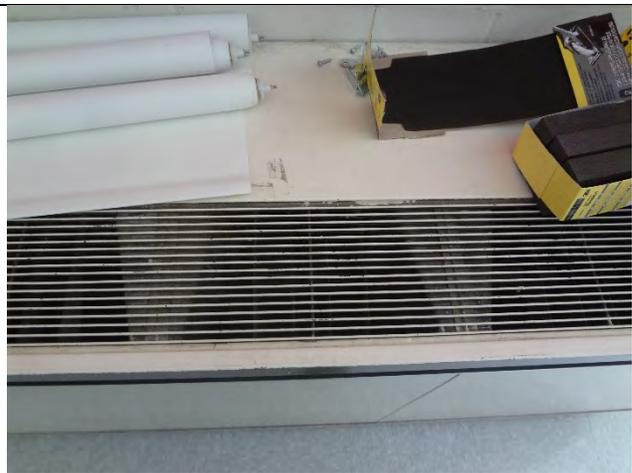
Figure H10: Clean Cabinet Unit Heater Interior (H)

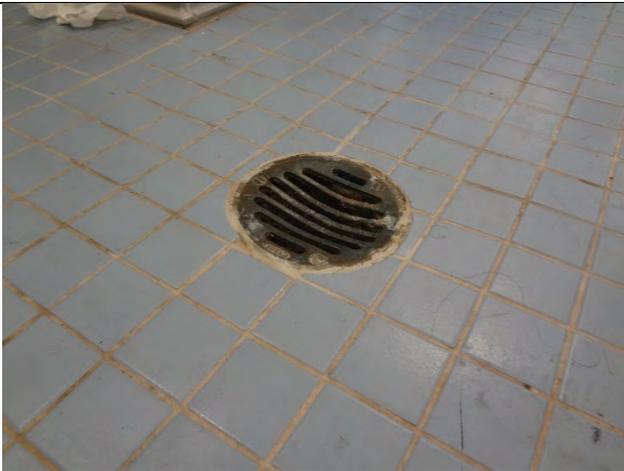
*Figure P3: Damaged Drain Gate (M)*

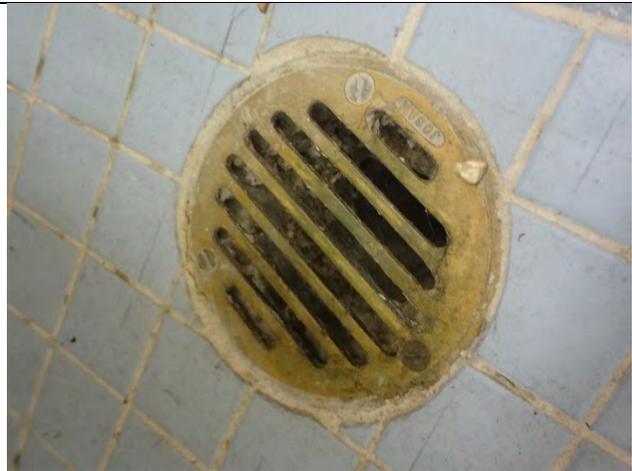
*Figure P4: Plugged Shower Drains (M)*

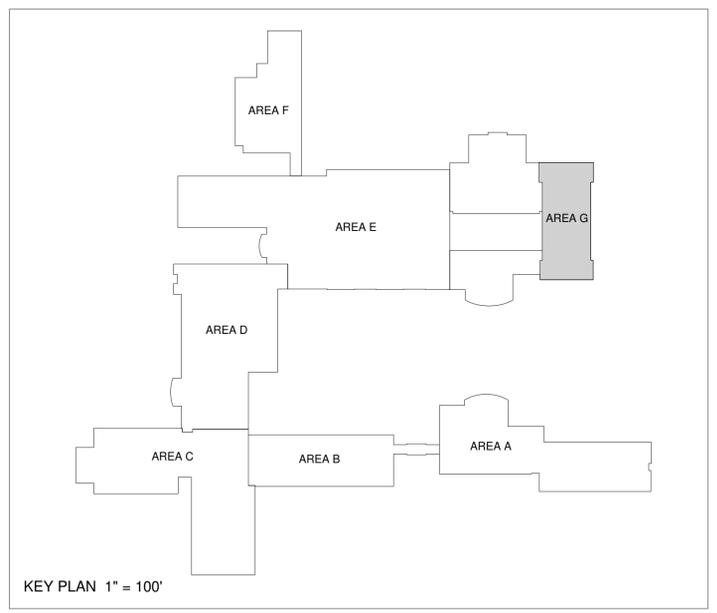
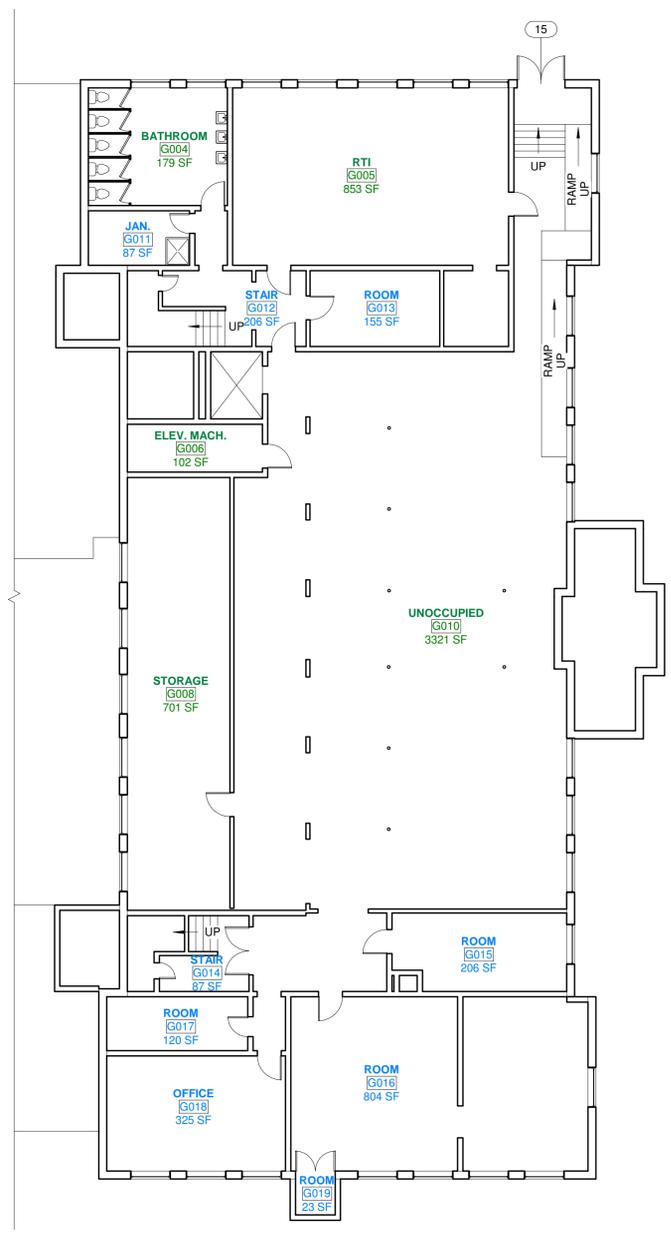
① AREA G BASEMENT  
3/32" = 1'-0"

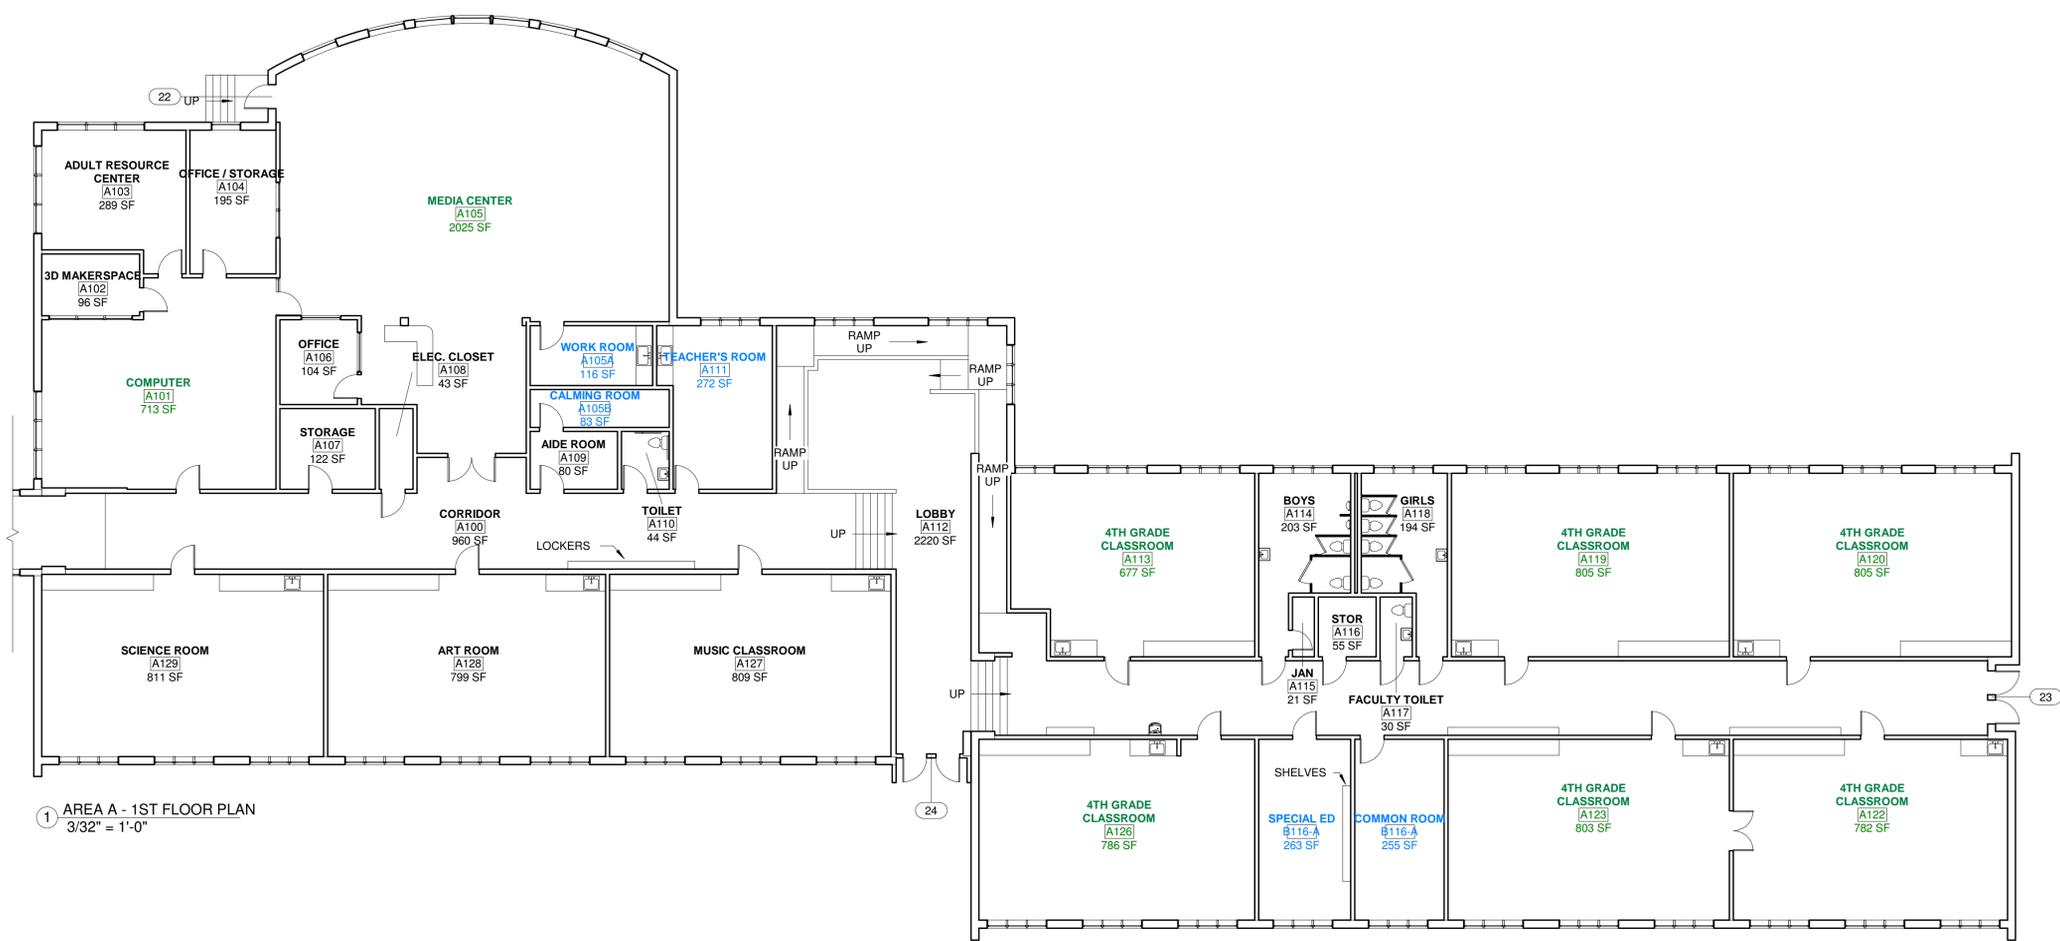
1 AREA A - 1ST FLOOR PLAN  
3/32" = 1'-0"

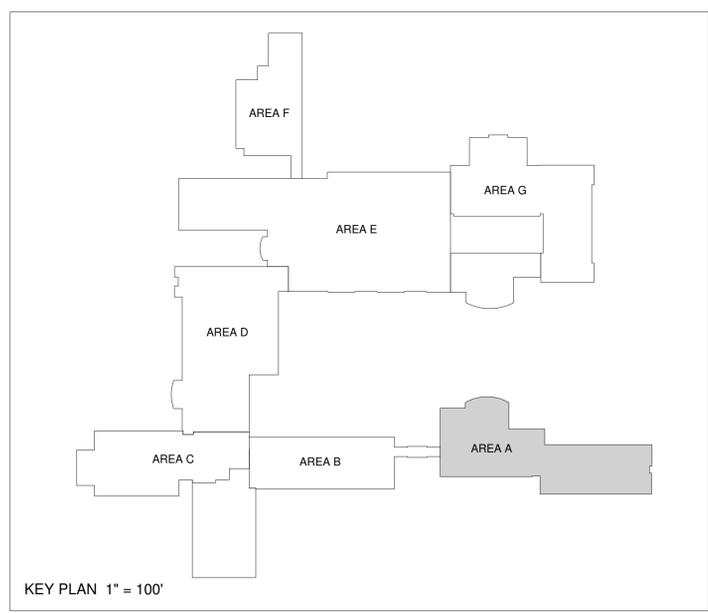
ROOM TAG LEGEND	
ROOM NAME [RM #] AREA SQFT	ROOM TAG PROVIDED BY FACILITIES
ROOM NAME [RM #] AREA SQFT	ROOM TAG BY EXISTING CONDITIONS
ROOM NAME [RM #] AREA SQFT	ROOM TAG ASSIGNED BY SSA

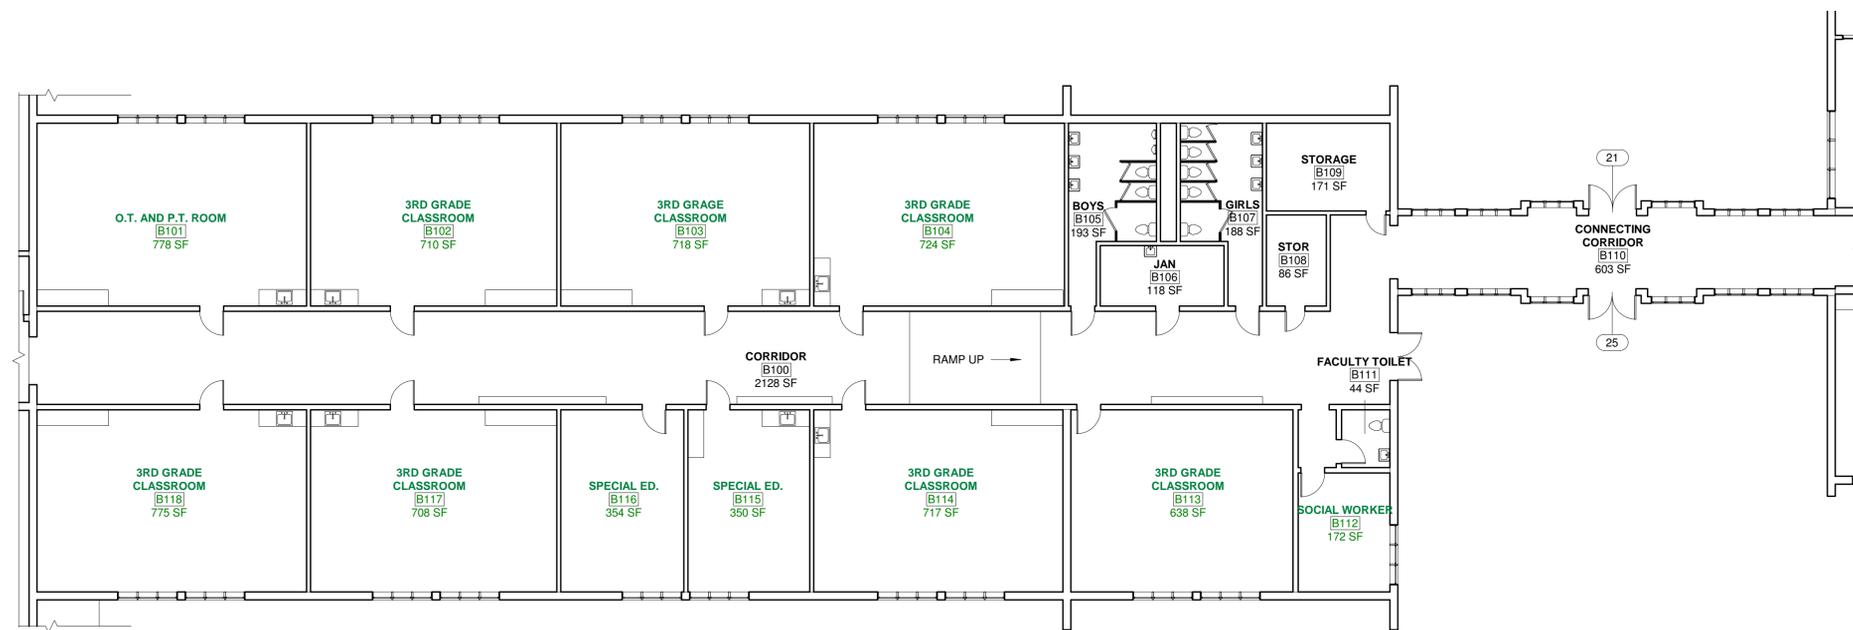
1 AREA B - 2ND FLOOR PLAN  
3/32" = 1'-0"

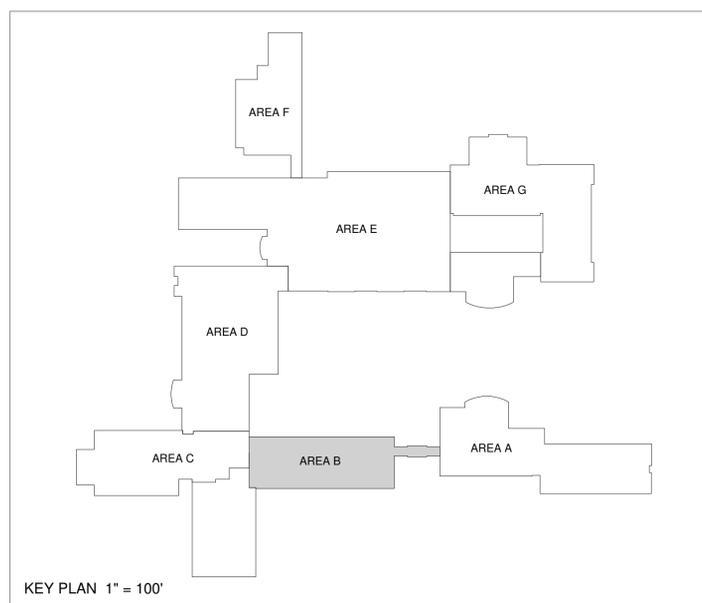
PROJECT NAME:  
**CAPE ELIZABETH  
ELEMENTARY  
AND MIDDLE**

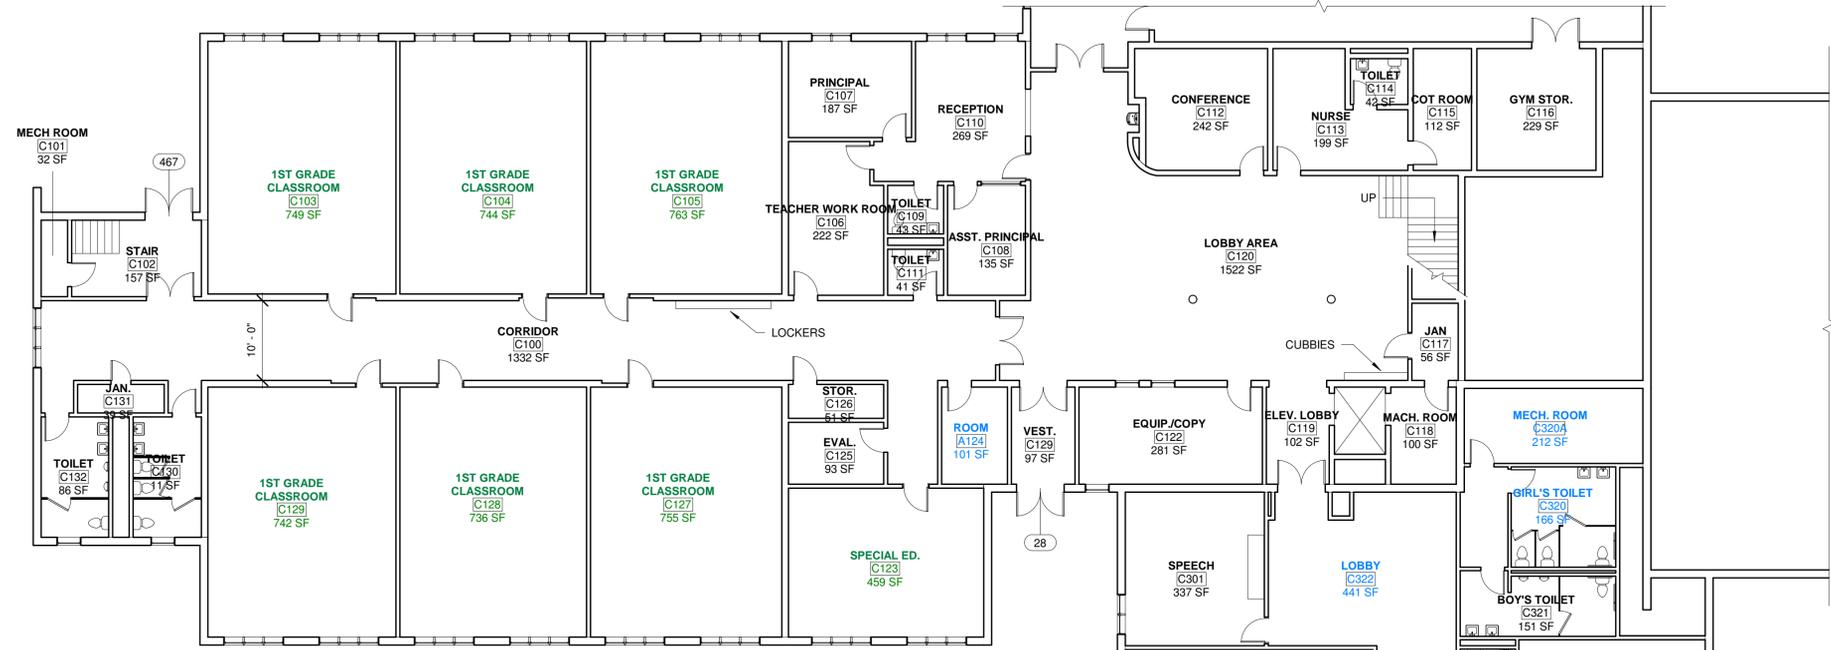
1 AREA C - 1ST FLOOR  
3/32" = 1'-0"

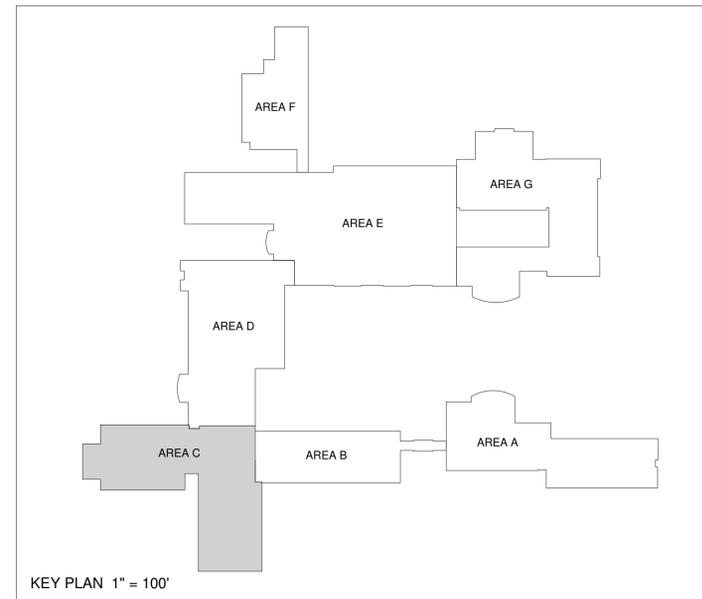
ROOM TAG LEGEND	
ROOM NAME [RM #] AREA SQFT	ROOM TAG PROVIDED BY FACILITIES
ROOM NAME [RM #] AREA SQFT	ROOM TAG BY EXISTING CONDITIONS
ROOM NAME [RM #] AREA SQFT	ROOM TAG ASSIGNED BY SSA

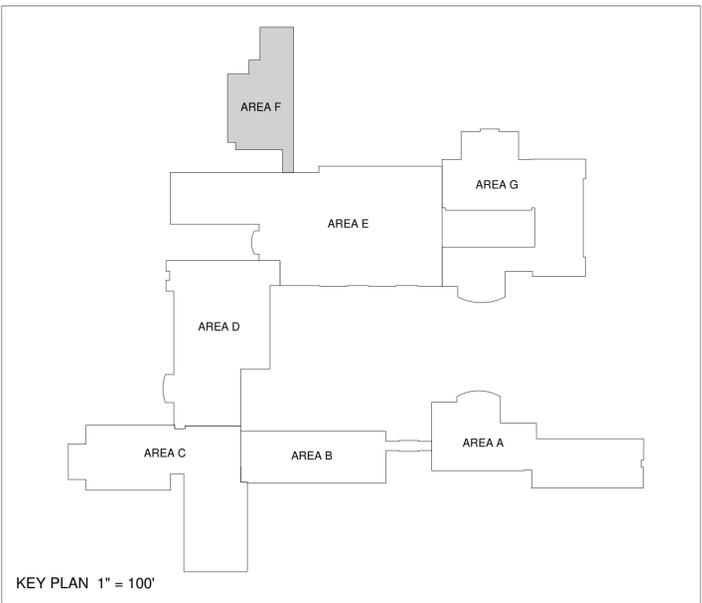
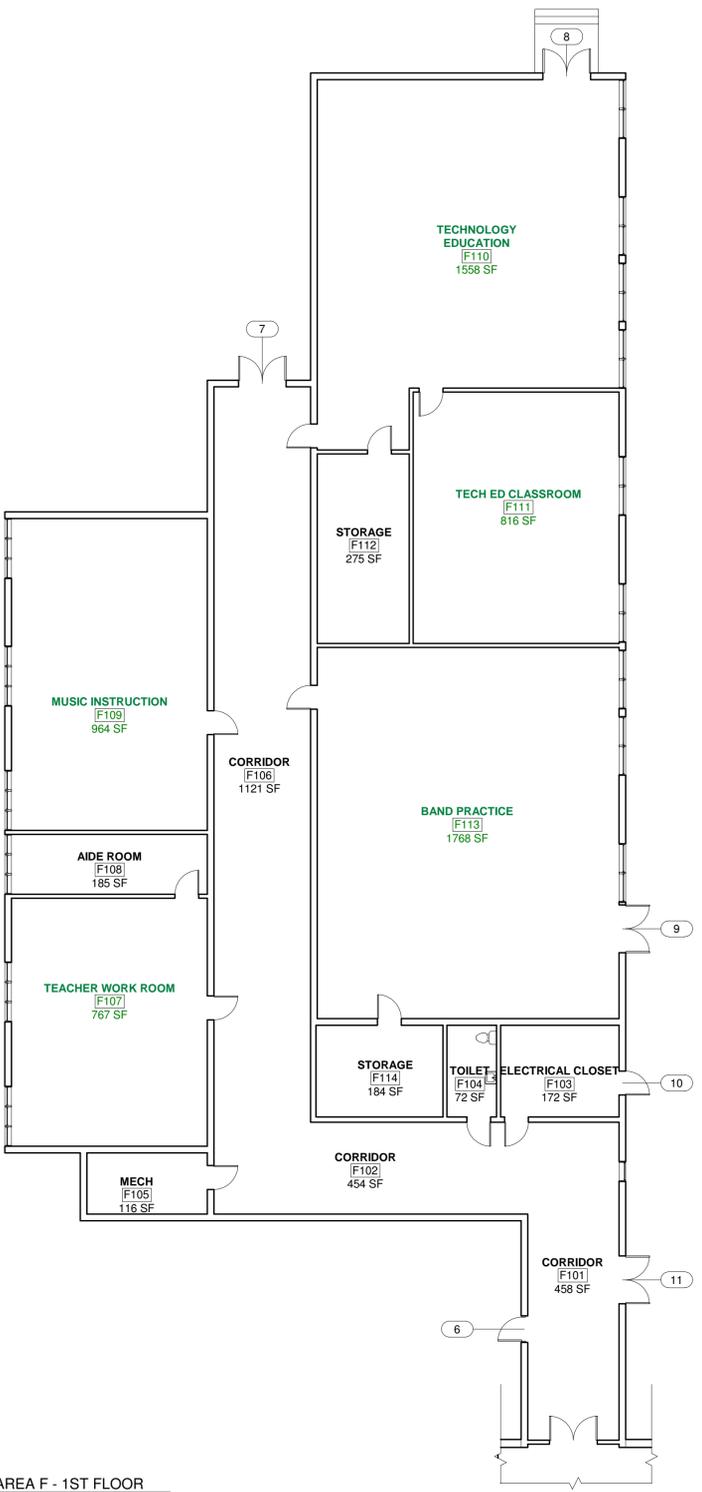
① AREA F - 1ST FLOOR  
 3/32" = 1'-0"

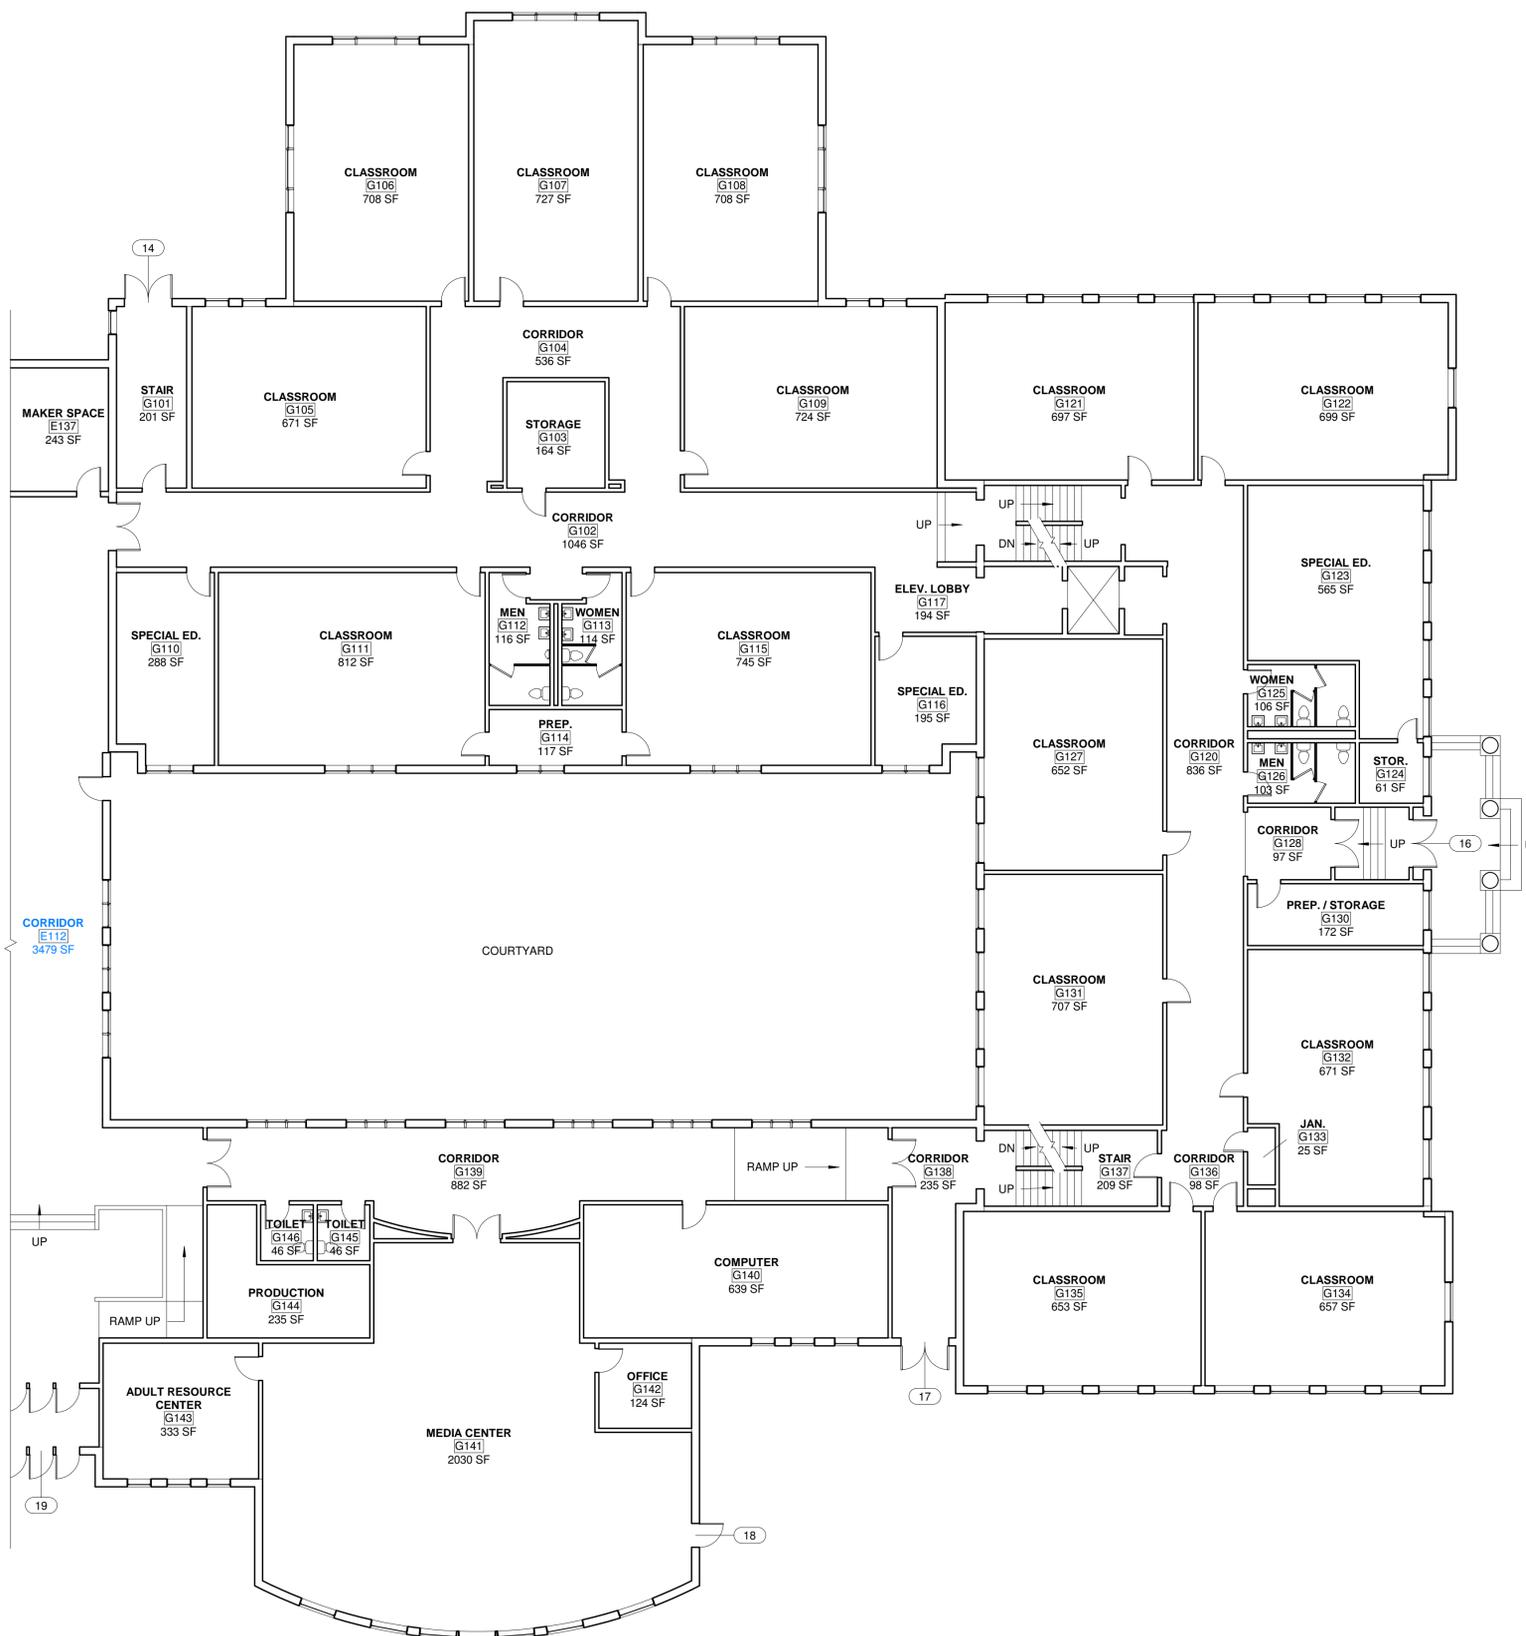
ROOM TAG LEGEND	
ROOM NAME [RM #] AREA SQFT	ROOM TAG PROVIDED BY FACILITIES
ROOM NAME [RM #] AREA SQFT	ROOM TAG BY EXISTING CONDITIONS
ROOM NAME [RM #] AREA SQFT	ROOM TAG ASSIGNED BY SSA

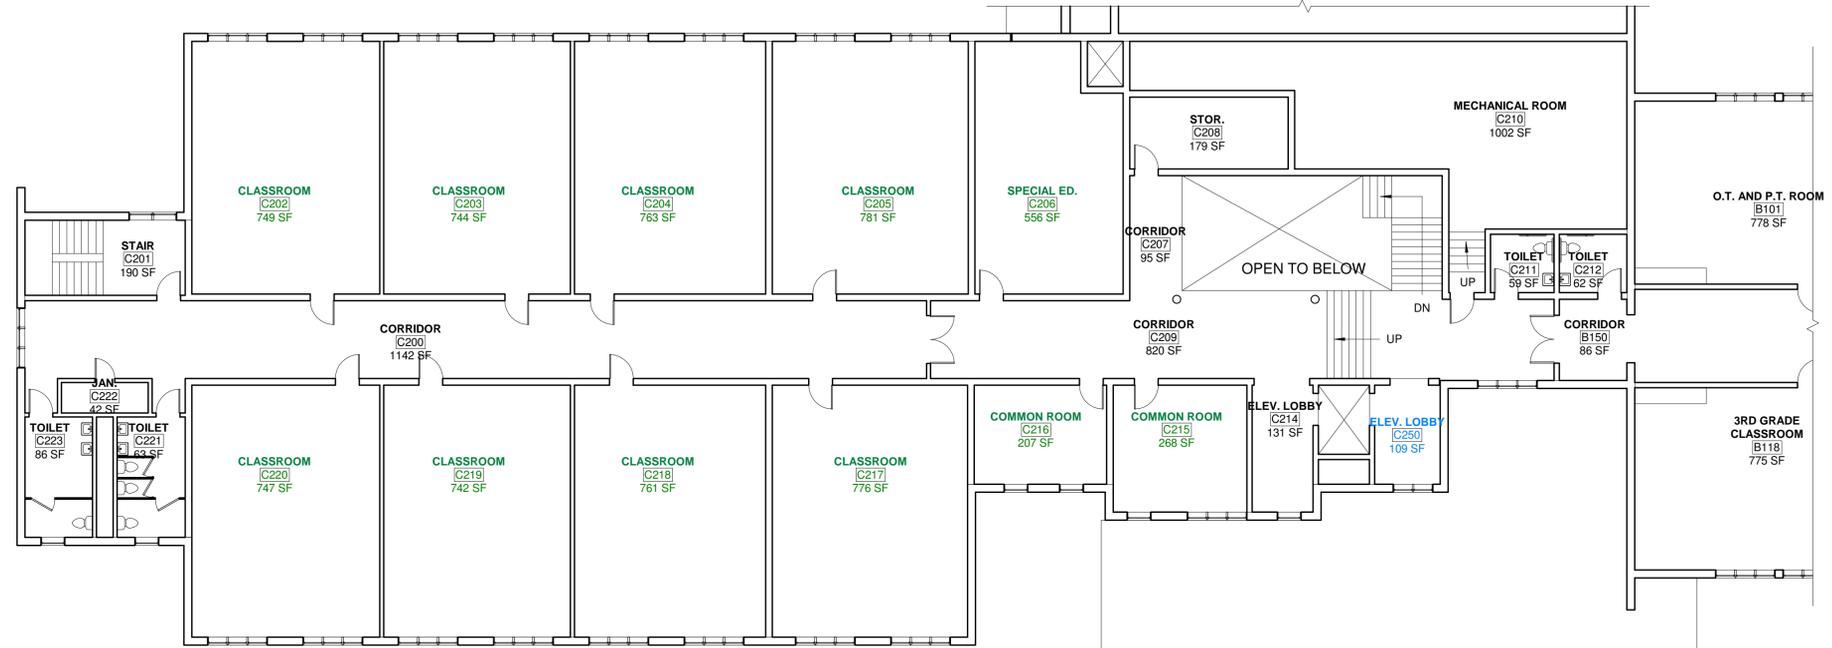
1 AREA C - 2ND FLOOR PLAN  
3/32" = 1'-0"

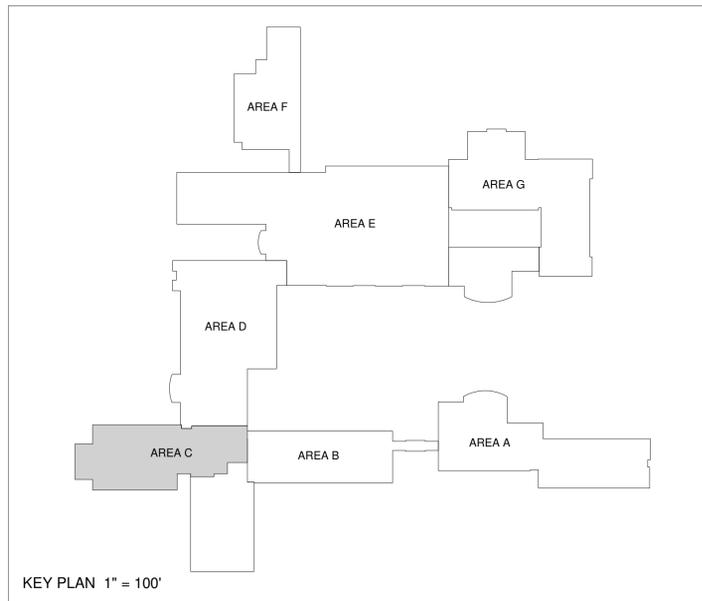
PROJECT NAME:  
**CAPE ELIZABETH  
ELEMENTARY  
AND MIDDLE**
