Prepared for:

Cape Elizabeth Schools

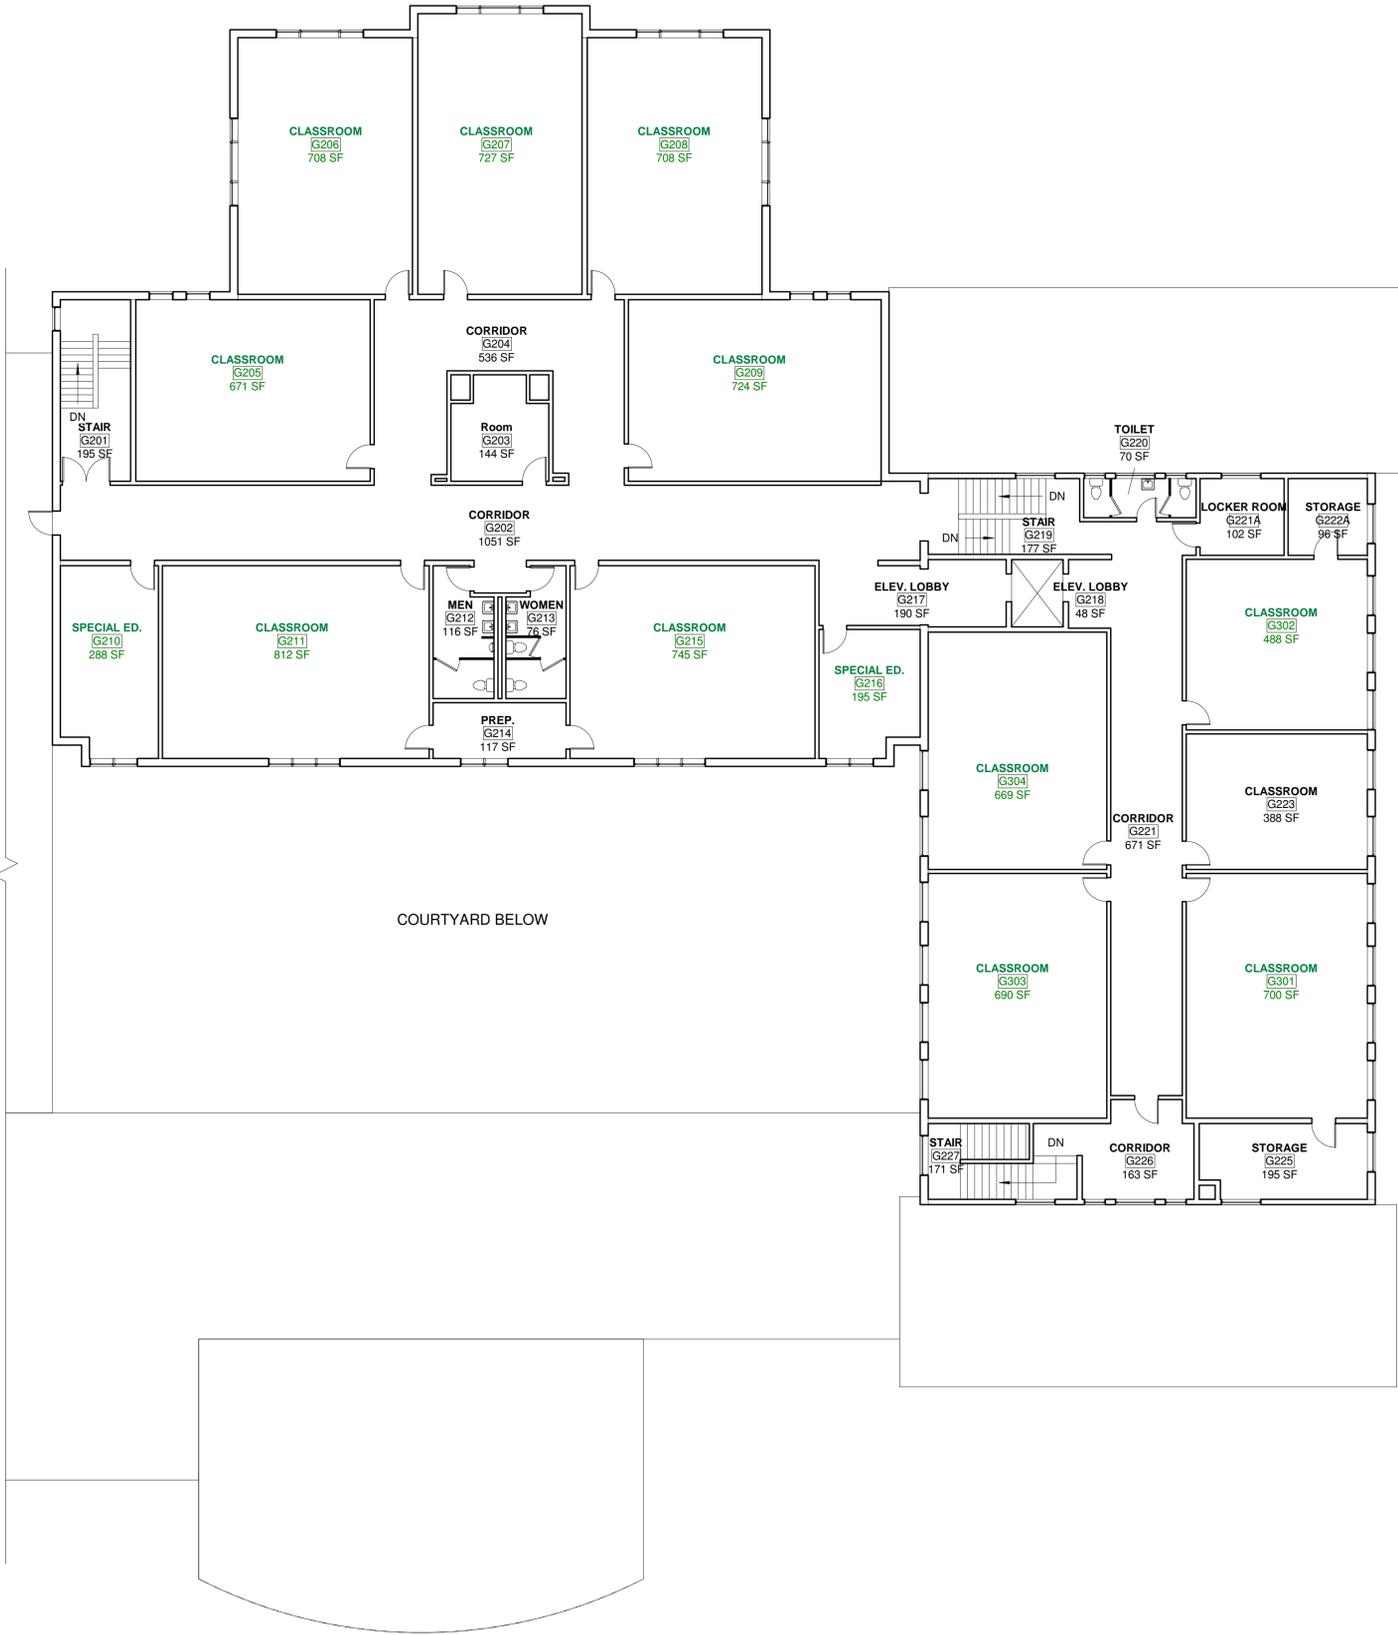
① AREA G - 2ND FLOOR PLAN  
 3/32" = 1'-0"

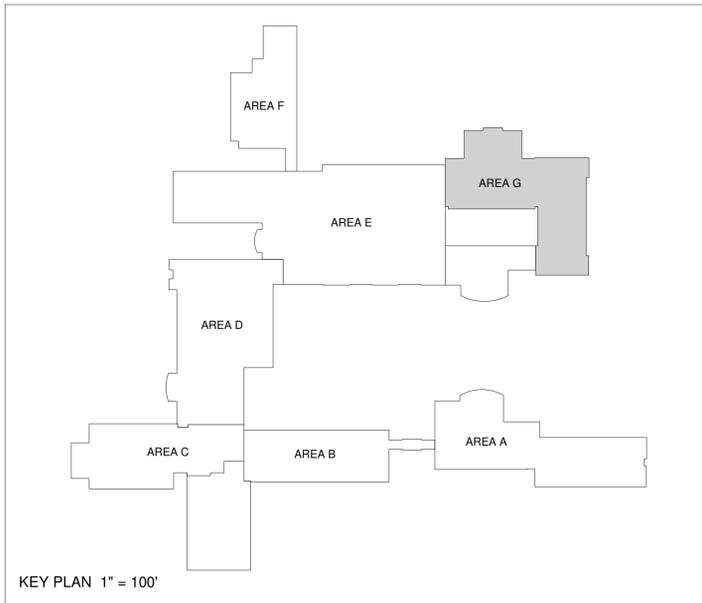
ROOM TAG LEGEND	
ROOM NAME [RM #] AREA SQFT	ROOM TAG PROVIDED BY FACILITIES
ROOM NAME [RM #] AREA SQFT	ROOM TAG BY EXISTING CONDITIONS
ROOM NAME [RM #] AREA SQFT	ROOM TAG ASSIGNED BY SSA

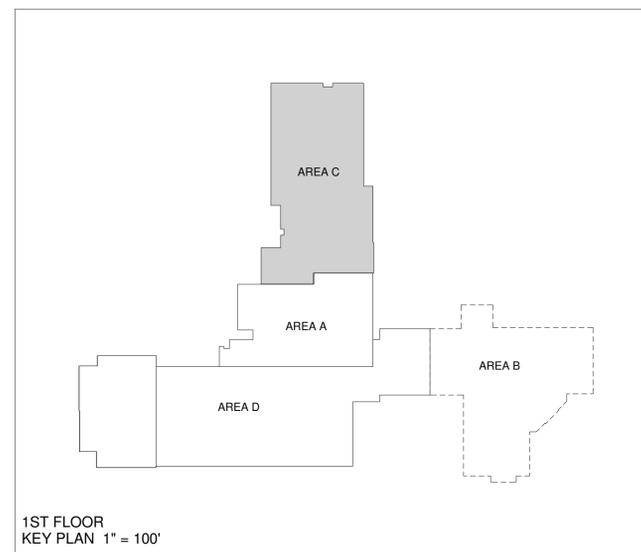
1 1ST FLOOR - C PLAN  
3/32" = 1'-0"

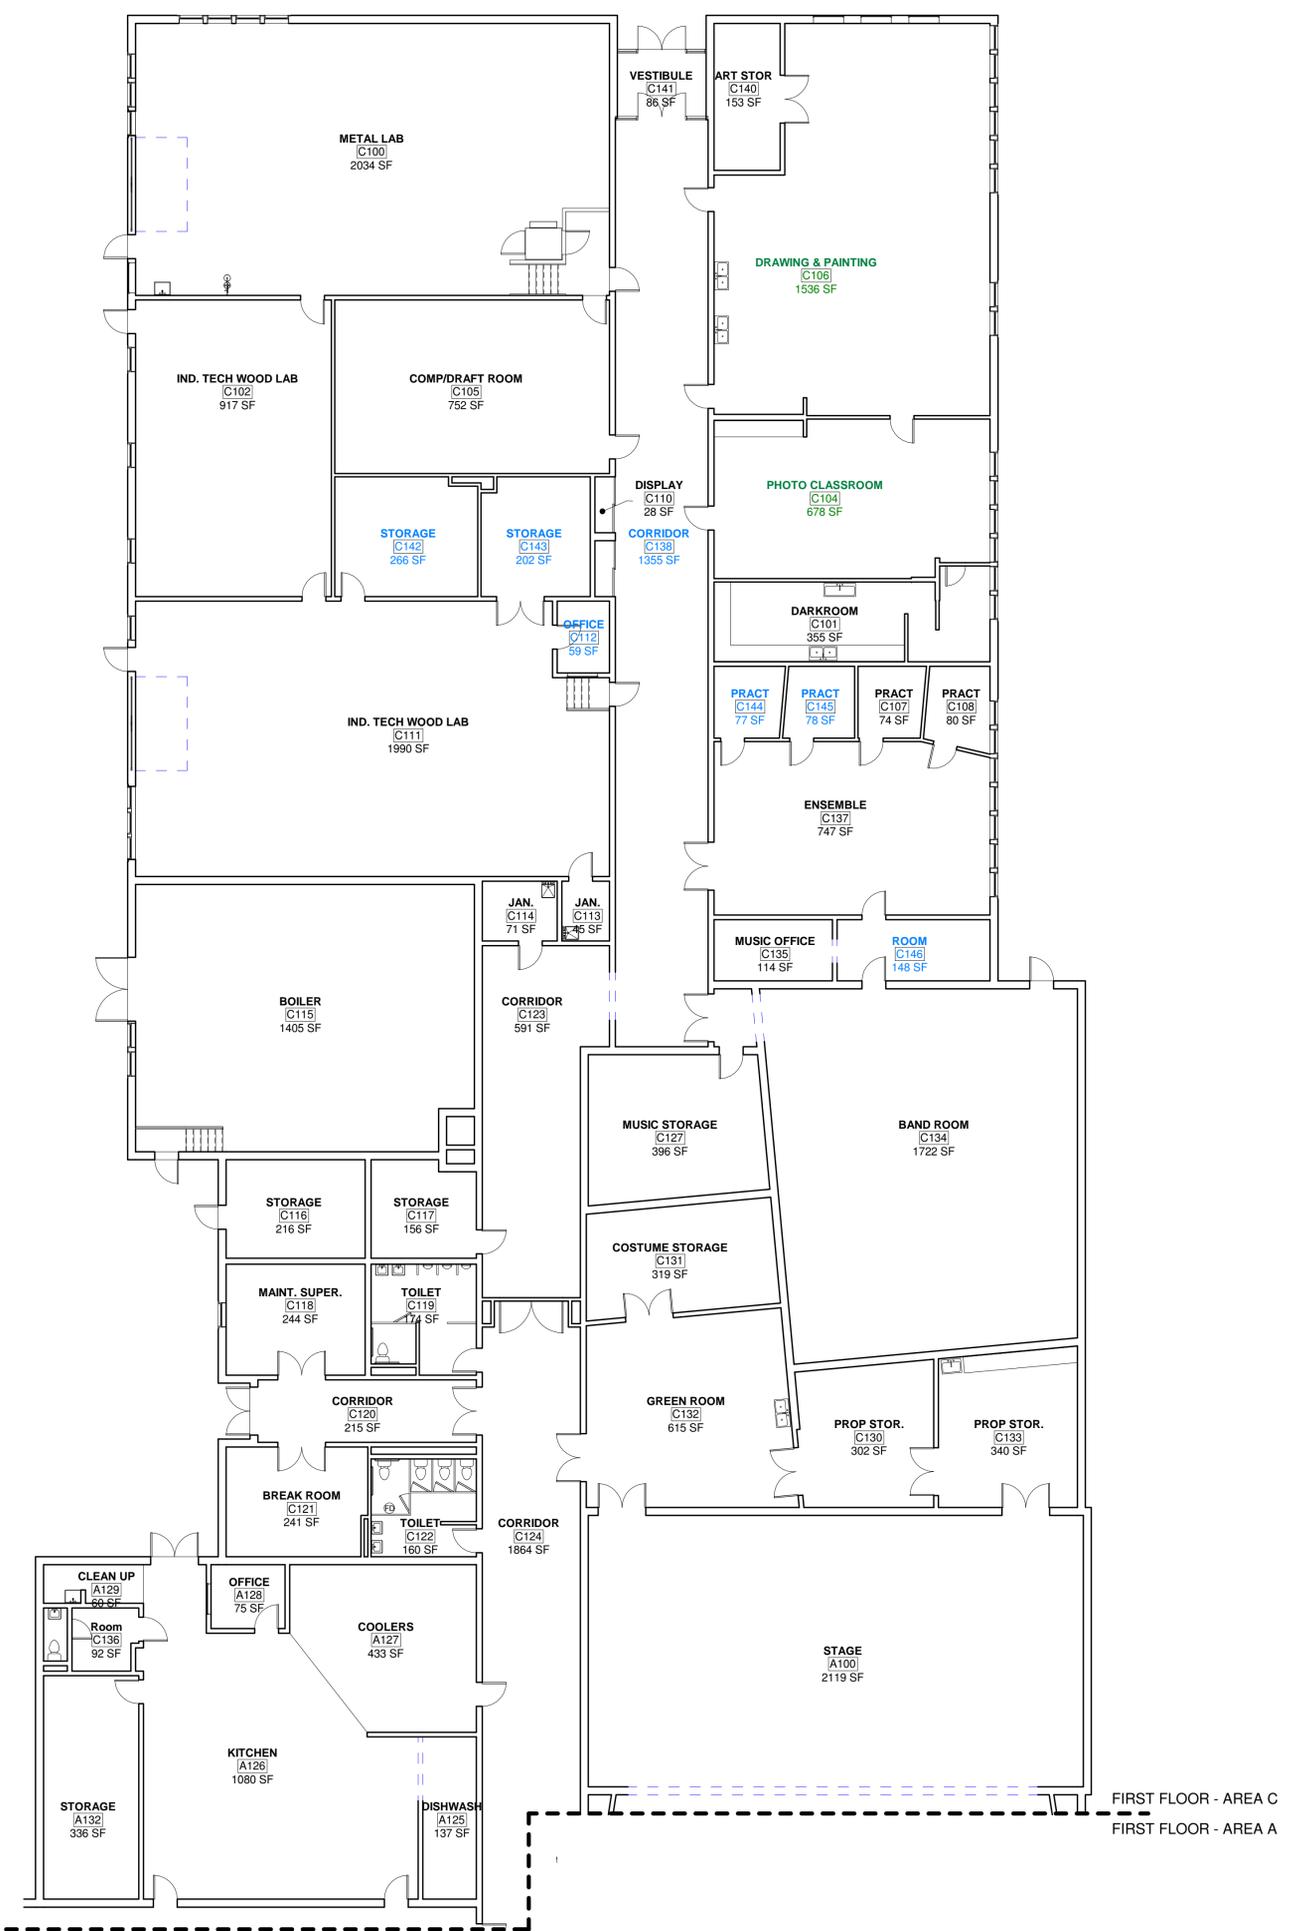
ROOM TAG LEGEND	
ROOM NAME RM # AREA SQFT	ROOM TAG PROVIDED BY FACILITIES
ROOM NAME RM # AREA SQFT	ROOM TAG BY EXISTING CONDITIONS
ROOM NAME RM # AREA SQFT	ROOM TAG ASSIGNED BY SSA

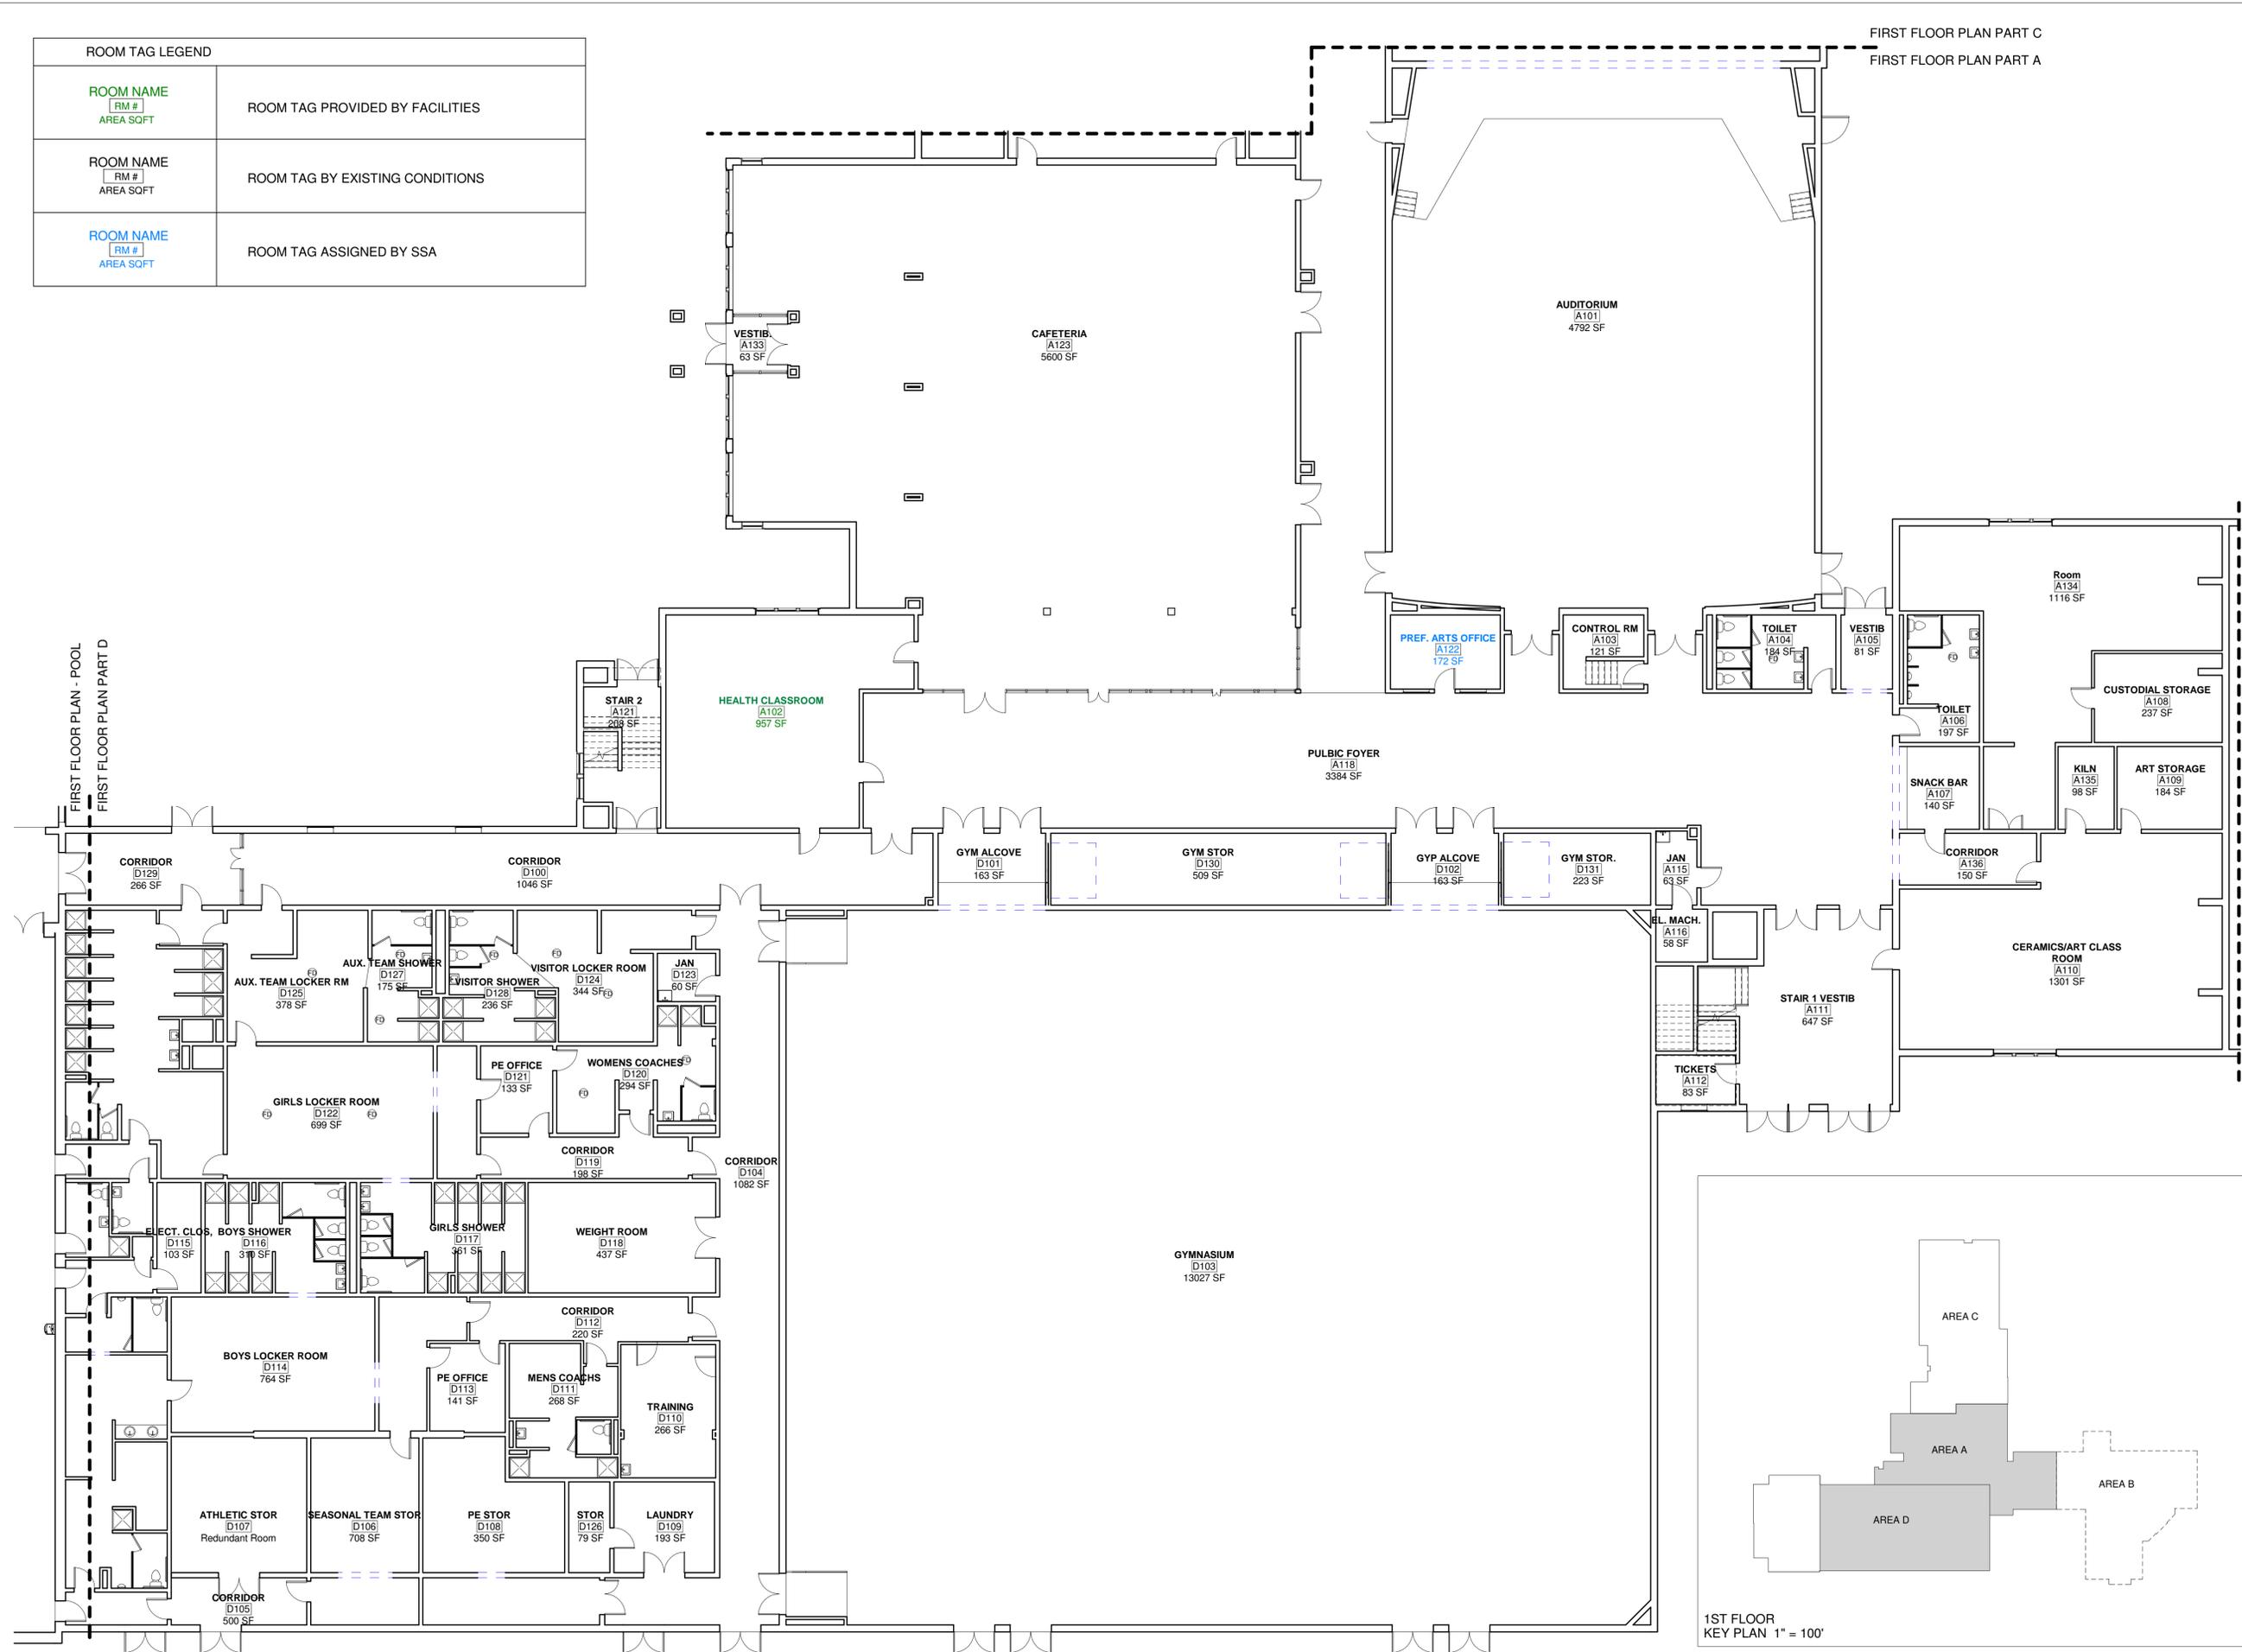
FIRST FLOOR PLAN PART C  
FIRST FLOOR PLAN PART A

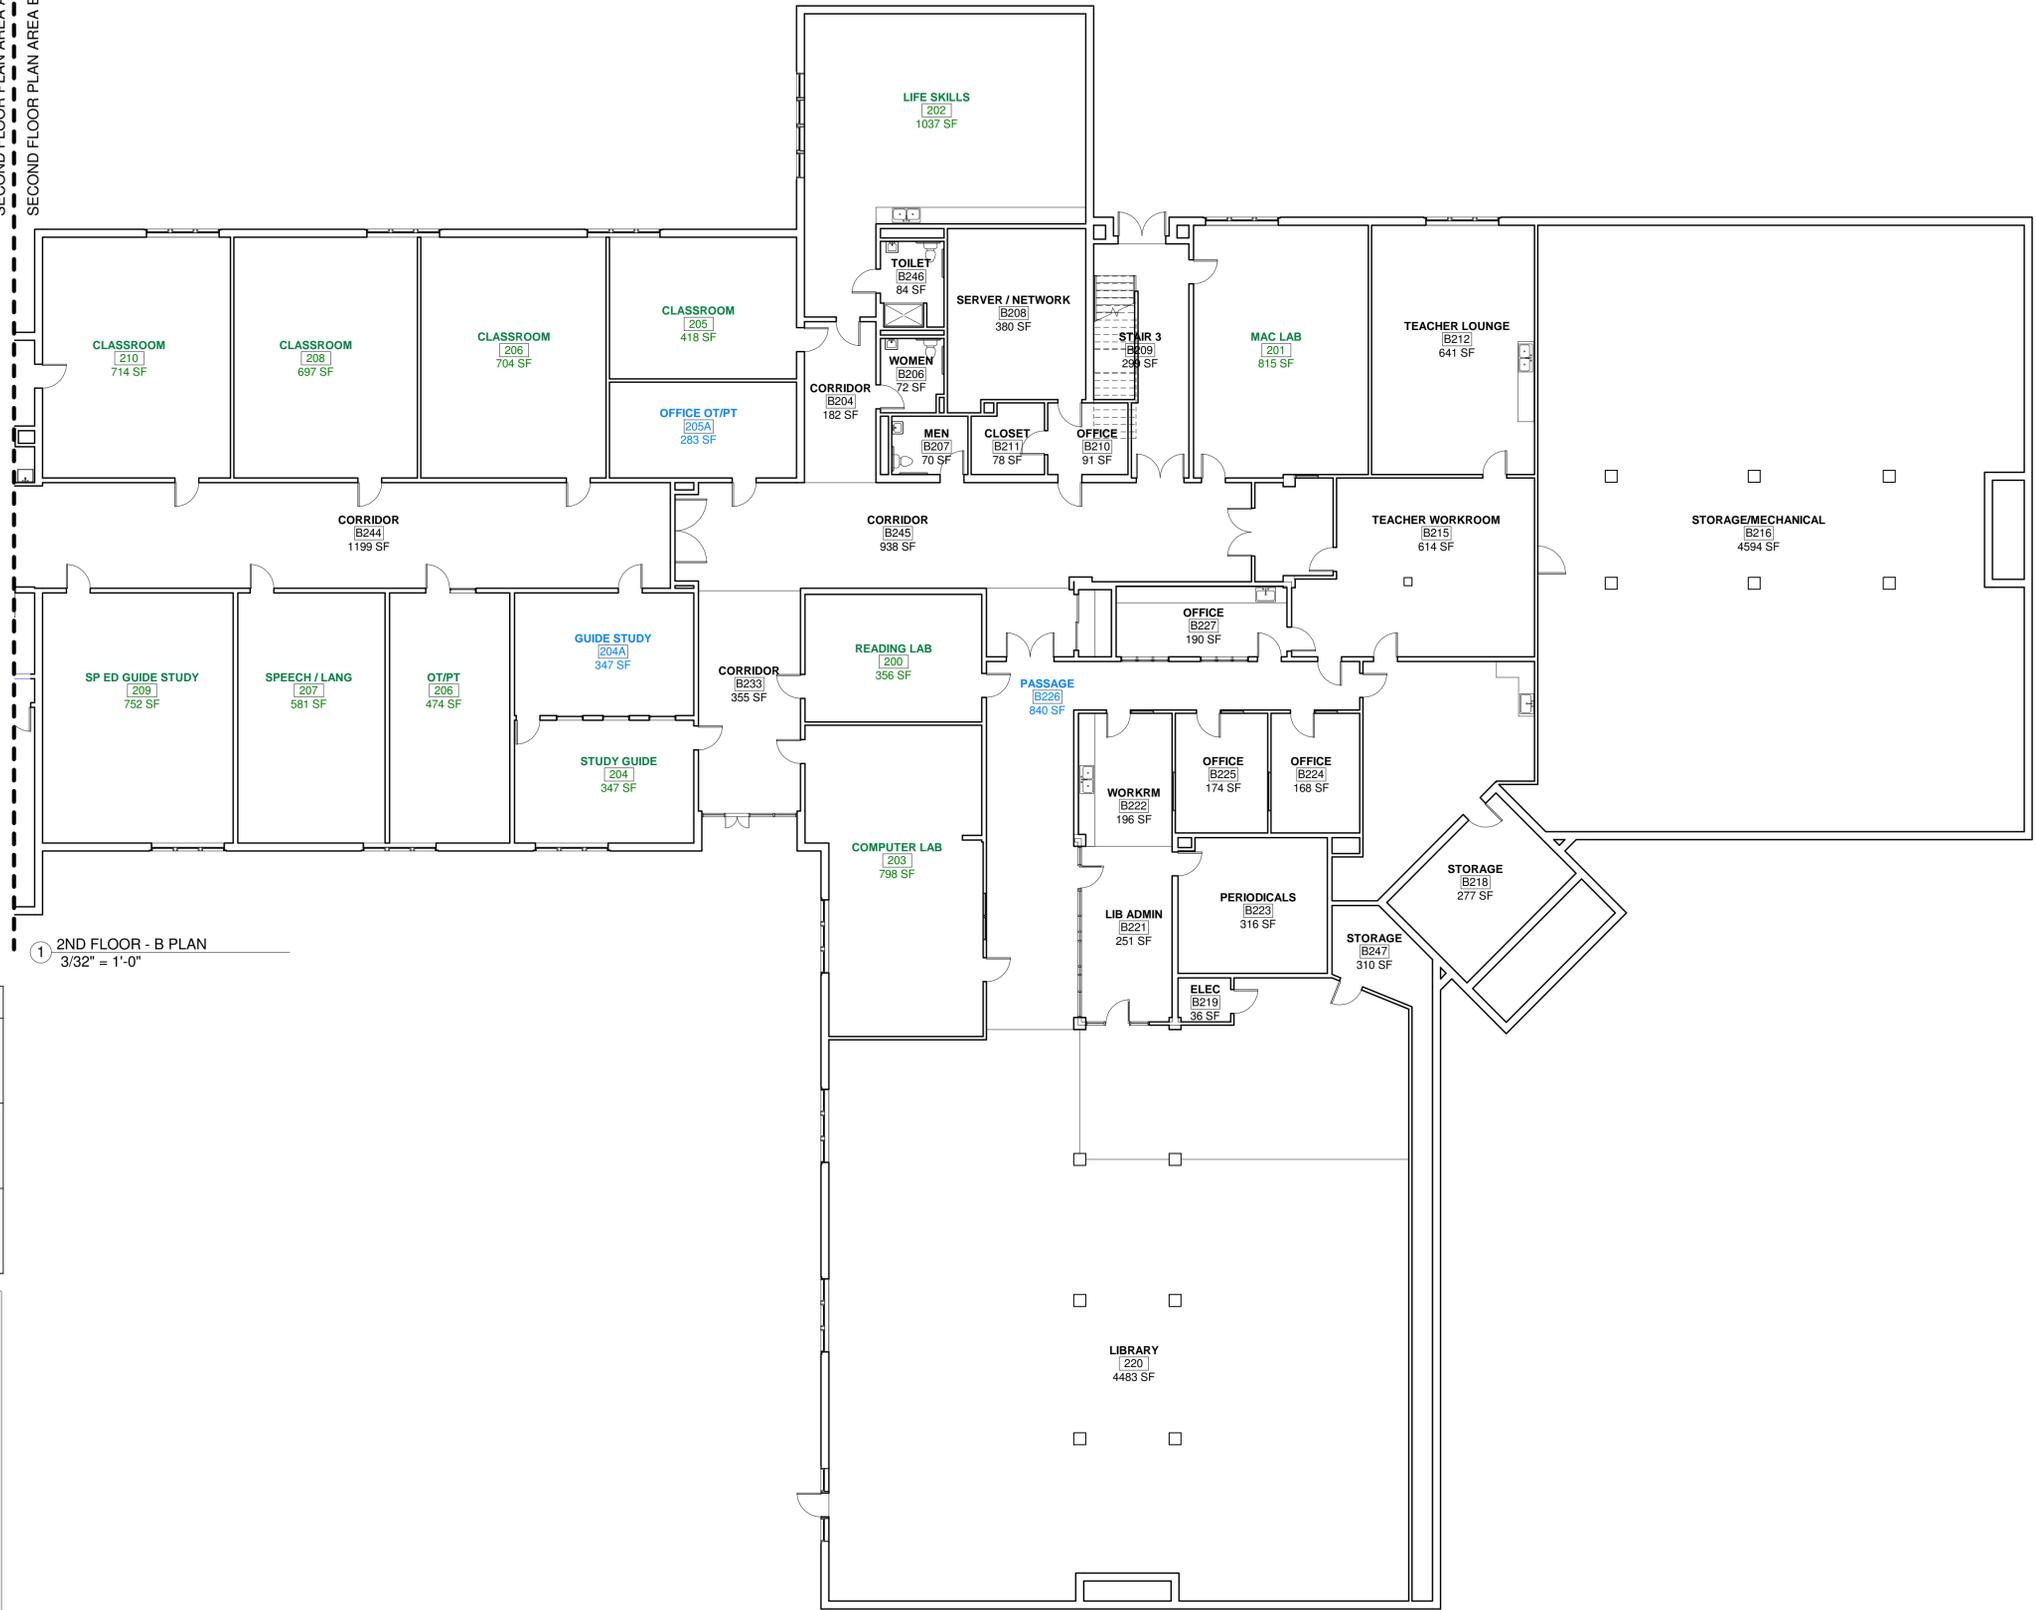
1 2ND FLOOR - B PLAN  
3/32" = 1'-0"

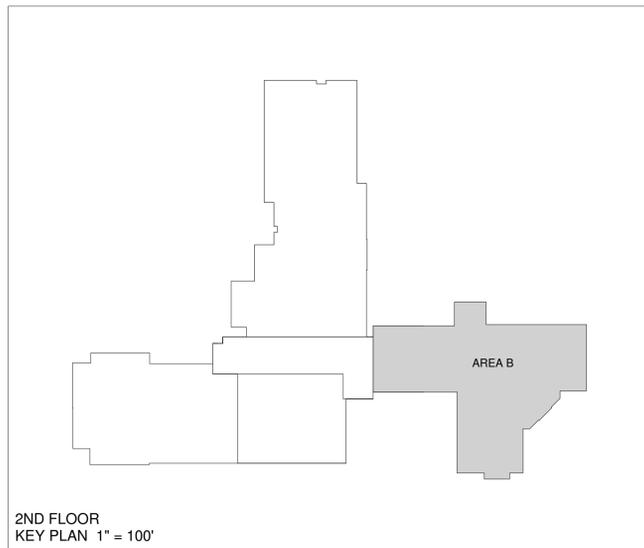
PROJECT NAME:  
**CAPE ELIZABETH  
ELEMENTARY  
AND MIDDLE**

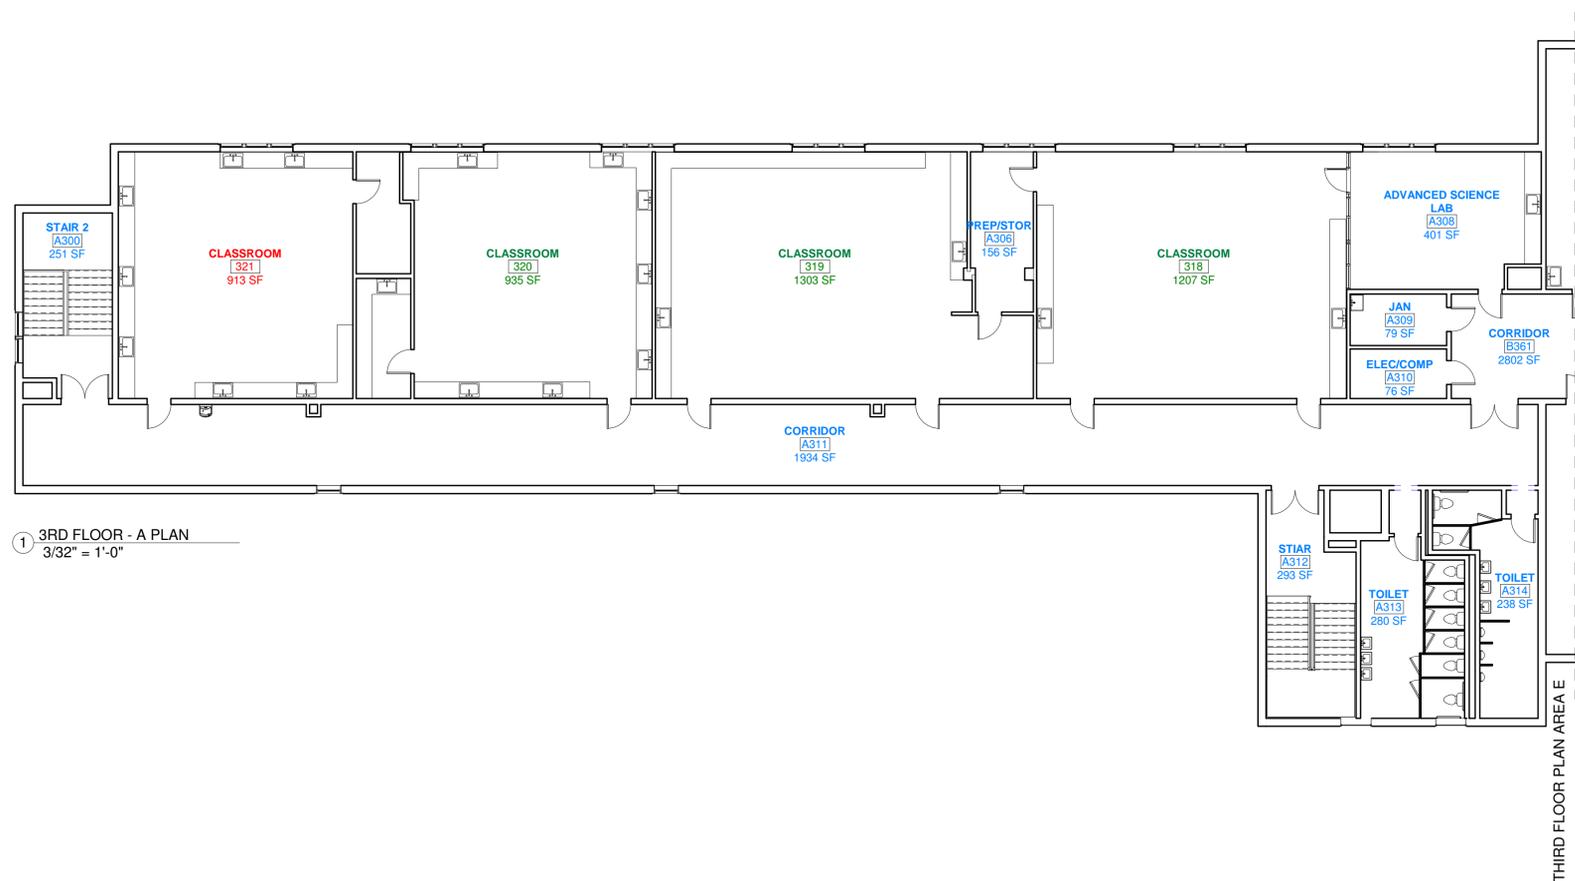
1 3RD FLOOR - A PLAN  
3/32" = 1'-0"

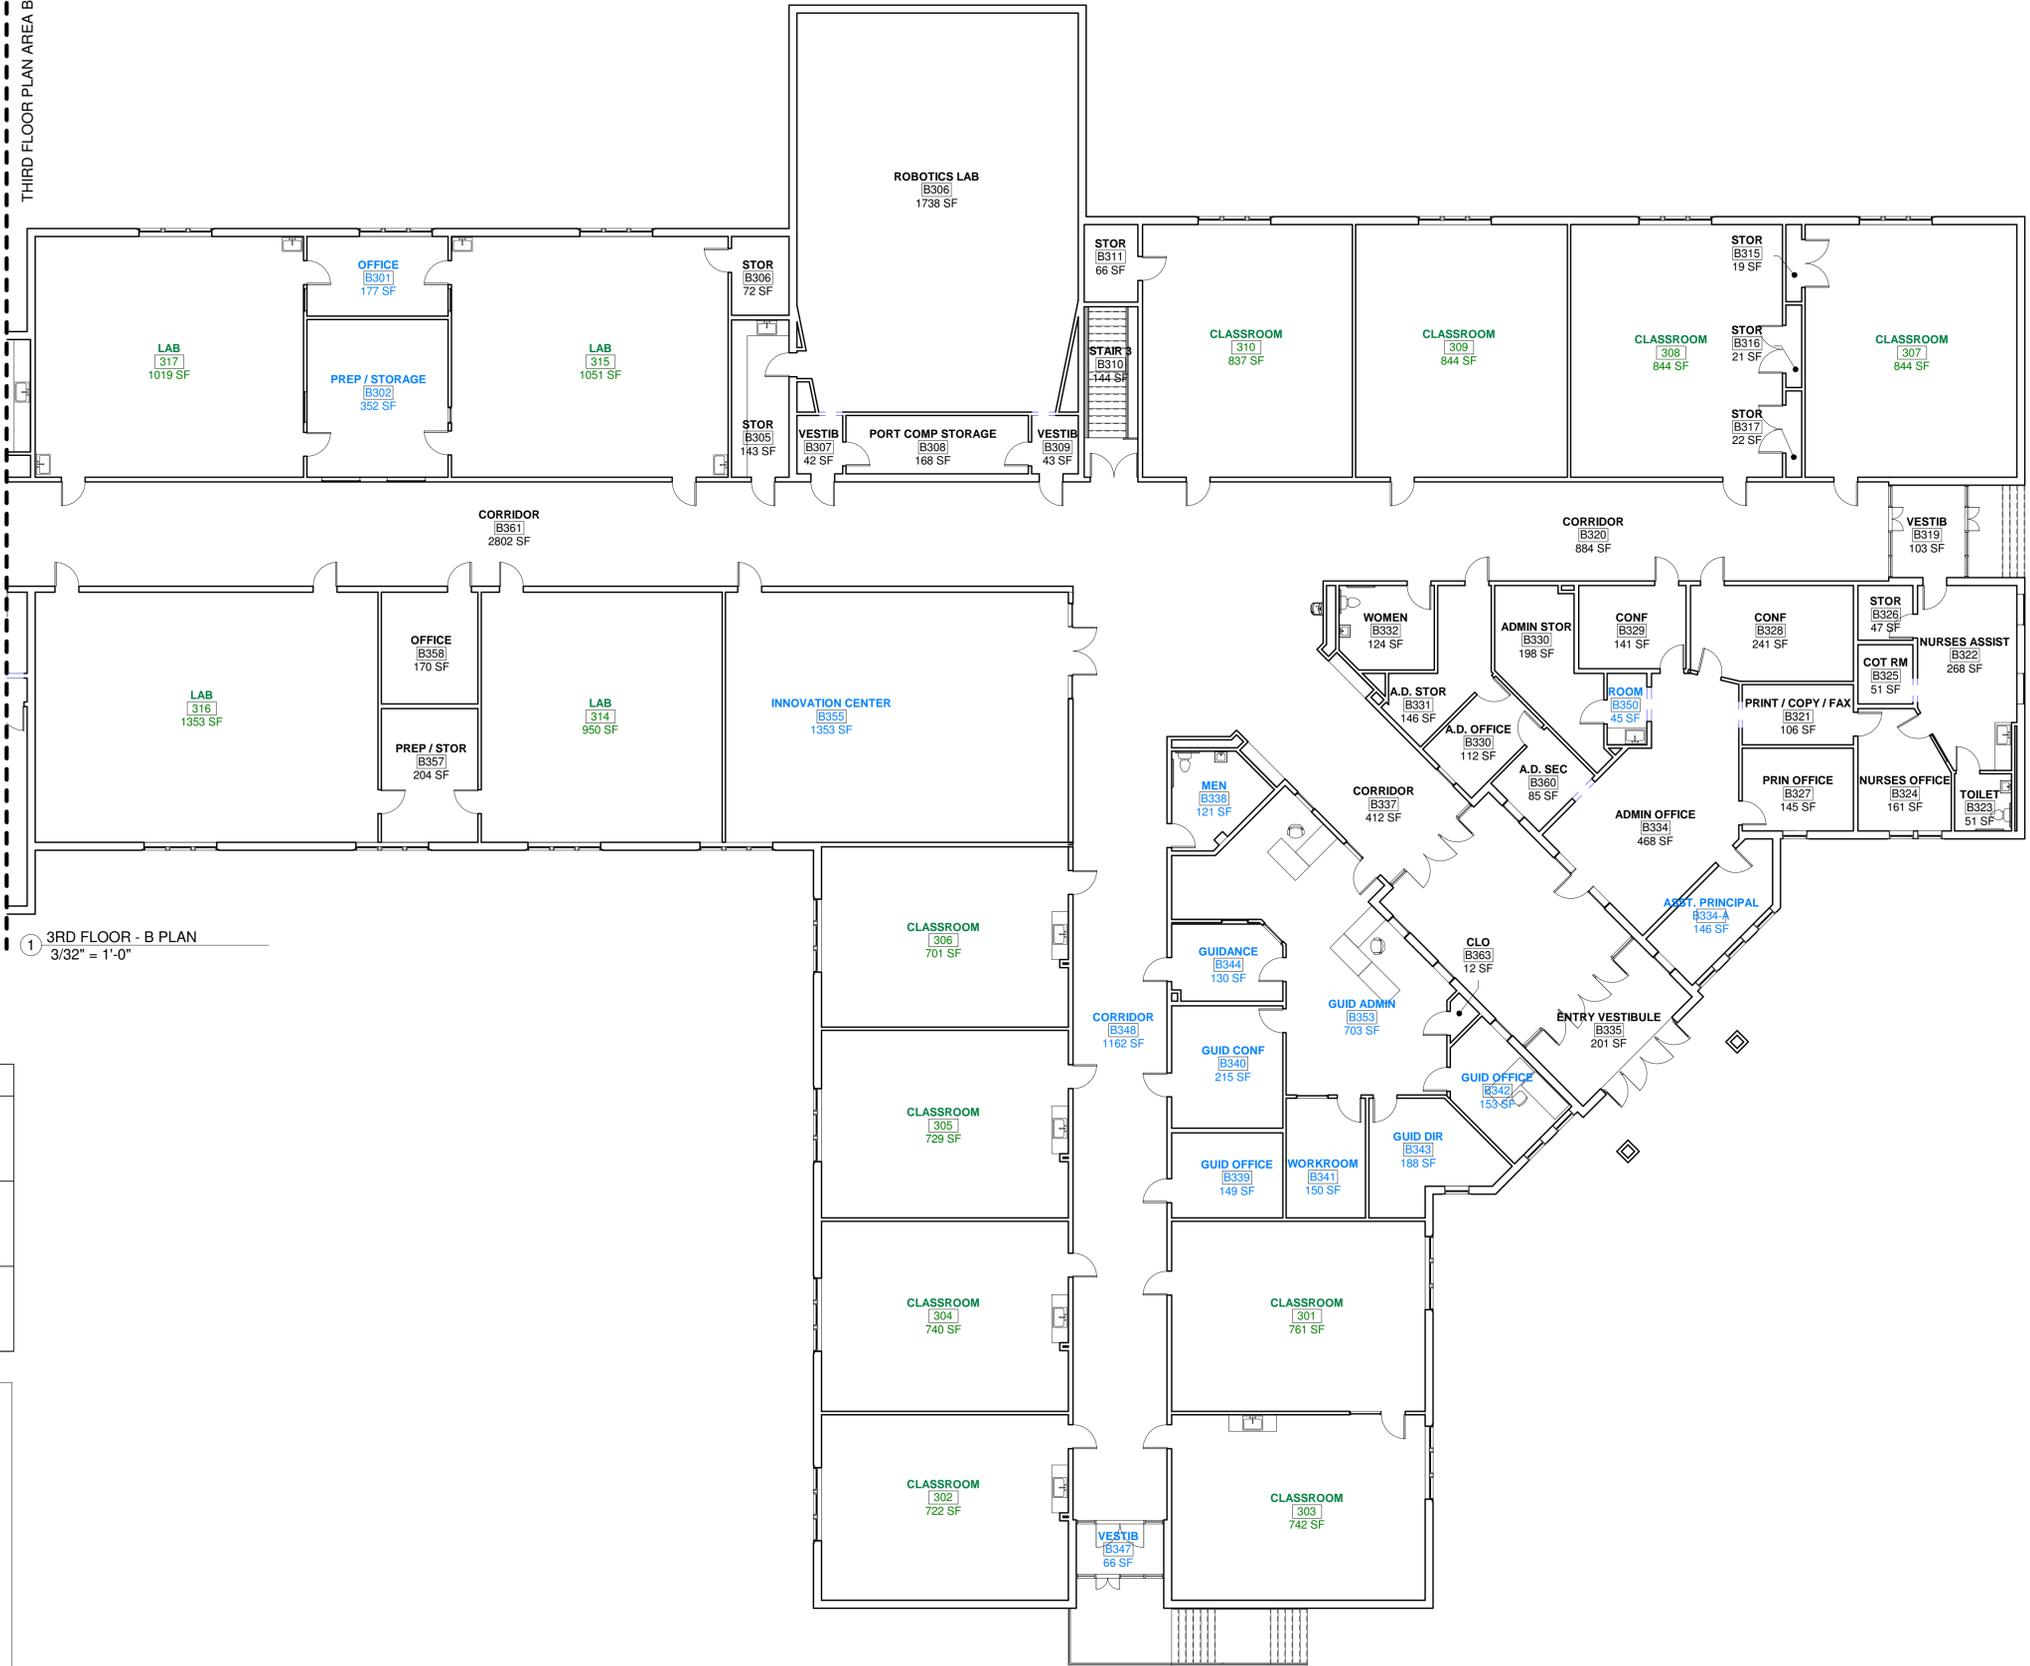
① 3RD FLOOR - B PLAN  
3/32" = 1'-0"

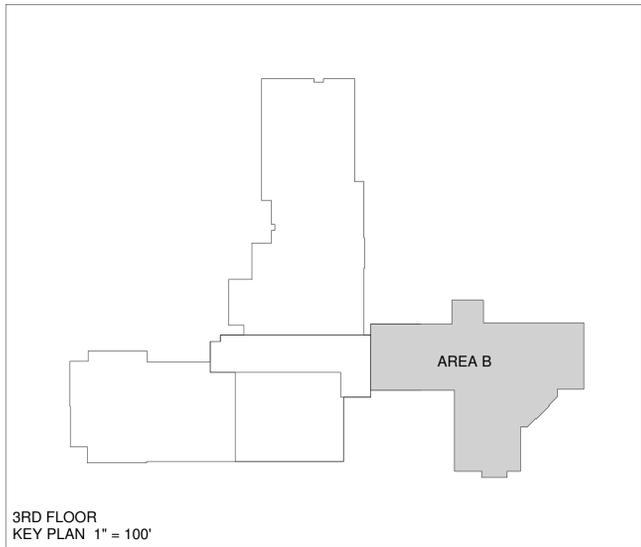
3RD FLOOR  
KEY PLAN 1" = 100'
