Limited Asbestos Report

Faras Elementary School
401 West Fir Avenue
Pirtleville, Arizona 85626

Douglas Unified School District
1132 East 12th Street
Douglas, Arizona 85607

October 31, 2017

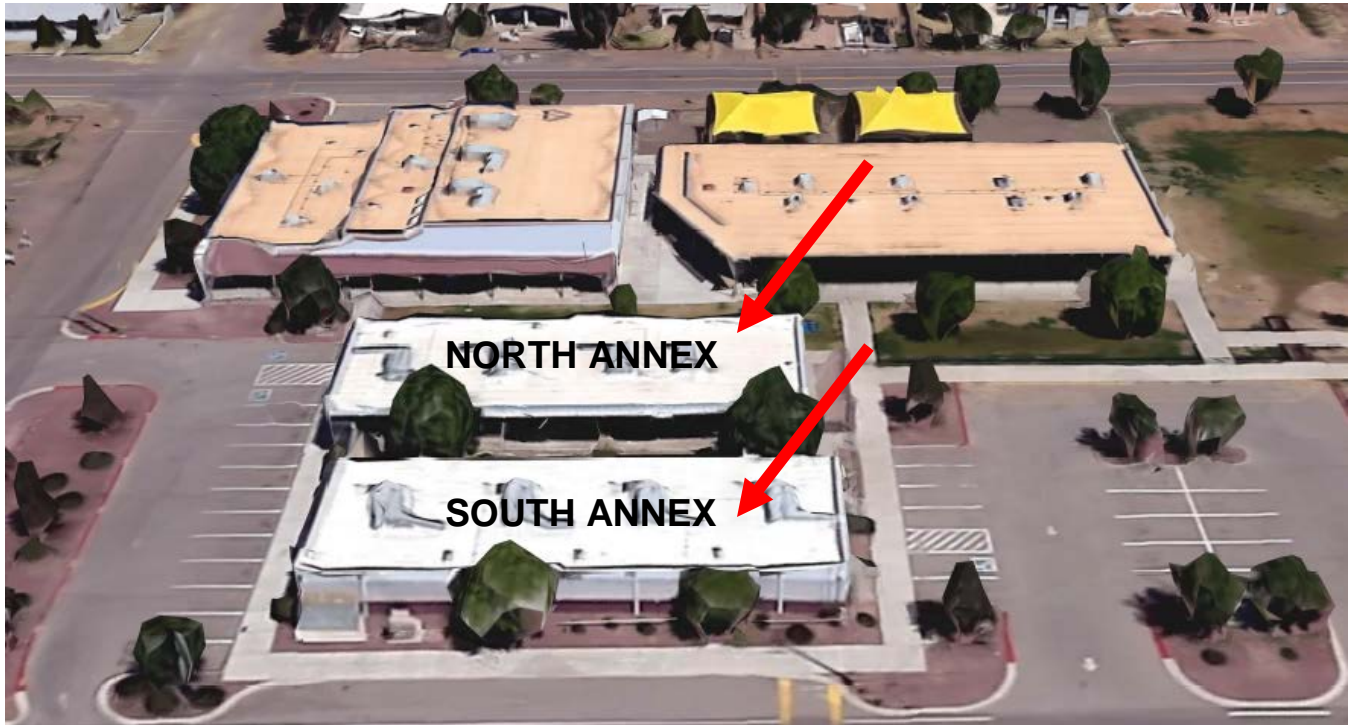
SITE MAP

Site Overview of Faras Elementary School. The North and South Annex buildings are identified by the red arrows.

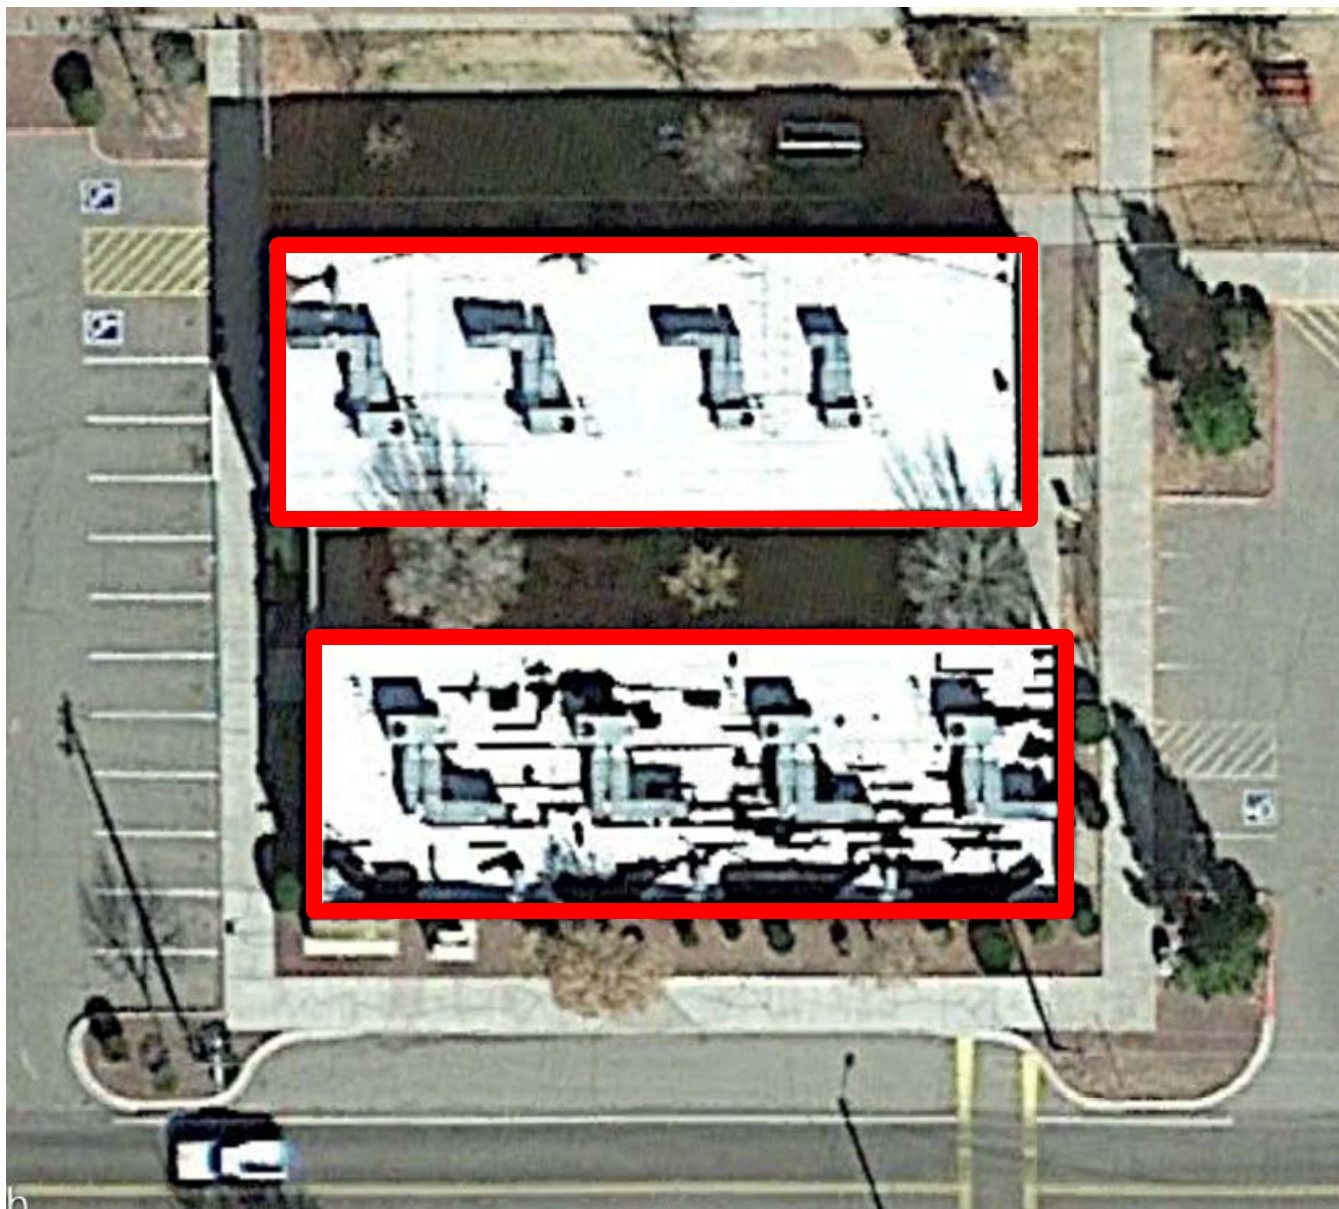
ACM LOCATION MAP

The sampled building materials outlined in Table 1, were reported by laboratory PLM analysis to contain > 1% asbestos.

Material	Location	NESHAP Category	OSHA Classification	Estimated Quantity	Laboratory Results
Building Sealant (Tan Sealant with Multi-Layered Paint)	South Annex	Cat. II / N/A	Class II	< 160 SF	7% Chrysotile
Building Sealant (Tan Sealant with Multi-Layered Paint)	North Annex	Cat. II / N/A	Class II	< 160 SF	7% Chrysotile

Building Sealant (Tan Sealant with Multilayered Paint)

RTC recommends that the asbestos-containing material (ACM) be removed by a qualified asbestos abatement contractor. The contractor should comply with all governing regulatory agencies guidelines.
