INDOOR AIR QUALITY ASSESSMENT

**Green Meadow Elementary School
5 Tiger Drive
Maynard, MA**

Prepared by:
Massachusetts Department of Public Health
Bureau of Environmental Health
Indoor Air Quality Program
September 2018

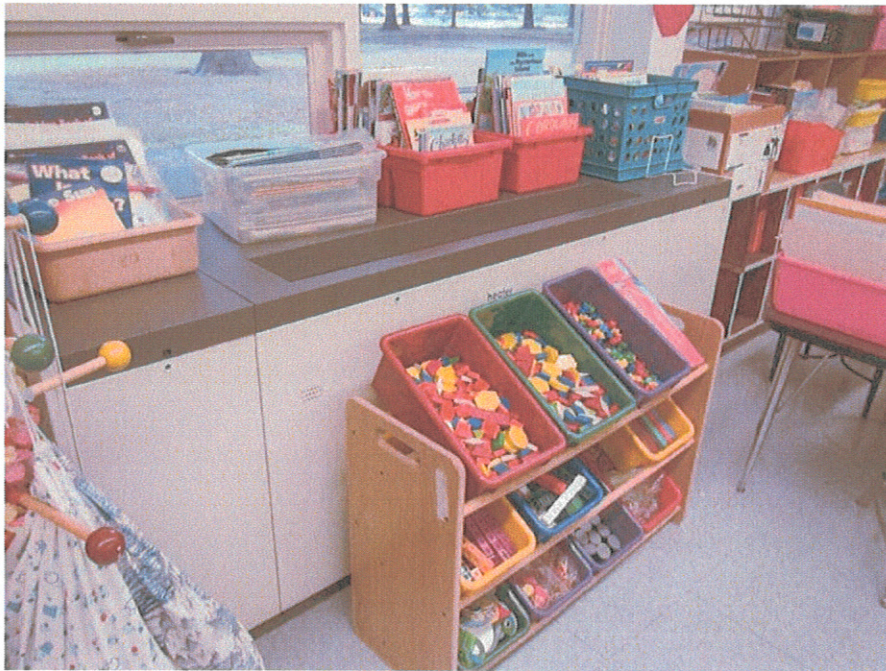
Picture 1

Mechanical ventilation is provided by univents located near the windows of classrooms (“univents”, Picture 1), or, in some cases, above the ceiling. Univents draw air from the outdoors through a fresh air intake located on the exterior wall of the building (Picture 2) and return air through an air intake located at the base of the unit. Fresh and return air are mixed, filtered, heated or cooled and provided to rooms through an air diffuser located in the top of the unit (Figure 1). In many areas items were on top or in front of univents (Pictures 1 and 3; Table 1), which can block air circulation.

Classroom unit ventilator (univent), note obstructions in front

1. Operate univents equipment *continuously* during occupied periods. Remove all obstructions from the front and top of the univents.
2. Work with staff to monitor/adjust computerized HVAC system for fresh air intake/comfort.

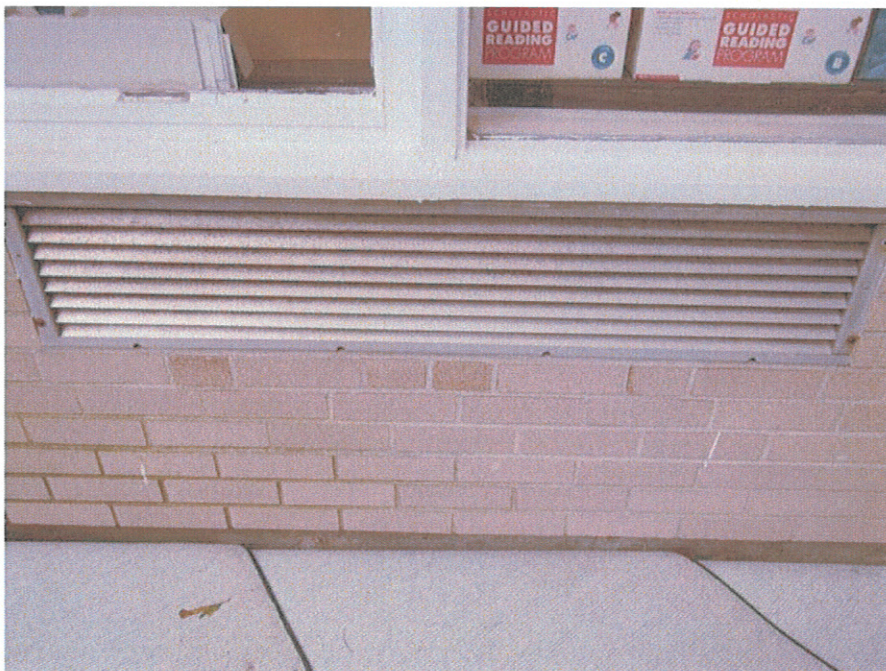
Picture 2

Fresh air intake for univent, note that louvers are dusty

21. Regularly clean AHU cabinets, supply/return/exhaust vents, WAC housings and filters, and personal fans to avoid aerosolizing accumulated particulate matter.

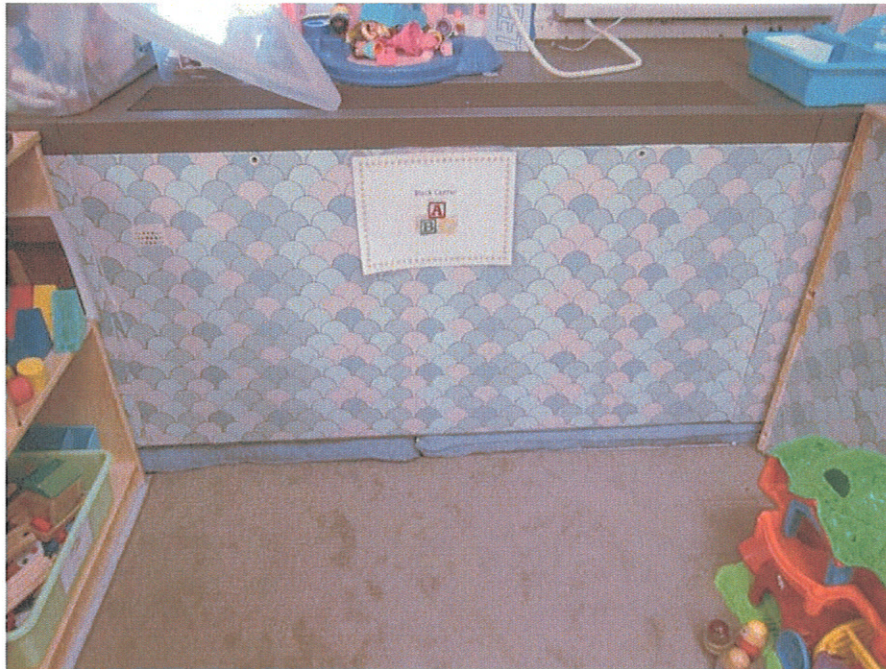
Picture 3

Univent with return vent along the bottom obstructed

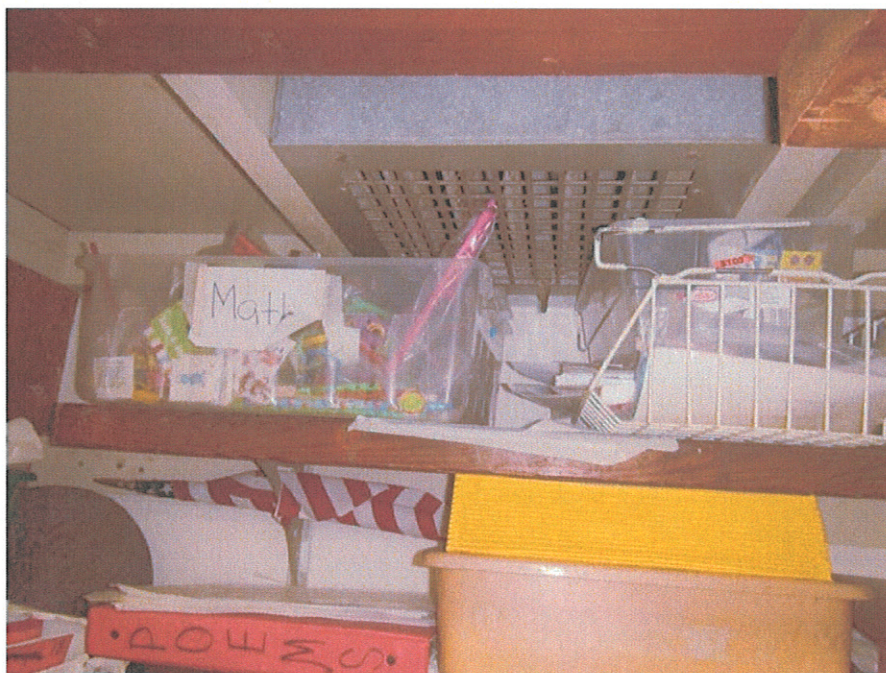
Picture 4

Exhaust vents are located along interior walls of classrooms, with some in closets (Picture 4); they are ducted to fans on the roof. Some exhaust vents were not working at the time of the assessment. In some cases, these vents are operated when a switch on the wall is turned on; some were found turned off; and others did not activate fan motors. As shown in Picture 4, some of the exhaust vents in closets were blocked with items which can reduce their effectiveness.

Closet-mounted exhaust vent, note materials obstructing flow

3. Use openable windows to supplement fresh air during temperate weather. Ensure all windows are tightly closed at the end of the day.
4. Ensure all exhaust vents are operable and switched on during occupied periods. Reduce clutter near closet-mounted vents to ensure air flow.

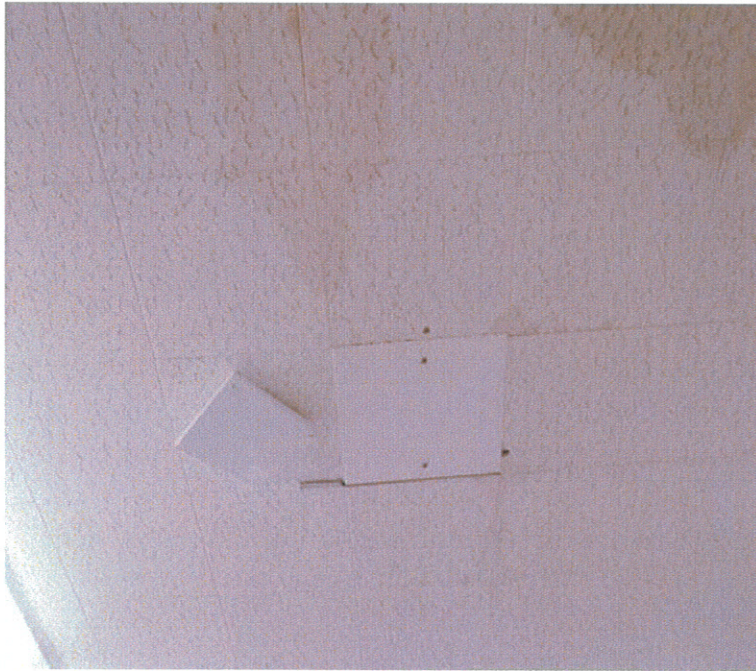
Picture 5

Water-damaged ceiling tiles and other ceiling materials were observed in classrooms, offices and other areas (Pictures 5-7; Table 1). A few ceiling tiles had dark stains that may indicate mold growth. Water-damaged ceiling tiles should be replaced, with priority given to those with evidence of mold growth. Some tiles in the school are of an interlocking type (spline) that are difficult to replace.

Water-damaged ceiling tiles of the interlocking type

10. Replace any water-damaged ceiling tiles and wall materials. During replacement, examine the area above these tiles for mold growth and odors and remediate as necessary.

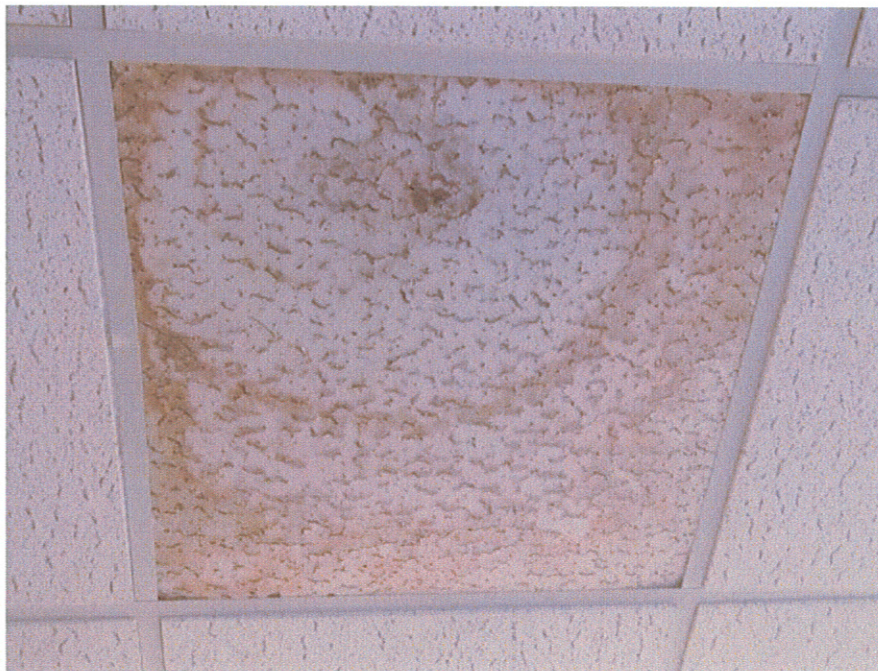
Picture 6

Water-damaged ceiling tile with dark stain suggesting mold growth

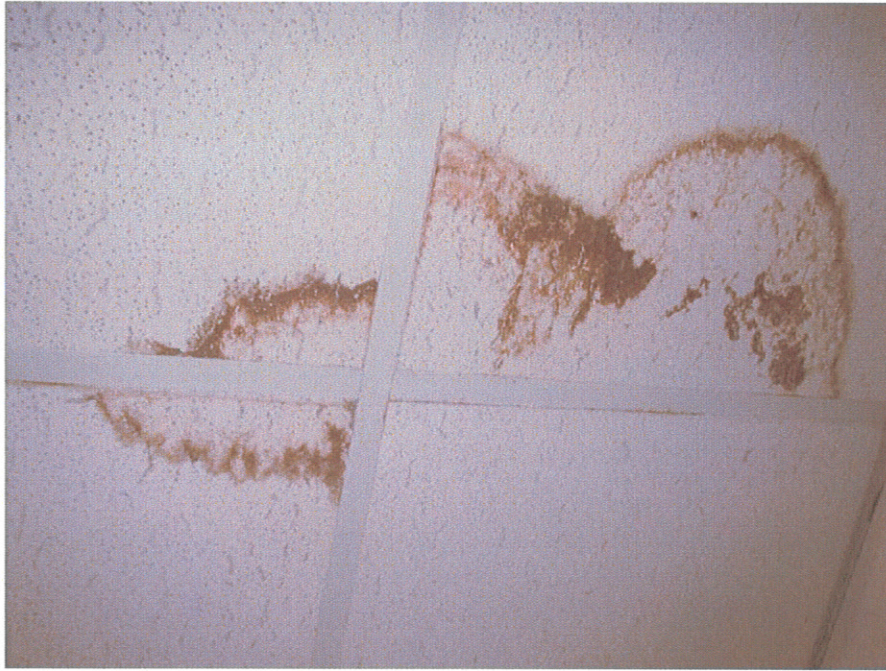
Picture 7

Most stained tiles are from roof leaks. Building maintenance staff reported that a section of the flat roof on the original wing was patched within the last two years and this has reduced the leaking in that section of the building. SMS staff report that the shingles on the newer section of the roof peak are reaching the end of their service life. Gutters and downspouts were damaged and leaking (Picture 8 and 9) in some areas, likely due to ice-related damage in previous winters. Damage to gutters can increase the likelihood of leaking along the building edges when water builds up and does not drain. When water drains close to the building from leaking gutters, this can lead to damage and potential water infiltration along the foundation.

Water-damaged ceiling tiles

13. Consider a long-term plan for roof repairs to reduce leaking.
14. Clean and disinfect interior of refrigerators and freezers with mild detergent or antimicrobial agent. Consider replacing poorly-sealed or mold-contaminated gaskets. Clean spilled food promptly, and clean out the refrigerator of expired items on a regular schedule.

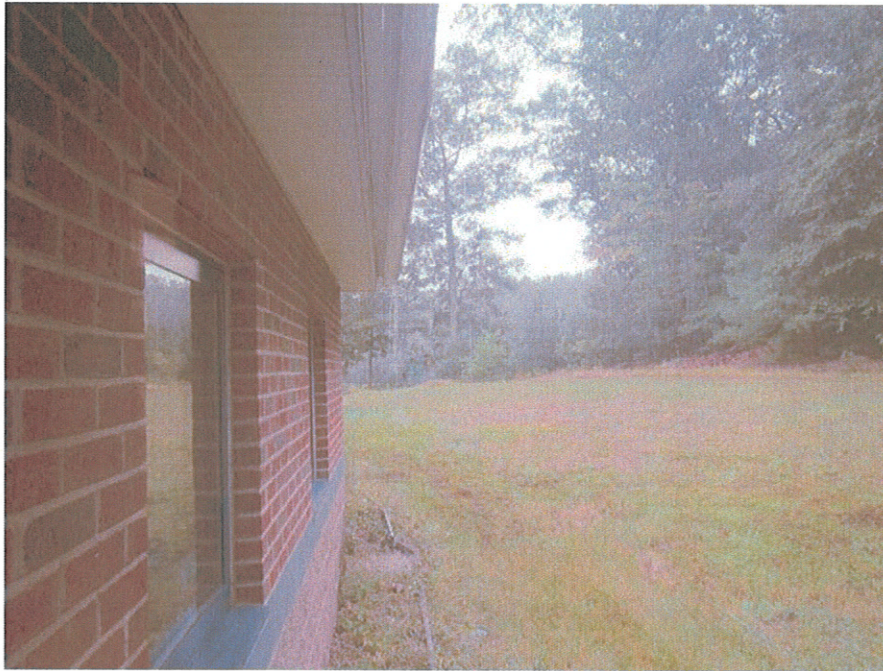
Picture 9

Water running over edge of gutter, note puddle near foundation

11. Ensure the ceiling tile system is intact/complete to prevent odors and particulates from migrating into occupancies spaces.
12. Repair gutters, downspouts and related drainage to remove water away from the building.

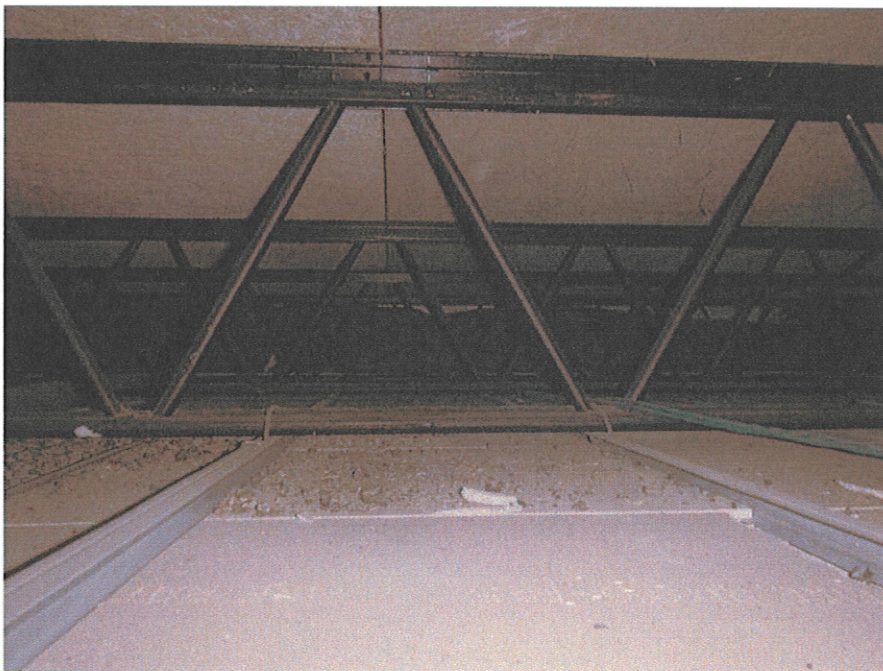
Picture 10

The area above the ceiling tile system was examined in classroom 7B. Note that the area above the ceiling tile system in most parts of the school is a wide open space (Pictures 10 and 11). This allows any moistened tiles to dry quickly most of the time, with less chance of any microbial growth. In the room examined, near the outside edge of the building where there are soffit vents, there is some insulation. This insulation was dry at the time of the visit. When any stained ceiling tiles are removed for replacement, the area above should be examined for odors, water-damaged materials, insulation and other conditions and remediated as necessary.

Air space between ceiling tiles and roof deck

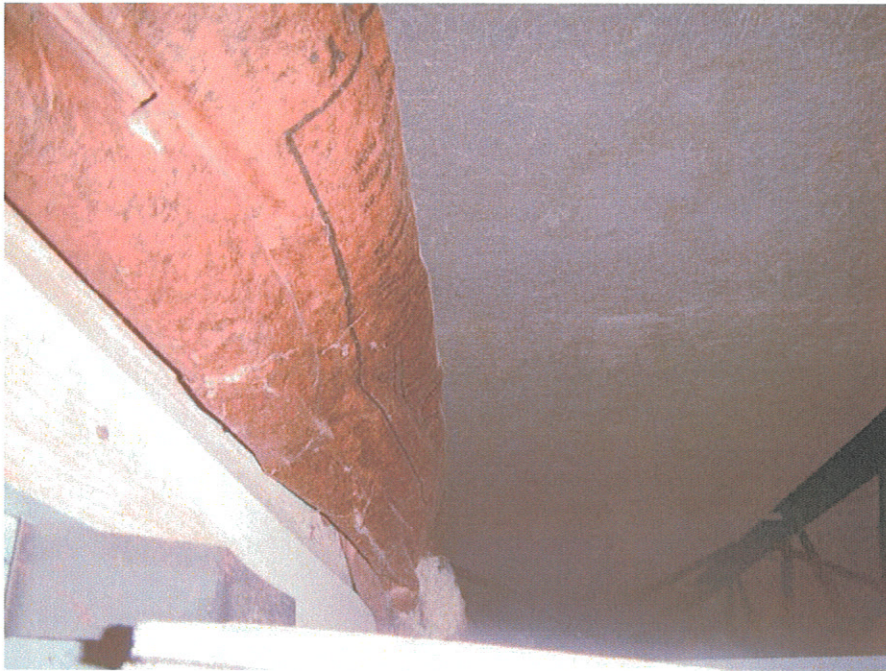
Picture 11

Area above ceiling tile system showing insulation along the outer edge, which was dry

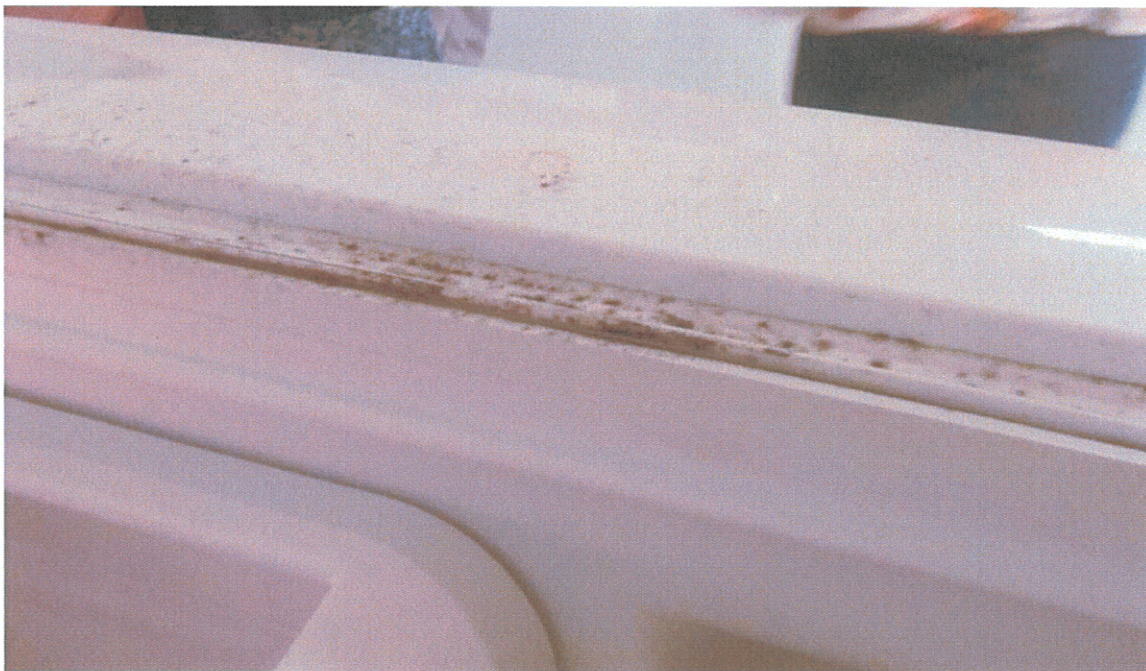
Picture 12

Mold growth was observed on the refrigerator gasket in the teacher’s lunch room (Picture 12). Refrigerators should be cleaned on a regular schedule, including disinfection of gaskets and the interior with an antimicrobial solution. Mold growth on gaskets can be an indication that the gaskets are too worn to seal properly and should be replaced.

Mold-stained gasket in teachers' lunchroom

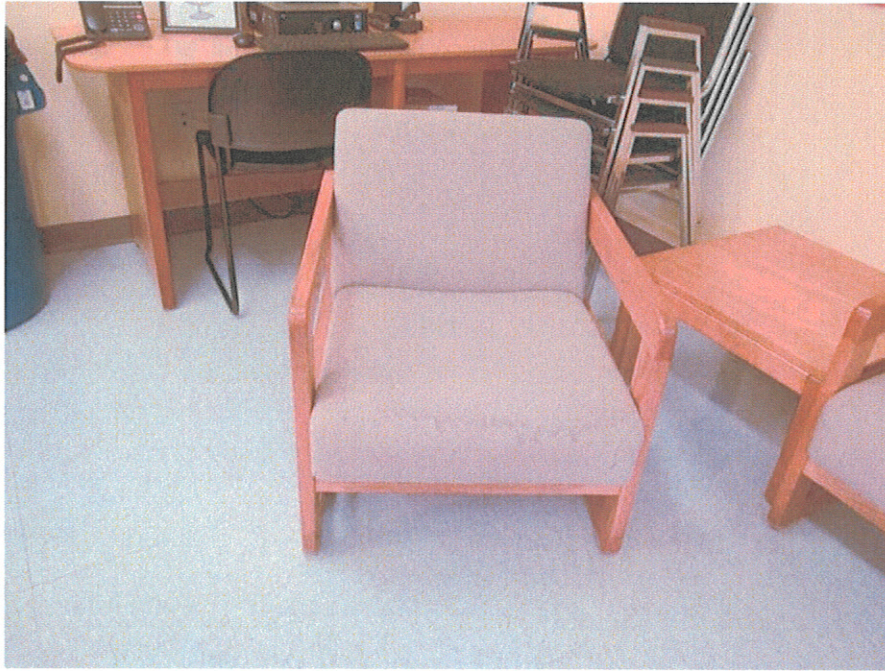
Picture 13

A water-damaged upholstered chair was also noted in the teacher’s lunchroom (Picture 13). Any items which have been water-damaged and not dried promptly, or that show signs of microbial growth such as moldy odors should be discarded. In general, the US Environmental

Water stains on upholstered chair

15. Remediate or discard any other water-damaged porous materials such as upholstered furniture, carpeting, papers and other items.
16. Repair any leaking plumbing in sinks. Avoid storing large amounts of materials or porous materials under sinks.

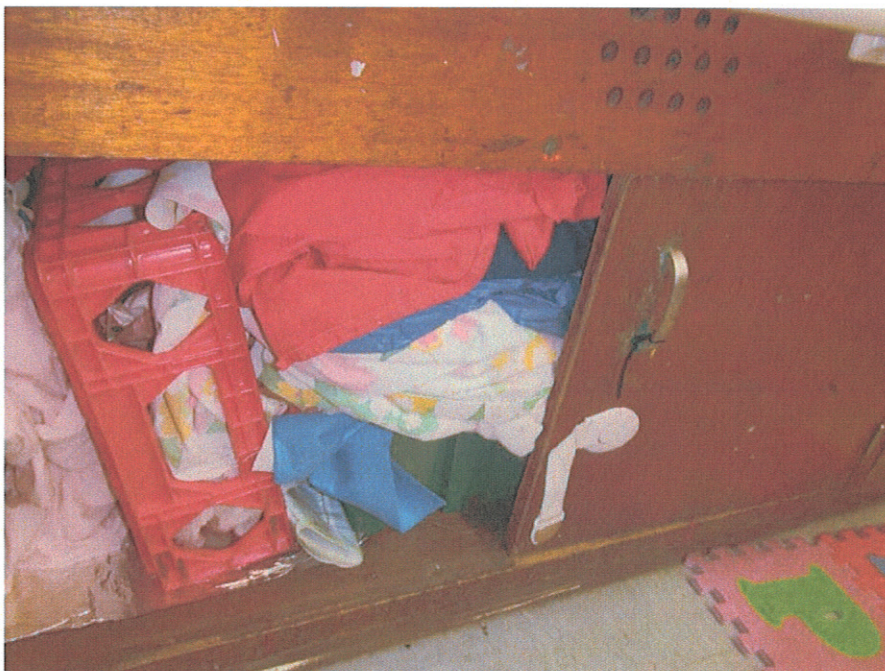
Picture 14

Many classrooms had sinks. In some rooms, the sink backsplashes had a gap which can allow water into the porous material underneath (Table 1). This can lead to water damage and mold growth. Some sinks also had plumbing leaks, which should be repaired. Many sinks also had a significant amount of items stored underneath, which makes it difficult to detect leaks (Picture 14). Porous items (paper, cardboard) should not be stored underneath sinks as it is a moist environment.

Significant amounts of porous items under a classroom sink

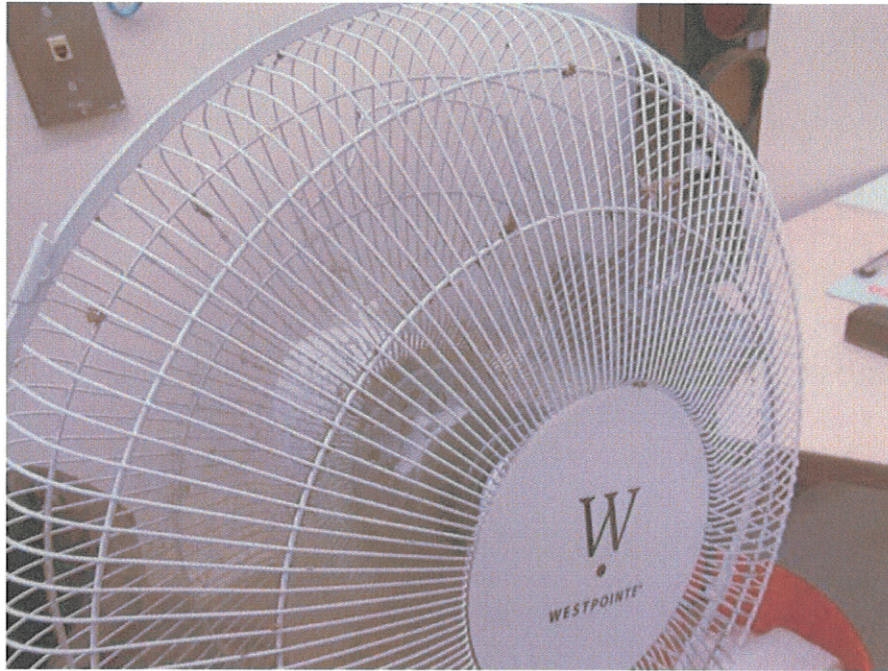
Picture 15

Many classrooms had personal or stand fans to provide circulation. Some of these had dusty blades/housing (Picture 15, Table 1). Some exhaust vent louvers were also observed to be dusty. This dust can be reaerosolized when the equipment is activated. Univent cabinet diffusers also had debris inside (Picture 16) which can be a source of odors, especially when heated. Note that univents are equipped with filters, which should be changed on a regular schedule, two to four times a year. Filters are reportedly changed three times a year (Picture 17). This type of filter, however, does not provide much filtration. It is recommended that pleated filters with a minimum efficiency rating value (MERV) of 8. However, with the age of the univents, they may not be able to operate with higher efficiency filters.

Dusty fan

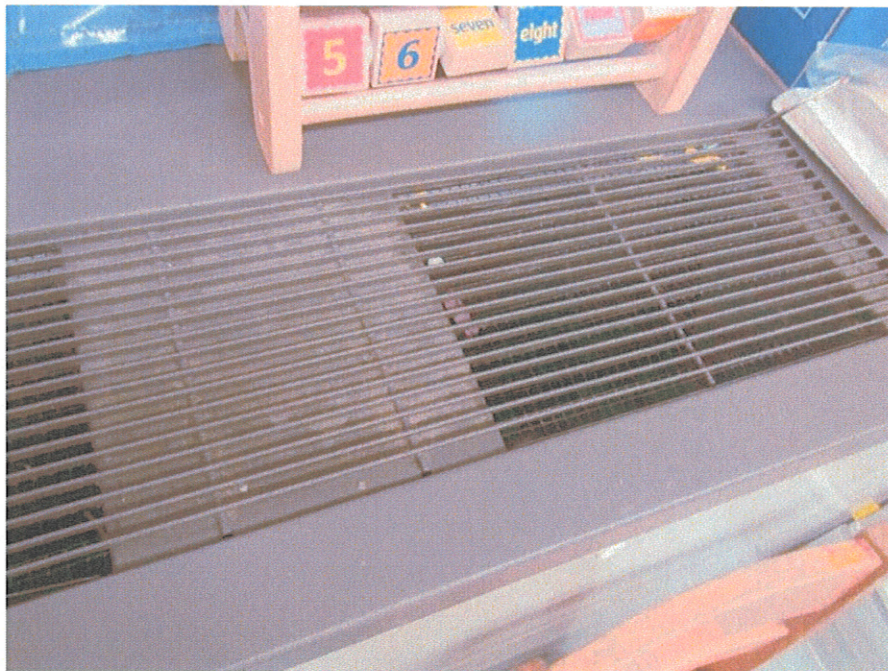
Picture 16

Debris in univent diffuser

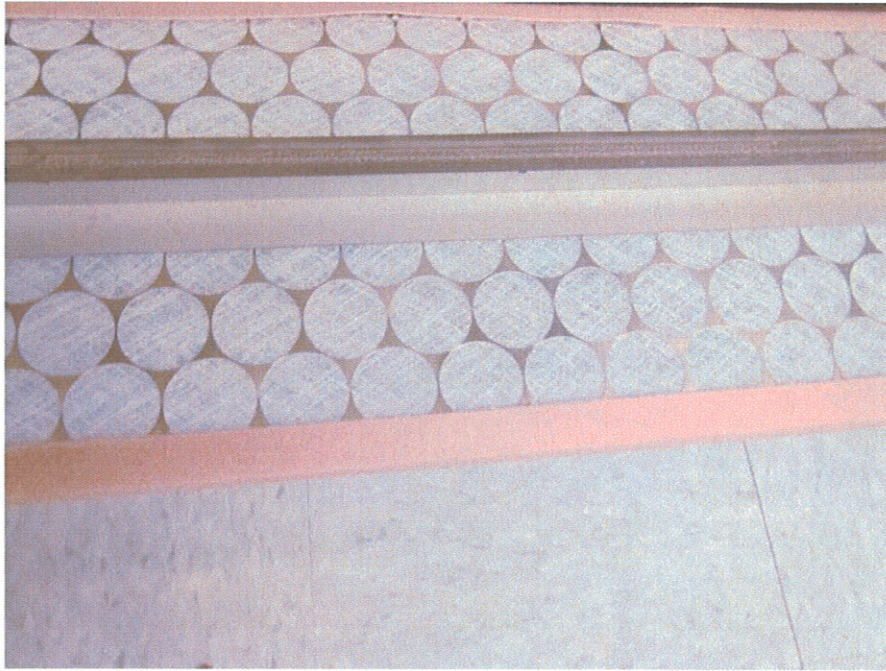
Picture 17

Filter in classroom univent

20. Continue to change filters for HVAC equipment 2-4 times a year. The MDPH recommends using pleated filters of Minimum Efficiency Reporting Value (MERV) of 8, which are adequate in filtering out pollen and mold spores (ASHRAE, 2012). Consult with an engineer to determine if current ventilating equipment can be used with more effective filters.

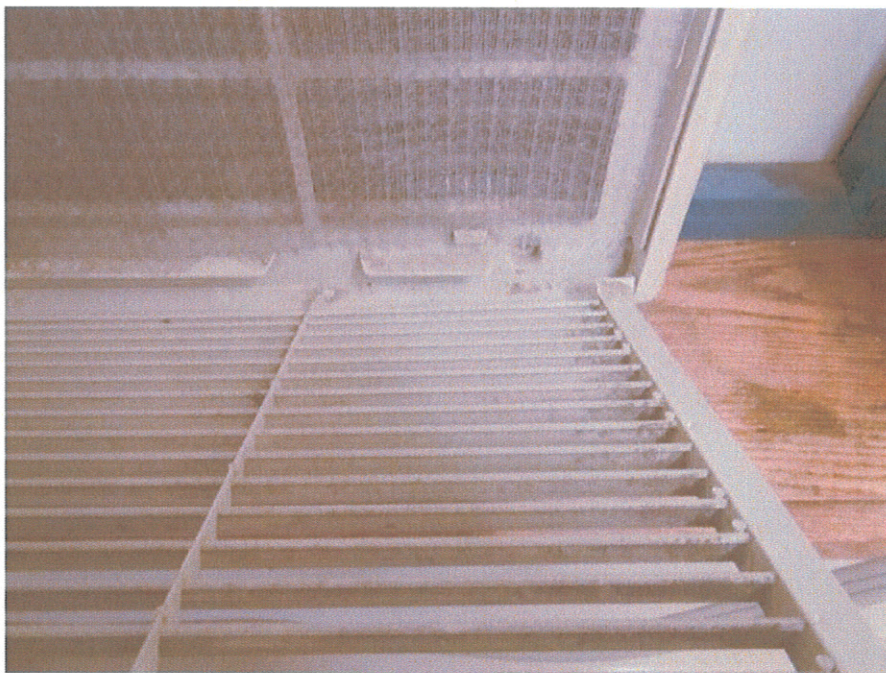
Picture 18

Window air conditioners were also dusty in some places (Picture 18). Furthermore, these units have filters which need to be cleaned regularly.

Window air conditioner housing and filter are dusty

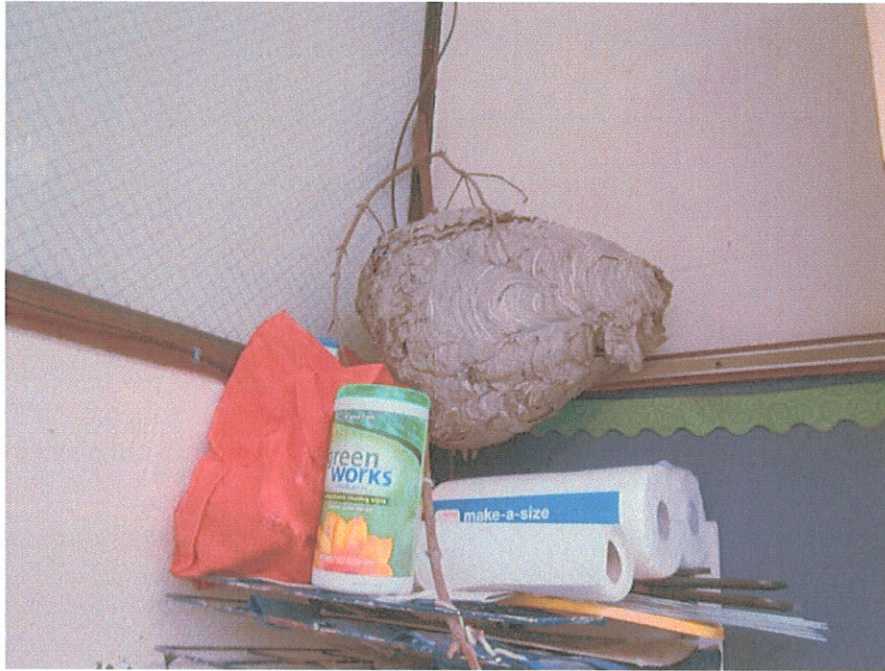
Picture 19

In many areas, items, including books, papers, toys and decorative items were observed on floors, windowsills, tabletops, counters, bookcases, and desks. These items can make it difficult for custodial staff to clean. It is particularly important that porous items, including boxes, papers, books and toys, be kept off the floor and away from areas that may become damp from condensation or leaks. Organic items, such as science demonstrations (Picture 19) can be a source of mold, allergens and odors, and should be carefully vetted before being brought into classrooms or removed entirely.

Science item (wasp nest) in classroom

23. Examine items brought into classrooms, including books, toys, and particularly organic items for science demonstrations, for any sign of water damage, mold, odors or allergens. Discard any suspect items.
