# CAPE ELIZABETH FACILITIES STUDY

## SCHOOL BOARD WORKSHOP

# BUILDING MAINTENANCE CONCEPTUAL CASE STUDY

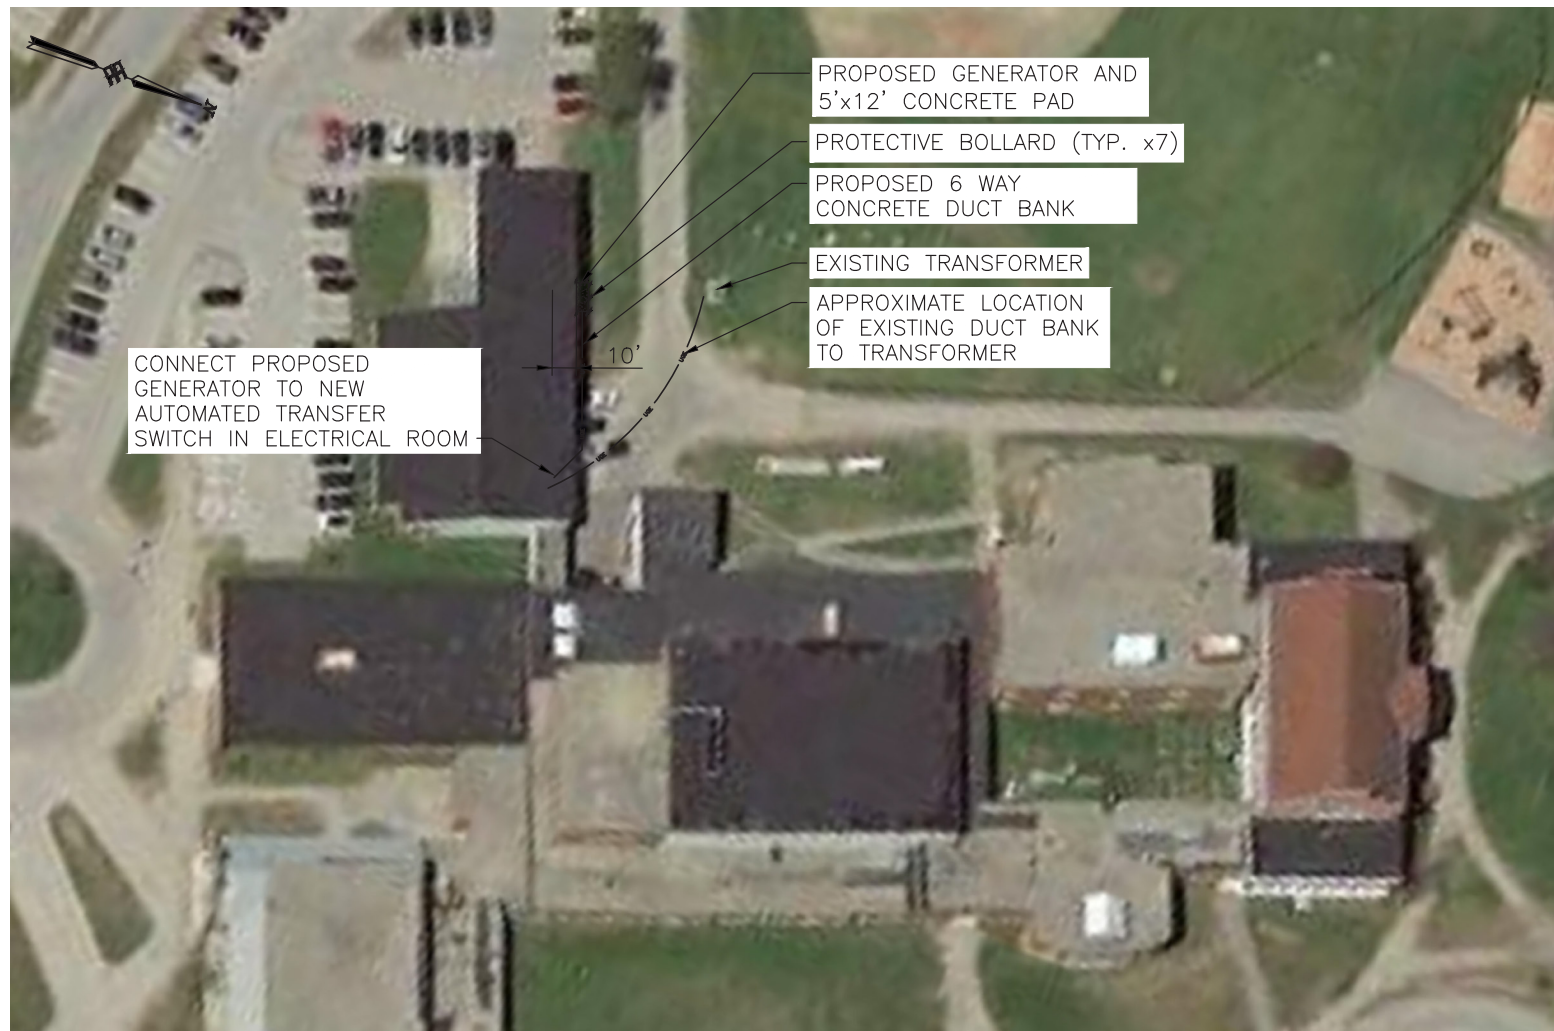
## CHALLENGES:

- NO BACKUP GENERATOR EXISTS FOR ELEMENTARY AND MIDDLE SCHOOL BUILDINGS

## PROPOSED SOLUTION

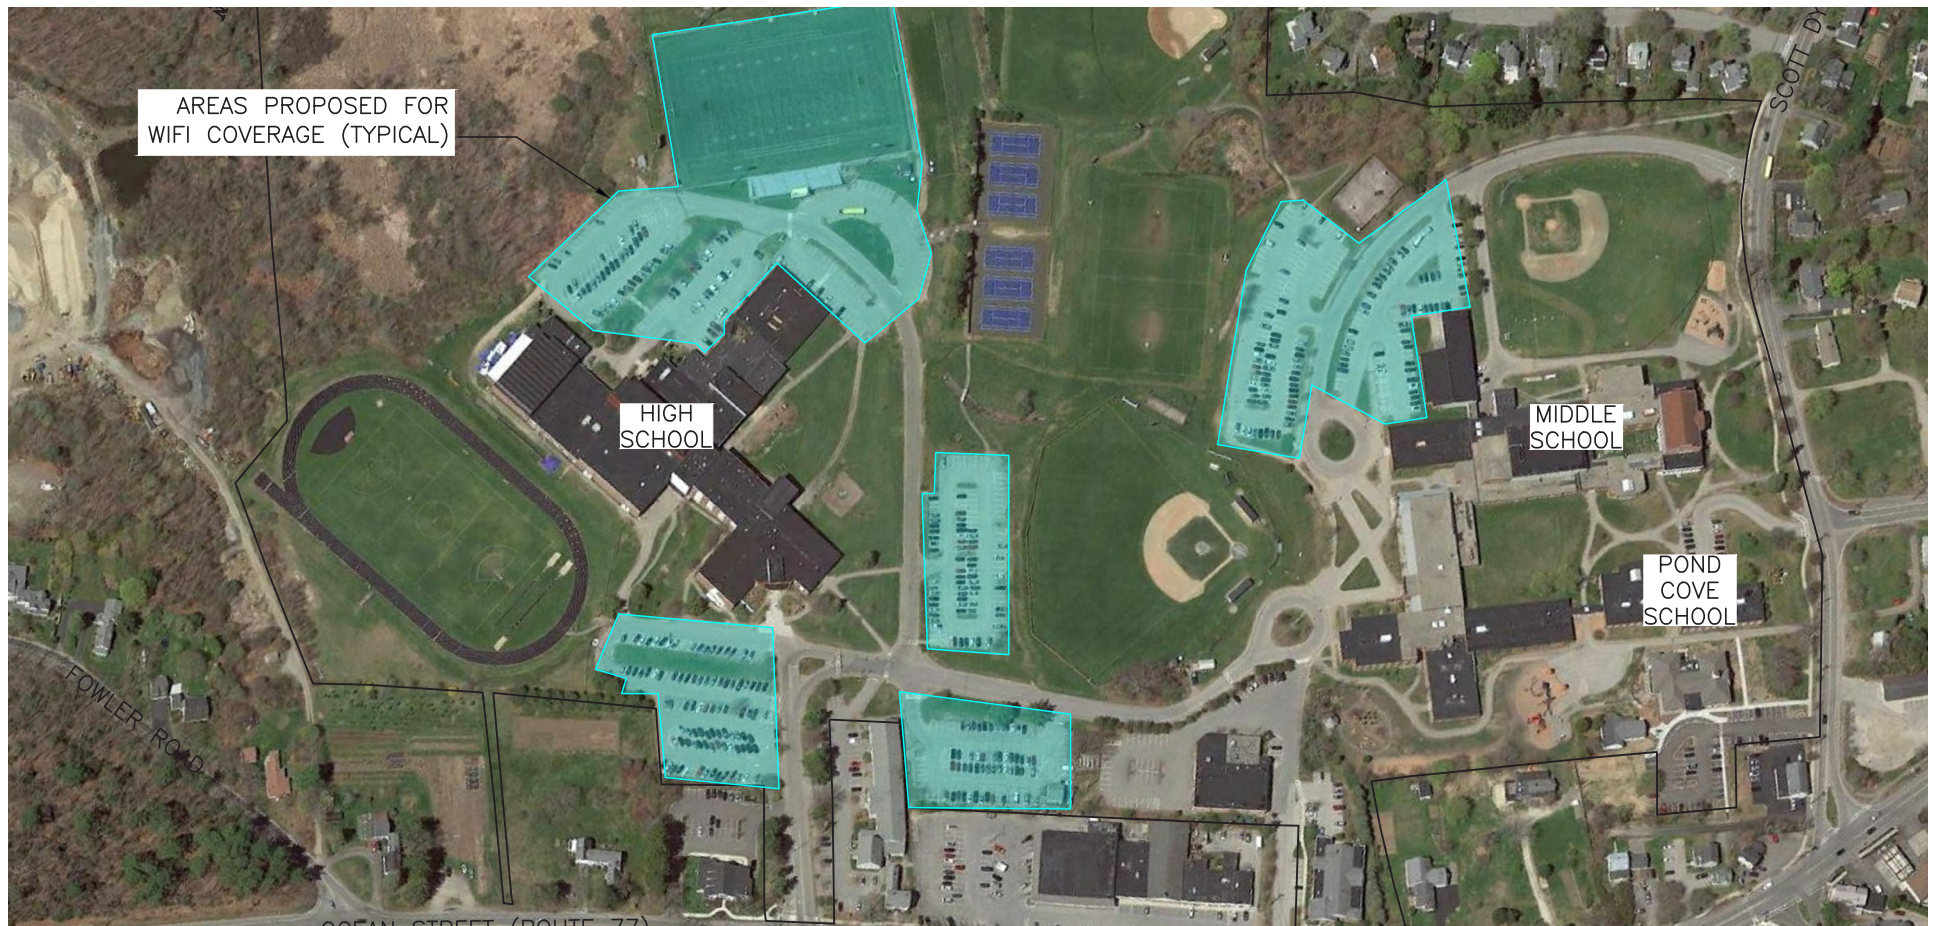
## CAFETERIA CHALLENGES:

- KITCHEN IS UNDERSIZED
- SERVING SPACE EXTENDS INTO DINING ROOM
- ADDITIONAL P.O.S. STATIONS REQUIRED
- FLOOR LEVEL CHANGES LIMIT FLEXIBILITY
- MS: (2) 20 MINUTE SEATINGS OF 275 EACH
- LS: (3) 25 MINUTE SEATINGS OF 185 EACH
- KITCHEN SERVICE & TRASH REMOVAL CROSSES PATHS WITH STUDENTS

## AUDITORIUM CHALLENGES:

- NO DEDICATED SPACE FOR CONTROL AND LIGHTING BOOTH
- DUAL USE OF TABLES/BENCHES FOR BOTH CAFETERIA AND AUDITORIUM: SEATS ARE UNCOMFORTABLE
- FLOOR RISE INSUFFICIENT
- STAGE IS UNDERSIZED AND STAGE FLOORING IS POOR FOR INTENDED USE
- WALLS NEED ACOUSTIC TREATMENT
- INADEQUATE SUPPORT SPACE (GREEN ROOMS, DRESSING ROOMS, ETC.)
- TRANSITION BETWEEN DINING & PERFORMANCE REQUIRES SIGNIFICANT TIME

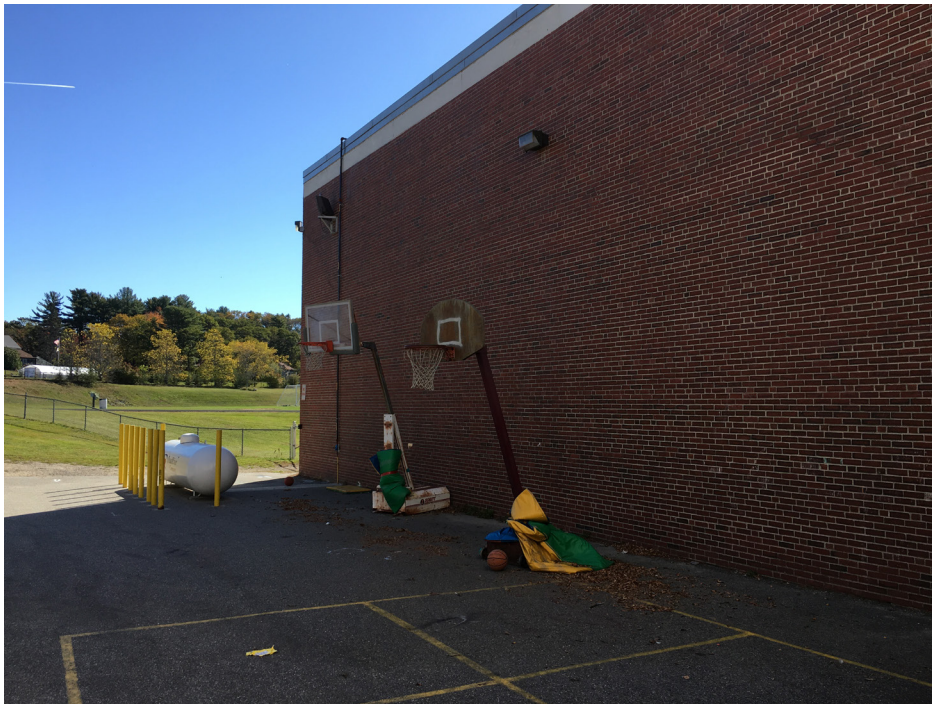
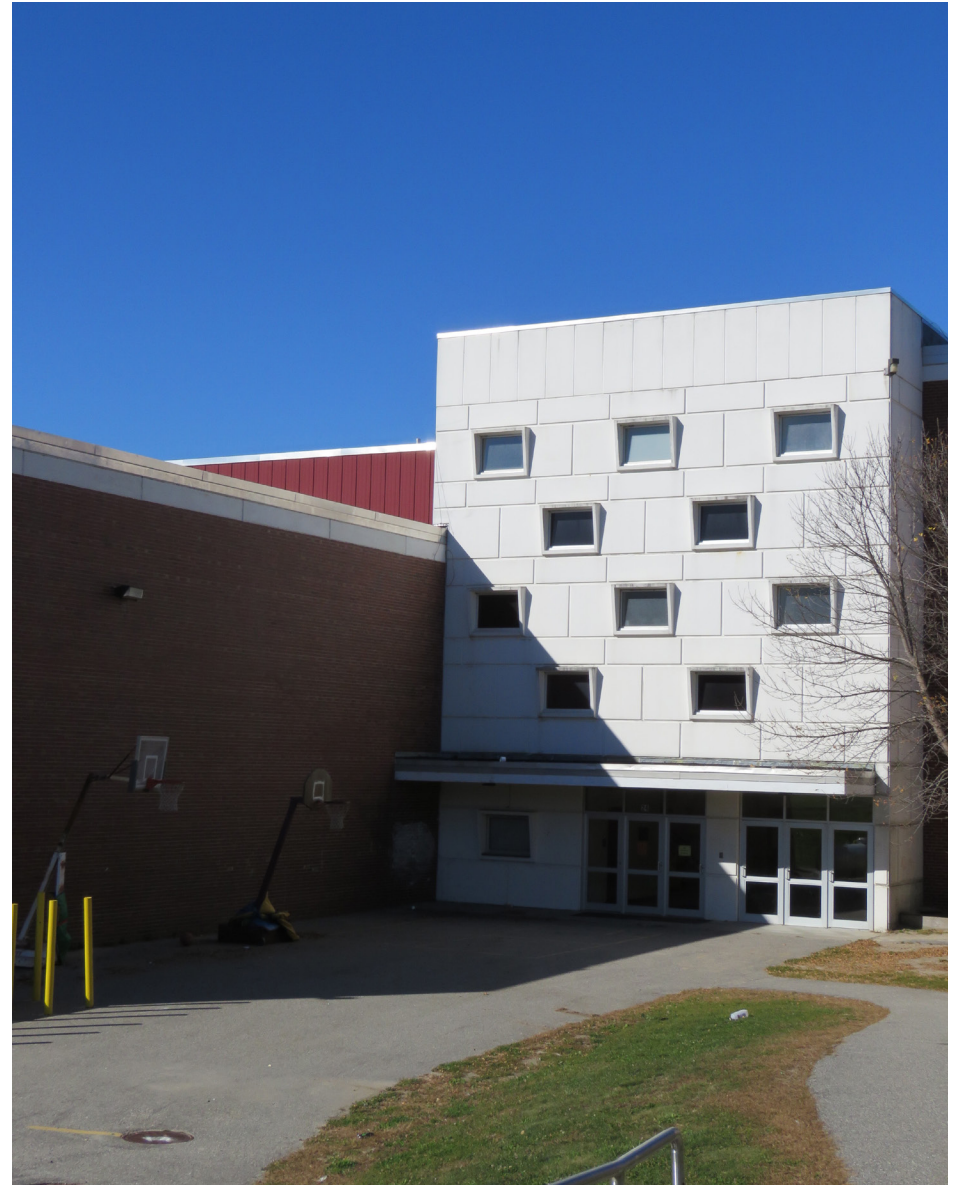
## CHALLENGES:

- INEFFICIENT USE OF EXISTING EXTERIOR SPACE
- ENTRY LACKS CLEAR DEMARCATION
- ENTRY DOORS NEED REPLACED

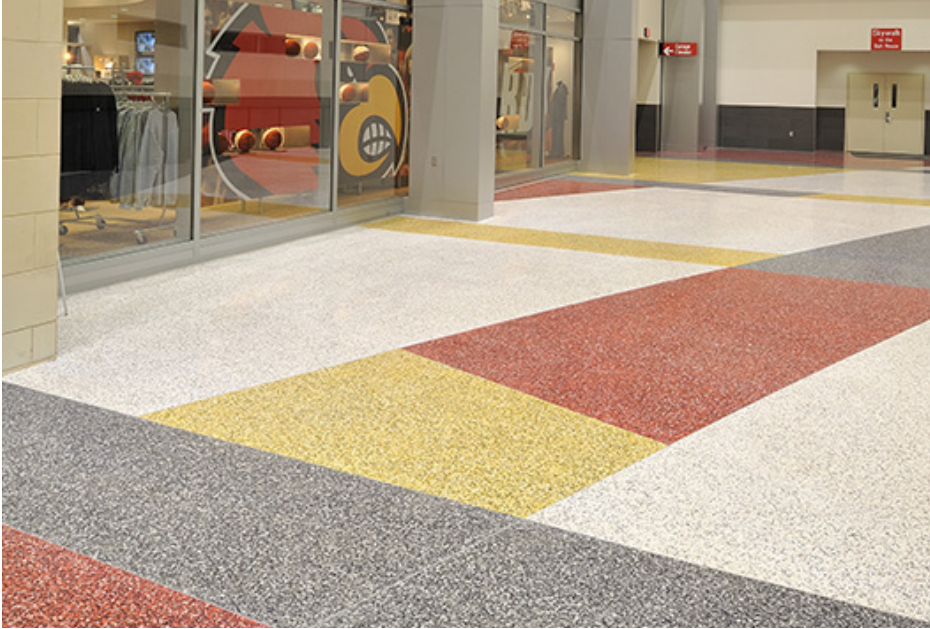
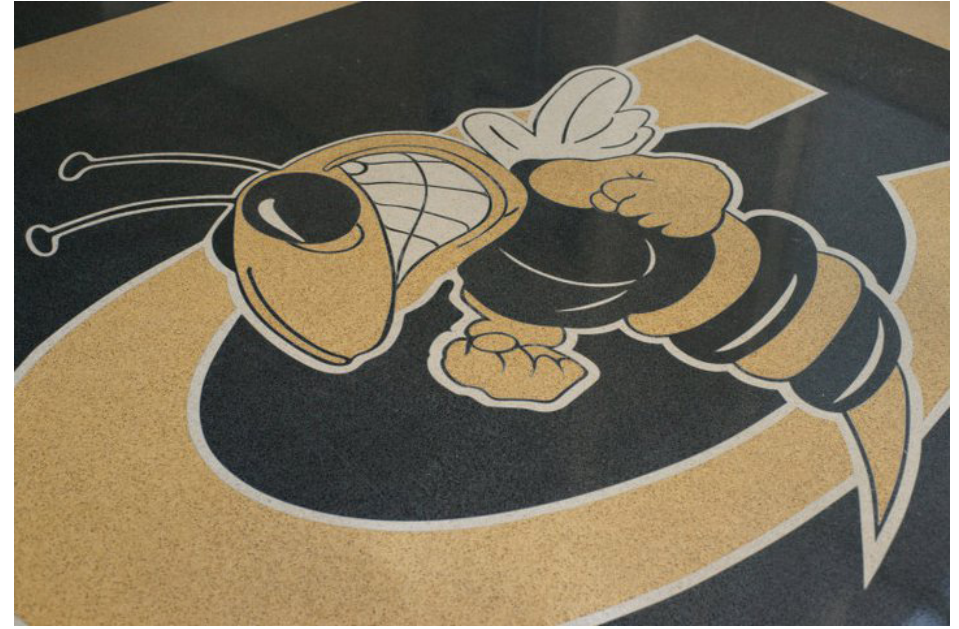
EPOXY TERRAZZO FLOORING

- FLOORS TYPICALLY LAST LIFETIME OF STRUCTURE  
SEAMLESS (NO JOINTS)  
NO COLOR FADE  
RESISTANT TO CHEMICALS  
VIRTUALLY UNLIMITED COLORS AND PATTERNS POSSIBLE  
LIMITED MAINTENANCE REQUIREMENTS
- NO WAXING
  - WATER-BASED SEALERS
  - DAILY DAMP MOPPING

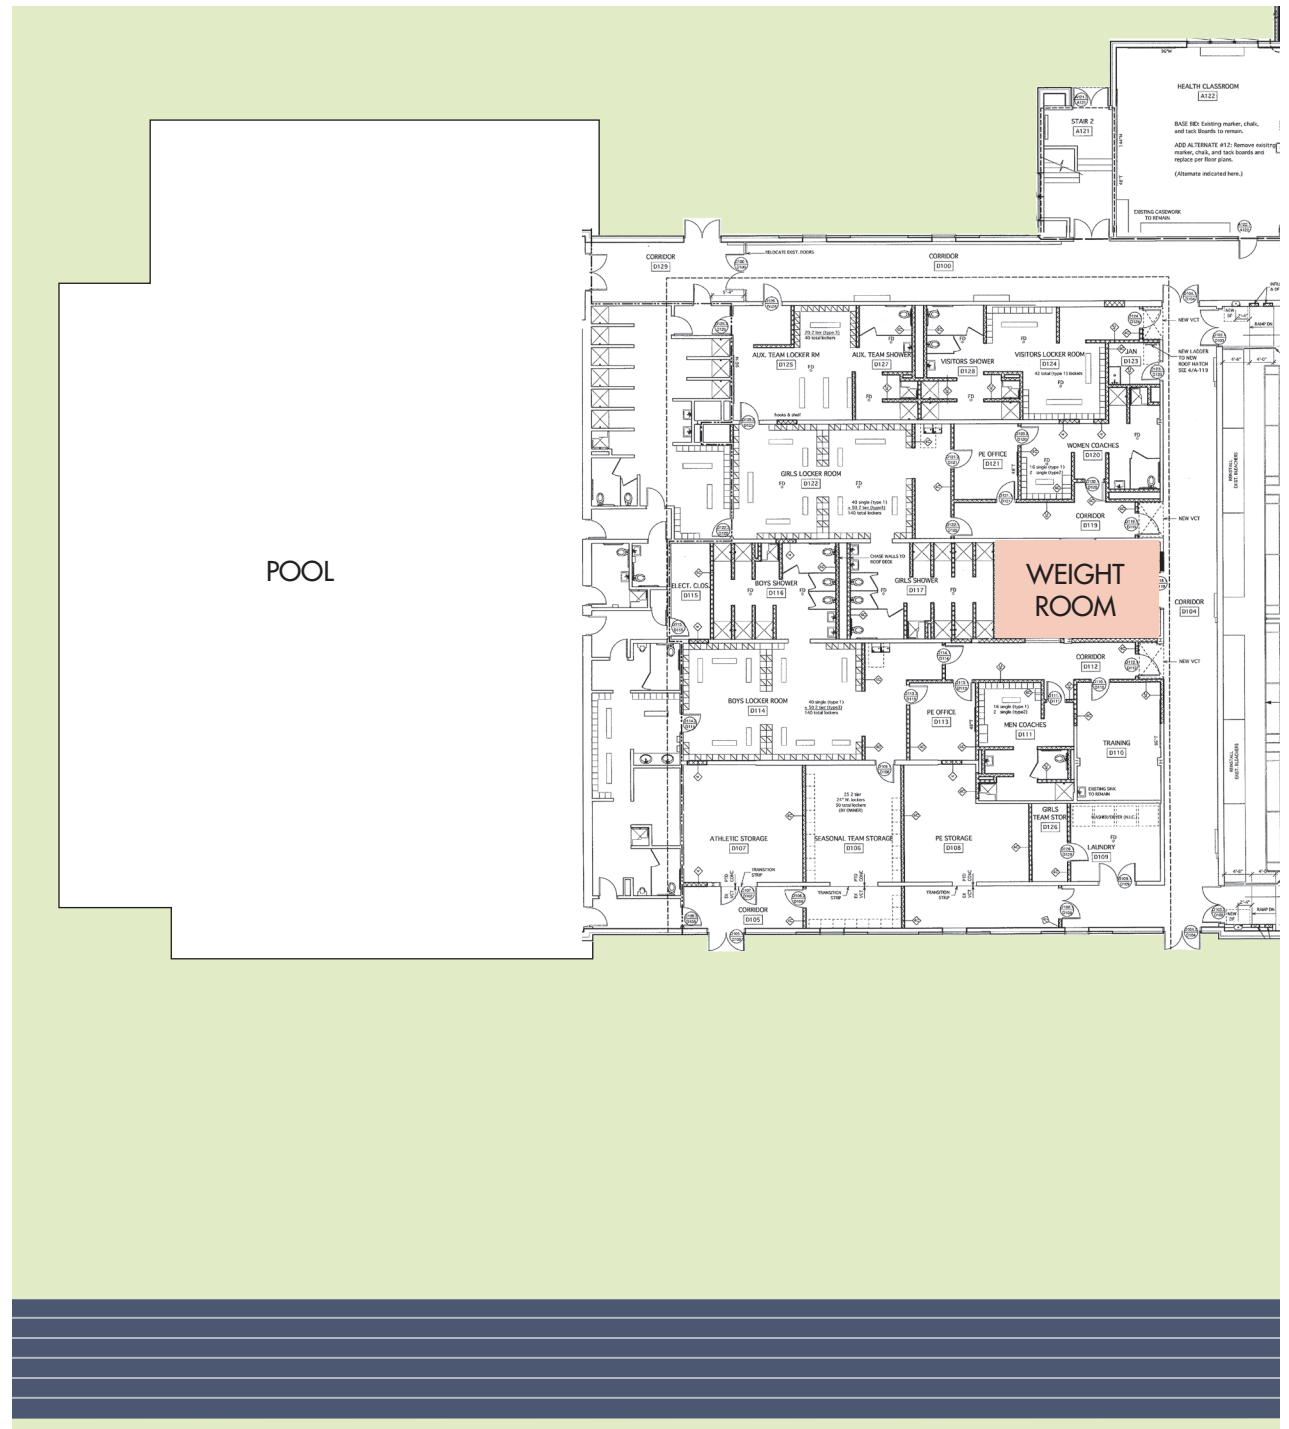
## CHALLENGES:

- WEIGHT ROOM IS UNDERSIZED
- MALE AND FEMALE FACILITIES NEED TO BE EQUALIZED (TITLE IX)
- INADEQUATE STORAGE
- CORRIDOR & LOCKER ROOM FLOORING HOLDS DIRT AND REQUIRES SIGNIFICANT MAINTENANCE
- NO GENDER-NEUTRAL FACILITIES

- ADDITION TO HOUSE NEW FITNESS ROOM, MULTI-PURPOSE CLASSROOM, AND STORAGE SPACE
- EQUALIZE BOYS' AND GIRLS' TEAM LOCKERS
- PROVIDE GENDER-NEUTRAL FACILITIES
- REPLACE CORRIDOR AND LOCKER ROOM FLOORING WITH SEAMLESS MATERIAL REQUIRING LESS MAINTENANCE (TERRAZZO OR SIMILAR)
