**PHASE I  
ENVIRONMENTAL SITE ASSESSMENT  
KIM 88 SCHOOL DISTRICT  
425 STATE STREET  
KIM, COLORADO**

October 4, 2013  
Project No. 500692001

Subject: Phase I Environmental Site Assessment  
Kim 88 School District  
425 State Street  
Kim, Colorado

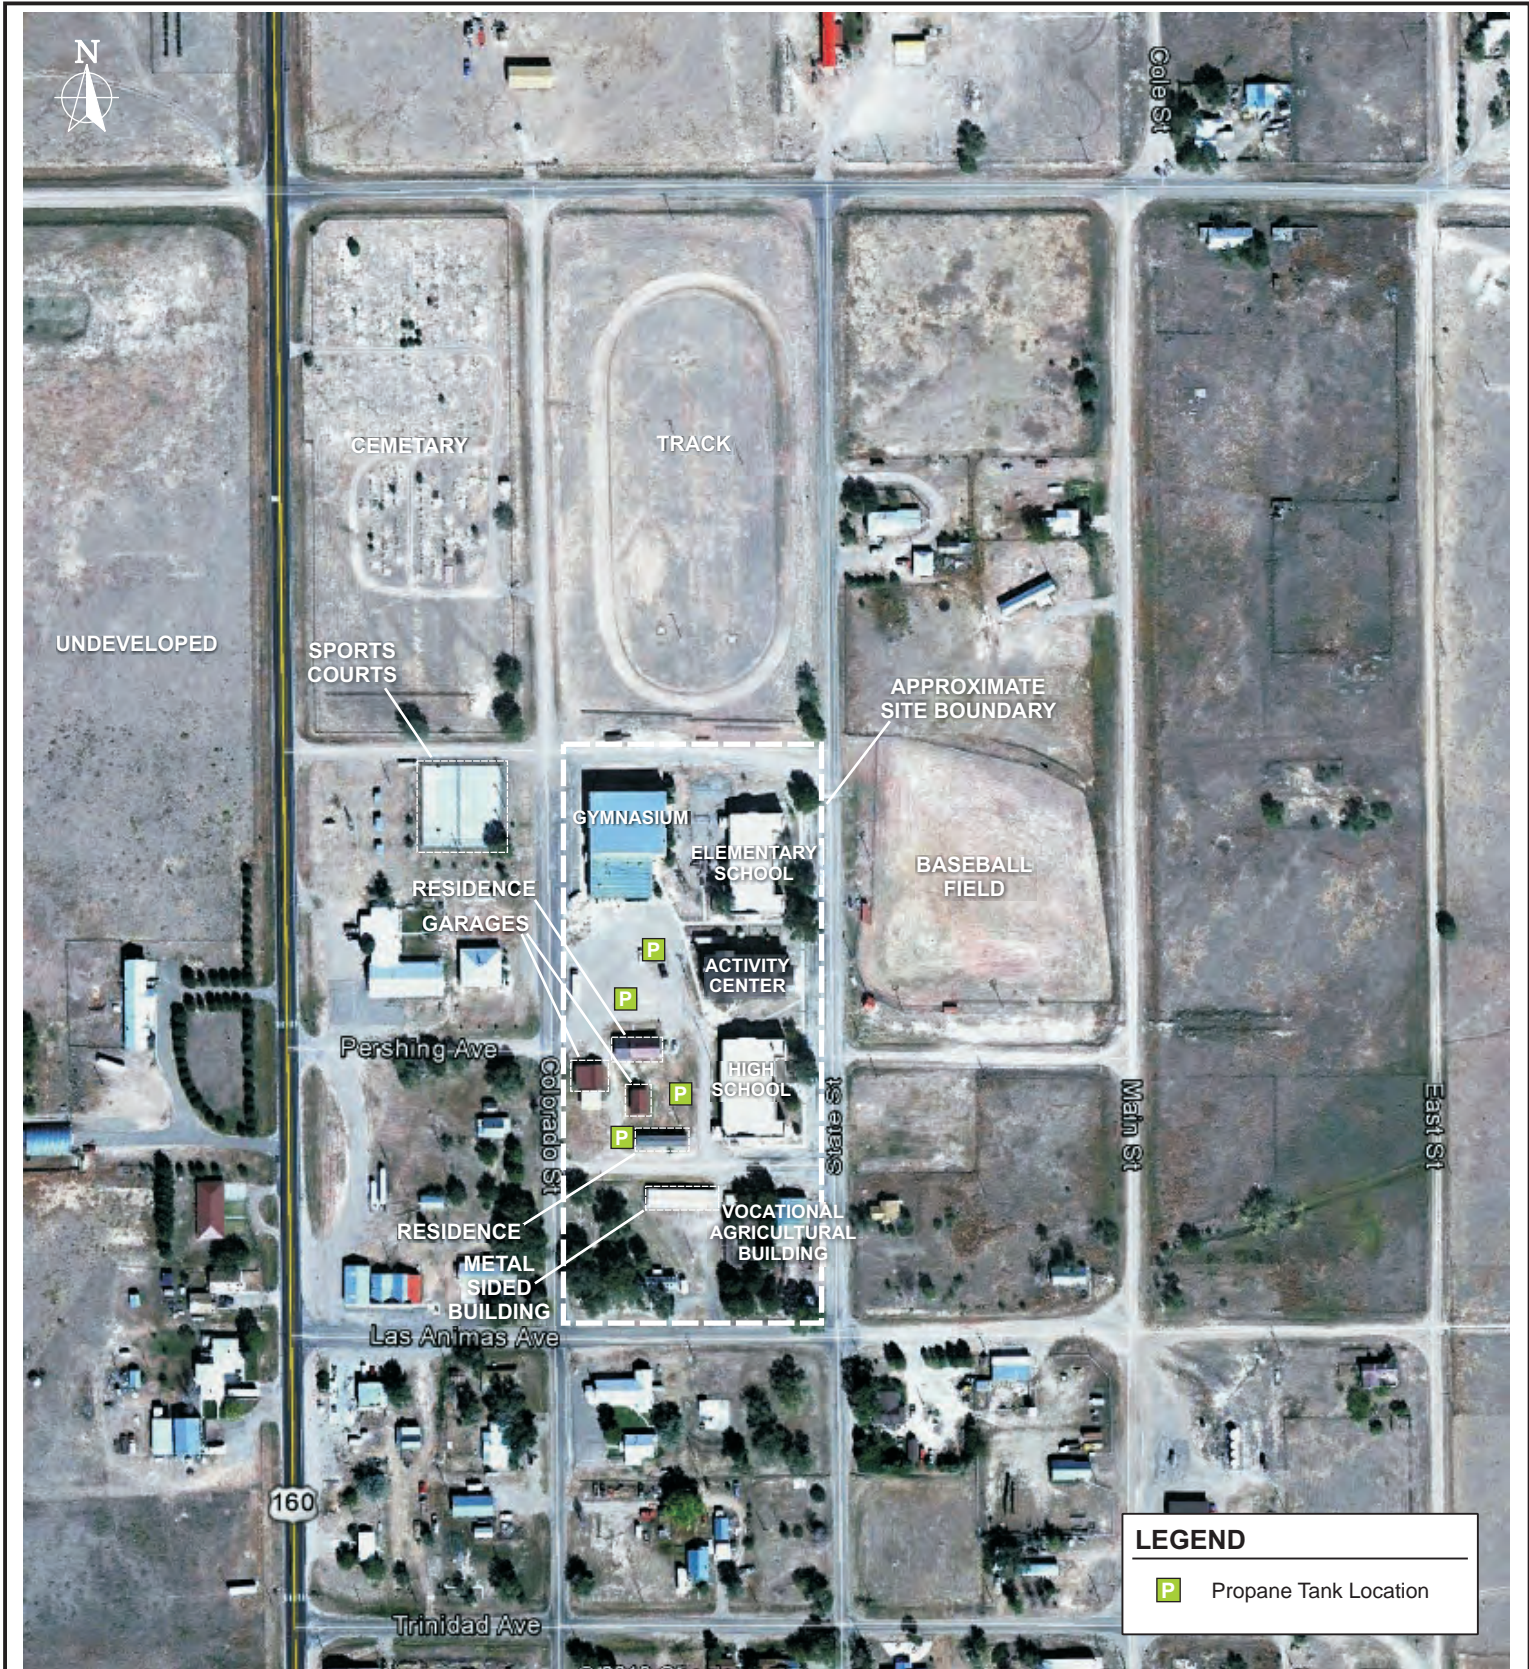
During the site reconnaissance, six propane ASTs were observed throughout the site. The location of the ASTs is indicated on Figure 2. The ASTs are used store propane for the purpose

of heating the school. A variety of sizes of tanks were observed and the tanks appeared to be in good condition.

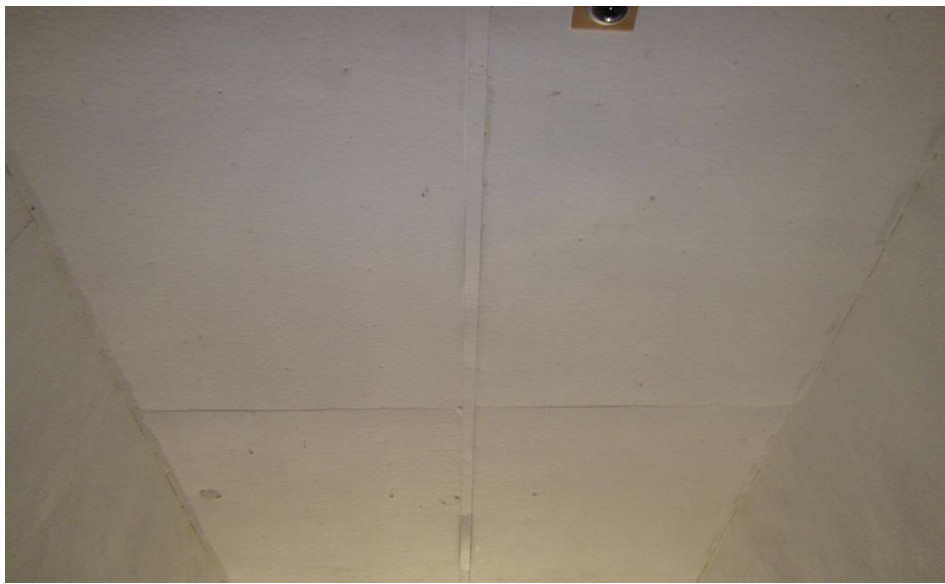
**Photo 2**                      **Location: Inside Elementary School**                      **Date: 08/06/2013**  
Looking at large ceiling tiles

- According to the documents provided by the Colorado Department of Public Health and Environment (CDPHE) regarding asbestos in the site buildings and the date of construction (1938), the existing buildings located on the site could contain asbestos and lead-based paint. Proposed plans included the demolition of three of the four main buildings. Ninyo & Moore recommends a comprehensive Hazardous Building Material Survey for asbestos containing materials and lead-based paint be conducted by a professional licensed by the CDPHE, prior to demolition activities.

Ninyo & Moore recommends a comprehensive Hazardous Building Material Survey for asbestos-containing materials and lead-based paint be conducted by a professional licensed by the CDPHE, prior to demolition activities.

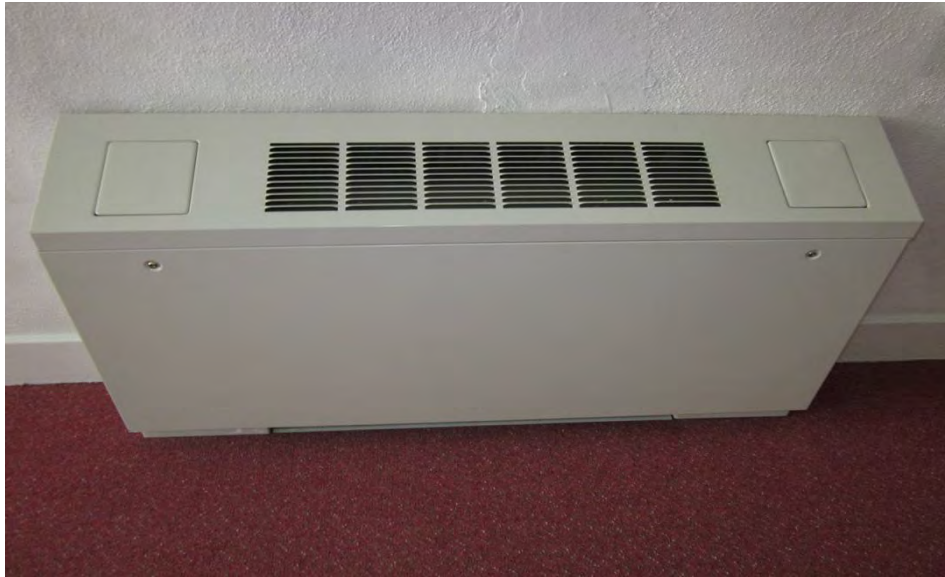
**Photo 5**                      **Location: Inside Elementary School**                      **Date: 08/06/2013**  
Looking at the heating unit

At the time of the site reconnaissance, the site did not have central heating or air conditioning. Portable air conditioning units and heating units were observed throughout the buildings. According to school personnel, the various buildings are heated by hot water radiators, space heaters, forced air furnaces and/or fan coil units. In addition, six pro-

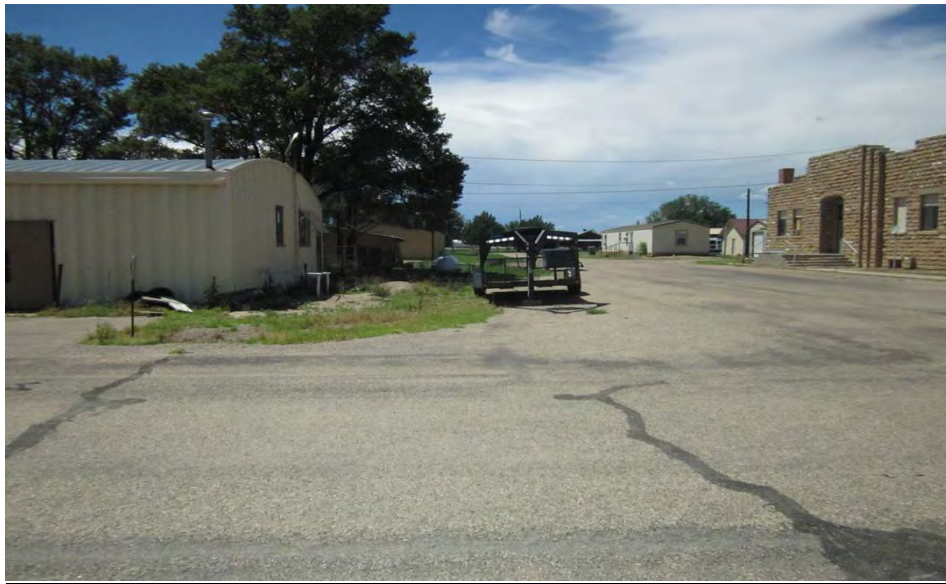
**Photo 10**                      **Location: Southeast Corner of Site**                      **Date: 08/06/2013**  
Facing west, looking at vocational agricultural building with propane tank

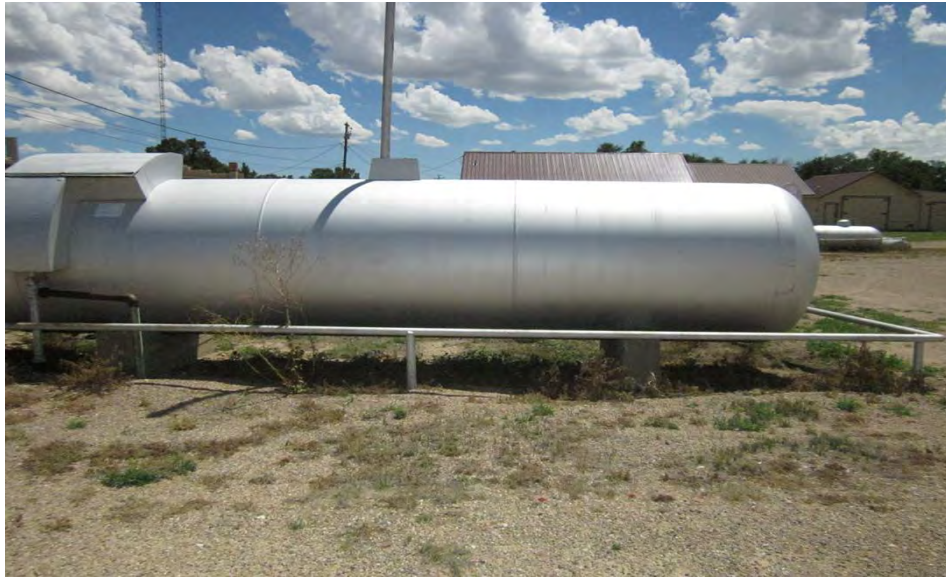
**Photo 21**      **Location: West Side of School**      **Date: 08/06/2013**  
Looking at propane AST

At the time of the site reconnaissance, six propane ASTs were observed at the site. The propane ASTs were used to provide heating to the school and natural gas utilities were not observed on the site. Retail-sized household cleaning chemicals were observed inside of one of the custodial closets. Several canisters of compressed gas, reportedly used for welding, were observed in the vocational agricultural building, near the southwest site corner. Several cans of paint and solvents were stored in the vocational agricultural building inside a metal cabinet. Evidence of leaks or spills was not observed in the vicinity of the chemicals being stored on site. Ninyo & Moore does not consider these features to represent RECs for the site.

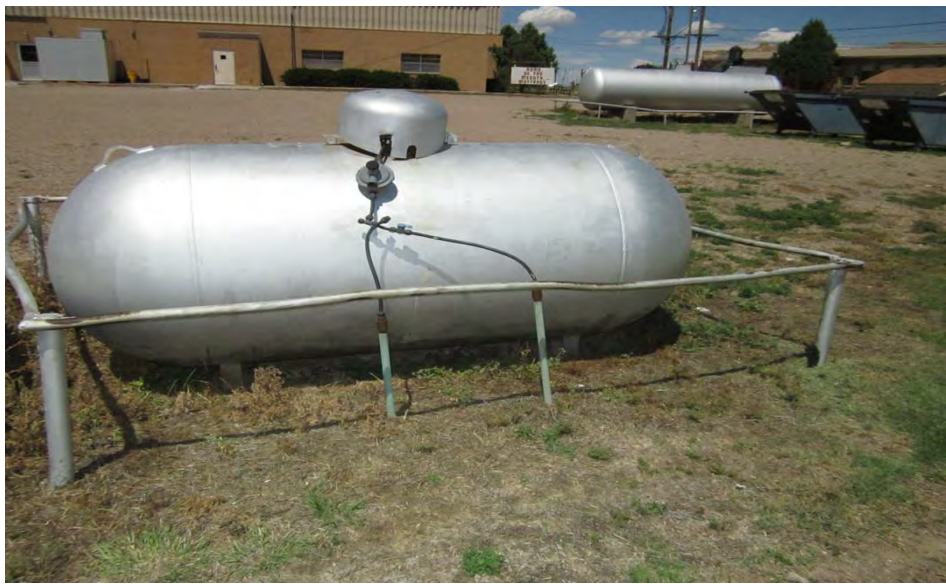
**Photo 22**      **Location: West Side of School**      **Date: 08/06/2013**  
Looking at smaller propane AST

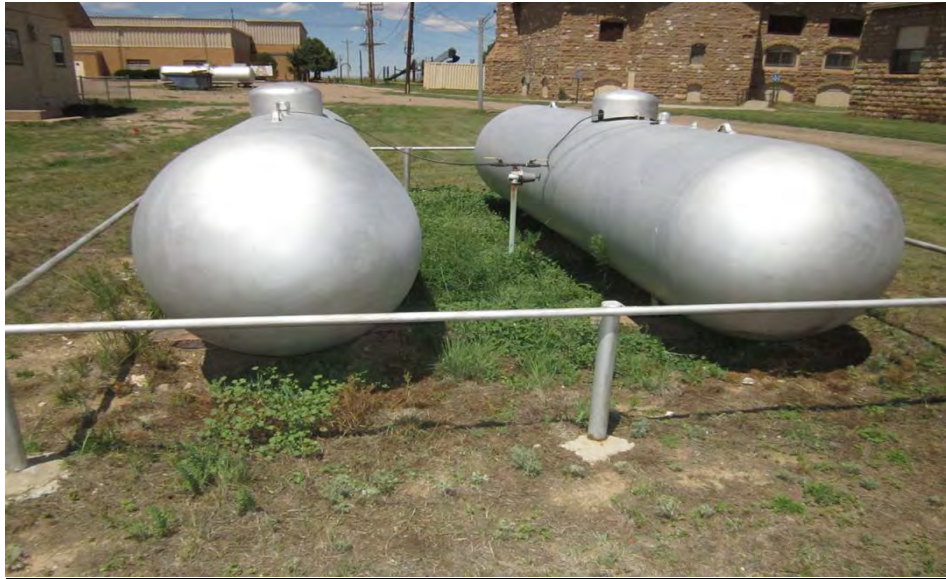
**Photo 23**      **Location: West Side of School**      **Date: 08/06/2013**  
Looking at two propane ASTs

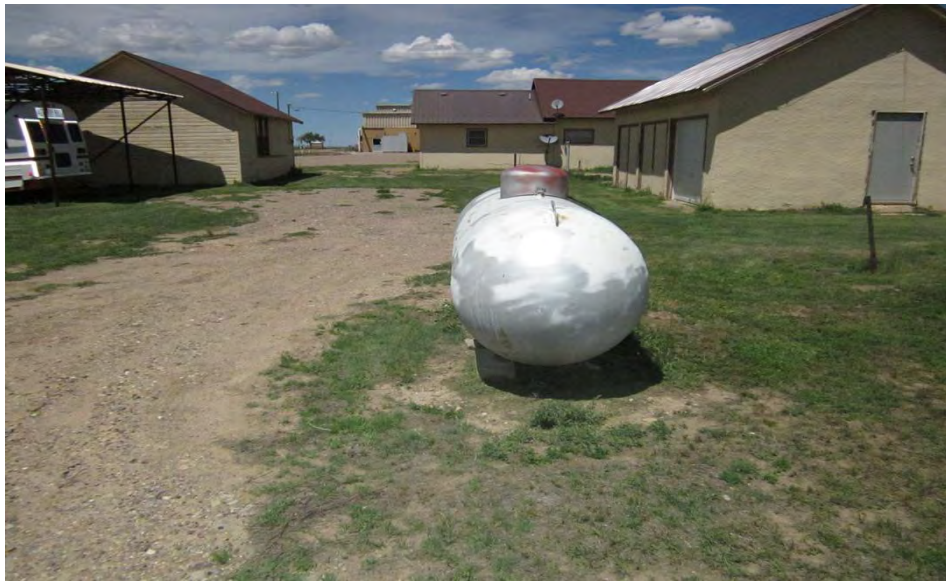
**Photo 24**      **Location: West Side of School**      **Date: 08/06/2013**  
Looking at propane AST

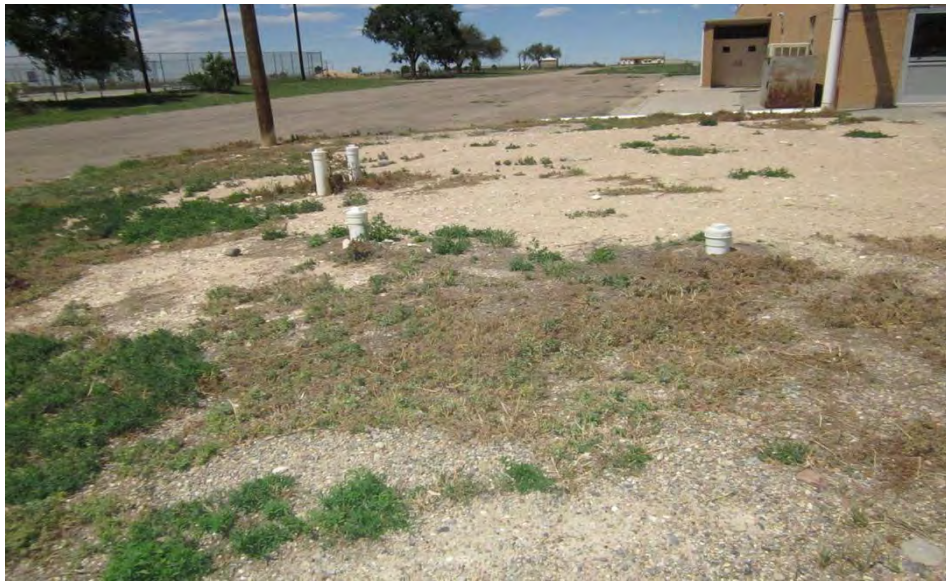
**Photo 30**      **Location: West Side of Site**      **Date: 08/06/2013**  
Facing north, looking at pipes protruding from septic system

During the site reconnaissance, a septic field with protruding PVC stick-ups was observed on the western boundary of the site. The presence and use of the septic system was confirmed by the School Superintendent, Monica Johnson. Ninyo & Moore does not consider the septic system to represent a REC for the site.

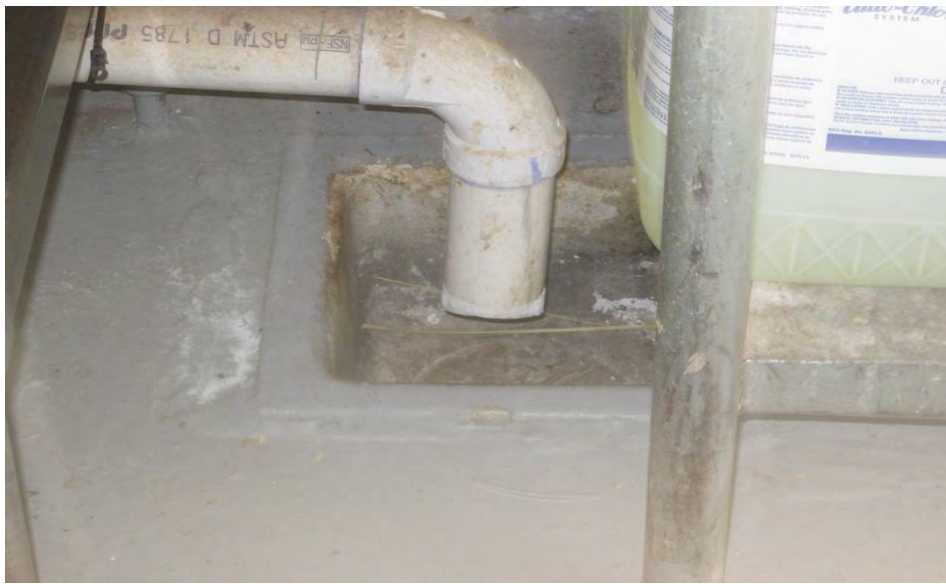
**Photo 34**      **Location: Inside Elementary School**      **Date: 08/06/2013**  
Looking at drain on floor in kitchen

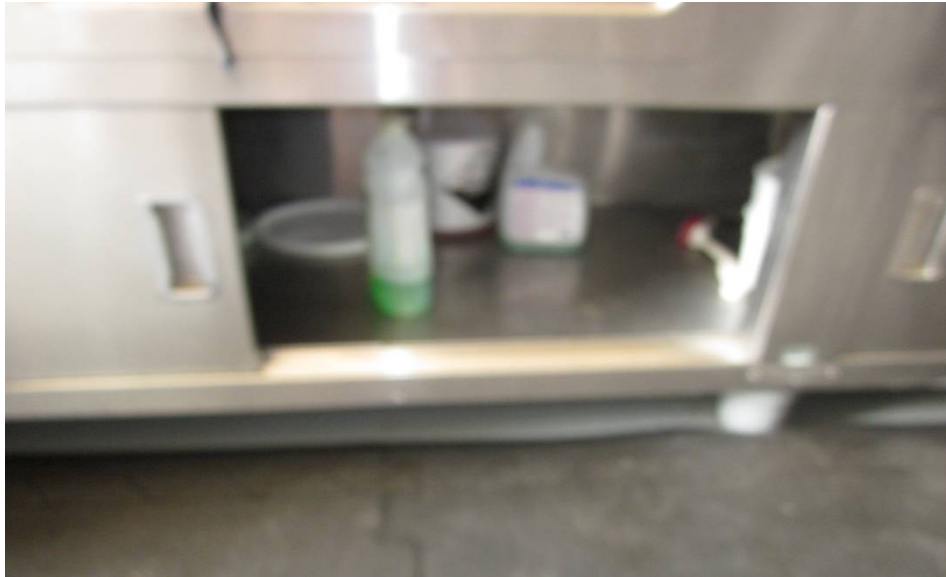
**Photo 35**      **Location: Inside Elementary School**      **Date: 08/06/2013**  
Looking at storage of basic kitchen cleaning chemicals

- Cleaning chemicals in retail-sized containers are located within the school buildings. Additionally paints and solvents in retail-sized containers and compressed gas canisters are also stored in the vocational agriculture building. Leaks or spills were not observed within the vicinity of the chemicals being stored. Ninyo & Moore does not consider the storage and use of these chemicals a recognized environmental condition (REC) for the site.

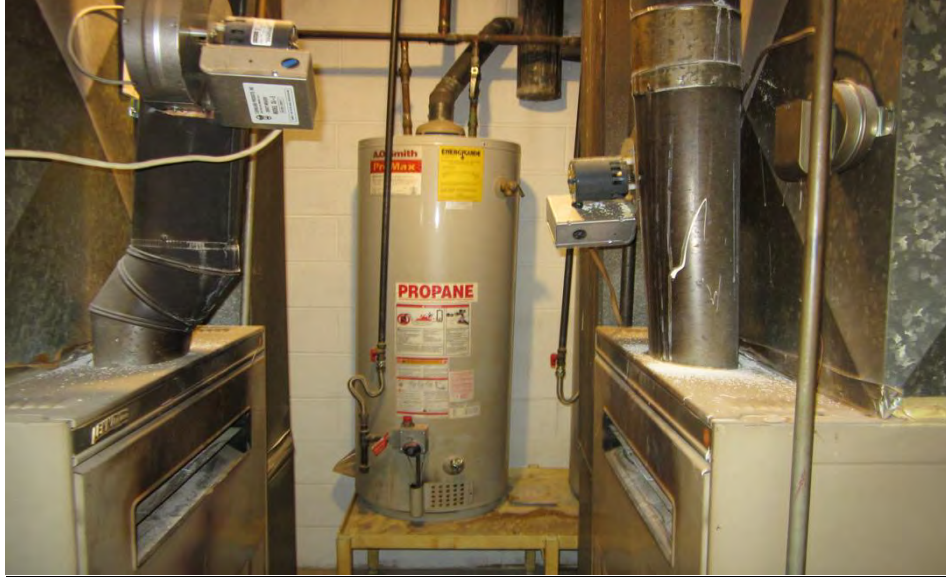
**Photo 37**      **Location: Inside Elementary School**      **Date: 08/06/2013**  
Looking at mechanical room with water heater

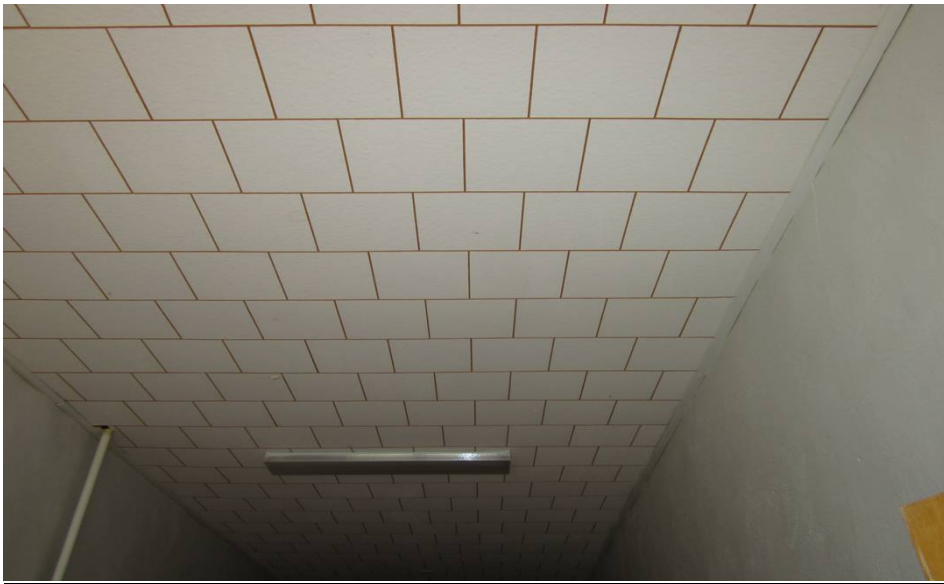
Looking at ceiling tiles in building 3

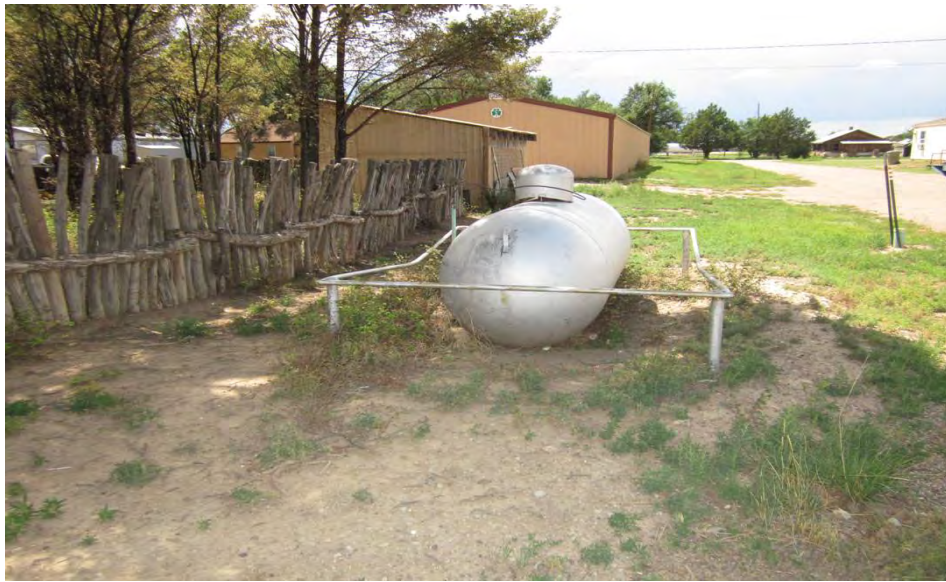
**Photo 46**                      **Location: Near Vocational Building**                      **Date: 08/06/2013**  
Looking at propane AST

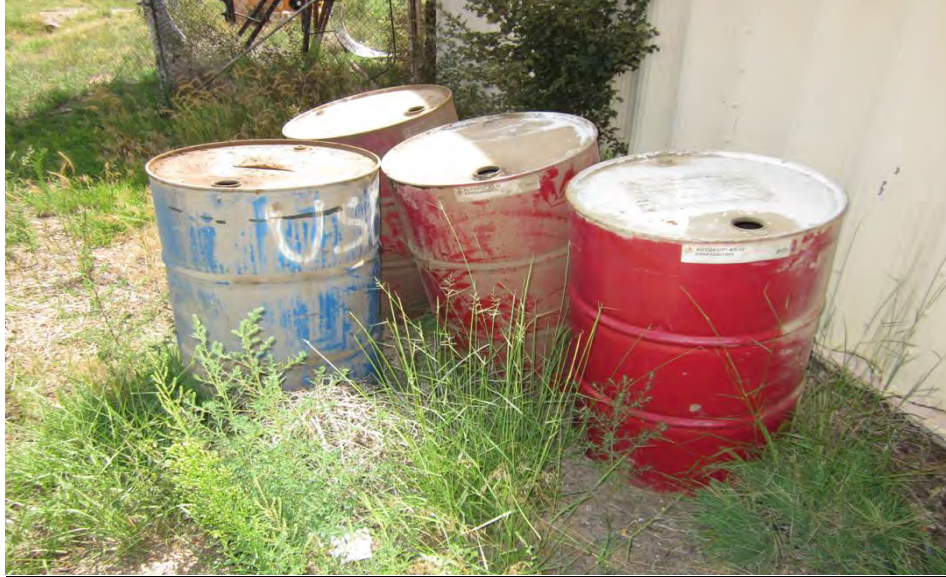
Looking at empty 55 gallon drums that are used in the welding class

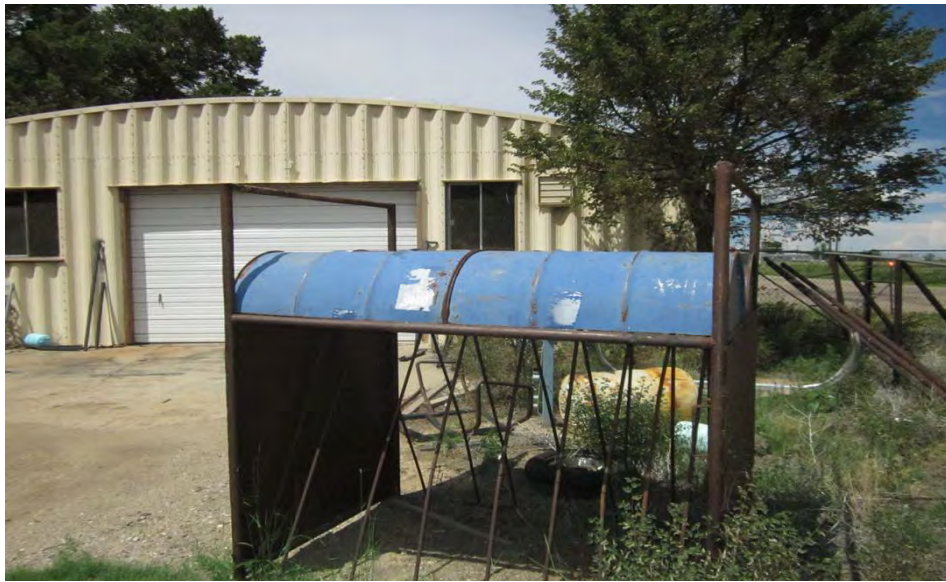
Looking at empty 55 gallon drums that are used in the welding class

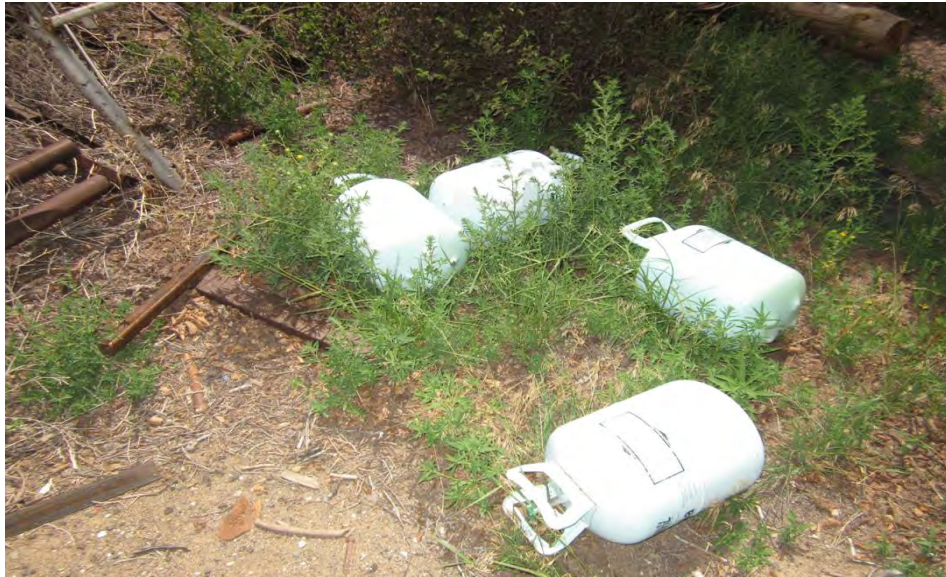
**Photo 49**      **Location: Near Vocational Building**      **Date: 08/06/2013**  
Looking at empty propane tanks
