# BARRINGTON PUBLIC SCHOOLS MASTER PLAN

## STAGE 1 RIDE SUBMISSION

TOWN of BARRINGTON PUBLIC SCHOOL DISTRICT  
283 COUNTY ROAD  
FEBRUARY 15, 2023

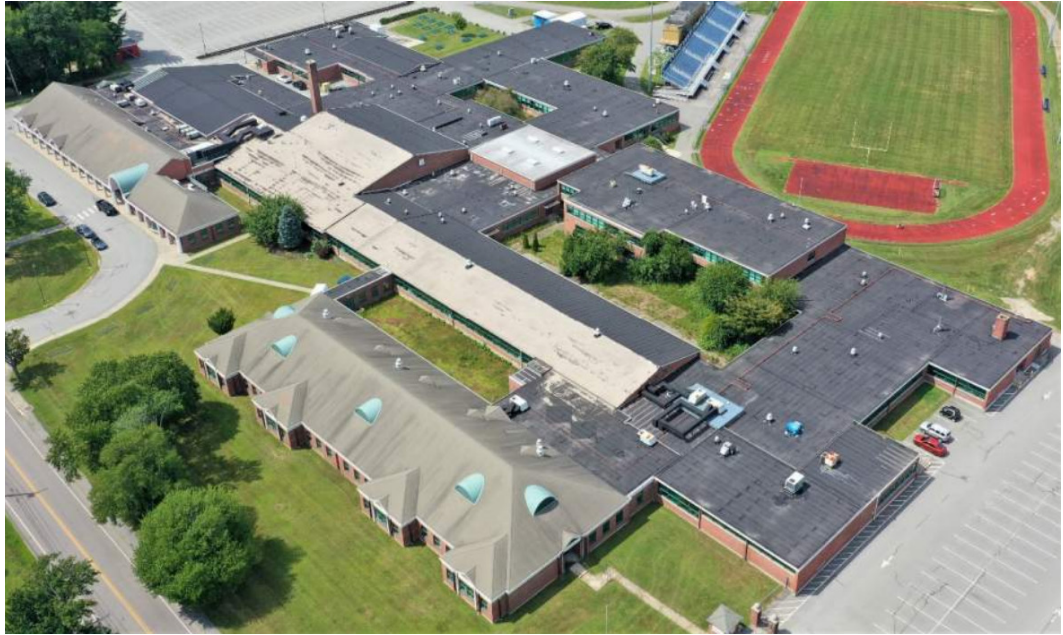
Overall aerial photo of Barrington High School at 220 Lincoln Avenue, looking northwest taken by Odeh Engineers with a drone

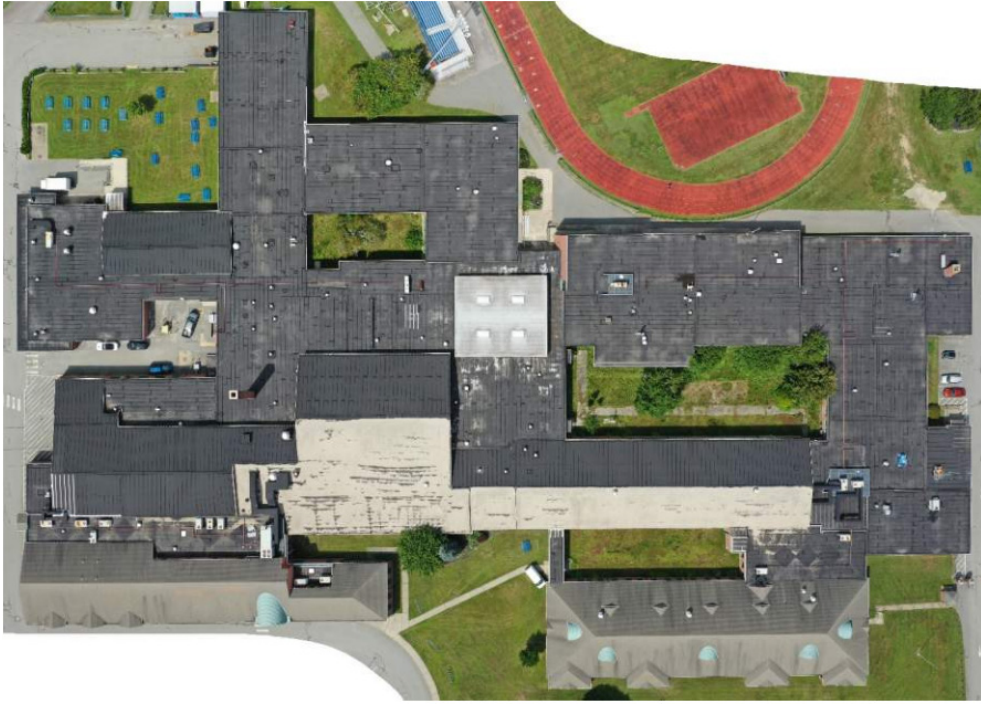
Overall aerial photo of Barrington High School at 220 Lincoln Avenue taken by Odeh Engineers with a drone. North is oriented upwards on the page

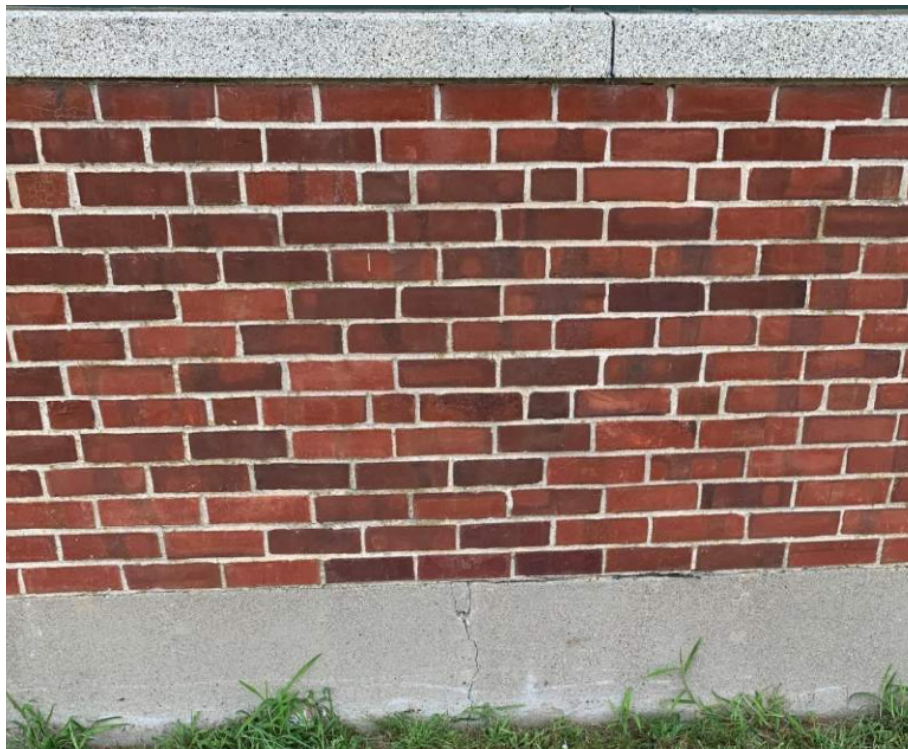
Based upon what could be see above grade, the foundation walls appear to be cast in place concrete.

Photo of typical cast-in-place concrete foundation wall

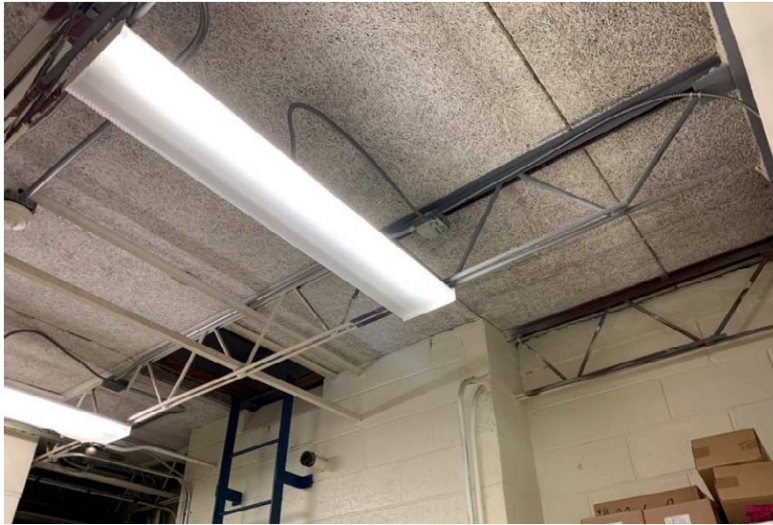
Photo of open web steel joists supporting tectum roof panels in one of the utility rooms.

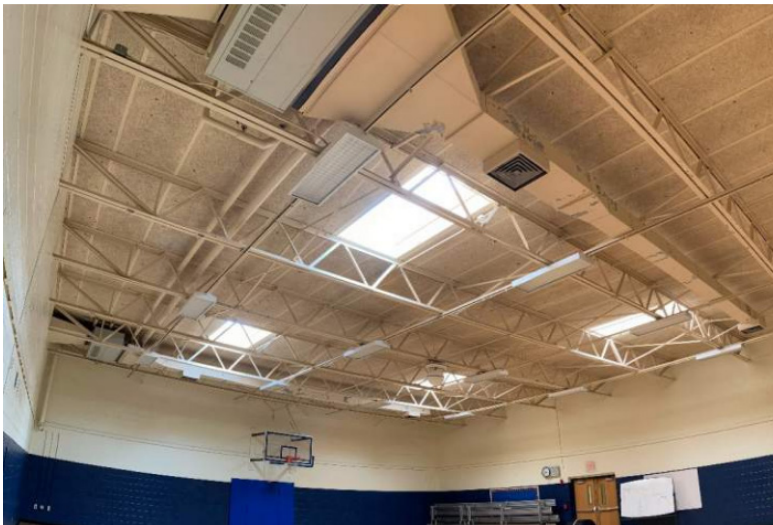
Photo of long span steel joists in the auxiliary gym supporting tectum roof panels.

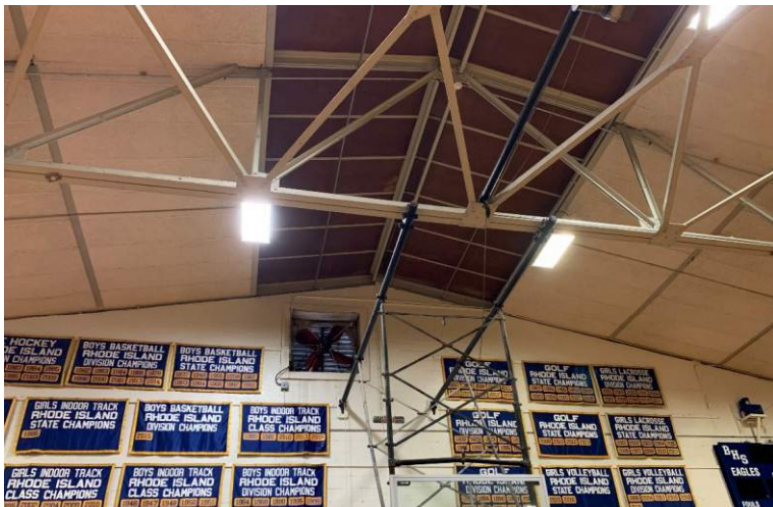
Photo of a metal truss in the gym supporting tectum roof panels.

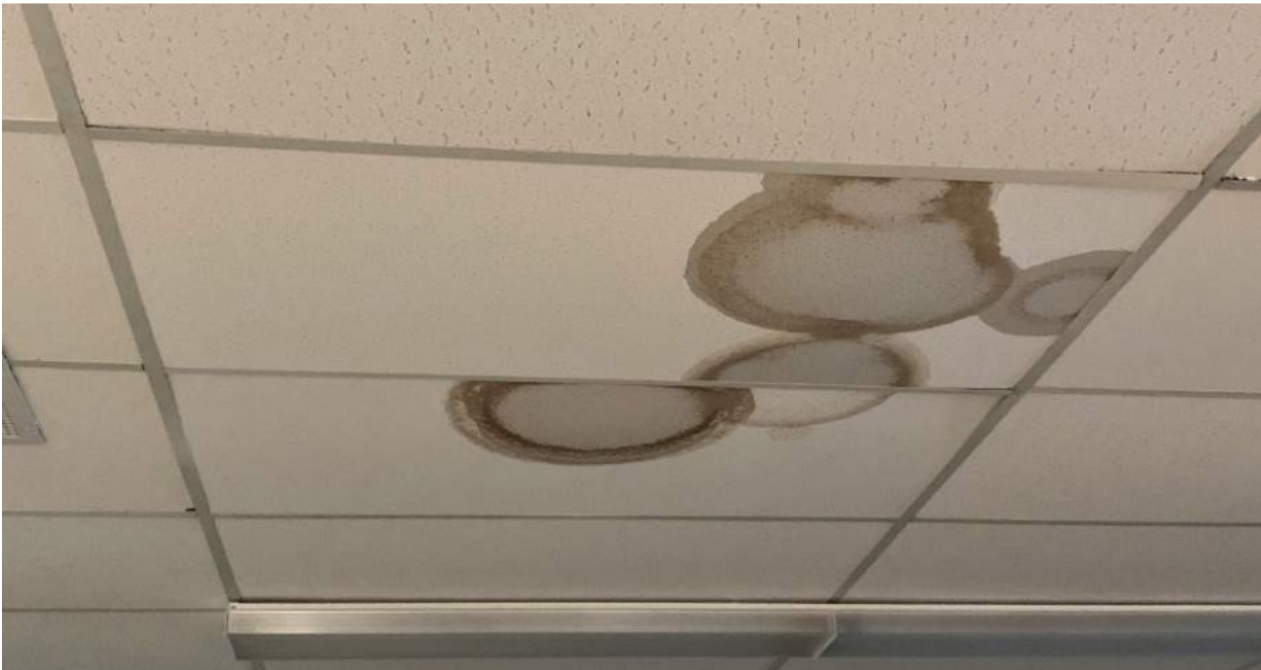
## WATER STAINED CEILING TILES

Comments and recommendations: In several locations throughout the building, water stained ceiling tiles and active water leaks were observed. Prolonged water infiltration may cause deterioration to the roof elements, structural system, and interior finishes. Further investigation is required to determine the cause of the water infiltration.

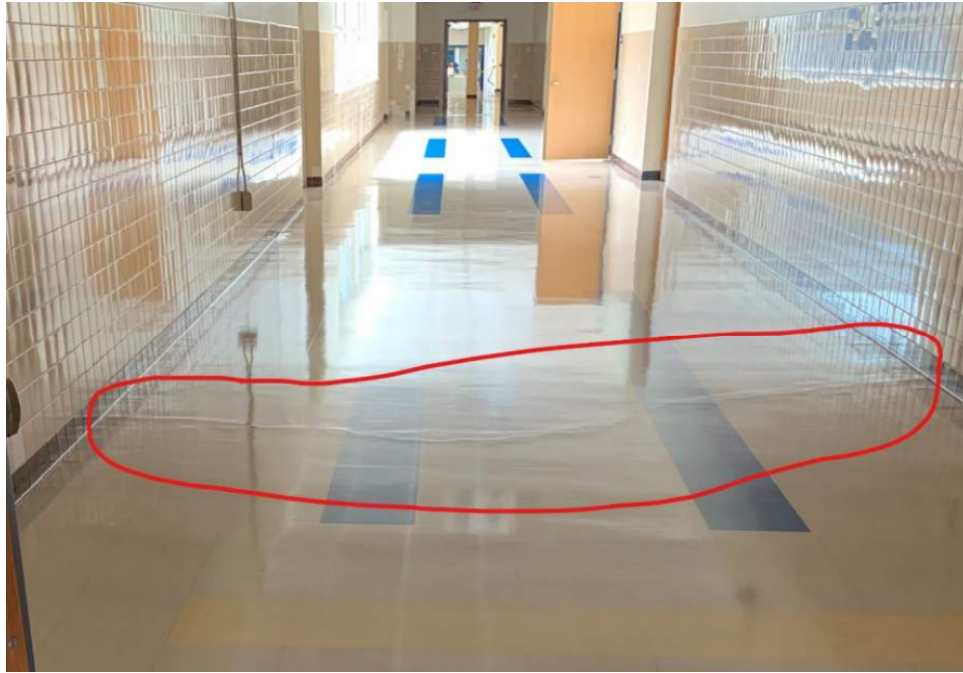
### CRACKS IN THE FLOOR FINISH

Comments and recommendations: In several locations throughout the building, the floor finish is cracked and/or raised which may create a tripping hazard. These cracks may be due to the cracking of the concrete slab underneath due to settlement and/or insufficient control joints. It is recommended that the floors be repaired as necessary to provide a smooth walking surface.

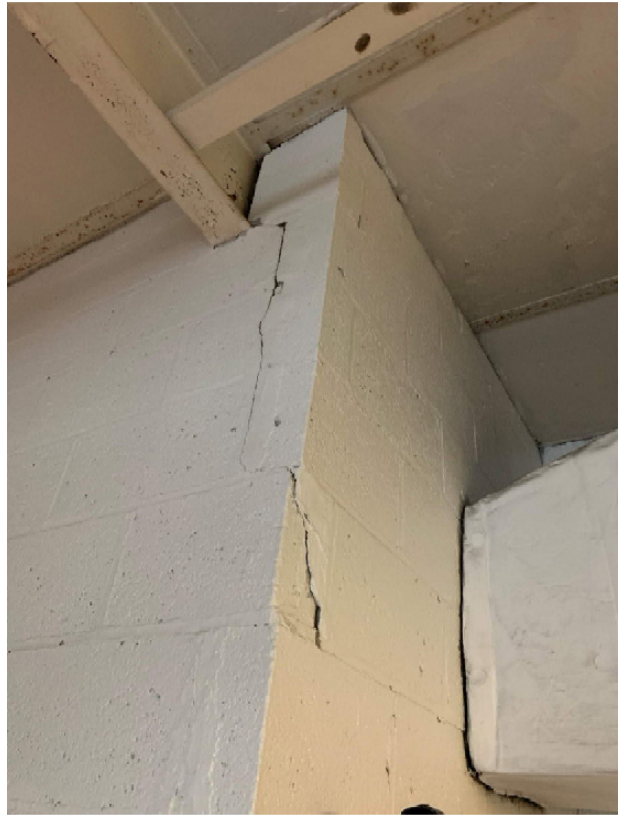
### VERTICAL CRACKING IN INTERIOR CMU WALLS

Comments and recommendations: In various locations throughout the building, the cmu walls have vertical cracks through the cmu and at the mortar joints. These vertical cracks do not appear to currently pose a structural hazard and most likely resulted from horizontal dimensional changes (expansion and contraction) of the building materials due to changes in temperature and humidity. It is recommended that these cracks be periodically monitored to confirm that the cracks are dormant.

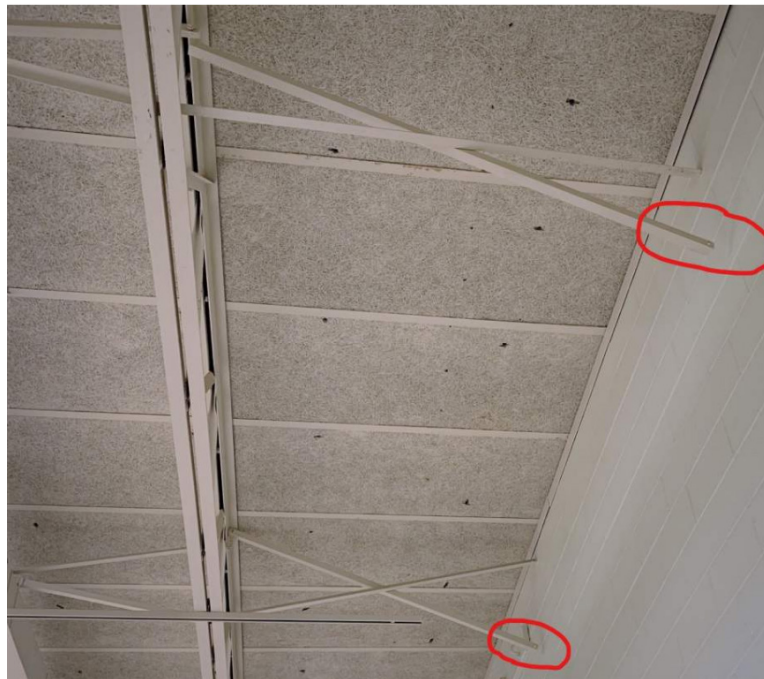
### POSSIBLE UNDER-DESIGNED ROOF TRUSSES SUPPORTING BASKETBALL HOOPS

Comments and recommendations: In the main gymnasium, the basketball hoop support framing is connected to the roof trusses between panel point and is not reinforced at these locations. It is recommended that the existing structural drawings be reviewed and/or the metal truss manufacturer be contacted to verify that the trusses were designed to support the basketball hoop framing as it has been built.

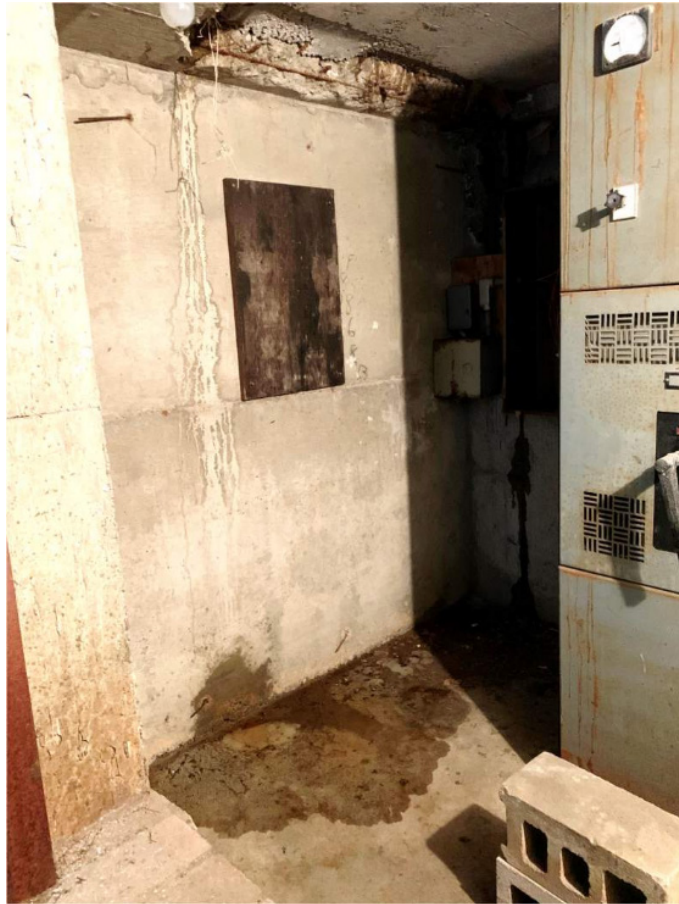
Comments and recommendations: In the electrical room adjacent to the boiler room, there are several locations of cracked and spalled concrete, rusting reinforcement bars, efflorescence and water was actively leaking into the room. Due to the significance and potentially hazardous nature of the equipment in this room, it is recommended that the concrete, reinforcement, and water penetrations be repaired at once.

Additional photo showing spalled concrete, exposed and rusting reinforcement bars and efflorescence in the electrical room adjacent to the boiler room.

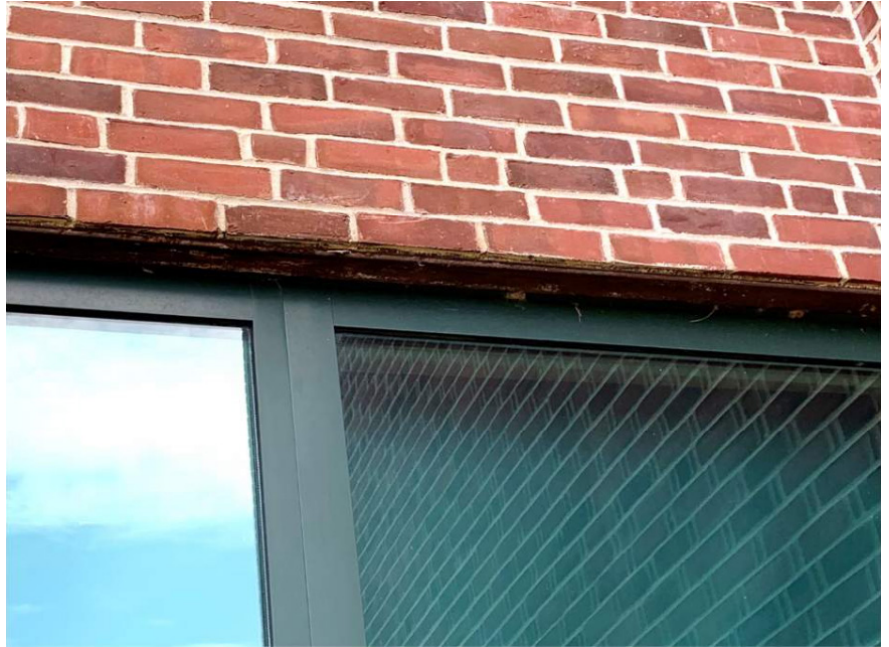
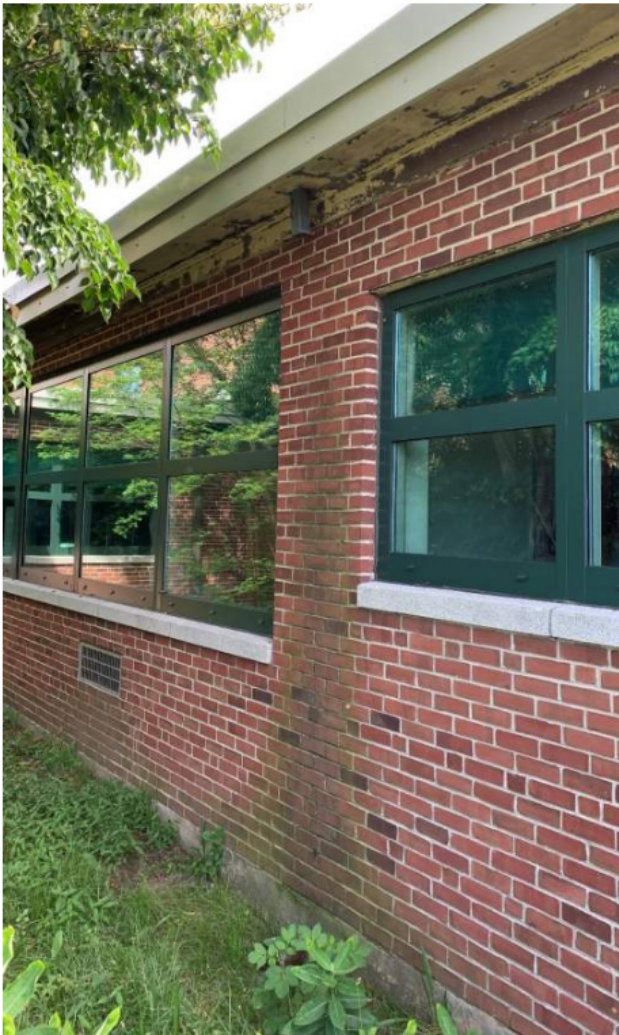
## LINTEL RUSTING

Comments and recommendations: The lintels are showing signs of rusting at several locations. The rusting does not appear to currently pose a structural hazard, however, rusting of the lintels can sometimes result in expansion which then can cause cracking of the adjacent materials if this expansion cannot be accommodated. A lack of weep holes will trap water behind the brick which could further accelerate rusting. It is recommended that the areas of rust be cleaned, primed, and finished with an appropriate coating system and weep holes be installed.

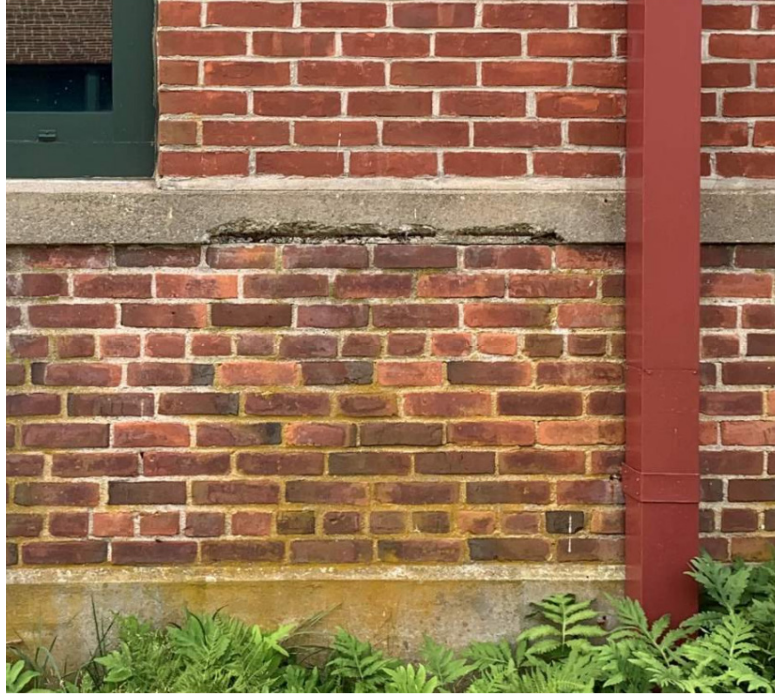
### SPALLED CONCRETE AND EXPOSED REINFORCEMENT BAR AT WINDOW SILL

Comments and recommendations: Spalled concrete and exposed reinforcement bars at the concrete window sill were observed at various locations. The exposed reinforcement bar has rusted. If the rust is allowed to continue developing, more concrete could spall off, potentially causing property damage or personal injury. It is recommended that the spalled concrete and rusted reinforcement be repaired using high-performance concrete repair products.

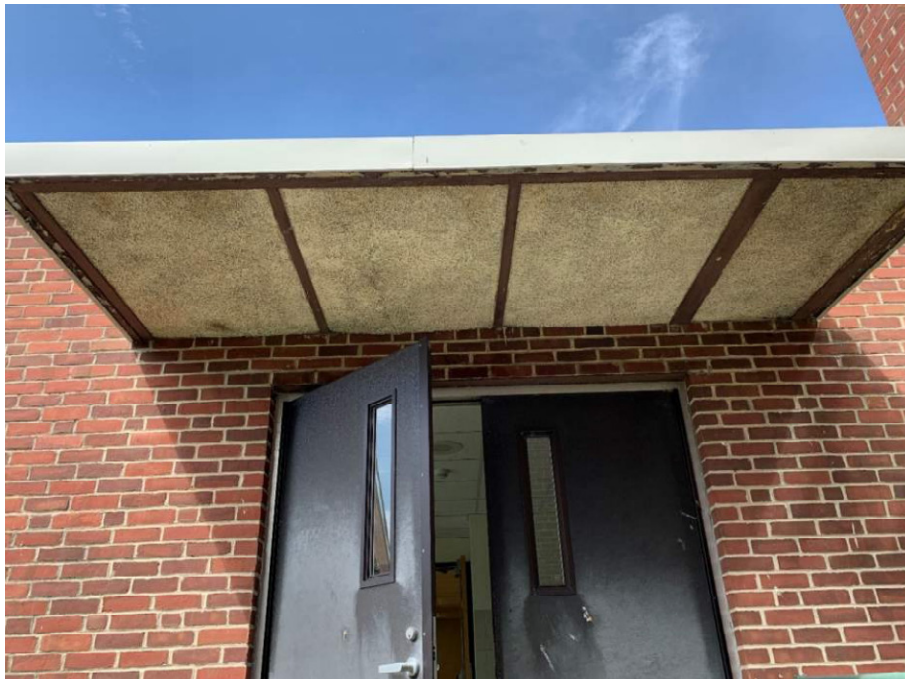
### RUSTED STEEL AND DAMAGED ROOF PANELS

Comments and recommendations: In the north-eastern courtyard, both roofs above the doors appear to have rusting framing and damaged panels. If the rust is allowed to continue to develop or the damaged panels are not repaired, it could eventually lead to failure and collapse, potentially causing property damage or personal injury. It is recommended that the rust be removed, and the framing be re-finished with an appropriate coating system and that the panels be replaced.

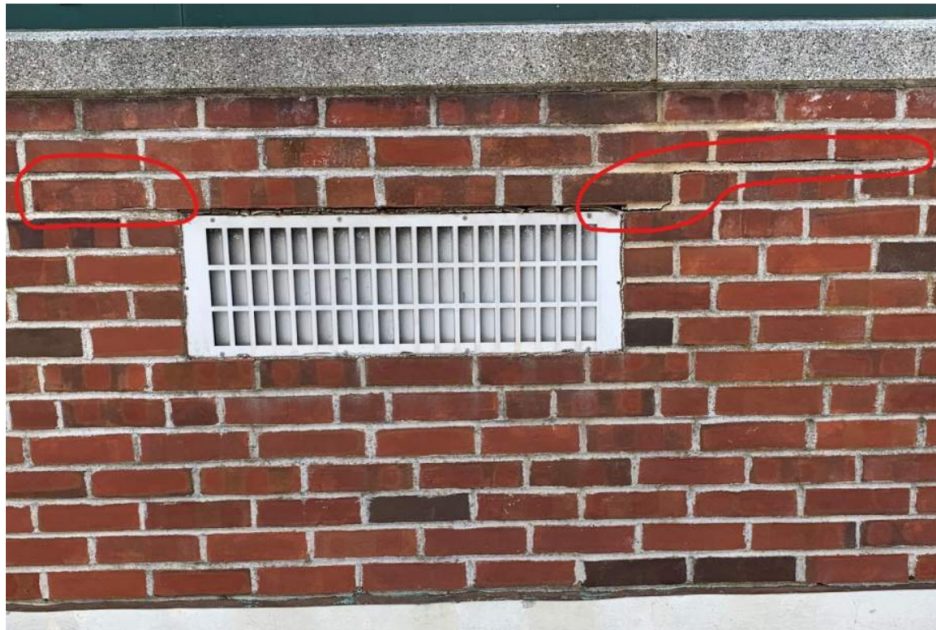
## BRICK JOINT CRACKING AT VENTS

Comments and recommendations: At most of the wall vents, the adjacent brick mortar joints have cracked. While these cracks do not appear to currently pose a structural hazard, these cracks may allow water and air infiltration into the building envelope. To extend the life of the exterior brick veneer walls and to protect the building structure and the interior finishes, it is recommended that a maintenance program be established to repair the cracks in the exterior brick masonry walls.

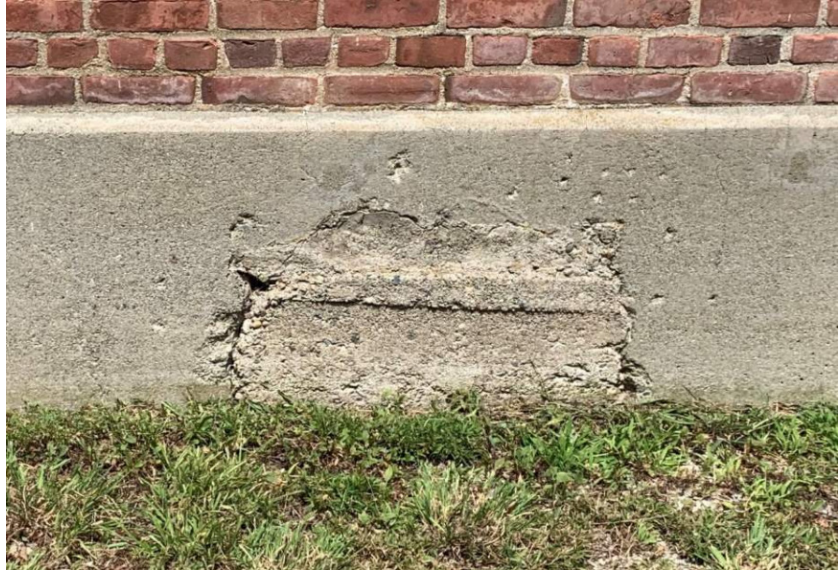
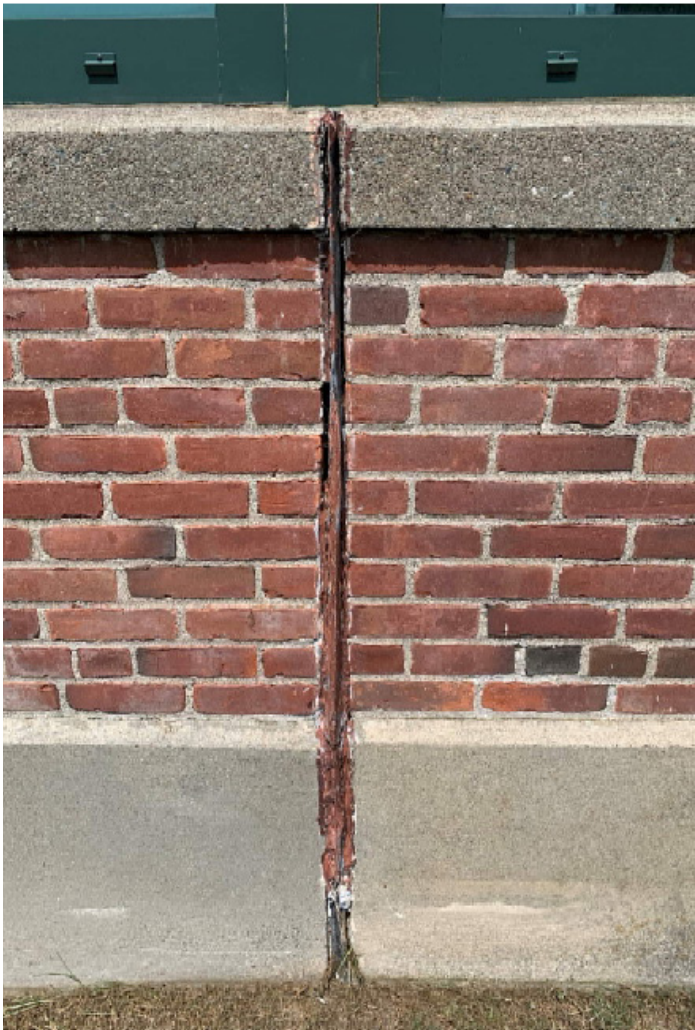
### PREVIOUS CONCRETE REPAIRS

Comments and recommendations: There are a few various locations of previous concrete repairs which appear to have voids. These voids do not appear to currently post a structural hazard; however, these voids may allow water and air infiltration into the building foundation. To extend the life of the concrete walls and to protect the building, it is recommended that the concrete voids be repaired with high-performance concrete repair materials.

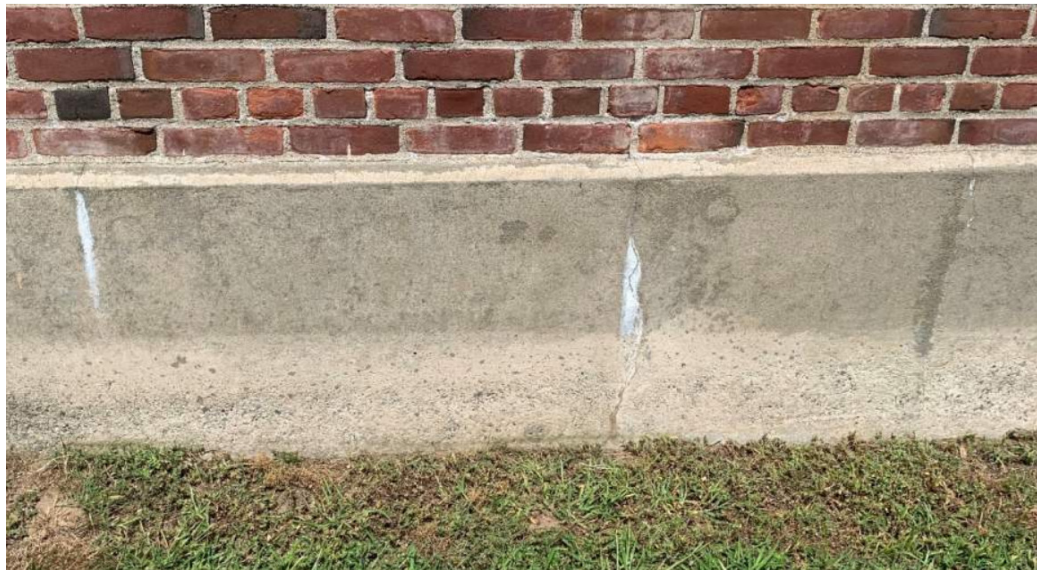
### CONTROL JOINTS IN THE EXTERIOR WALL HAVE AGED AND FAILED

Comments and recommendations: There are several locations where the control joints in the exterior wall have aged, cracked and/or failed which may allow water and air to infiltrate the building envelope and possibly cause damage to the building structure and/or architectural finishes. It is recommended that a maintenance program be implemented to remove and replace all of the aged and failed control joints.

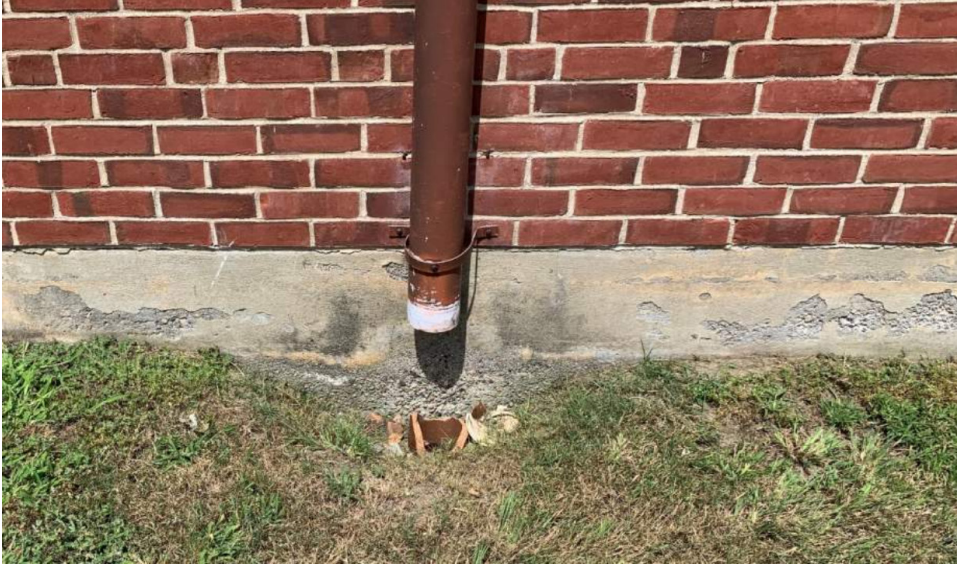
## DISCONNECTED DOWNSPOUT AND CONCRETE SPALLING

Comments and recommendations: At various locations, downspouts are no longer connected to the drainage system and part of the concrete has been eroded away. While this does not currently appear to be a structural hazard, if allowed to continue, additional concrete spalls, and possibly concrete cracks and exposure of reinforcement, may occur which could allow water and air infiltration into the building envelope which could lead to damage to the structure. To extend the life of the exterior concrete walls and to protect the building structure, it is recommended that the downspouts be properly connected, and a maintenance program be established to repair the cracks in the exterior concrete walls.

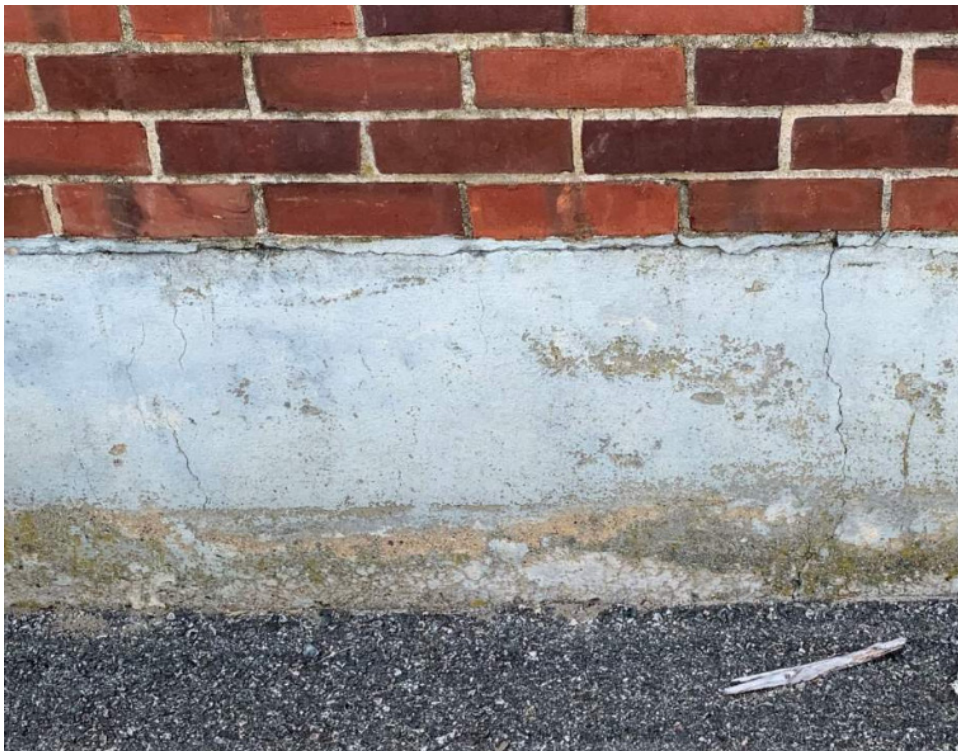
## MINOR CONCRETE WALL CRACKING

Comments and recommendations: There are various locations of minor concrete cracking at the exterior concrete walls. These cracks do not currently appear to pose a structural hazard. To extend the life of the concrete walls and to protect the building, it is recommended that a maintenance program be established to repair the cracks in the exterior concrete walls.

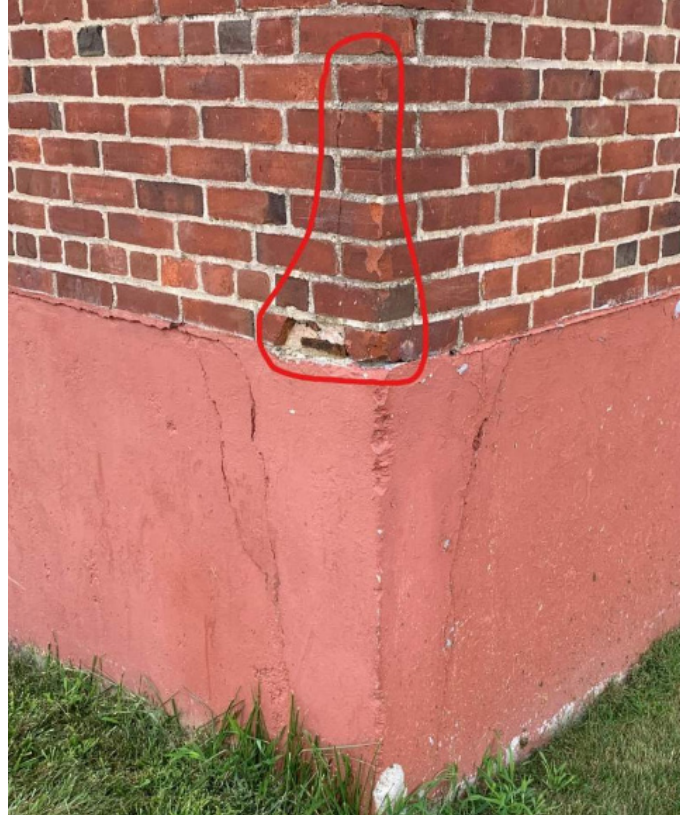
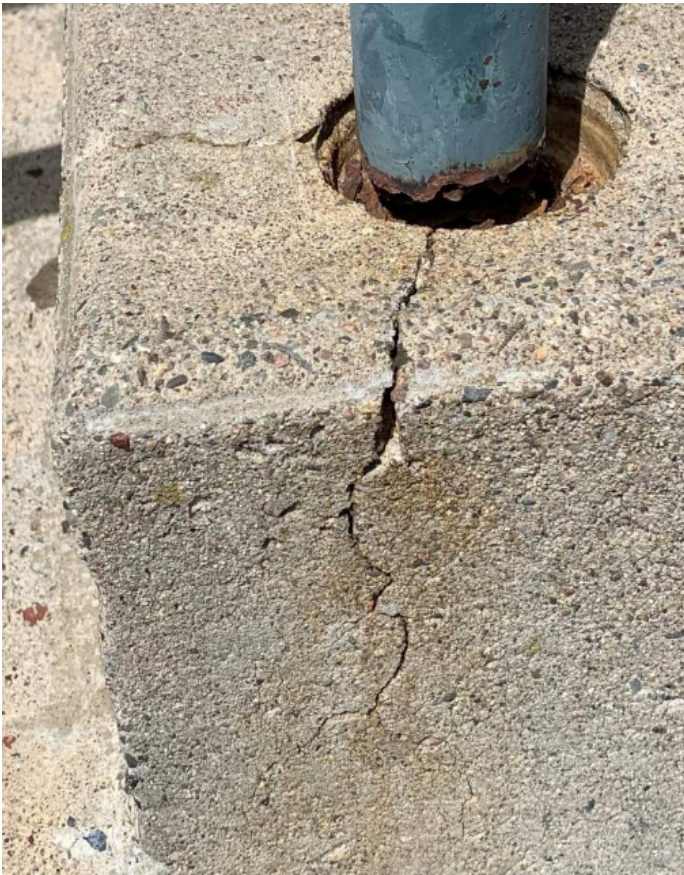
### MAJOR CONCRETE WALL CRACKING

Comments and recommendations: There are few locations of major concrete cracking at the exterior concrete walls. While they do not currently appear to be a structural hazard, the cracks are large enough to possibly allow water and air infiltration into the building envelope which could lead to damage to the structure. To extend the life of the concrete walls and to protect the building, it is recommended that the concrete cracks be repaired with high-performance concrete repair materials.

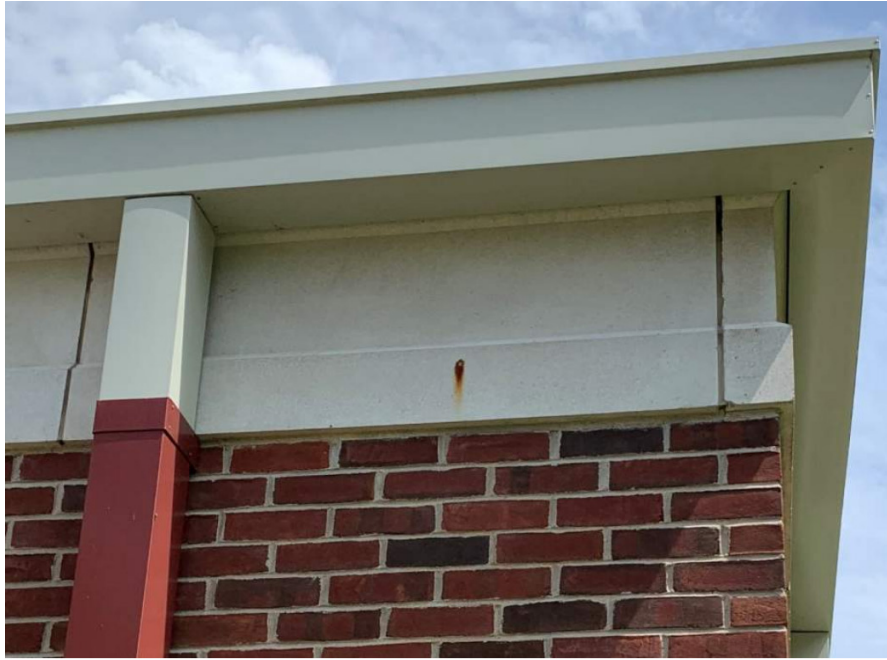
## STAINING ON PRE-CAST COMPONENTS

Comments and recommendations: At various locations, rust staining was observed on several pre-cast components. To extend the life of the components and to protect the building structure and the interior finishes, it is recommended that a building envelope specialist be consulted to determine the source and cause of the staining and the required repairs.

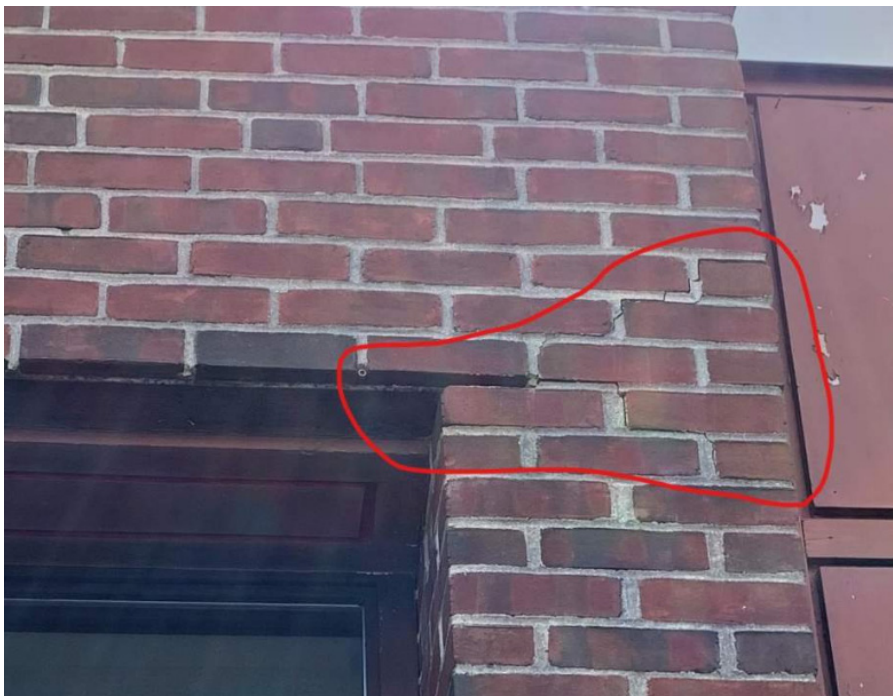
## RUSTED LINTEL AND BRICK JOINT CRACKS ADJACENT TO LIBRARY.

Comments and recommendations: Rust on a window lintel and cracked mortar joints were observed adjacent to the library. The cracked mortar joints may be caused by settlement, or the expansion of the steel lintel due to rust. While it currently does not appear to post a structural hazard, the rust should be removed from the lintel and be re-finished with an appropriate coating system, and the cracks should be periodically monitored to confirm they are dormant.

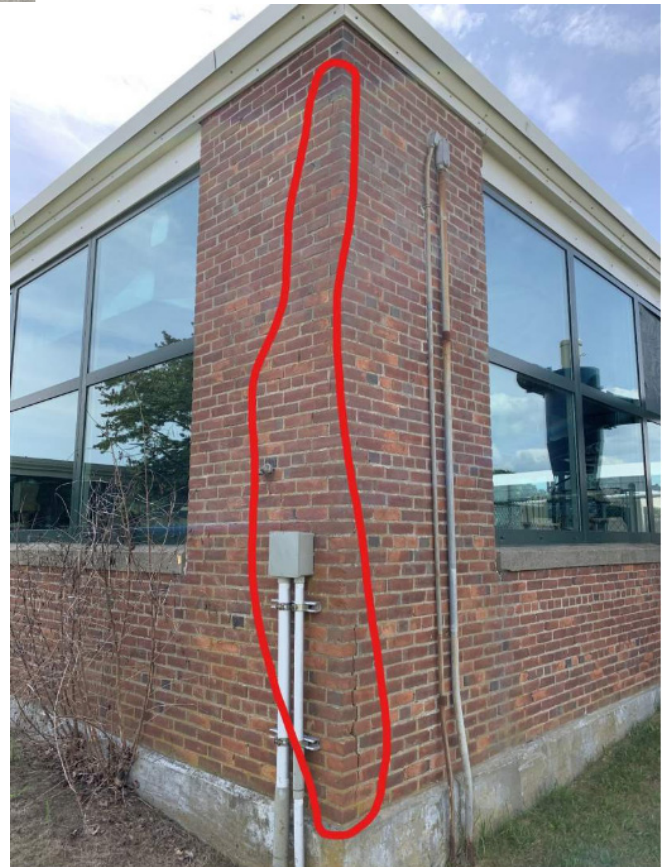
### BRICK CRACKS AT THE NORTH EAST CORNER OF THE WOOD SHOP

Comments and recommendations: The exterior north east corner of the wood shop has several cracks in the brick. These cracks do not appear to currently pose a structural hazard. However, these cracks may allow water and air infiltration into the building envelope. To extend the life of the exterior walls and to protect the building structure and the interior finishes, it is recommended that a maintenance program be established to repair the cracks.

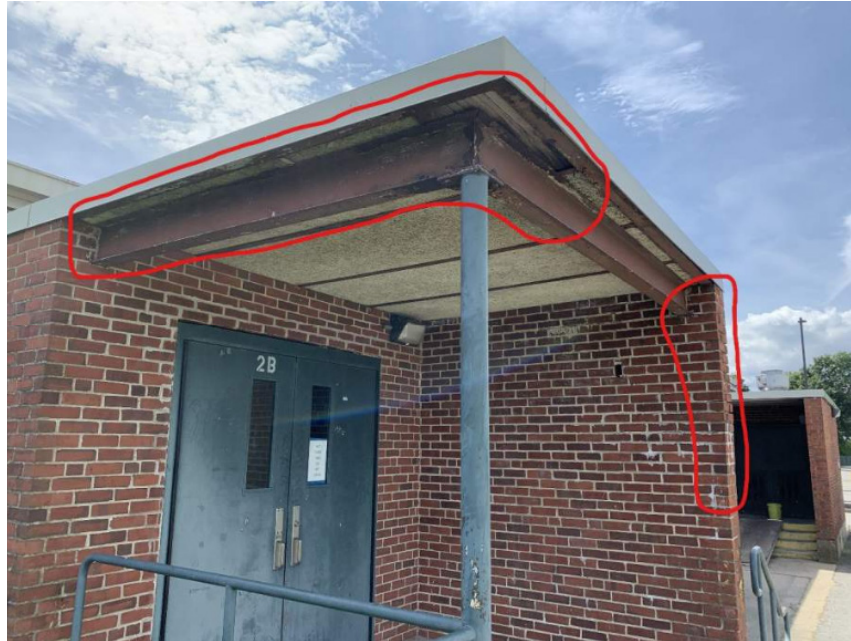
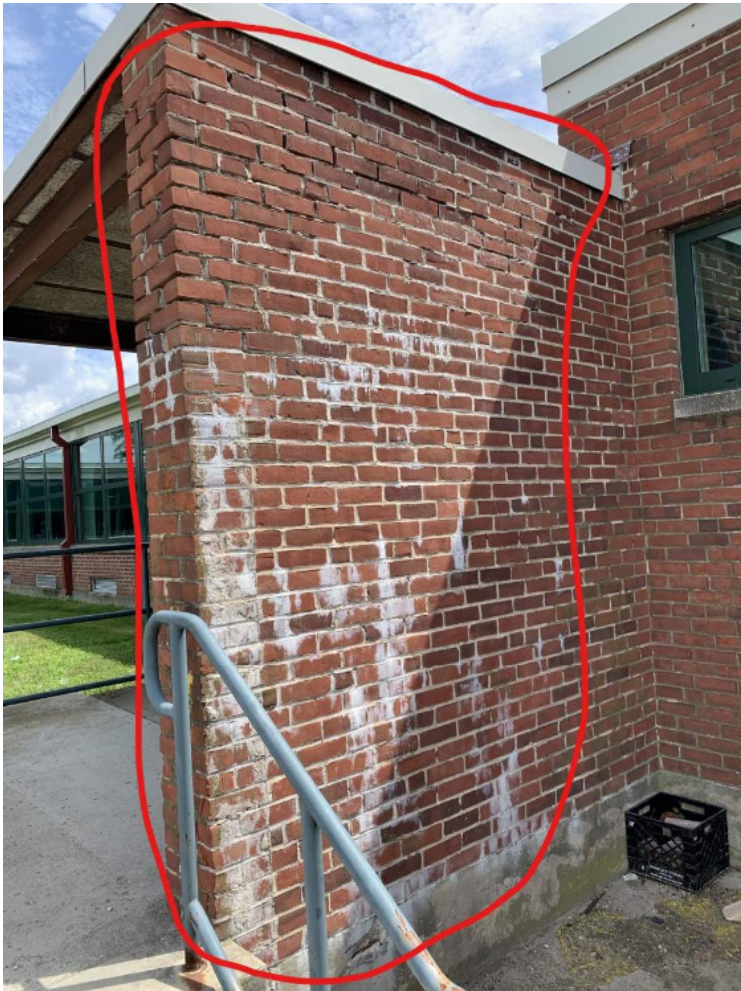
## RUSTING FRAMING, ROOF PANEL DETERIORATION AND DAMAGED BRICK.

Comments and recommendations: At the north side entrance to the cafeteria, the roof framing is rusted, the panels are deteriorated and the brick wall to the west has several cracks and is slightly displaced. Due to the extent of deterioration, and its location at an entrance/exit, it is recommended that this area be rebuilt or repaired at once.

*Additional photo of the west wall that is adjacent to the cafeteria's north side entrance.*

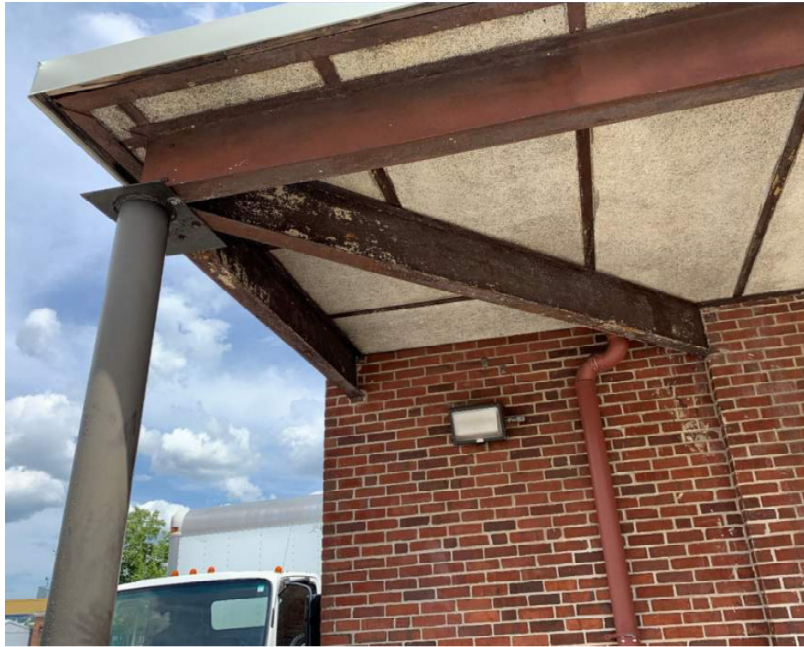
## RUSTED STEEL AND DAMAGED ROOF PANELS

Comments and recommendations: The canopy roof framing along the west face of the kitchen area appears to have rusting framing and damaged panels. If the rust is allowed to continue to develop or the damaged panels are not repaired, it could eventually lead to failure and collapse, potentially causing property damage or personal injury. It is recommended that the rust be removed, perform any repairs to the framing, and then re-finish the framing with an appropriate coating system and the panels be replaced.

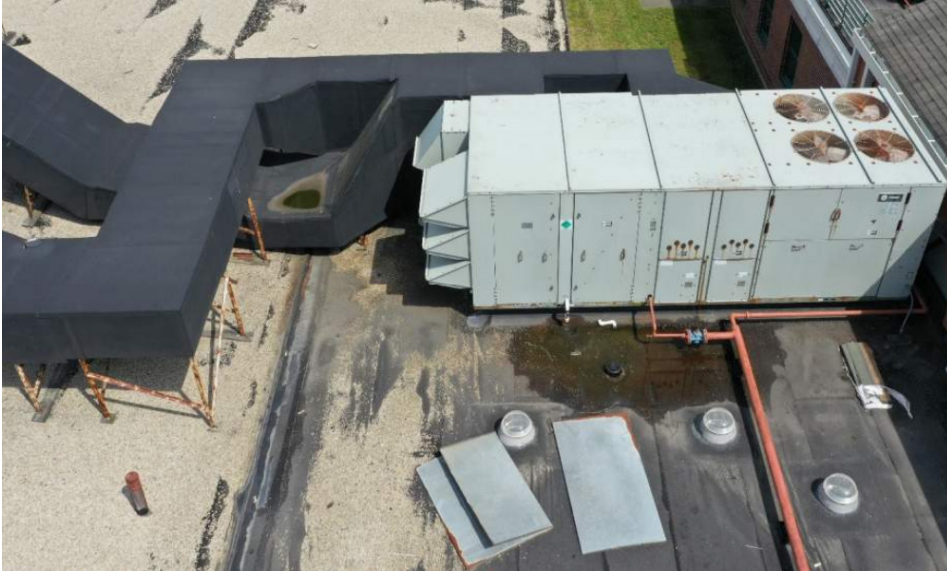
## PONDING WATER, RUSTED DUCT SUPPORTS, SHEET METAL

Comments and recommendations: The flat portion of roof at the south west area of the building has ponding water. Ponding of water can cause the roof to sag due to the weight of the water. As the roof sags, more water can become entrapped in the low spot of the roof, causing additional sagging. The roof structure must be adequately pitched, or tapered insulation below the roof membrane must be installed, to allow the water to flow to the roof drains. The roof drains must also be cleaned of any obstructions. The framing supporting the ductwork is showing signs of rust and should be inspected for deterioration. There are pieces of sheet metal on the roof which should be removed before they can be moved by wind and possibly cause damage to property or injure personnel. In addition, the roof structure must be investigated for snow drifting loads surrounding all rtu's and exposed ductwork.

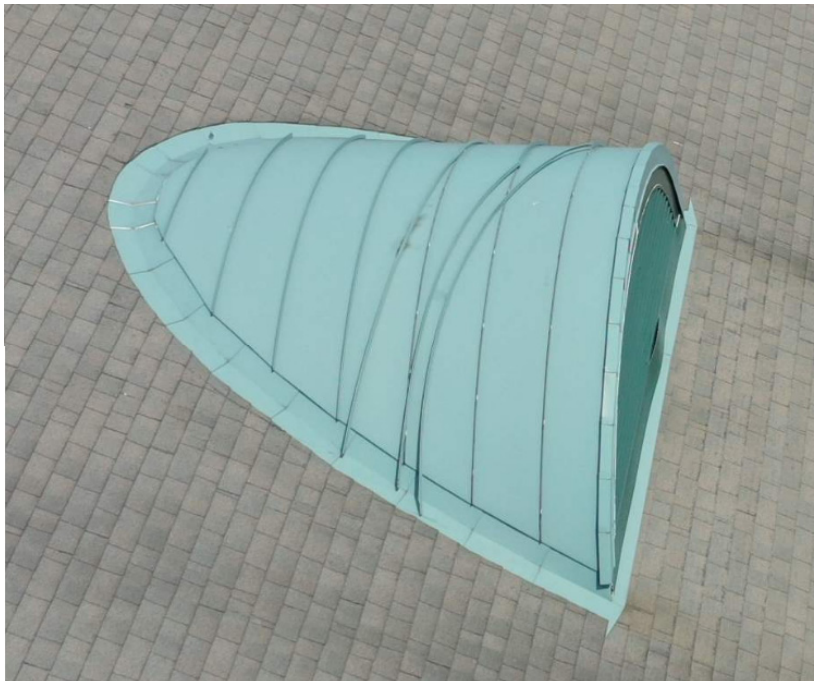
## DORMER ROOF UN-SEAMED, BUCKLED FLASHING

Comments and recommendations: The curved dormer on the south face, east end has become un-seamed and a portion of the flashing has buckled. These deficiencies may allow water and air to infiltrate the building envelope and possibly cause damage to the structure and interior architectural finishes. It is recommended that these repairs be performed by a contractor that specializes in metal roofing systems.

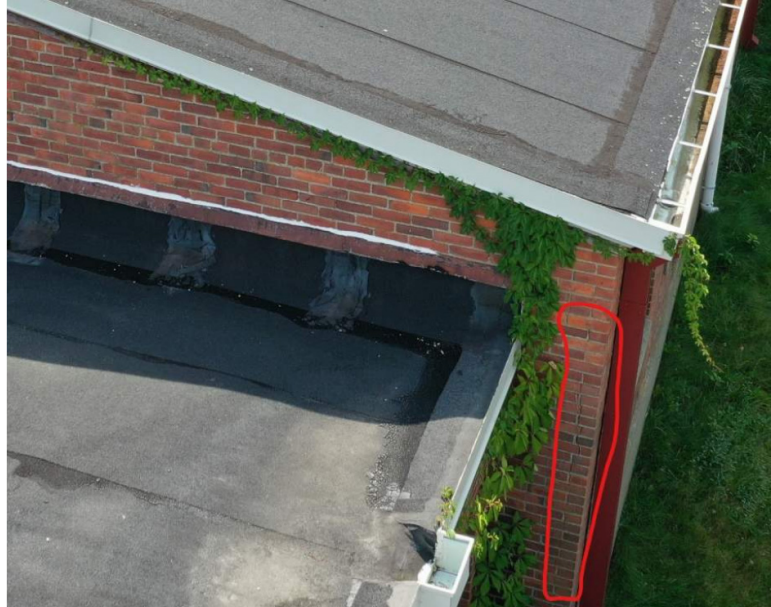
### VEGETATION UNDER ROOF EAVE, BRICK CRACKS

Comments and recommendations: At the north east courtyard's south east corner, vegetation is growing along the edge of the flashing and vertical cracks in the brick are visible. It is recommended that the vegetation be removed as it can create openings in the building envelope which may allow water and air infiltration that could cause damage to the structure and/or interior finishes. It is recommended that cracks in the bricks be repaired for the same reasons. In addition, the roof structure must be investigated for snow drifting loads at all high/low roof areas.

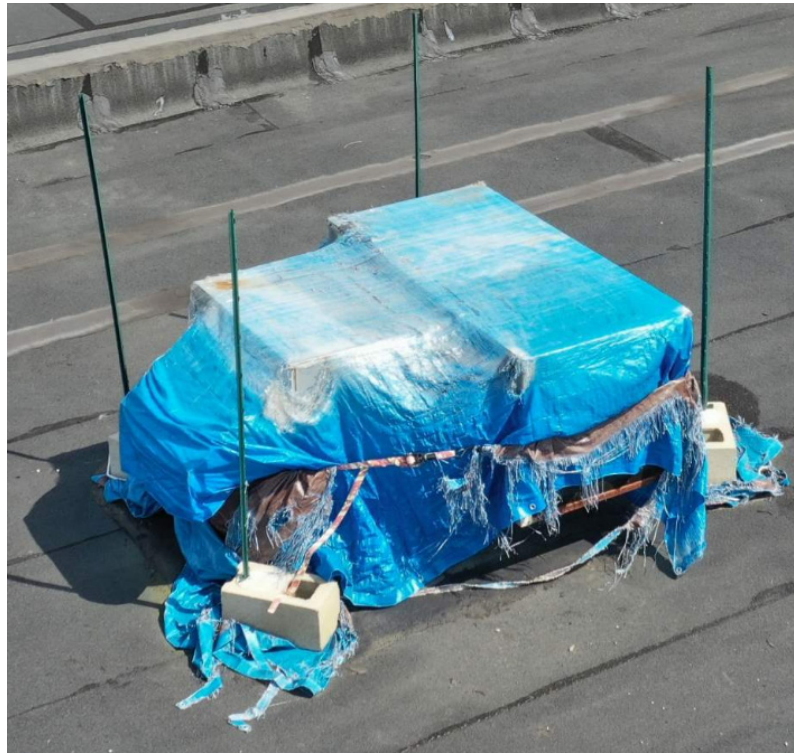
### ROOF TOP UNIT TARP DETERIORATED

Comments and recommendations: The tarp which has been wrapped over a roof top unit (RTU) on the east side roof appears to have reached the end of its usable life. It is recommended that the tarp be removed and replaced. In addition, the roof structure must be investigated for snow drifting loads surrounding all rtu's and exposed ductwork.
