# BARRINGTON PUBLIC SCHOOLS MASTER PLAN

## STAGE 1 RIDE SUBMISSION

TOWN of BARRINGTON PUBLIC SCHOOL DISTRICT  
283 COUNTY ROAD  
FEBRUARY 15, 2023

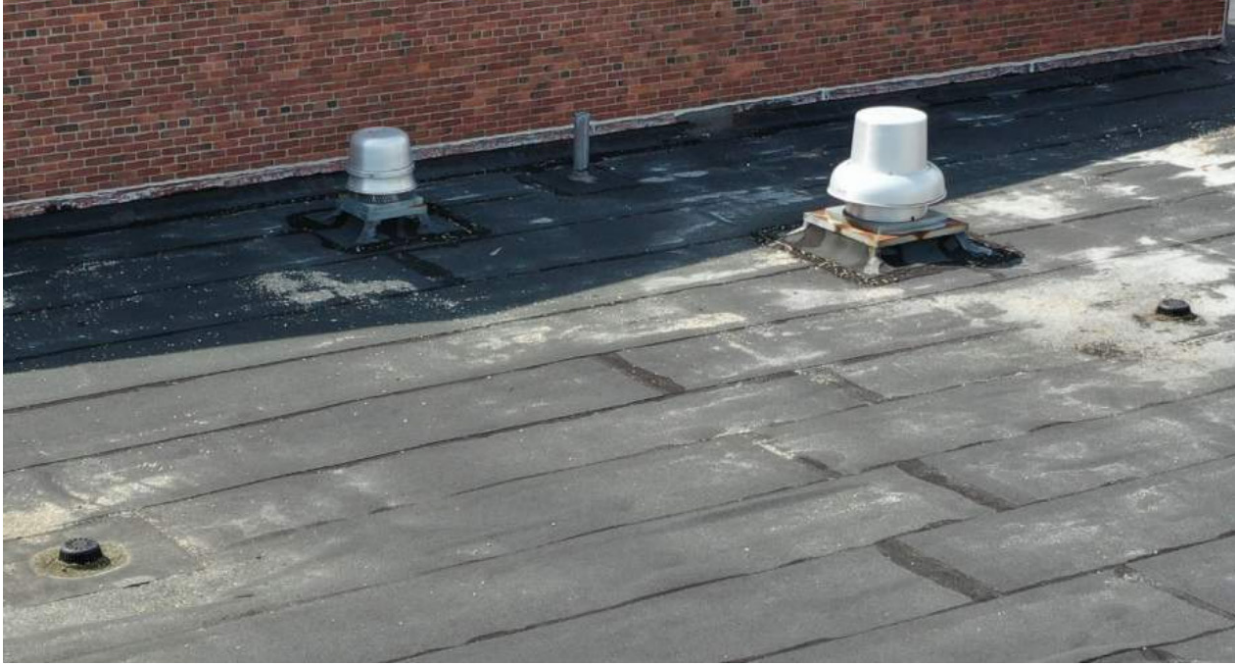
## PARTIALLY OBSTRUCTED ROOF DRAINS

Comments and recommendations: At various locations, roof drains appear to be partially obstructed. Obstructed roof drains can cause water ponding which can cause the roof structure to sag due to the weight of the water. As the roof sags, more water can become entrapped in the low spot of the roof, causing additional sagging. The roof structure must be adequately pitched, or tapered insulation below the roof membrane must be installed, to allow the water to flow to the roof drains. It is recommended that the roof drains be cleaned on a regular basis. In addition, the roof structure must be investigated for snow drifting loads at all high/low roof areas.

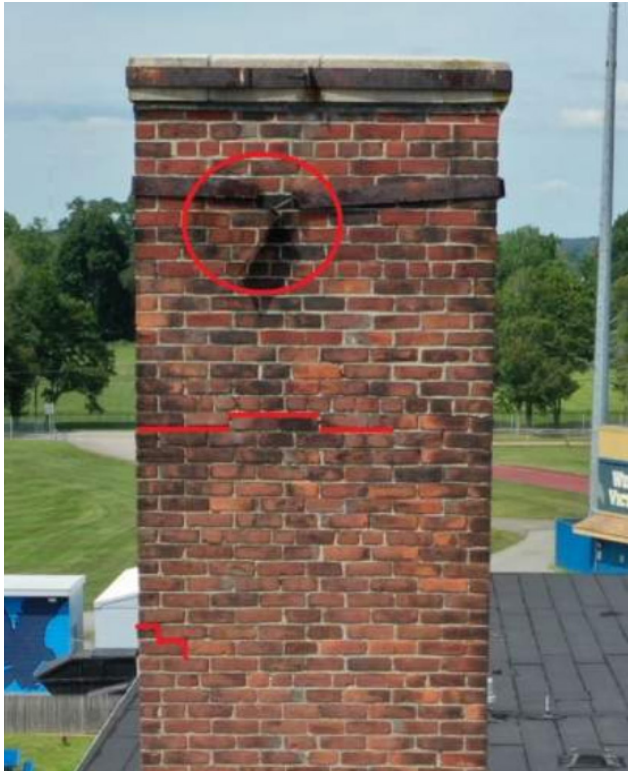
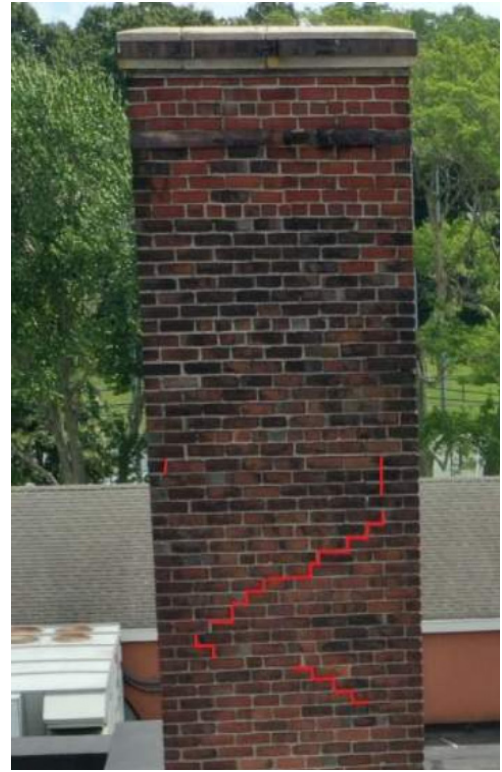
## BRICK CRACKS IN WEST CHIMNEY

Comments and recommendations: The brick chimney at the west end of the building has several cracks in the bricks and mortar joints at the top. Also, the lower steel band is no longer connected on one side. It is recommended that the brick and mortar joints structural integrity be further investigated and that the steel band either be removed or replaced.

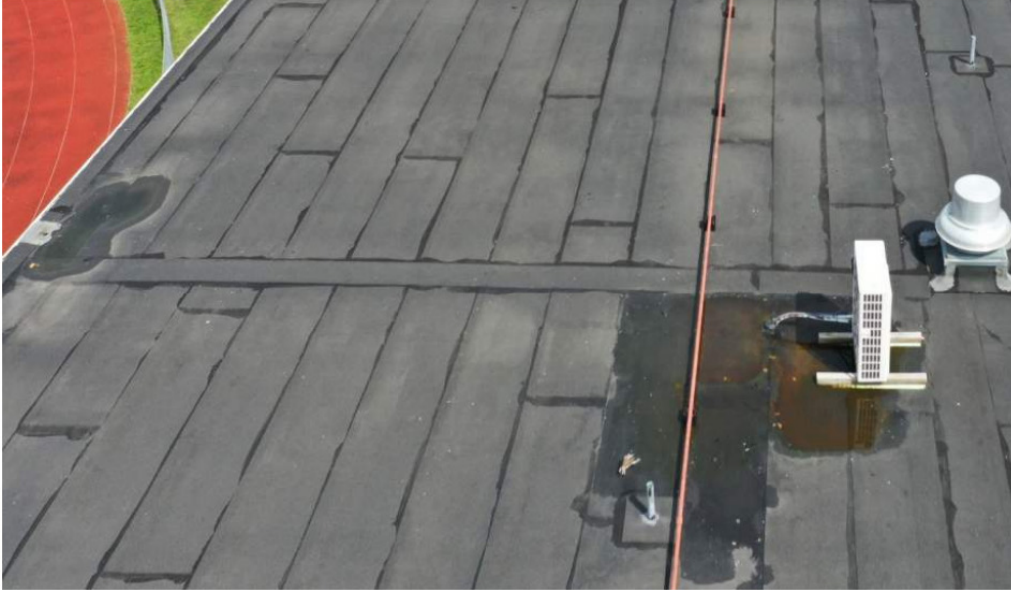
## PONDING WATER

Comments and recommendations: The flat portion of roof at the north east area of the building has ponding water around a piece of equipment and adjacent to a roof edge drain. Ponding of water can cause the roof to sag due to the weight of the water. As the roof sags, more water can become entrapped in the low spot of the roof, causing additional sagging. The roof structure must be adequately pitched, or tapered insulation below the roof membrane must be installed, to allow the water to flow to the roof drains. The roof drains must also be cleaned of any obstructions.

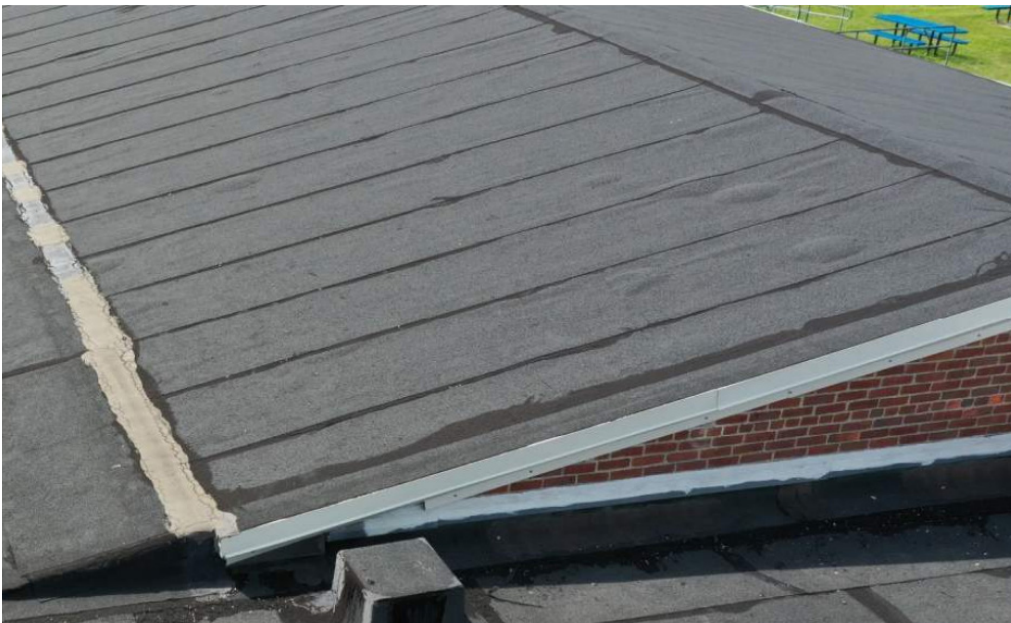
## ROOFING MATERIAL DETERIORATION

Comments and recommendations: At various locations the roofing material is detaching (bubbling) from the substrate and the joint materials are cracked and appear brittle. The deficiencies do appear to currently pose a structural hazard at this time. However, if the conditions continue to deteriorate, water and air may infiltrate the building envelope and cause damage to the structure or interior finishes. It is recommended that the roofing and joint materials be inspected and repaired by a roofing contractor specializing in these roofing systems. In addition, the roof structure must be investigated for snow drifting loads at all high/low roof areas.

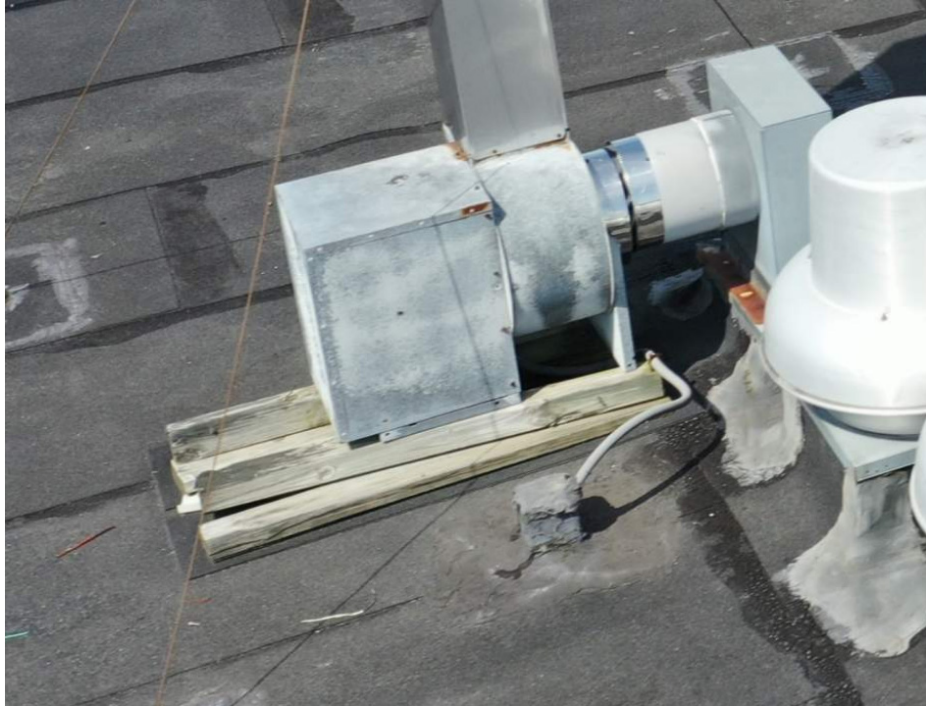
## EQUIPMENT SUPPORT DETERIORATION

Comments and recommendations: At various locations on the roof, the wood supporting equipment has deteriorated and/or is no longer connected to the roof below. Insufficient support of the equipment could allow it to displace during strong winds. It is recommended that new pressure-treated equipment support framing be installed. In addition, the roof structure must be investigated for snow drifting loads surrounding all rtu's and exposed ductwork.

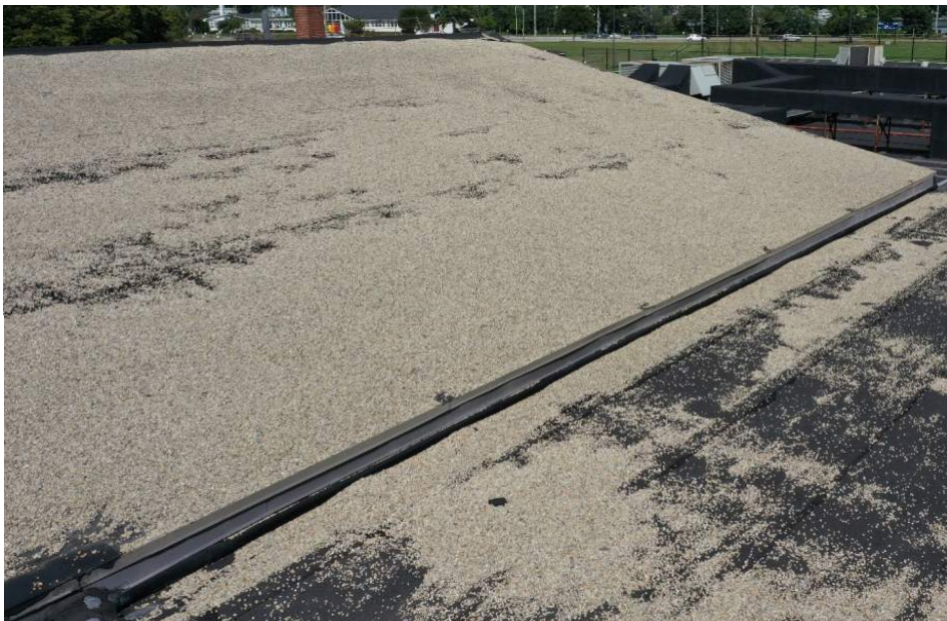
## BALLASTED ROOFING

Comments and recommendations: The ballasted roofs along the southern side of the building appears to have reached the end of its service life. The ballast is no longer adhering to the membrane and is falling onto adjacent roofs and into gutters. It is recommended that the ballasted roofs be removed and replaced.

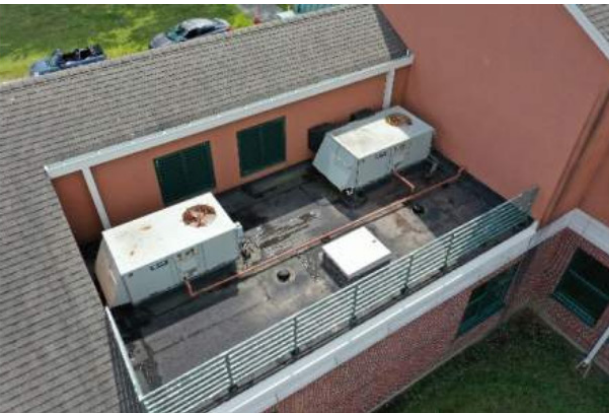
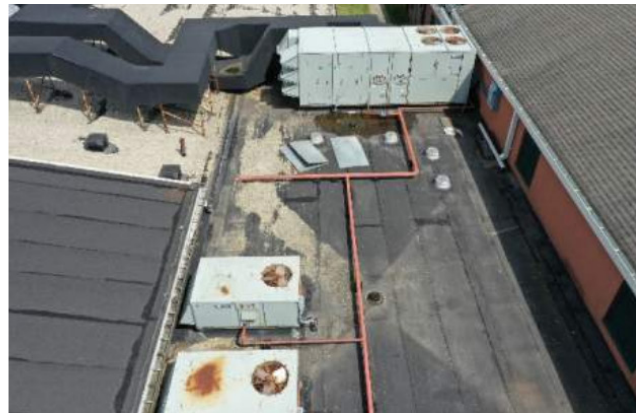
*Photos of rtu's and high/low roof conditions.*

## SNOW DRIFT AT HIGH/LOW ROOF AND RTU AREAS

Comments and recommendations: Snow drifting can occur at high/low roof areas and around rtu's. Based on our experience, buildings designed prior to 1978 did not account for snow drifting as it was not required by the Building Code at that time. As we have not received existing structural drawings, nor had access to the roof structure, the roof framing shall require further investigation to determine its load carrying capacity. This is a serious issue since we have observed the failure of several school roofs during blizzard conditions within the last 30 years.

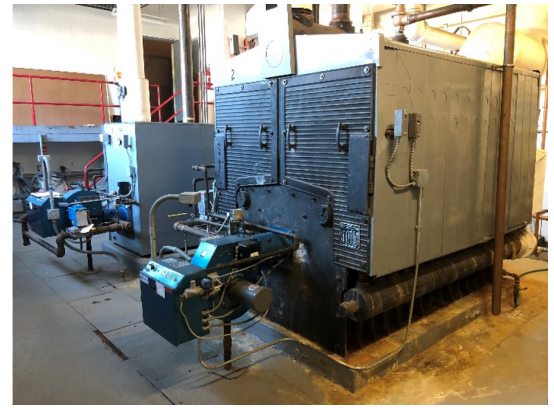
Existing Boilers (Boiler Room #1)

1. The building has two boiler rooms serving their own sections of the building. The first boiler room contains two (2) gas fired boilers. One (1) antiquated gas-fired boiler, manufactured by H.B. Smith Co. Inc., model M450L Mills, with 15 cast iron sections. The boiler has a natural gas input of 4,956 MBH, with an output of 3,965 MBH making it 80% efficient. The boiler utilizes a Power Flame Burner, model C3-G-25. The boiler is well past its useful life expectancy. A newer gas-fired boiler, manufactured by Weil-Mclain., model 88. The boiler has a natural gas input of 4,113 MBH, with an output of 3,270 MBH making it 80% efficient. The boiler utilizes a Power Flame Burner, model WCR3-G-25.

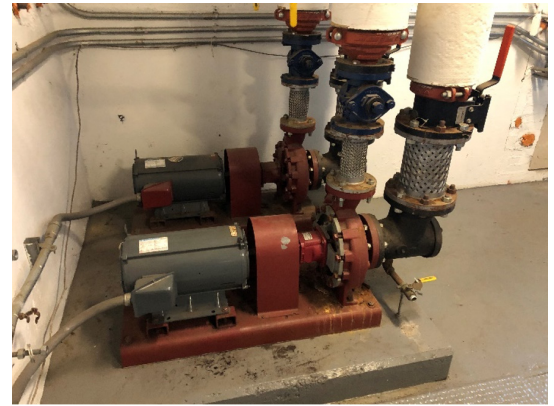
Pumps (Boiler Room #1)

3. Heating hot water is circulated to air handling units, fin tube radiation, unit ventilators, unit heaters, convectors, etc. via two (2) floor mounted end suction pumps. The heating hot water is distributed via insulated piping throughout the building. The end suction pumps appear to be in acceptable condition.

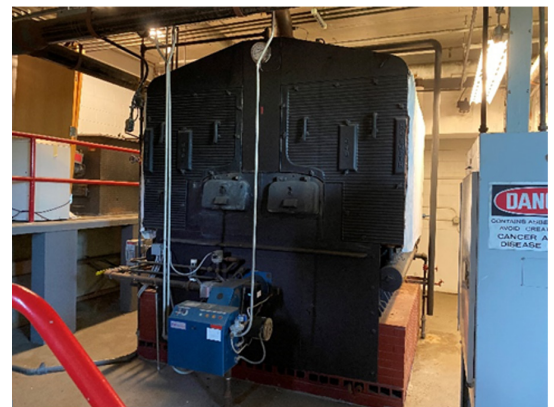
Existing Boilers 1 (Boiler Room #2)

5. The second boiler room contains two (2) antiquated oil-fired boilers, manufactured by H.B. Smith Co. Inc., 640 series. The boilers have a oil input of 37.5 GPH. The boilers utilize Power Flame Burners, model C3-CB. The boilers are well past their useful life expectancy.

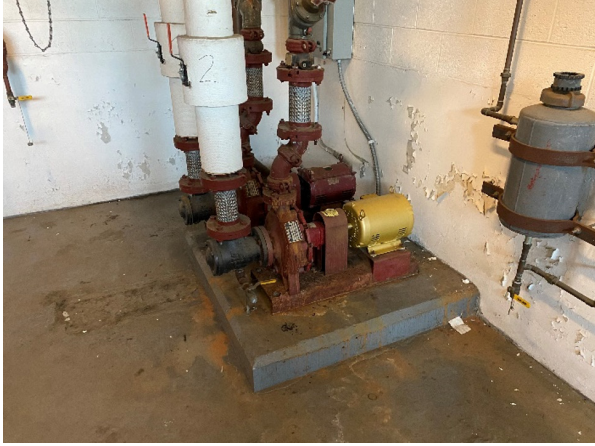
Existing Pumps (Boiler Room #2)

7. Heating hot water is circulated to air handling units, fin tube radiation, unit ventilators, unit heaters, convectors, etc. via two (2) floor mounted end suction pumps. The heating hot water is distributed via insulated piping throughout the building. Insulated piping in this boiler room appears to be in poor condition, showing signs of water damage from leaks. The end suction pumps are manufactured by Armstrong, model 3x2x10-4030 (130 GPM) and appear to be in poor condition.

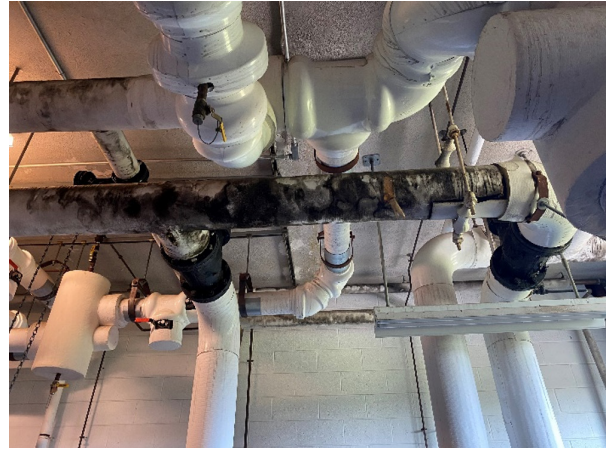
Water damaged insulation (Boiler Room #2)

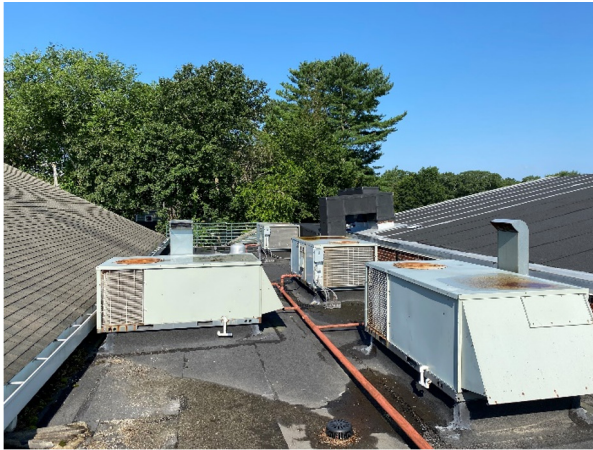
Typical Packaged Rooftop Units

The building is not fully air conditioned. Packaged heating and cooling rooftop units are installed where air conditioning is required. These units serve areas such as the auditorium, library, and administrative areas.

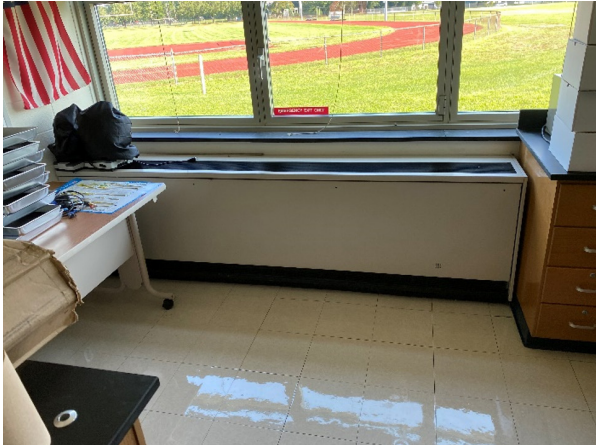
Classroom Unit Ventilator

1. Floor mounted classroom unit ventilators are utilized for the heating and ventilation requirements for most classroom spaces. Each unit is equipped with a hot water heating coil, supply fan and filter, and dedicated outdoor air louver. The unit ventilators appear original to the building. The classroom spaces are provided with exhaust systems to remove any outdoor air that is introduced through the unit ventilators which helps maintain a neutral pressure within the space. Classroom (exhaust) is served by roof mounted exhaust fan systems. The unit ventilators are generally past their expected useful service life.
2. Restrooms, janitor's closets and utility rooms are exhausted by roof mounted exhaust air fans. There are many roof curbs which appear to have been abandoned and flashed over. Providing reason for concern as to the level of ventilation in the school.

2. The classroom unit ventilators should be replaced with a more energy efficient system. Classroom unit ventilators use a considerable amount of energy as they bring in ventilation air, which is heated, only to be exhausted to the outdoors. We recommend providing dehumidified (partial AC) displacement air with a Variable Air Volume (VAV) terminal unit to all classrooms. The systems allow for individual control in each room with CO2 demand control ventilation. Maintenance is minimized as everything is performed at the rooftop unit or indoor air handling unit.

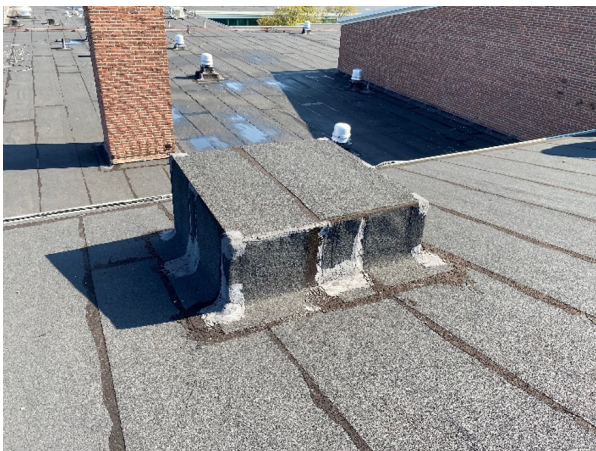
Abandoned Curb

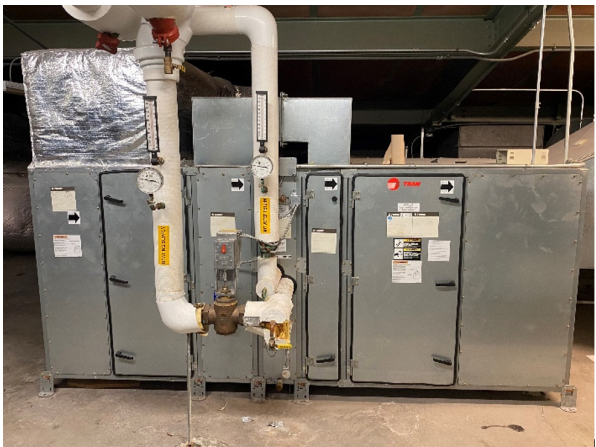
Air Handling Unit

There is one (1) indoor air handling unit providing heating and ventilation to the gymnasium. The units is in a mechanical mezzanine accessed near the auditorium lobby.

4. Air handling units that provide ventilation air to corridors, offices, etc should be replaced and supply dehumidified (partial AC) displacement air with a Variable Air Volume (VAV) terminal unit to each respective space.

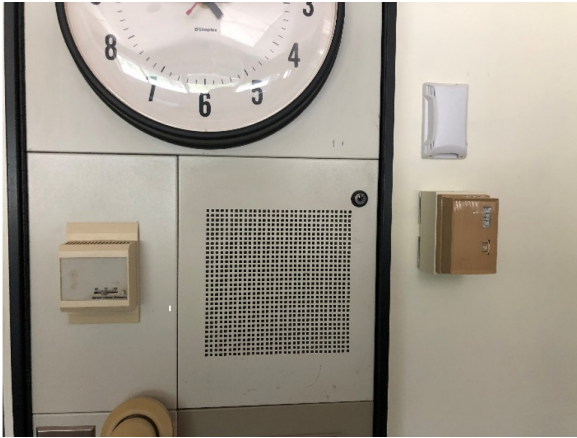
1. The building HVAC control system appear to be standalone in nature. Various types of digital and electronic thermostats were witnessed within the building. Some spaces have multiple thermostats serving the same area, provided from a range of manufacturers such as Honeywell, Schneider Electric, and Barber Colman. This is assumed to control different pieces of equipment independently as no building management system, or related control panels, appeared to be present.

*Various Thermostats Serving Same Space*

6. The ATC system should be further upgraded. Provide new DDC controls for all equipment such as fin tube, unit heaters, Unit Ventilators, AHU, pumps, etc. Along with new controls, a building management system (BMS) is recommended to help track and maintain all mechanical systems, provide scheduling, and alert the school of any problematic equipment as soon as possible.

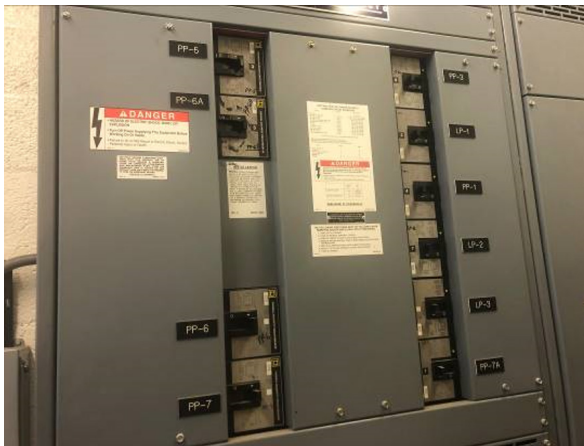
Main Switchboard

1. There is one service present at the facility. The service is rated at 120/208 Volt, 3 Phase, 4 Wire. The existing main switchboard has a 2,000 amp rated switch. The switchboard is manufactured by Square D and is in good condition.
2. There is a utility company transformers located outdoors adjacent to the Main Electric Room. The site is on one secondary meter located outdoors adjacent to the Main Electric Room. The service is underground to the building.
3. There are electrical sub-panels located throughout the building, both in closets and exposed in public areas. The panels are circuit breaker type; however, the some of them are obsolete and in poor condition. The panels are manufactured by Frank Adams which no longer produces electrical distribution equipment and Square D.

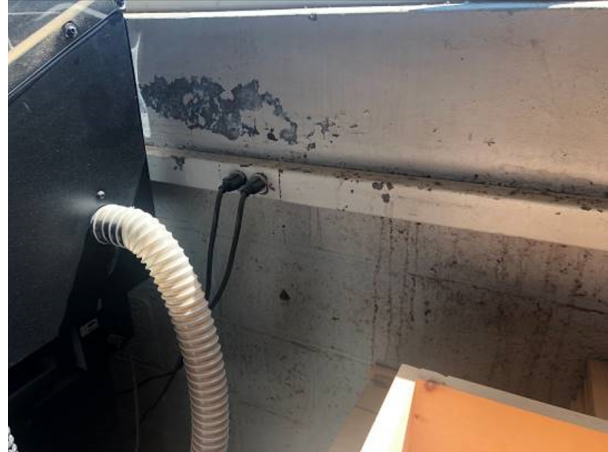
Shop Plug Strip

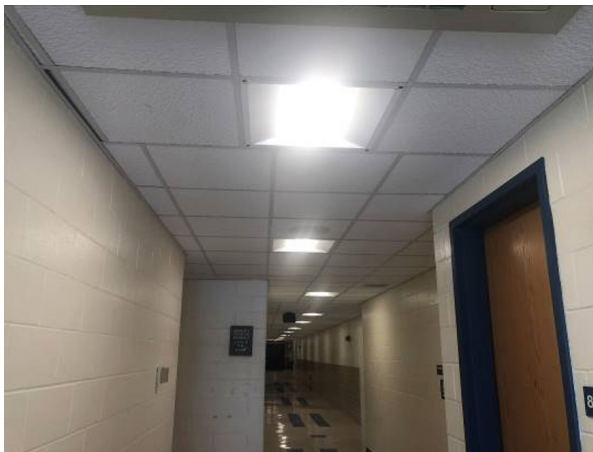
Corridor Lighting

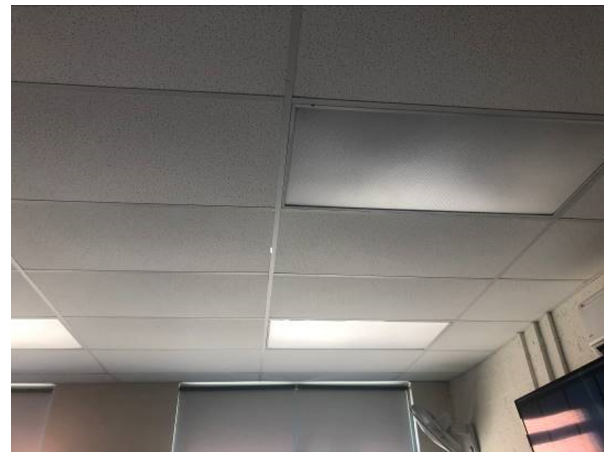
Classroom Lighting

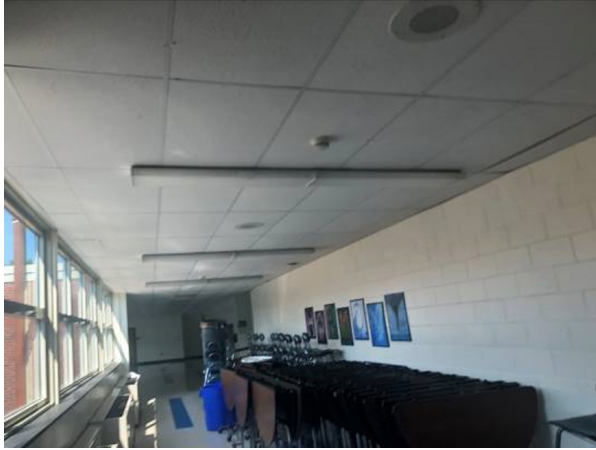
Cafeteria Lighting

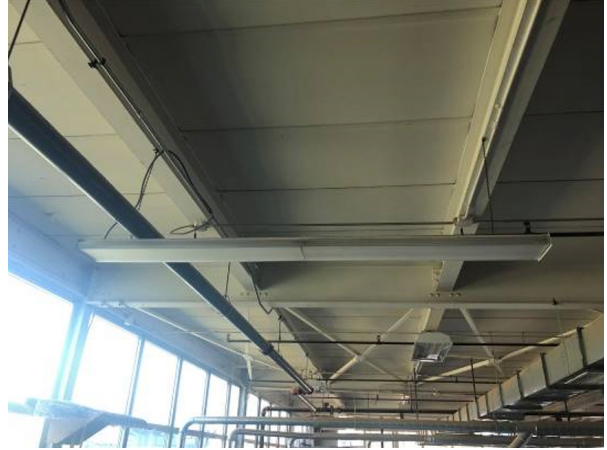
Shop Lighting

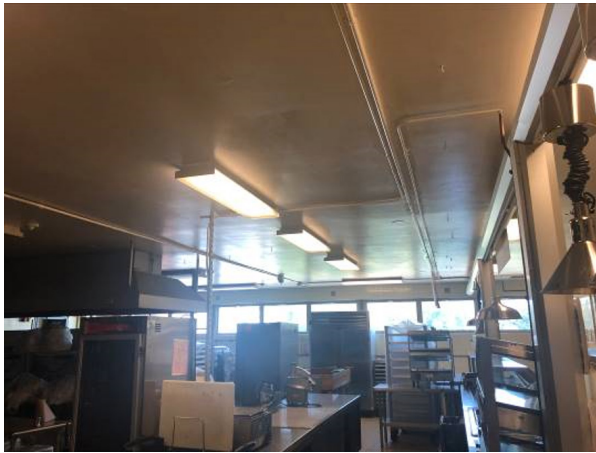
Kitchen Lighting

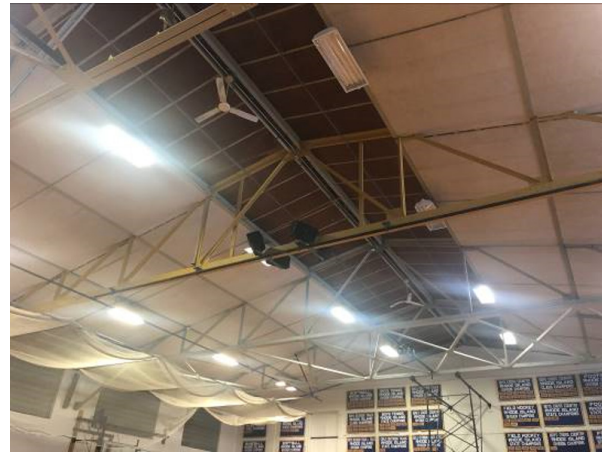
Gym Lighting

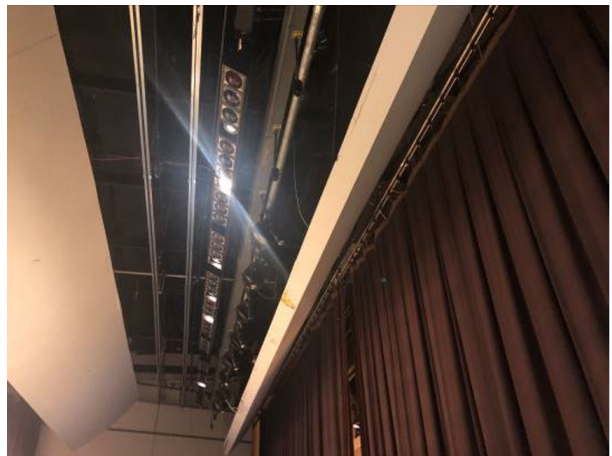
Stage Lighting

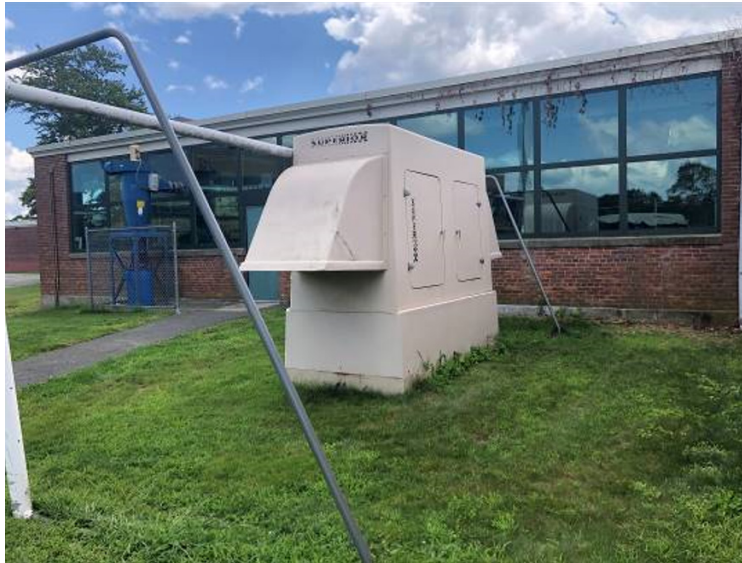
Generator

1. There is an emergency generator present that services the building. Location of automatic transfer switches was not available.
2. The generator is rating was not available, 120/208V, 3 Phase, 4 Wire, diesel fired, manufactured by Superior and located in a weatherproof enclosure. The generator and enclosure are in fair condition.

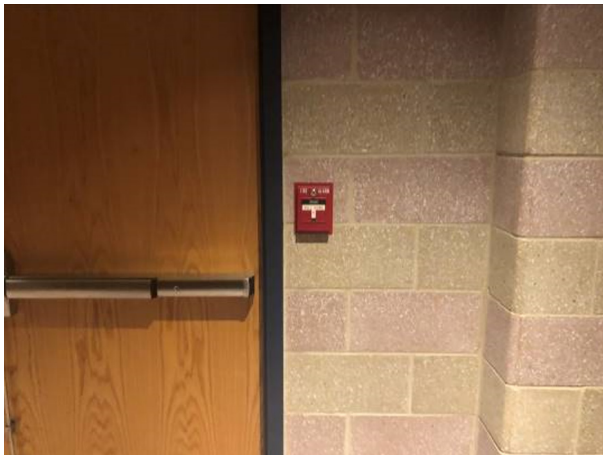
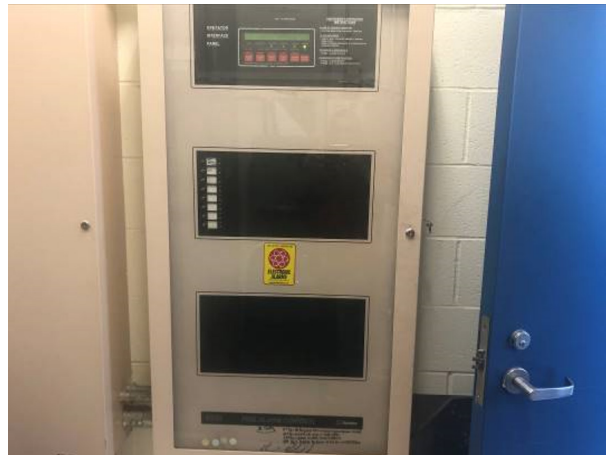
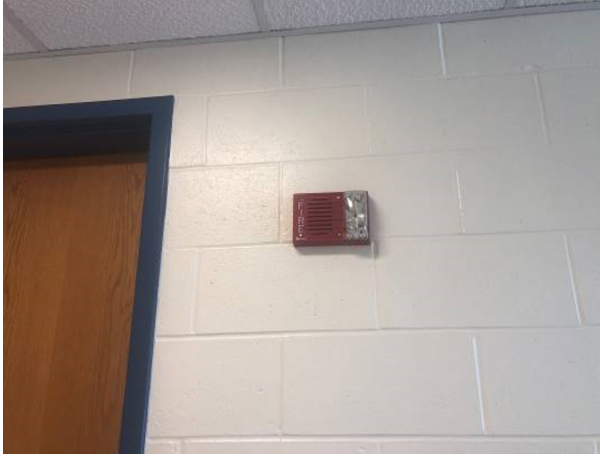
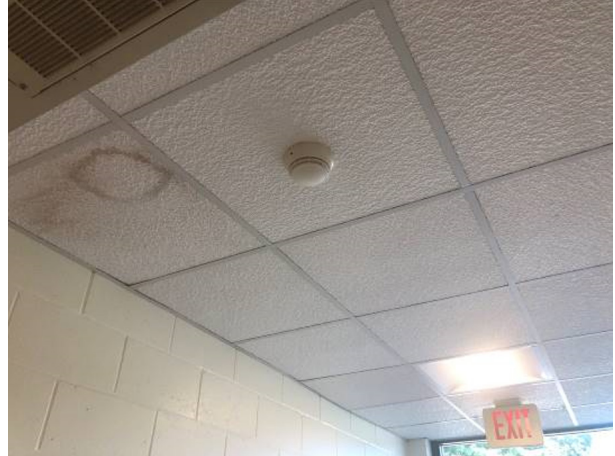
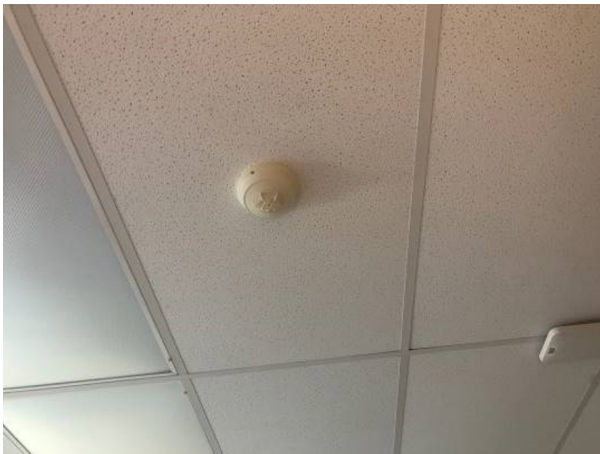
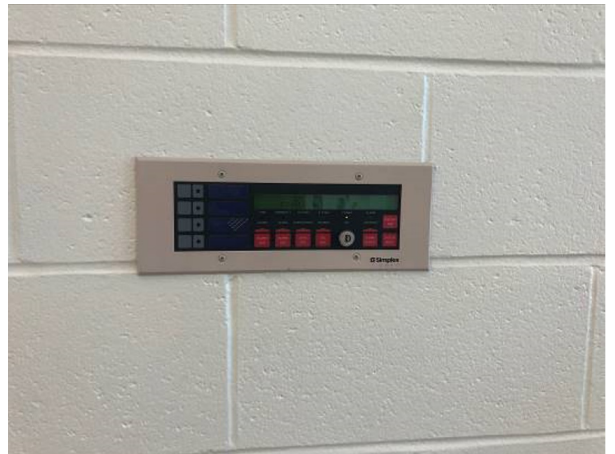
1. The fire alarm system is an original Simplex 4100 addressable system. The system is obsolete. The fire alarm notification devices do not meet code and detection is limited. The building does not have a sprinkler system except in the Auditorium. The fire alarm system is in need of replacement.

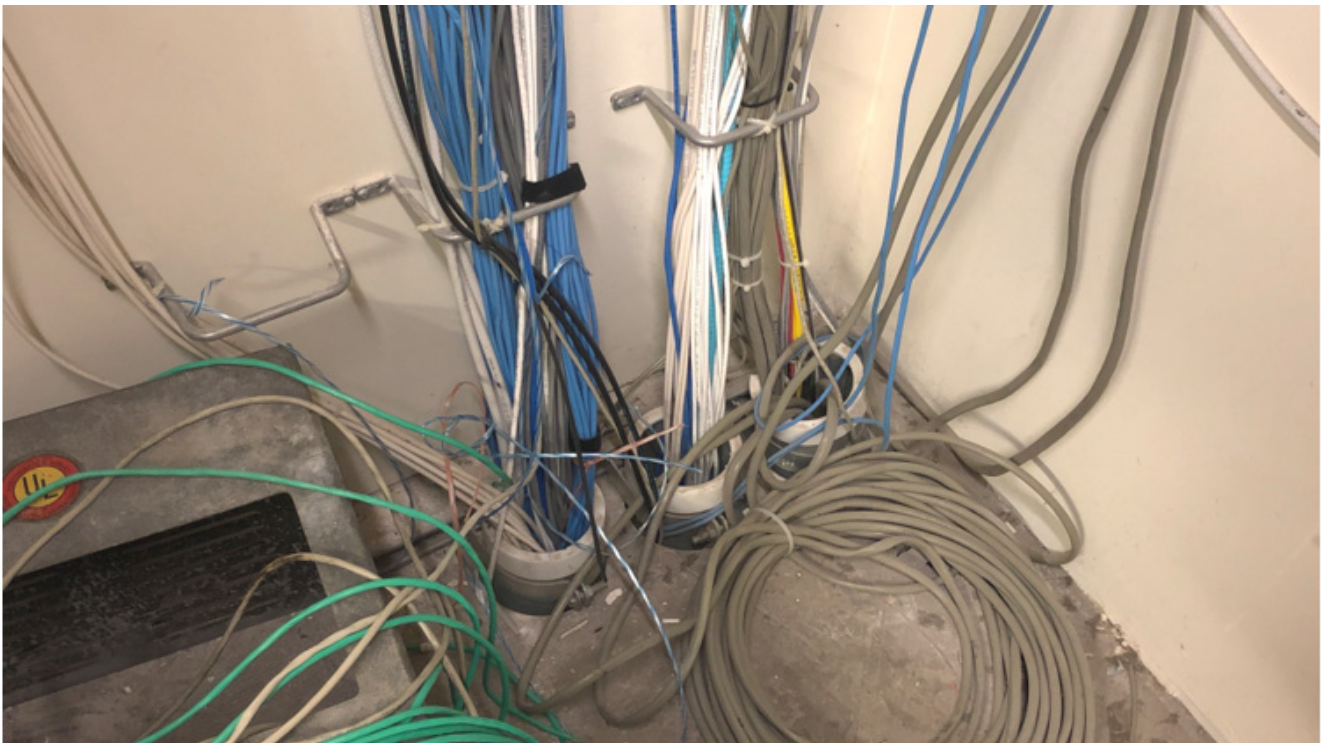
1. Barrington High School has (1) MDF & (5) IDFs. It should be noted that IDF4 could not be reviewed during the existing conditions site visit.
2. Horizontal Ethernet cable is a mix of Category 5e, Category 6, and Category 6A, with a mix of Plenum and Riser Cable.
3. Backbone cable between data rooms includes 6 strand multi-mode fiber optic cable to each IDF originating from the MDF.
4. The MDF and all IDF's have dedicated power, which is sufficient for the electronic devices in each room.
5. Grounding and bonding protection for all low voltage devices within the MDF and all IDF's is not in place.
6. The MDF has dedicated cooling units. All IDF's ranged from warm to hot.
7. Most penetrations / sleeves for cable pathways could not be observed, but many that were visible did not have proper firestopping. Firestop all penetrations. Photo of non-firestopped

*Photo of non-firestopped penetrations for cable pathways*

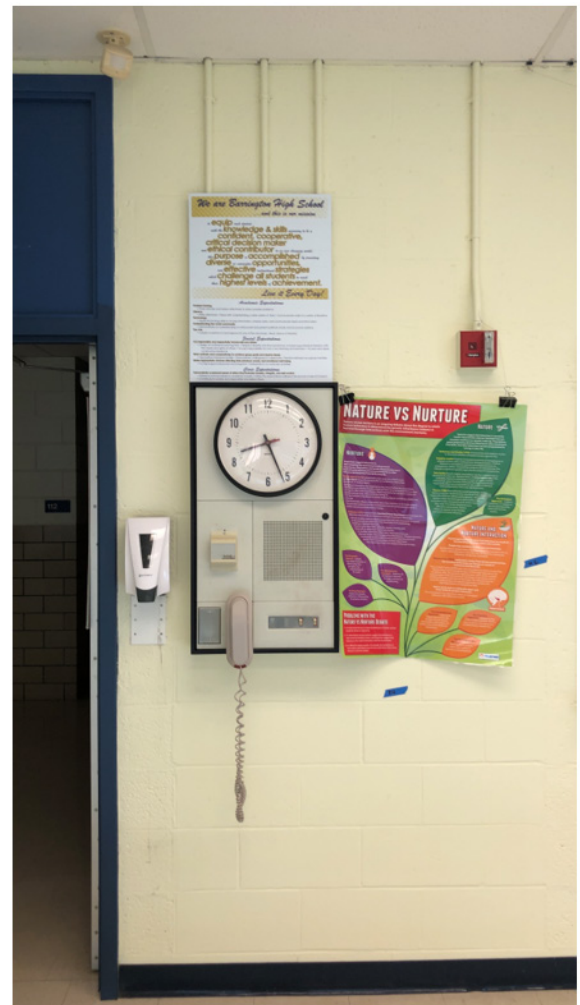
Photo of typical classroom Phone / Clock / PA Speaker assembly

8. Replace the Simplex Wired Master Clock with a modern, wireless Master Clock.
9. Replace all hardwired clocks in all spaces with Wireless clocks.

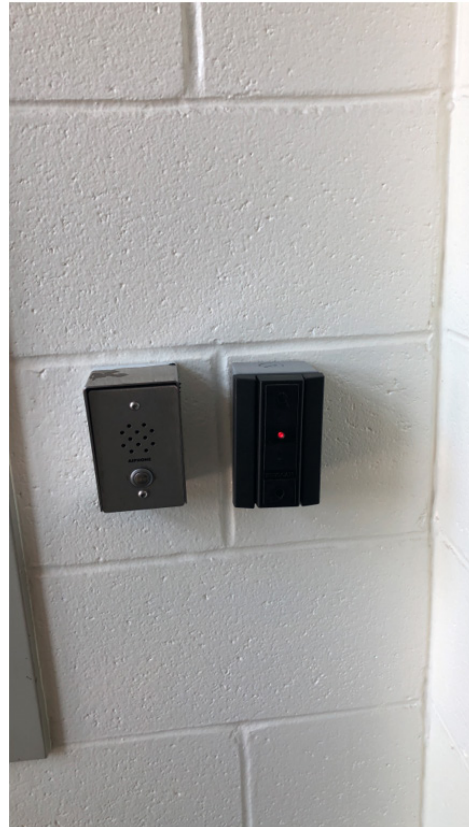
4. The front entrance does not have any access control. A two-way communication device and card reader is installed at the first set of interior vestibule doors. High School staff confirmed that the first set of doors into the main entrance are rarely locked.

*Picture of communication device and card reader*

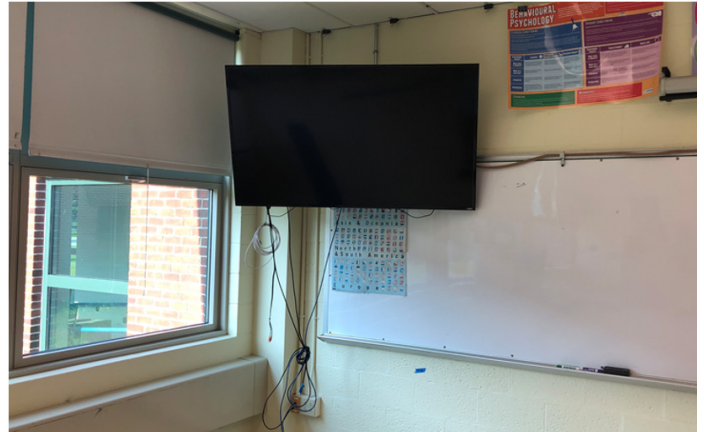
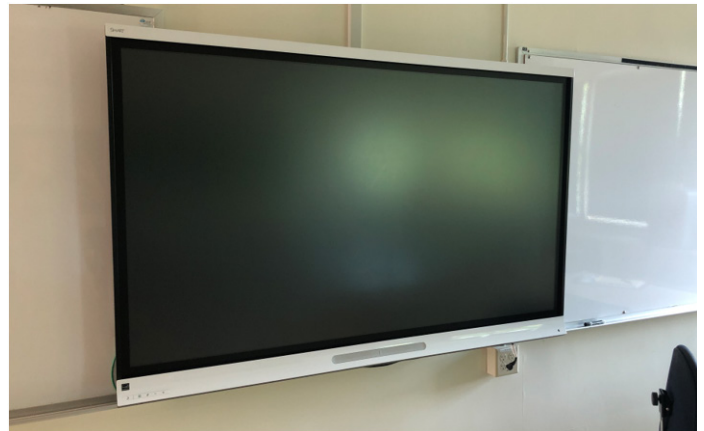
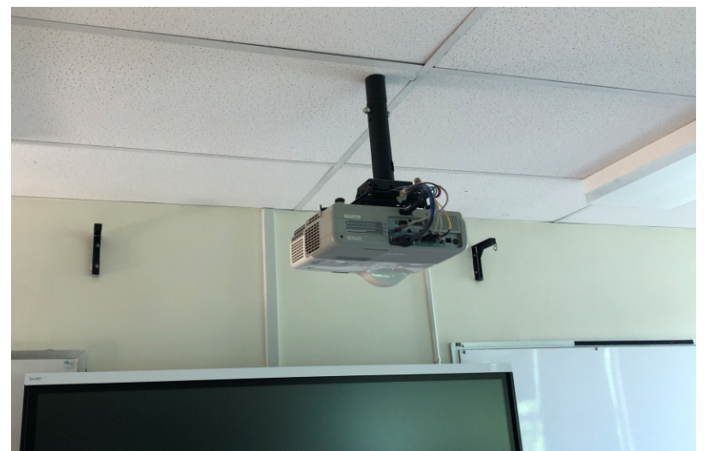
1. Classroom Audio-Visual Findings
  - a. Classrooms on the first floor have wall mounted TV's and Apple TV's. Cable is not properly dressed and protected, and classrooms do not have visible external speakers.
  - b. Most classrooms on the second floor have SMART interactive displays. Two to four classrooms on the second floor have speakers that may be integrated into the interactive display systems.
  - c. Many classrooms have projectors or manual screens. It is not clear if they are in use.

*Photo of typical classroom AV display*

*Photo of classroom AV system on second floor.*

*Photo of ceiling mounted projector.*

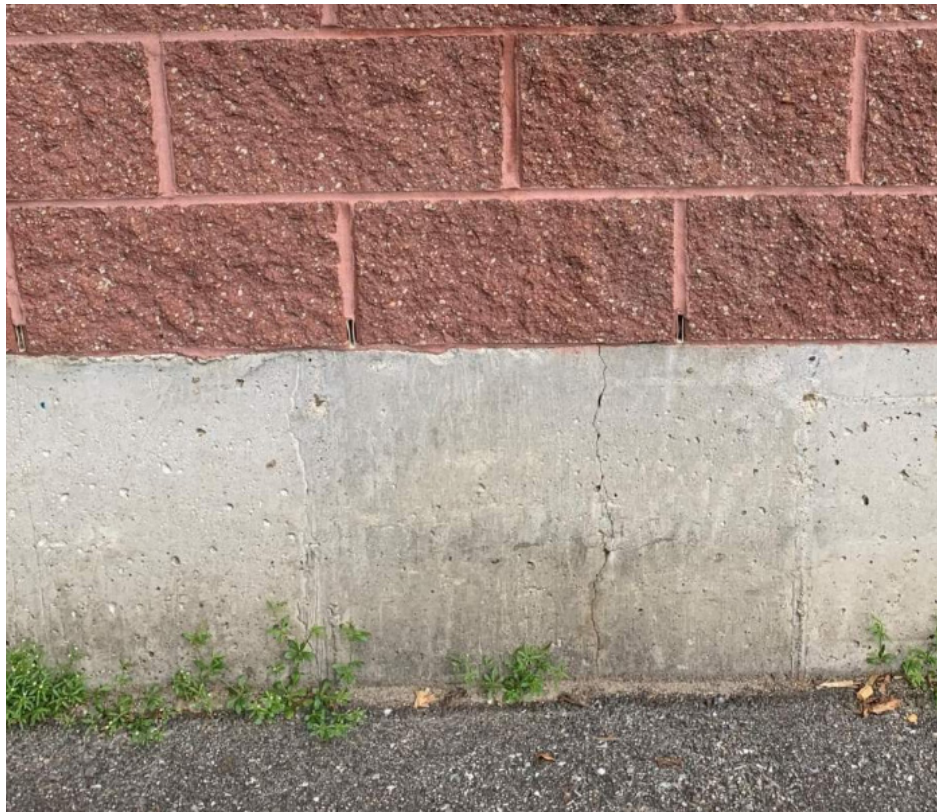
Based upon what could be see above grade, the foundation walls appear to be cast in place concrete.

Photo of typical cast-in-place concrete foundation wall

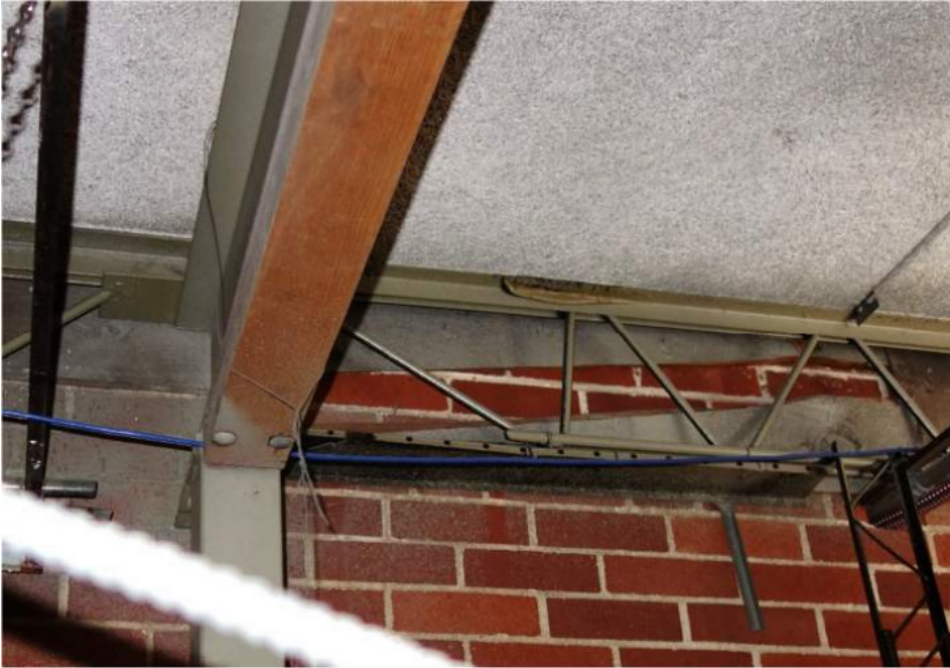
Based upon what was visible, the roof framing appears to be open web steel joists with either tectum panels or metal deck, supported by steel beams and columns or concrete masonry unit (cmu) walls

*Photo of open web steel joist and tectum roof panels and bearing upon a steel beam*

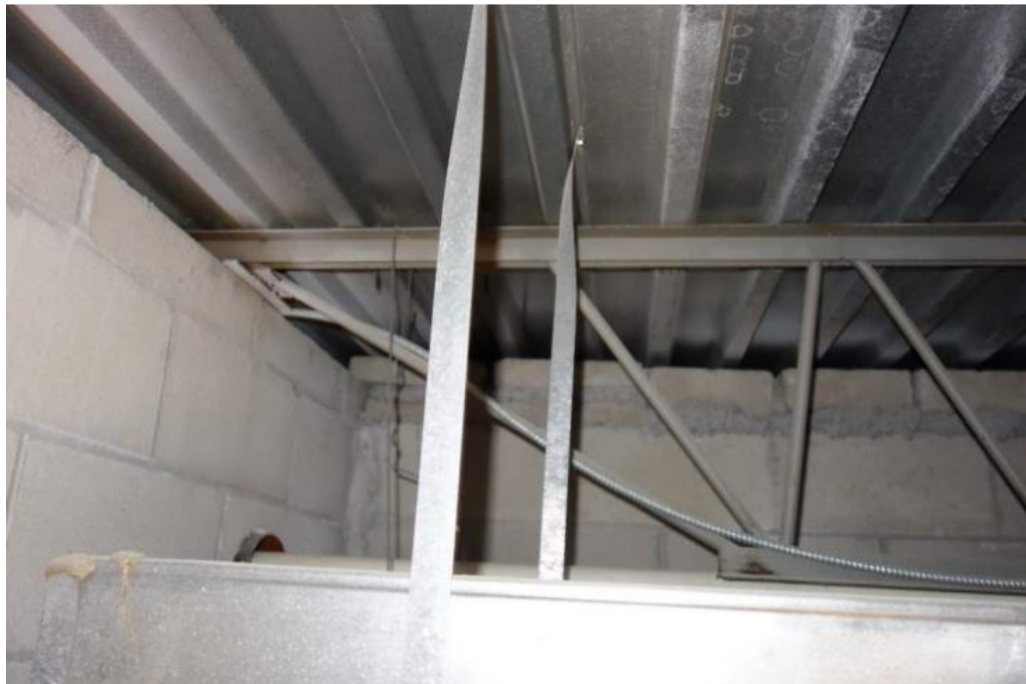
*Photo of open web steel joist and metal roof deck bearing upon a cmu wall.*

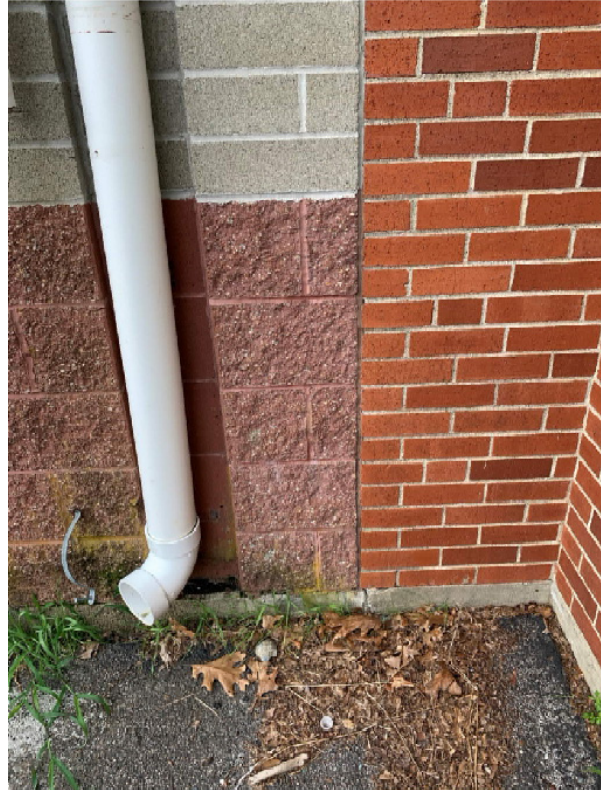
Photo showing the two typical exterior wall systems.

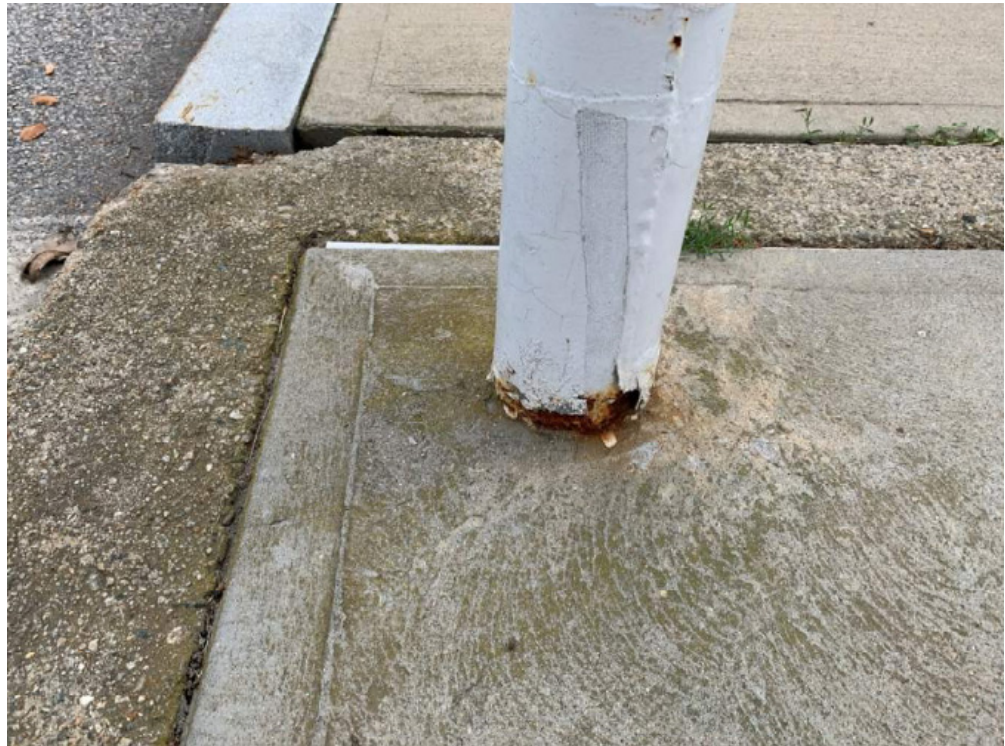
## RUST AT CANOPY COLUMN BASES

The main entry columns are rusting at their bases. The rusting does not currently appear to pose a structural hazard, however, if the rusting is allowed to continue, the columns may fail and allow the canopy to collapse, potentially causing damage to property or injuring personnel. It is recommended that the column bases be cleaned of rust, inspected for deterioration, repaired if necessary and then finished with an appropriate coating system.
