# BARRINGTON PUBLIC SCHOOLS MASTER PLAN

## STAGE 1 RIDE SUBMISSION

TOWN of BARRINGTON PUBLIC SCHOOL DISTRICT  
283 COUNTY ROAD  
FEBRUARY 15, 2023

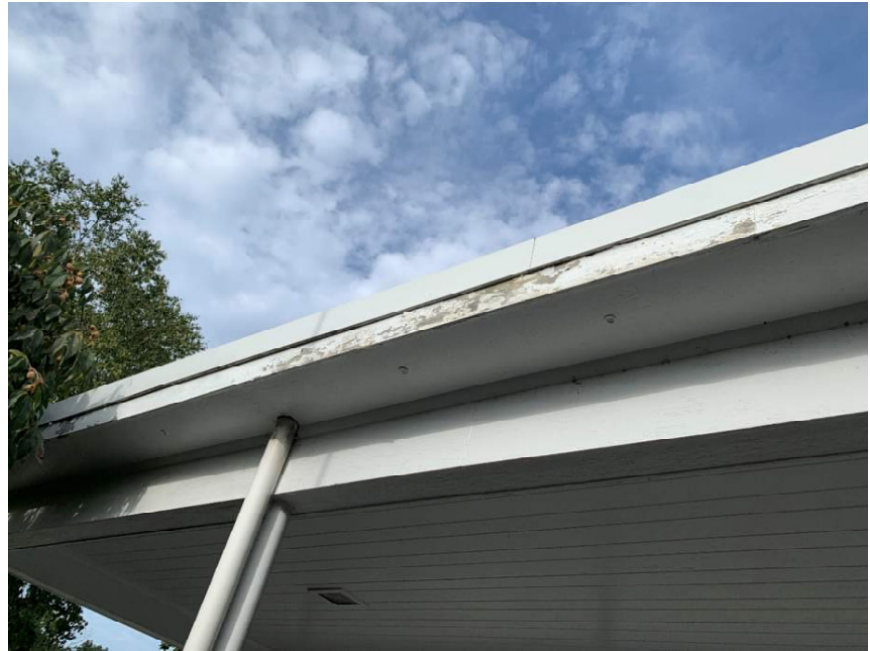
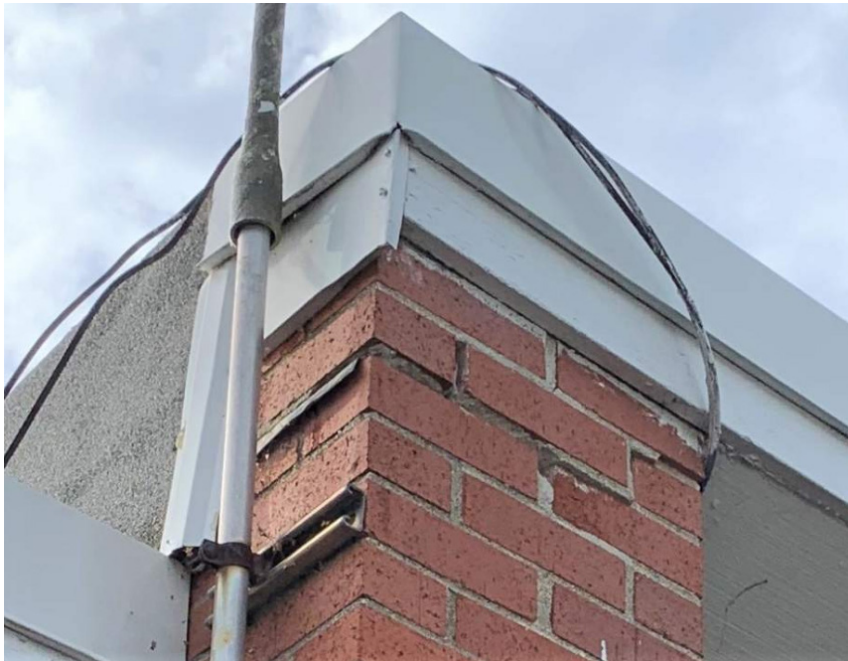
## PEELING PAINT AND WOOD DETERIORATION

Comments and recommendations: Peeling paint and wood deterioration on the soffit was observed at various locations. Peeling paint may allow the deterioration of the wood and allow water and air infiltration into the building envelope which could cause damage to the walls, structure, and interior finishes. To extend the life of the exterior walls and to protect the building structure and the interior finishes, it is recommended that the peeling paint be removed, and the soffit be re-finished with an appropriate coating system.

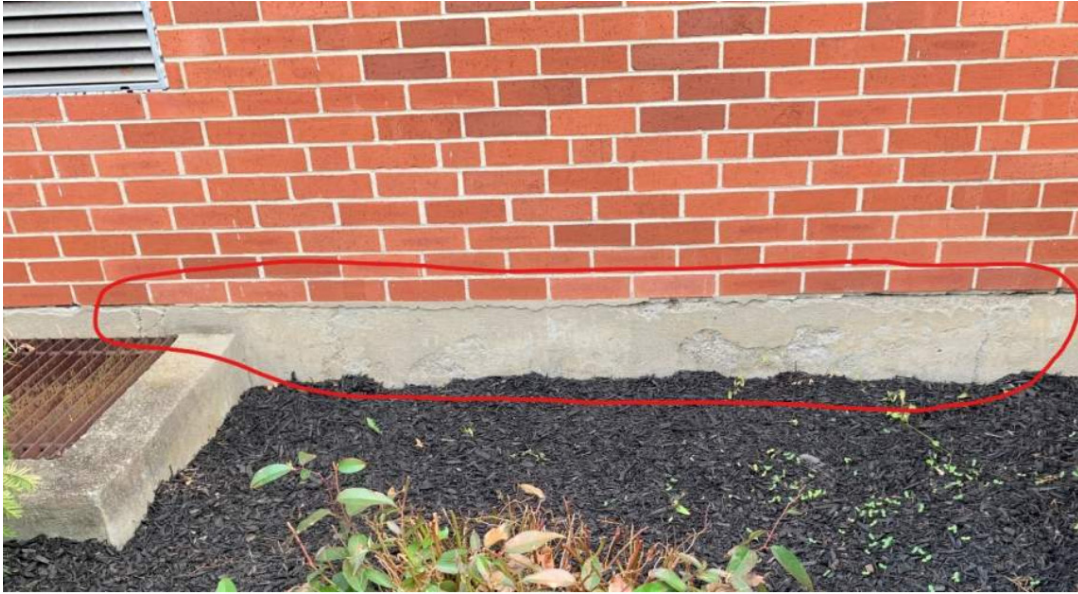
### MAJOR CRACKS IN THE EXTERIOR CONCRETE FOUNDATION WALLS

Comments and recommendations: At various locations, the concrete foundation wall has major (larger than 1/16" wide) cracks. These cracks and spalls do not appear to currently pose a structural hazard. However, they may allow water and air infiltration into the building envelope. To extend the life of the exterior concrete foundation walls and to protect the building structure and the interior finishes, it is recommended that a maintenance program be established to repair these cracks in the exterior concrete foundation walls.

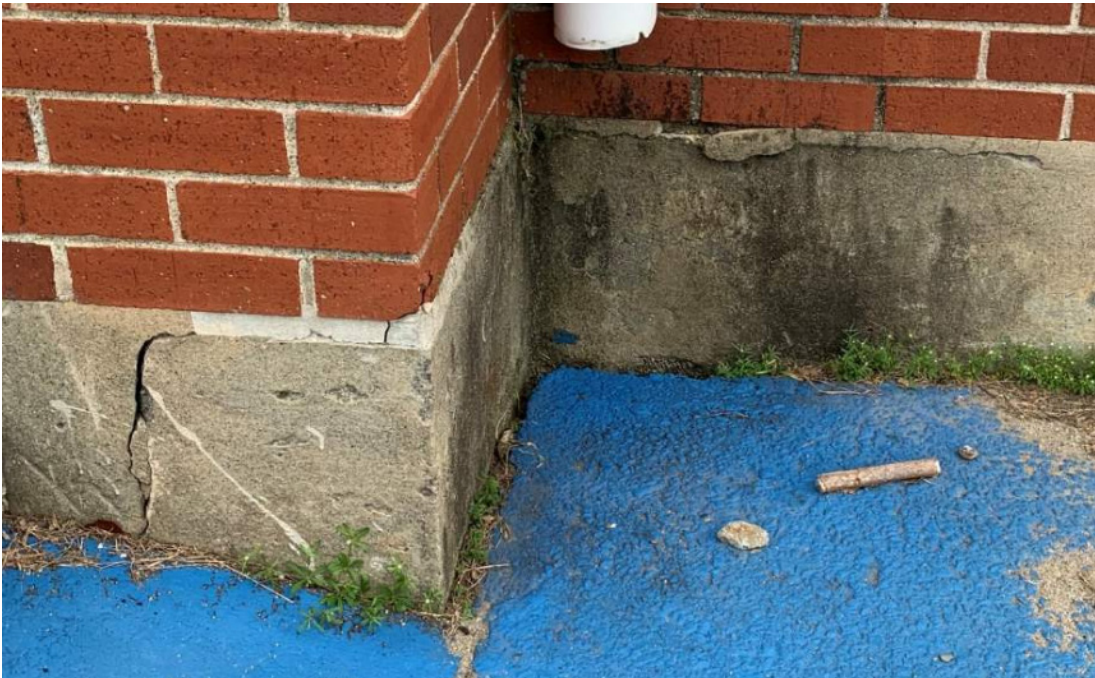
## VERTICAL AND STEP CRACKING IN CMU WALLS

Comments and recommendations: In various locations, the cmu walls have vertical and step cracks through the cmu and at the mortar joints. These cracks do not appear to currently pose a structural hazard and most likely resulted from a combination of vertical displacement due to foundation settlement and horizontal dimensional changes (expansion and contraction) of the building materials due to changes in temperature and humidity. It is recommended that these cracks be periodically monitored to confirm that the cracks are dormant.

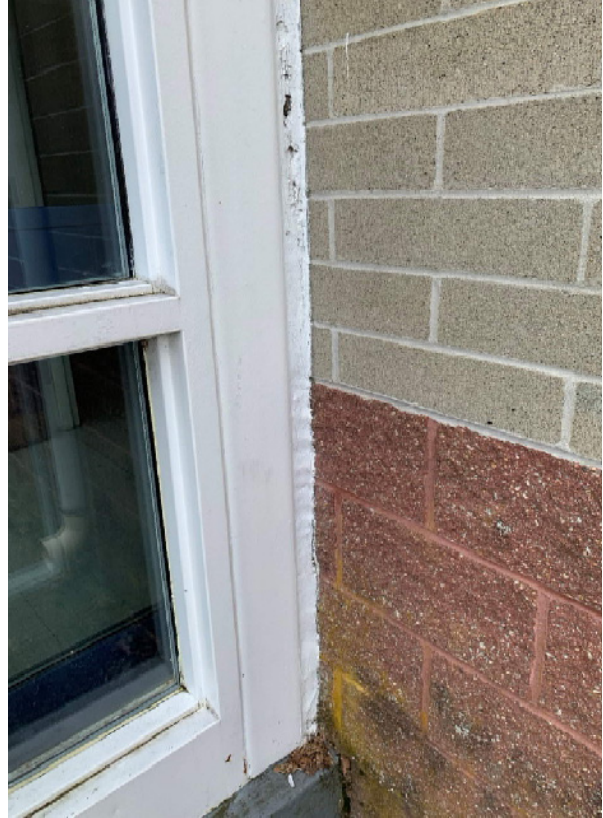
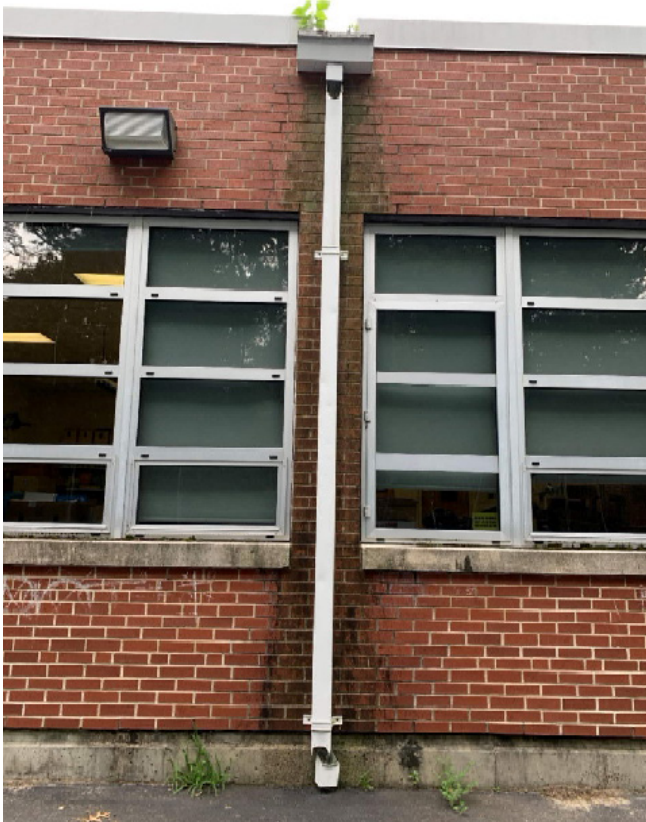
## CONTROL JOINTS IN THE EXTERIOR WALL HAVE AGED AND FAILED

Comments and recommendations: There are several locations where the control joints in the exterior wall have aged, cracked and/or failed which may allow water and air to infiltrate the building envelope and possibly cause damage to the building structure and/or architectural finishes. It is recommended that a maintenance program be implemented to remove and replace all of the aged and failed control joints.

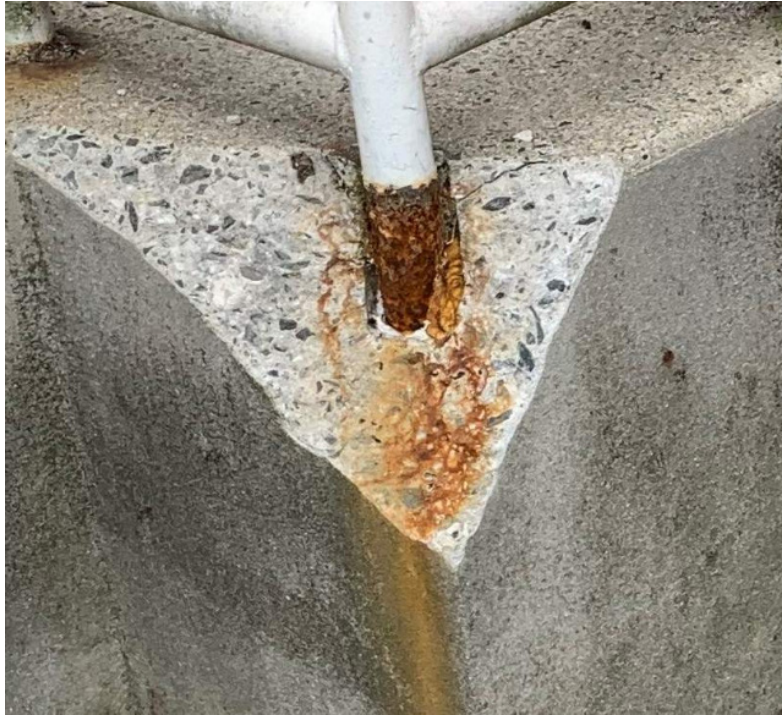
## RAILING POST RUSTING AND CONCRETE CRACKING

Comments and recommendations: At several locations, railings posts are rusted at the base and/or the adjacent concrete is cracked or spalled. While not a structural hazard, this is a life-safety hazard as failure of a railing post could result in property damage or personal injury. It is recommended that the rusted posts and cracked concrete be repaired.

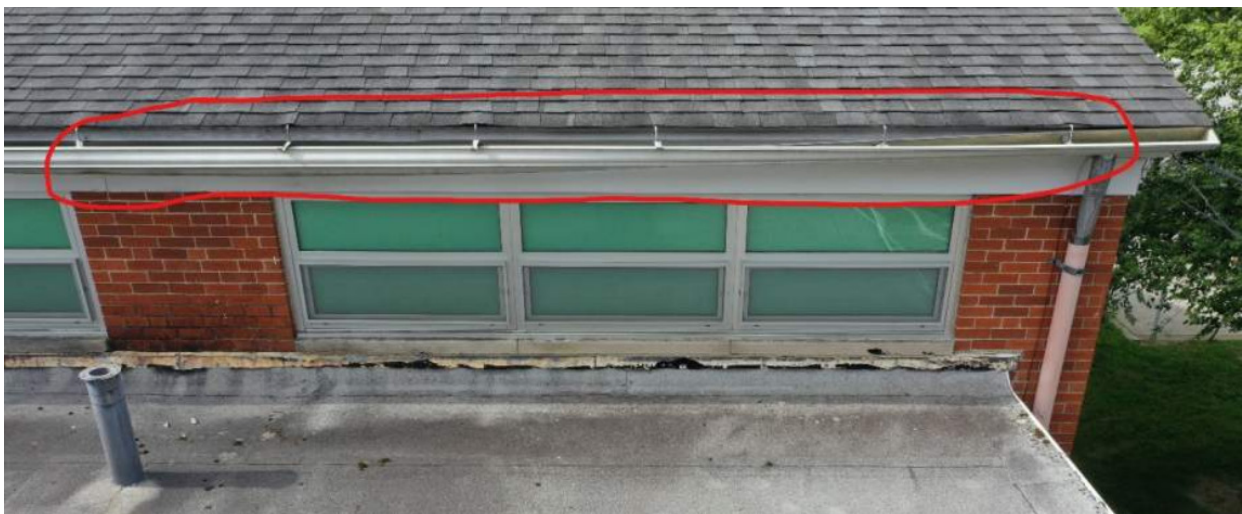
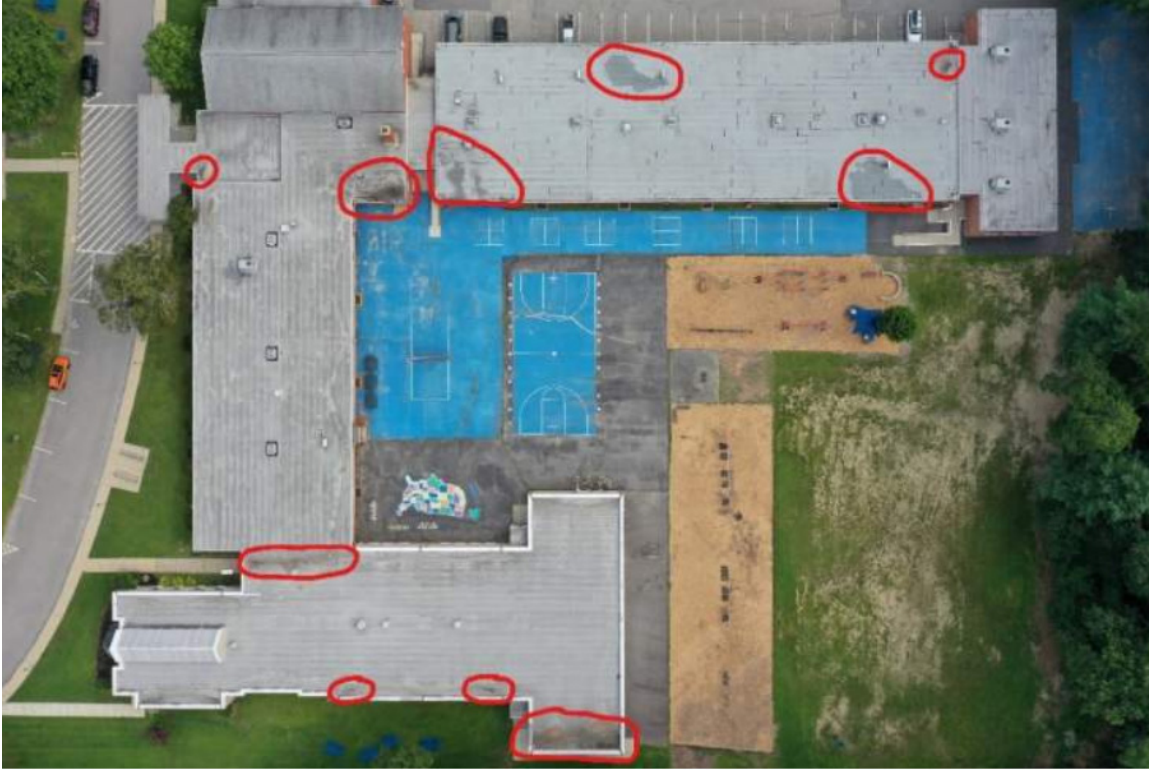
## DISCONNECTED GUTTER

Comments and recommendations: Along the north eave of the gabled roof, it appears that the gutter is disconnected or otherwise damaged. This could possibly allow water to flow down the face of the wall and/or window and possibly infiltrate the building envelope which could cause damage to the structure and/or architectural finishes. It is recommended that gutter be repaired or replaced.

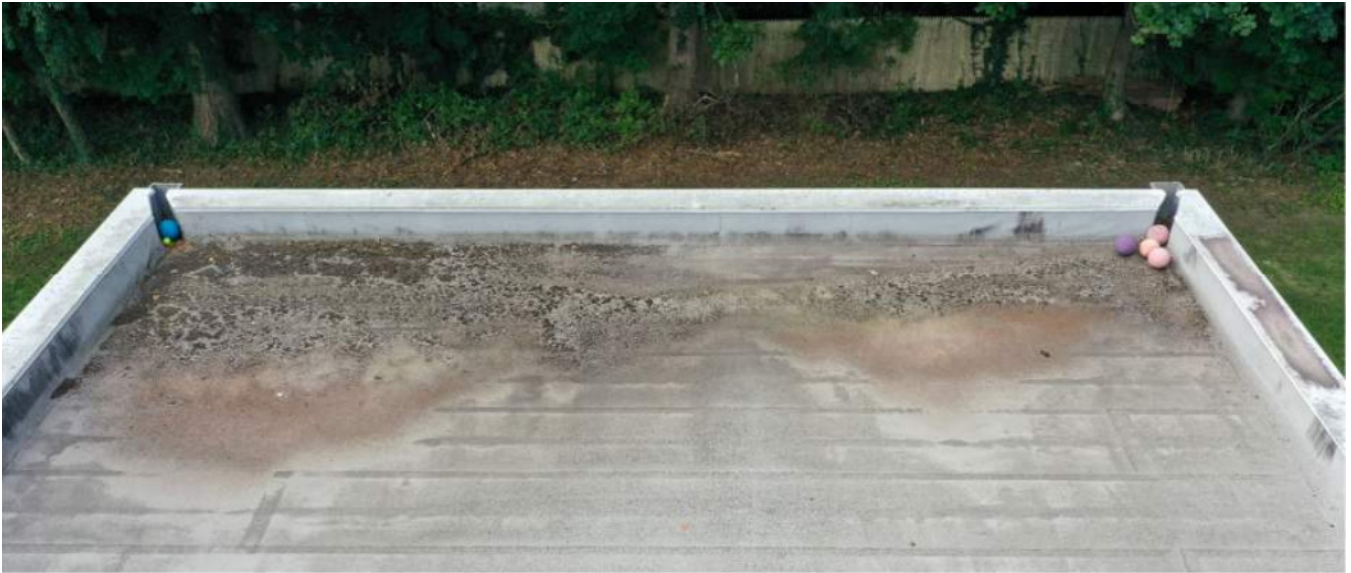
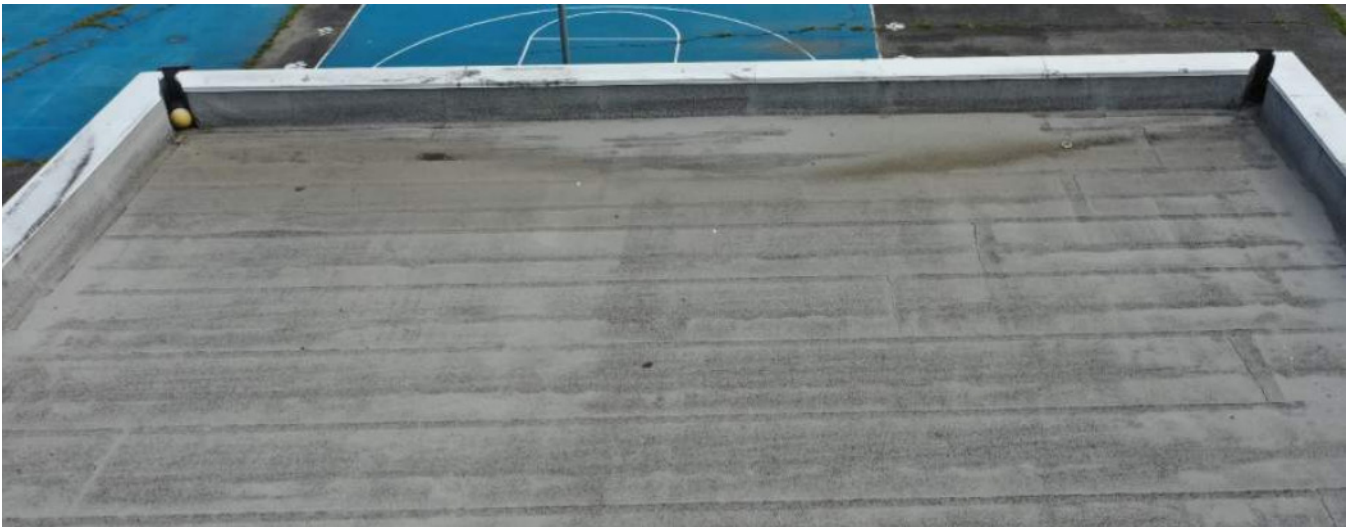
### **OBSTRUCTED DRAINS AND EVIDENCE OF PONDING AT SOUTH EAST ROOF**

Comments and recommendations: The roof drains at the roof south east roof appear to be obstructed and there is evidence of ponding water. The roof drains must be cleared of obstructions. Ponding of water can cause the roof to sag due to the weight of the water. As the roof sags, more water can become entrapped in the low spot of the roof, causing additional sagging. The roof structure must be adequately pitched, or tapered insulation below the roof membrane must be installed, to allow the water to flow to the roof drains.

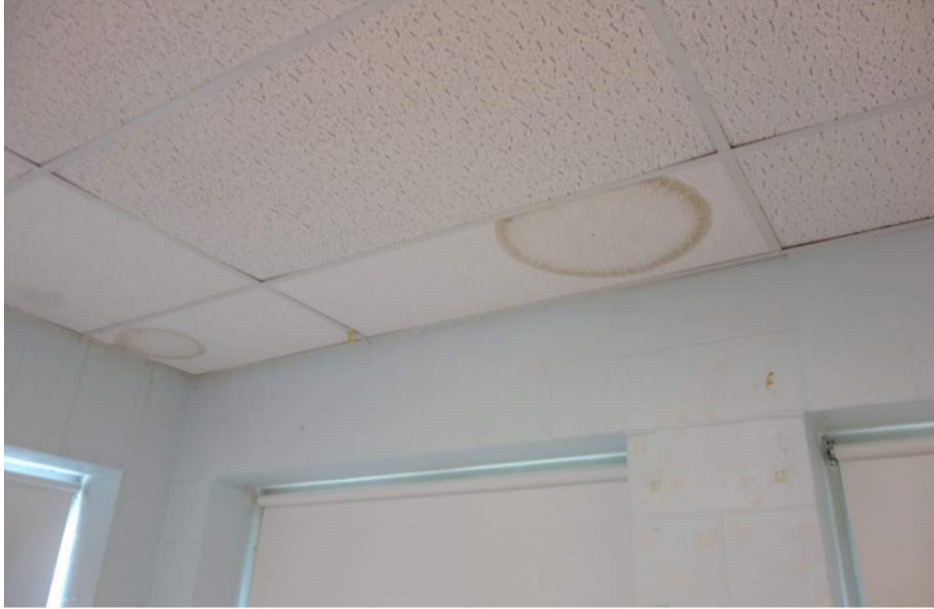
## WATER STAINED CEILING TILES.

Comments and recommendations: In several locations throughout the building, water stained ceiling tiles and active water leaks were observed. Prolonged water infiltration may cause deterioration to the roof elements, structural system, and interior finishes. Further investigation is required to determine the cause of the water infiltration.

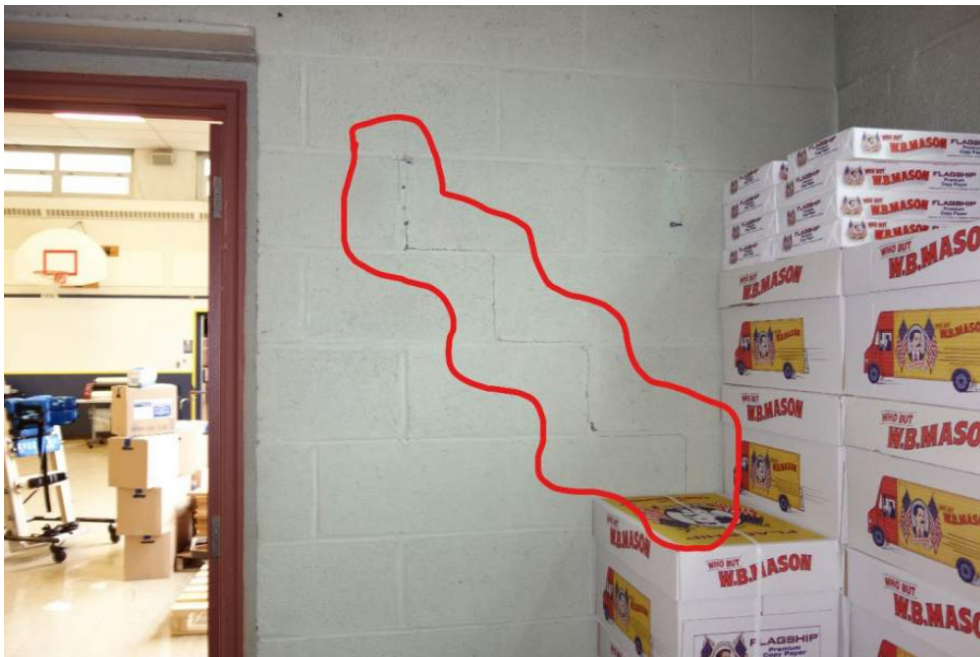
## STEP CRACKING IN INTERIOR CMU WALLS

Comments and recommendations: In various locations throughout the building, the cmu walls have step cracks at the mortar joints. These step cracks do not appear to currently pose a structural hazard and most likely resulted from vertical displacement due to settlement of the foundations. It is recommended that these cracks be periodically monitored to confirm that the cracks are dormant.

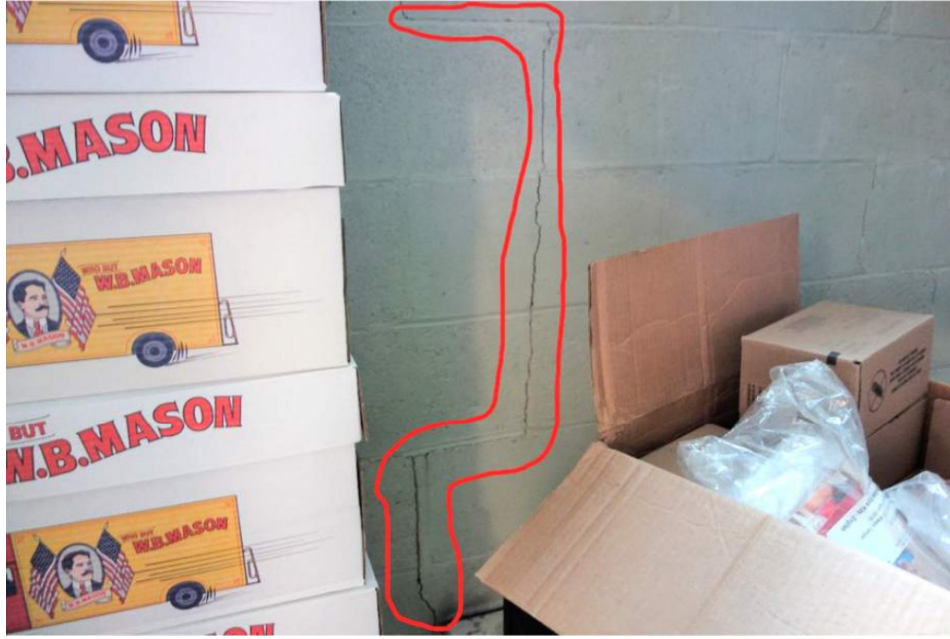
### VERTICAL CRACKING IN INTERIOR CMU WALLS

Comments and recommendations: In various locations throughout the building, the cmu walls have vertical cracks through the cmu and at the mortar joints. These vertical cracks do not appear to currently pose a structural hazard and most likely resulted from horizontal dimensional changes (expansion and contraction) of the building materials due to changes in temperature and humidity. It is recommended that these cracks be periodically monitored to confirm that the cracks are dormant.

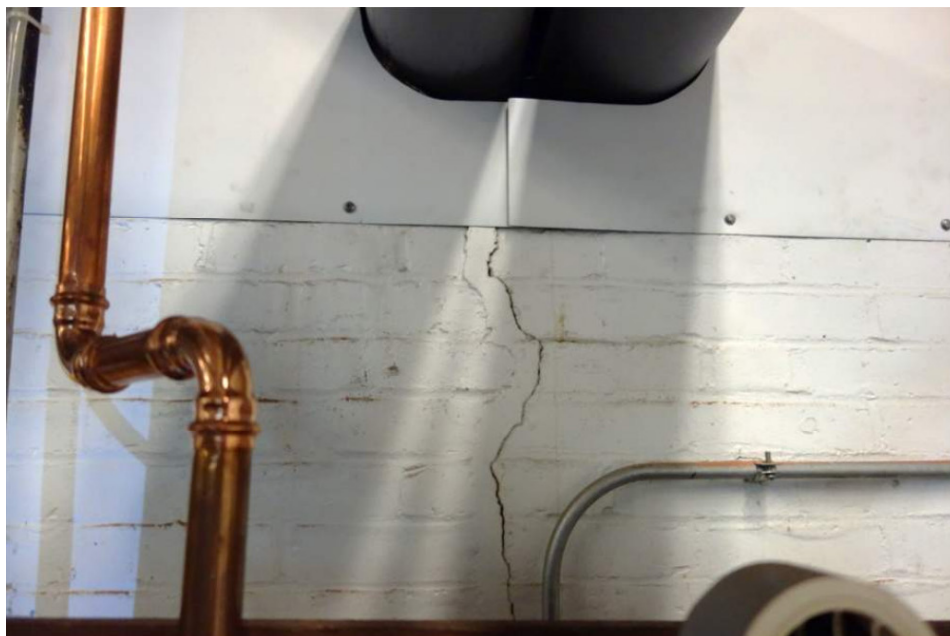
### CRACKING IN INTERIOR BRICK WALLS

Comments and recommendations: In the boiler room of the building, the brick walls have vertical cracks through the brick and at the mortar joints. These vertical cracks do not appear to currently pose a structural hazard and most likely resulted from horizontal dimensional changes (expansion and contraction) of the building materials due to changes in temperature and humidity. It is recommended that these cracks be periodically monitored to confirm that the cracks are dormant.

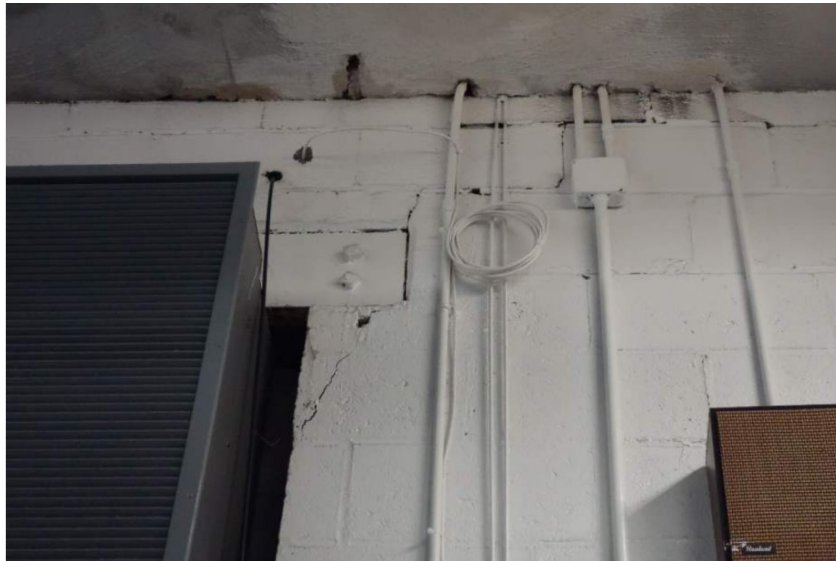
## LINTEL BEARING CONDITION

In the boiler room along the southern wall the cmu wall on which the lintel bears has cracks through the cmu and at mortar joints. If left unattended the crack could worsen and lead a failure. It is recommended that this area be immediately repaired using high-performance concrete repair products.

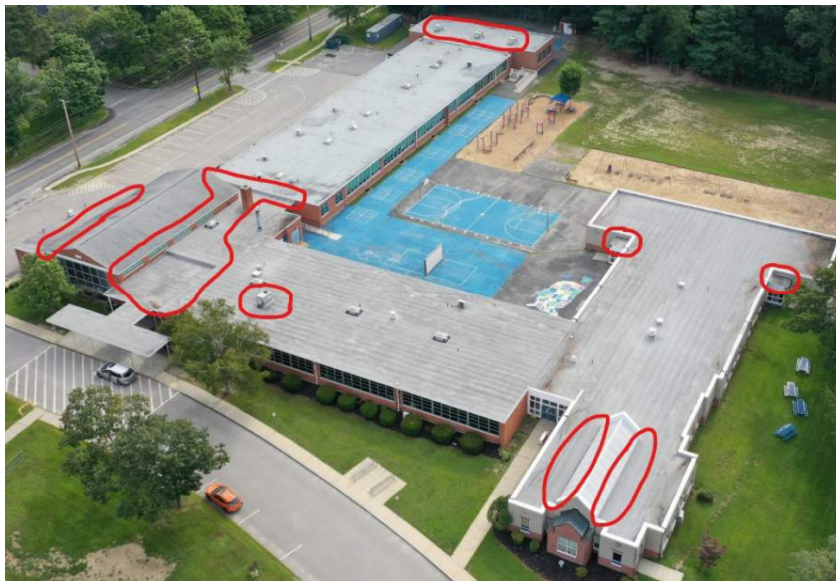
## SNOW DRIFT AT HIGH/LOW ROOF AND RTU AREAS

Comments and recommendations: Snow drifting can occur at high/low roof areas and around rtu's. Based on our experience, buildings designed prior to 1978 did not account for snow drifting as it was not required by the Building Code at that time. As we have not received existing structural drawings, nor had access to the roof structure, the roof framing shall require further investigation to determine its load carrying capacity. This is a serious issue since we have observed the failure of several school roofs during blizzard conditions within the last 30 years.

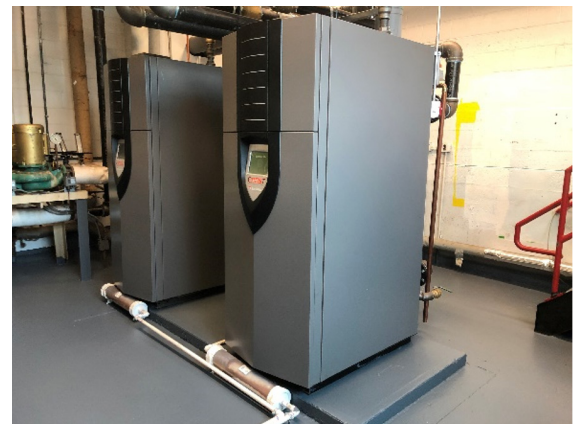
*Condensing Boiler*

2. The building has just received a boiler upgrade in 2020 where two (2) new high efficiency gas condensing boilers were installed. These two new boilers will replace the existing Ajax boilers indicated above. These two new boilers are manufactured by Lochinvar, model FBN1501. Each have an input capacity of 1,500 MBH and an output of 1,443 MBH making them 96% efficient.

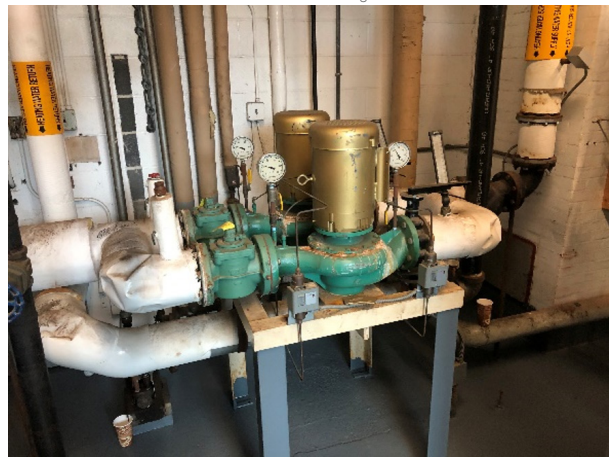
*In-line Pumps*

5. Heating hot water is circulated to unit ventilators, unit heaters, convectors, fin-tube radiation, etc. via two (2) in-line pumps. The pumps operate in a lead lag fashion to maintain system pressure. There is an additional two in-line pumps which serve the addition portion of the building which houses the library. The heating hot water is distributed via insulated piping throughout the building. Some piping within the boiler room and throughout the building is missing sections of insulation. The piping system is a combination of copper and black schedule 40 steel. The pumps do show signs of corrosion on the impeller body which could imply that a failure is in the near future. The two main in-line pumps should be replaced.

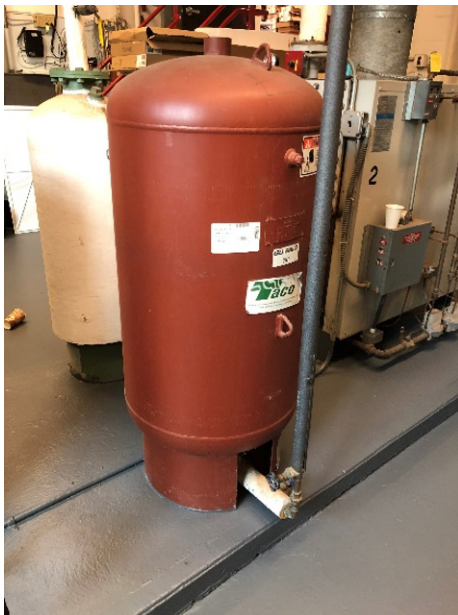
*Expansion Tanks*

6. The heating plant is equipped with all necessary hydronic accessories, such as air separators, expansion tanks and chemical treatment for proper operation. The accessories are of the same vintage as the boilers except for the expansion tank that appears to be recently replaced.
7. The classrooms, Gym/Multipurpose room and Library are provided with fan coils and unit ventilators, the administration area and the Computer/Art/Music classrooms are equipped with dedicated rooftop units which utilizes gas for heating and direct expansion for cooling, and the lobbies and vestibules utilize ceiling and wall mounted unit heaters for their heating purposes.

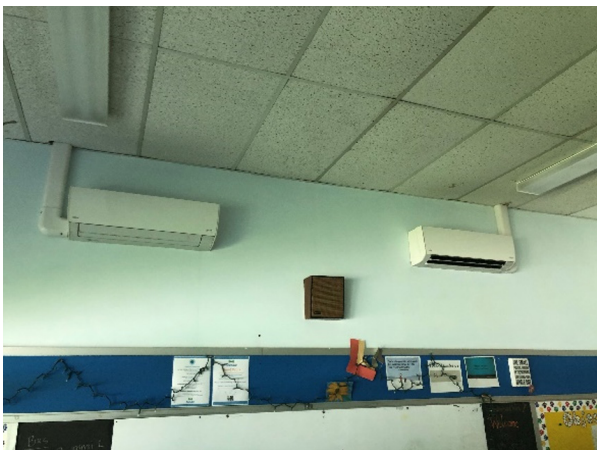
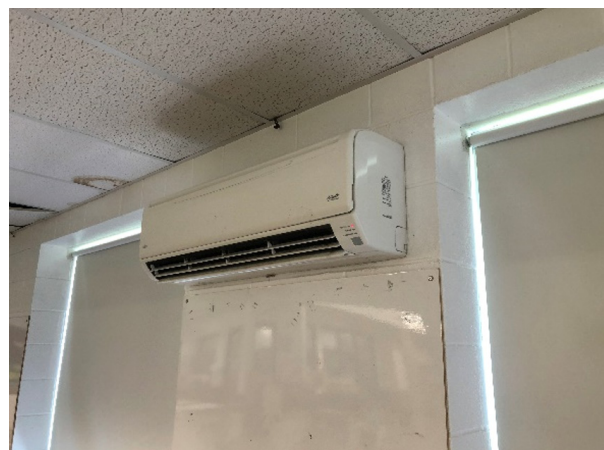
Ductless Cooling Units

1. The building is not fully air conditioned. Individual window air conditioners and ductless split systems are installed where air conditioning is required. The main conference room is equipped with one ductless split unit, classrooms 1, 2, 5 & 6 also have several ductless split systems, the Library is provided with one and the Teachers Work room also has one ductless split. These units are associated with outdoor air cooled condensers and are interconnected with the indoor unit via refrigerant piping. These units are provided with their own manufacture's standalone thermostats.

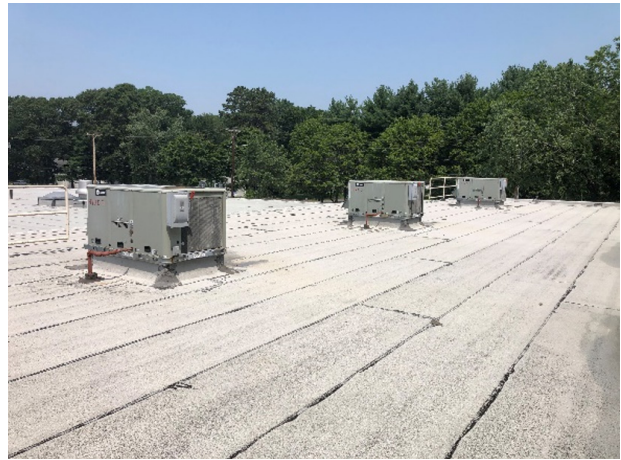
Admin RTU

2. The Administration area and the Computer/Art/Music rooms are provided with dedicated rooftop units which provide ventilation, heating and air conditioning to all the spaces. The units are equipped with a gas fired furnace, direct expansion cooling, supply fan, filters and direct outside air hood. These units are associated with a galvanized sheet metal duct distribution system which supplies and returns air from the unit to the spaces. The tempered air terminates within the spaces via ceiling mounted grilles. The units do appear to be connected to the building management system and are controlled by a wall mounted KMC thermostat.

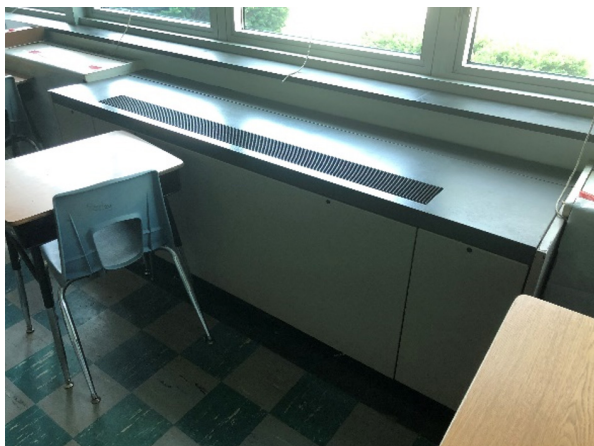
Typical Unit Ventilator

1. Wall mounted classroom unit ventilators are utilized in all classrooms, Gym/multipurpose room, and Library. Ventilation air is introduced to each of these units through an exterior wall-mounted louver. Each unit is equipped with a hot water heating coil, supply fan and filter. The spaces are provided with exhaust systems to remove any outdoor air that is introduced through the unit ventilators which helps maintain a neutral pressure within the space. The overall exhaust systems are served by various central roof mounted exhaust fan systems. The unit ventilators installed are generally past their expected useful service life.
2. Restrooms, janitor's closets and utility rooms are exhausted by roof mounted exhaust fans, there are a couple of janitor rooms which are not provided with any exhaust which is not code compliant.

4. Replace all existing terminal heating units with new hot water heating units including direct digital control (DDC) valves for increased efficiency, controllability, and longevity.

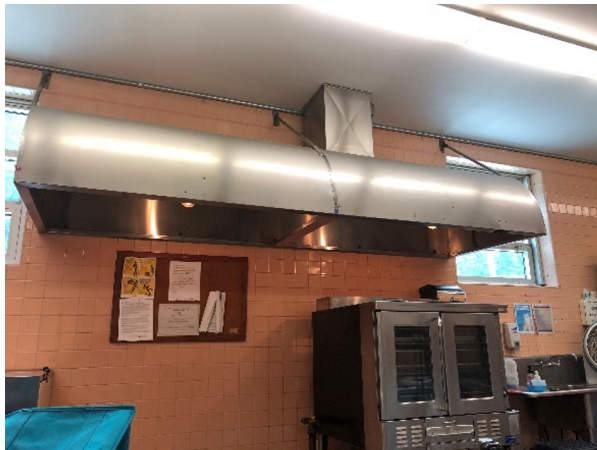
Kitchen Hood

1. The kitchen does not appear to be a full working kitchen. The main kitchen hood does not appear to be code compliant; the hood is not provided with any fire suppression system, or grease filters, and the exhaust fan does not appear to be UL 762 compliant. There is no dedicated make-up air system provided for the kitchen. Make-up air is provided by the air handling unit described above that serves the Gym/multipurpose room.
2. The kitchen utilizes a horizontal cabinet unit heater to provide heat, whereas there is no dedicated air handling unit for this space.
3. The dishwasher is not provided with any exhaust system.

2. Provide some level of air-conditioning for all regularly occupied spaces for increased health, productivity, comfort, and building longevity.
3. Provide a mechanical source of tempered make-up air for the kitchen area for code-compliance.

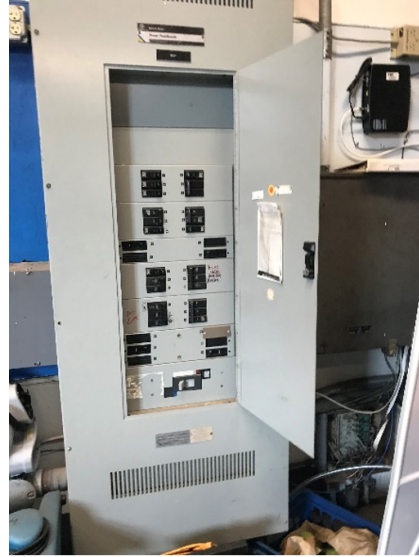
Main Dist. Panel in Boiler Room

1. The original building main distribution panel is located in the boiler room and is rated at 350 amperes 120/208v, 3 phase, 4w with a main breaker. The panel is newer and backfeeds local as well as remote panels throughout the facility, these panels are generally located in non-electrical spaces. Most panels are flush mounted in corridors. The original building panels were manufactured by Westinghouse and are in poor condition.

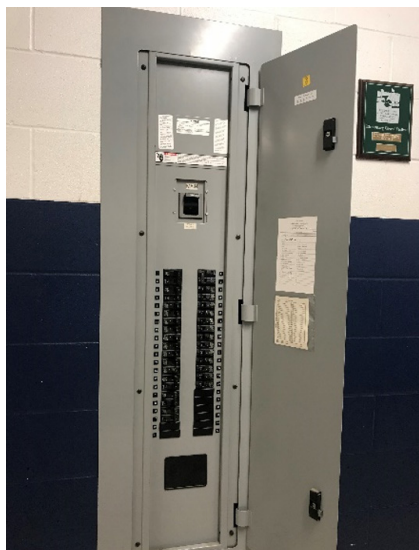
2002 Additional Panel

2. The panel boards within the library addition were manufactured by GE and are in good condition. These panels are located within an electric room.
3. The panel board in the 2002 addition was manufactured by Siemens and is in good condition. The panel is located in the corridor.

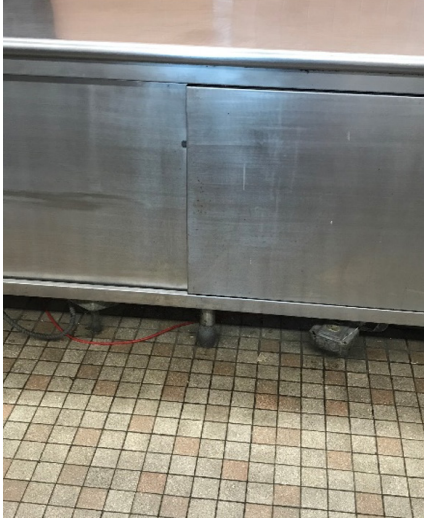
7. The typical classroom has one receptacle per wall. Some classrooms have added surface wire mold raceways.
  8. In general most receptacles near sinks have GFI protection. But some do not. Boiler room & certain kitchen receptacles are not GFI protected. Kitchen receptacles below cabinets are mounted face-up. The use of extension cords is ongoing in kitchen.

*Kitchen Face-Up Non-GFI Receptacles*

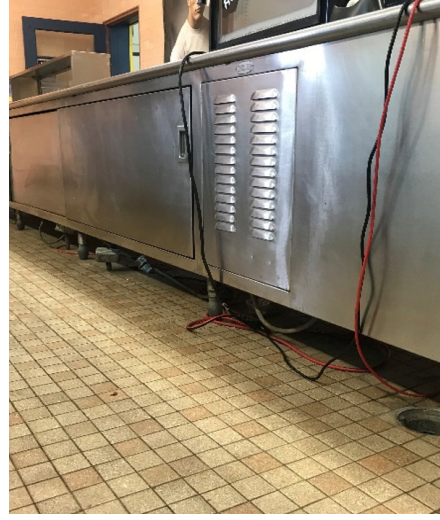
*Extension Cord Use*

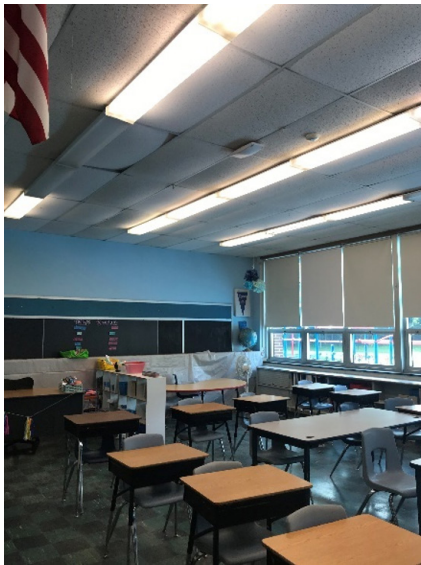
*Typical Classroom Lighting with Surface Wraparounds*

2. All of the existing non-led lighting in the building should be upgraded to LED fixtures with integral dimming drivers for reduction in energy consumption and reoccurring lamp replacement costs.

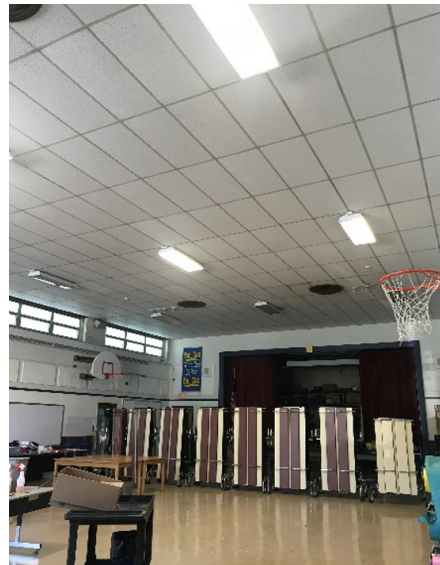
*Multi-Purpose Room Lighting*

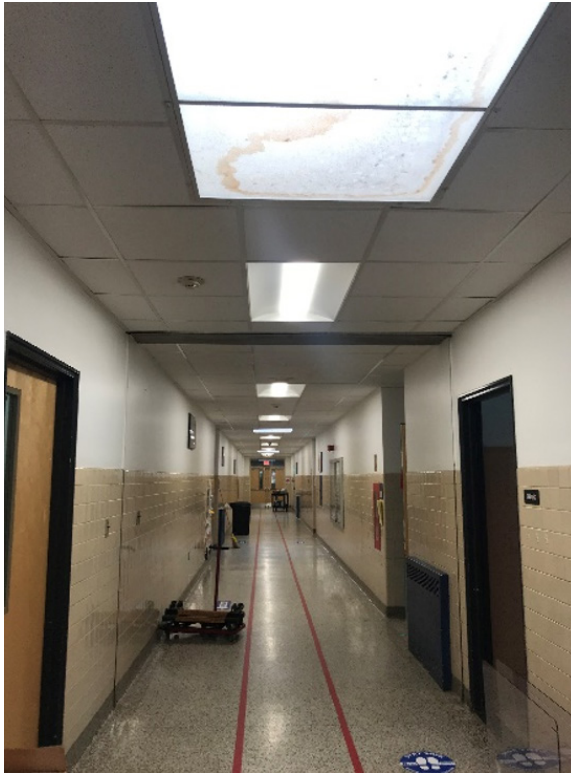
5. Corridor lighting is controlled with local line voltage switches. There is no automated lighting control system or daylight harvesting sensors installed in the school.

Corridor Lights

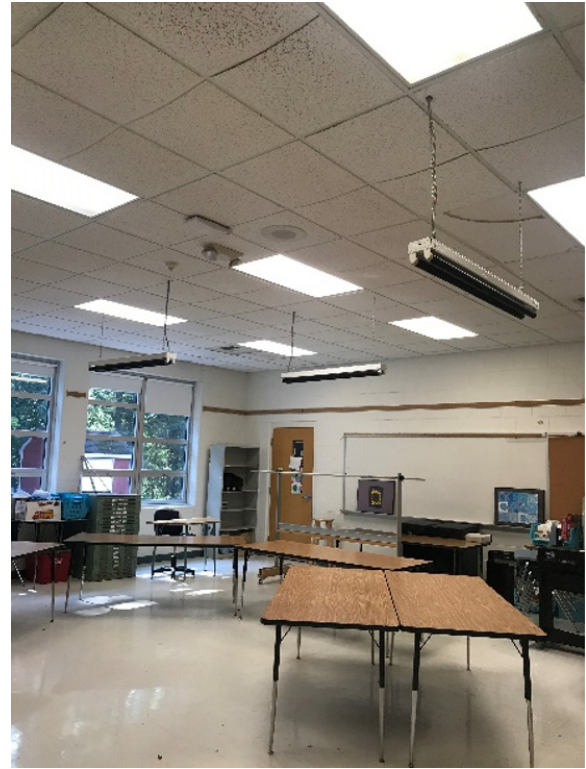
Typical Classroom Lighting in the Addition

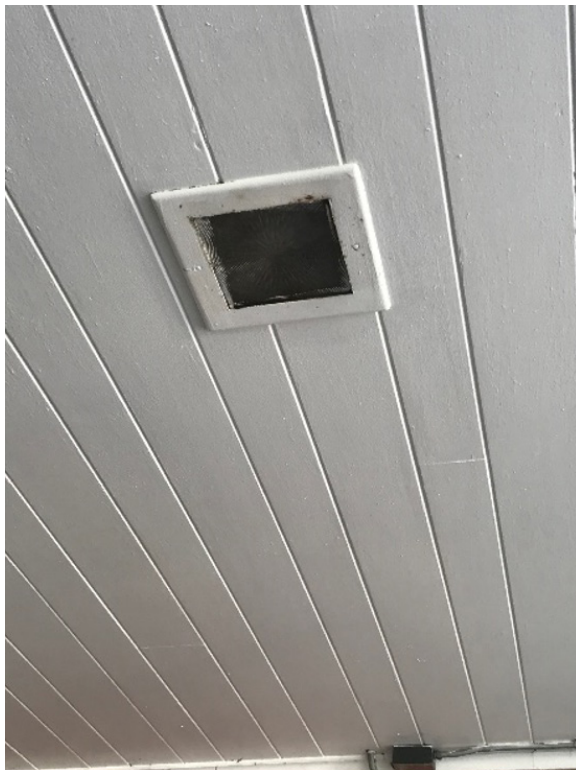
Recessed Canopy Light

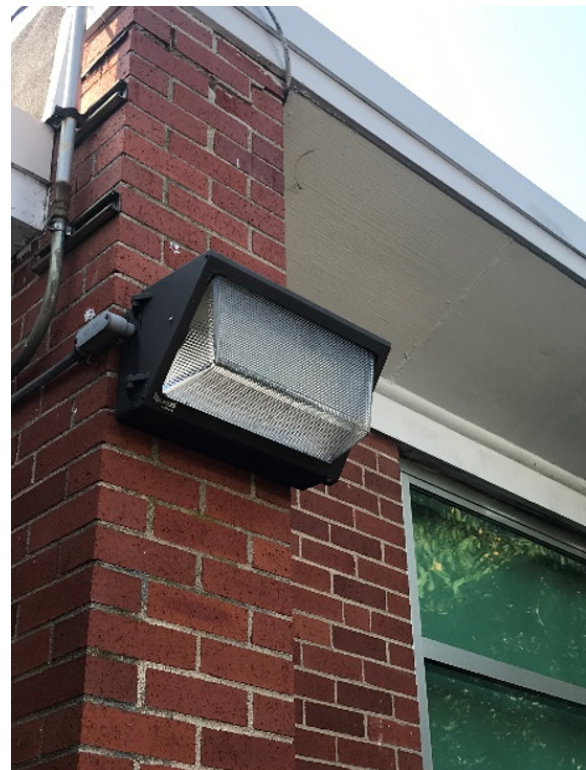
6. Exterior lighting consists of building mounted wall packs with HID sources. These fixtures do not provide adequate light. There are no pole mounted lights for parking areas and roadways.

Exterior Wall Pack

5. Exterior lighting should be replaced with LED/dark sky compliant fixtures. Pole lights should be provided in parking lot areas & roadways.
6. A test should be performed to determine the compliance of the current emergency battery units providing the required emergency egress lighting. Exterior egress lighting should be provided at all egress doors.

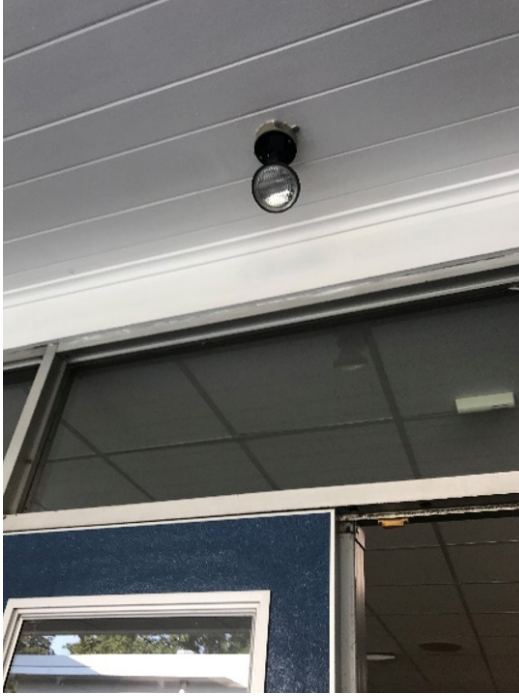
There is no generator at this facility. Emergency lighting is accomplished using central emergency battery units with remote heads as well as self-contained battery units. Exit signs are LED with battery back-up. The condition varies on these units from fair to good. A test was not done to confirm code compliance at the time of the visit. Various corridors & kitchen do not have emergency lighting. Exterior doors have one remote head, two are required.

*Exterior Door Remote Head*

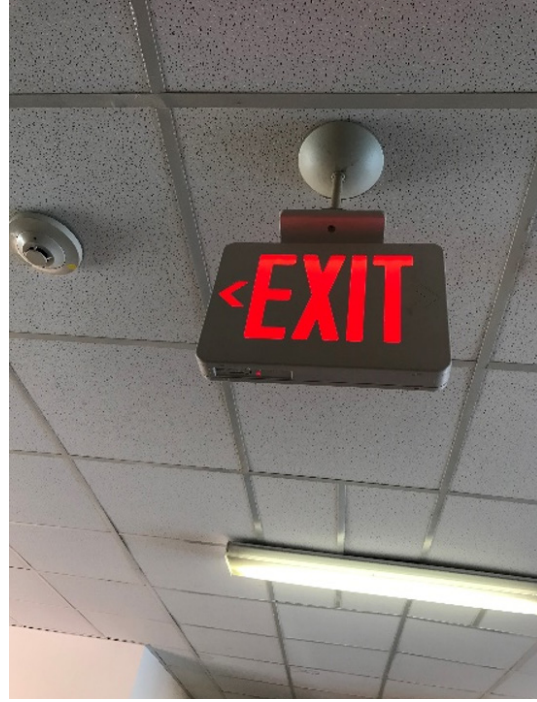
*Exit Sign*

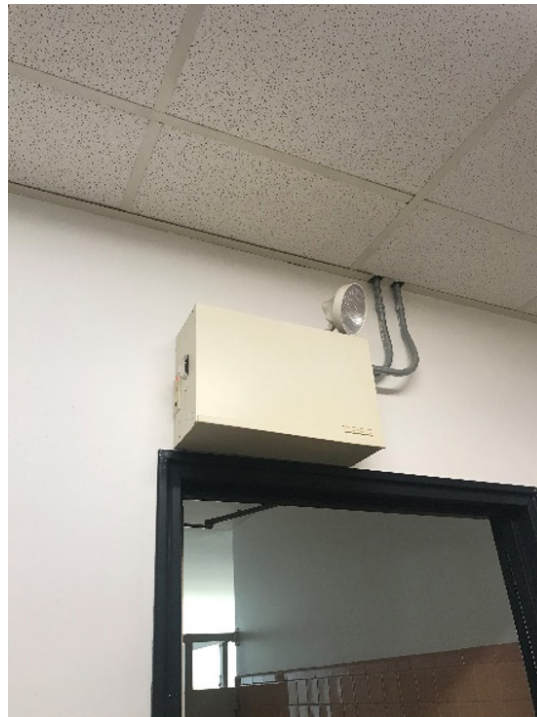
*Central Battery Unit*

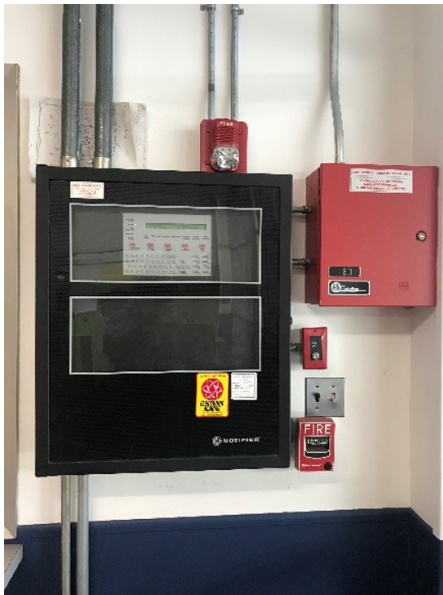
1. The fire alarm system consists of an addressable Notifier control panel with horn/strobe notification appliances. The school has full coverage for detection. The system is in fair condition however it does not meet current code. Educational use group is required to have a voice evacuation system. The Sigcom #1106 radio master box is located inside the main lobby adjacent to the control panel. Heat detectors located above ceiling and below stage are tied to alarm indicating lights on the wall. Heat detectors located above ceiling and below stage are tied to alarm indicating lights on the wall.
2. Strobes are ADA compliant however coverage is inadequate. Classrooms have mini-horns but no strobes.
3. Corridor doors as well as most classroom doors are held open with magnetic door holders. The stage local sound system does not mute upon fire alarm activation.

Fire Alarm Control Panel and Radio Box

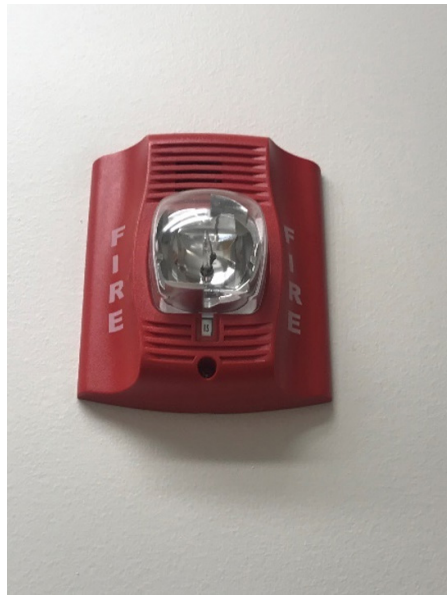
Horn/Strobe

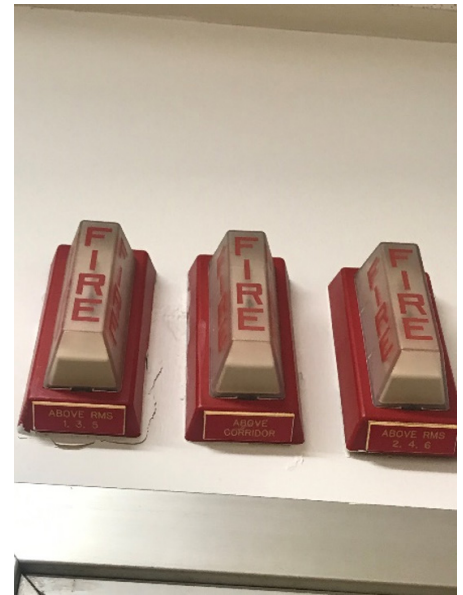
Above Ceiling Heat Detector Indicators

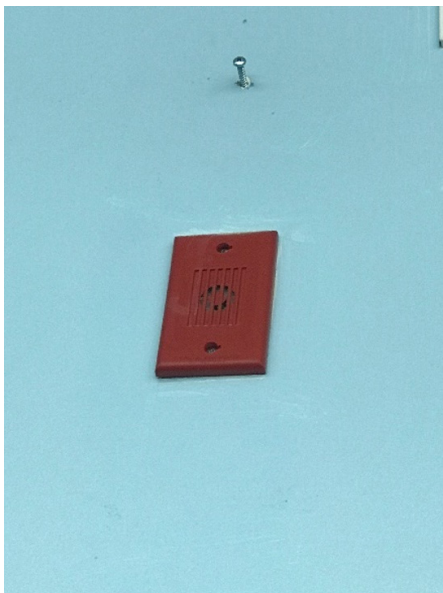
Classroom Mini-Horn

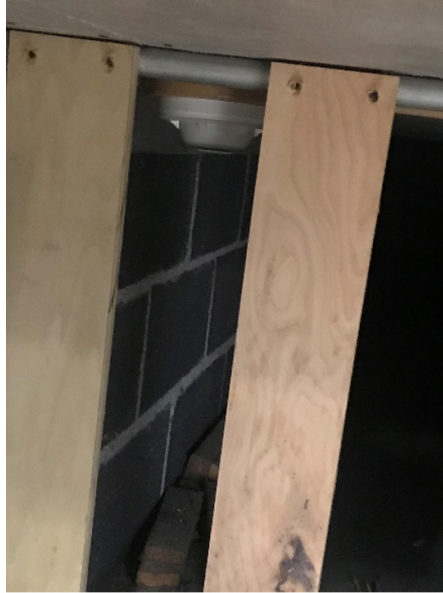
Heat Detector Below Stage

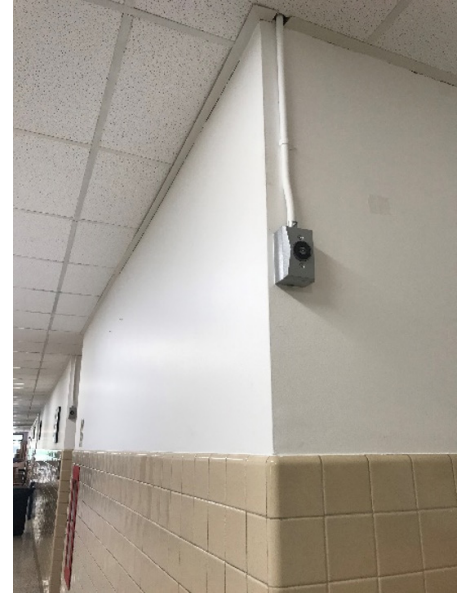
Classroom Magnetic Door Holder
